STIRLING'S QUARTERS AT VALLEY FORGE NATIONAL HISTORICAL PARK
HISTORIC STRUCTURE REPORT

PREPARED BY:
JOHN MILNER ARCHITECTS, INC.
104 LAKEVIEW DRIVE, CHADDS FORD, PA 19317

JANUARY 2006

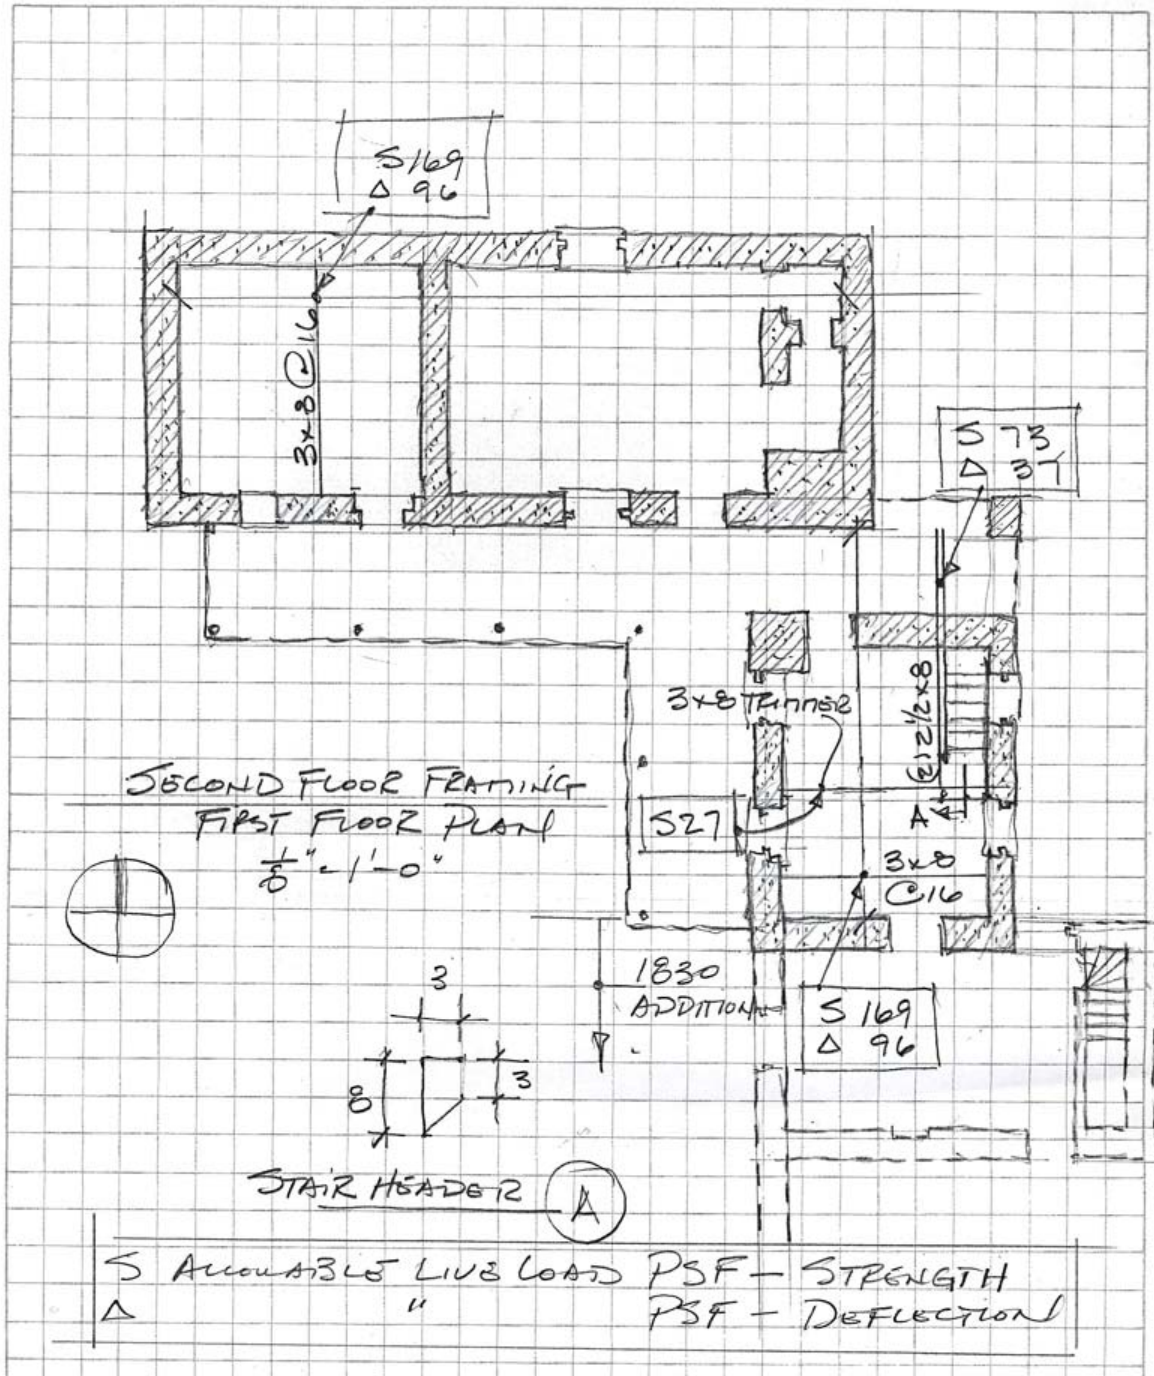
Figure S-6: Sketch of Second Floor Framing Plan at 1926 northwest addition. (Note: Image is not to scale).

The second floor of the addition is framed with 3x8 joists at 16" centers. The allowable live load capacity of the framing, in general, is limited by the stiffness criteria to slightly less than 100 PSF. At the southern section of the addition, a 3x8 trimmer spanning east-west has been dapped to accommodate the desired head clearance at the stairway. The resultant reduced section adversely

affects the shear strength. Accordingly, the live load capacity of approximately 60 SF of floor is limited to less than 30 PSF.

At the second floor where the 3x8 trimmer has been modified to accommodate head clearance at the stair, remove portions of the plaster ceiling and reinforce the 3x8 trimmer with double 2x8 sisters connected with bolts to the south face of the existing member.

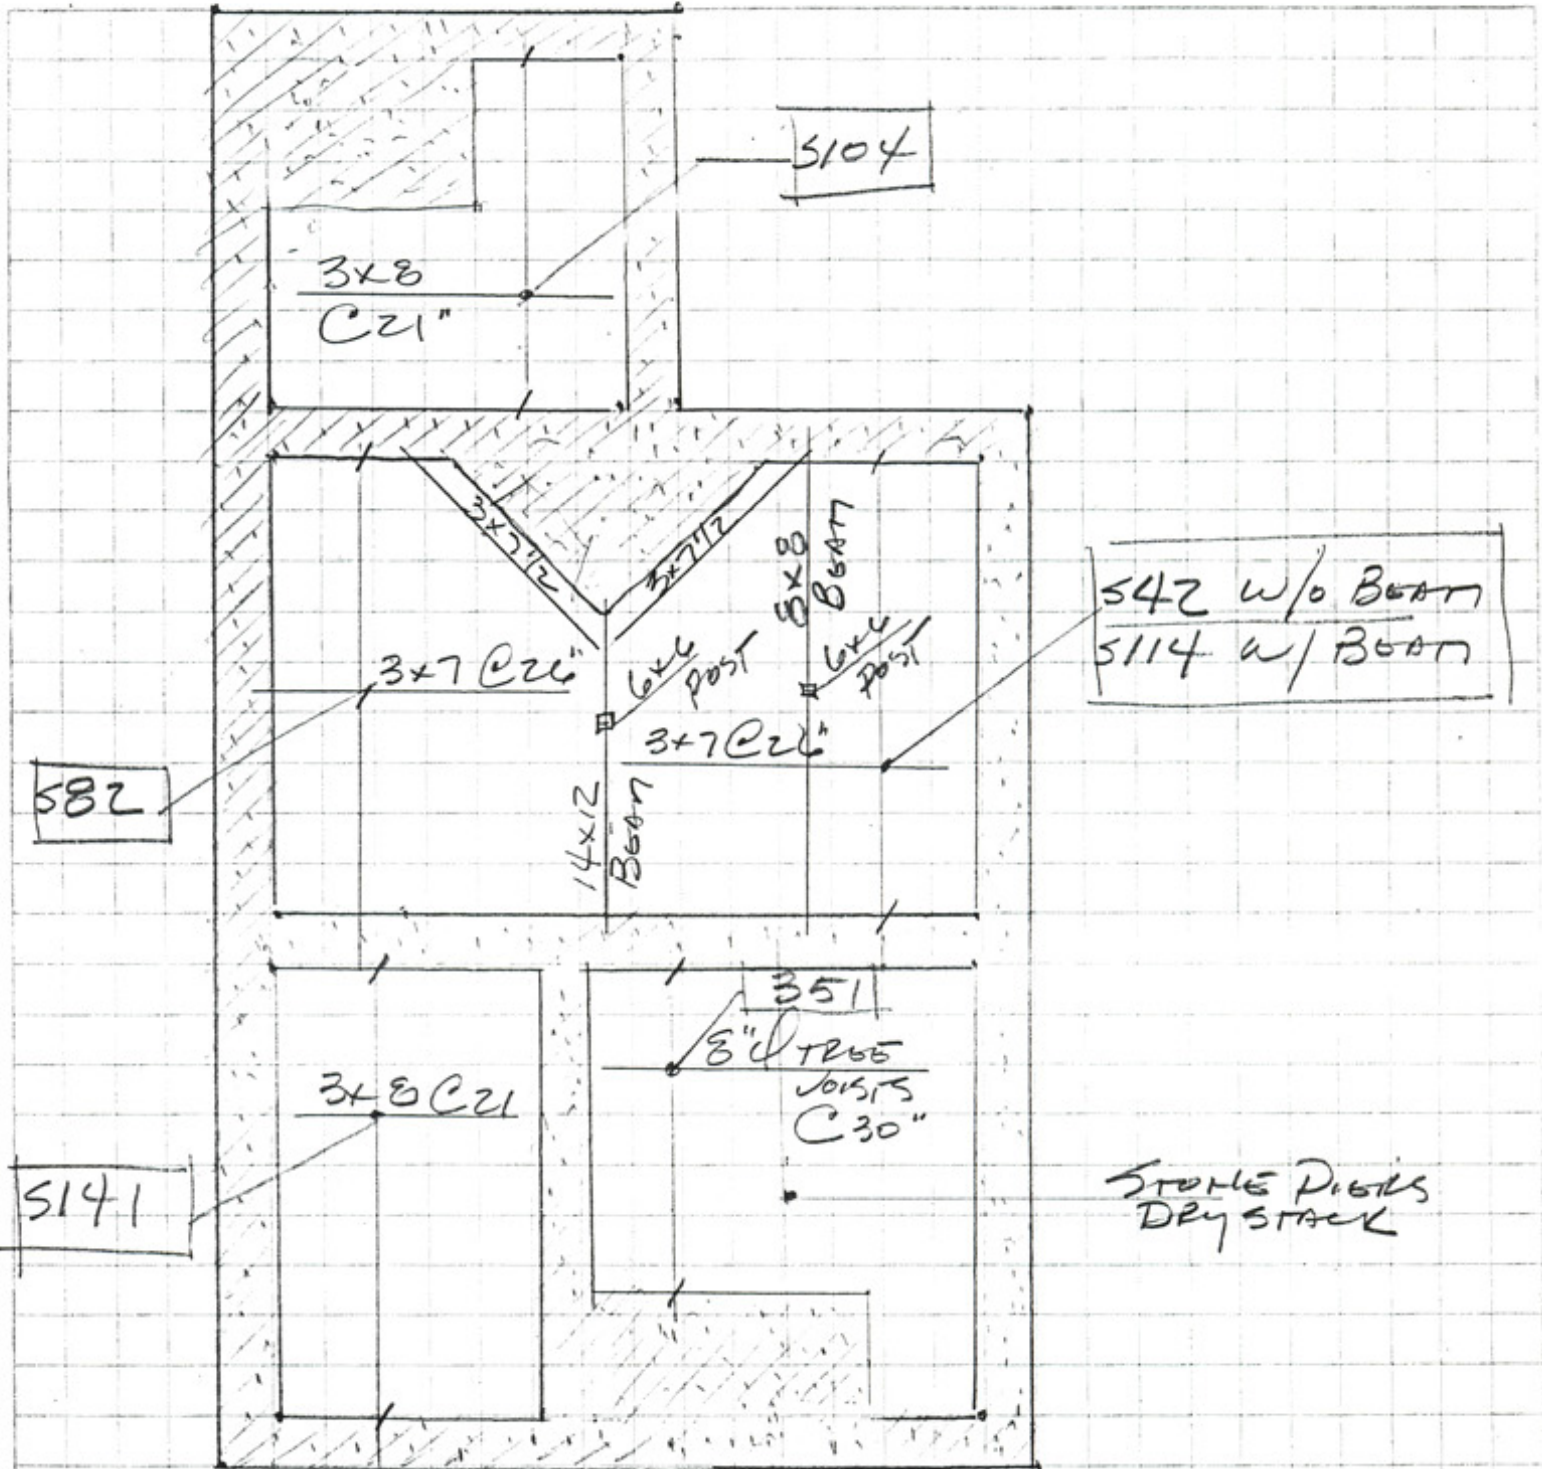
FIRST FLOOR FRAMING PLAN

The first floor framing installed over a shallow crawl space is comprised of 8" diameter tree joists spanning north-south and bearing on the exterior masonry walls and an interior row of central piers formed from dry stack stones. The joists are in poor condition with extensive termite damage; especially at the south end adjacent to the bearings. The 9x8 hearth header has very little section remaining due to the extent of the infestation. The original framing configuration with the piers in place provided enough strength

Constructed of uncoursed, rubble stone masonry this addition rises two levels over a full basement. The first floor is framed with 3x8 joists at 21" centers spanning north-south and bearing on the exterior masonry. Termite damage is prevalent here, similar to the condition of the first floor throughout the building. At least 3 of the joists have been consumed by termite infestation. Provided the joists are replaced with similar section and strength, the allowable live loading would be approximately 100 PSF.

In summary, the first floor framing is in poor condition due to a combination of moisture at the bearings and infestation by termites. Damaged and deteriorated timber, which approaches over half the original members, should be removed and the building be treated by a certified pest control firm to ensure that there is no termite activity in and around the building. The reframing of the first floor can be a restoration effort whereby the original framing sizes and joinery can be provided or alternately, conventional framing can be used to provide a floor structure that meets the proposed loading requirements of the floor. A decision must be made regarding the preferred method of addressing the structure of the first floor framing. Based on what has been previously done with regard to replacement of the rafters, it appears that replacement with conventional framing is an acceptable alternative.

Provide ventilation and damp proofing of the crawl space. Replace the stone piers with concrete masonry set on new footings and reframe the floor with pressure treated timber of similar section to the tree joists so that masonry bearings can be reused.

Replace the deteriorated framing with pressure treated members of similar section.

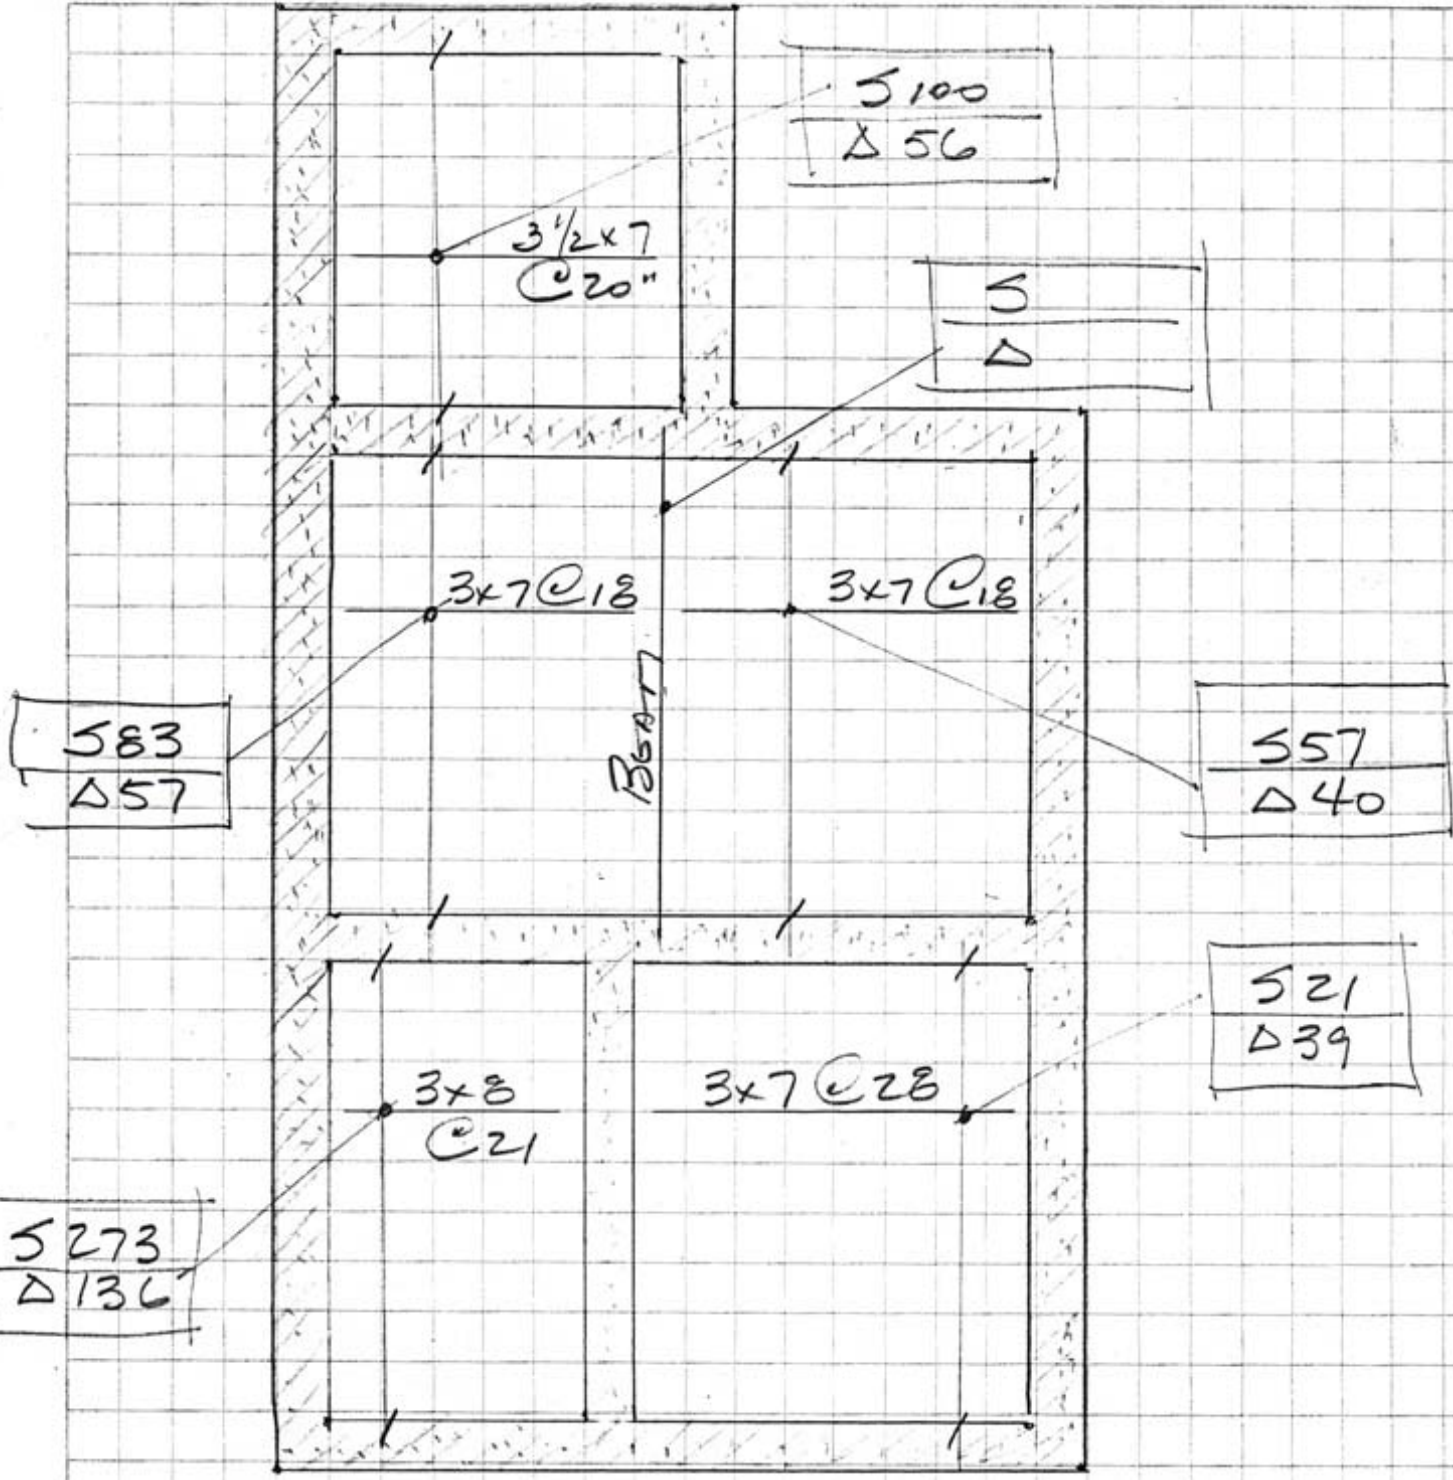
SECOND FLOOR FLOORING PLAN
 $\frac{1}{8}'' = 1'-0''$

The framing of the second and third floor is provided by 3x7 joists set at approximately 20" centers spanning north south. An east- west running summer beam, positioned 2' north of the geometric center of the building, is concealed at both levels. At the third level on the south side, the joists are dressed with chamfered corners. The framing appears to be in good structural condition. The allowable tributary live loading for the floor is limited by the deflection of the joists on the south side to 36 PSF. This is without consideration of the summer beam which is concealed and therefore the capacity is unknown.

The floor framing of the second and third levels of this block appears in good condition – 3x7 at 28" centers in the 1769 section and 3x8 at 21" in the 1810 addition. Noteworthy is that the second floor joists in the 1769 addition are visually enhanced with beaded corners. Strength is not an issue for the floor framing in the 1810 addition; however, in the 1769 section, the allowable safe live loading for the floor is limited by strength to 21 PSF. At the third level the joists at the south span are chamfered to improve the exposed appearance. The capacity of the third floor is limited by stiffness to 26 PSF.

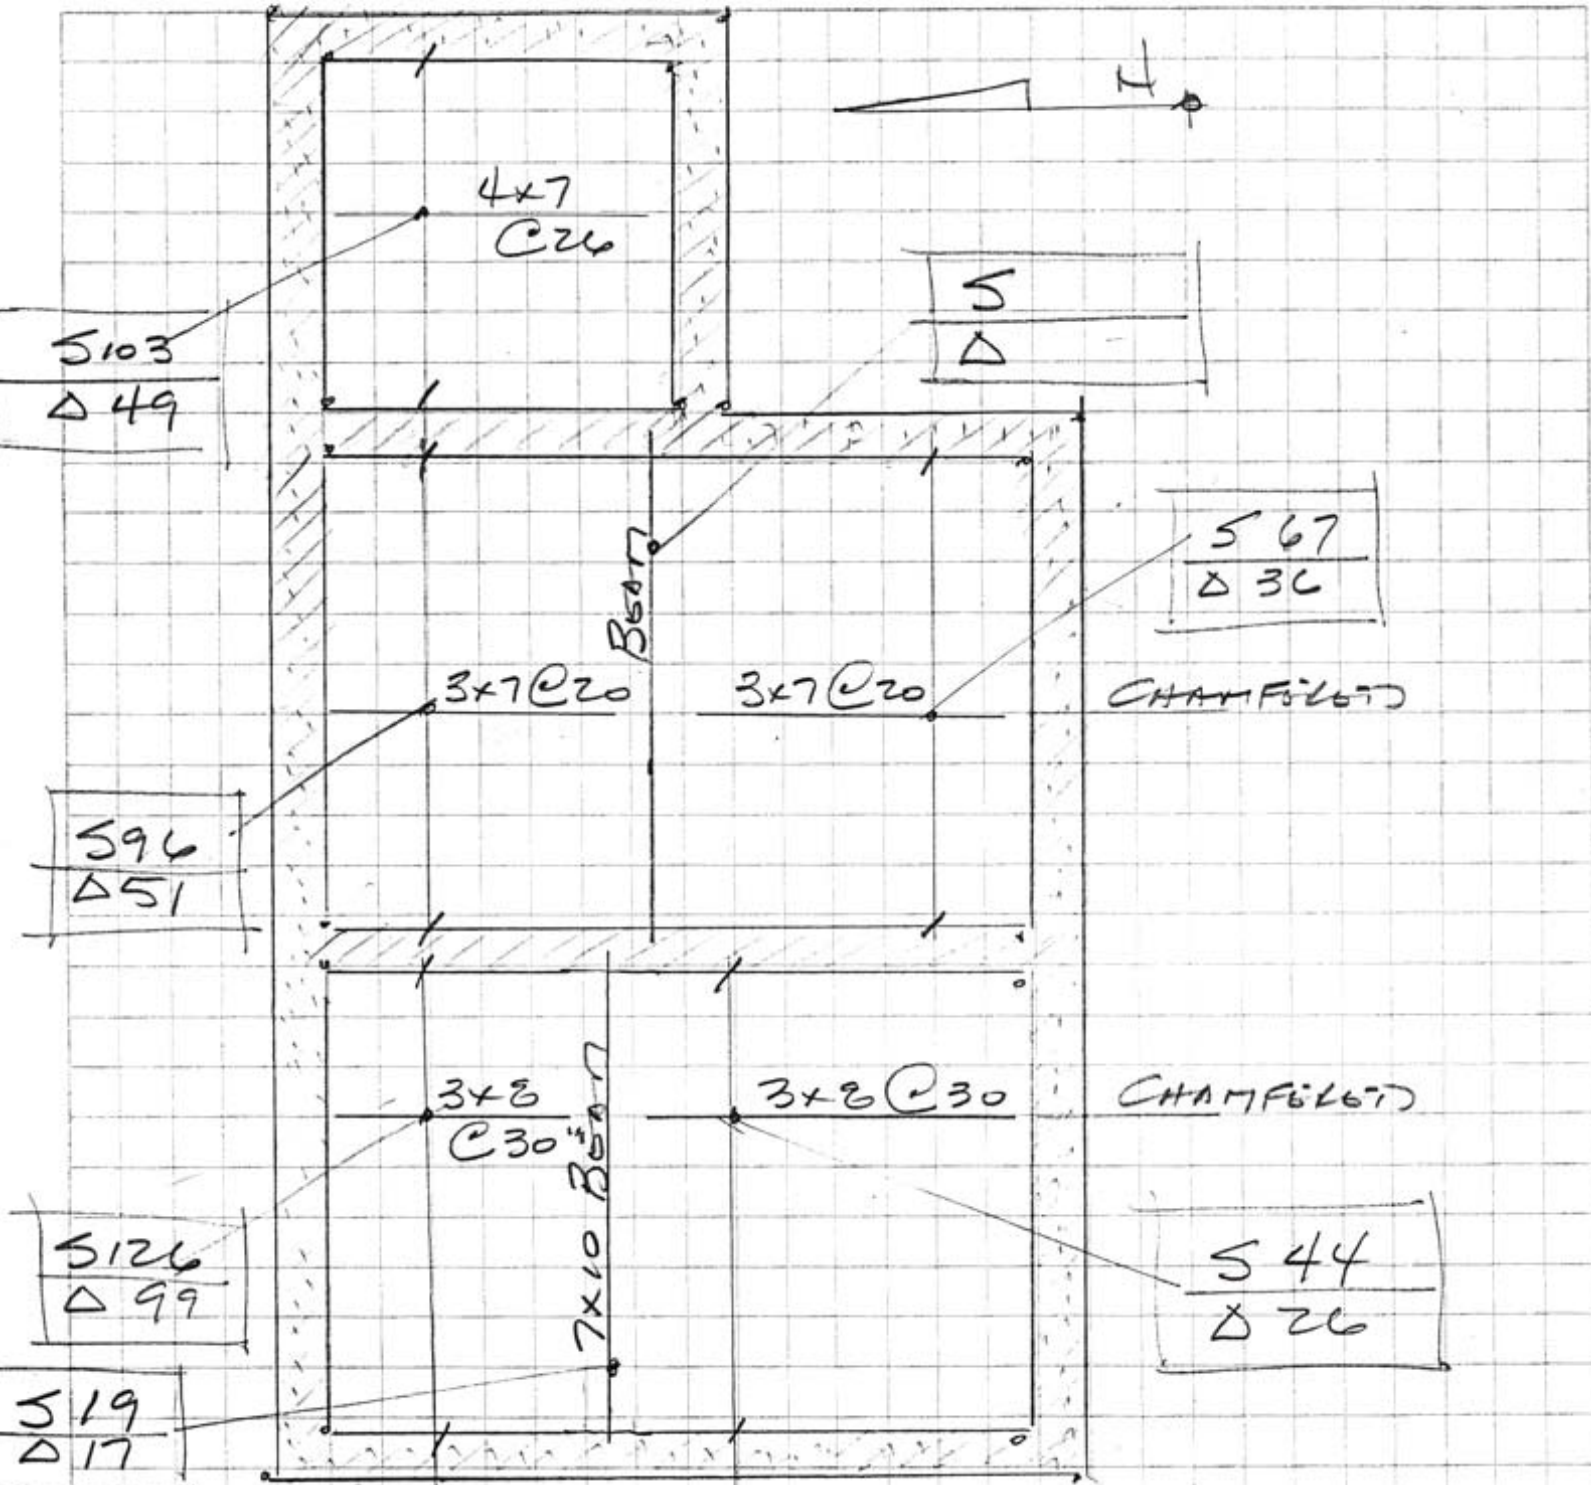
3RD FLOOR FRAMING PLAN
1/8" = 1'-0"

Second and third floor framing is in good structural condition – 3 ½ x7 at 20" centers and 4x7 at 26" centers at the second and third floors, respectively. The allowable live loading at both floors is limited by the stiffness of the joists to approximately 50 PSF. No repairs are required for these members provided the allowable live loading meets the proposed programming requirements for the space.

The upper floors of the building are in good structural condition with the strength of the members meeting the live loading requirements for office use (50 PSF) except for the framing at the second floor above the 1769 kitchen and the third floor summer beam in the same block. The greatest limitation with regard to future use is the stiffness of the framing on the south side of the building at both the second and third levels of the building. Strengthening and stiffening can be provided by sistering; however, where the framing was originally exposed (chamfered and beaded corners) some decisions must be made regarding finishing of the ceilings. An additional concern is with regard to the capacity of the concealed summer beams at both the second and third levels of the original 1769 block. These members must be uncovered in order to determine their structural properties.

The joists at both levels 2 and 3 are in good condition with no repairs needed. In the event a greater capacity for floor loading is required, the joists at all levels can be strengthened by sistering; however, decorative chamfers and beads would be concealed by ceiling finishes that would be needed to cover the unsightly sistering work.

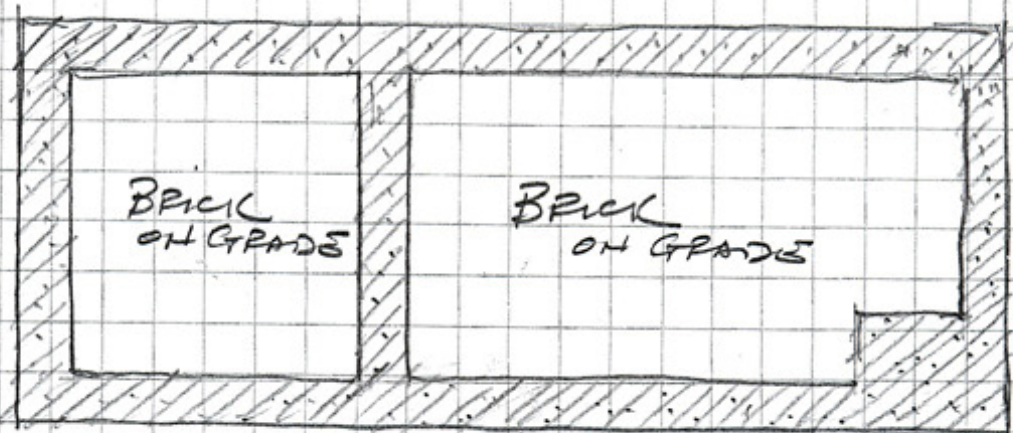
FIRST FLOOR FRAMING
FOUNDATION PLAN
1/8" = 1'-0"

The first floor (south block) is framed with 3x8 joists set at 16" centers and spanning east-west over an earthen subgrade situated less than a foot below the bottom of the joists. The space below the framing is unventilated. Poor site drainage adjacent to the east wall of the block has caused wet conditions in the stone masonry. Finding favorable environment, termite infestation has consumed the eastern end of the joists.

Regrading the site, to lower grade and provide positive drainage away from the building appears difficult to achieve. Accordingly, remove the timber joists and replace with slab on grade construction. Excavate the subgrade inside the building; install vapor barrier and 4" of stone prior to casting a 4" thick concrete slab. Install pressure treated furring strips and marine plywood subfloor in preparation of the placement of the finish flooring. Coordinate the requirements of HVAC and piping.

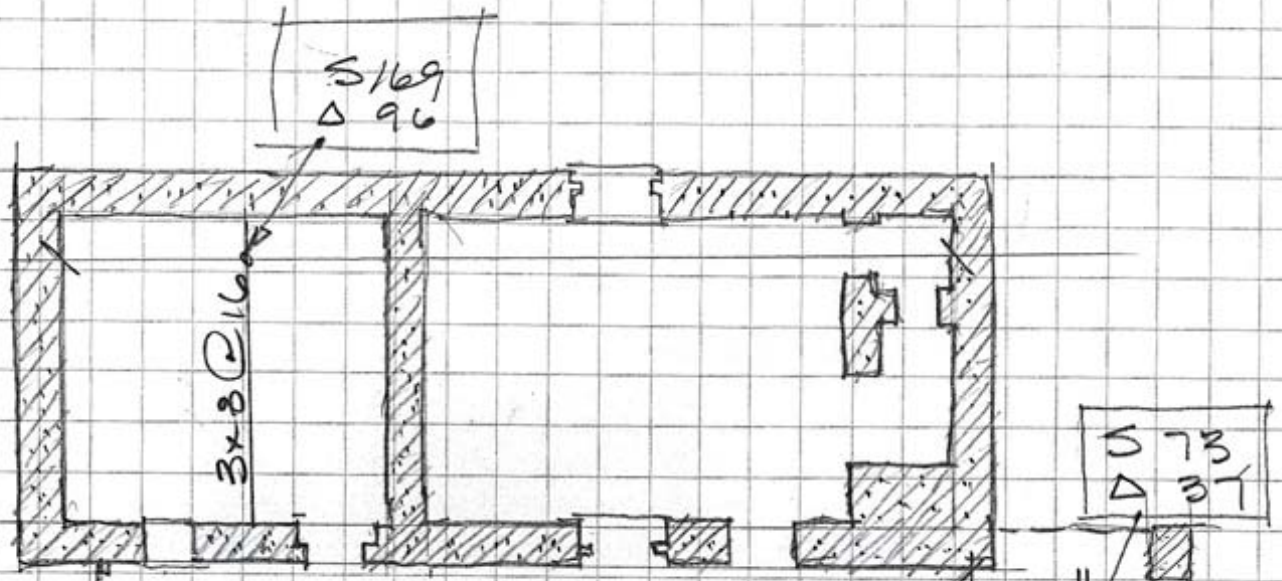
SECOND FLOOR FRAMING
FIRST FLOOR PLAN
1/8" = 1'-0"

The second floor of the addition is framed with 3x8 joists at 16" centers. The allowable live load capacity of the framing, in general, is limited by the stiffness criteria to slightly less than 100 PSF. At the southern section of the addition a 3x8 trimmer spanning east-west has been dapped to accommodate the desired head clearance at the stairway. The resultant reduced section adversely affects the shear strength. Accordingly, the live load capacity of approximately 60 SF of floor is limited to less than 30 PSF.

Remove portions of the plaster ceiling and reinforce the 3x8 trimmer with double 2x8 sisters connected with bolts to the south face of the existing member.

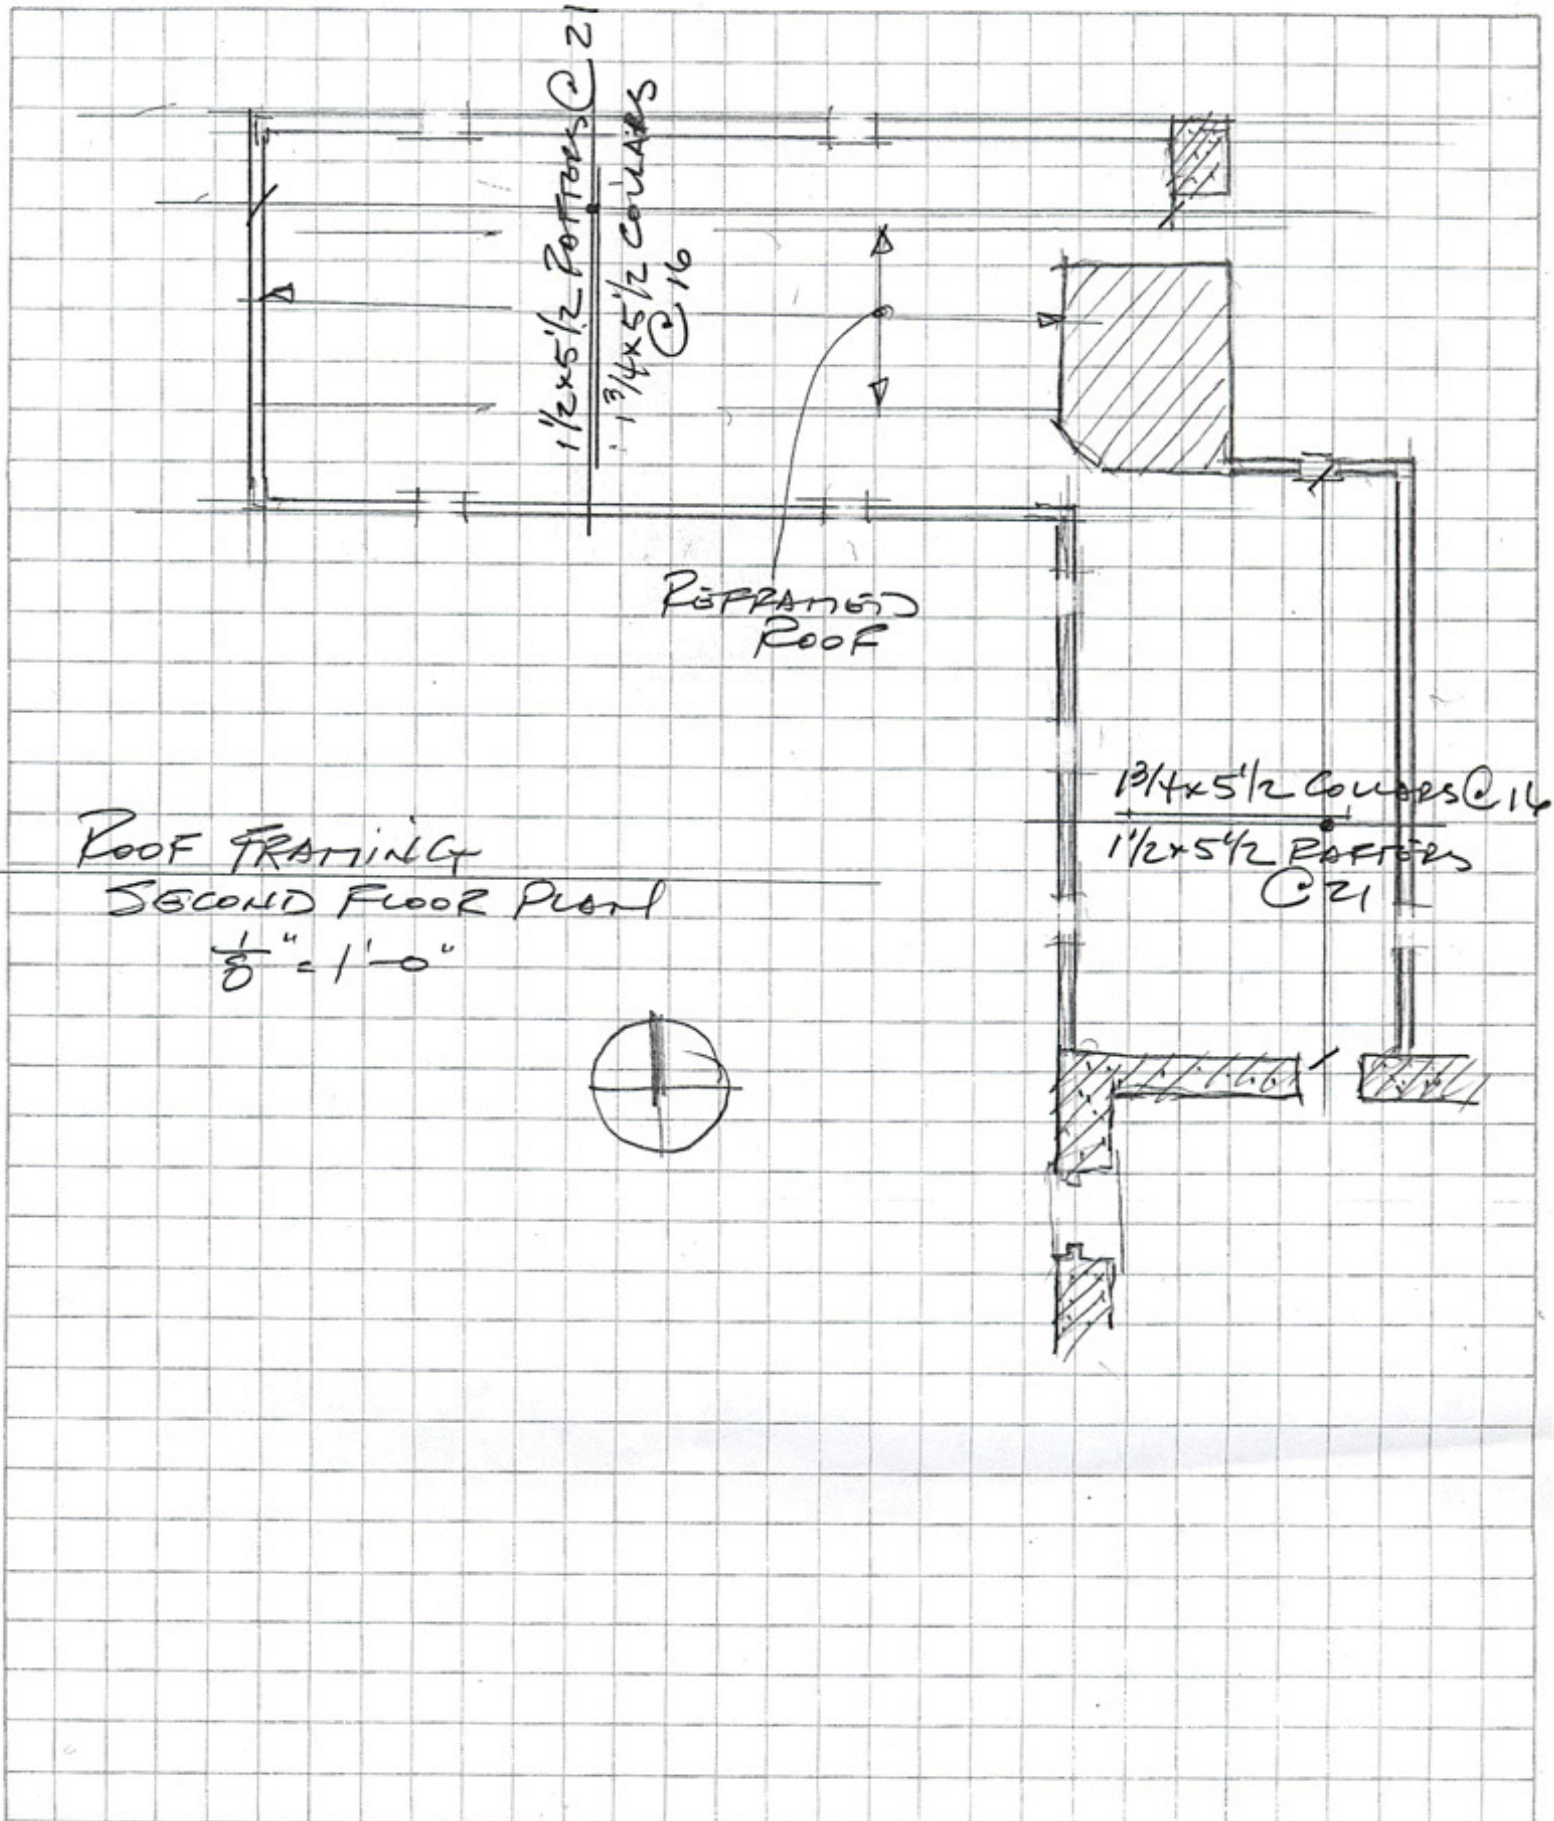
ROOF FRAMING
SECOND FLOOR PLAN
 $\frac{1}{8}'' = 1'-0''$

The roof is gable form and framed with 1 ½" x 5 ½" rafters at approximately 21" centers. The rafters are tied with the attic floor joists which are the same section but set at 16" centers. The attic floor joists bear on a 3x5 member (purlin orientation) that spans between the rafters. Although the framing arrangement is somewhat uncommon, the stability of the assembly is witnessed by a straight eave line and plumb second level walls.

In the northern section of the addition, the upper portions of the roof framing have been replaced. The char that can be observed on some of the members is witness to a fire, which probably started in the chimney located at the east end of the section. The subsequent repair of the roof structure involved removal of the damaged upper half of the roof including the ridge and then splicing on a replacement roof. The approach allowed the eave and attic section to remain

intact, which simplified the repair. Unfortunately, the method of splicing the rafters was poorly conceived. The damaged rafters were square cut and the ridge section of the roof removed. Then a 2x6 wood plate purlin was end nailed to the cut rafters. This provided a means for toenailing the replacement rafters that form the ridge of the roof. The connection has no bending strength and as a result has separated due to the tension at the bottom of the splice, causing noticeable sag in the member.

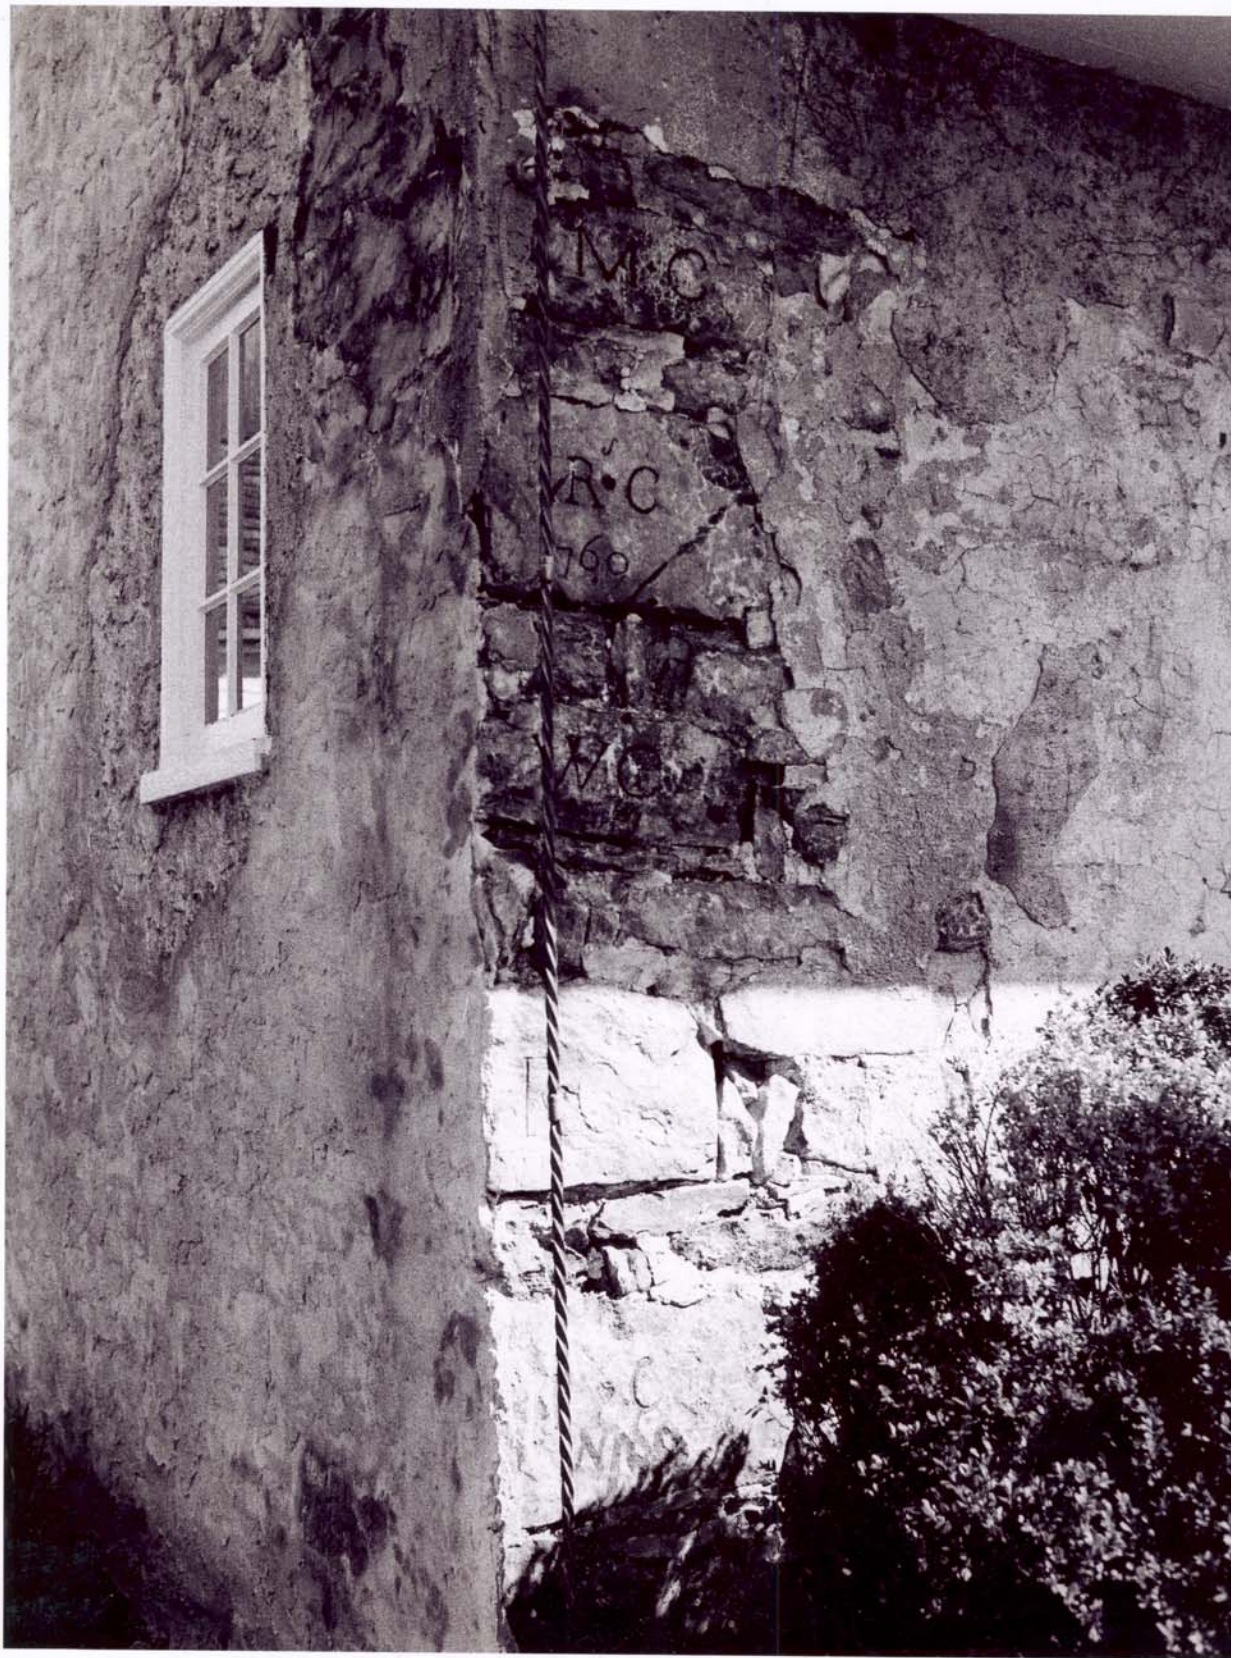
- Archive photographs taken in 1984 record five (5) sets of initials at the southwest corner of the south façade. Several of these inscriptions were covered with stucco between 1984 and 1994; only three are currently exposed: one stone with the inscription "W. C. September 1769" and two stones with the inscription "R. C. 1769." (Note 2/SE) (Archive Photo 1)

Archive Photo 1
Corner stones with inscribed initials and dates at southeast corner of west block.

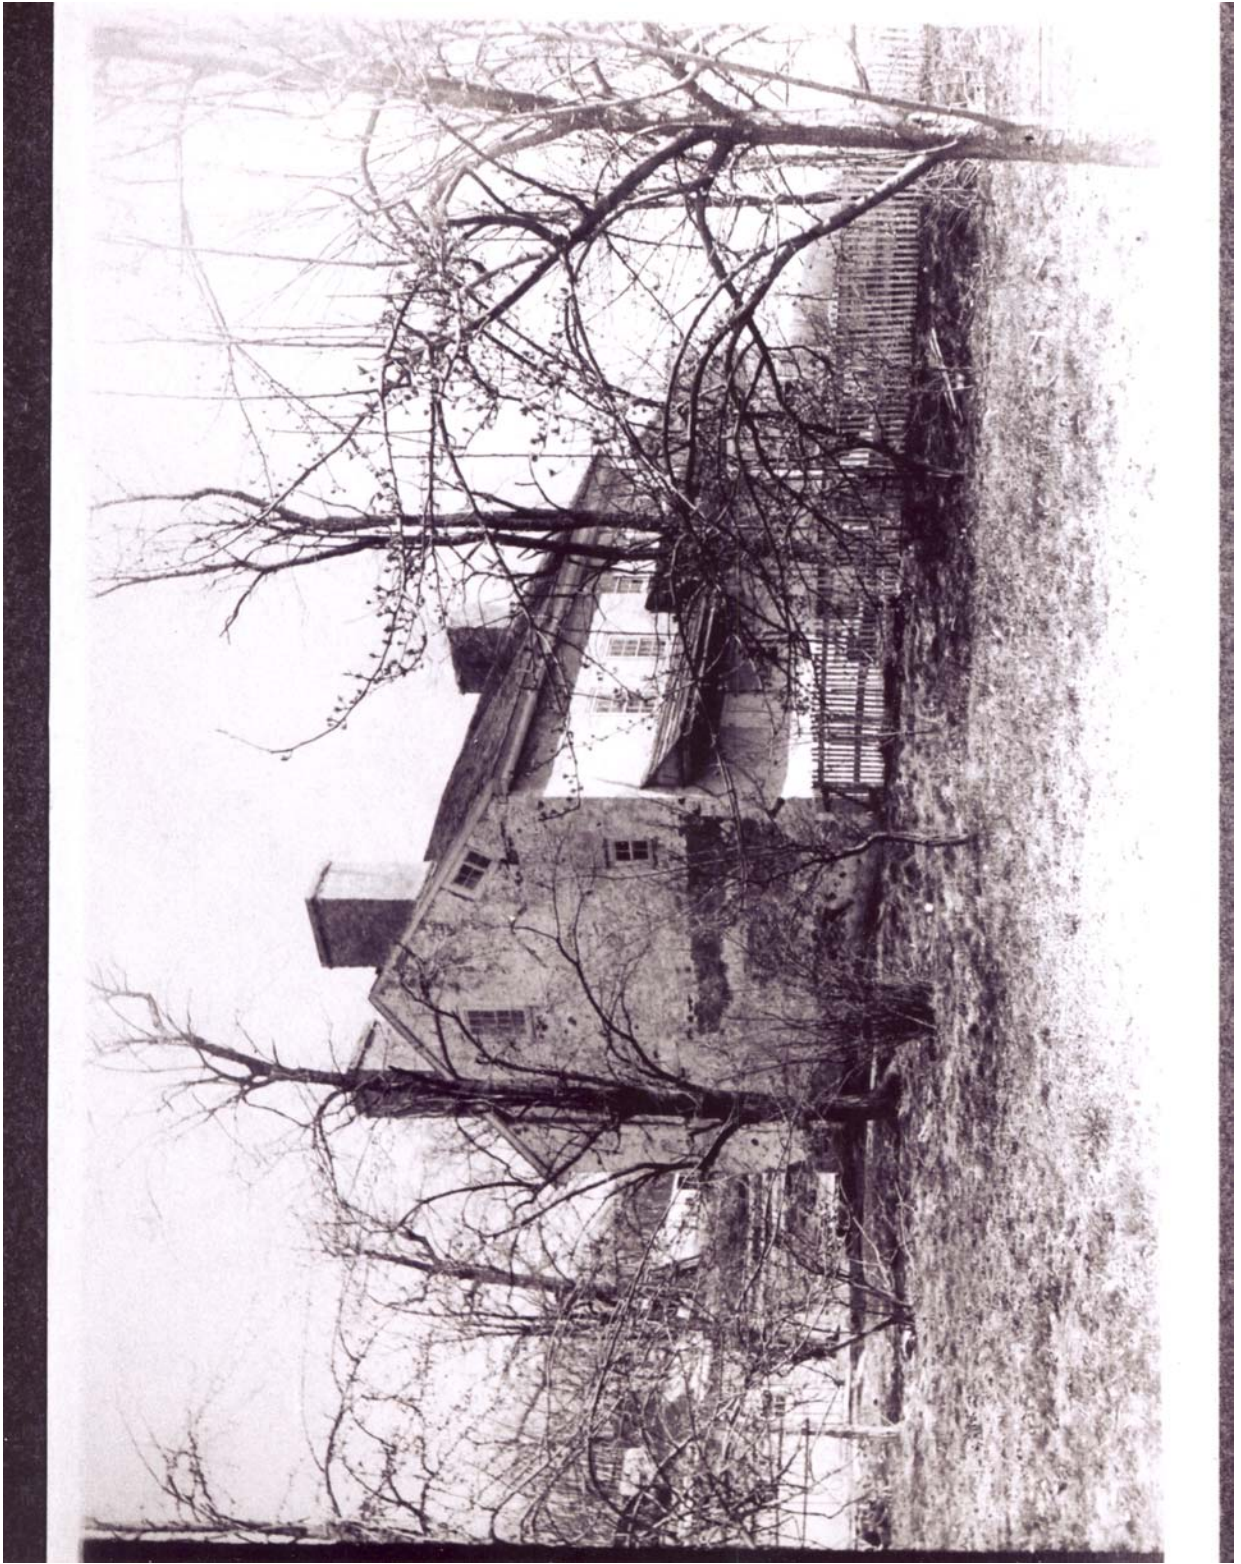
- There is a single chimney mass projecting from the south roof of the west block. The location of the chimney is consistent with the location of the original kitchen fireplace. The original chimney has been extended in height, however, as part of the various renovations to the house.
- A vertical crack to the south of Window 208 represents the location of a former chimney that was added when the west block was expanded to the north c. 1810. An archival photograph shows the chimney in place in 1902. The chimney was removed as part of the 1926 renovations. (Photo WEB, Note 5/WE) (Archive Photo 3)

- Double casement window on west wall was added in 1926. Archive photos show a four-light casement window on this wall up until the 1926 renovations. (Note 3/206) (Archive Photos 3 & 7)
- 6/6 single-hung, wood windows on south wall appear to date to c. 1810 when this wing was raised to a full two stories.

- The roof framing is not original (see Structural Evaluation). A 1902 photo shows that the roof height was originally the same as the main block. The Liggets lowered the roof during their renovations of the building c. 1926. (Archive Photos 3 & 6)
- Plaster on the east wall runs above the existing collar ties to a straight horizontal line. This line was probably the underside of the collar ties of the higher roof. Without the earlier collar ties, it is difficult to tell if the ceiling was plastered, but there is a slight curve at the top of the plaster which suggests a plaster ceiling. (Note 6/303)

- Window 303: six-light wood sash window set in a modified wood frame. Archive photos of the west gable show that this opening was previously a 6/6 window before the roof was lowered. (Archive Photos 3 & 7)
- The six-light window surround is also patched with gray cement which is likely related to the roof lowering and the changing of the 6/6 window.

Archive Photo 3
Oblique view of main house,
looking northeast.

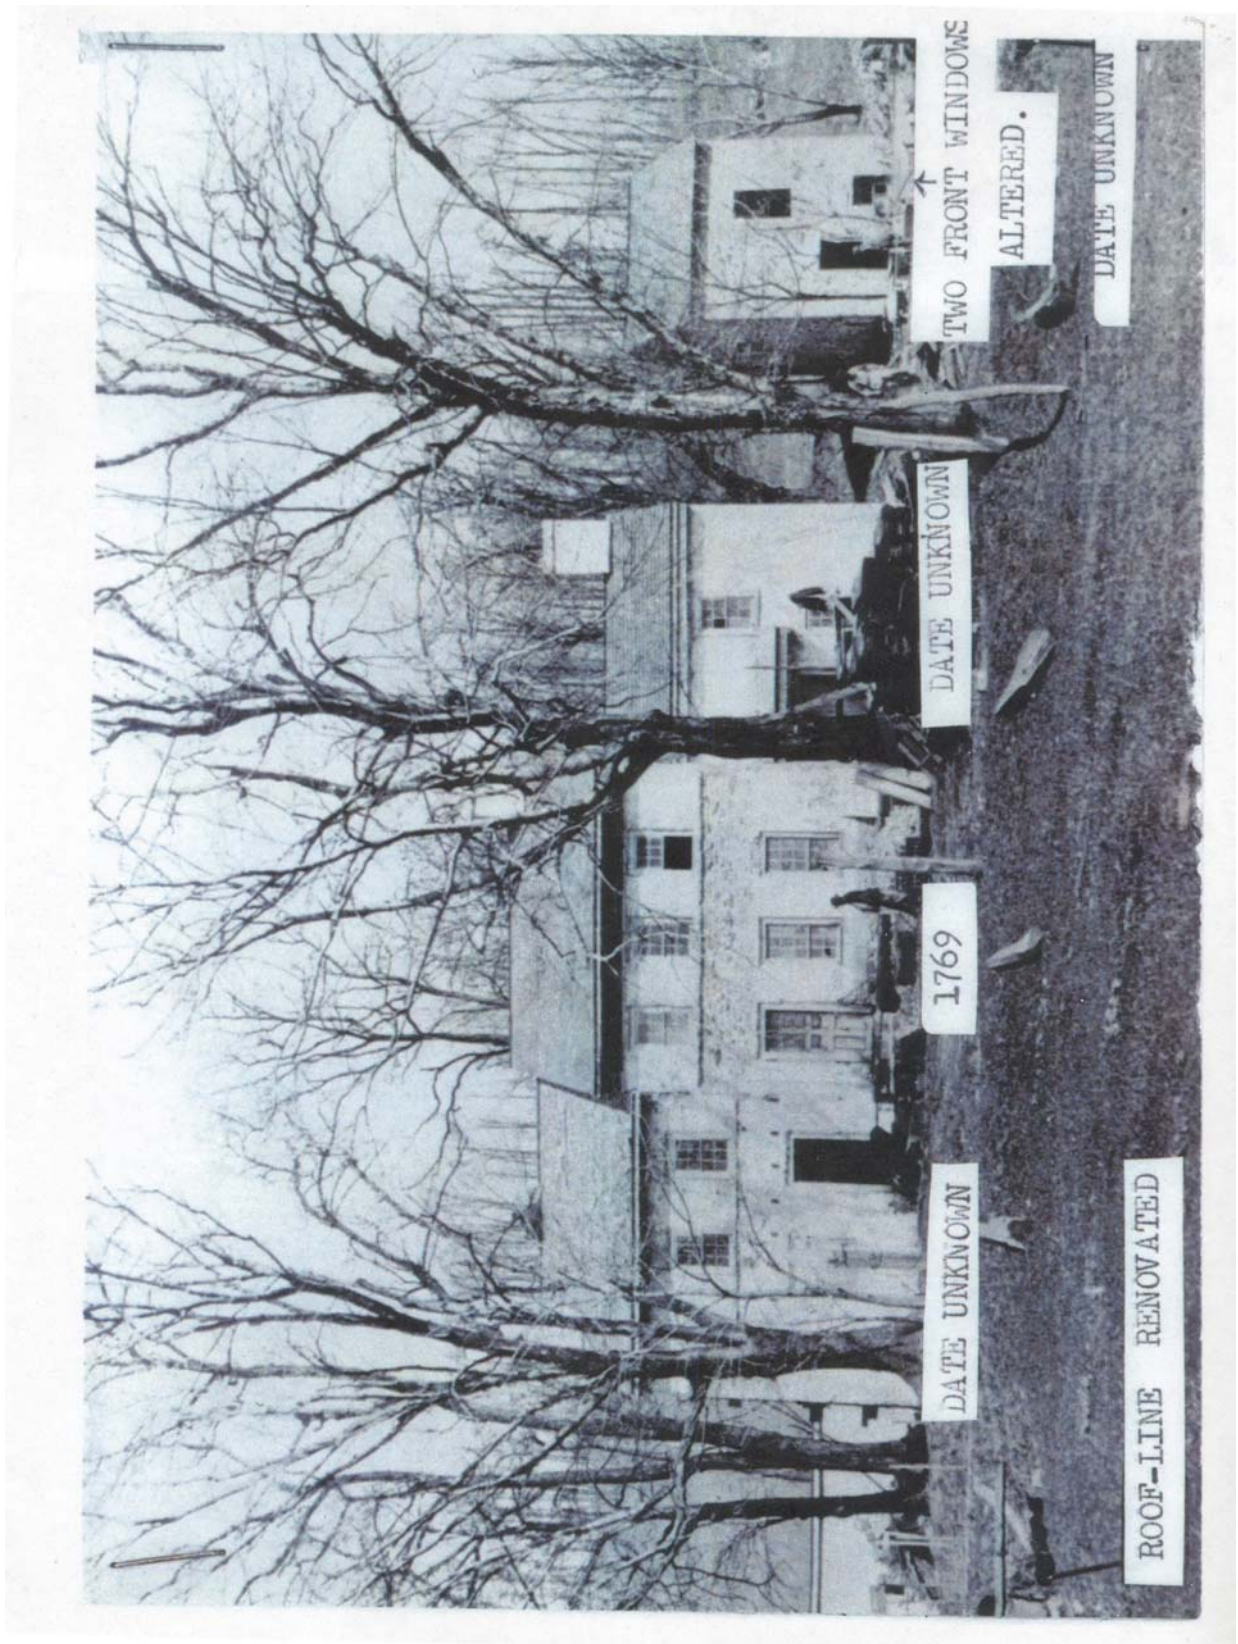
- The south entrance door appears to be a new masonry opening. The door and frame appear to be 20th-century. Archive photographs from c. 1925 do not show a door in this location. Instead, a door is located more in the center of this south wall. (Note 2/108) (Archive Photos 6 & 7)

Archive Photo 6
 South elevation of main house
 and small barn, looking north.
 (Captions are attached to photo.)
