STIRLING'S QUARTERS AT VALLEY FORGE NATIONAL HISTORICAL PARK
HISTORIC STRUCTURE REPORT

PREPARED BY:
JOHN MILNER ARCHITECTS, INC.
104 LAKEVIEW DRIVE, CHADDS FORD, PA 19317

JANUARY 2006

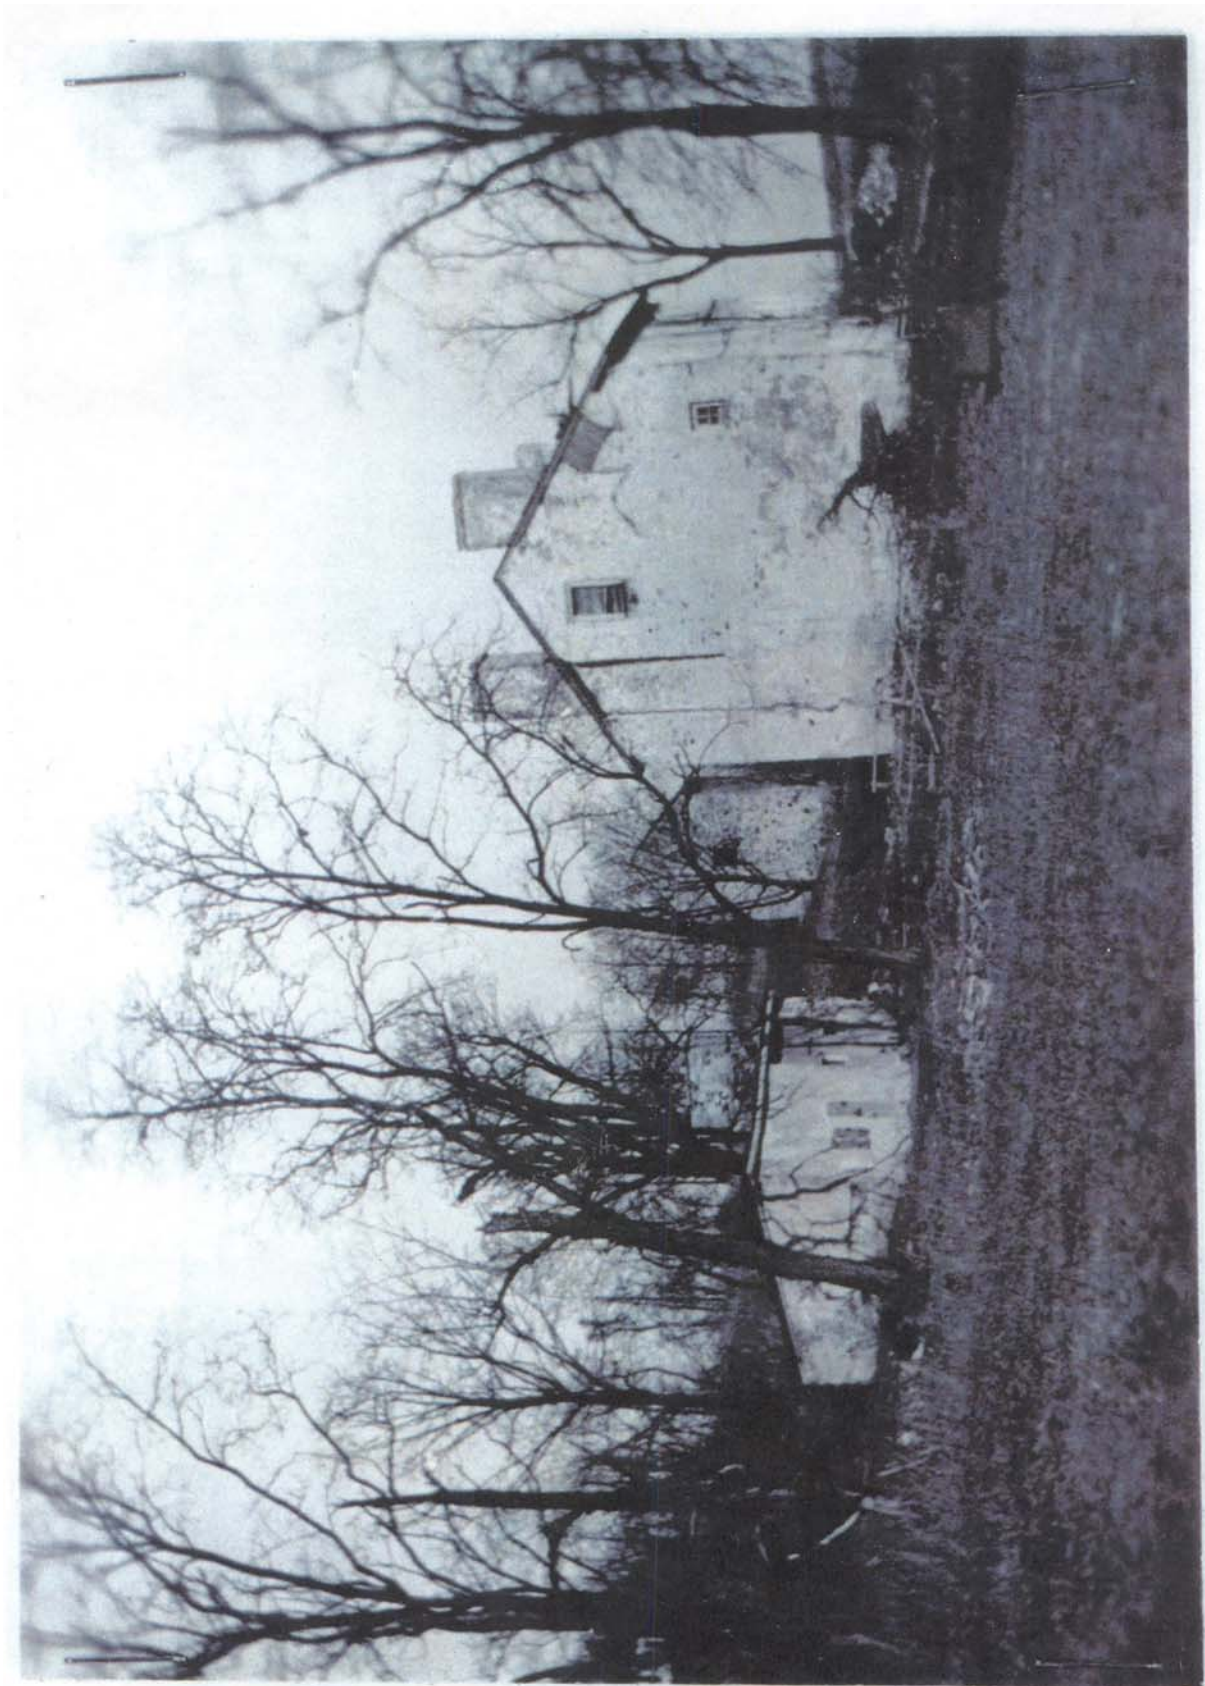
- Window 111: 4-light wood casement window which appears to be a 20th-century replacement. The masonry window opening appears in a c. 1925 photograph. A new exterior screen was installed in late 2005. (Photo 109c, Note 5/109) (Archive Photo 7)
- Window 112: 4-light wood casement window which appears to be a 20th-century replacement. Unfortunately, in the c. 1925 photograph that shows this side of the springhouse, the center of the wall is blocked by a tree and it is difficult to see if

the masonry window opening is original. A new exterior screen was installed in late 2005. (Note 6/109) (Archive Photo 7)

- Double casement window on west wall was added in 1926. Archive photos show a four-light casement window on this wall up until the 1926 renovations. (Note 3/206) (Archive Photos 3 & 7)
- 6/6 single-hung, wood windows on south wall appear to date to c. 1810 when this wing was raised to a full two stories.

- Window 303: six-light wood sash window set in a modified wood frame. Archive photos of the west gable show that this opening was previously a 6/6 window before the roof was lowered. (Archive Photos 3 & 7)
- The six-light window surround is also patched with gray cement which is likely related to the roof lowering and the changing of the 6/6 window.

Archive Photo 7
West elevation of main house,
small barn, and springhouse,
looking north.
