# VICKSBURG NATIONAL MILITARY PARK

## PEMBERTON'S HEADQUARTERS

(WILLIS-COWAN HOUSE)

# HISTORIC STRUCTURE REPORT

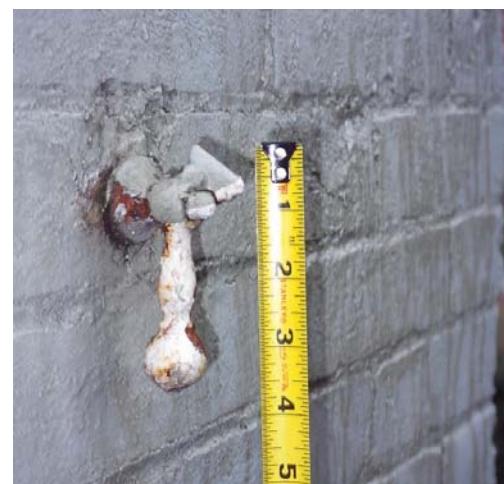
**Figure C – 11** Shutter dog

Also in the masonry flanking the windows of the north, east, and west elevations of the 1835-36 house, are remnants and ghost marks of a shutter dog design popular in the second and third quarters of the nineteenth century.

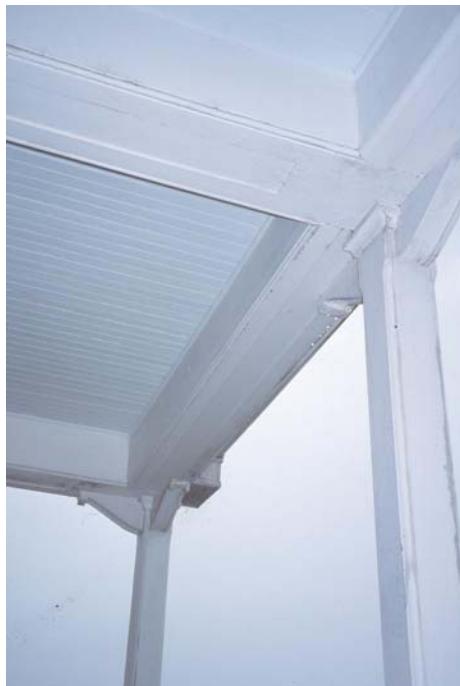
The current porch was probably constructed as part of the 1850-51 effort to create a more grand house for a forthcoming wedding celebration. From the photographs it can be determined that the brick piers along the first-floor level beneath the columns were added in the early twentieth century, and the first-level concrete porch deck and entrance steps were later installed as replacement elements at mid-century.

**Figure C - 14** Construction of the front porch

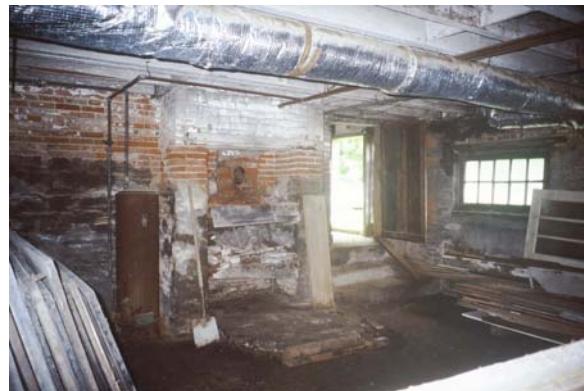
**Figure C - 15** Room 001

- **Flooring:** Hand-made brick dry laid in a sand bed in a staggered stretcher course pattern. An additional layer of brick, partially intact, is laid on top of the floor between the supports for fireplace of Room 105 and extends about 4'-0" into the room; the platform was probably installed for a heating or cooking device when the flue was added in the late nineteenth or early twentieth century.

- **Walls:** Until the late twentieth century, the brickwork of the walls was exposed. Then a Portland cement-rich stucco was applied on the interior surfaces of all interior walls to a height of about 5'-0," probably in an attempt to stem groundwater infiltration. The 12" above this stucco is eroded from rising damp, and is damp to the touch. The remaining distance up to the ceiling joists retains evidence of whitewash.

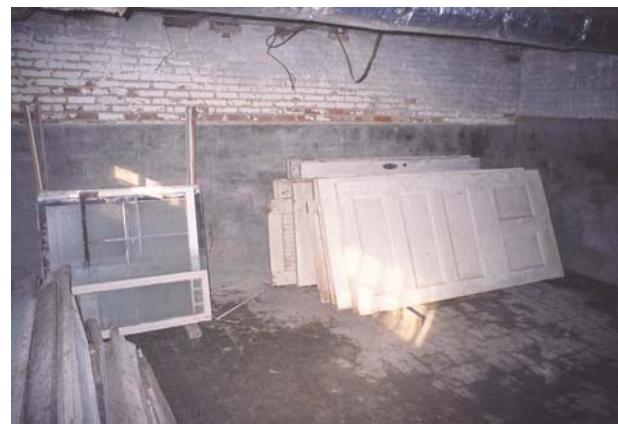
*Figure C – 16 Original doors in storage in Room 001*

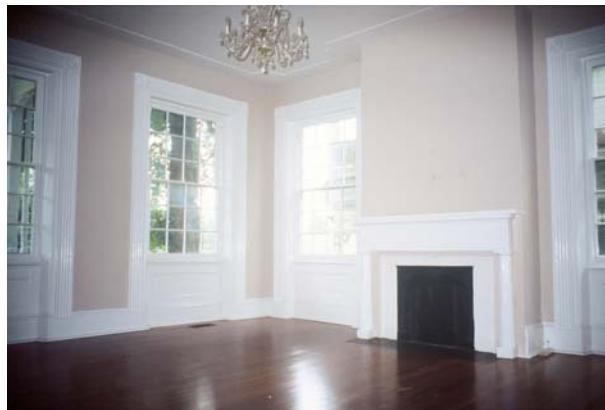
*Figure C - 17 Room 101*

- *Flooring:* The 1919 era, tongue-and-groove, 3 $\frac{1}{4}$ " pine flooring is laid east-to-west on top of the original random width flooring.
- *Walls:* Early lime plaster, perhaps original, was patched in 1997-99.
- *Doors:* The original five-panel door is now missing and presumably is among the doors stored in Room 001. The doorway retains its 1835-36 vintage, Greek Revival style, paneled jambs and head, and fluted casing with corner blocks.
- *Windows:* Four, 1835-36 vintage, floor-to-lintel window units have splayed paneled jambs and heads, fluted floor to lintel casings, recessed panels, and 12-over-12 light, double-hung, window sash. All sash are the original 1835-36 Type A. Three of the sashes, however, and the muntins of the lower sash of the two north windows and the lower of the southeast

window, have been replaced with Type C muntins, probably a Civil War era repair.

- *Other Features:* A plexiglass panel in the ceiling provides a view to a shattered joist reportedly damaged during the Siege of Vicksburg. A built-in bookcase was installed in a door opening in the south wall in 1997-99. According to the owner who made the change, Andrew Johnson, the Victorian 4-panel door and flat board door casing matched that of the doorway that leads from Room 108 to Room 110, as well as the doorways of the Kitchen, Room 109.

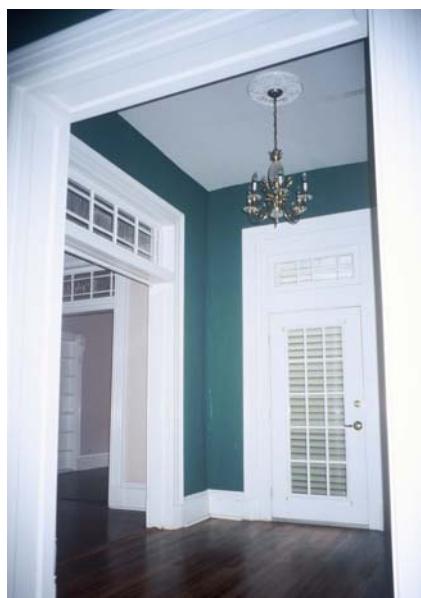
Room 106A

- *Flooring:* The 1970s, tongue-and-groove, 2½" red oak flooring was laid east-to-west here and in Room 105 into which Room 106 opened. By the 1990s, there was termite damage throughout the red oak flooring of Rooms 105 and 106. During the remodeling of 1997-99, the perimeter of the original Dining Room, Room 105, was re-established, and the Dining Room Extension, Room 106, was subdivided. Red oak flooring was salvaged from the area that became Room Section 106B, and used to patch the flooring of 106A and 105. In its place, a plywood subfloor with carpet was installed in the resultant bathroom of Room 106B.

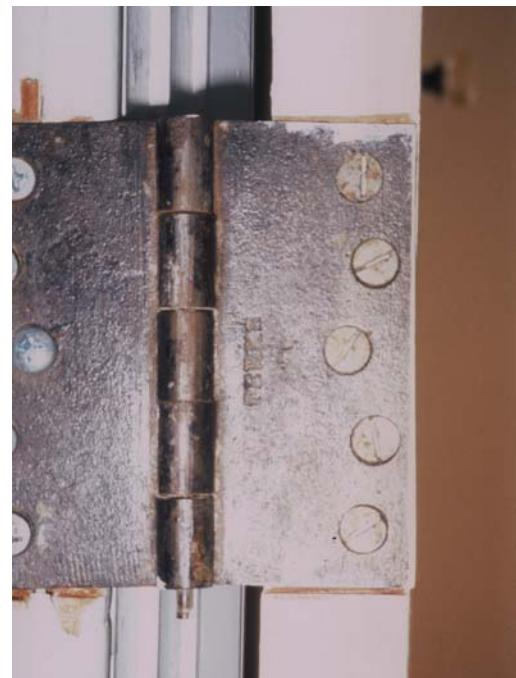
Figure C - 30 "PERKS" Hinge

- *Doors:* In the doorway to the Hall, Room 202, an original five-panel door is hung with two early, 4½", 5-knuckle, iron butt hinges with the fabricator's mark: "PERKS;" a modern, 5-knuckle hinge has been added at mid-section of the door. This doorway retains its original 1835-36 vintage, Greek Revival style, paneled jambs and head, and door casing. A second doorway, also with paneled jambs and header, opens to Room 208, a section of the original open porch that was enclosed to be a secondary space in 1850-51. The door is a five-panel door hung with two modern 5-knuckle butt hinges. This doorway has Greek Revival style trim, probably dating to 1850-51, mimicking the 1835-36 trim found elsewhere.

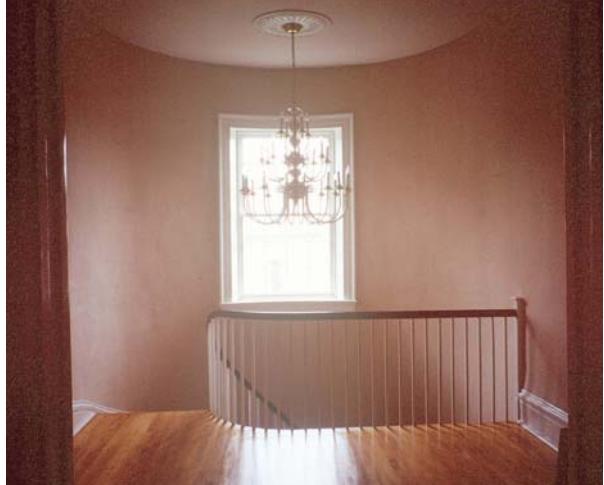
- Figure C - 33   Room 204*
- *Flooring:* The 1970s, tongue-and-groove, 2½" red oak flooring is laid east-to-west on top of the original random width flooring.

- *Walls:* Early lime plaster, probably original, was patched in the 1997-99 repair effort.
  - *Doors:* A double doorway with a transom matching that of the Hall, Room 202, opens to the west; the doors are now missing but presumably are among those stored in Room 001. A doorway for a single-leaf door leads to the Northwest Bedroom, Room 203, and another to the Southwest Bedroom, Room 205. All three doorways have 1835-36 vintage, Greek Revival style, paneled jambs and heads, and fluted door casing.

- *Windows:* A single window unit with double-hung, 12-over-12 light sash is centered on the west wall. One sash is 1835-36 era Type B and the other is Type C and a Civil War era repair.

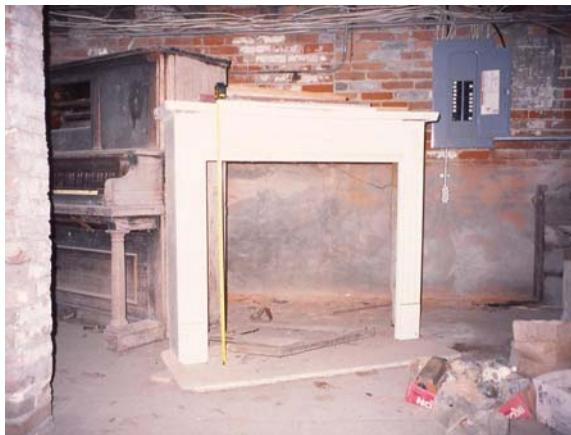
**Figure C – 40    Room 208 mantel**

- *Ceiling:* The early lime plaster ceiling was replaced with gypsum board in 1997-99.
- *Baseboards:* The baseboards of both 208A and 208B are modern, dating to the 1997-99 remodeling.
- *Fireplace & Mantel:* A small, corner fireplace was installed in 1850-51. In 1997-99, the firebox was blocked off and the mantel placed in storage in Room 002. The mantel is made of painted wood. Its most distinctive feature is the decorated frieze containing a classical urn at the center flanked by a garland on either side.

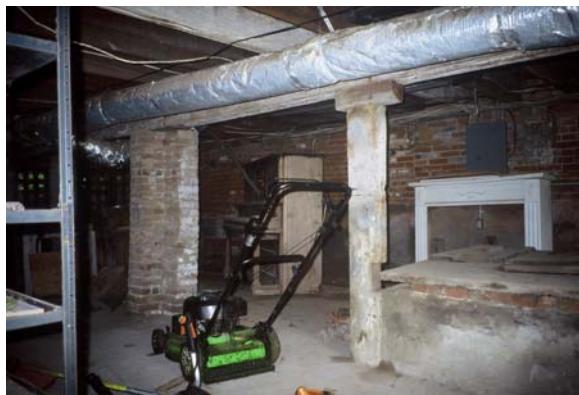
*Figure C - 41 Room 002*

- *Flooring:* Poured cement, set at grade, forms the flooring. This cement was poured after the brick piers were constructed. An earlier flooring of brick or even dirt may be below the current cement flooring.
- *Walls:* The 1835-36 south foundation wall of the house ell and porch forms the north wall of this space. The east one-half of the south wall is the remnant wall of the Kitchen Building, now demolished; the

west one-half of this wall was constructed in 1919. From grade up to a height of about 3'-3", the brickwork has been parged with a Portland cement-rich stucco, undoubtedly an attempt to stem rising damp. The east and west ends are enclosed with lattice work also dating, probably, to 1919.

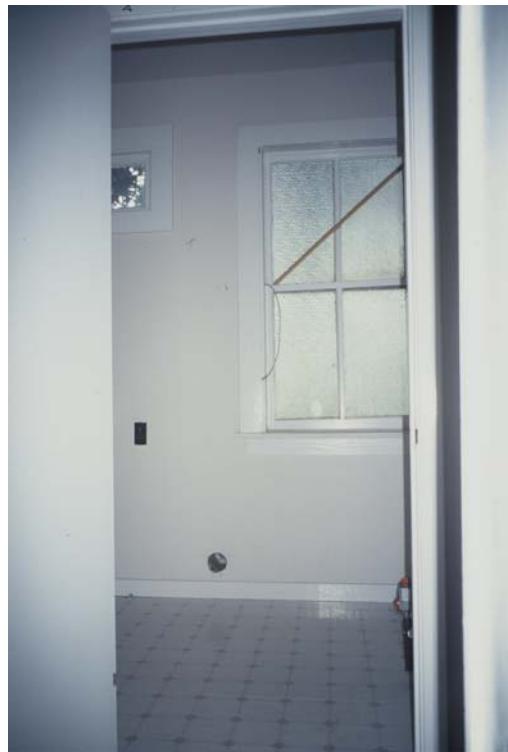
Figure C - 46      Room 110B

*Room 110A & B:* This small, frame addition was constructed c.1913 to provide indoor restroom facilities. During the repairs of 1997-99, a gypsum board on stud wall was installed to subdivide the room into a Half-Bath (Room 110A) and a Laundry Room (Room 110B).

- *Flooring:* Sheet vinyl flooring was installed throughout during the repairs of 1997-99.
- *Walls:* Gypsum board was installed on the walls during the repairs of 1997-99.

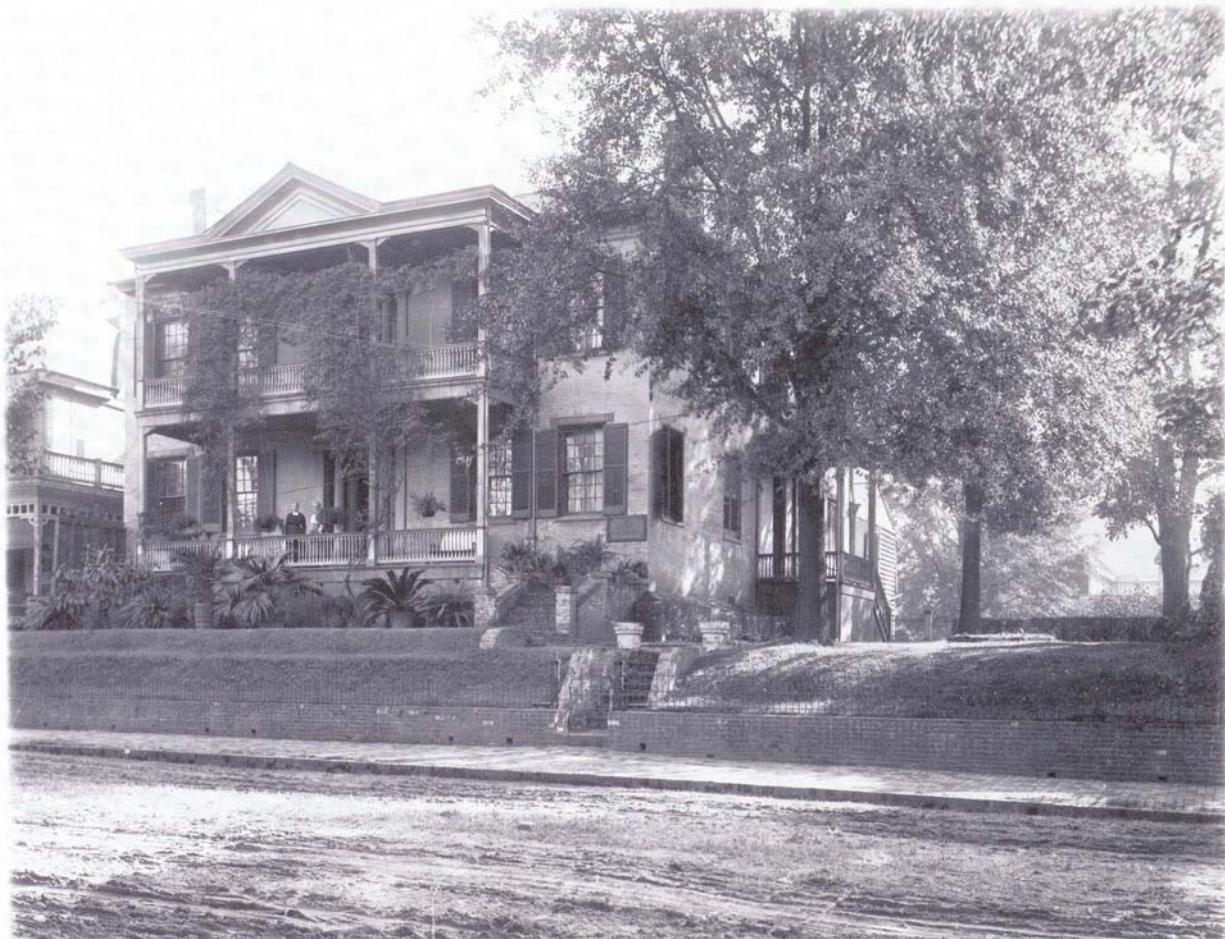
8. Source: Old Court House Museum, J. Mack Moore Collection, Negative #105  
Photographer: Unknown  
Date: Unknown

Pemberton's Headquarters, during  
Siege, 1001 Crawford St.

Note the one-story weatherboarded addition with shed roof at the back of the ell

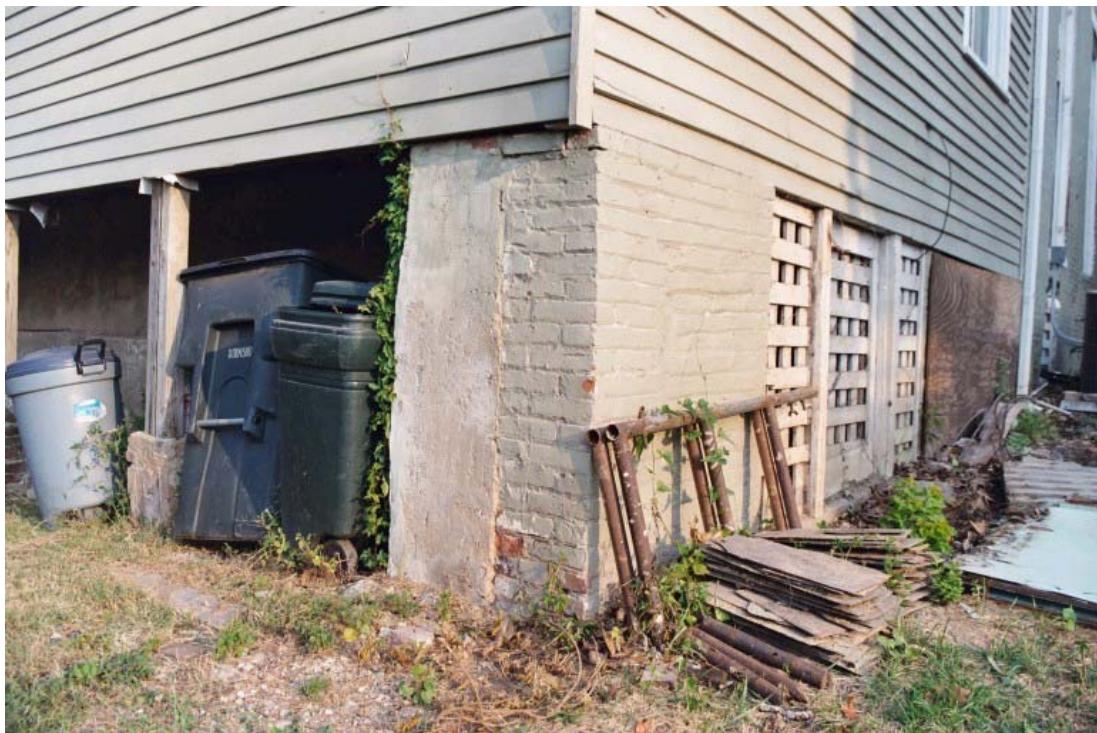
**Figure 1**

The rear of the building contains a cantilevered floor propped up with miscellaneous supports which appear to be added. (Fig. 1) The framing in this area is questionable, with double dropped 2x8s supporting scabs and simple span fill-in joists between the masonry wall and the outside face of the framed exterior wall.

South ell showing added supports for cantilevered floor

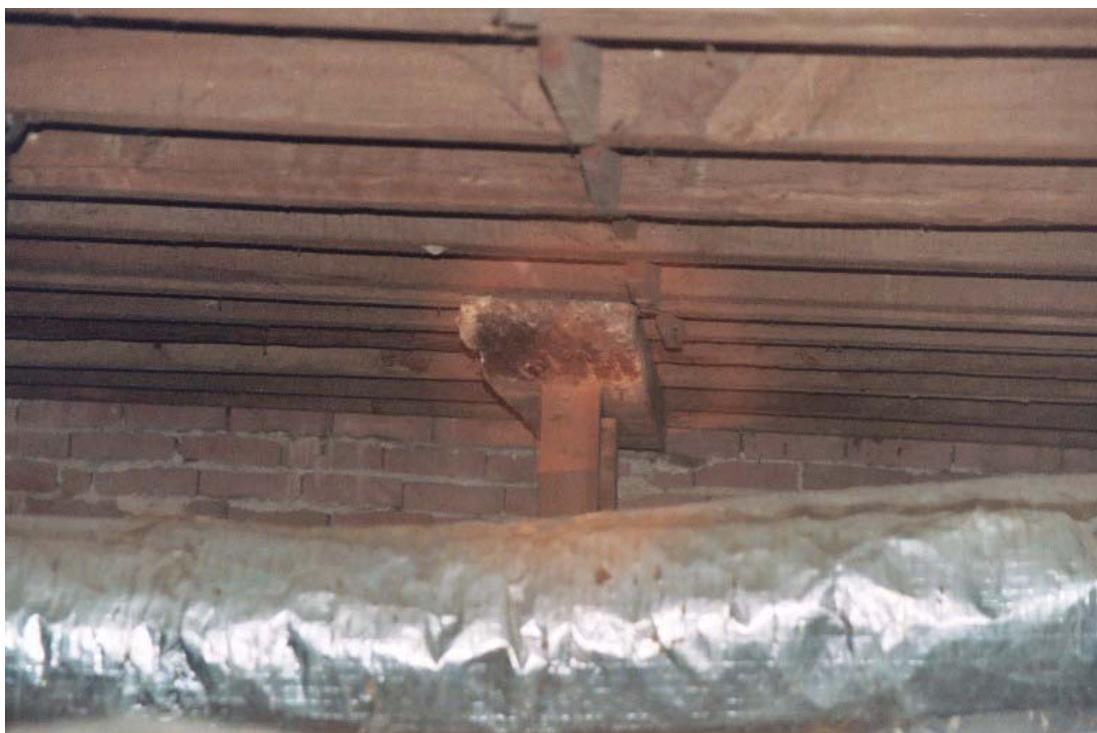
**Figure 2**

These areas are in good condition except for some deterioration in the northeast section. In that area, the floor has been propped up with two posts and a 4x12 plate. (Fig. 2) This area contains termite tubes on the face of several joists.

Added supports under northeast room (Room 101)

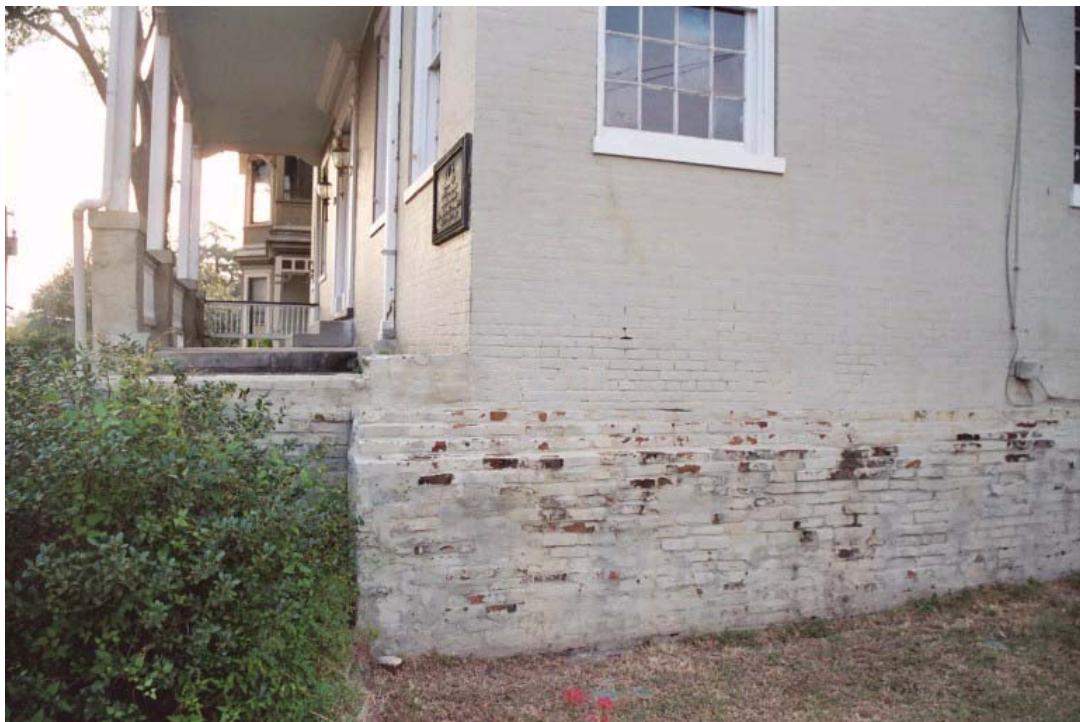
**Figure 3**

It appears that some differential settlement has occurred in the northeast corner of the building due to the instability of earth cuts and slopes in this area. A brick retaining wall apparently contains the exterior wall on two sides of this corner of the house. It appears that the retaining wall on the side was constructed first. Bricks were laid up in stair step fashion to protect the top surface of the earth between the face of the house and the inside face of the retaining wall. Without exploratory excavation, we do not know the configuration of the retaining walls or the bottom of the wall elevation relative to grade in this area. (Fig. 3, 4)

Retaining wall at northwest corner

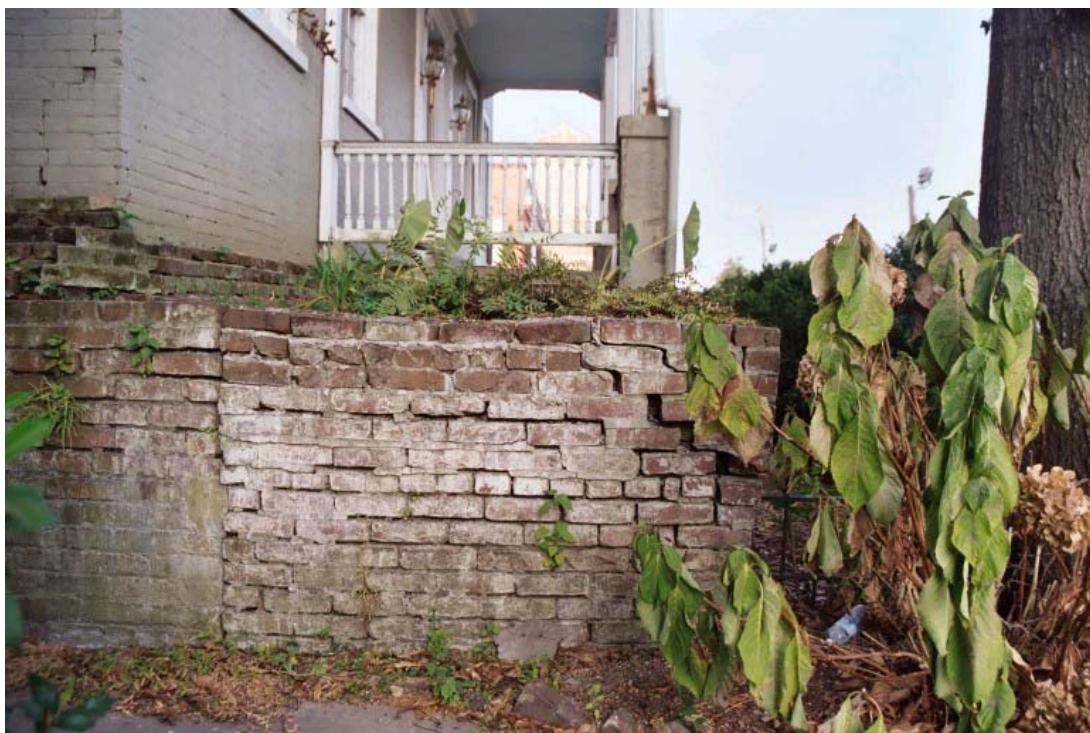
**Figure 4**

Retaining wall at northeast corner

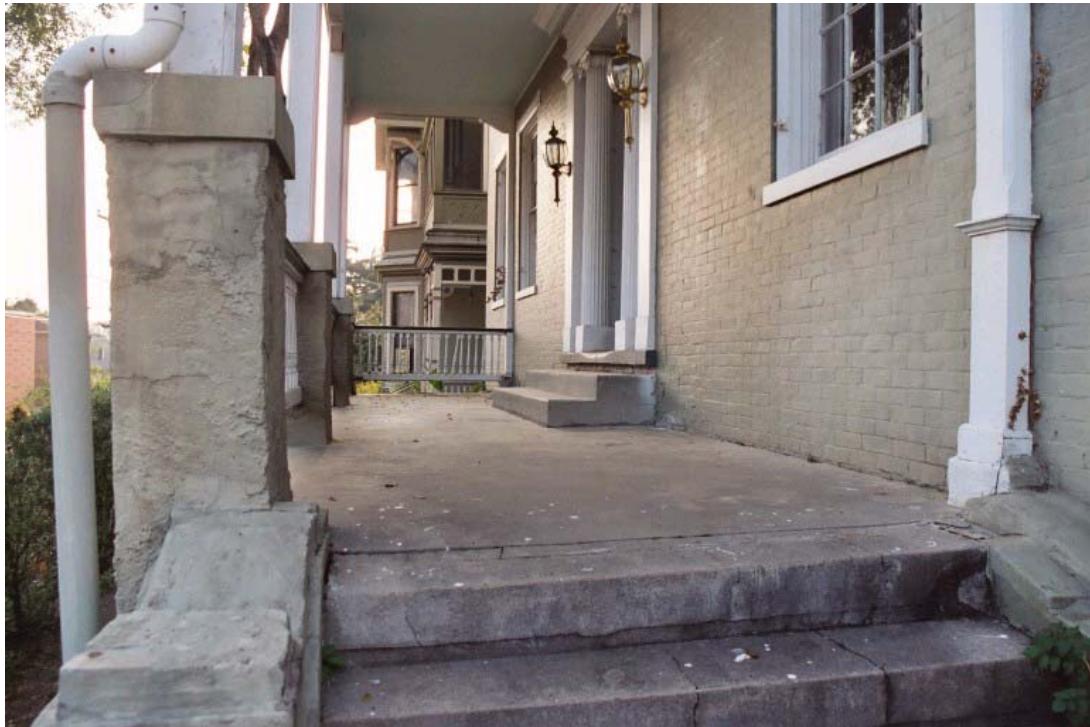
**Figure 5**

The concrete front porch, on the street side of the house, appears to be cast on earth fill. Any repairs to the steps or the porch will have to consider this. (Fig. 5)

Concrete front porch

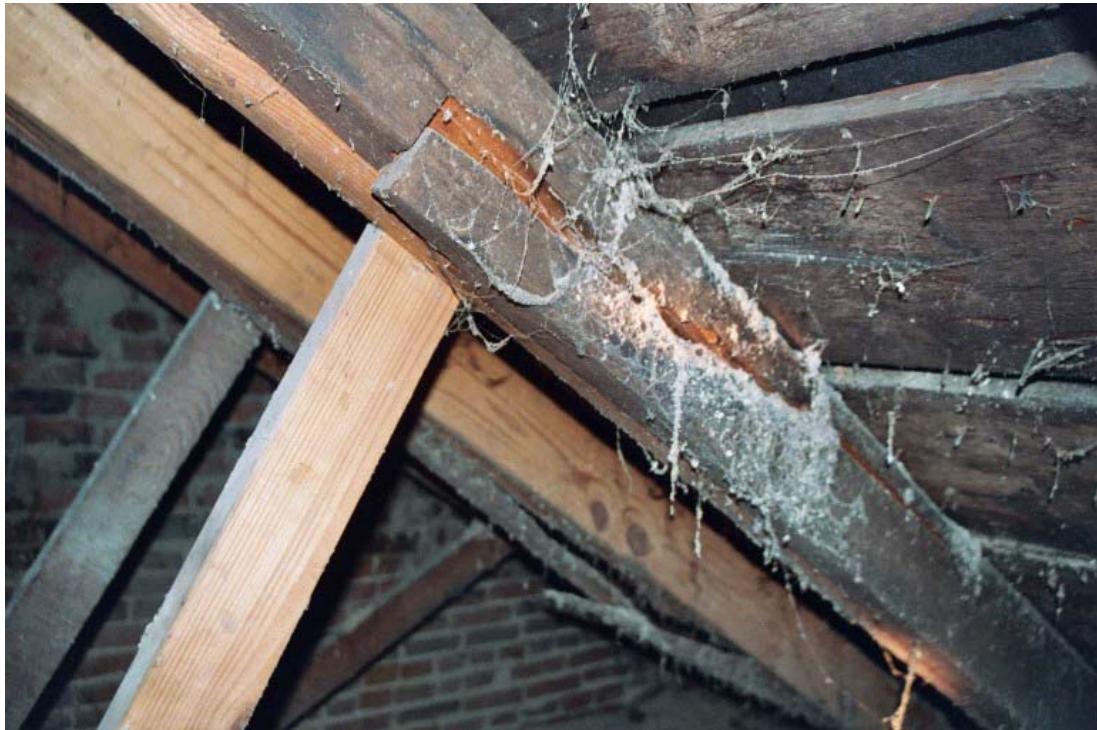
**Figure 6**

The roof framing consists of 2 ¾" x 5" to 2 7/8" x 4 ½" rafters spaced approximately at 24 inches on center. Ceiling joists are approximately 3" x 8 ½" in size. There are at least four fractured rafters which can be observed in the attic in the vicinity of the southwest chimney. They have been scabbed and propped up with 2x braces from the ceiling joists below. (Fig. 6)

Fractured rafters near southwest chimney

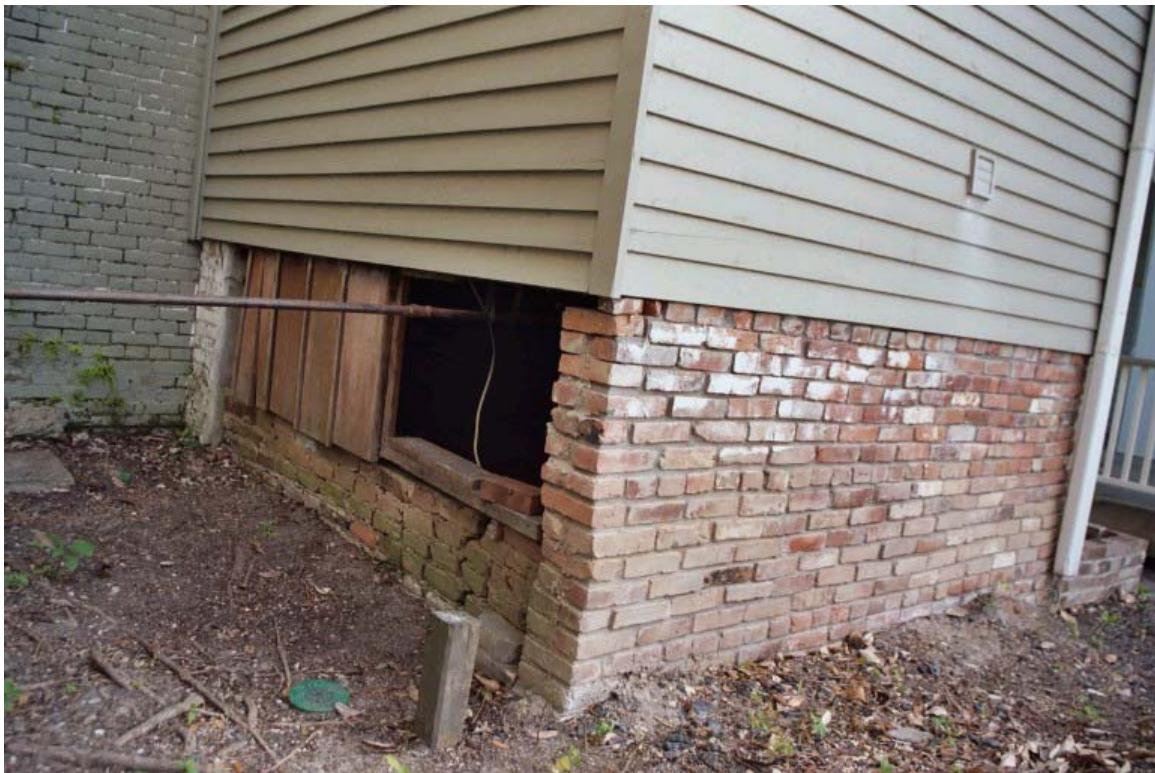
**Figure 7**

Southeast addition

Masonry restoration and repairs are recommended at several exterior locations including around lintels, at the front porch, and in the southeast and northeast corners of the building. The small, c. 1913 southeast frame addition is in poor condition with regards to masonry and framing. Consideration should be given to rebuilding or removing this portion of the building. (Fig. 7)
