# CARETAKER'S HOUSE AND GARAGE

## Weir Farm National Historic Site Wilton, Connecticut

Historic Structures Report

Volume II- B

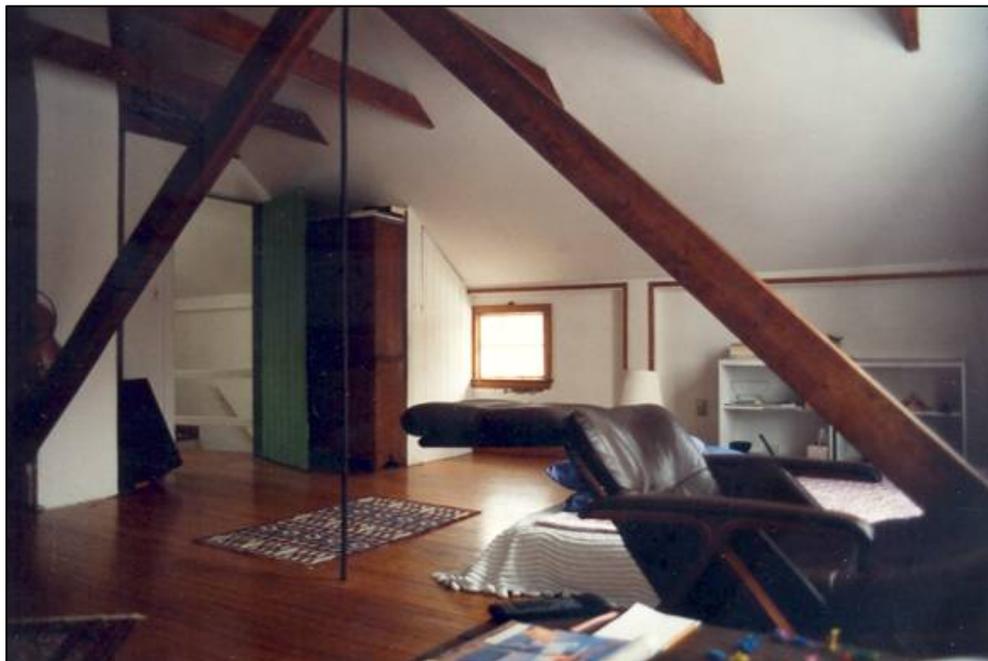
A closet has been built into the northeast corner of the room (fig. 2.15). The closet measures 2 feet 9 inches wide by 3 feet 6 inches deep. The exterior of the closet is composed of the same matchboard siding used to construct the closet door.

Figure 2.15. Caretaker's house: Main bedroom [Room 202], looking northeast (1994).

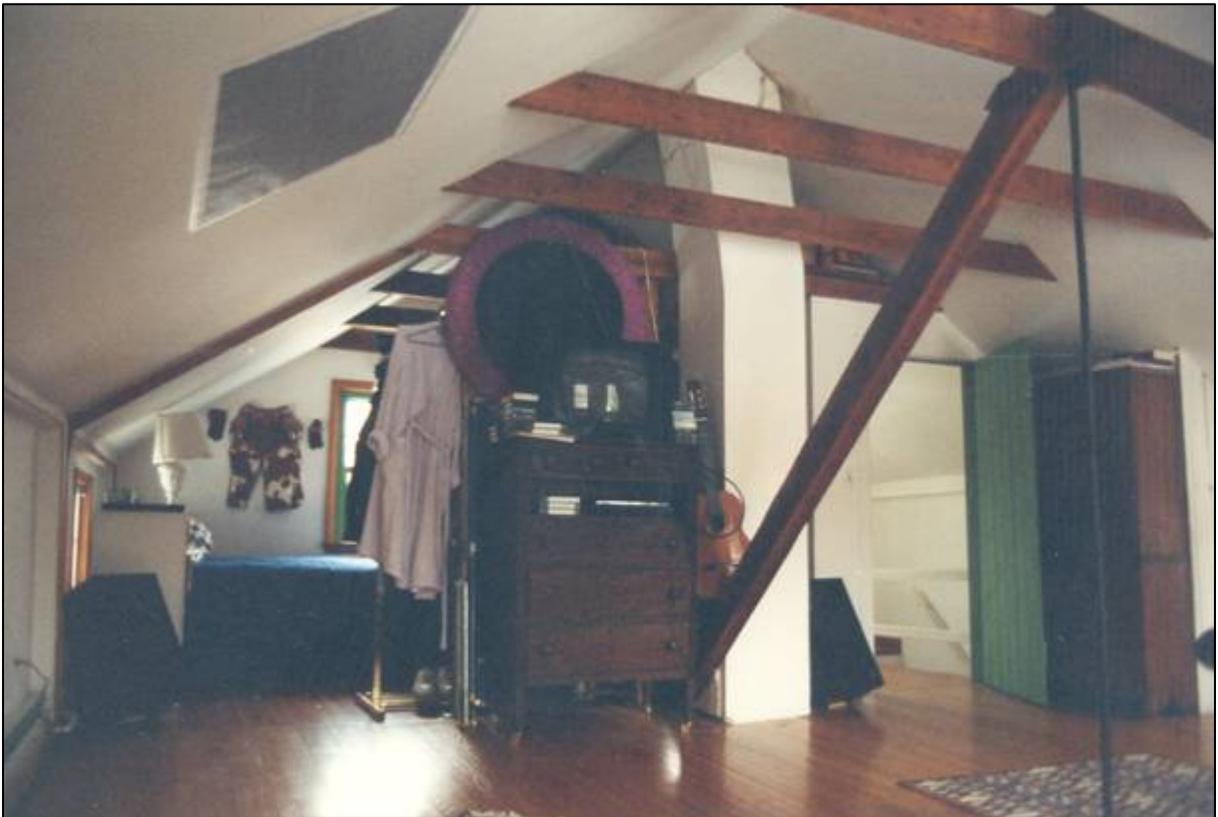
The room is accessed from the second- story hall (Room 201) by a doorway on the east wall. Structurally, the partition wall that originally divided the room from the main bedroom has been removed, and the room is open to the south (fig. 2.16). A temporary partition and a passageway have been created by furniture placement along the line of the north bedroom's former south wall. The threshold of the former doorway between the two bedrooms is extant.

**Figure 2.16.** Caretaker's house: North bedroom [Room 203], looking north from main bedroom (1994).

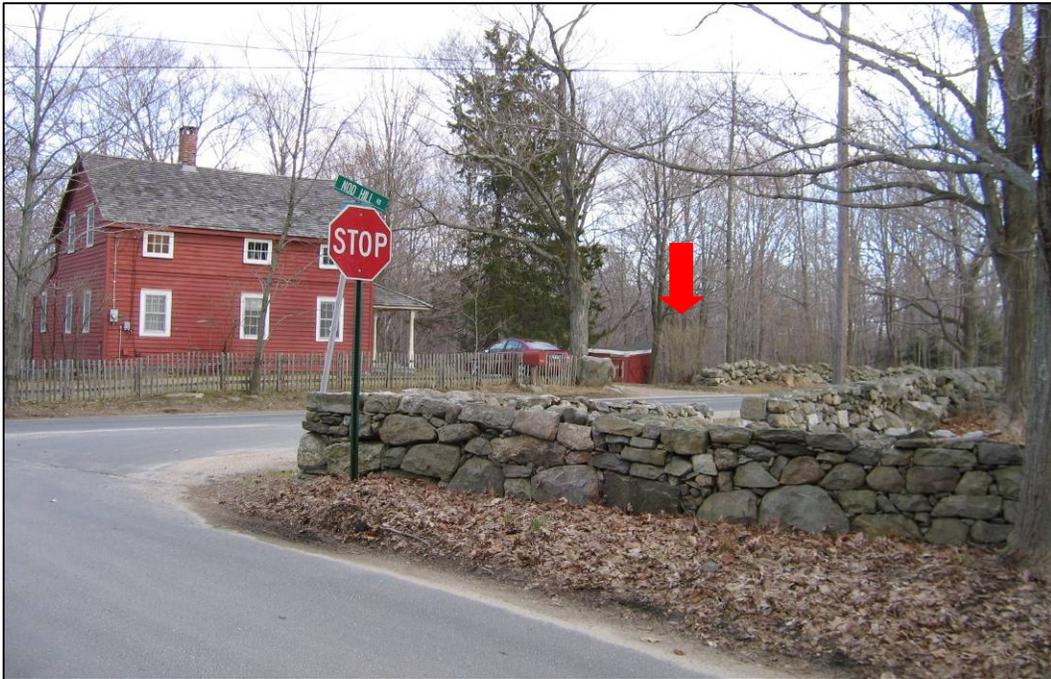
The original structure associated with the present caretaker's garage is thought to be the "carriage house" as listed in the 1861 inventory for the estate of Lewis Beers. This inventory is the earliest known record of the structure's existence.<sup>1</sup> While the carriage house no longer survives, it is represented by shallow rubble- stone foundations abutting the south side of the caretaker's garage (figs. 3.1- 3.2).

**Figure 3.1.** Caretaker's house and garage, looking east from Nod Hill Road and Pelham Lane (2007). Red arrow indicates original carriage house location.

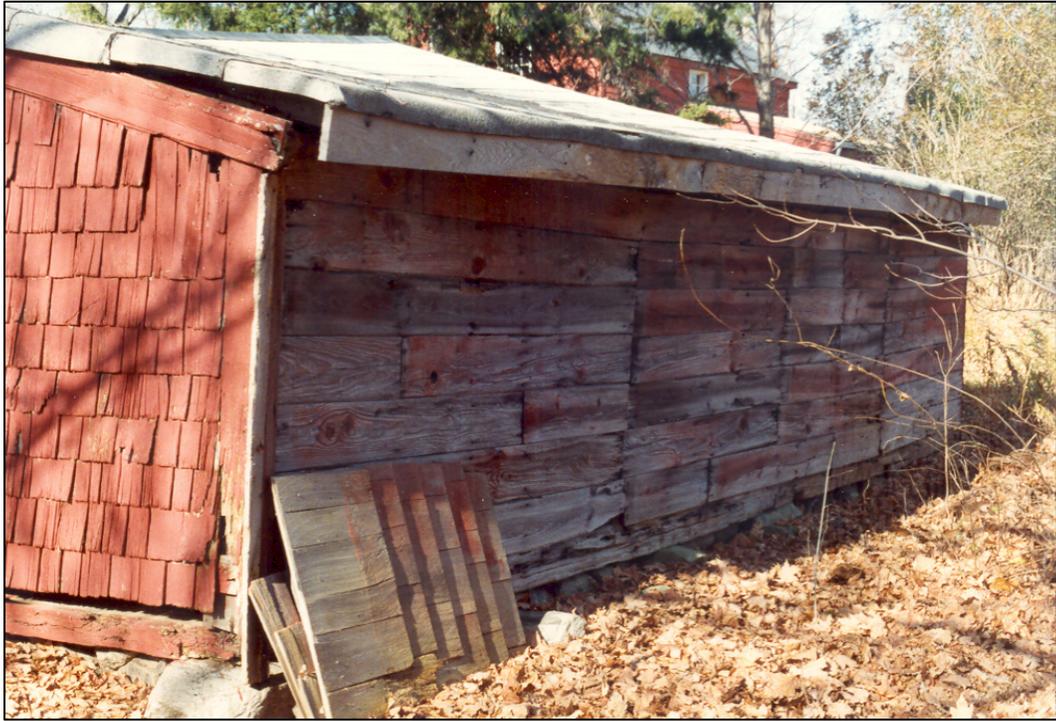
The back wall (figs. 3.7- 3.8) has no openings. The wall is sheathed with horizontal tongue-and-groove boards nailed to the wall studs, without any covering. The origin of these boards is unclear, but they may have been salvaged from the demolished carriage house. The boards are extremely deteriorated.

The roofing on the back roof slope consists of 1 x 8 sheathing boards (running north/south) and asphalt roll roofing with unsecured edges extended over the eave and rake boards. The sheathing and roll roofing of the center bay are deteriorated and open to the weather (see figs. 3.7- 3.8).

**Figure 3.7.** Caretaker's garage: East elevation (1994).

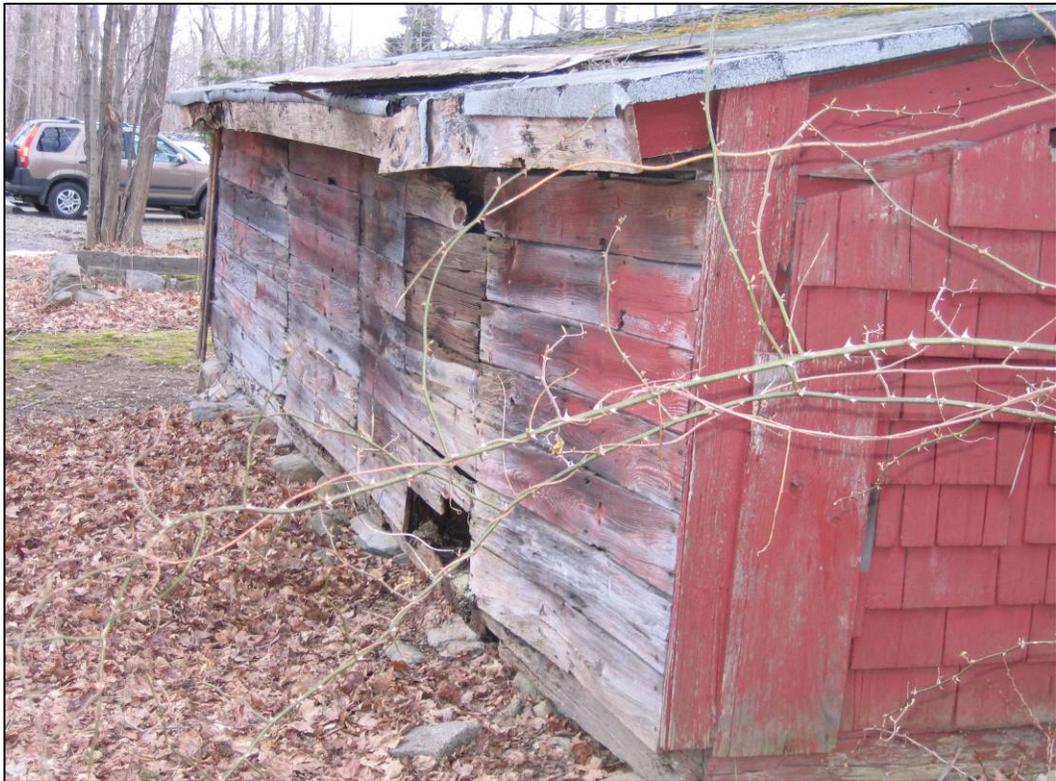
**Figure 3.8.** Caretaker's garage: East elevation (2006).

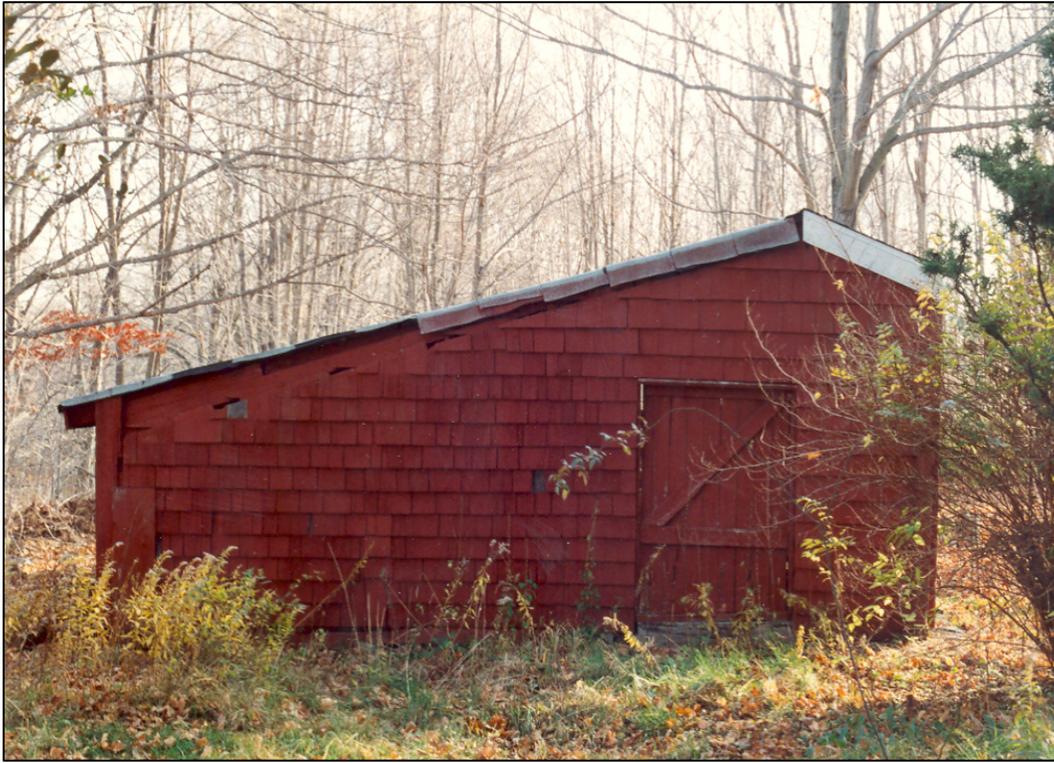
The north elevation (fig. 3.9) is sheathed with horizontal tongue-and-groove boards measuring  $4\frac{1}{8}$  by three-quarters of an inch, spaced 5 to 6 inches apart and clad with wood shingles. Corner and rake boards resemble those in figure 1.20. Doorway D102 is not shown in figure 1.16. It has no trim; its door consists of reused planks with an exterior Z-frame and remnants of white paint on the interior. Orin Bass recalled that there was no doorway in this location during the 1930s and 40s, and that the only entrance into the garage was through the vehicular doorways.<sup>17</sup>

Figure 3.9. Caretaker's garage: North elevation (1993).

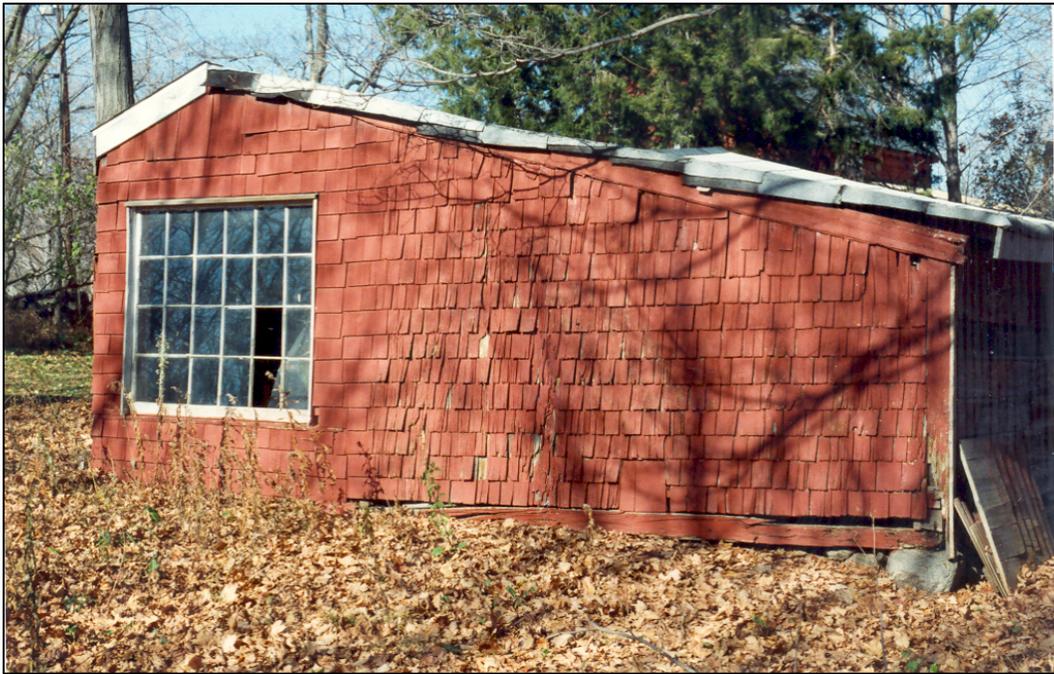
The south elevation originally abutted the carriage house. Orin Bass stated that there were no openings between the carriage house and garage during the 1930s and 40s.<sup>18</sup> The present wall (fig. 3.10) is thought to have been constructed after the demolition of the carriage house. The wall is sheathed with a combination of square-edge and tongue-and-groove boards spaced approximately 5 to 6 inches apart and clad with wood shingles. The large window with a multipane sash (W103) presumably dates from the 1970s.

Figure 3.10. Caretaker's garage: South elevation (1993).

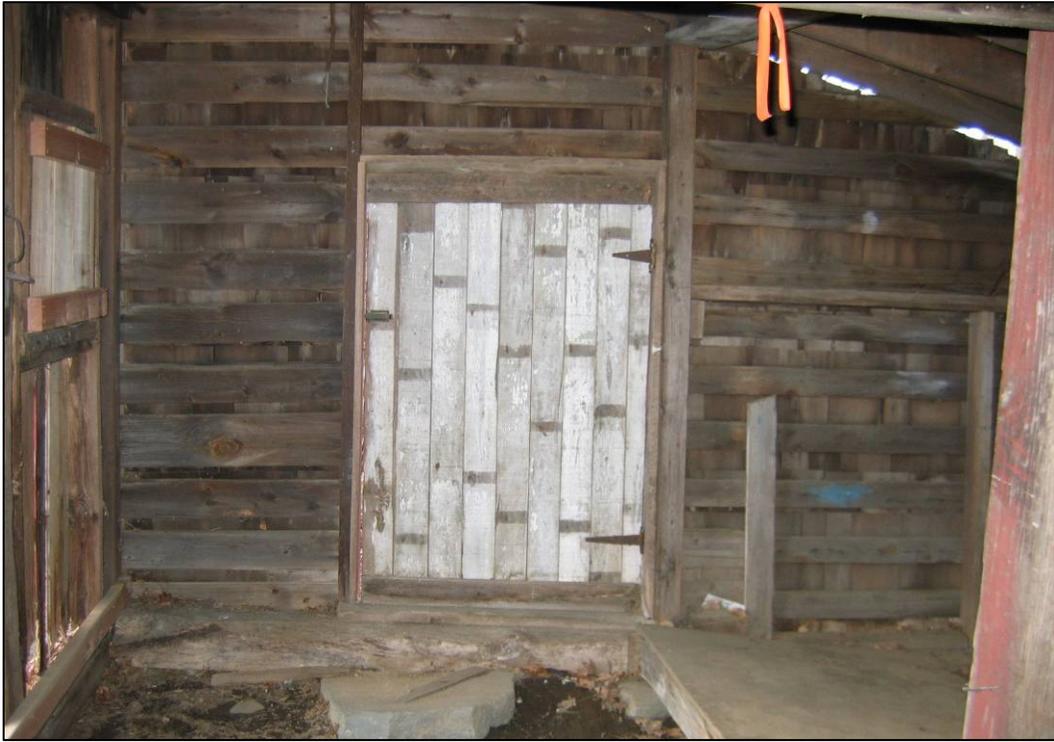
The back, east wall (figs. 3.13- 3.14) is a load- bearing wall. The framing is uniform and probably relatively intact from the original 1930s construction. The framing consists of studs (2 x 4 actual) spaced approximately 3 feet on center, extending from a sill measuring 4 by 5 ½ inches to a top plate comprised of two 2 x 4s.

The interior of the garage is unfinished, exposing the wall and roof framing (see figs. 3.13- 3.14). The back (east) wall has fiberglass insulation and horizontal boards nailed to the studs in the north and center bays. In front of this area are salvaged timbers (approximately 6 x 6) spanning between post footings, presumably to create storage racks above the dirt floor.

Light- blue paint survives on the original carriage house doors on the front facade (see fig. 3.12). In addition, white paint survives on the sashes of windows W101 and W103, and on the door of doorway D102 (see fig. 3.13).

**Figure 3.13.** Caretaker's garage: Interior view of north wall (2006).

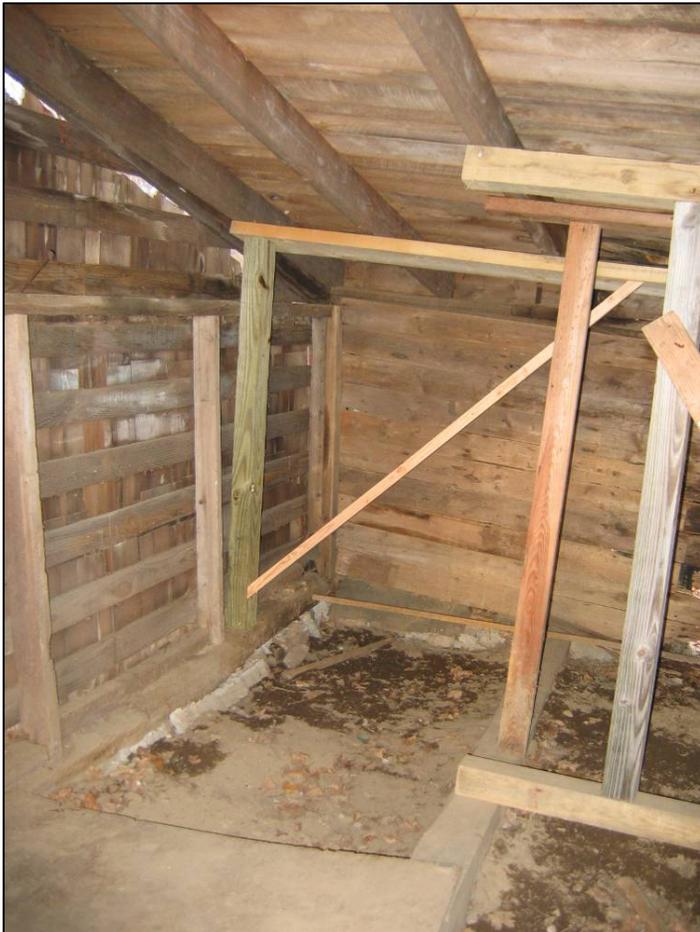
**Figure 3.14.**  
Caretaker's  
garage: Interior  
view of northeast  
corner (2006).

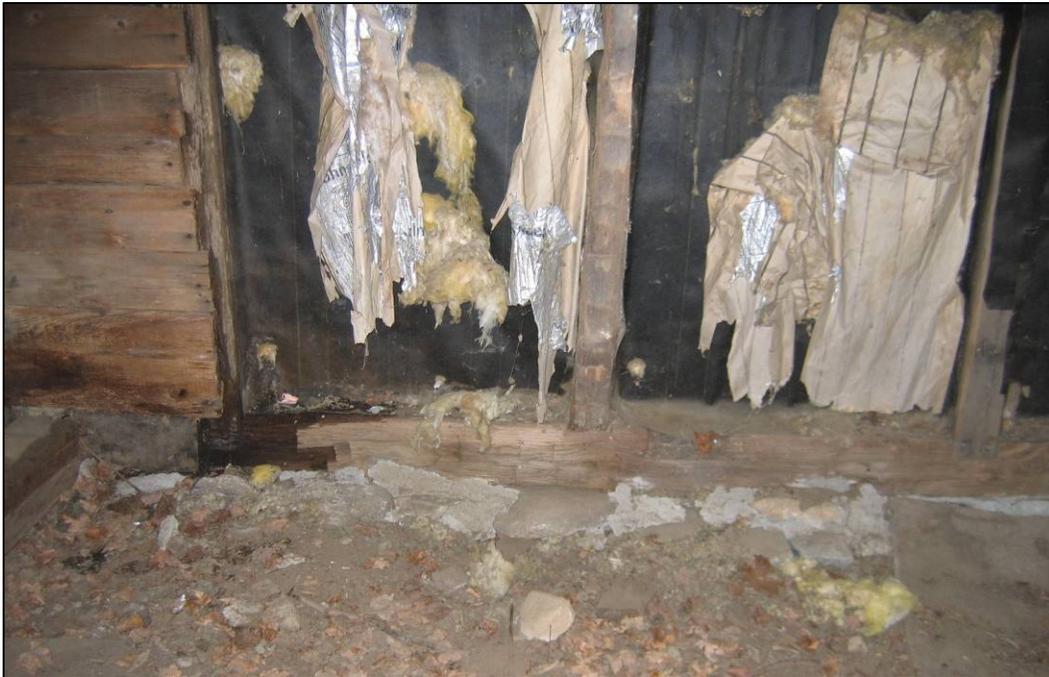
The north wall (figs. 3.15- 3.16) is not a load- bearing wall. The framing is uniform and probably intact from the 1930s, with the exception of that for doorway (D102). The framing consists of 2 x 4 studs, at 4 feet or more on center, supported on a sill (4 x 6 at the east end and 7 x 8 ½ at the west end). At the west end the studs extend from the sill to the roof. At the east end the studs extend to a plate at the level of the back (east) wall plate. There is a 4 x 4 post at the east jamb of doorway D102, which supports a beam running through the center of the building. The origin of the post and beam is not known.

**Figure 3.15.** Caretaker's garage: Interior view of east wall (2006).

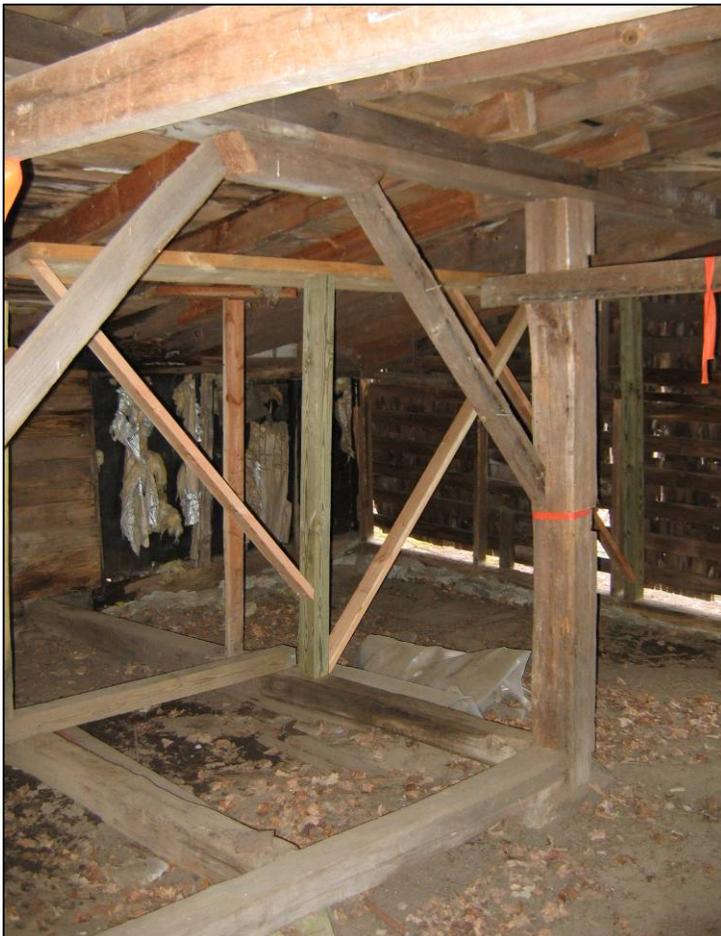
**Figure 3.16.**  
Caretaker's  
garage: Interior  
view, looking  
southeast (2006).
