M'CLINTOCK HOUSE

**Women's Rights
National Historical Park**

Historic Structure Report

THE M'CLINTOCK HOUSE
HISTORIC STRUCTURE REPORT

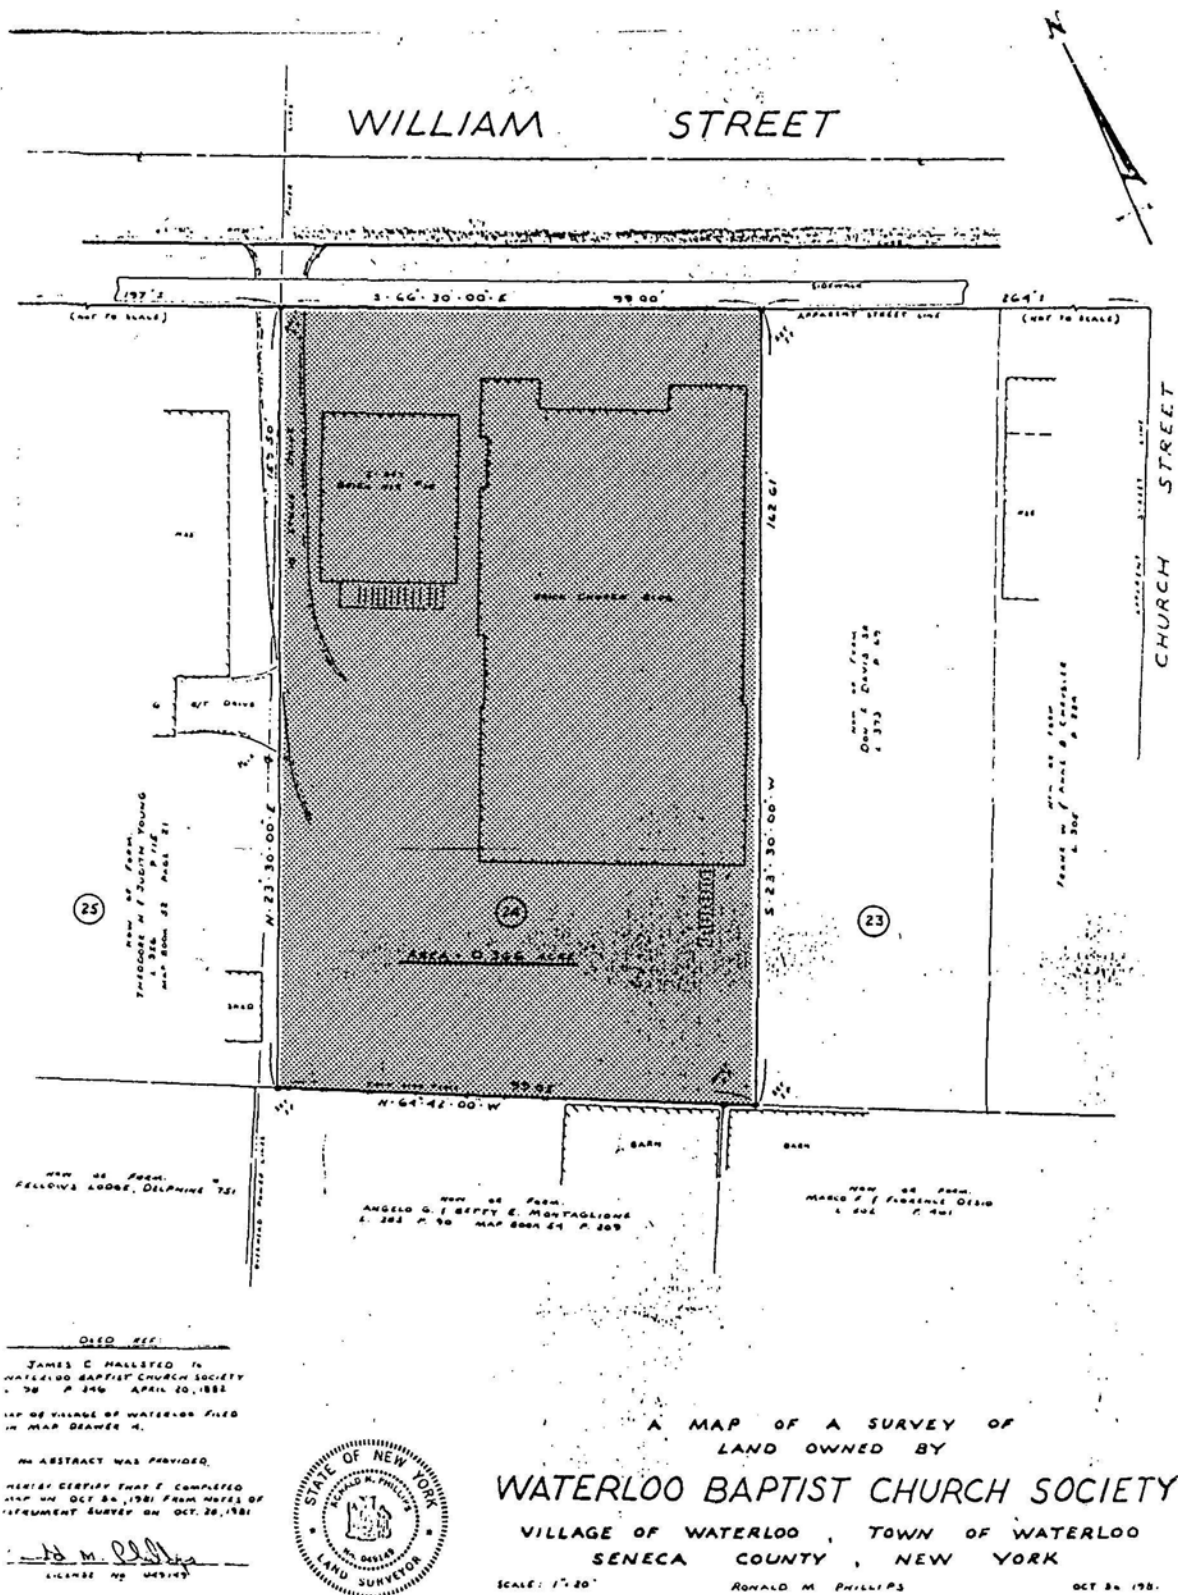
Figure 38. "A Map of a Survey of Land Owned by Waterloo Baptist Church Society," October 30, 1981.

On October 30, 1981, a licensed land surveyor prepared "A Map of a Survey of Land Owned by Waterloo Baptist Church Society" on William Street in Waterloo, New York (fig. 38).⁸² This map details both the site and the buildings thereon. The lot is identified as number 24, measuring 99.0 feet along the north boundary, 162.61 feet along the east, 99.05 feet along the south, and 159.50 feet along the west, for a total of 0.366 acres. Only two buildings are shown: the "Brick Church Bldg" and the "2- Sty Brick Hse #14." Missing from the southwest corner of the lot is the one-story automobile garage previously shown on the Sanborn maps of 1948 and 1958. Also missing from the back of the house is the south wing, replaced by an exterior staircase that exists today.

Fences are known to have bordered the north, west, and south property lines during the years of church ownership. A white picket fence in the front yard is documented by the photograph dated circa 1879 (fig. 19). Possibly it was this fence that was mentioned in the Trustees' meeting on August 25, 1889, when it was "Resolved that the Fence in front of the Church Lot be removed." Lester Semtner, who played in the parsonage during the years 1908-1909, remembers that the backyard had a high board fence with a gate. A low picket fence was also located along the west property line at about this time, based on another photograph dated circa 1910 (fig. 30). Both the high board fence and the low picket fence were later removed and replaced by a metal chain-link fence on the south side only. The chain-link fence was in place by October 1981, according to a survey and map made of the property at that time (fig. 38).

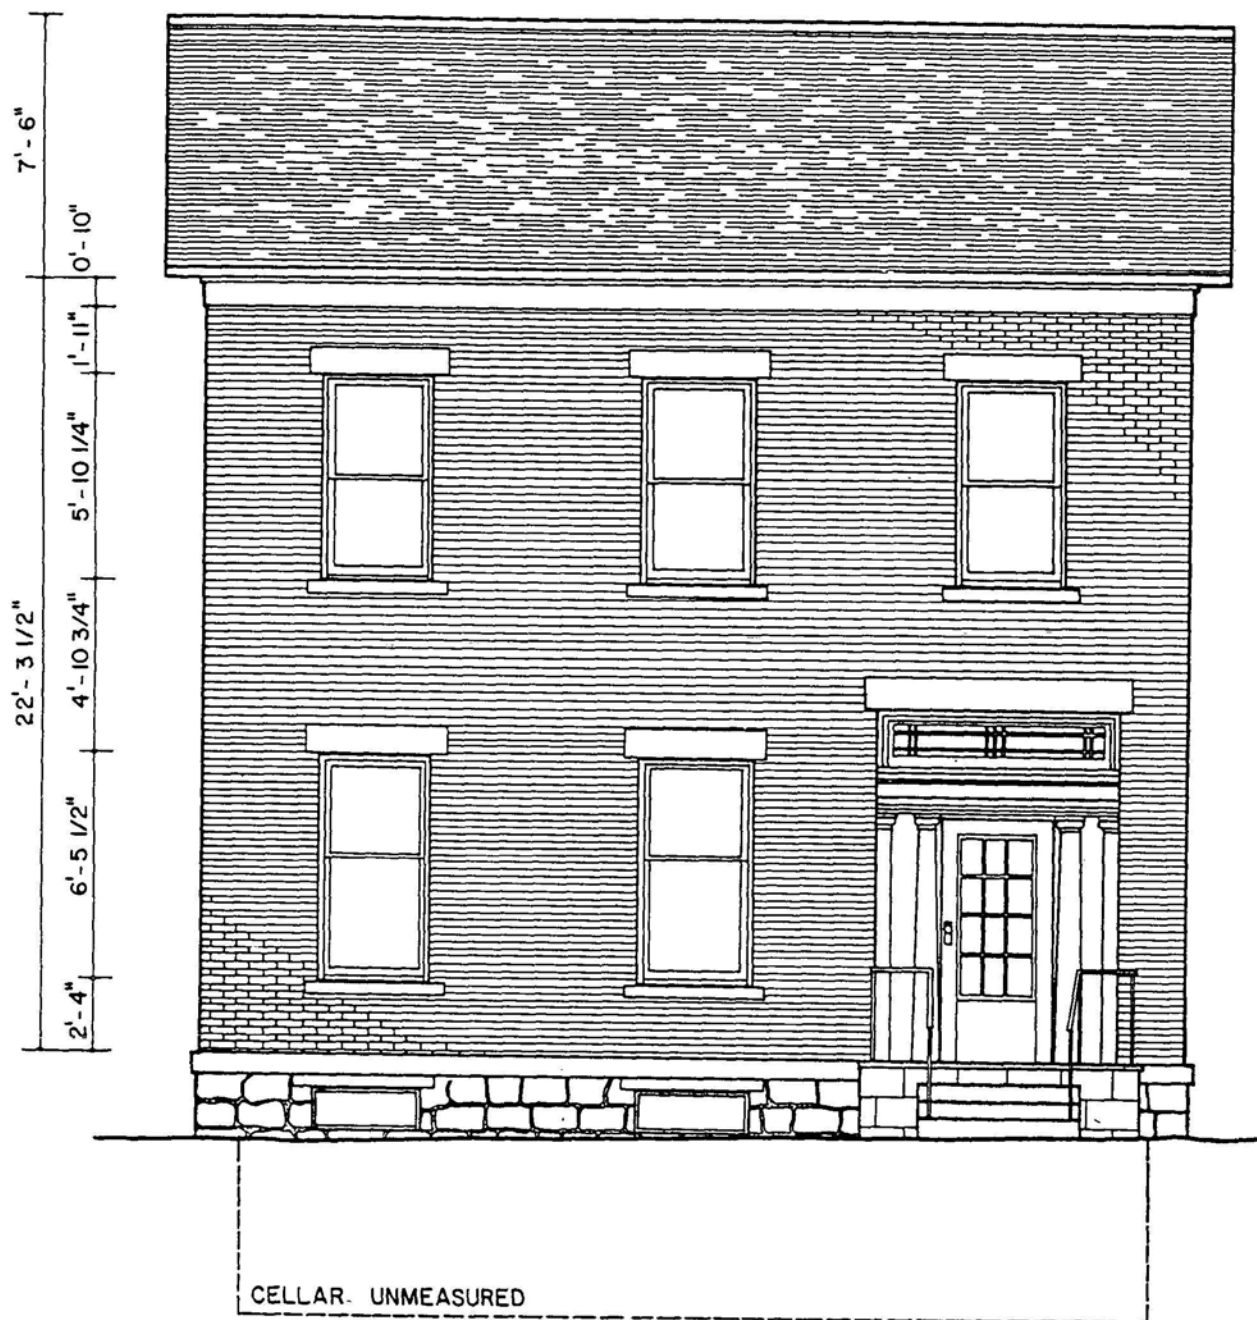
Figure 39. M'Clintock House: North (Front) Elevation [1988].

EXTERIOR MATERIALS
 ROOF: ASBESTOS SHINGLES ON WOOD
 SHEATHING & STRUCTURE
 WALLS: BRICK WITH LIMESTONE WATER
 TABLE, STONE CELLAR
 STOOP: CONCRETE ON STONE

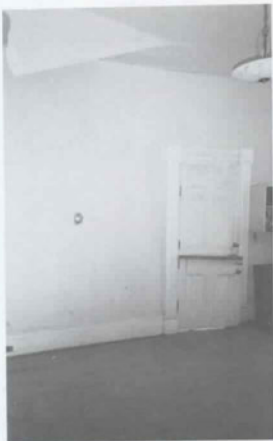
Figure 72. M'Clintock House: Room 102 (Parlor), West Wall [1988].

West Doorway. The doorway at the north end of the west wall (fig. 72) is the principal entrance into the room, opening directly from the entrance/stair hall. The architrave is original with deep moldings, plinth blocks, and molded corner blocks. The six-panel door is original and features six recessed, molded panels on both sides. It measures 33 1/4 inches wide by 80 1/4 inches high by 1 5/8 inches thick. As stated in connection with Room 101, the narrow width may be the result of alterations, while the unusual thickness relates to the panel configuration.

Two shelves and a coat rack are attached to the north wall between the windows (fig. 73). A smaller two-shelf unit hangs on the west wall north of the doorway (fig. 72). The shelves are made of wood. The coat rack consists of a horizontal piece of wood to which are attached 14 metal coat hooks. None of these elements are historic. They most likely were

A Honeywell thermostat is attached to the west wall south of the doorway (fig. 72). It, too, was part of the gas-fired central-heating system.

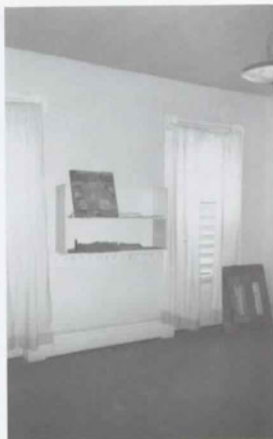
Figure 73. M'Clintock House: Room 102 (Parlor), North Wall [1988].

Two windows are in the north wall of Room 102 (fig. 73). Their original architraves are the most formal window architraves in the house. They extend to the floor and incorporate a recessed, molded wood panel beneath each window opening. The architraves consist of deeply molded side and top pieces, molded upper corner blocks, and plain plinth blocks. These match those of the doorways in the room.

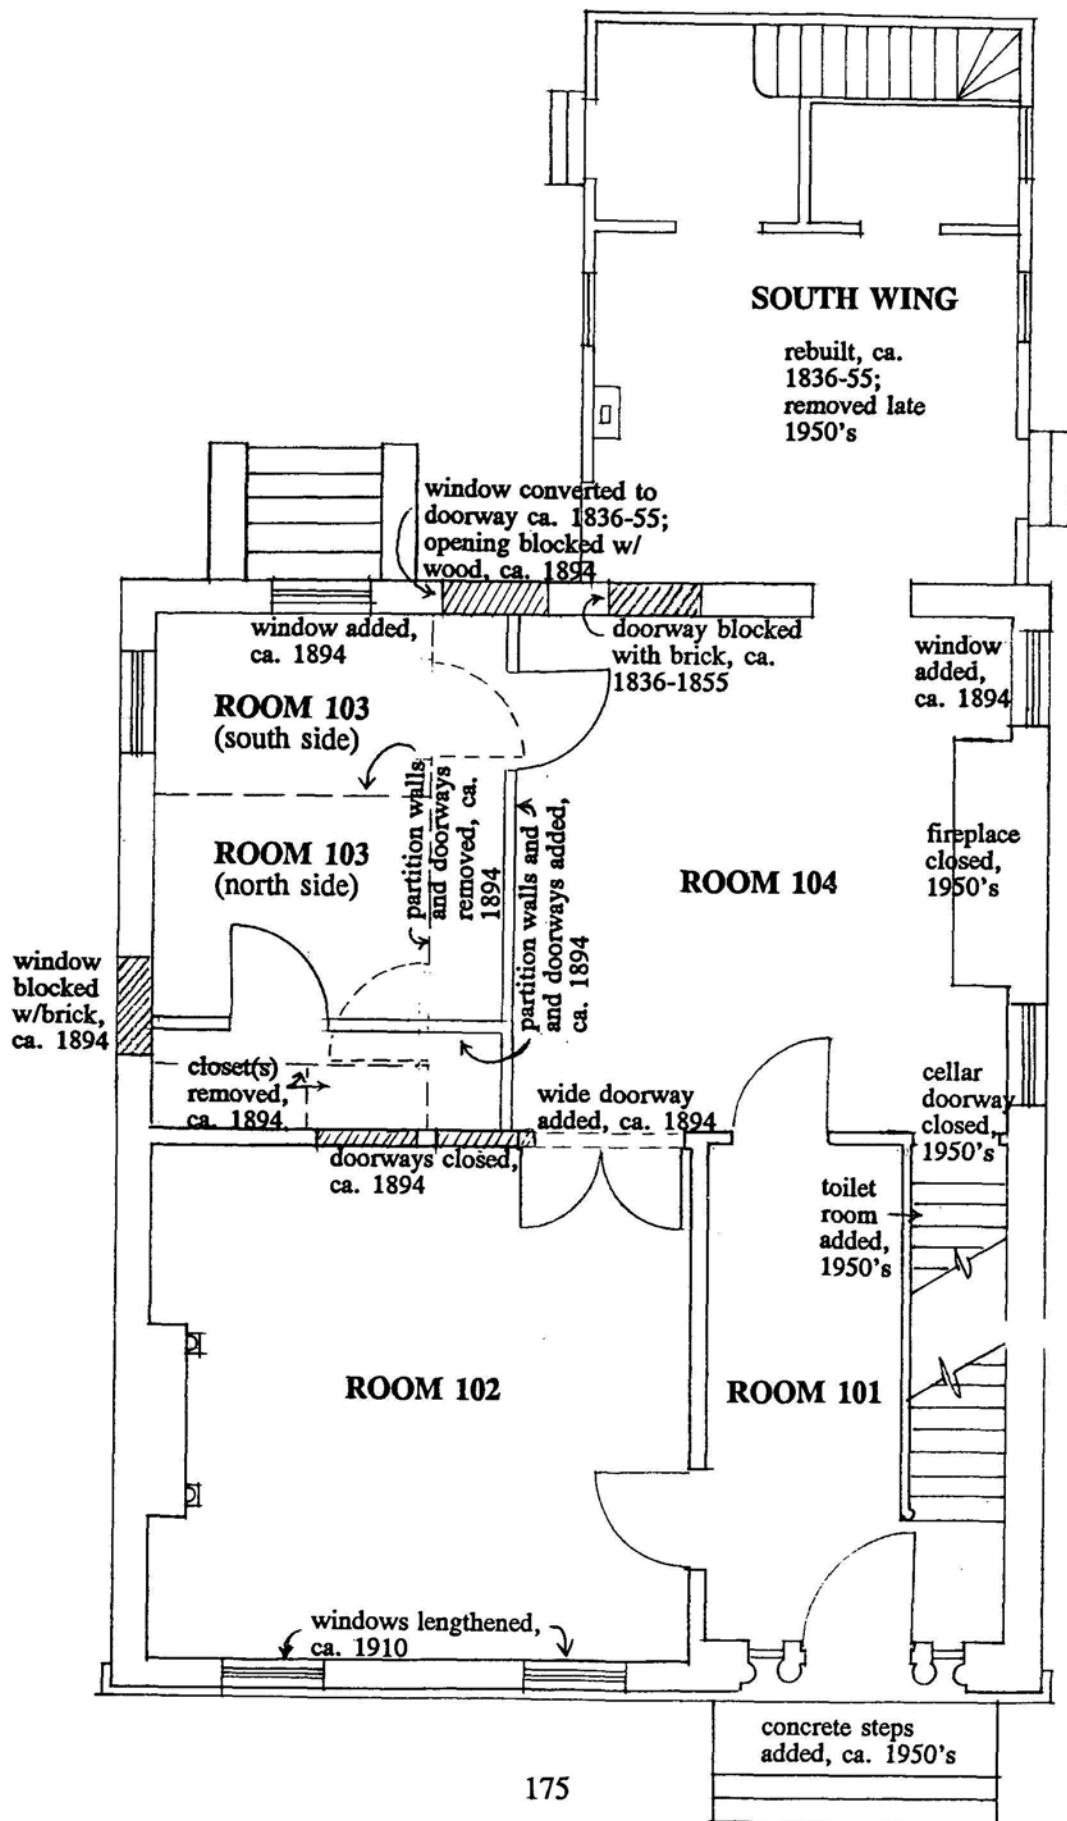
Figure 75. M'Clintock House: Alterations to First Story.

One reason for closing up the earlier doorway to Room 104 and building a new doorway farther west in the same wall is cited in the church records; i.e., to get a larger doorway. Another reason seems to relate to remodeling activity in the rear part of the main house. It is thought that the original partition between Rooms 103 and 104 was relocated at this time, and it is clear that the new partition would have run directly into the earlier doorway (see figure 75).

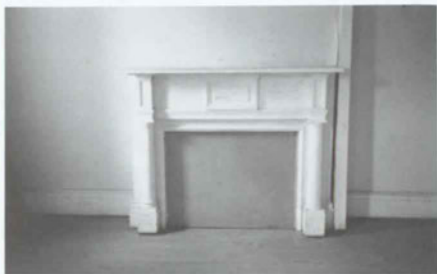
Figure 76. M'Clintock House: Room 102 (Parlor), East Wall, Chimney Breast and Fireplace Mantel [1988].

Background. The fireplace, located in the center of the east wall, is original (figs. 76-77). The earliest source of heat for the room was most likely provided by an open fire in the fireplace. At some time, probably the late 19th century, a stove was installed in the parlor fireplace. This is based on the round plaster patch in the chimney breast (fig. 77). The fireplace is no longer in operation, nor does the later stove remain. Nevertheless, many historic features of the fireplace survive.

A vertical sheet-metal duct is attached to the south side of the chimney breast and covered with wallpaper (fig. 76). It also was part of the gas-fired central-heating system, conveying hot air to the second story.

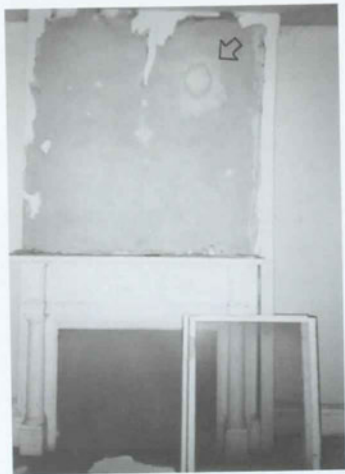
Figure 77. M'Clintock House: Room 102 (Parlor), Patch in Chimney Breast at Former Stovepipe Hole [1988].

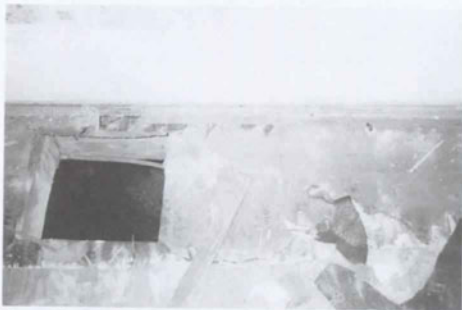
There are two floor registers in the parlor. One is in the northwest corner of the room, while the other is located along the south wall (fig. 78). Both appear to have been part of the gas-fired central-heating system installed in or shortly after 1958.

Figure 78. M'Clintock House: Room 102 (Parlor), Floor at South Wall, in Location of Former Doorway [1988].

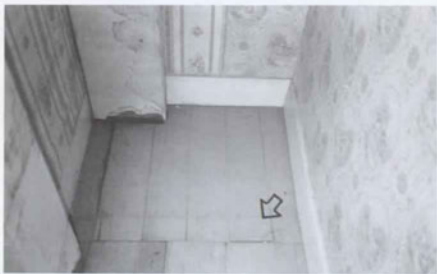
Figure 87. M'Clintock House: Room 103 (Southeast Room), Closet Floor at West End, Showing Location of Earlier Wall [1988].

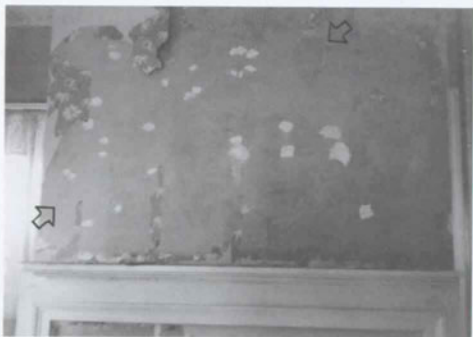
Figure 92. M'Clintock House: Room 104 (Kitchen/Dining Room), Chimney Breast; arrows indicate stovepipe patch and wallpaper note shown below [1988].

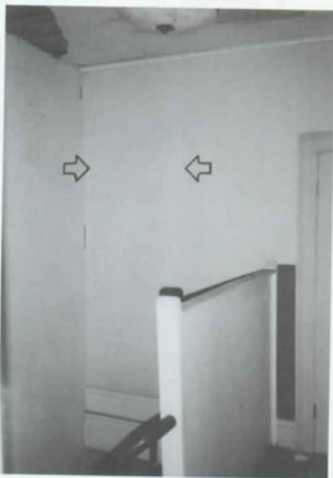
The plaster ceiling in the hall may be original. This ceiling is in poor to fair condition, with a small area of plaster loss exposing the wood lath along the west wall (fig. 95).

Figure 95. M'Clintock House: Room 201 (Upper Stair Hall), North Wall (arrows show remnant of original closet partition) [1988].

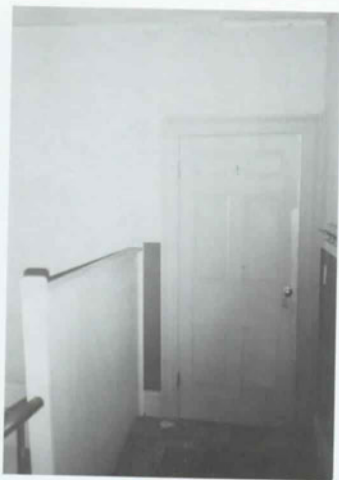
Figure 96. M'Clintock House: Room 201 (Upper Stair Hall), East Side of North Wall, Showing Door Reused from Former Closet [1988].

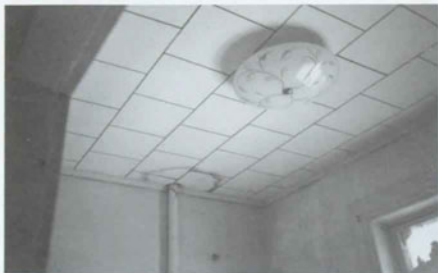
The ceiling in the toilet room is covered with acoustical ceiling tiles that measure 12 inches square (fig. 100). The perimeter of the ceiling is finished with a wood molding. Both were no doubt installed in the late 1950's when the toilet room was created. The tiles are in good condition, except for a water stain around the vent at the west wall. It is not known if the original plaster ceiling survives above the tiles.

Figure 100. M'Clintock House: Room 201, North End (Toilet Room), Ceiling Looking Northwest [1988].

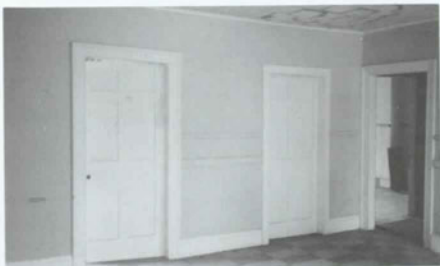
The ceiling is covered with acoustical tiles that measure 12 inches square (fig. 102). The perimeter of the ceiling is rimmed by a wood molding in cornice position. The tiles are in generally poor condition, with water stains in the center (at the light fixture) and at the west wall. The tiles probably date to the late 1950's. The condition of the ceiling above the tiles is not known.

South Doorway, East End of Wall. This original doorway (fig. 102, left) connects with the small bedroom in the southeast corner of the house (Room 203). While physical evidence uncovered in 1993 found that the doorway opening had been originally framed as a wall, it appears that the doorway was in place when Room 203 was plastered. This alteration may have occurred during construction circa 1835. See the subsequent section, "Room 203, Doorways," for details.

West Doorway. This doorway (fig. 102, right) is the primary entrance into the room, leading from the upper hall. It was initially thought that this doorway was in its original, unaltered location. However, additional physical evidence uncovered in 1993 proved that the doorway had been moved to its present position in the late 1950's. Stud mortises in the threshold position indicate that the present doorway was originally framed as a wall. Other physical evidence identified the original doorway to Room 201 as being farther north in the east wall.

South Doorway, West End of Wall. This doorway (fig. 102, center) provides access from Room 202 to the east half of Room 204. It is not original, although it does incorporate some original material. The architrave consists of plain boards and is clearly not original. However, the six-panel door is old, reused material, based on its mortised construction and paint

Figure 102. M'Clintock House: Room 202 (Northeast Bedroom), Looking Southwest [1988].

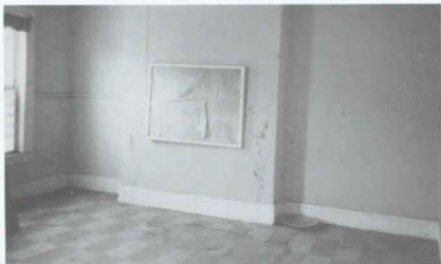
The floor is covered with asphalt tiles, 9 inches square, that are laid in alternating colors of brown and tan (fig. 104). They were most likely installed in the late 1950's. It is not known if the old floorboards survive beneath the tiles. The floor itself sags from east to west, with the lowest point at the southwest corner of the room.

A piece of original baseboard was removed from the south wall where the west-end doorway was added in the late 1950's. A section of original, reused baseboard has been installed across the closed-up fireplace firebox on the east wall (fig. 104). It probably came from the north end of the upper hall when the toilet room was installed there, based on its molding style and paint layering. Another piece of original baseboard was also removed from the south end of the west wall when the existing doorway to Room 201 was installed in the late 1950's. The baseboard segment may have been reused at the original doorway location (which was filled in at that time), near the north end of the west wall.

Figure 104. M'Clintock House: Room 202 (Northeast Bedroom), East Wall, Showing Chimney Breast Lacking Fireplace Mantel [1988].

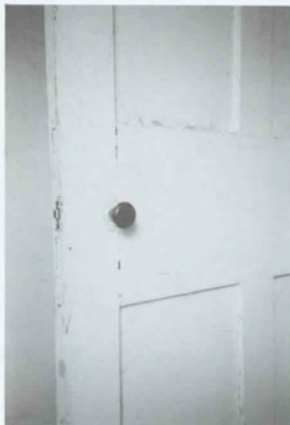
The architrave is original and identical in style to the architrave of the west doorway. The six-panel door (fig. 105) swings into Room 203. It appears to be original, based on the paint analysis, its mortised construction, and the lack of physical evidence for an earlier door. The door measures 34 inches wide by 82 inches high by 1 1/4 inches thick. The panels are recessed and unmolded on both sides.

Figure 105. M'Clintock House: Room 202 (Northeast Bedroom), South Wall, Original Doorknob on East Door [1988].

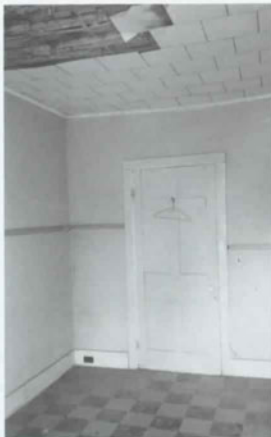
The floors of both the west and the east halves of the room are covered with asphalt tiles that are 9 inches square and laid in alternating colors of brown and tan (fig. 110). These are believed to date to the late 1950's. No tiles have yet been removed, but they probably were laid on top of the original floorboards, as was done in Room 203. The only area where the old floorboards are exposed is the closet in the southwest corner of the west half of the original room. The floor itself has a noticeable slope from south to north, with the lowest point being at the north wall.

Figure 110. M'Clintock House: Room 204 (Southwest Bedroom), East Half Looking Northwest [1988].

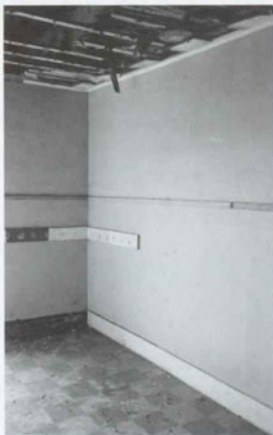
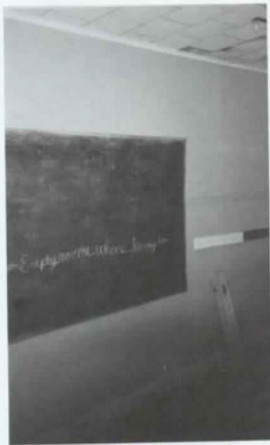
The north-south partition wall that divides the room in half is finished with plasterboard (figs. 113, 117). The wall was most likely installed in the late 1950's.

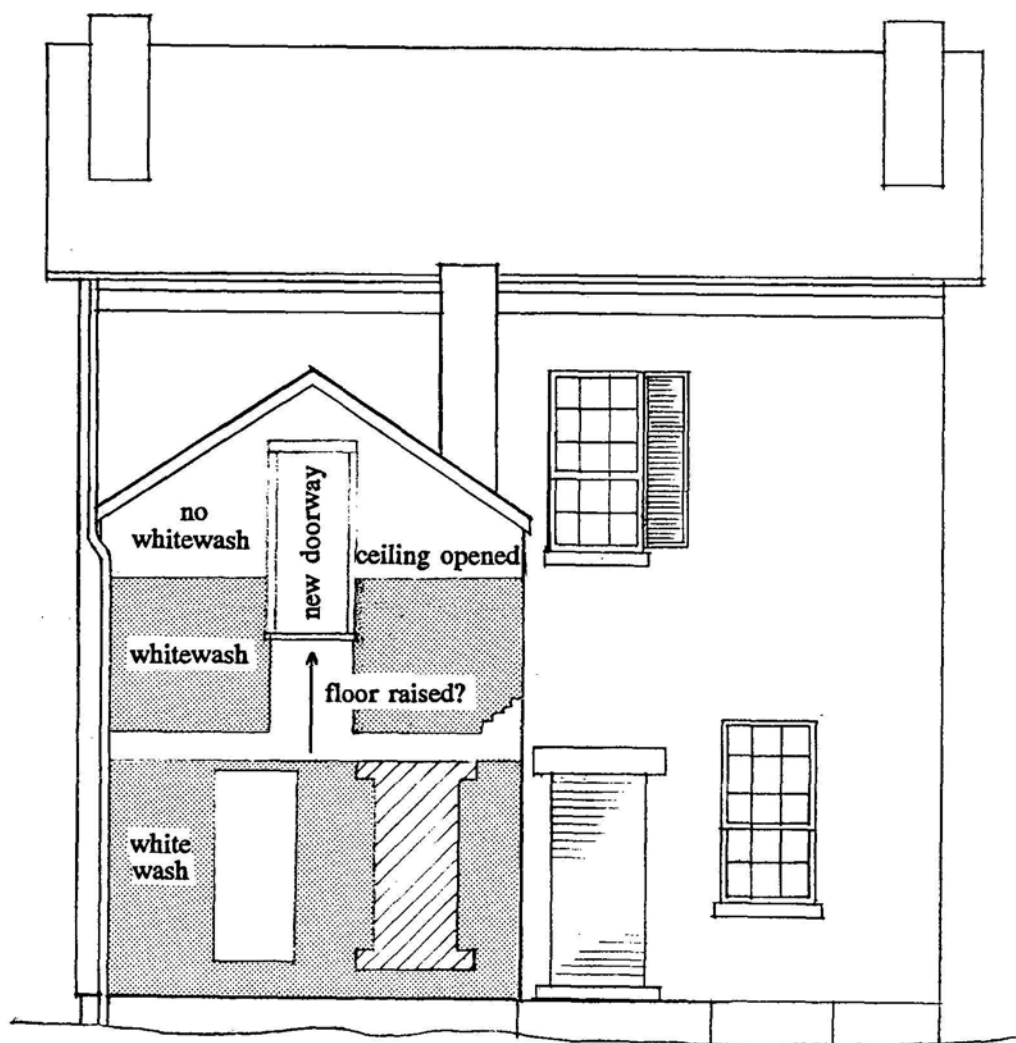
The architectural investigation confirmed a circa-1894 date for this alteration work and provided some idea of what it involved (see figure 119). It appears that a second-story doorway (extant today) was created in the south brick wall of the main house, to link the second story of the wing to the main house. Specific evidence that the doorway is a later addition includes the broken brickwork around the doorway opening and the associated portland-cement mortar. It was initially thought that the doorway was created from an original window. However, a careful search failed to uncover any physical evidence of a former original window lintel above the doorway.

Figure 119. M'Clintock House: Diagram of Physical Evidence Suggesting Probable Alterations to Second Story of South Wing, Circa 1894.
