The History and Architecture of the **POINT REYES LIFEBOAT STATION**

Historic Structure Report

by
DEWEY LIVINGSTON
HISTORIAN, POINT REYES NATIONAL SEASHORE
and
STEVEN BURKE
HISTORICAL ARCHITECT, DENVER SERVICE CENTER

POINT REYES
NATIONAL PARK SERVICE
1991

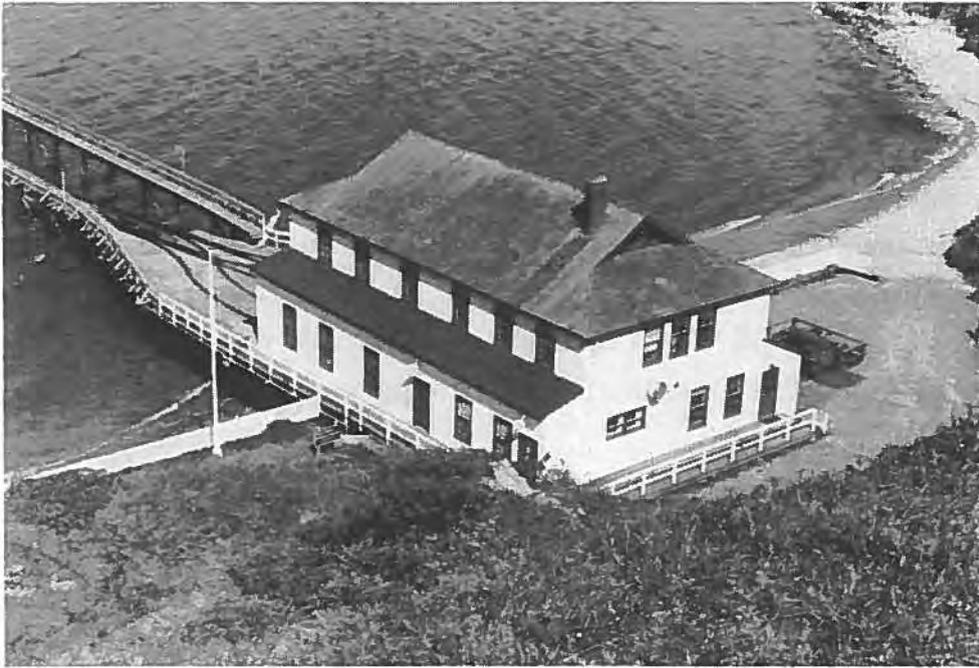
Figure 1 - Southwest view of boathouse and launch ramp from above.

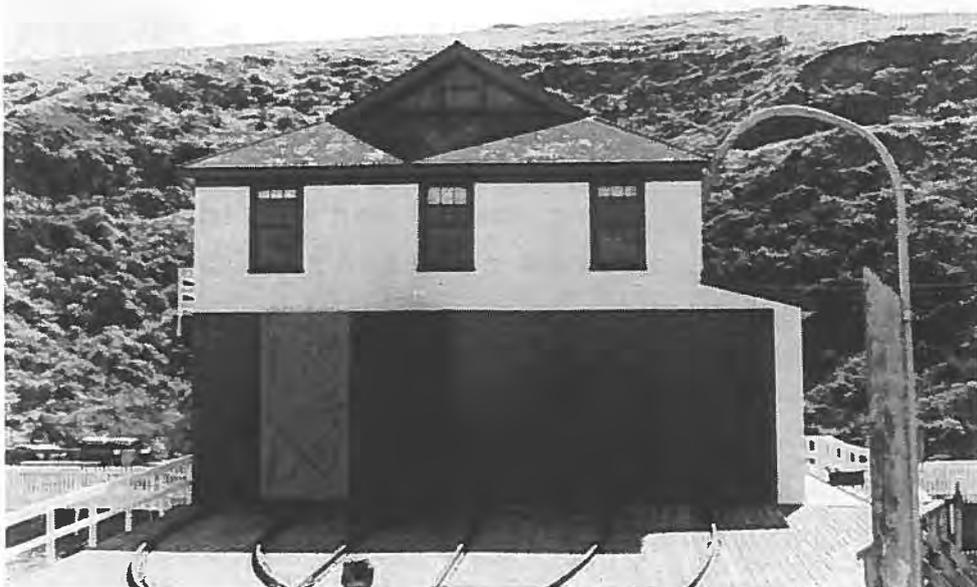
Figure 2 - North elevation of the boathouse showing wall openings.

The boathouse, simple in form, is punctuated heavily by windows and doors on all four elevations. The north elevation (facing Drakes Bay) consists primarily of three very large double doors, designed to be accessible for storage of the motor lifeboats. The large type T 36-foot motor lifeboat was stored in the center bay while the 26-foot rail-launched surfboats were stored in the end bays. Also on the north elevation are three double-hung windows on the second story of the building (above the boat doors) and three small windows in the attic gable of the roof (Figure 2).

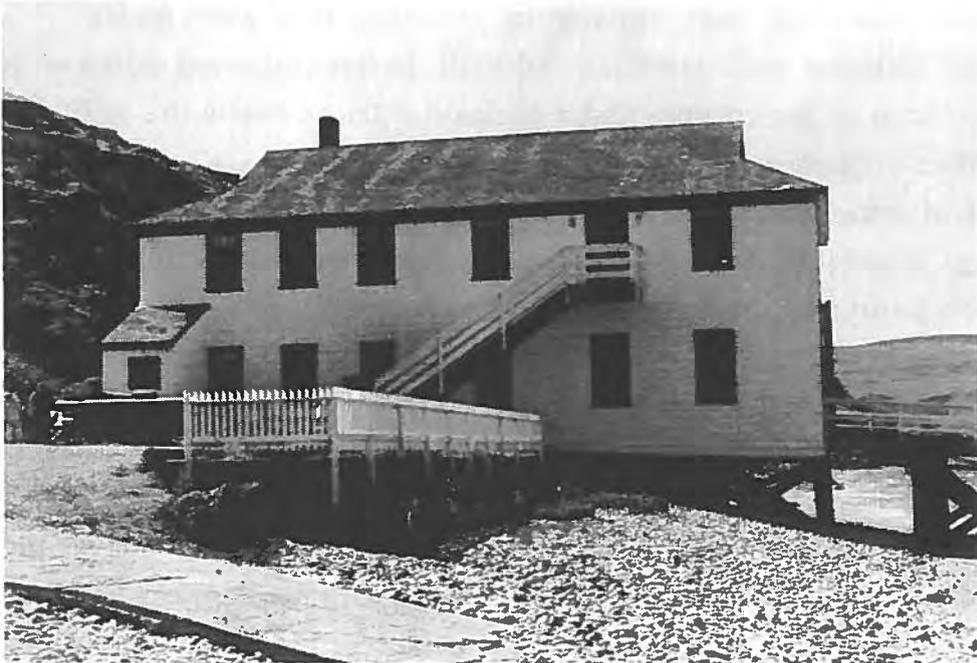
The east elevation exhibits two rows of six windows each, one row on the first floor and one row on the second floor. All openings on the east side are uniform in size except those windows which are located on the shed entry room and at the landing of the first floor stair. The east elevation of the entry room has a small, 2-over-2 wood window (Figure 3).

Figure 3 - East elevation of the boathouse showing wall openings.

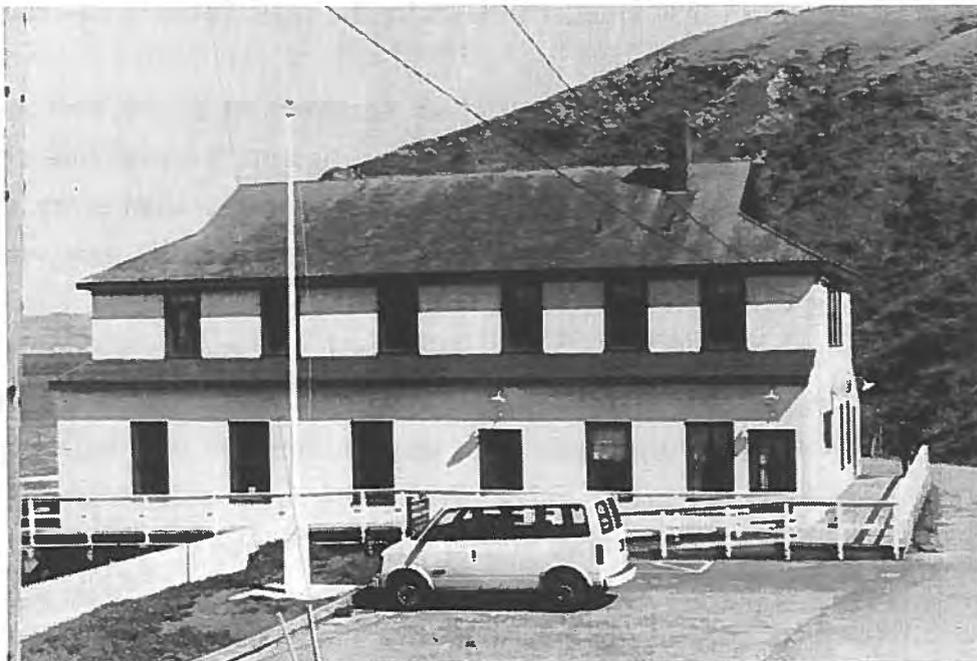
Figure 4 - West elevation of boathouse showing wall openings

The west elevation is similar in design to the east with the exception of the 1946 addition which expanded the first floor. A shed roof covers the addition. The window placement in the addition remains similar to the original configuration, with five double-hung windows on the first floor and six windows on the second. Two doors are located on this elevation, one which leads directly into the boat room and the other into the kitchen (Figure 4).

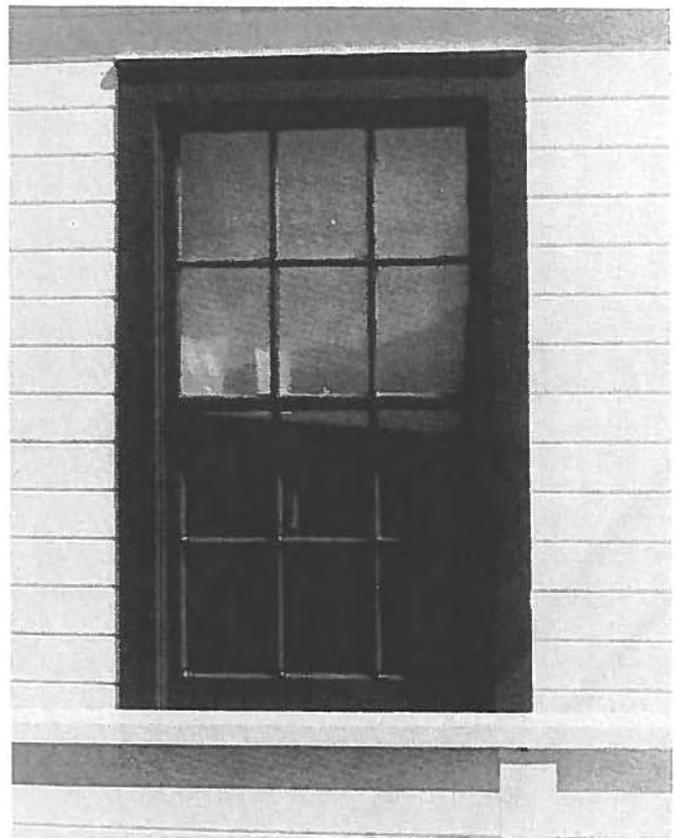
The existing windows in the boathouse are important historical features to the building. All the windows in the structure are wood double-hung with the exception of the two small windows in the gable ends of the roof (Figure 5). The majority of the windows in the structure are 6-over-6 and are the same size with the exception of the kitchen windows and the window at the landing of the interior stairway. They are all smaller.

Figure 5 - Typical double-hung window on boathouse.

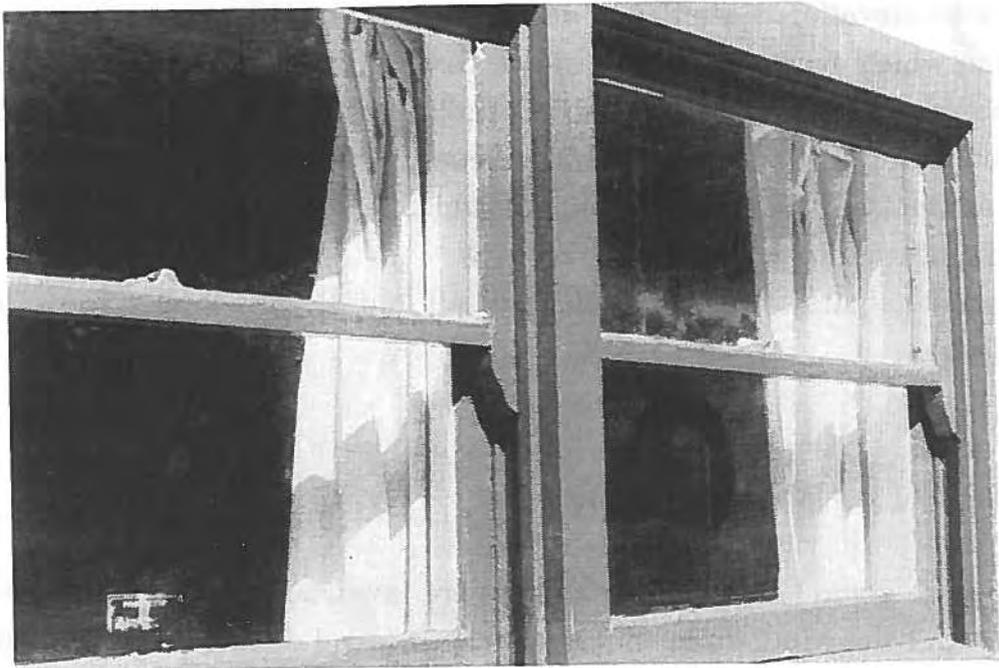
All window sashes are simple in design and show little ornamentation other than the kitchen window and the window located on the second story, east side, first window from the south. The upper stile of these windows extends below the upper meeting rail. Several windows in other structures at the lifeboat station, including the residence, garages, pumphouse and other private structures in the immediate area also

Figure 6 - Kitchen windows showing decorative upper stiles.

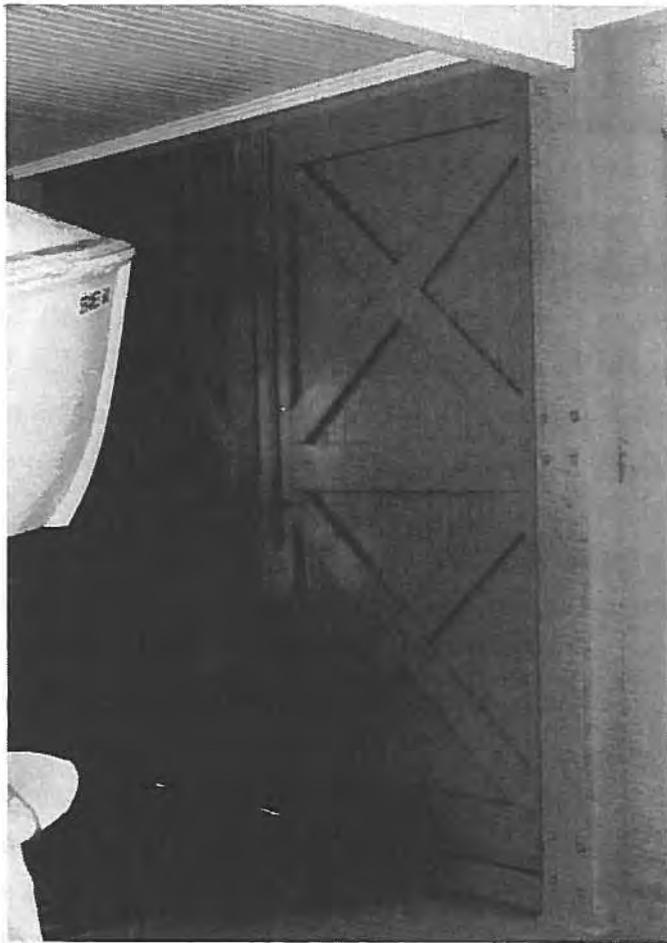
*Figure 8 - View of
inside of large
double boat doors.*

All three doors are raised above the floor by a six-inch wood curb. The doors are in excellent condition and function properly. A missing part of the door system is the 4" x 4" vertical post which acted as a door stop/hold. The post originally went through the floor of the launchway and was bolted to the frame from below. Recently, this post was cut level with the floor surface (Figure 9).

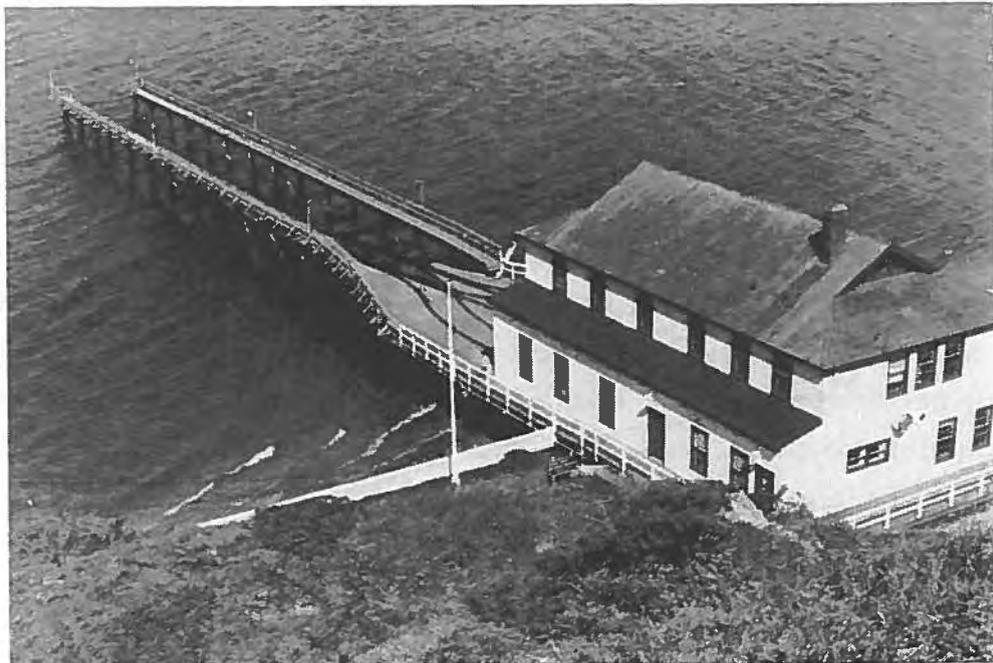
The Point Reyes Lifeboat Station boathouse has a hip roof on the original portion of the building, and shed roofs on the 1946 west addition and east entry room. The hip roof, on the north and south ends of the structure, rises to a point where it dies into a windowed gable (Figure 10).

Roofing material on the original building portion is wood shingles attached to 1" x 6-3/4" tongue-and-groove sheathing on 2-1/8" x 7-1/2" rough-sawn rafters. The ridges are covered with shingles. The existing shingles were painted red when installed in 1976. Weathering during the intervening 15 years has resulted in a worn and faded appearance. This roof portion shows years of wear with cupped and missing shingles.

Figure 10 - View of boathouse showing hip, gable and shed roof configurations.

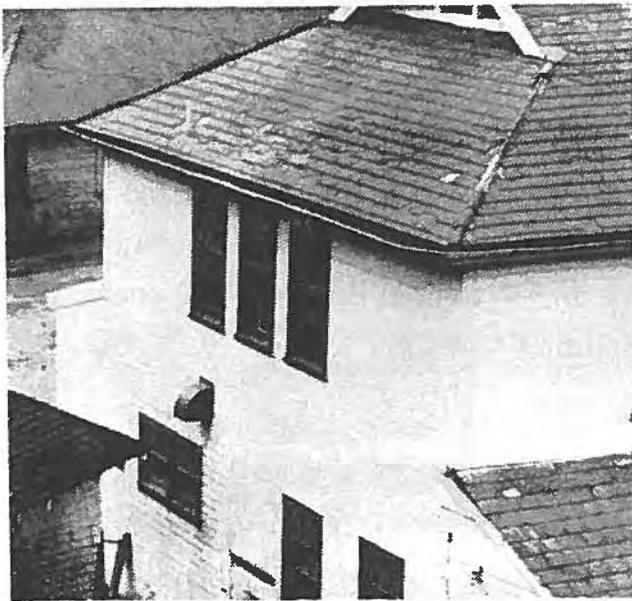
At the present time the boathouse has no gutters or downspouts. Historical photographs show that the building had metal gutters in 1956 (Figure 11); at one time it may have had wood gutters similar to those currently found on the residence and other outbuildings at the Point Reyes Lifeboat Station. Though the building has recently been repainted, depressions in the siding and on the fascia indicate where the original downspouts and gutters were once attached (Figure 12).

*Figure 11 (above) - Detail of 1956 photo showing metal gutters (U.S. Coast Guard).
Figure 12 (right) - Indentation in siding from old downspout.*

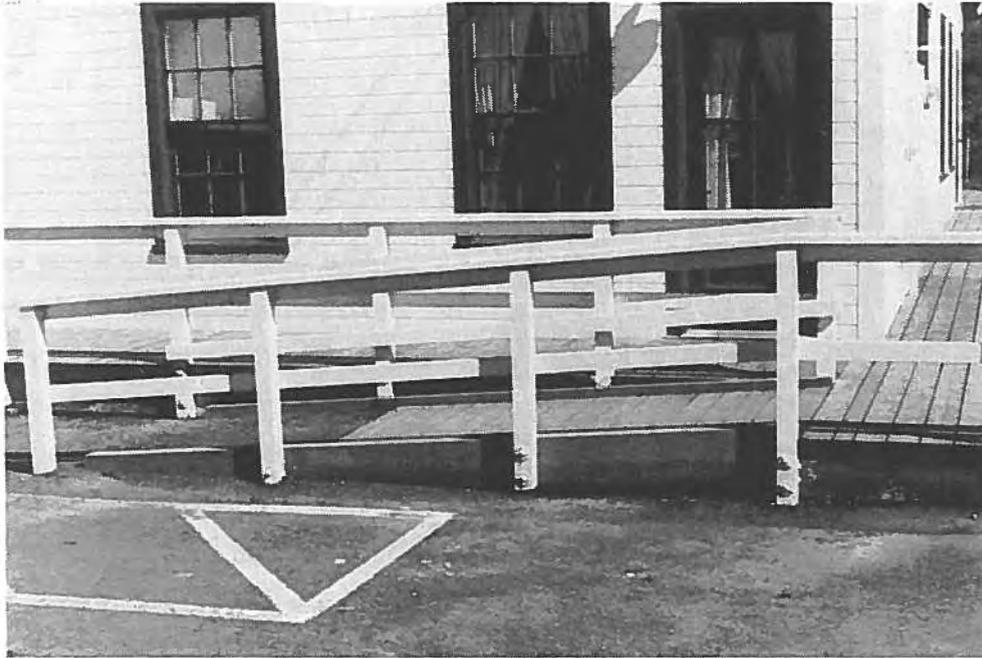
During the 1988-89 rehabilitation, the walkway on the west side of the building was rebuilt and a new wider walkway added to the south side of the structure. By providing this walkway, a formal entrance to the kitchen and mess hall was established. A handicapped accessible ramp at the southeast corner of the walkways (for access to the east and south walkway), was also constructed during the 1988-89 rehabilitation (Figure 13). The walks are wood frame construction with 4" x 4" vertical posts, 2" x 4" rails and 2" x 6" treated decking. All posts and railings are painted white to match the building's siding.

Figure 13 - New handicap accessible ramp and footwalks on the east and south elevations of the boathouse.

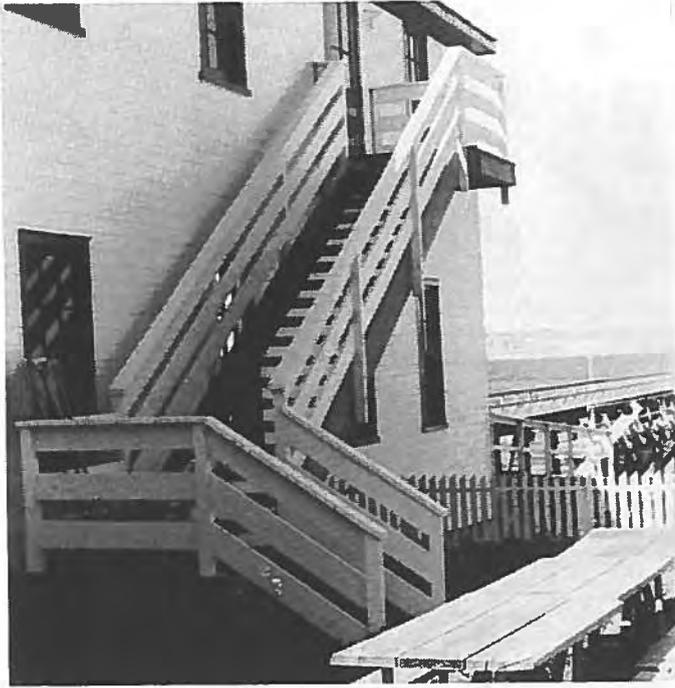
The exterior stair, designed and constructed by the park, consists of 4" x 14" rough sawn timber stringers attached to cantilevered joists at the top of the stair. The cantilevered landing consists of 4" x 10" joists extending into the structure 12' 0" and bolted to the existing second floor joists. The stair treads consist of 4" x 14" rough sawn timbers attached to the stringers by bolts through steel angles. Two steps up from ground level is another landing consisting of timber joists with 2" x 6" decking.

Figure 14 - Exterior stair on east elevation of boathouse.

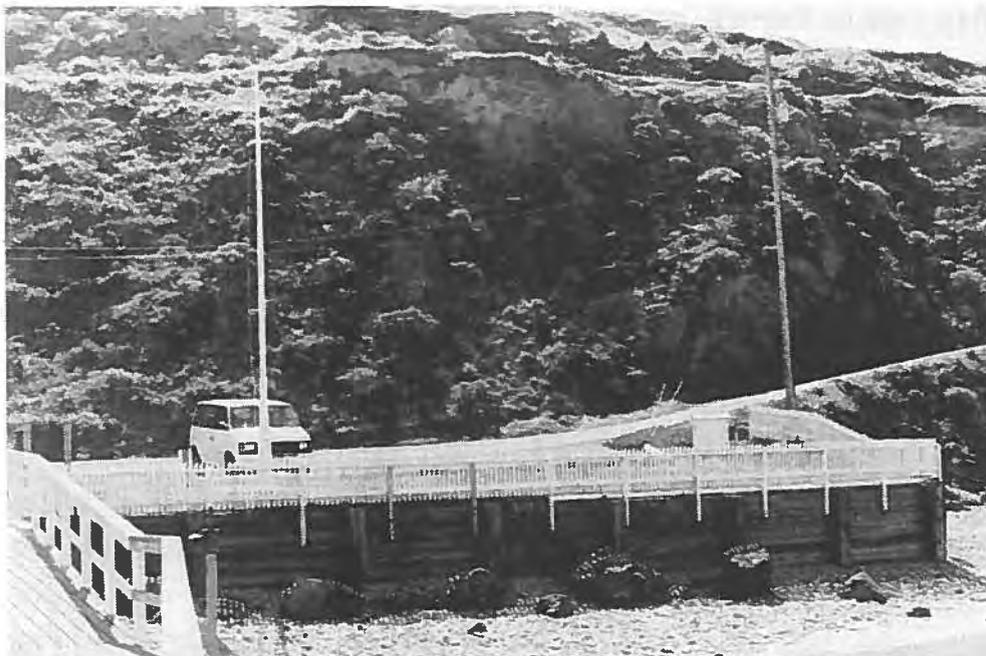
A white picket fence is found on both the east and west sides of the boathouse on the cribbage that was originally built as a retaining wall to provide an area for parking near the building. Because historical photographs show a picket fence in this location, a new one of similar appearance to the original was built in 1990. Pickets are approximately 3'-0" high, made of 1" x 3" boards and cut off at the top at a 45-degree angle (Figure 16).

Figure 16 - Picket fence, flagpole and small building west of boathouse.

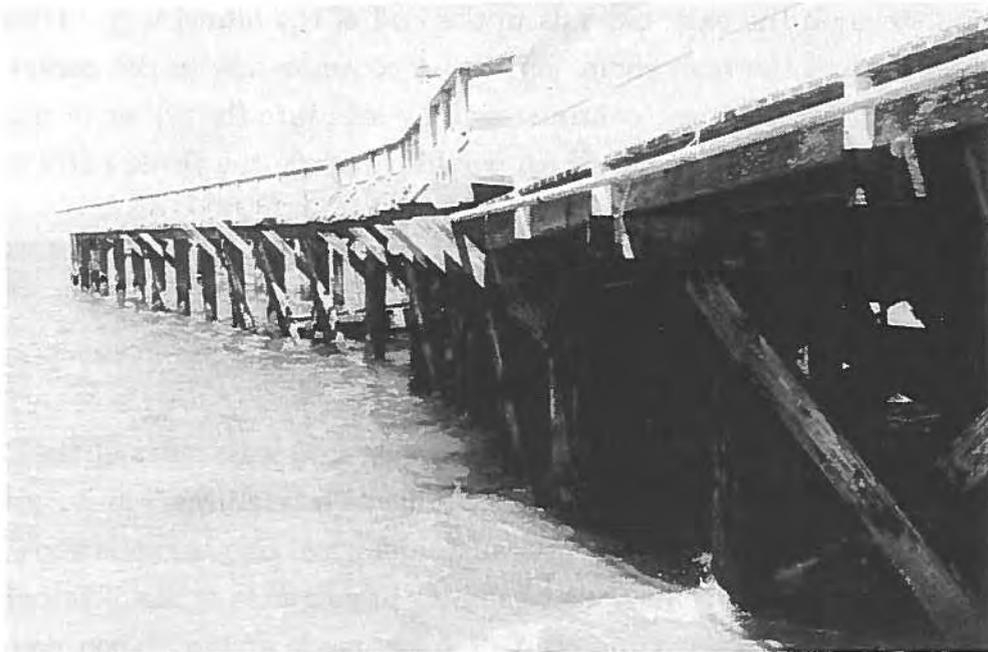
Figure 17 - Launch ramp from west side.

The existing launchway dates from 1946. A recent inspection report (Baumgard DSC, 1991), temporary stabilization in 1989, and some emergency stabilization executed in 1975-76, substantiates the need for a thorough structural analysis leading to recommendations for the launchway (Figure 17).

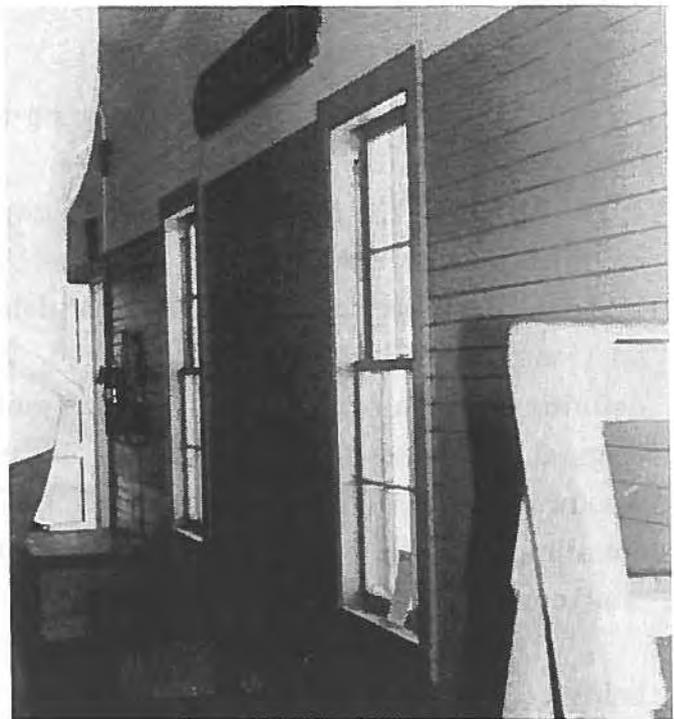
The boat room walls and ceiling are sheathed with 1" x 3" tongue-and-groove wood siding (Figure 18). The lower portion of the walls and all of the window and door trim are painted grey while the upper portion of the walls are painted yellow. The grey color on the lower portion of the walls steps up and down at different

Figure 18 - Tongue-and-groove walls, floor, and ceiling in boatroom.

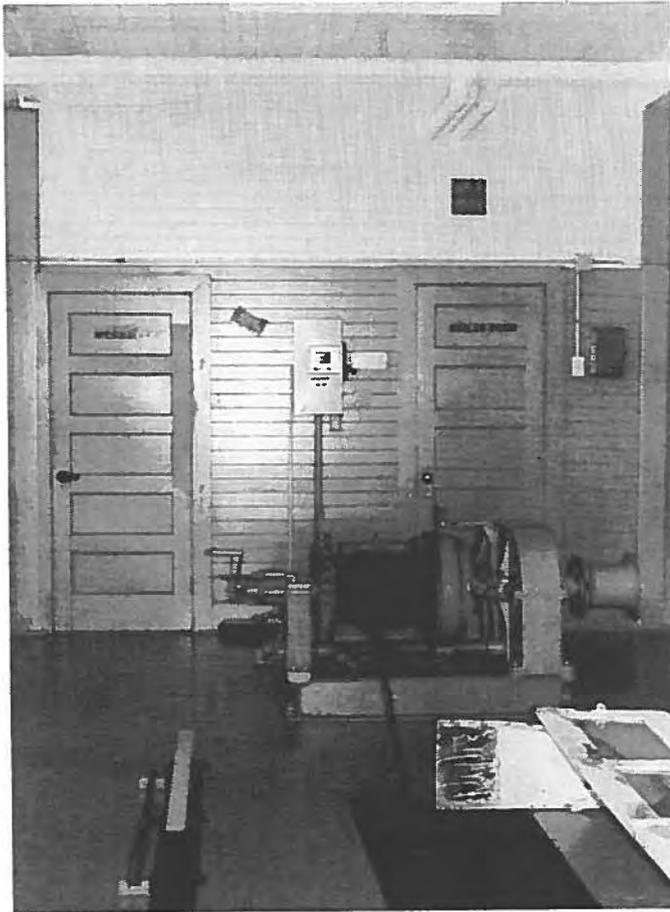
Figure 20 - Original wood-paneled doors in the boat room.

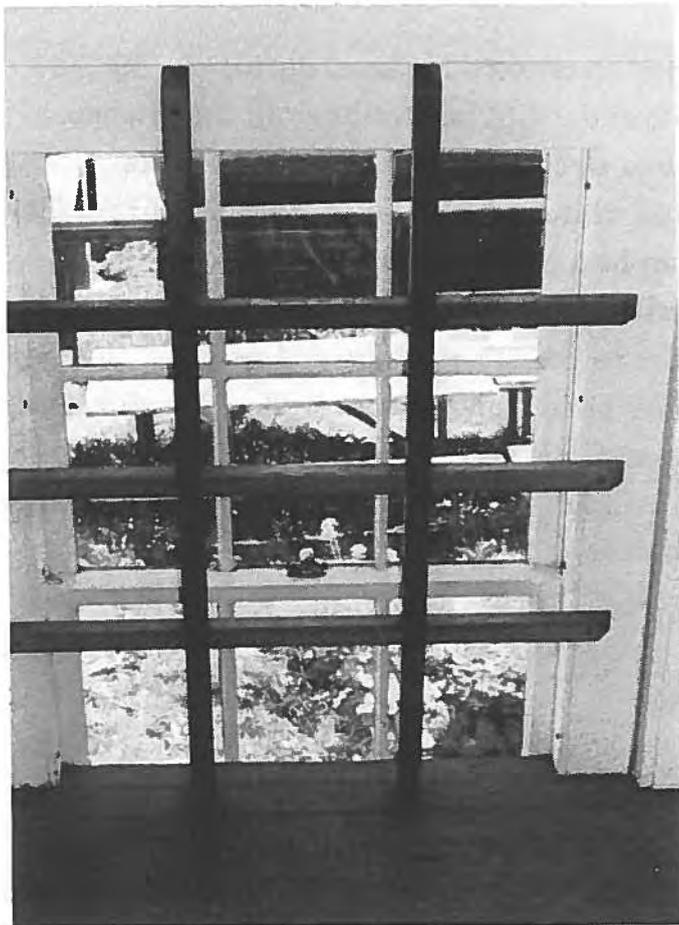
Figure 21 - Window with new grid at stair landing.

Because windows in the building have not been altered, the original window trim remains intact. Also, because a window is located at the landing of the stair, an unpainted wooden grid was mounted to the inside window frame to protect it from damage. The contemporary-looking grid consists of 2" x 2" boards, cross lapped and finished with a polyurethane sealer. The grid is attached to the inside window frame with screws (Figure 21).

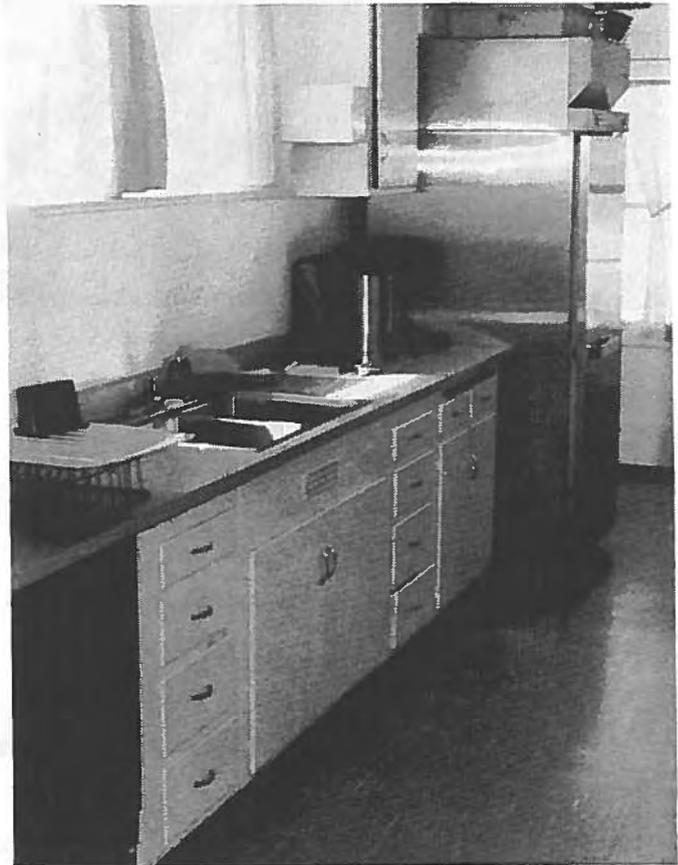
The kitchen base cabinet has doors under the sink, with drawers on each side. Another set of cabinet doors is located on the west end of the base cabinet with two drawers above. Above these drawers, just under the counter top, is a pullout cutting board. On the east side of the base cabinet, next to the dish washer, is a single cabinet door. Base cabinet doors, drawers and frames are constructed of both solid woods and plywood. On the east side of the windows, three upper cabinets extend up to a soffited ceiling, while on the west side of the windows only one upper cabinet still exists (Figure 22).

Figure 22 - Kitchen, with upper and lower cabinets, new appliances, and new floor tile.

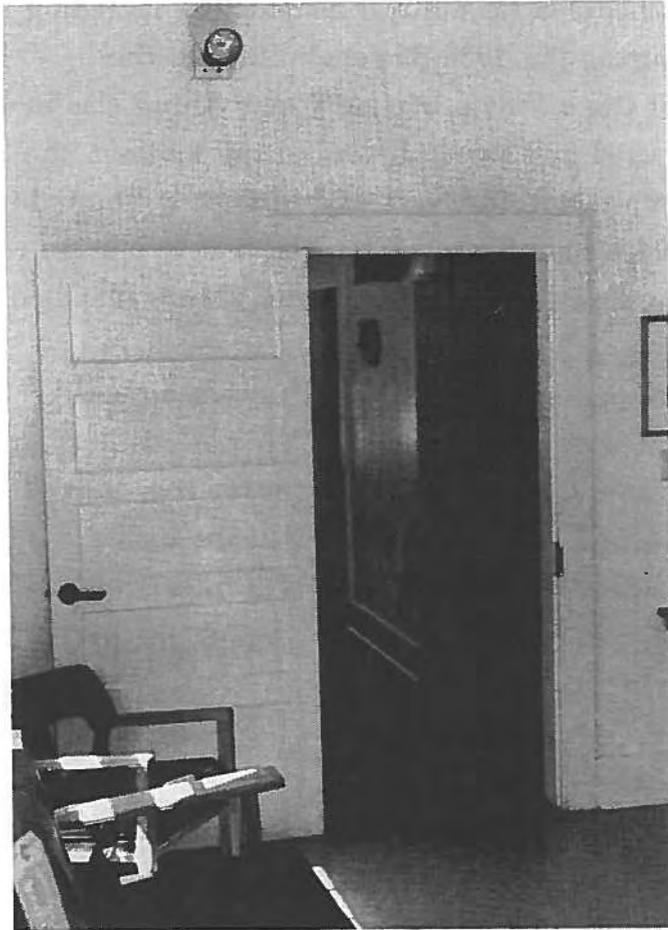
Figure 23 - New wood-paneled door between mess hall and kitchen.

Three doors were installed during the 1988-89 building rehabilitation (Figure 23). The doors, one linking the mess hall to the kitchen, one the kitchen to the handicap accessible sleeping room, and one the handicap accessible sleeping room to the handicap accessible bathroom, are painted white and measure 3'-0" x 6'-8". Specifically manufactured to match the existing historical doors, the new doors are solid core and each feature five equally spaced raised panels.

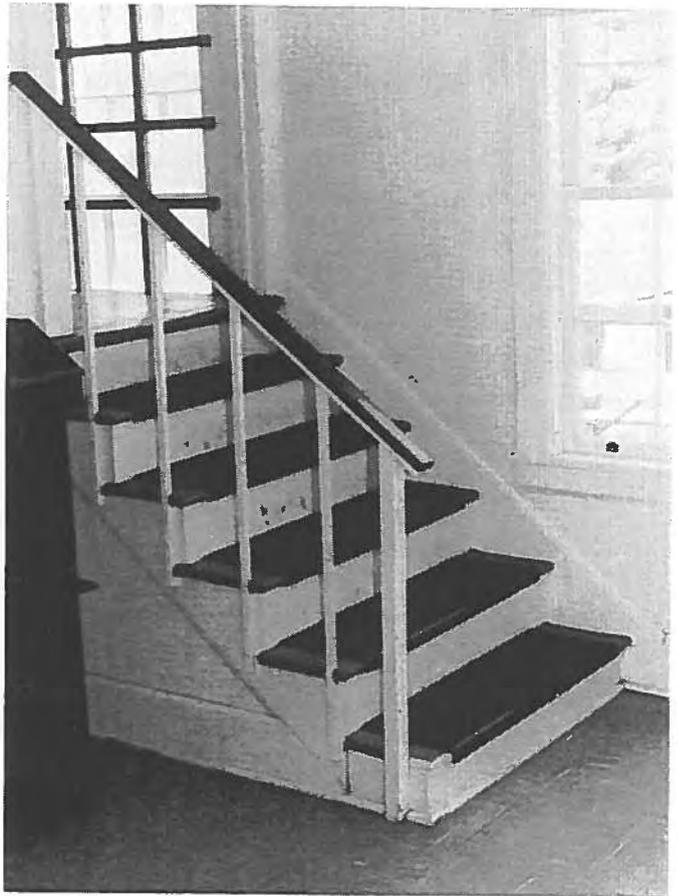
Because the lower portion of the stair protrudes out into the mess hall, a guard rail was provided on the left side. Still original to the stair, the guard rail consists of five tubular metal balusters extended down and bolted to the stringer. The top rail of the balustrade consists of two parts, a metal rail welded to the balusters and a wood rail mounted to the top of the metal rail (Figure 25).

Figure 25 - Lower portion of the first floor stair.

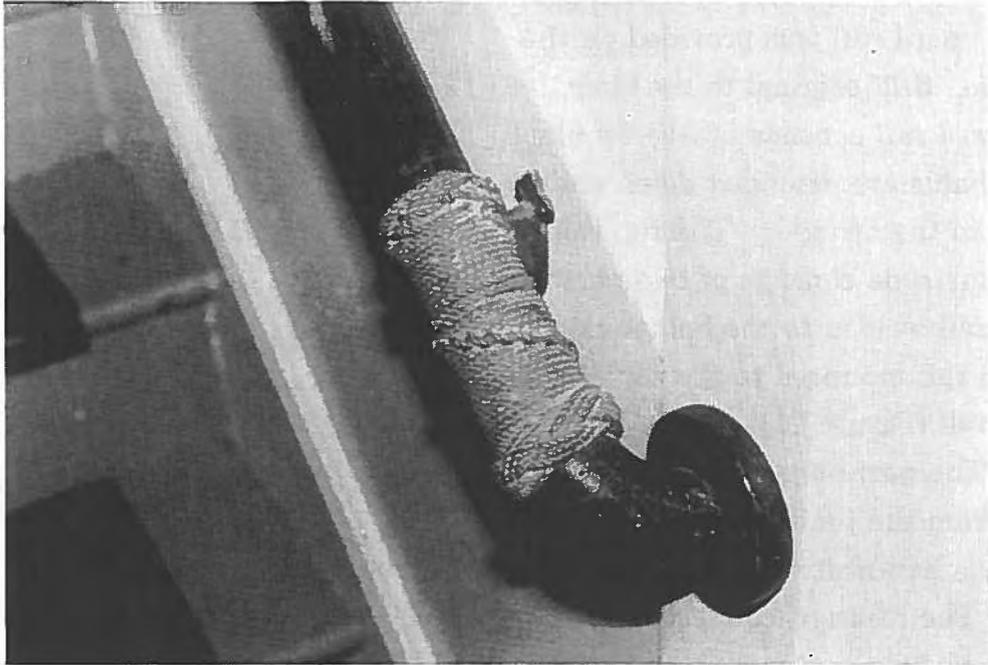
The ends of the railings turn into the wall and are attached to a circular mounting block which is attached to the wall. Immediately before the return, at the top and bottom of both handrails, a nautical-type detail consisting of twisted cord is found. A single strand of cord, twisted and wrapped around the handrail, covers approximately 7" of the railing. At the bottom and the top of the twisted cord detail, two sets of three single twisted strands are braided together and wrapped around the railing. Running diagonally just below the median of the cord cover is a length of two strands of twisted cord, twisted again for a more prominent appearance, and wrapped diagonally around the railing. At the current time, the handrailings and the twisted cord details are in good condition (Figure 26).

Figure 26 - Nautical-type twisted cord detail on first floor stair handrailing.

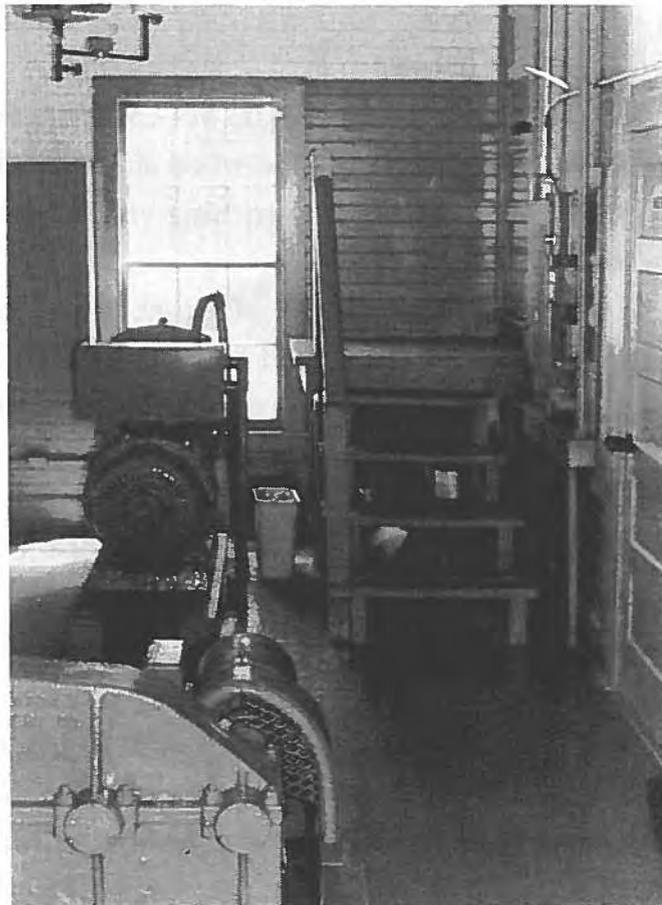
The boatroom stair includes heavy timber stringers with two 2" x 6" boards, spaced about 1/2" apart, for treads. The stair rises from west to east, has four treads, five open risers and a landing at the top constructed of 2" x 6" boards butted together. An open balustrade, consisting of 4" x 4" posts with a rounded 2" x 4" railing, is attached to the landing on the north (open) side of the stair. This stair is painted grey (Figure 27).

Figure 27 - Stair in boat room leading to first floor landing.

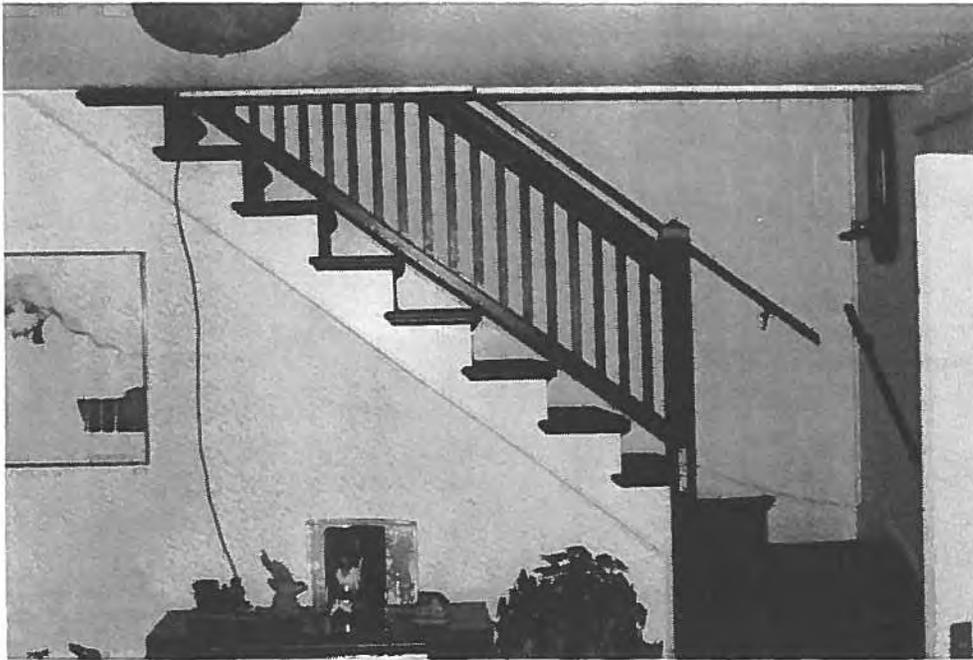
Other than minor maintenance and some cosmetic work, the interior of the residence appears to be in good condition. All interior woodwork, other than the stairs leading from the living room to the second floor, is painted as well as all of the walls. All ceilings have a textured surface. The majority of the interior doors are original, having five raised panels and the original hardware. The kitchen has textured walls and ceilings and several built-in wood cabinets with a plastic laminate counter-top and a stainless steel sink. Several of the light fixtures are original as are plumbing fixtures in the bathrooms. All carpeting is wall-to-wall

Figure 5 - Interior of residence, stairs leading from living room to second floor.

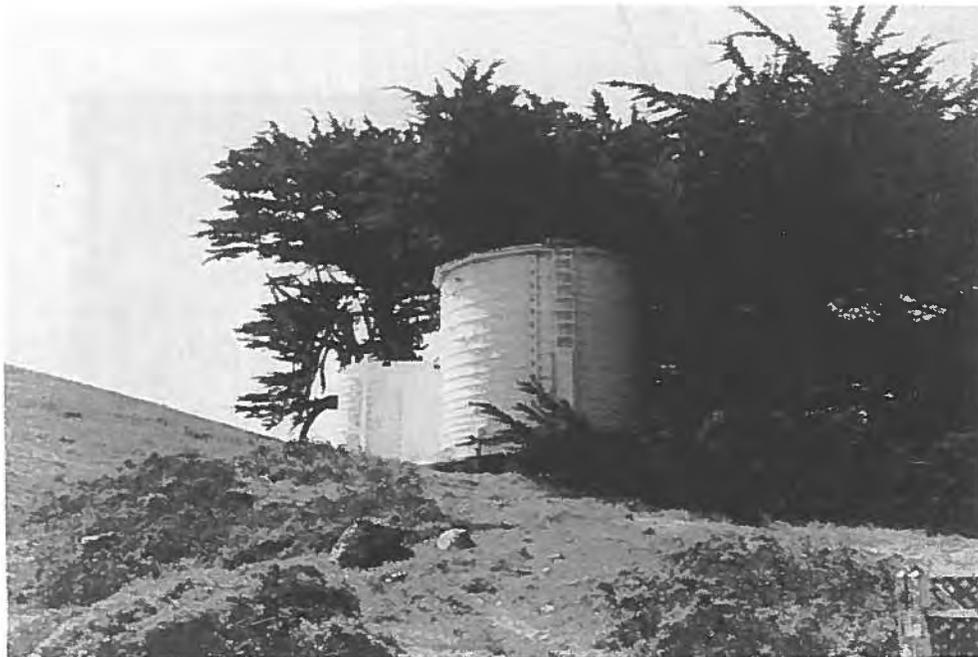
No doubt Fourchy and his superiors used Hunt's report in making a determination to abandon the beach station and build a new one on Drakes Bay. Engineers surveyed the area in 1912 and chose a suitable location near the lighthouse landing, then purchased the property from heirs of Howard in 1913. For a number of reasons, however, no construction occurred for another 13 years. Meanwhile, in March of 1915, the U. S. Life-Saving Service was merged with the

Currently two water tanks are located on the hill just above the residence. Both tanks are constructed of wood and rest on heavy timber mats on top of concrete supports. The larger of the two tanks appears to be the newer of the two, however, both tanks are in good condition. The tanks are constructed of vertical boards tied together with round metal straps. Both tanks are painted white and have ladders leading to the top.

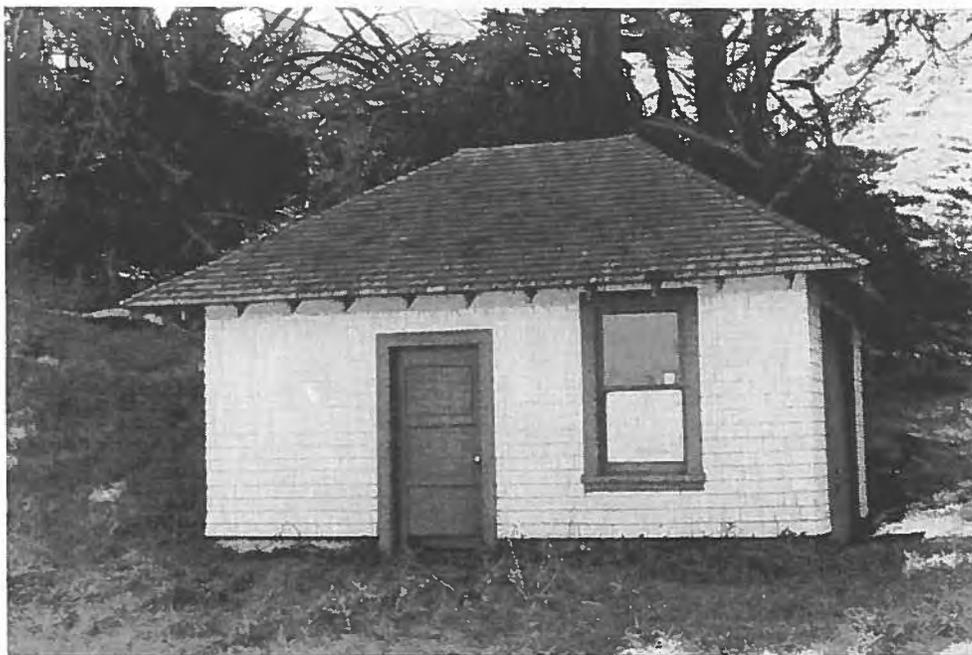
Figure 11 - North elevation of small garage.

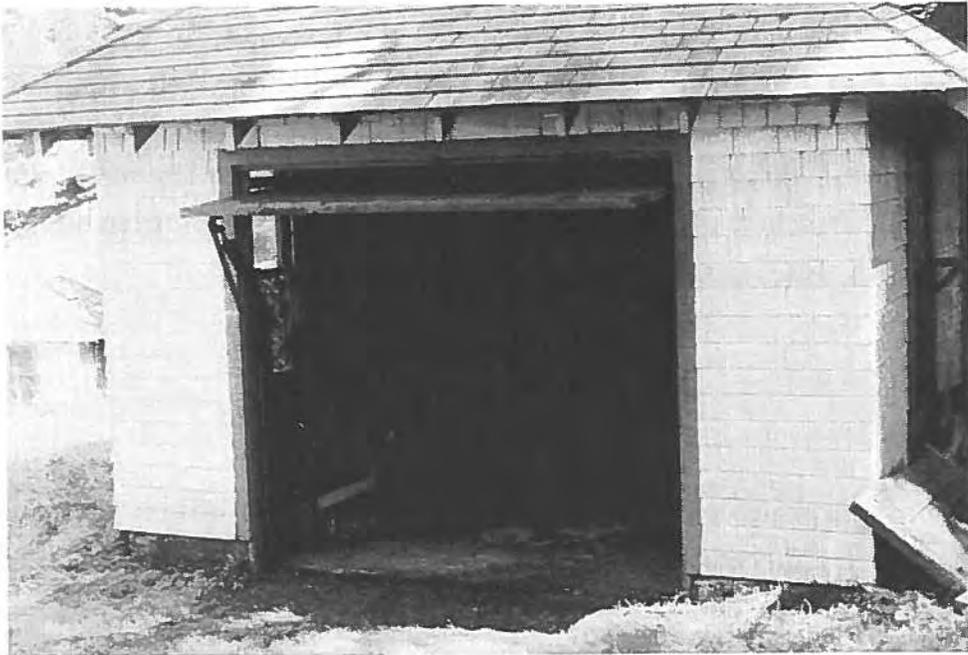
Figure 12 - West elevation of the garage showing overhead door.

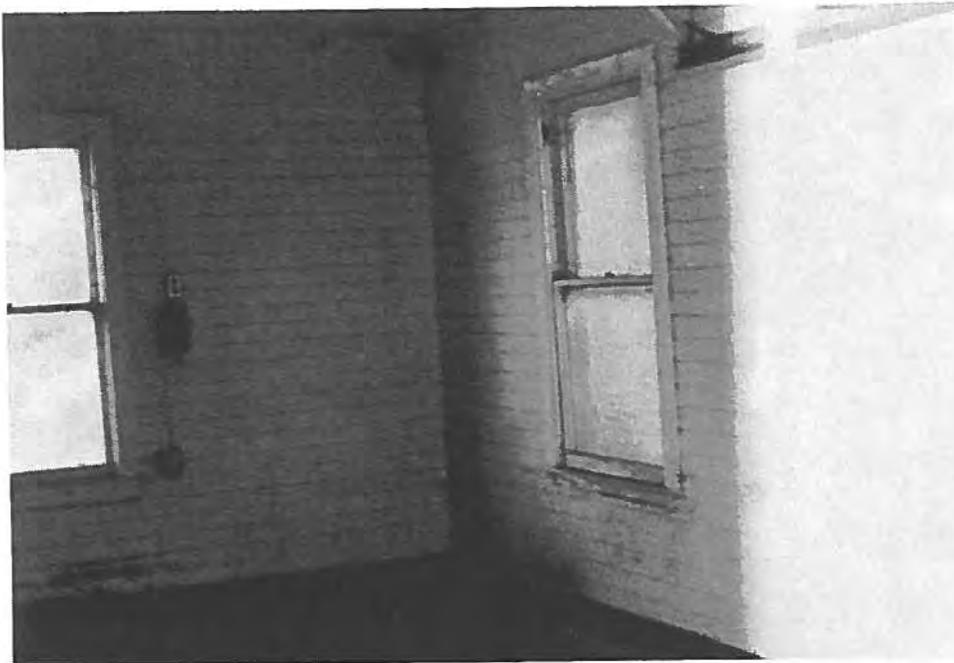
Figure 13 - Interior of small garage.

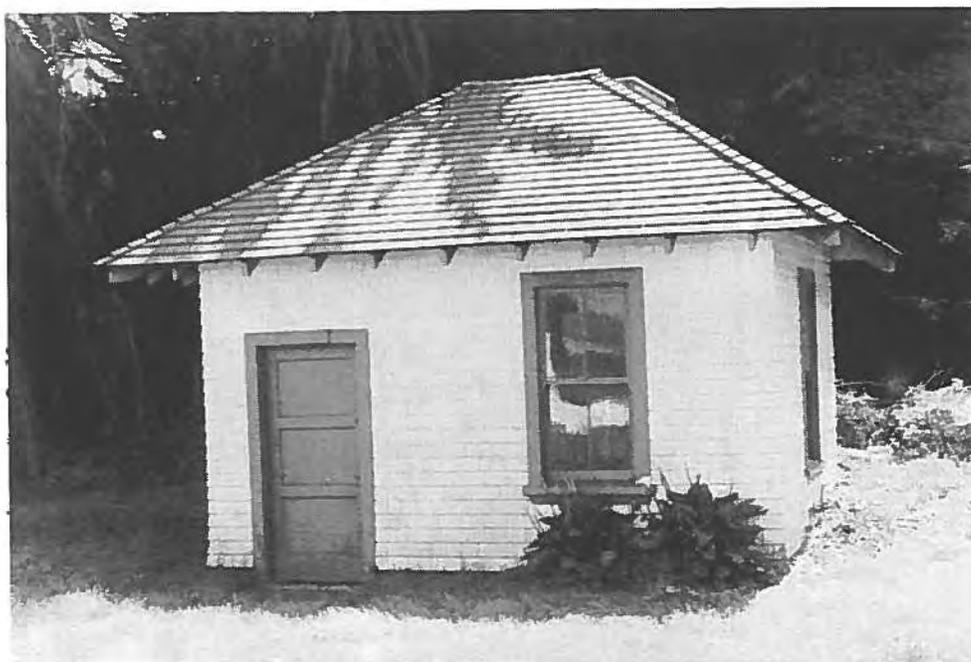
Figure 14 - North elevation of pumphouse.

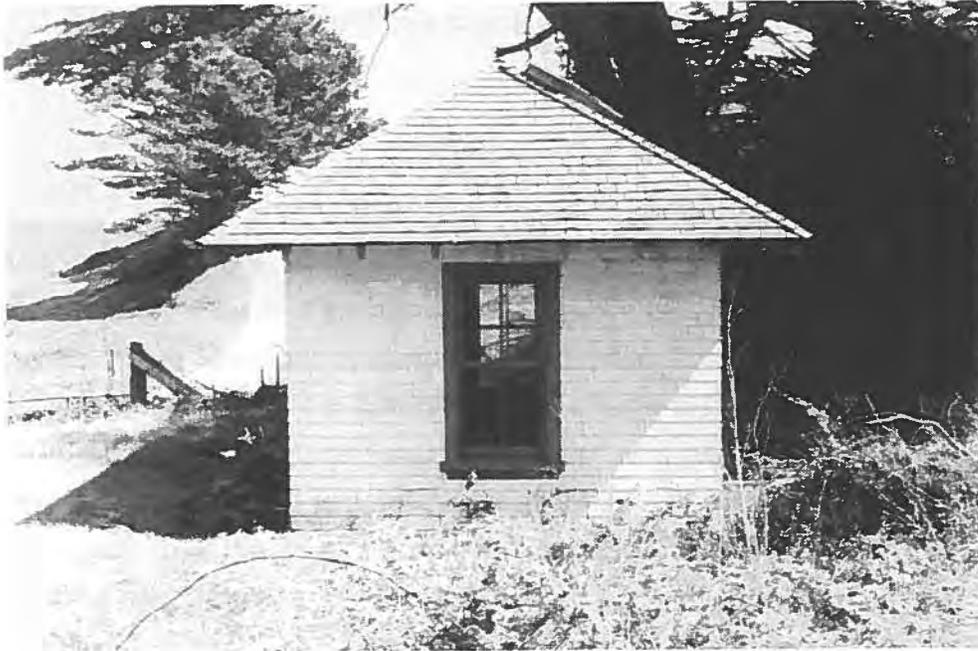
Figure 15 - West view of pumphouse.

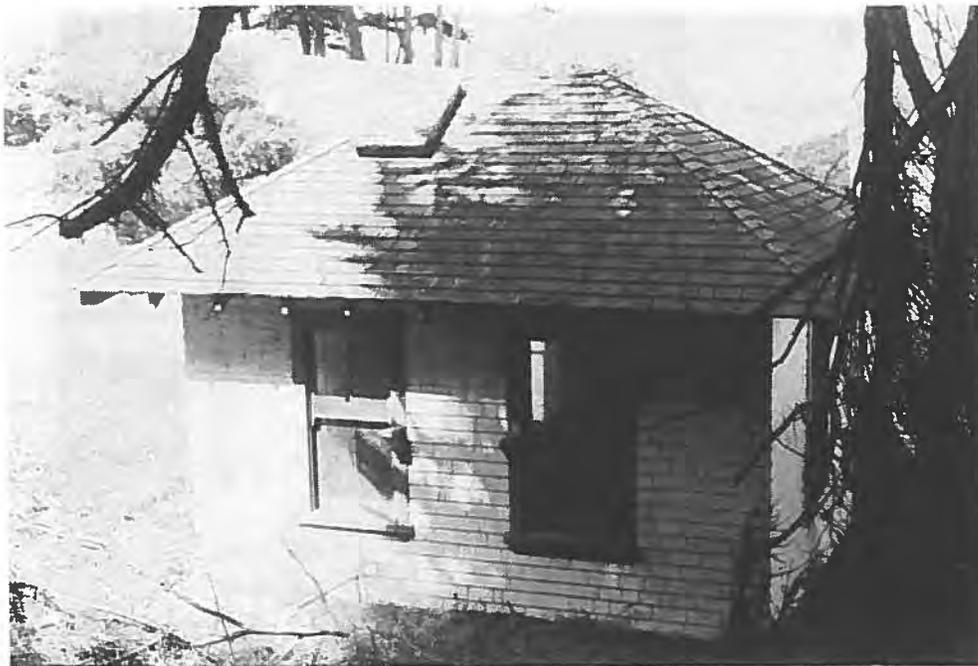
Figure 16 - South elevation of pumphouse showing roof vent.

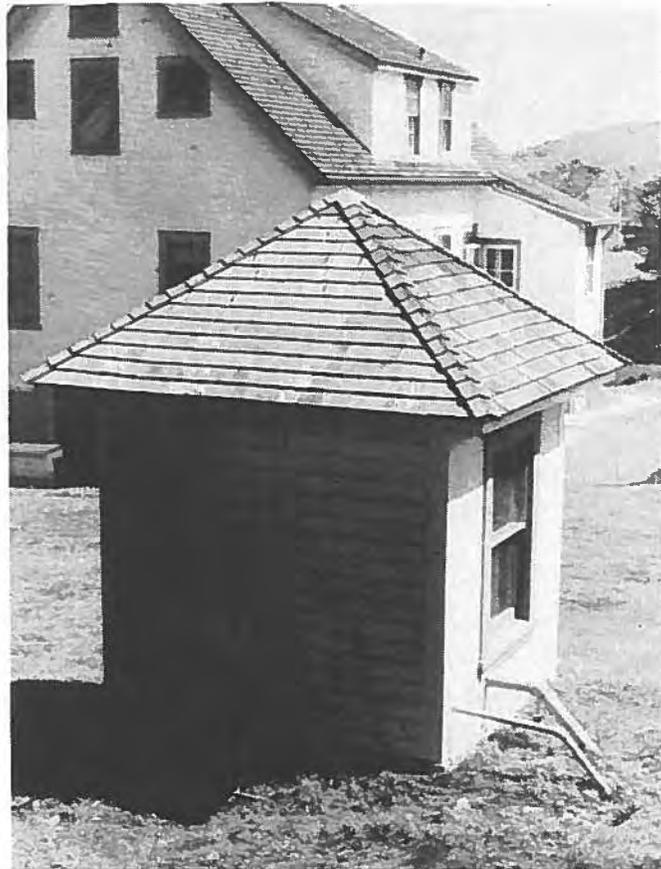
Figure 17 - Southwest corner of fire booster pumphouse.

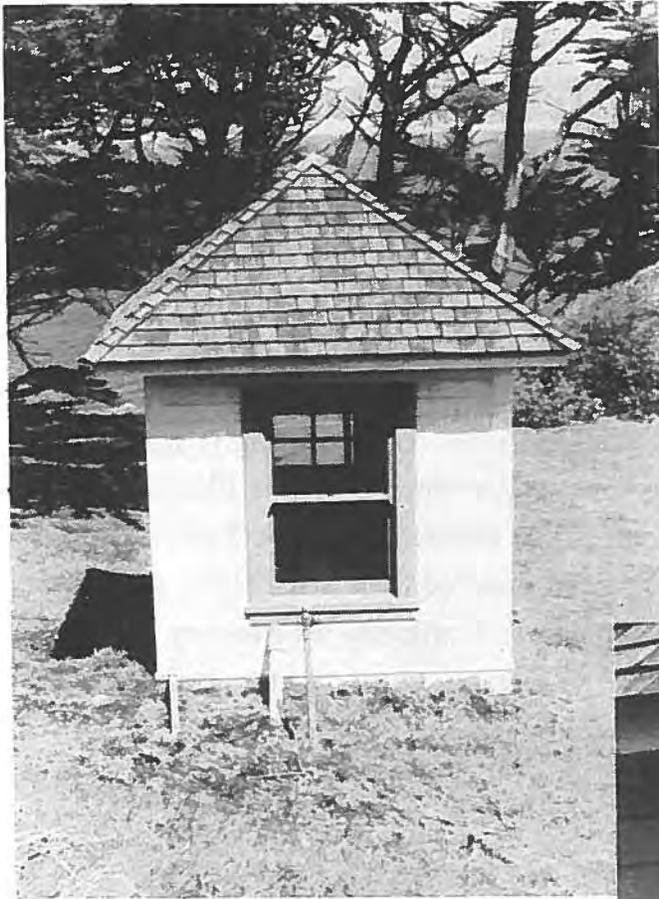
Figure 18 - East elevation of fire booster pumphouse.
