The History and Architecture of the **POINT REYES LIFEBOAT STATION**

Historic Structure Report

by
DEWEY LIVINGSTON
HISTORIAN, POINT REYES NATIONAL SEASHORE
and
STEVEN BURKE
HISTORICAL ARCHITECT, DENVER SERVICE CENTER

POINT REYES
NATIONAL PARK SERVICE
1991

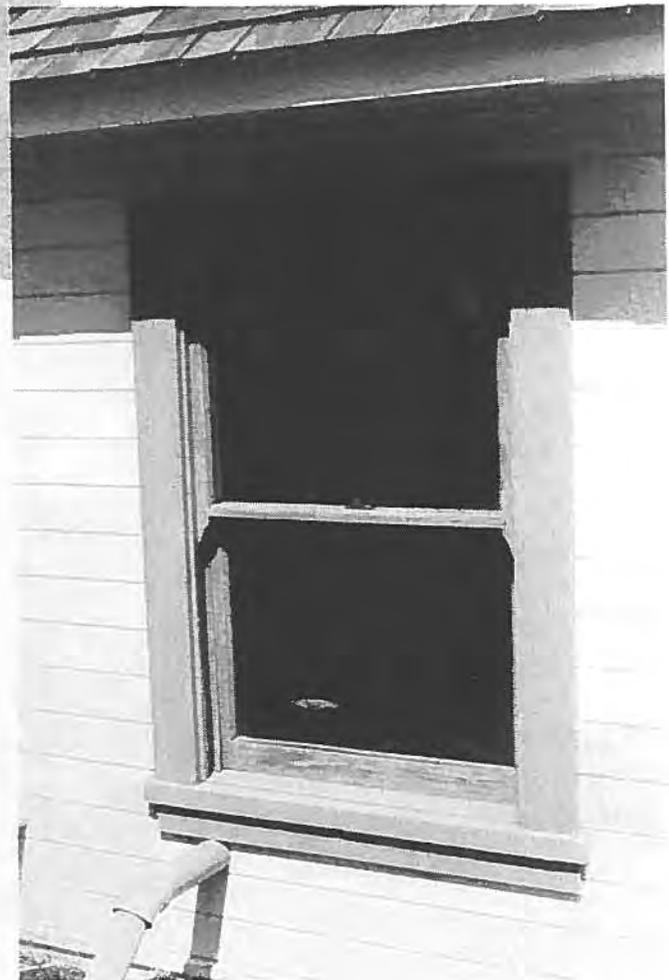
Figure 19 - Typical double-hung window in fire booster pumphouse.

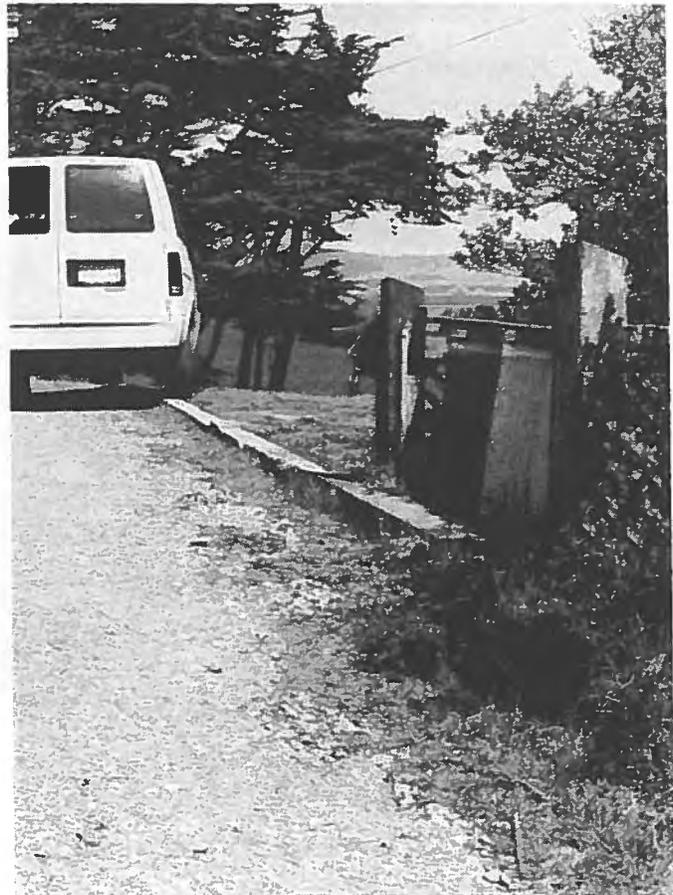
Figure 20 - Stone curb along driveway at residence.

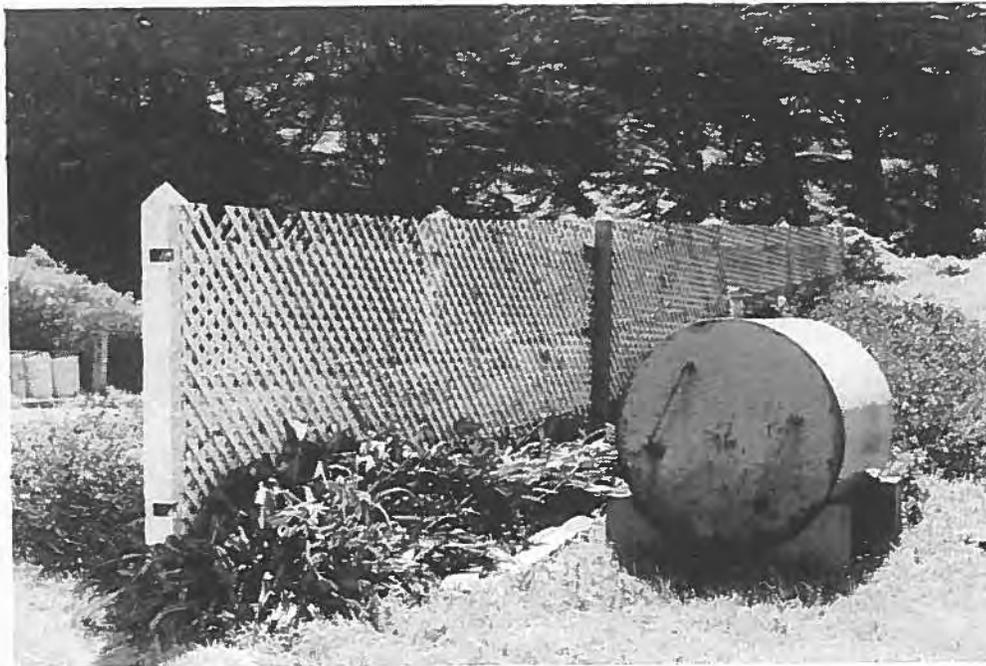
Also directly behind the house is a tall lattice fence installed to screen an existing fuel tank. Although the lattice may have been a recent addition to the fence, the posts appear to be old. The small fuel tank rests on two concrete supports and is located just west of the fence and driveway. Both the fence and the fuel tank are painted white.

Figure 22 - Lattice fence and small steel tank located on the south side of the residence.

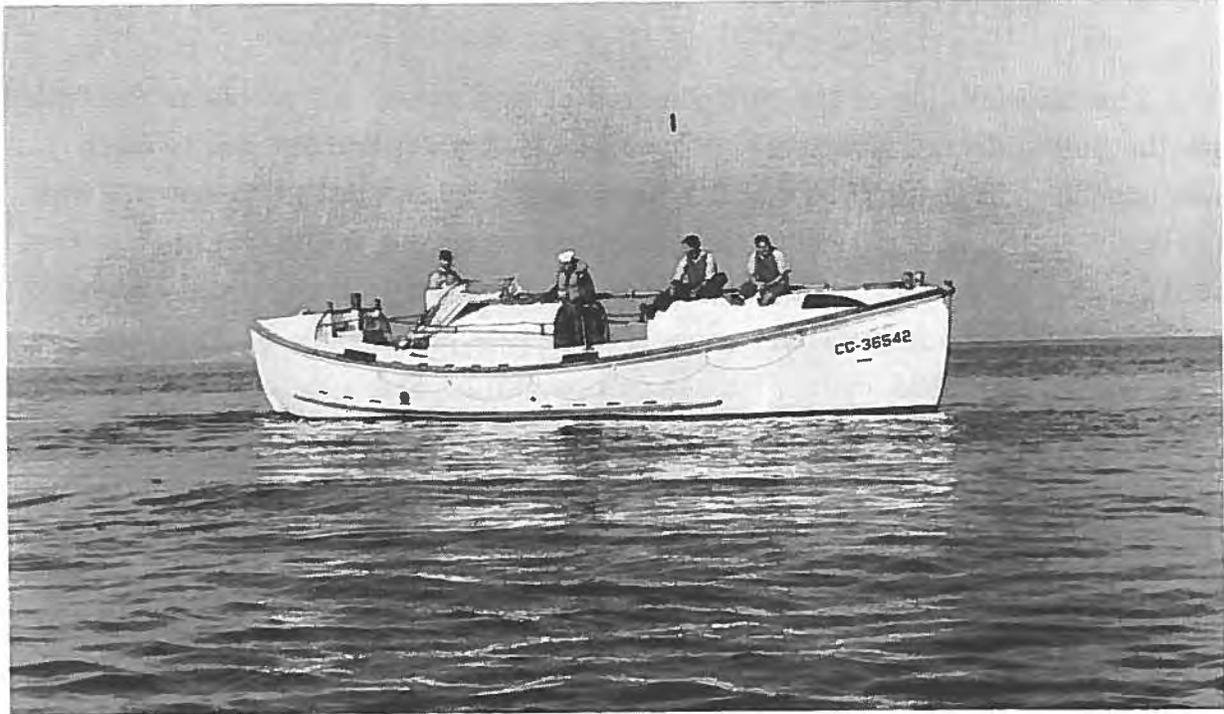
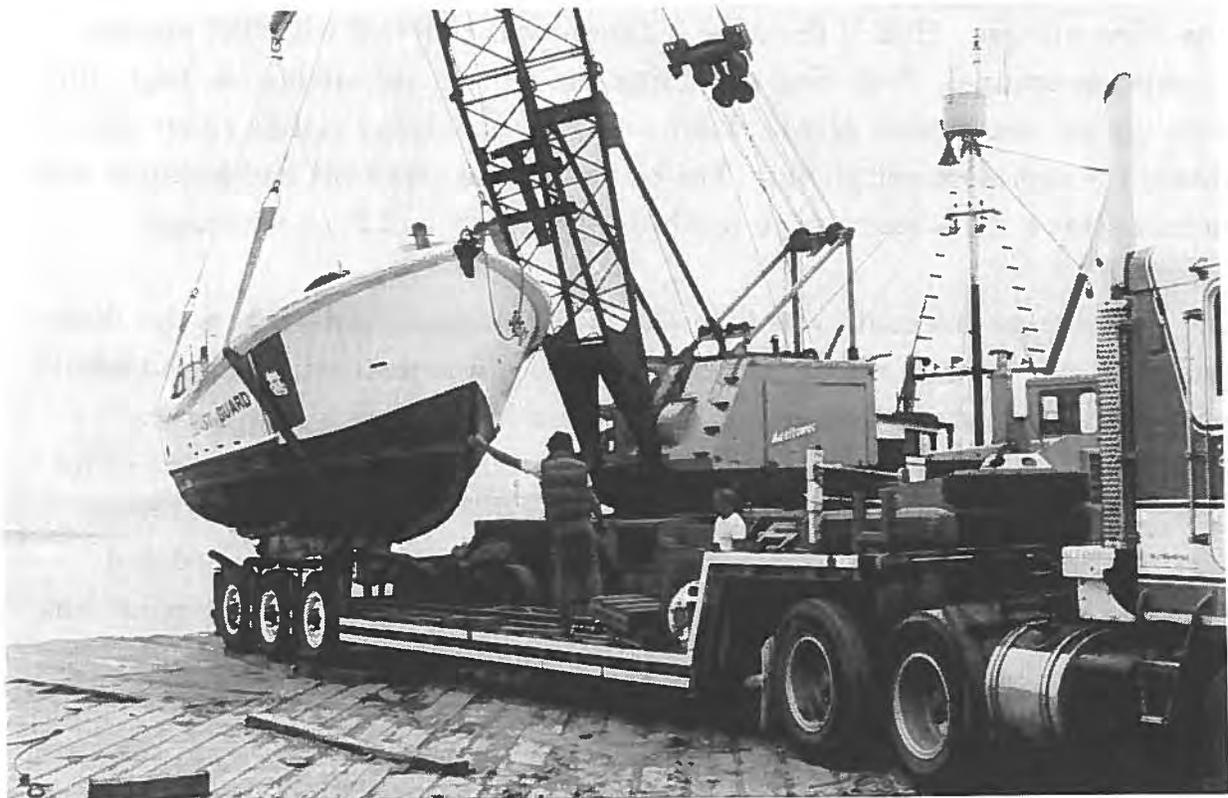
Top, No. 36542 afloat in Drakes Bay, 1962 (Courtesy of Jim Crunk); bottom, boat being loaded at Humboldt Bay for travel to Point Reyes, 1982. (NPS)
