Building: 56 Fitness Center

Structural Assessment: Structurally Sound

National Park Service
Virgin Islands National Park | Caneel Bay
Structural Assessment Report

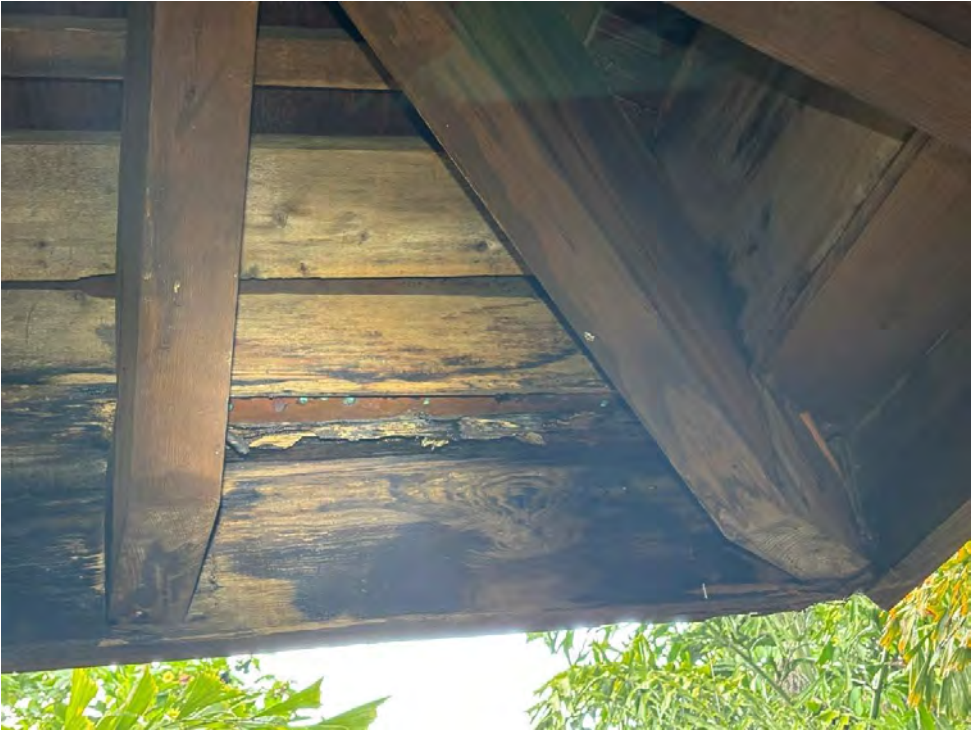
Component	Material	Notes
Floor	Concrete	
Walls (Structural)	Stone	Stone piers support 4 timber trusses.
Roof	Wood Framed / Wood Shingles	Rafters at north-east corner shows signs of termite damage and rotted wood. Minor missing wood shingles throughout roof structure.

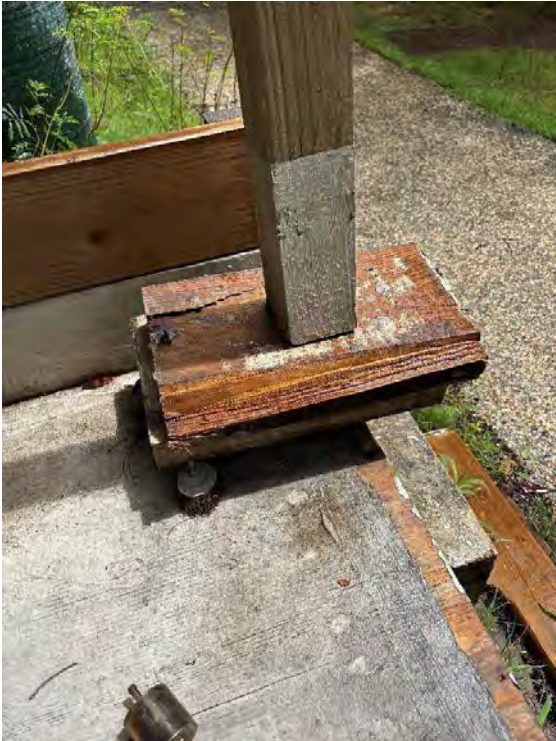
Component	Material	Notes
Floor	Wood Framed / Plywood Deck	
Structure	Wood	Open structure with a wood post at each of the 4 corners. The front two posts have been cut and are supported on stacked wood scraps. The posts are leaning and have no positive connection to the blocking or deck below.
Roof	Wood Framed / Plastic Corrugated Deck	Minor damage to roof deck.

- Structure appears to not meet requirements of National Fire Protection Association (NFPA) regarding supporting generators on flammable surfaces and clearance surrounding generators. Further review recommended to assess code compliance for generator structure.

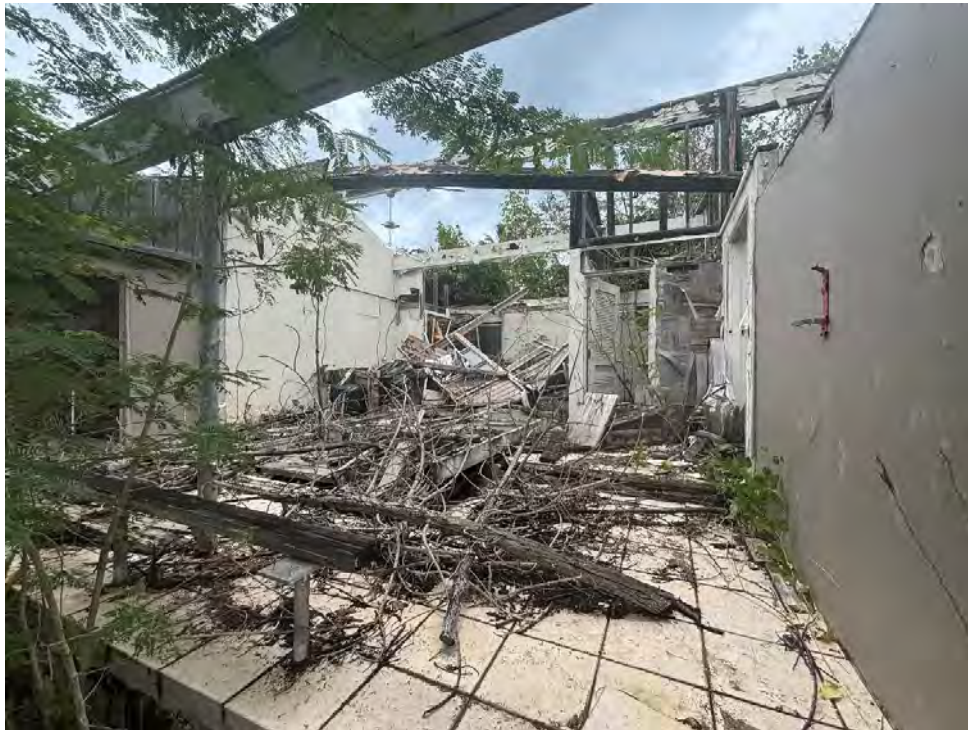
- Severely corroded steel columns at base, collapse of exterior slabs, and collapsed concrete wall.
