**National Park Service**  
Virgin Islands National Park | Caneel Bay  
Structural Assessment Report

**Building: 28 Caneel Beach Units 26-29**

**Structural Assessment: Structurally Sound**

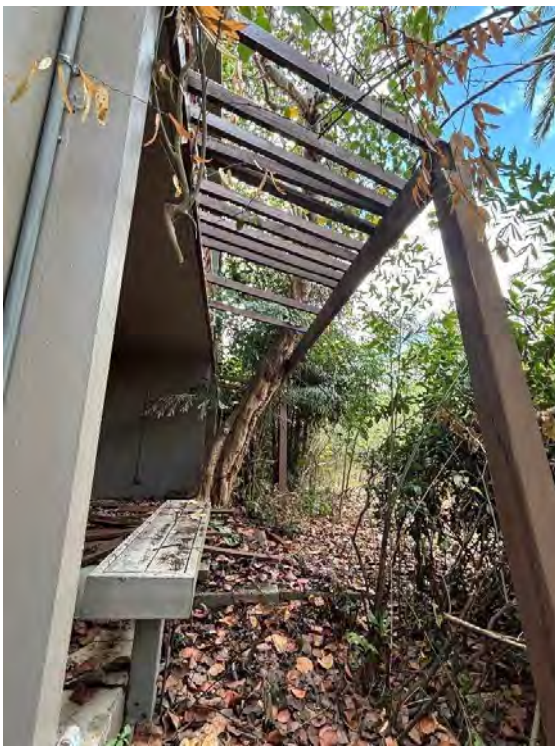
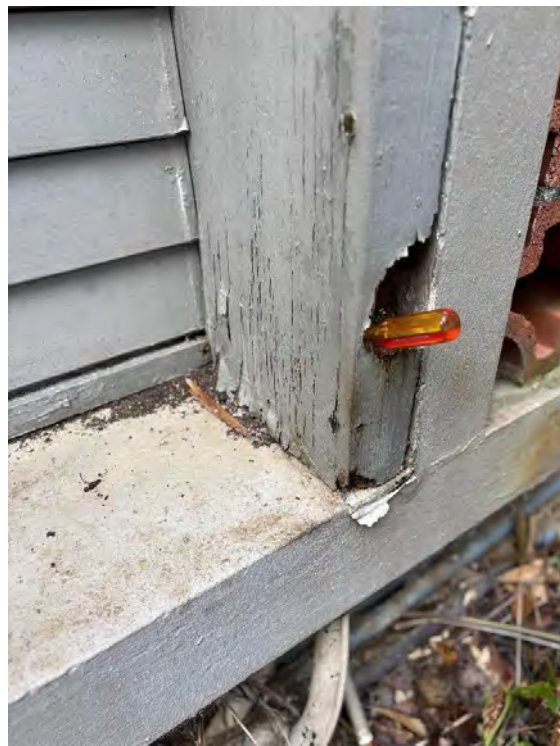
**Building: Caneel Beach Phone Booth**

**Structural Assessment: Structurally Sound**

Component	Material	Notes
Floor	Concrete	
Walls (Structural)	Wood	
Walls (Non-Structural)	N/A	
Roof	Wood framed/ Wood shingles	Roof has deteriorated, causing seat to deteriorate.

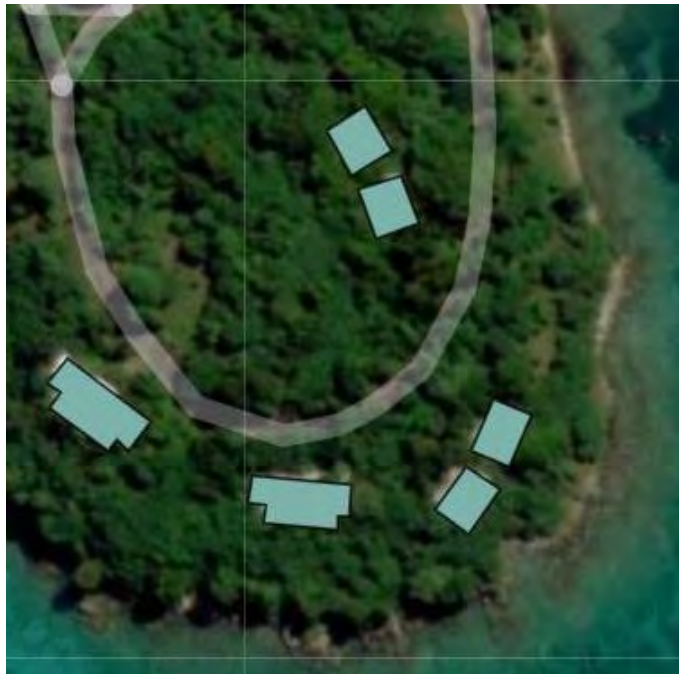
**Building: 29 Cottage Point Units 50-51**

**Structural Assessment: Potentially**

**Repair or Rebuild**

Component	Material	Notes
Floor	Concrete	Signs of efflorescence with stalactites at underside of porch slab.
Walls (Structural)	Concrete / Steel Posts	Unable to verify condition of steel pipes where they framed into wall.
Walls (Non-Structural)	Light Gage Metal Framing	The light gage metal framing appears to be a renovation that started post hurricane damage and was abandoned prior to completion.
Roof	Concrete / Membrane	Spalling at underside of concrete roof where ceiling finishes had been removed. Unable to determine extent of spalls where finishes remained. Signs of previous renovations which cut back the wall creating a longer beam span. It is unknown if this modification with properly designed.
Stairs/Railings	Wood Railings / Benches	Wooden benches and railings on south side have failed. Posts under porch concrete slab are notched.

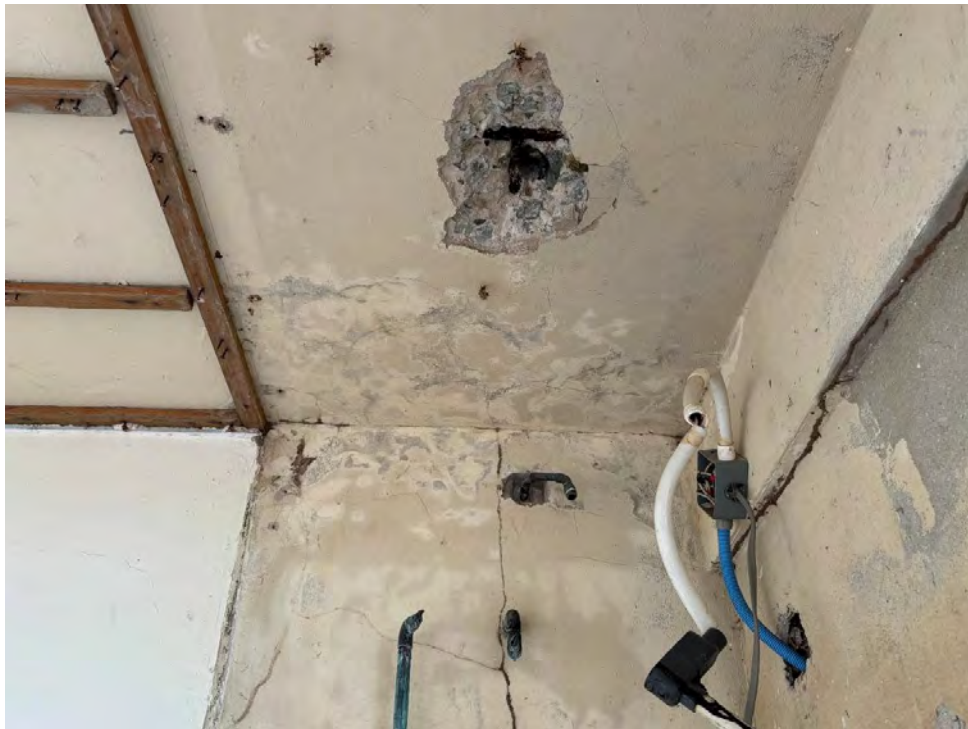
**Building: 32 Cottage Point Units 56-57**

**Structural Assessment: Structurally Unsound**

Component	Material	Notes
Floor	Concrete	
Walls (Structural)	Concrete / Steel Posts	Unable to verify condition of steel pipes where they framed into wall.
Walls (Non-Structural)	Wood Framing	Partitions previously demolished.
Roof	Concrete / Membrane	Significant spalling at underside of concrete roof slabs. Beam cracked.  Previous renovations cut back the wall creating a longer beam span. It is unknown if this modification with properly designed.
Stairs/Railings	Wood Railings	Wooden railings deteriorated.

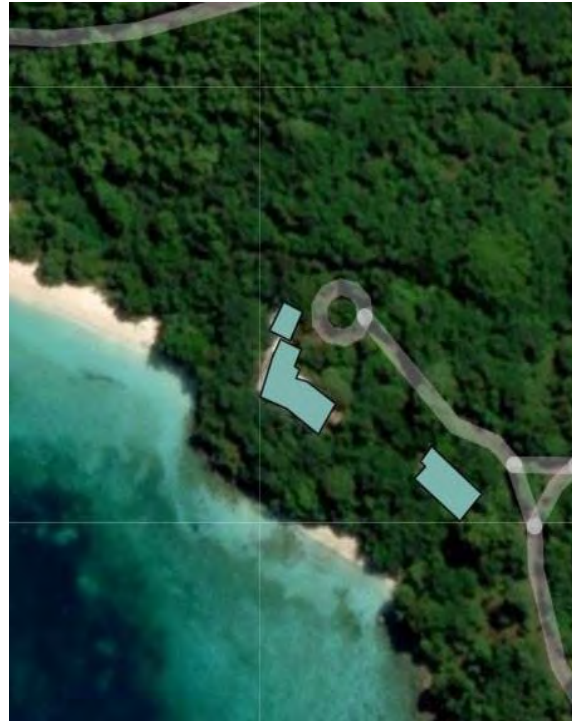
**Building: 96 Cottage 7 Unit 7A**

**Structural Assessment: Potentially**

**Repair or Rebuild**

Component	Material	Notes
Floor	Concrete	Slab separation/cracking along entire north side.
Walls (Structural)	Concrete	Concrete cracks around north window.
Walls (Non-Structural)	Wood	
Roof	Concrete	
Stairs/Railings	Wooden Steps / Aluminum Railing	Wooden steps deteriorated and leaning.
Sidewalk	Concrete

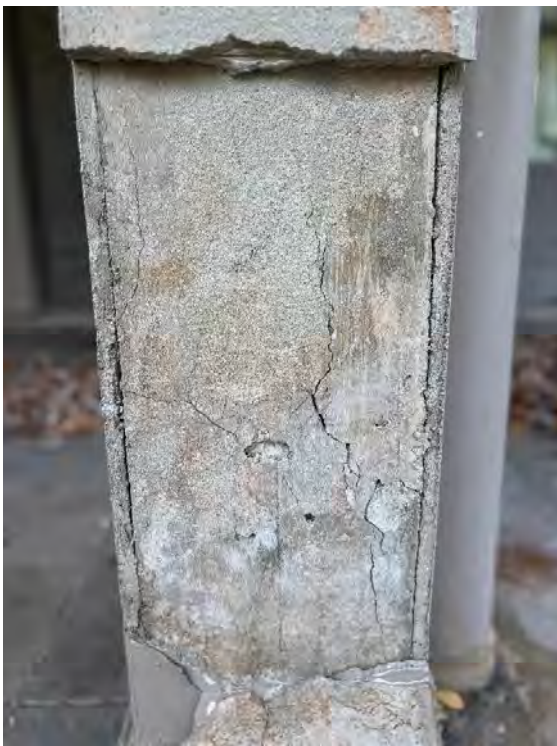
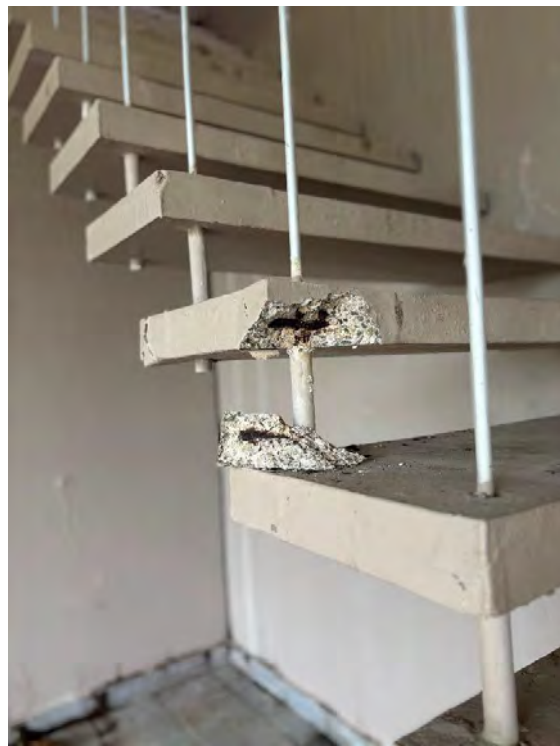
**Building: 35 Paradise Beach Units 64-66**

**Structural Assessment: Structurally Sound**

Component	Material	Notes
Floor	Concrete	
Walls (Structural)	Concrete	Minor concrete cracking, some cracks show signs of previous repairs. Spalled concrete at breezeway. Potential soil loss at foundation support for Unit 65 NW wall.
Walls (Non-Structural)	Wood Framed / Open CMU Walls	Open CMU wall at breezeway.
Roof	Concrete and Wood/ Membrane	Wood framed roof over Unit 66 porch. Roots growing from ceiling in Unit 65 (unable to access interior of unit) Vegetation on roof. Moisture pockets in paint at underside of roof overhang. Roof cracks.
Stairs/Railings	Wood	
Deck	Wood	Wood framed deck north side of Unit 65.

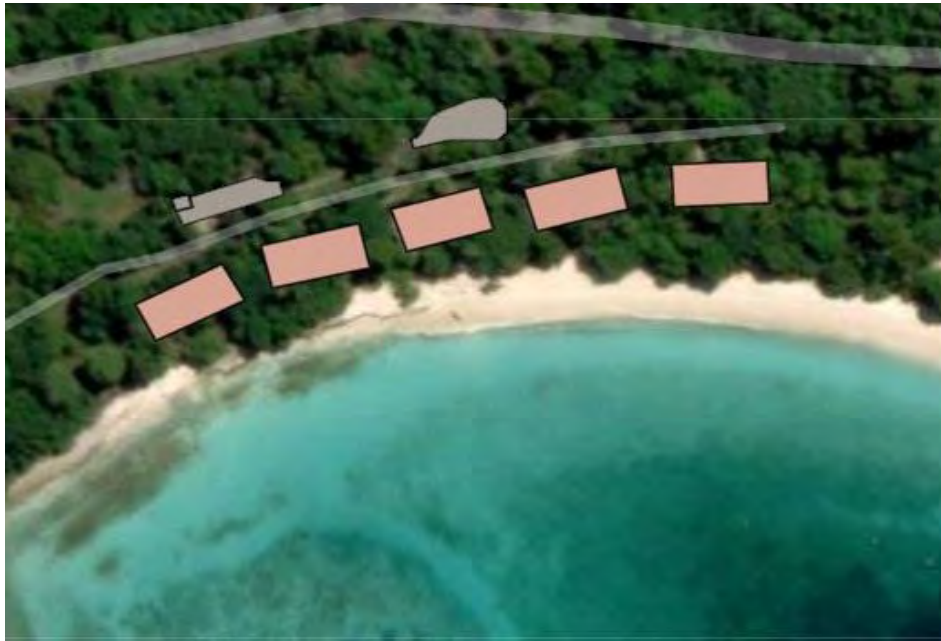
**Building: 37 Scott Beach Units 67-70**

**Structural Assessment: Potentially**

**Repair or Rebuild**
