National Park Service
Virgin Islands National Park | Caneel Bay
Structural Assessment Report

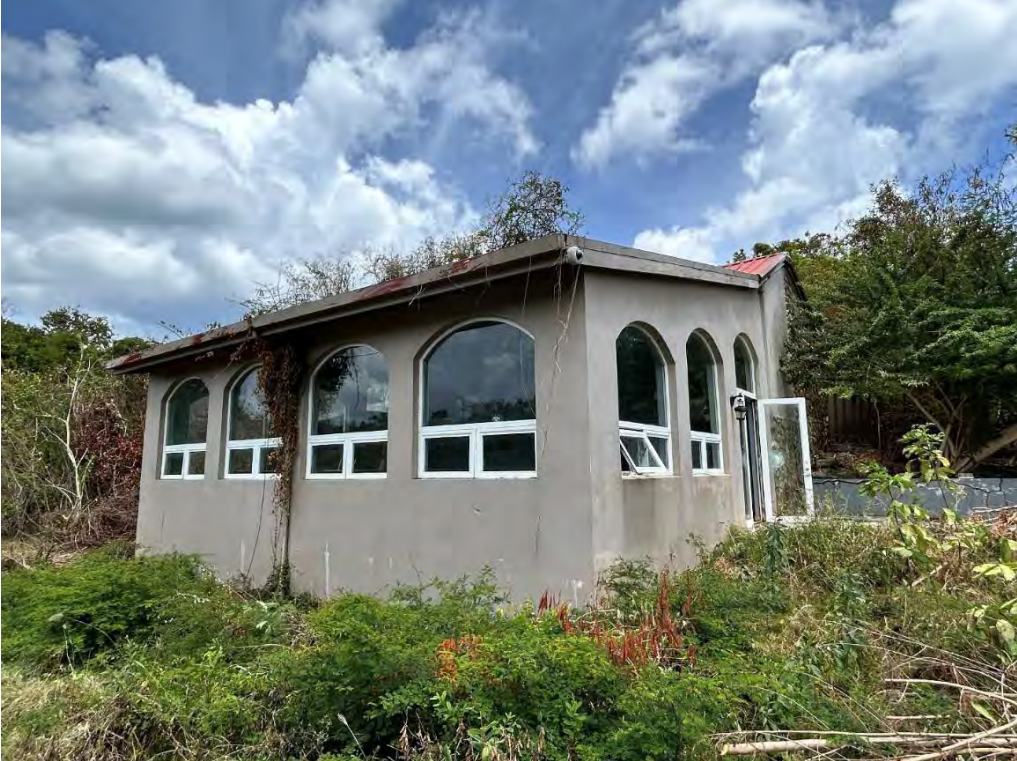
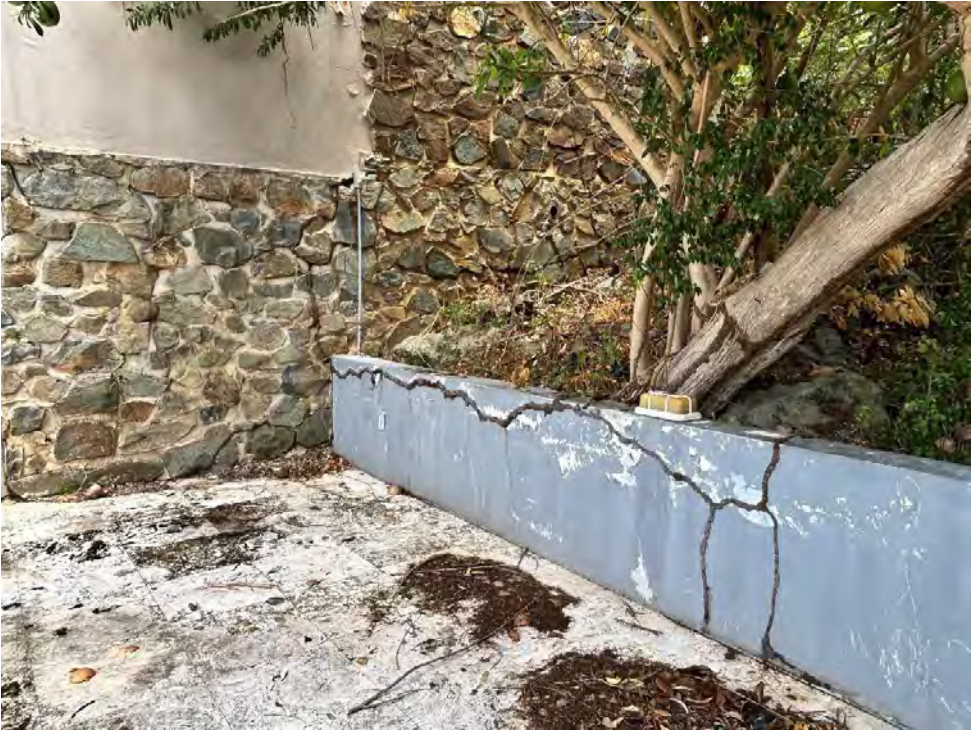
Building: 45 Turtle Bay Children’s Center “Turtle Town”

Component	Material	Notes
Floor	First Floor: Concrete Second Floor: Wood Framed	
Walls (Structural)	Stone (rear) Concrete	Cracking observed at stone base and stone lintel; repoint. Exposed rebar in capstone near bathroom addition.
Walls (Non-Structural)	Wood framed	Potential termite damage.
Roof	Wood framed/ Metal	Potential termite damage.
Sidewalk	Concrete

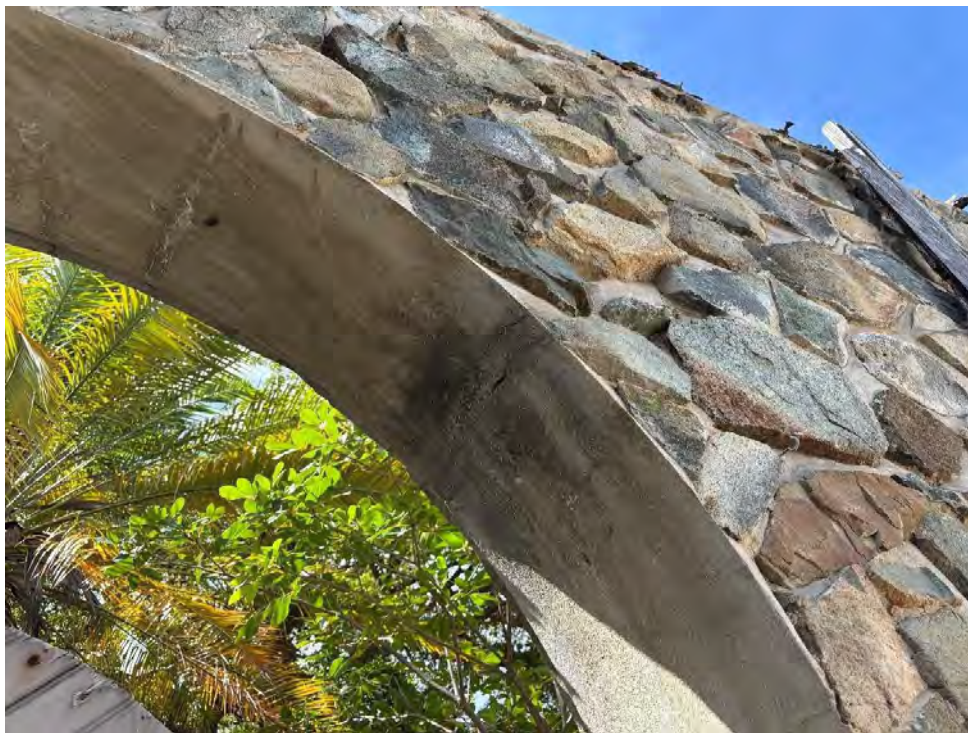
Building: 95 Turtle Bay Estate House Veranda

Component	Material	Notes
Floor	Concrete	Standing water in restroom/hallway area.
Walls (Structural)	Concrete / Stone	Missing stones in stone walls. Spalling concrete with corroded rebar at south wall. Mortar missing, loose, and cracked at south wall. Rusted lintel at exterior stairs.
Walls (Non-structural)	Wood / Doors	Rotten wood at base of infill walls between doors.
Roof	Wood Framed / Wood Singles	Some missing wood shingles. Signs of water intrusion and moisture damage on interior finishes. Signs of termite activity. Wood shed roof over exterior stairs is missing major support beam and has failed.
Stairs/Railings	Concrete / Wood Railings

- Wood framing at roof was not visible. Given water damage and signs of termite activity, it is likely there is additional wood damage not observed at this time. Future renovations should evaluate the structure further.

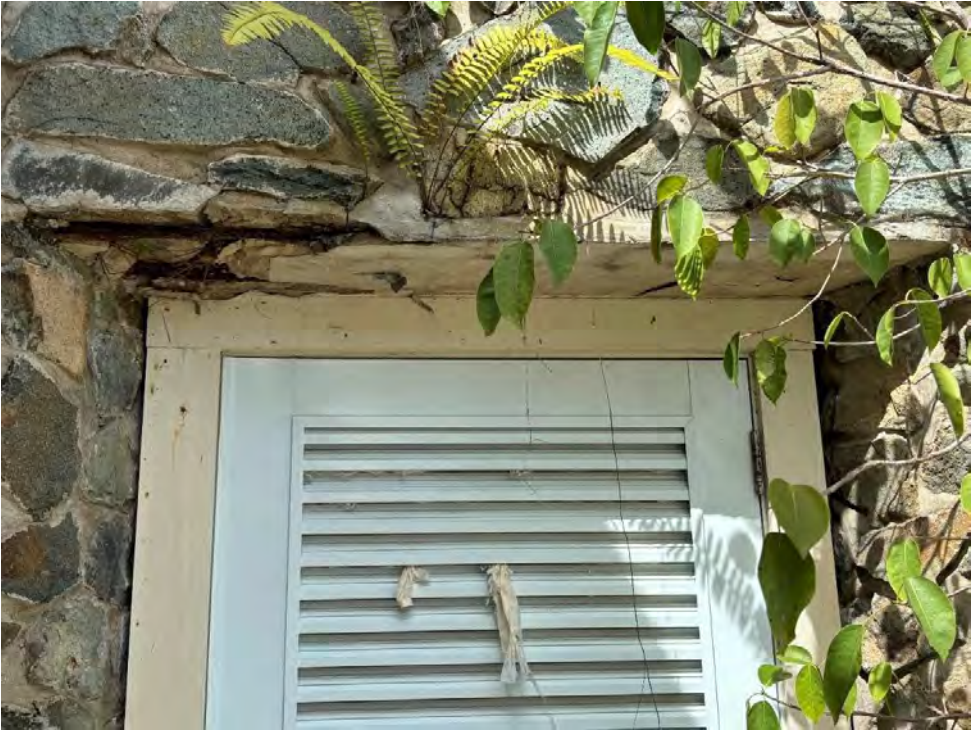
Building: 95 Turtle Bay Storage Shed (North)

Component	Material	Notes
Floor	Concrete	
Walls (Structural)	Concrete	Some moisture staining and cracking in skim coat on front concrete wall.
Walls (Non-Structural)	Concrete	Wood frame infill walls above concrete knee walls on right shed addition.
Roof	Wood framed/ Metal	
Sidewalk	Concrete

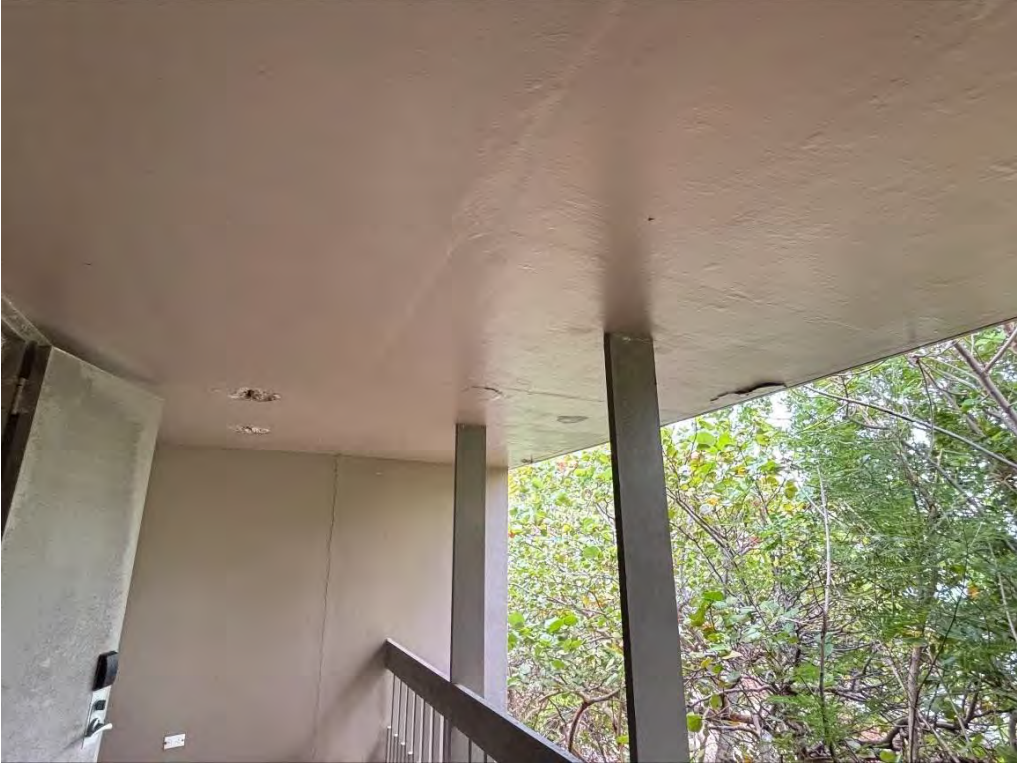
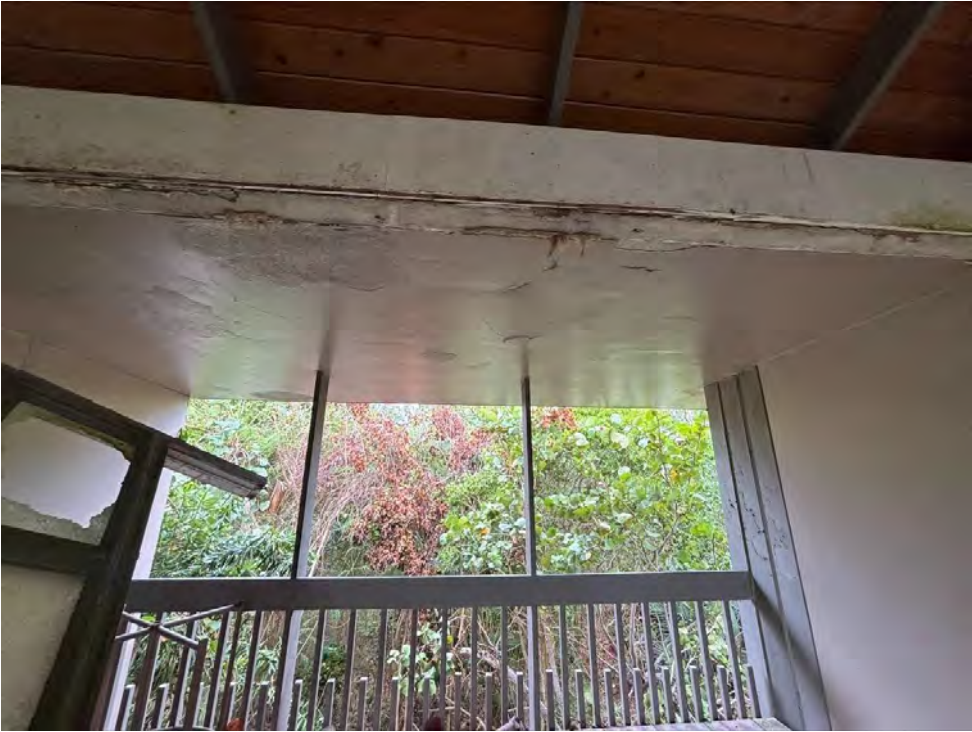
Building: 47 Hawksnest Beach Units 110-113, 122-125

Component	Material	Notes
Floor	Concrete	First floor has significant sand blown into the rooms.
Walls (Structural)	Concrete	Spalling on concrete columns with exposed rebar at east side between room 111 and the stairwell. Vertical cracks at geometry changes typical east and west side of second floor rooms (122, 123, 124, 125). Hairline crack in wall at second floor slab elevation between room 125 and stairwell wall. Spalled concrete noted at base of all stairwells.
Walls (Non-Structural)	Wood and Windows	Windows blown out (112 east, 113 east, 123 east). Walls collapsed (110 east).
2nd Floor	Concrete	Spalling and exposed rebar at edge of concrete slab where railing attached (122 east, 123 east, 124 east). Localized spalling at underside of slab throughout the building. At some locations rusted rebar is visible.
Roof	Concrete & Wood Framed / Membrane	Spalling on underside of slabs with exposed rebar in some locations. Localized spalling at underside of slab throughout the building. At some locations rusted rebar is visible.

Component	Material	Notes
Stairs/Railings	Concrete / Wood Railings	Railing connections to slabs have failed, predominantly on beach side. Stair walls have vertical crack at geometry change.
Sidewalk	Concrete

- Concrete walls and slabs, including underside of slabs, should be fully sounded to detect all areas of spalling and delamination.
- Remove existing railings and fully review edge of concrete slabs for damage.
- Repairs may consist of replacing damaged rebar with new rebar, cleaning and coating rebar with zinc rich paint, and repairing concrete.

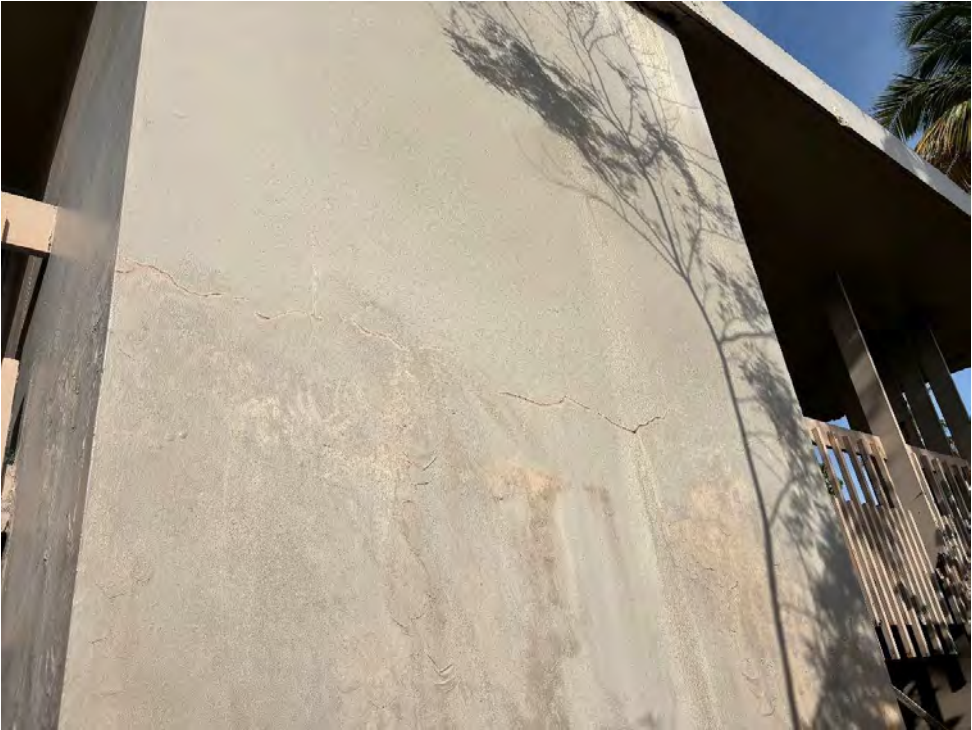
Building: 100 Hawksnest Beach Restroom

Component	Material	Notes
Floor	Concrete	
Walls (Structural)	Concrete	
Walls (Non-Structural)	Concrete	
Roof	Wood framed/ Wood shingles	Potential termite damage.

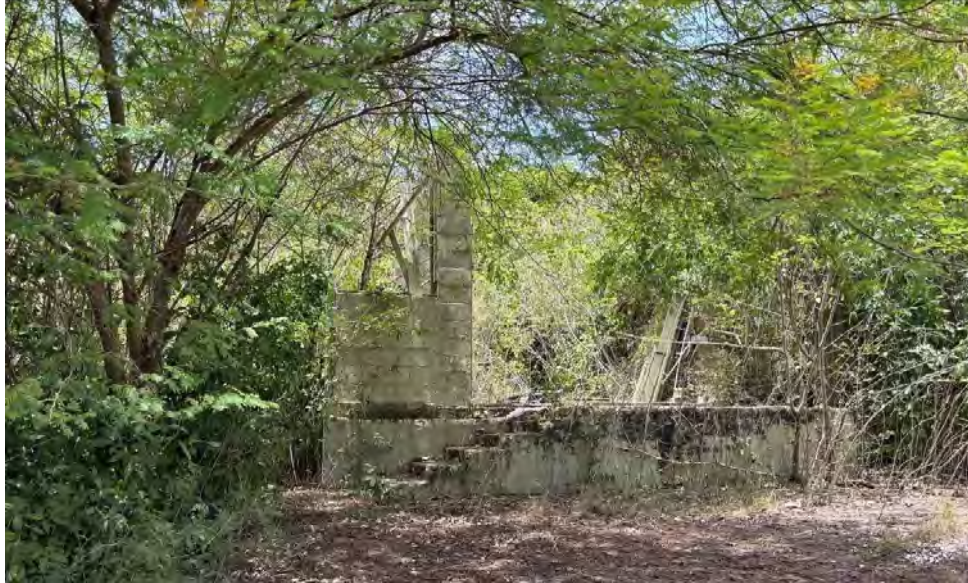
Building: 13A Electrical Complex

Component	Material	Notes
Floor	Concrete	
Walls (Structural)	Concrete	No cracks were noted from the outside.
Roof	Wood Framed / Metal Roof	Vegetation on roof. Unable to gain access to inspect roof from the interior.
