Building: 13B Generator Building

Structural Assessment: Potentially

National Park Service
Virgin Islands National Park | Caneel Bay
Structural Assessment Report

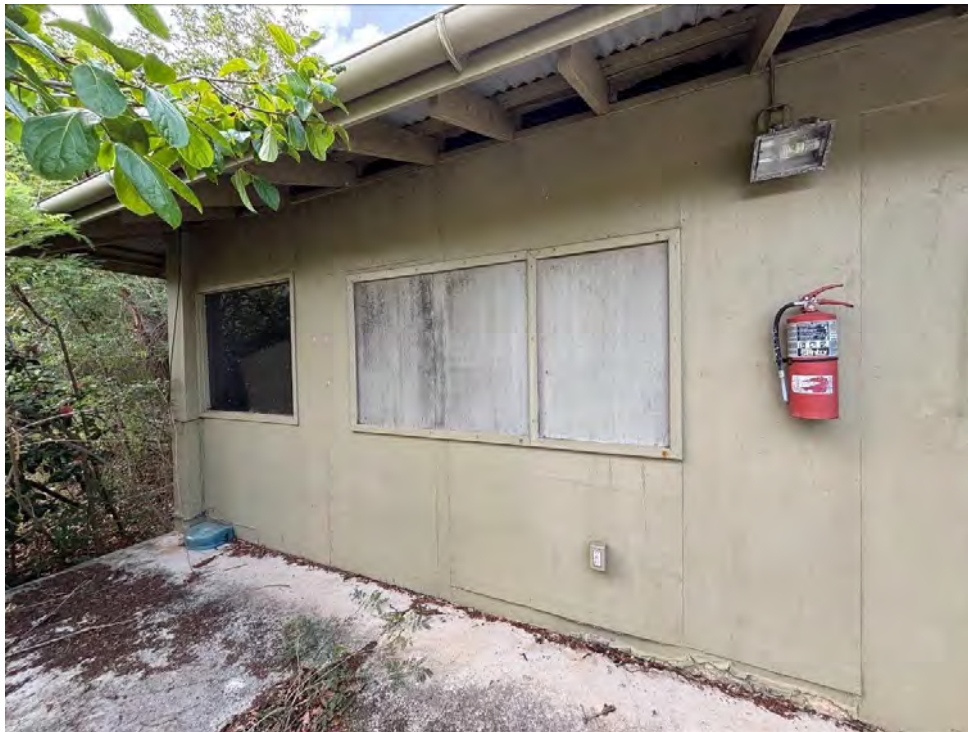
Building: 79 Engineering Warehouse

Component	Material	Notes
Floor	Concrete	
Walls (Structural)	Concrete	Horizontal crack in lintel. Cracks at joint between dive storage addition and main building. Failed walls at small shed addition to west of dive storage room.
Walls (Non-Structural)	Wood	
Roof	Wood Framed / Metal Deck	Roof collapsed at small shed addition to west of dive storage room.
Stairs/Railings	N/A	
Sidewalk	Concrete

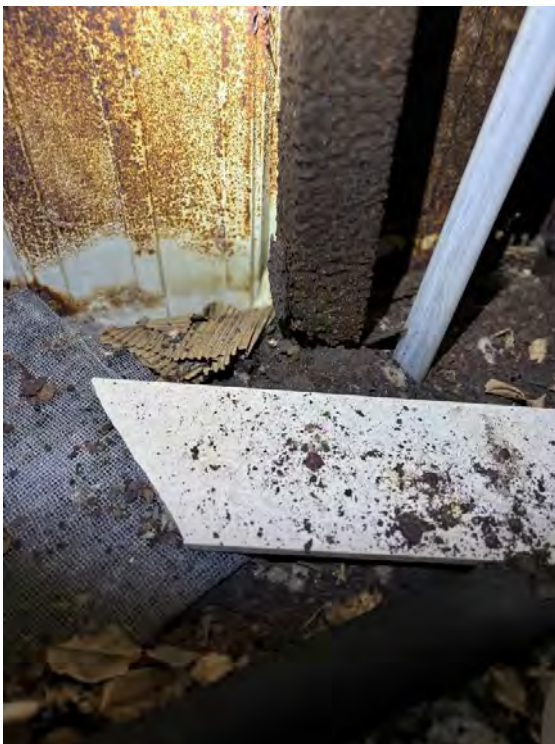
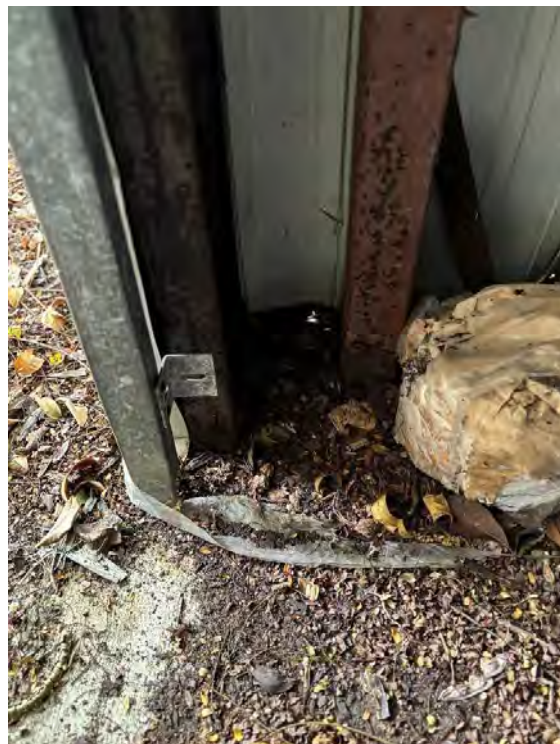
Building: 91 Human Resources

Component	Material	Notes
Floor	Concrete	
Walls (Structural)	Concrete	Signs of termites observed.
Walls (Non-Structural)	Concrete	
Roof	Wood framed / metal deck

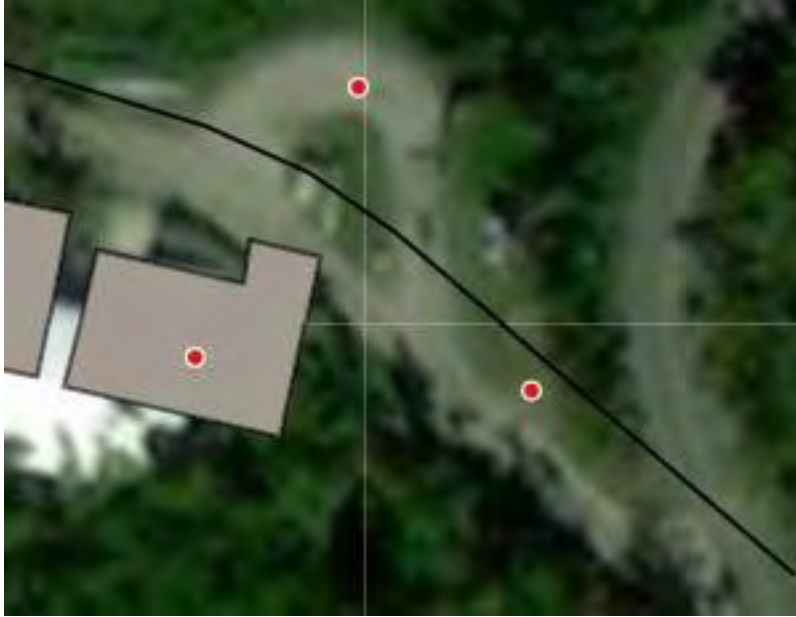
Building: R.O. Plant

Structural Assessment: Potentially Repair or Rebuild

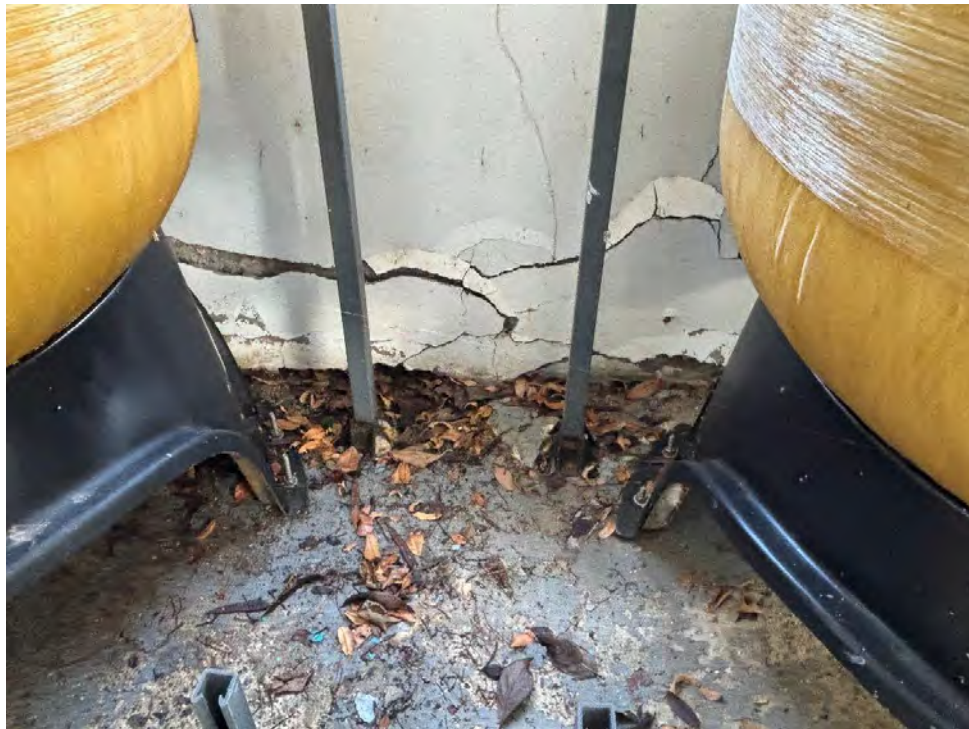
Building: R.O. Storage Shed

Structural Assessment: Structurally Sound
