National Park Service
Virgin Islands National Park | Caneel Bay
Structural Assessment Report

CANEEL BAY
PARK RETAINED STRUCTURES
STRUCTURAL ASSESSMENT REPORT

July 2025

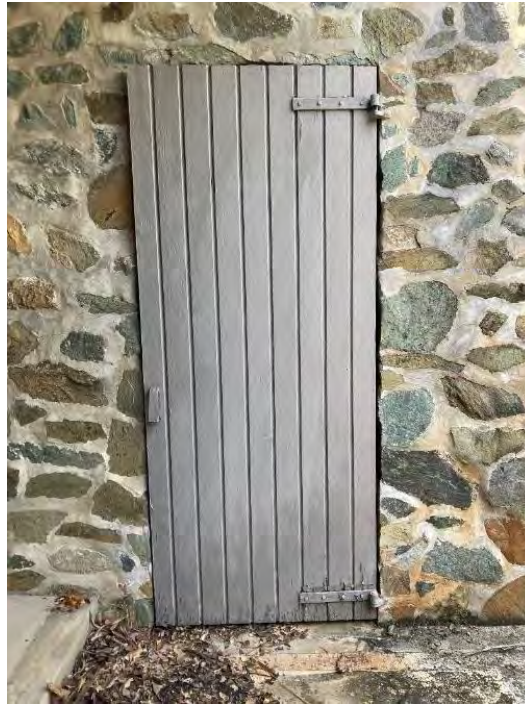
Figure 4 – Patio Communicating Door

The interior and exterior floors are slab on grade or suspended concrete slab. The interior slab on grade is polished slab. The exterior slab has smooth concrete and exposed aggregate concrete creating a grid pattern. Aluminum tube railings run along the north edge of the patio. The stone masonry wall dividing the two areaways has communicating doors between adjacent patios. The doors are wood framed with steel hardware.

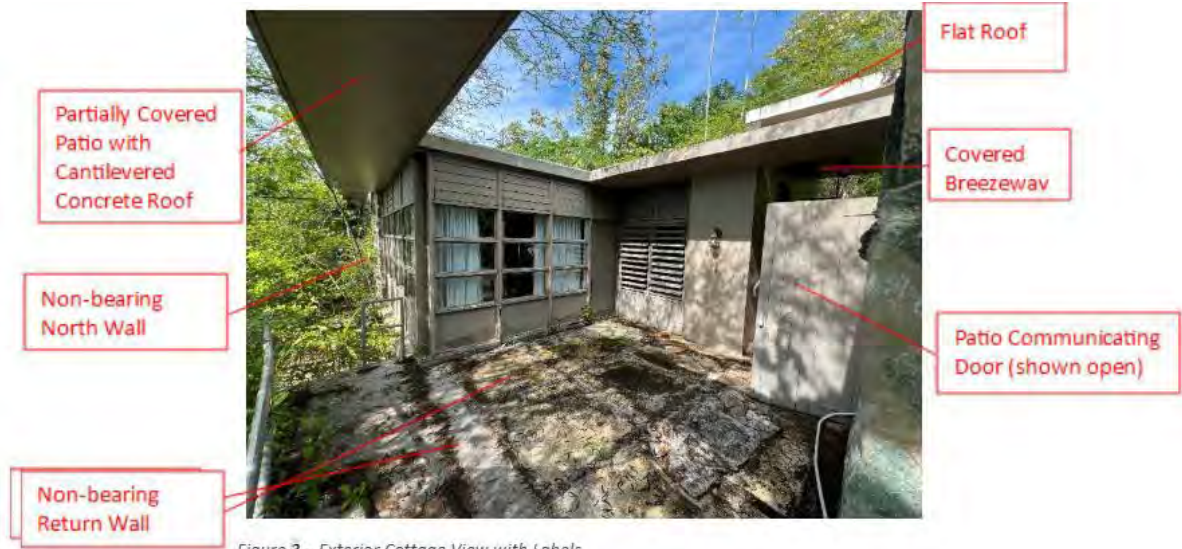
Figure 3 – Exterior Cottage View with Labels

The wood exterior framing walls are non-load bearing. The north facing walls consist of wood framed glass, and louvered walls. The return walls consist of the entrance door and wood framed glass and louvered walls. The wood framing of the return walls show signs or significant damage including complete failure and extensive insect damage. The condition of these walls is important for maintaining the building envelope system.
