**VIRGIN ISLANDS NATIONAL PARK
Cruz Bay, St. John, U.S. Virgin Islands**

**CANEEL BAY
ADDITIONAL STRUCTURES
STRUCTURAL ASSESSMENT REPORT**

**NATIONAL PARK SERVICE (NPS)
SOUTH EAST REGION (SER)**

July 2025

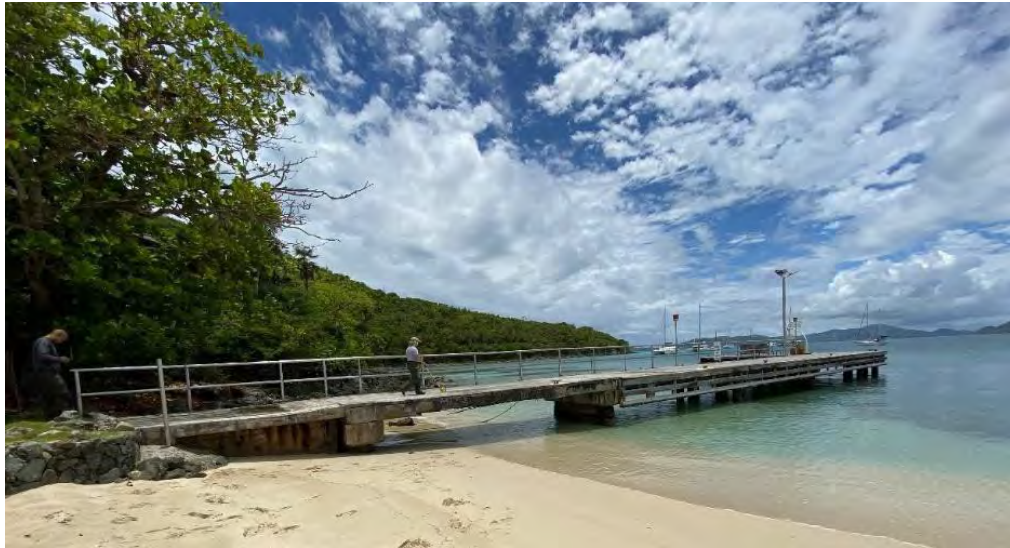
Concrete beams occur at the pile locations where they are supported by a minimum of two piles. The concrete beams appear to have been cast in place. The ends of the concrete planks are supported on the concrete beams. Generally the beams appeared to be in good condition. One beam had a delaminated section of concrete caused by rust jacking.

The topping slab on the planks is cracked and not bonded to the planks in some locations. The planks appear to be in generally good condition when viewed from the pier. However, inspection from the underside shows there is some significant damage to the underside of the planks. The concrete planks of the first full bay are in the worst condition. The bottom concrete has completely spalled off, the epoxy coating on most of the exposed rebar is completely gone and the rebar is severely corroded. The next bay of planks shows signs of delaminated concrete and rusting rebar but is less severe than the first bay. Conditions for the remainder of the pier range from good condition to severely corroded.

A marine engineer should be engaged to thoroughly evaluate the condition of the piles and their suitability for reuse with a repaired pier.

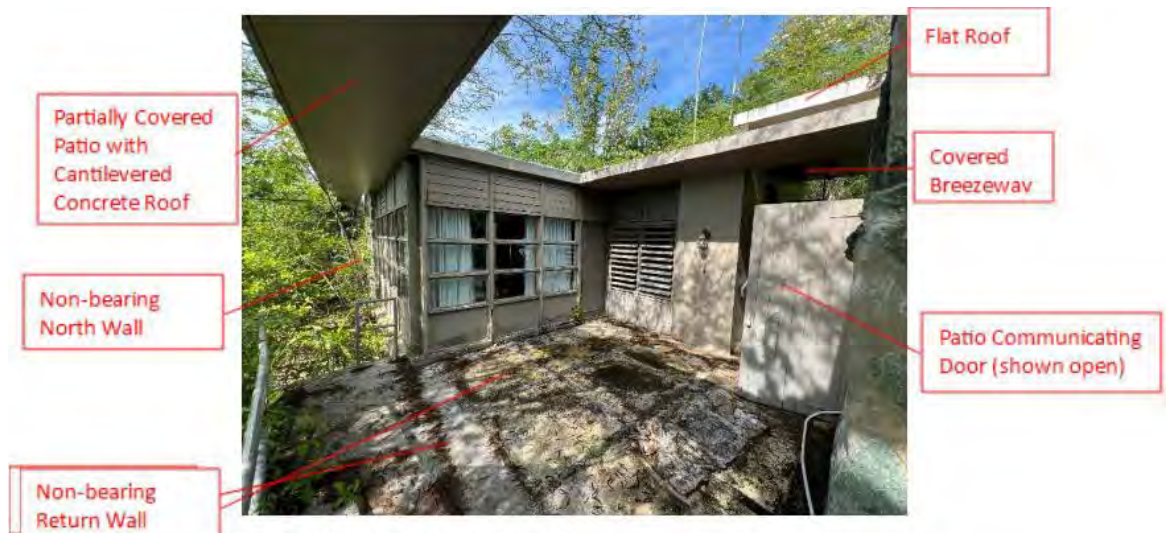
Figure 3 - Exterior Cottage View with Labels

The wood exterior framing walls are non-load bearing. The north facing walls consist of wood framed glass, and louvered walls. The return walls consist of the entrance door and wood framed glass and louvered walls. The wood framing of the return walls show signs or significant damage including complete failure and extensive insect damage. The condition of these walls is important for maintaining the building envelope system.
