**Building: 56 Fitness Center**

**Structural Assessment: Structurally Sound**

**National Park Service**  
Virgin Islands National Park | Caneel Bay  
Structural Assessment Report

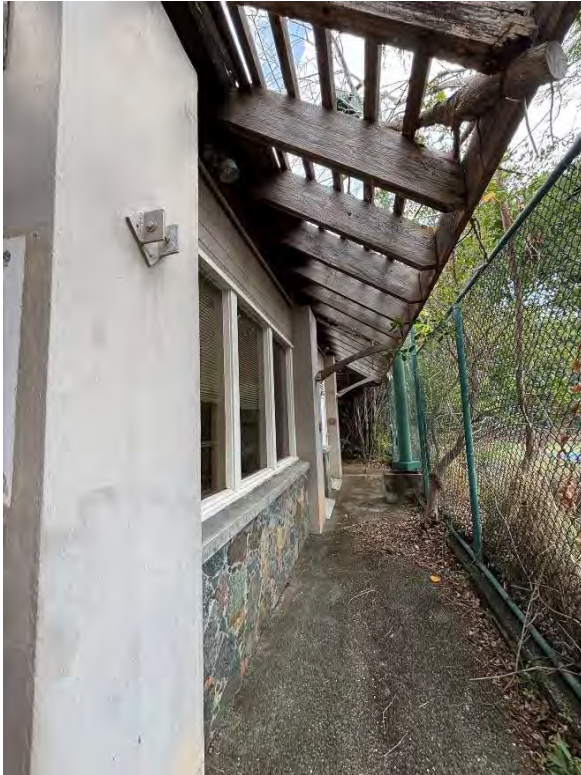
| Component | Material | Notes |
|---|---|---|
| Walls (Non-Structural) | Stone / wood infill | Wood section of walls is deteriorated. Potential termite damage. |
| Roof | Wood framed / wood shingles | Roof failed. Wooden bracing is rotted/termite damaged. Potential termite damage. |

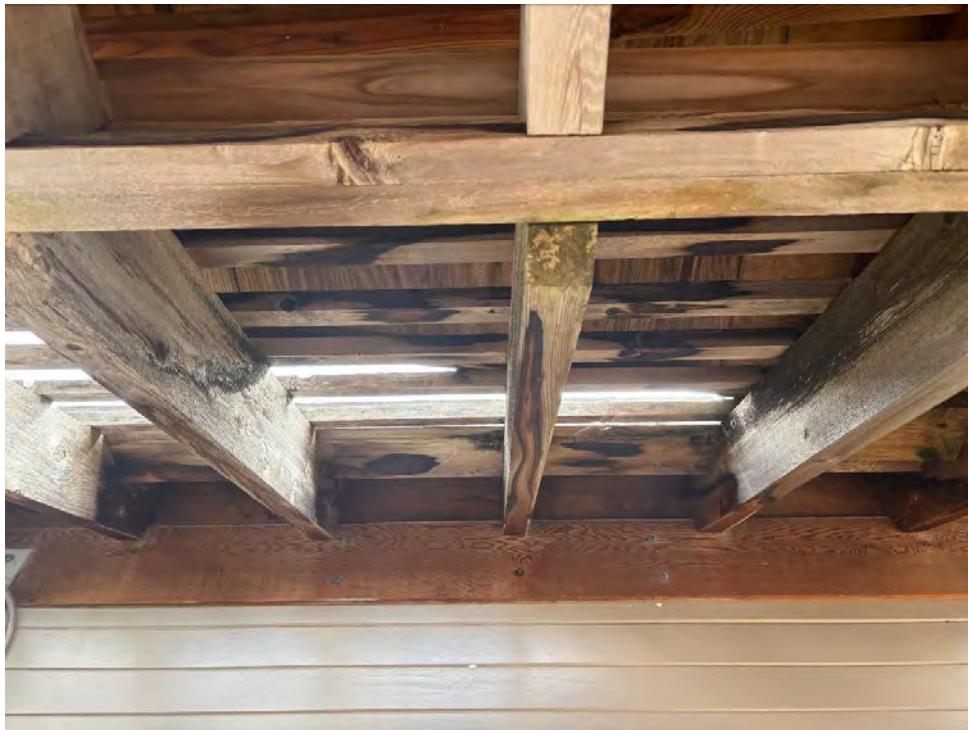
| Component | Material | Notes |
|---|---|---|
| Walls (Structural) | Concrete | Minor spalling at exterior walls. |
| Roof | Wood /<br>Metal Roof | Two rafter tails cracked at eaves. Metal roof attached directly to rafters (no plywood sheathing). |

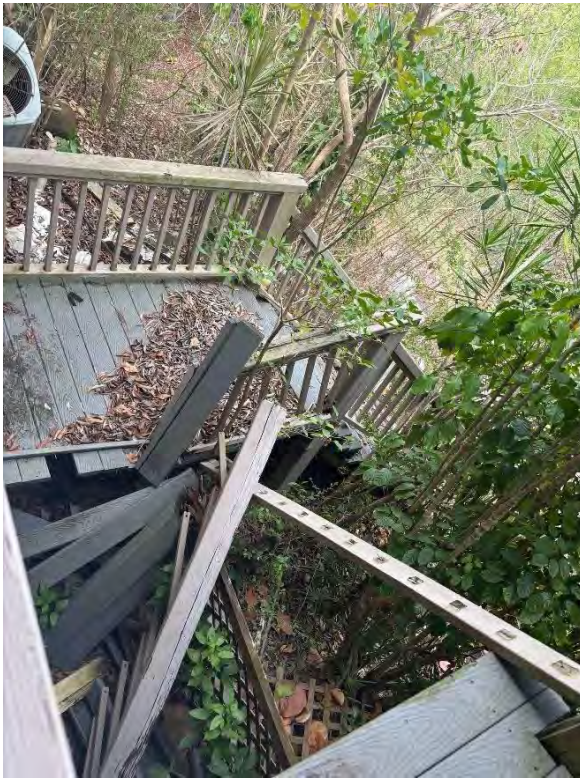
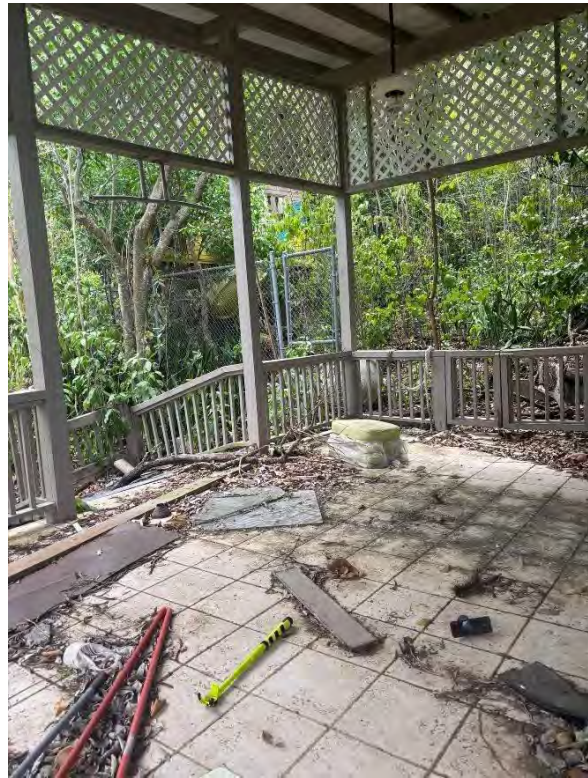
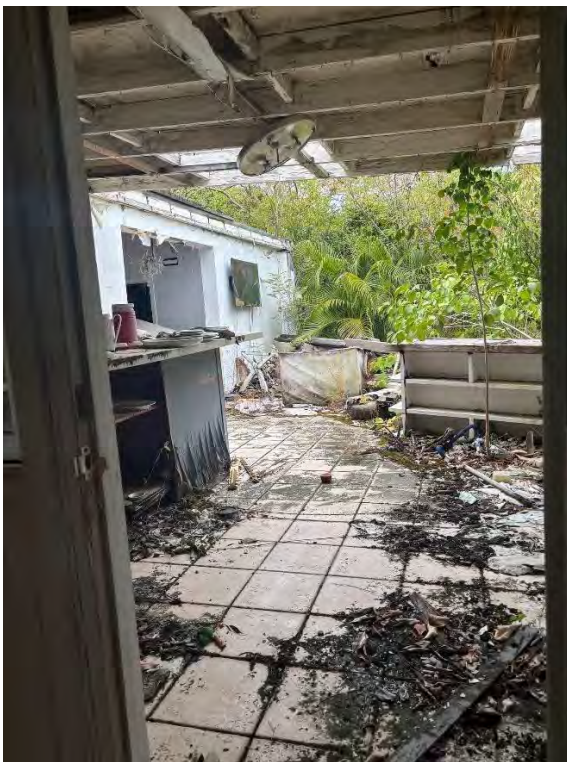
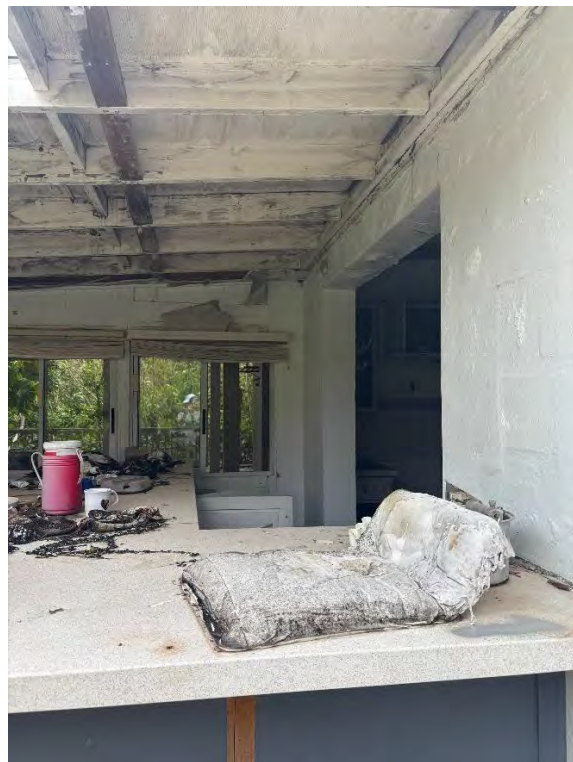
| Component | Material | Notes |
|---|---|---|
| Walls (Structural) | Concrete / Wood | Approximately half the building is concrete walls and the other half is wood framed walls. Concrete walls appeared to be stable.<br>Wood walls had completely failed. |
| Walls (Non-Structural) | Wood | It appears all non-structural wood walls had completely failed. |
| Stairs/Railings | Wood | Severely rotted and failed throughout the building. |

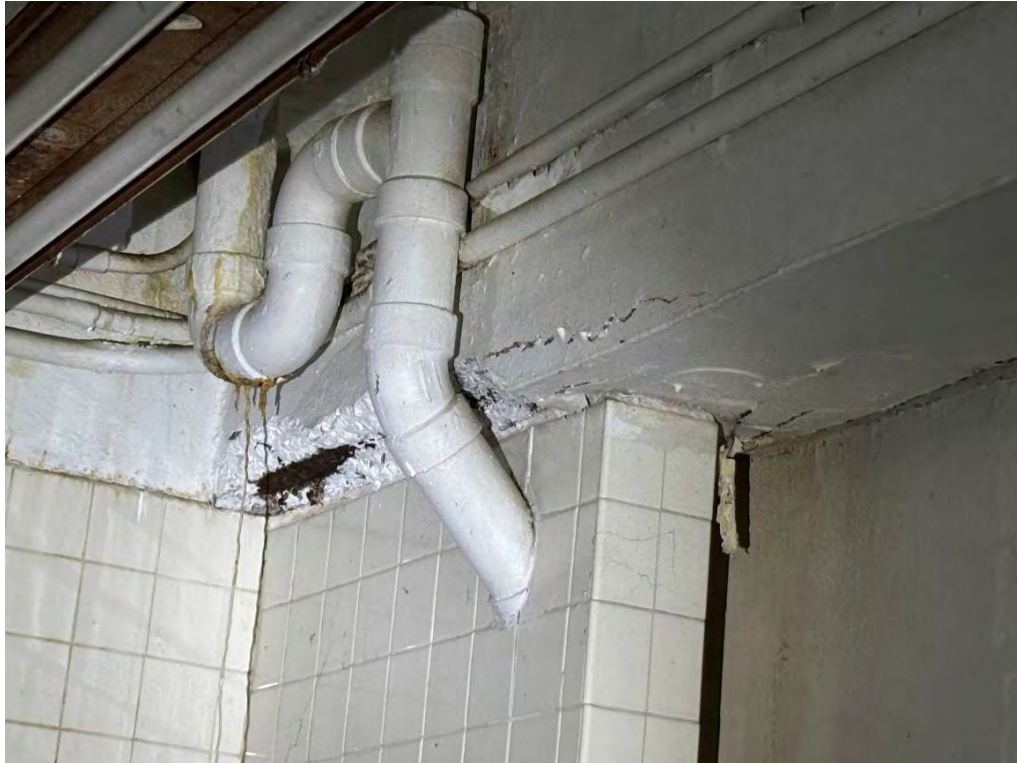
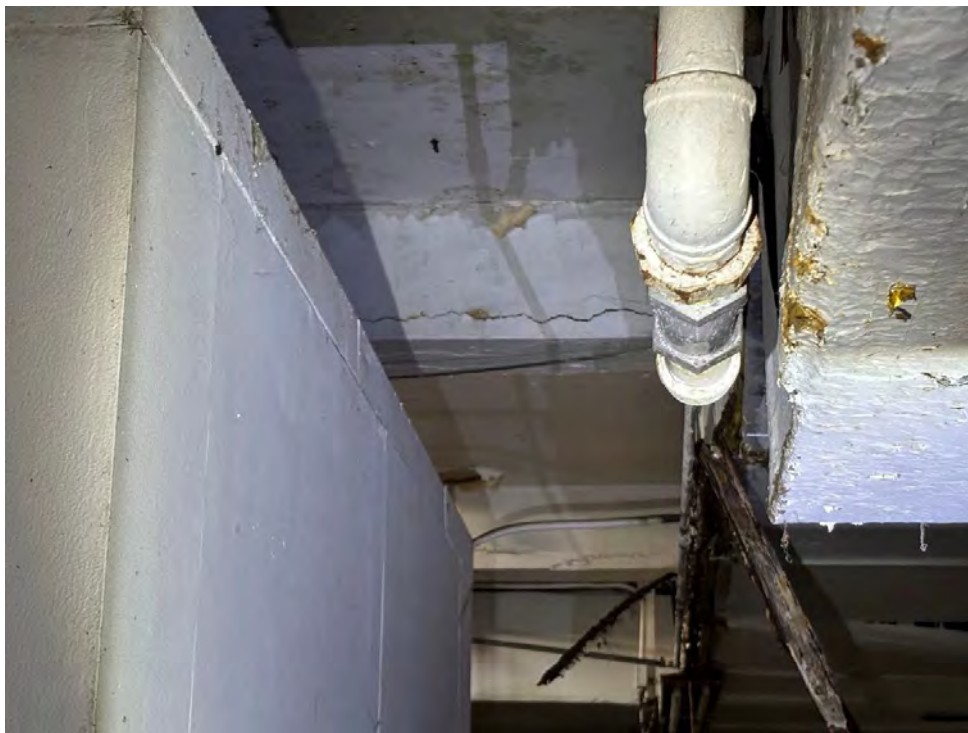
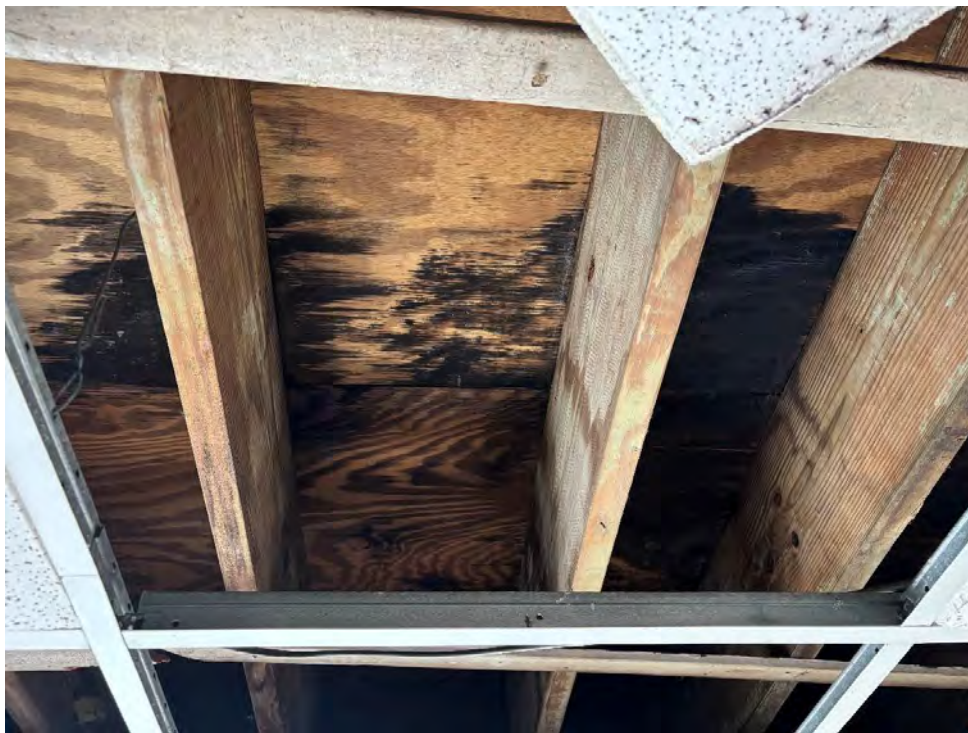
| Component | Material | Notes |
|---|---|---|
| Walls (Structural) | First Floor:<br>Stone/Concrete<br>Second Floor:<br>Concrete on west side, steel framing on east side, and wood framed shed addition further east. | Concrete beams supporting second floor cracked in kitchen area. Spalled beam to column connection with exposed, corroded rebar.<br><br>Tile finishes in kitchen area covered most walls and ceilings, so some structural conditions may be hidden.<br><br>Questionable construction design second floor. |
| Roof | Membrane on Concrete/Metal Decking<br><br>Mansard wood shingle roof on second floor admin offices | First floor roof is functionally failed, numerous areas of water infiltration and large hole in south east corner.<br><br>Wood shingles deteriorated and visible biological growth. |
| Stairs/Railings | Metal Stairs to Roof | Wood planks on roof catwalk deteriorated. Possibly an egress pathway due to occupancy on second floor. |

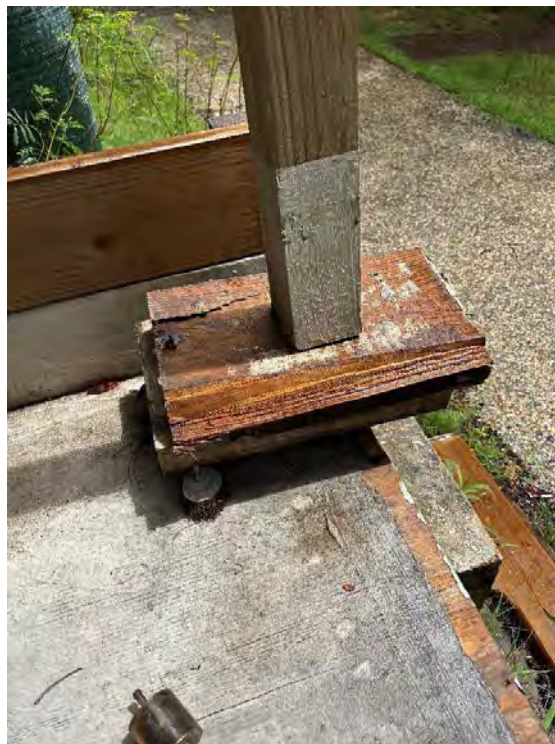
| Component | Material | Notes |
|---|---|---|
| Roof | Wood Framed / Plastic Corrugated Deck | Minor damage to roof deck. |

- Structure appears to not meet requirements of National Fire Protection Association (NFPA) regarding supporting generators on flammable surfaces and clearance surrounding generators. Further review recommended to assess code compliance for generator structure.

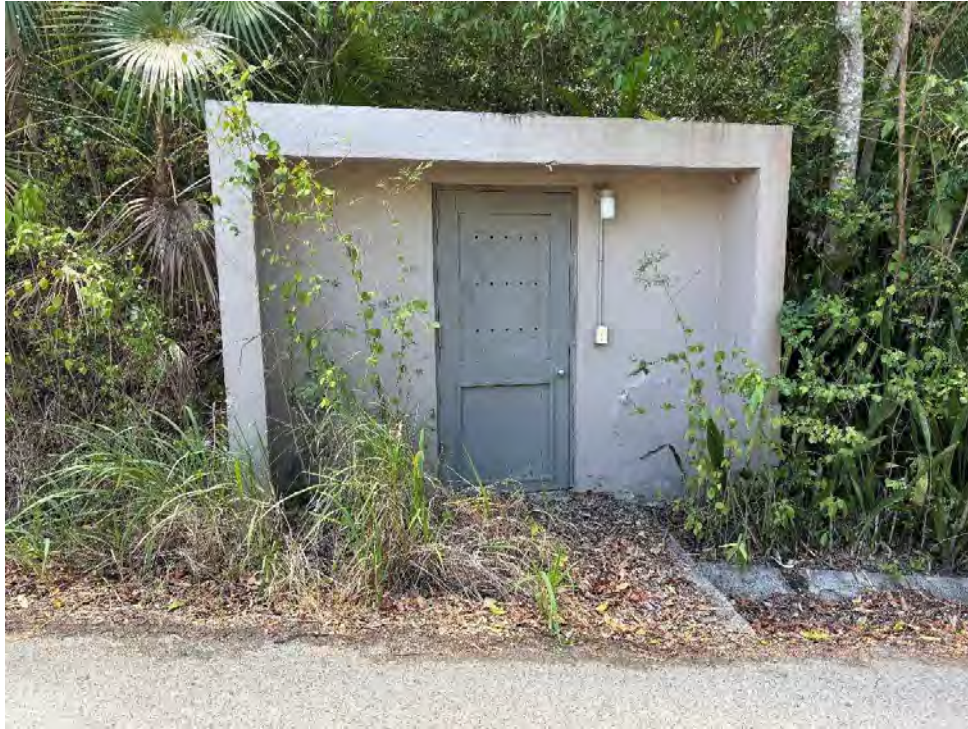
| Component | Material | Notes |
|---|---|---|
| Walls (Structural) | Concrete | Spall on roadside concrete wall. Note due to vegetation and soil elevation, unable to access three sides of the building. |
