**National Park Service**  
Virgin Islands National Park | Caneel Bay  
Structural Assessment Report

**Building: 28 Caneel Beach Units 26-29**

**Structural Assessment: Structurally Sound**

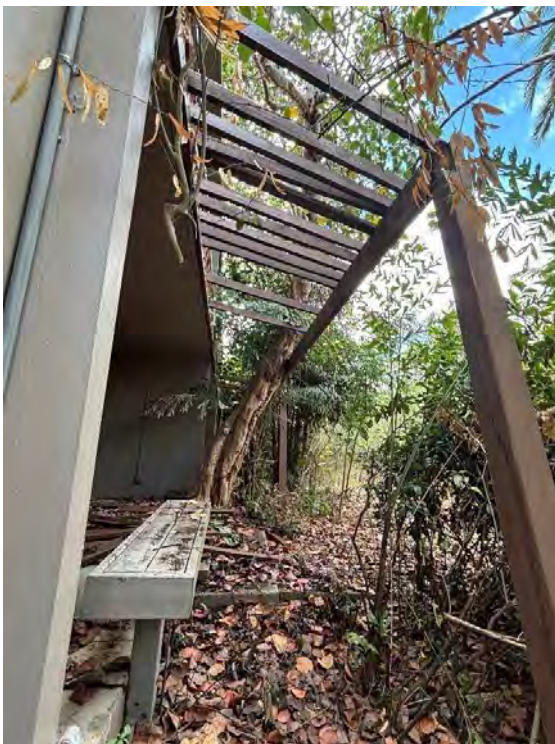
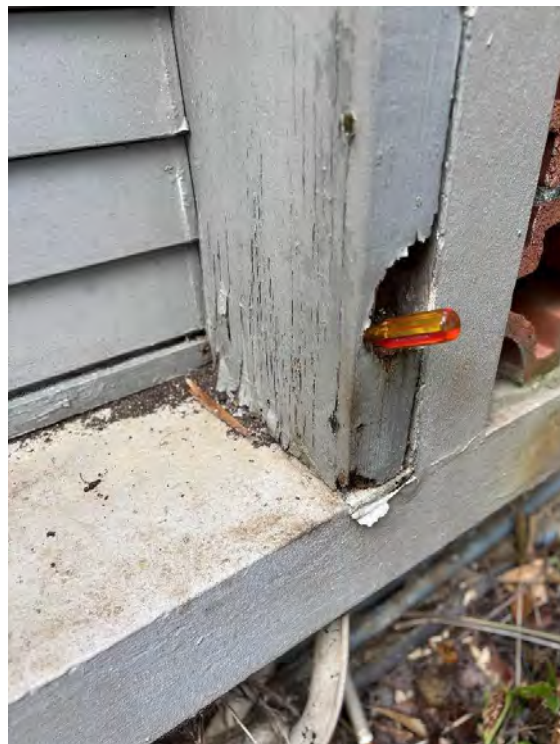
**Building: Caneel Beach Phone Booth**

| Component | Material | Notes |
|---|---|---|
| Roof | Wood framed/<br>Wood shingles | Roof has deteriorated, causing seat to deteriorate. |

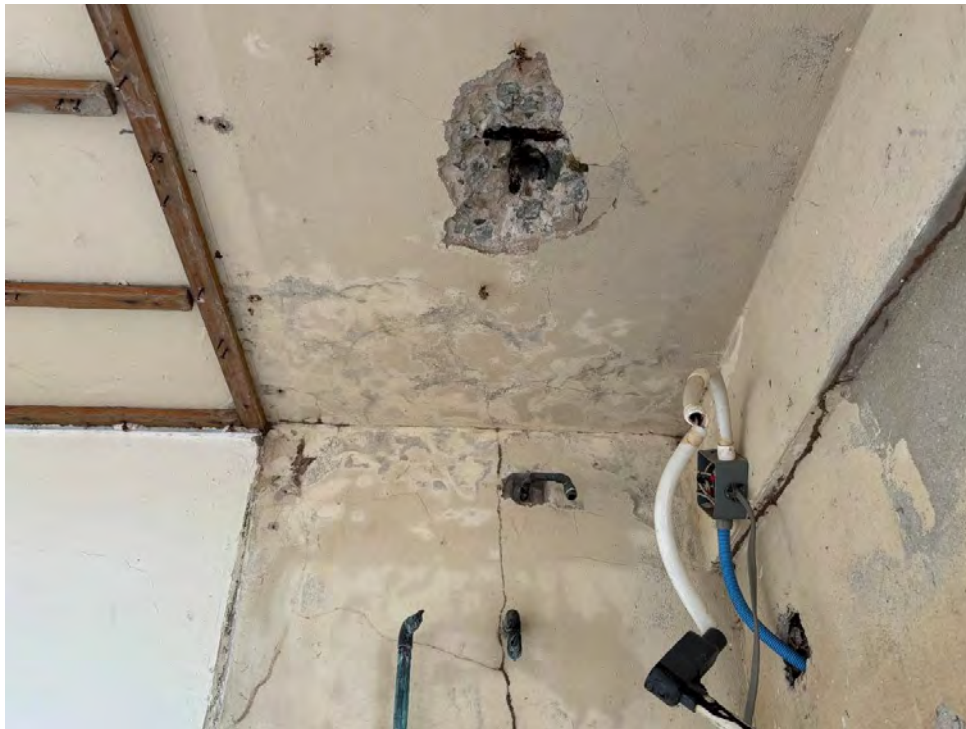
**Building: 32 Cottage Point Units 56-57**

| Component | Material | Notes |
|---|---|---|
| Roof | Concrete / Membrane | Significant spalling at underside of concrete roof slabs. Beam cracked.<br><br>Previous renovations cut back the wall creating a longer beam span. It is unknown if this modification with properly designed. |
| Stairs/Railings | Wood Railings | Wooden railings deteriorated. |
