**National Park Service**  
Virgin Islands National Park | Caneel Bay  
Structural Assessment Report

**Building: Turtle Bay Bus Stop (Adjacent to Units 87-98)**

**Structural Assessment: Structurally Sound**

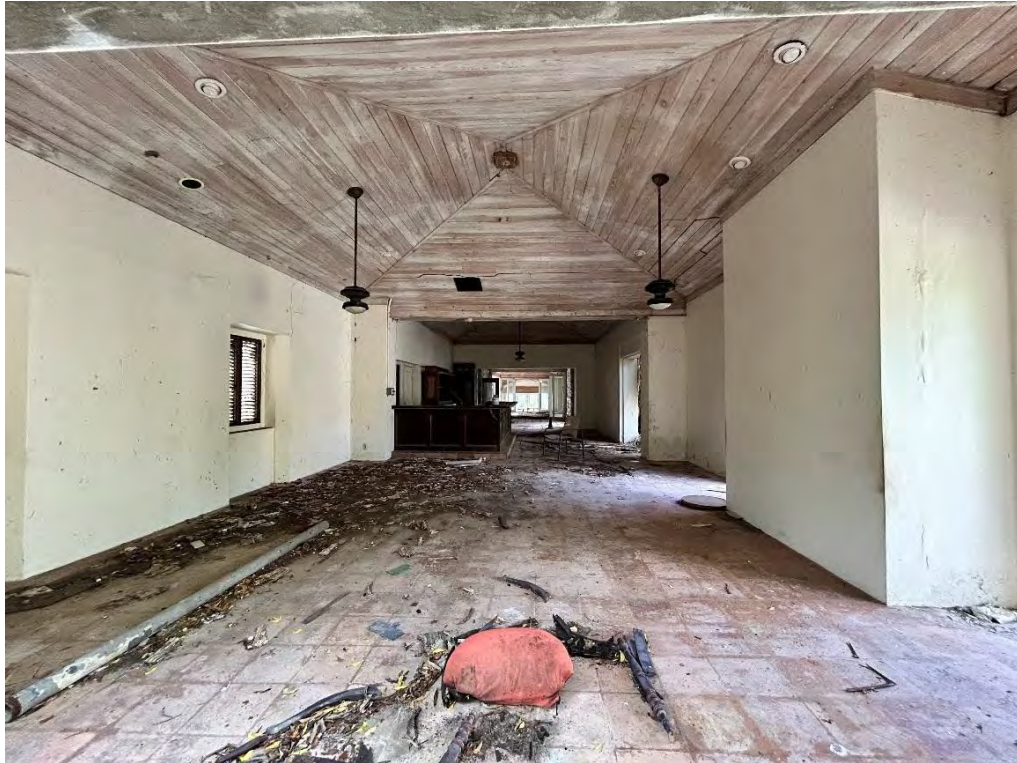
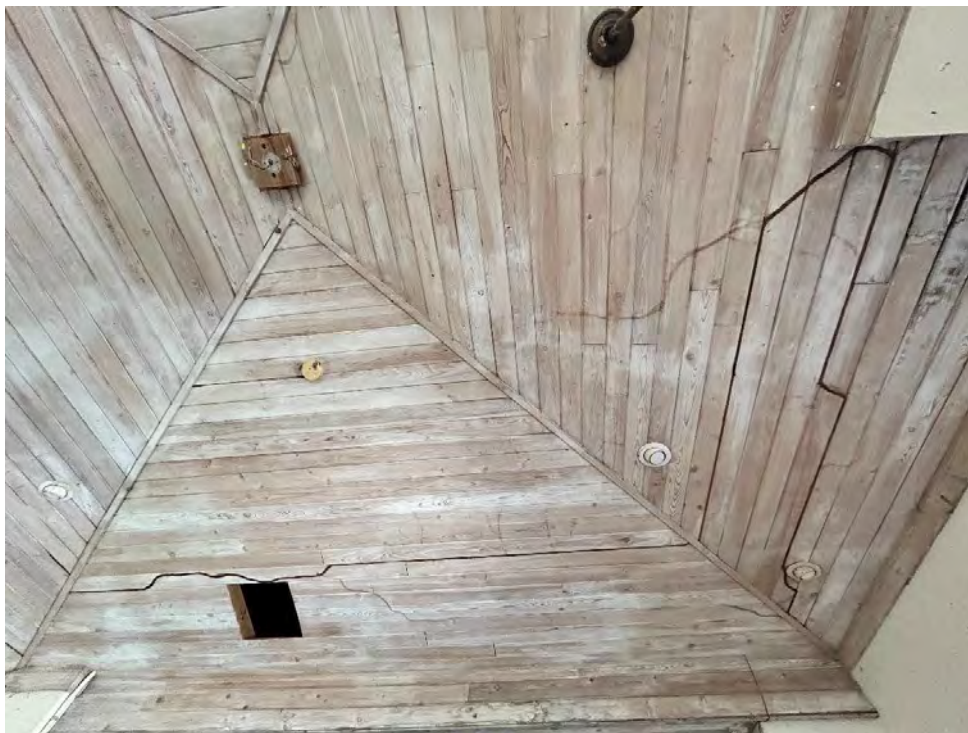
**Building: 95 Turtle Bay Kitchen & Nail Salon**

| Component | Material | Notes |
|---|---|---|
| Walls (Structural) | Concrete | Vertical crack in concrete end wall at Nail Salon. (Nail salon shares roofline and structural walls with kitchen area). |
| Walls (Non-Structural) | Wood framed | Wood frame infill walls above concrete knee walls. Water and termite damage. |
| Roof | Wood framed/<br>Wood shingles | Roof damaged, not watertight. Water and termite damage. |

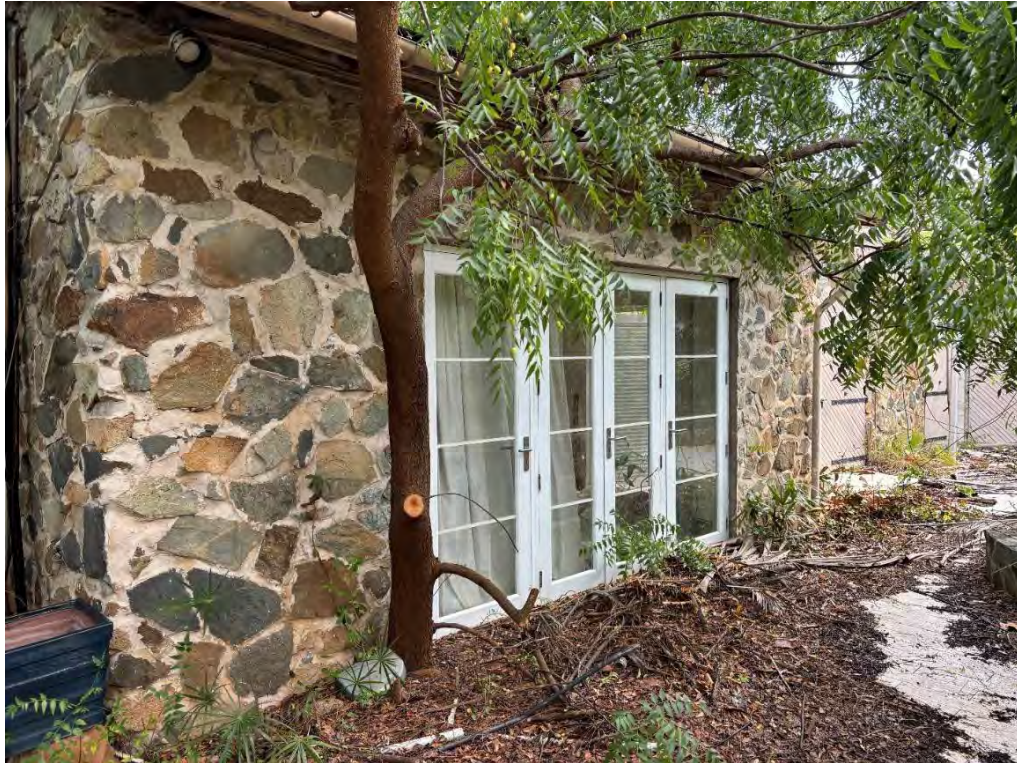
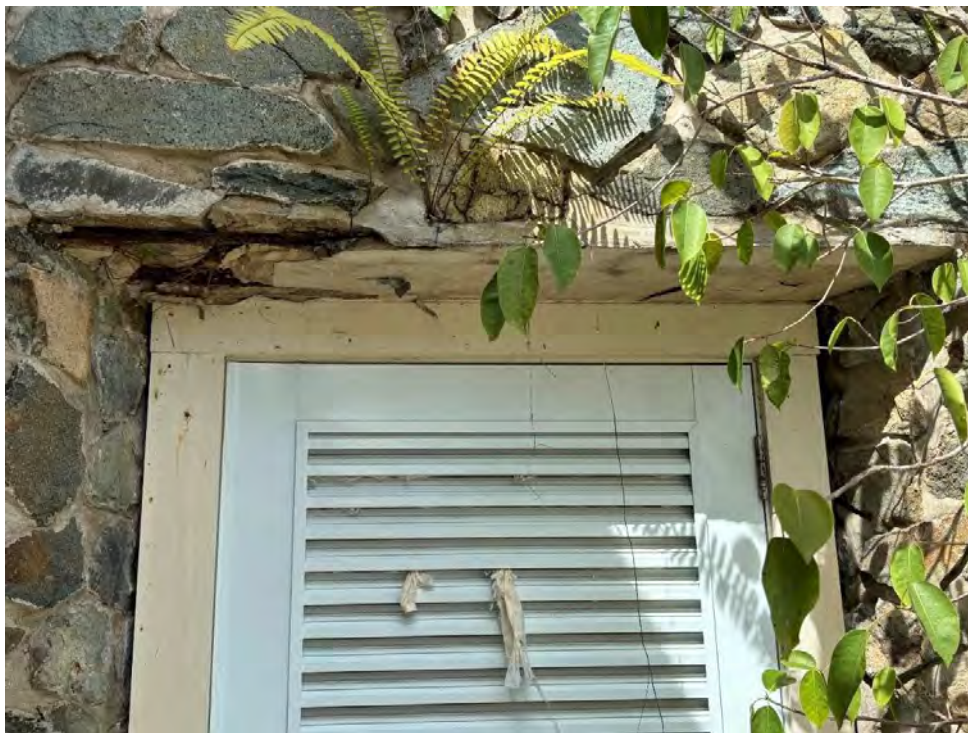
**Building: 95 Turtle Bay Storage Shed (North)**

| Component | Material | Notes |
|---|---|---|
| Walls (Structural) | Concrete | Some moisture staining and cracking in skim coat on front concrete wall. |

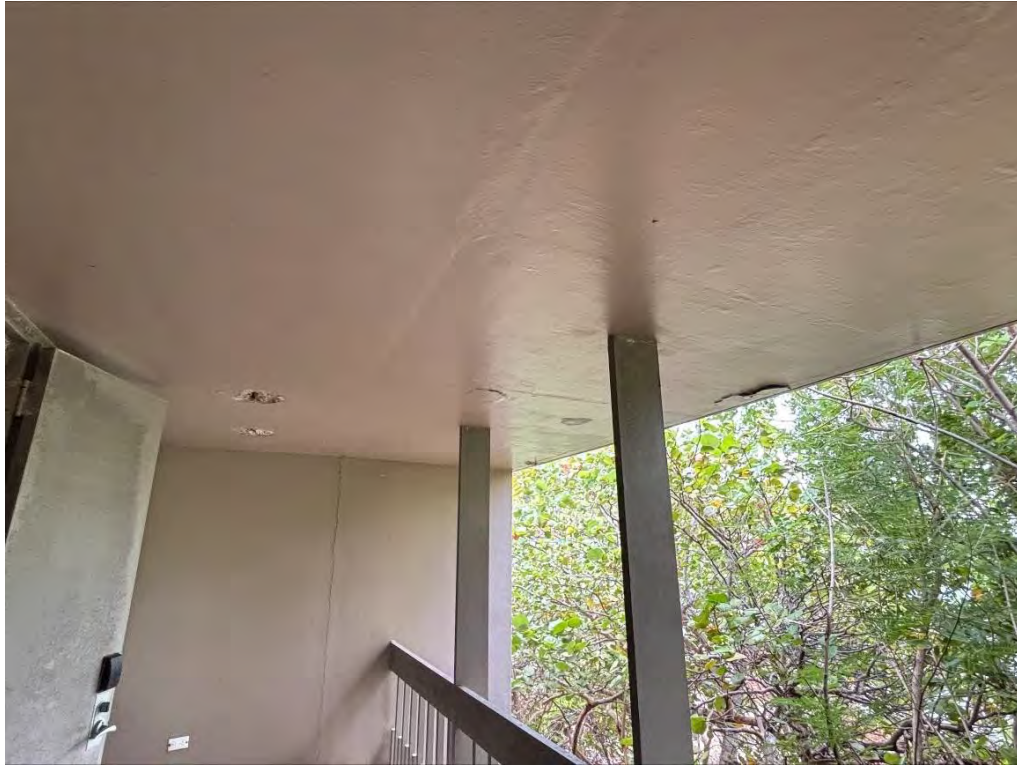
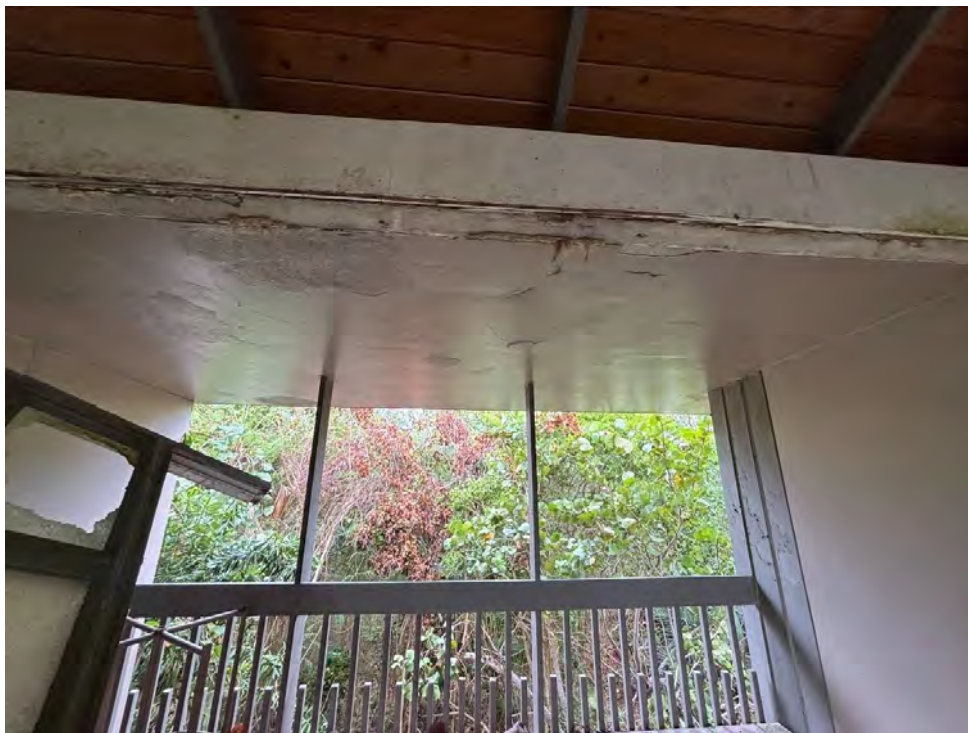
**Building: 47 Hawksnest Beach Units 110-113, 122-125**

| Component | Material | Notes |
|---|---|---|
| Walls (Structural) | Concrete | Spalling on concrete columns with exposed rebar at east side between room 111 and the stairwell.<br>Vertical cracks at geometry changes typical east and west side of second floor rooms (122, 123, 124, 125).<br>Hairline crack in wall at second floor slab elevation between room 125 and stairwell wall.<br>Spalled concrete noted at base of all stairwells. |
| 2nd Floor | Concrete | Spalling and exposed rebar at edge of concrete slab where railing attached (122 east, 123 east, 124 east).<br>Localized spalling at underside of slab throughout the building. At some locations rusted rebar is visible. |
| Roof | Concrete & Wood Framed / Membrane | Spalling on underside of slabs with exposed rebar in some locations.<br>Localized spalling at underside of slab throughout the building. At some locations rusted rebar is visible. |

| Component | Material | Notes |
|---|---|---|
| Stairs/Railings | Concrete / Wood Railings | Railing connections to slabs have failed, predominantly on beach side. Stair walls have vertical crack at geometry change. |

- Concrete walls and slabs, including underside of slabs, should be fully sounded to detect all areas of spalling and delamination.
- Remove existing railings and fully review edge of concrete slabs for damage.
- Repairs may consist of replacing damaged rebar with new rebar, cleaning and coating rebar with zinc rich paint, and repairing concrete.

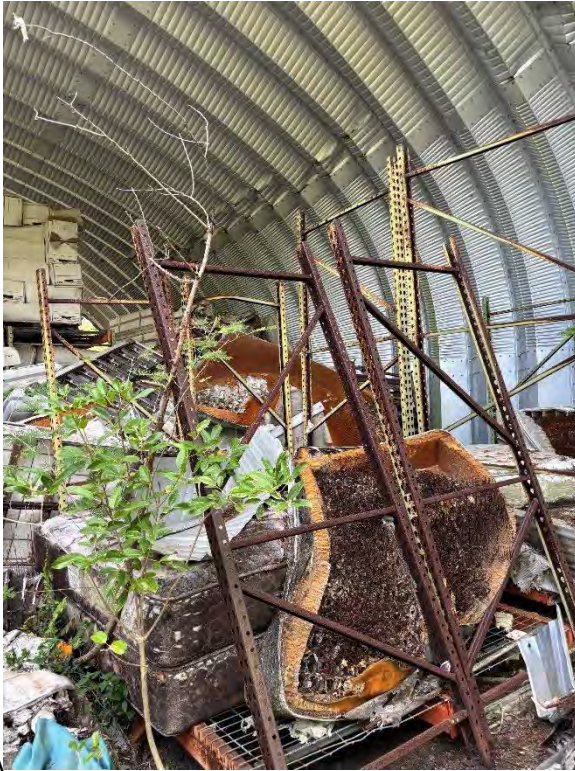
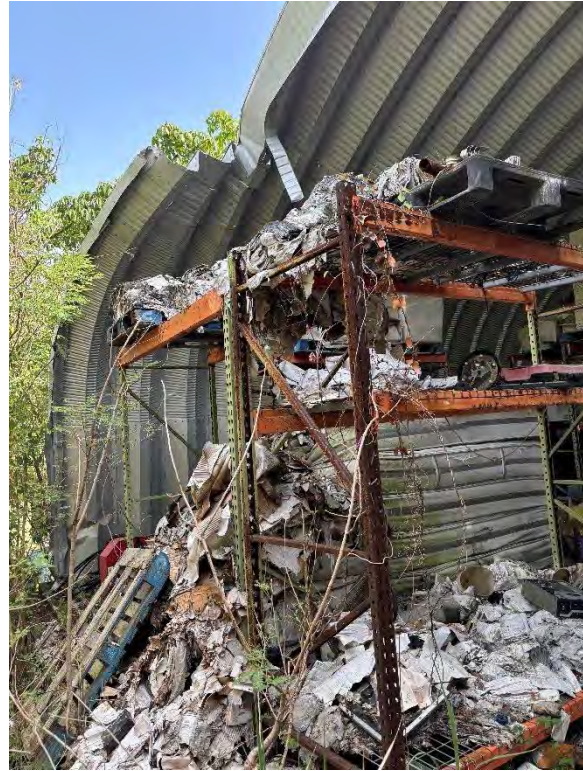
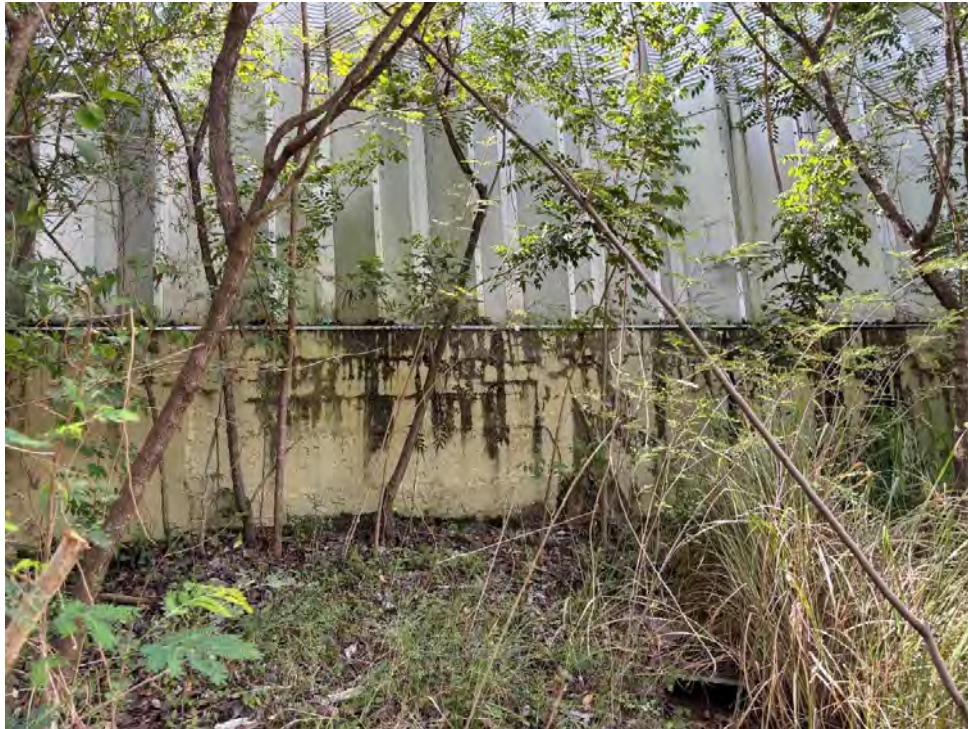
**Building: 11 Laundry**

**Structural Assessment: Potentially Repair or Rebuild**

| Component | Material | Notes |
|---|---|---|
| Walls (Structural) | Steel | Corroded bracing and metal framing members. |

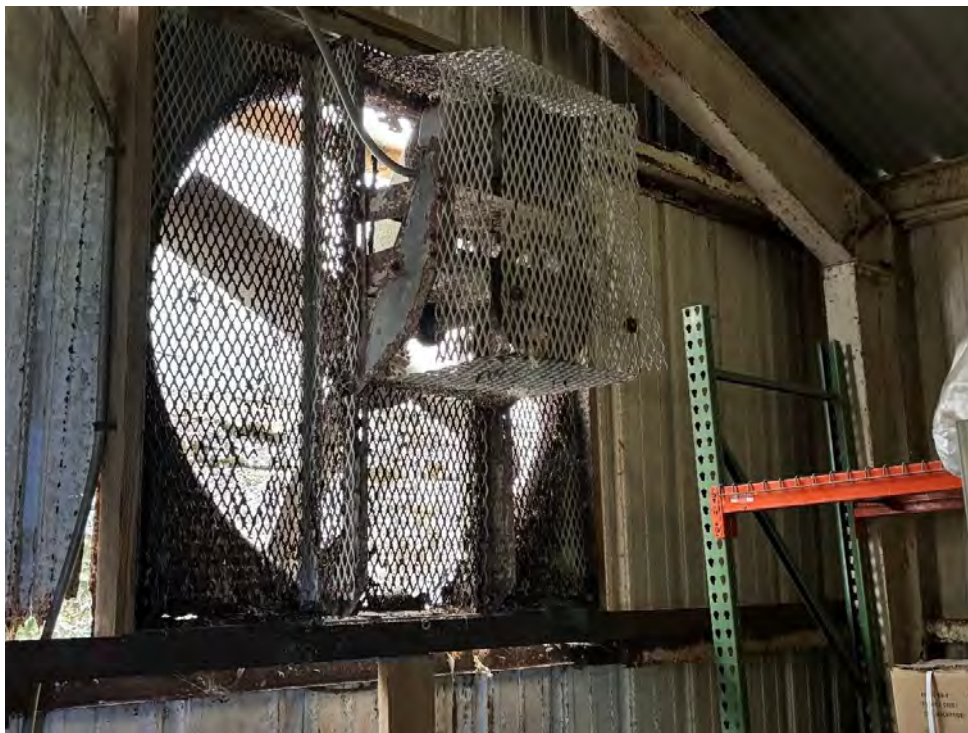
**Building: 12 Ice Plant**

**Structural Assessment: Structurally Unsound**

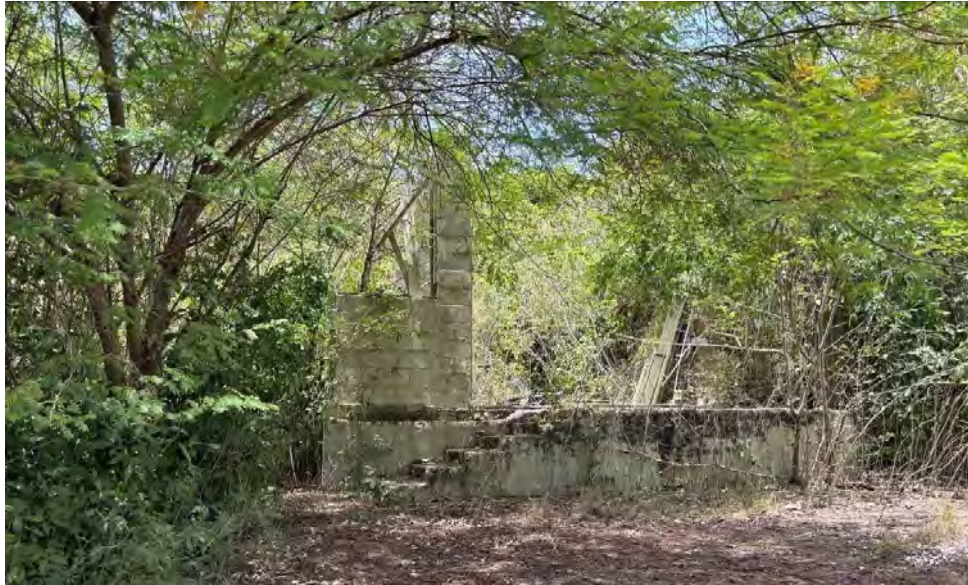
**Building: 13A Electrical Complex**

**Structural Assessment: Structurally Sound**

| Component | Material | Notes |
|---|---|---|
| Walls (Structural) | Concrete | No cracks were noted from the outside. |
| Roof | Wood Framed /<br>Metal Roof | Vegetation on roof.<br>Unable to gain access to inspect roof from<br>the interior. |
