**Building: 13B Generator Building**

**Structural Assessment: Potentially**

**Repair or Rebuild**

**National Park Service**  
Virgin Islands National Park | Caneel Bay  
Structural Assessment Report

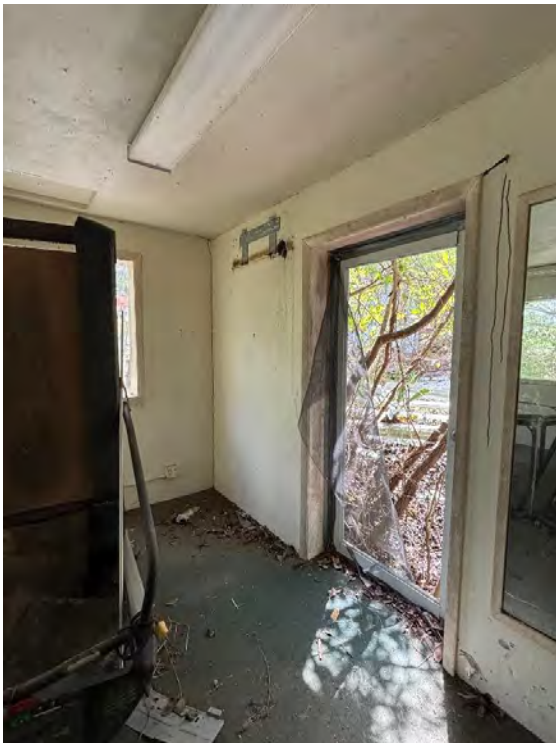
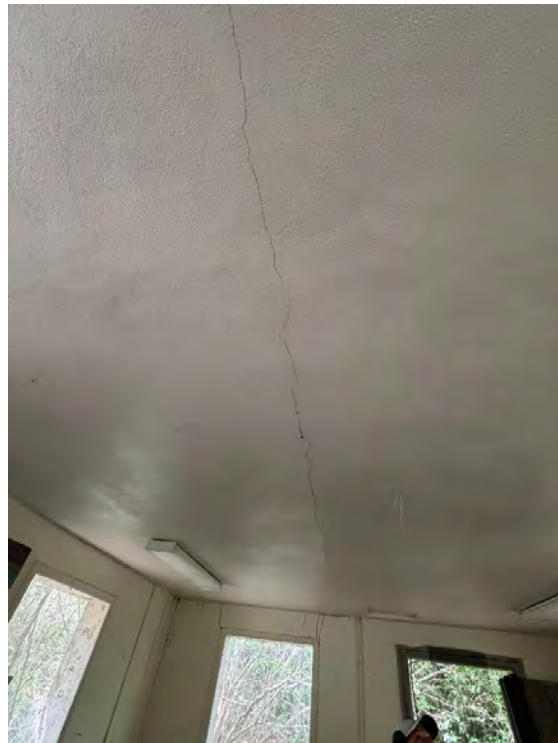
**Building: 77 Gift Shop Warehouse**

**Structural Assessment: Structurally Unsound**

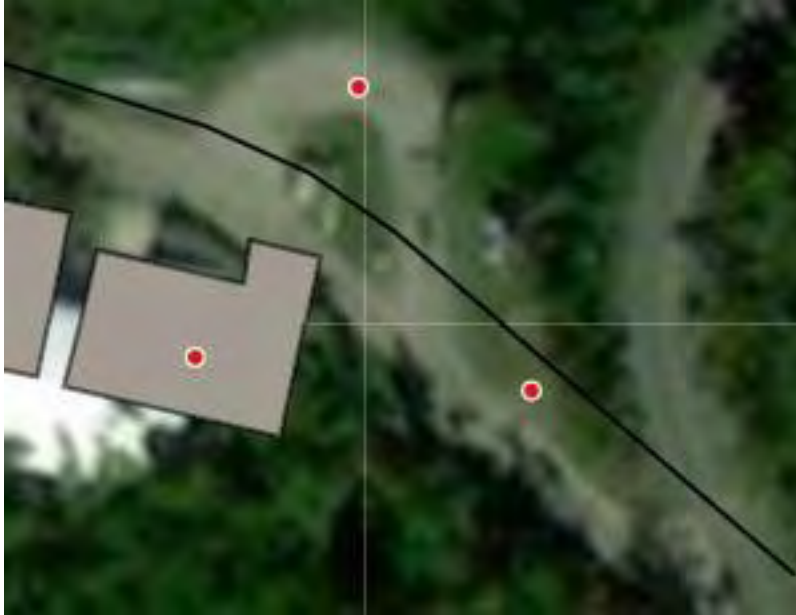
**Building: R.O. Plant**

**Structural Assessment: Potentially Repair or Rebuild**

| Component | Material | Notes |
|---|---|---|
| Plant Walls (Structural) | Concrete Knee Walls / Steel Columns Encased in Concrete | Concrete walls on north side are cracked, spalled and have severely rusted rebar. Concrete around steel columns has spalled. CMU wall on south side is acting as a retaining wall and has horizontal cracks along the length of the wall. |
