**National Park Service**  
Virgin Islands National Park | Caneel Bay  
Structural Assessment Report

## Structural Assessment Summary Virgin Islands National Park Caneel Bay

**CANEEL BAY**  
**ADDITIONAL STRUCTURES**  
**STRUCTURAL ASSESSMENT REPORT**

**Building: Pier (May 2024)**

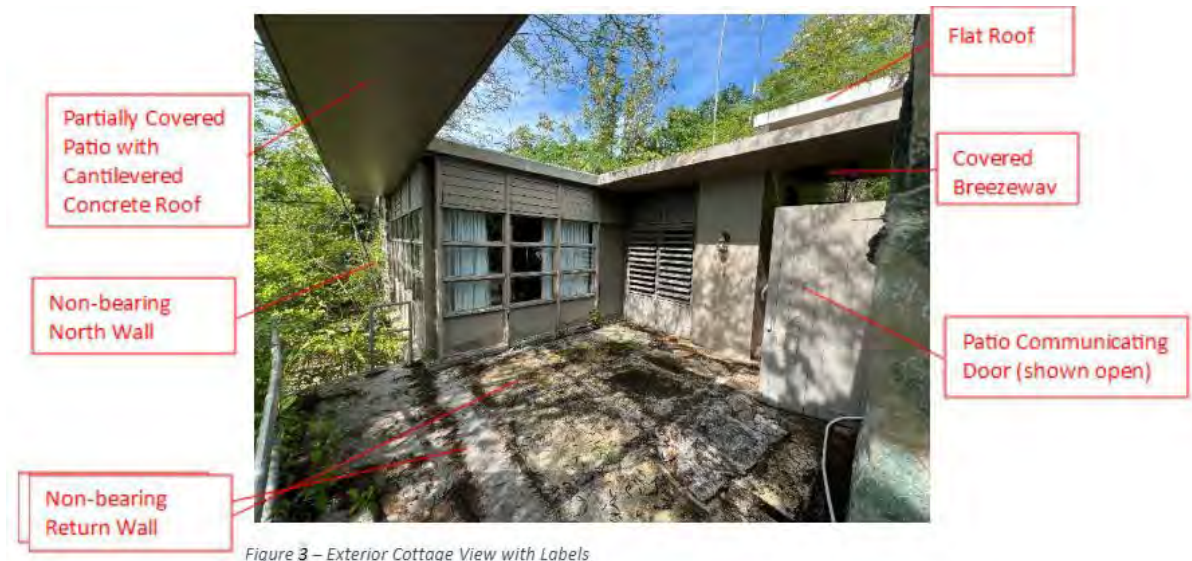
d. **Non-Load Bearing  
Walls**

The wood exterior framing walls are non-load bearing. The north facing walls consist of wood framed glass, and louvered walls. The return walls consist of the entrance door and wood framed glass and louvered walls. The wood framing of the return walls show signs or significant damage including complete failure and extensive insect damage. The condition of these walls is important for maintaining the building envelope system.
