# Existing Conditions

This chapter describes through narrative text, contemporary photographs, labeled base mapping, and analytical diagrams, the current conditions and extant landscape features associated with the Vicksburg National Military Park landscape. The first section—Environmental and Cultural Context and Setting—describes the battlefield within a regional and local context, including hydrological, geographical, and geological features, as well as the demographics and other traits that characterize the park’s contemporary setting and surrounding community. The second section—Site Description—describes the primary organizing elements and features that characterize the Vicksburg National Military Park landscape, including former park lands quitclaimed to the City of Vicksburg and Warren County in the 1960s. The third section—Landscape Description by Characteristic—depicts the individual extant landscape features and resources that together compose the Vicksburg National Military Park battlefield landscape. (See Fig. 7 and Fig. 8 for site location and context and study area boundary maps.)

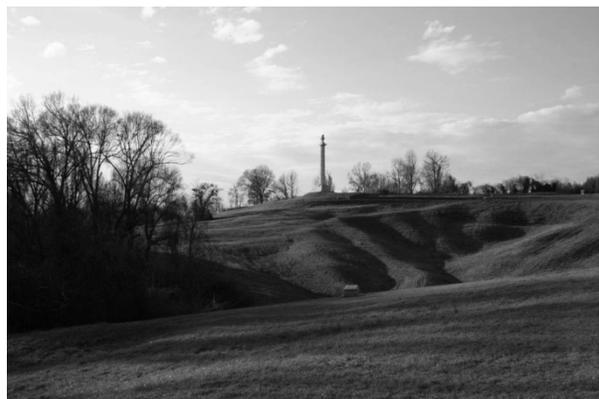
**FIGURE 71.** Remnant earthworks are in evidence throughout the park, and they are highly legible when covered with mown turfgrass. These earthworks lie southeast of the Louisiana State Monument and are part of the Great Redoubt complex. This view is from Pemberton Avenue, looking northwest.

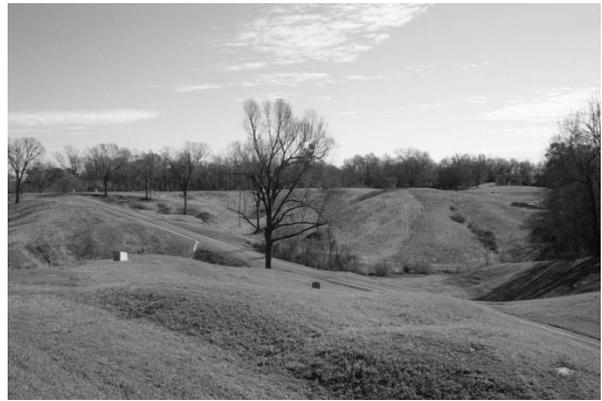
**FIGURE 75.** The Railroad Redoubt is one of the recently cleared areas of the park that is now maintained in mown turfgrass. This view is from a position southeast of the Texas State Monument, looking southeast.

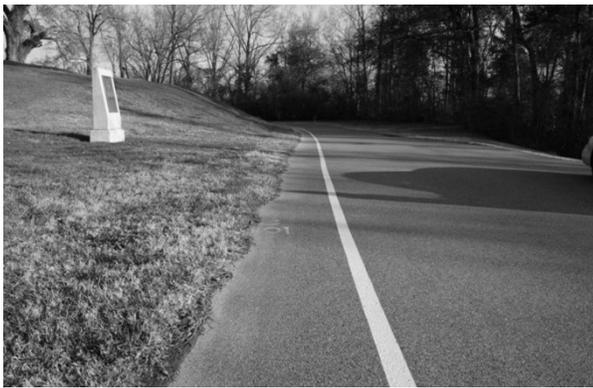
**FIGURE 81.** Union Avenue is the one-way asphalt-paved half of the park tour road that runs up its eastern and northern sides, following the Union siege lines and interpretive tour stops. This view is where it makes a hairpin turn to the east just past the Minnesota State Monument, looking east.

**Union Avenue.** Union Avenue is a sixteen- to twenty-foot-wide, one-lane, one-way, asphalt-paved road that is periodically edged by parking pull-offs associated with tour stops and monuments. A white stripe defines a walking lane along portions of the road margin (Fig. 81). Portions of Union Avenue are edged by concrete curbs on one or both sides, while some steeply-sloped sections are edged by asphalt-paved drainage ditches. Relatively level sections are edged by grass shoulders. The condition of Union Avenue varies along its length, but is generally in good condition. Condition issues observed include cracked and spalling pavement, grass growing into the road prism, and vegetative growth associated with pull-offs and parking areas. The majority of the area between Union Avenue and the park boundary is densely wooded. Existing vegetation helps to screen views of contemporary development outside of the park.

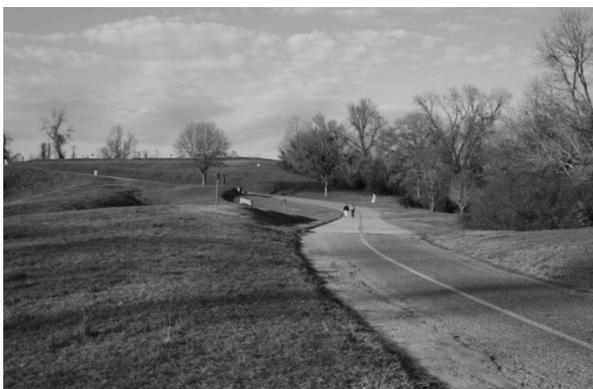
**FIGURE 82.** Pemberton Avenue connects Union and Confederate Avenues and provides access to the Surrender Interview Site Monument and the Old Administration Building. This view is looking north.

**Pemberton Avenue.** Pemberton Avenue is a quarter-mile long, twenty- to thirty-foot-wide, two-way, two-lane, concrete-paved park road, with numerous asphalt patches, located near the middle of the main battlefield unit of the park. Pemberton Avenue leads between Union and Confederate Avenues, and provides access to the Surrender Interview Site Monument, as well as to the Old Administration Building. Its southern section is edged by grass shoulders, while the south side of the northern section is edged with a concrete gutter. The landscape to either side of Pemberton Avenue is maintained in mown grass and views from the road area afforded of rolling terrain and nearby earthen fortifications and associated monuments, such as the Great Redoubt and the Louisiana State Monument. The road is generally in fair condition with cracked asphalt along the shoulders and at various expansion joints (Fig. 82).

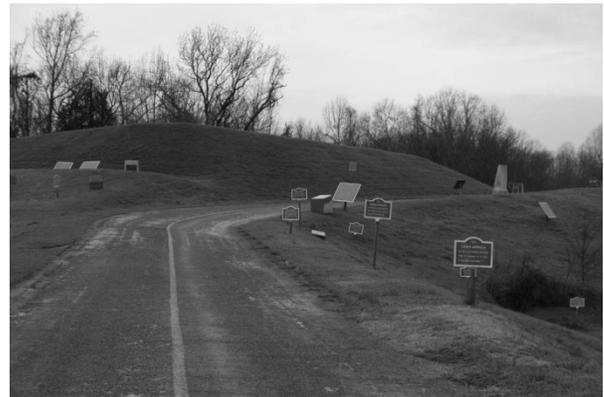
**Graveyard Road.** Graveyard Road is a quarter-mile-long, fifteen- to twenty-foot wide, two-lane, two-way, asphalt road in the northern third of the main battlefield unit that extends between Union and Confederate Avenues. The historic road corridor is edged by grass shoulders, and is in good condition. Tour stops five and ten are located at either end of the road and interpret Stockade Redan and Union attack of the fortification. Monuments, position markers, and tablets line the road corridor (Fig. 84).

**FIGURE 84.** Graveyard Road connects Union and Confederate Avenues in the northern part of the park's core area at the tour stops associated with Stockade Redan Attack and Stockade Redan. This view is from in between those two sites, looking west.

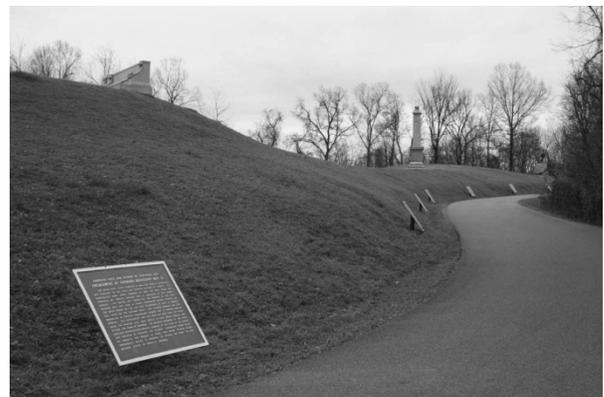
**Grant Avenue.** Grant Avenue is located in the northeast corner of the park. It extends east from Union Avenue, and provides access to Sherman and Grant Circles. The road is two-way, approximately twenty feet wide, and paved with asphalt. It has a grass shoulder. State monuments located along this road include Kansas, Rhode Island, and New York. Also located along the road corridor is the Mississippi African American Memorial. A small concrete parking area with concrete wheel stops is associated with the monument (Fig. 85). Grant Avenue is in good condition.

**FIGURE 85.** Grant Circle marks the site of Maj. Gen. Ulysses S. Grant's headquarters. This view is from the southern half of the circle, looking east.

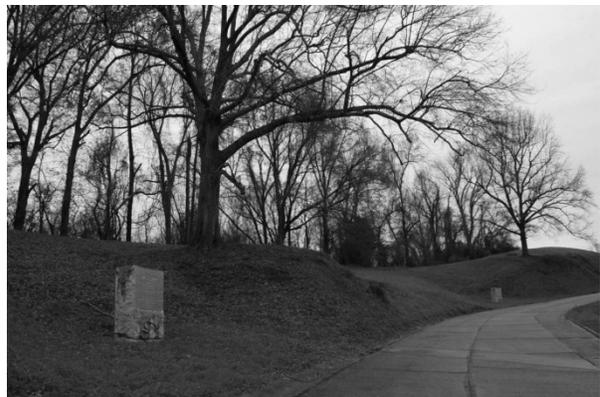
**Confederate Avenue.** Confederate Avenue generally runs along the western boundary of the park. The one-way road is twenty feet wide, has a single lane, and is primarily paved with concrete, although sections have been repaved or patched with asphalt. Concrete curbs, swales, and gutters edge the road corridor in places. A white stripe along the left side of the road designates a walking lane for pedestrians. As the concrete shows cracking and wear in many places, the road is considered to be in fair condition (Fig. 87).

**FIGURE 87.** Confederate Avenue follows the Confederate fortification siege lines along the southern and western halves of the park. It is twenty feet wide and paved mostly in concrete, in many places in only fair condition. This view is looking south, south of the bridge that crosses modern Jackson Road.

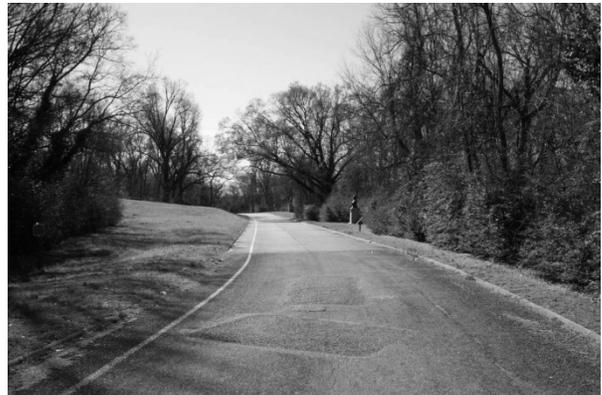
**South Loop.** The South Loop begins to the south of the visitor center. The road leading to the South Loop passes beneath a concrete overpass that conveys Clay Street past the park. It then passes over a bridge that spans the Kansas City Southern Railway line (Fig. 89) before splitting into the one-way loop that accesses the last three tour stops within the park. The one-way, single lane South Loop is approximately fifteen feet wide and paved with asphalt. A white stripe running along the left-hand side of the road designates a section as a pedestrian walking lane. The road is in fair condition due to cracking and patched sections of asphalt.

**FIGURE 89.** The South Loop is continuous one-way road that affords access to the tour stops south of the Visitor Center and Clay Street (Railroad Redoubt, Fort Garrott and Hovey's Approach). This view is west of the Texas State Monument, looking southwest.

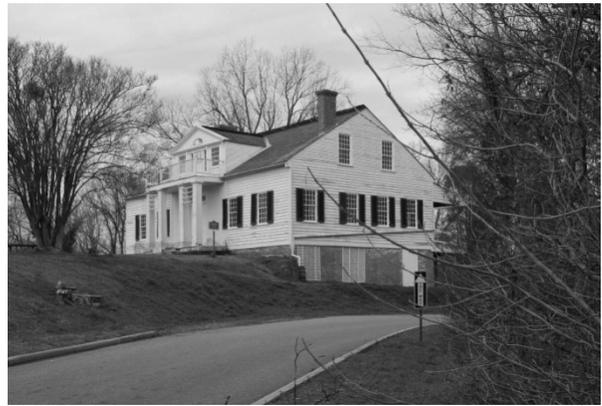
avoid artillery fire. The exterior walls are white-painted clapboard. The first floor windows are twelve-over-twelve double-hung units with green-painted wood shutters. The building has undergone several renovations and alterations since the Civil War. Prior to the completion of the Old Administration Building in 1936, the Shirley House was used as the park headquarters. The interior is currently in poor condition and the building is not currently open to the public.

**FIGURE 96.** Shirley House, view of the front and east side from Union Avenue.

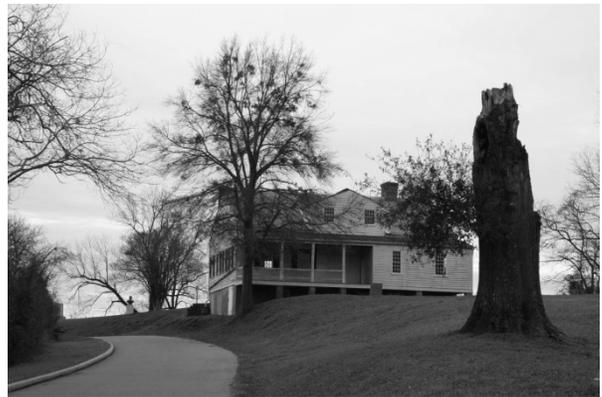
**FIGURE 97.** Shirley House, view of the back of the house from Union Avenue.
