HUNT HOUSE

Women's Rights National Historical Park Seneca Falls and Waterloo, New York

Historic Structure Report

January 2009

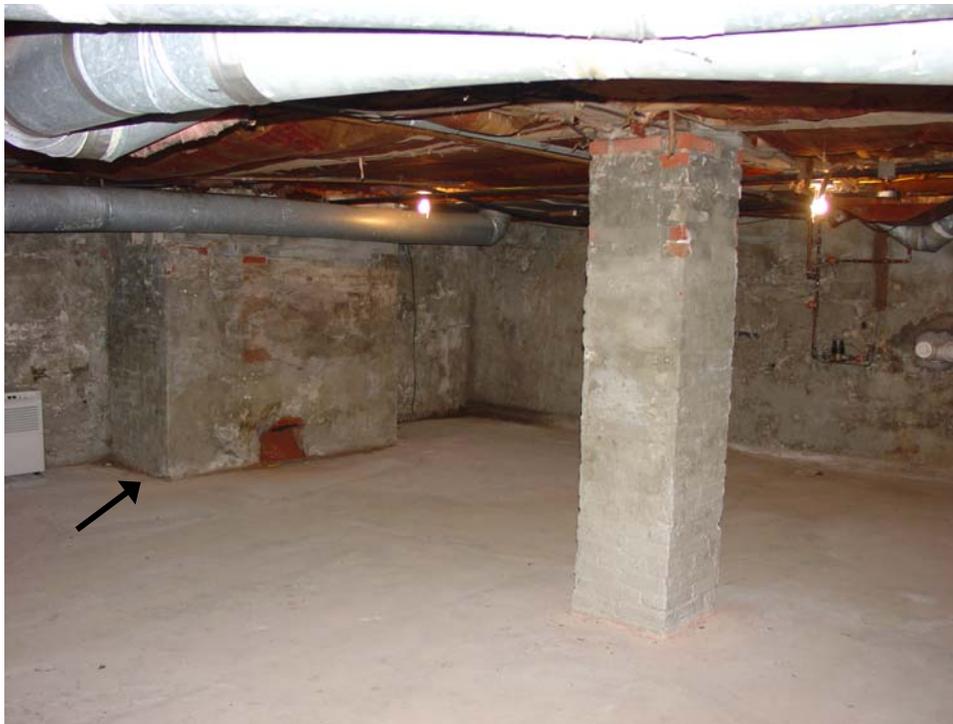
Figure 60. Cellar: View looking southeast, June 2007. Note chimney base at the east wall (at arrow).

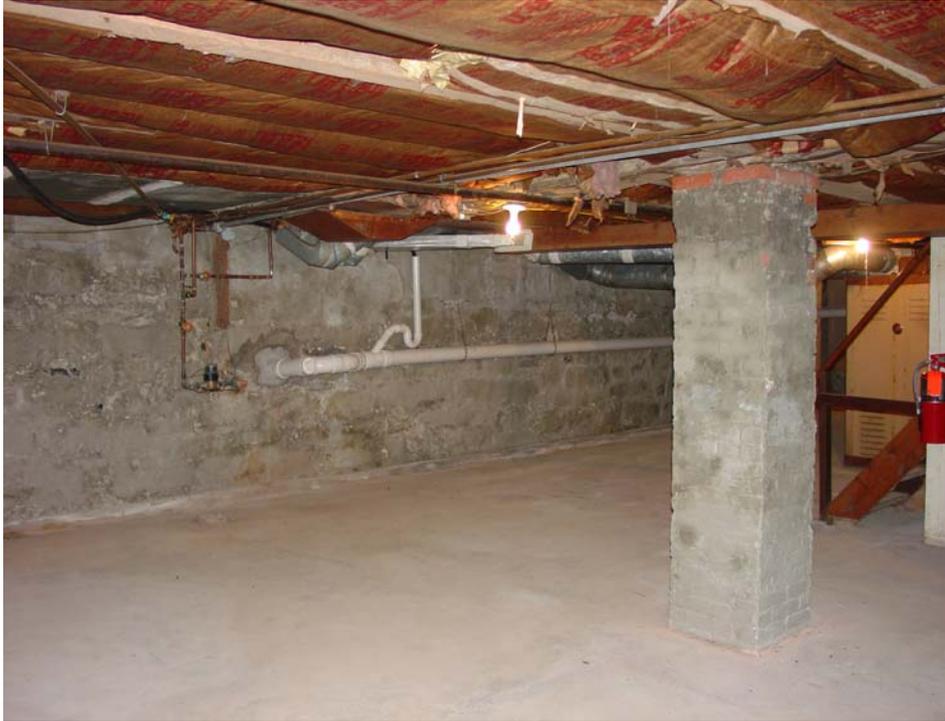
Figure 61. Cellar: View looking southwest, June 2007.

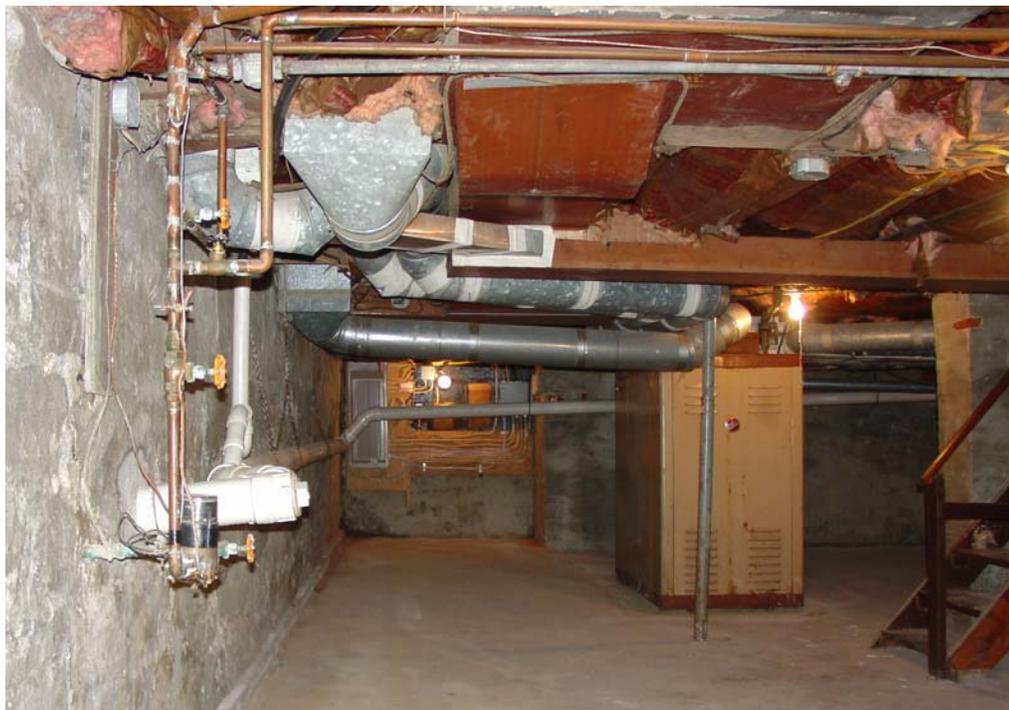
Figure 62. Cellar: Southwest corner showing the electrical panels (left) and furnace (right), June 2007.

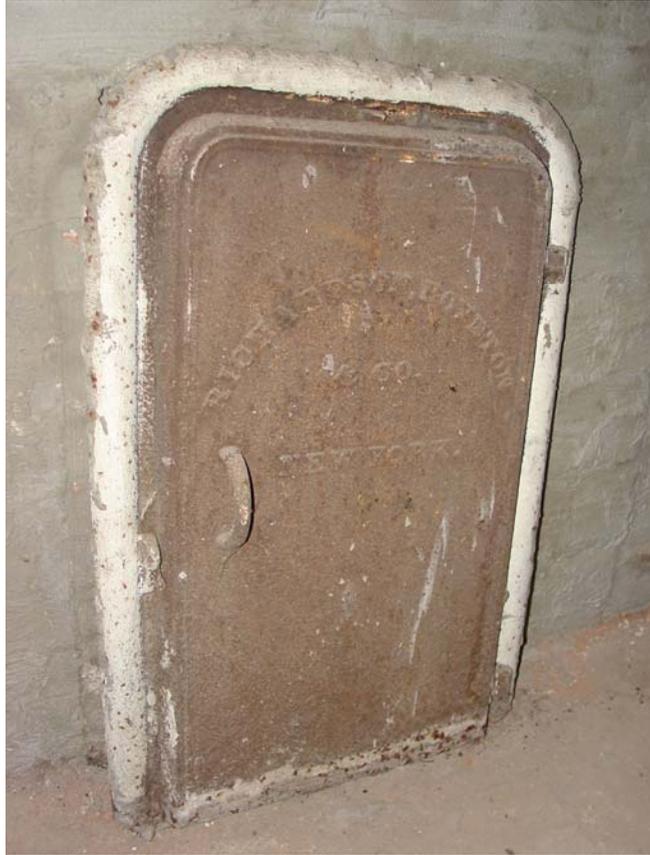
Figure 63. Cellar: Detached cast-iron door from an early furnace made by "Richardson, Boynton & Co., New York."

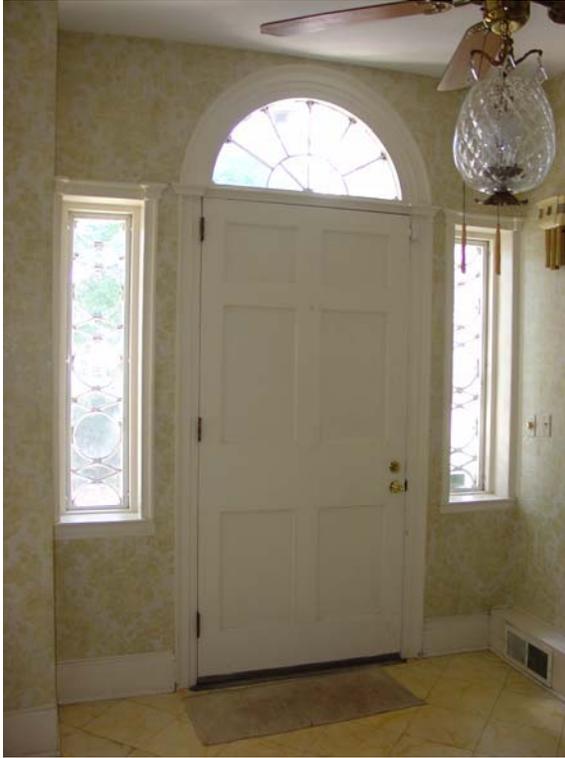
The main entrance to the house is the south exterior doorway of the lower hall (fig. 64). This doorway retains its original casings, flanking sidelights, and semi-circular fanlight. The existing 6-panel door is a later replacement installed circa 1945-60 by the Greenwoods, based on the analysis of the door's painted finishes. The modern hardware is contemporary with the door. The earlier door appears to have also had 6 panels, based on the earliest-known photograph of the house dated circa 1900 (fig. 18).

Figure 64. Room 101: Front doorway at the south wall, June 2007.

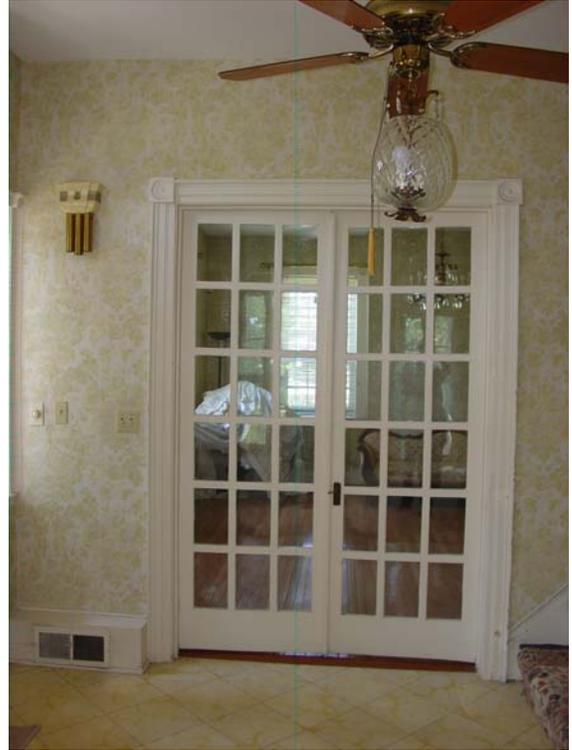
The first doorway on the left as one enters the house connects with the west dining room (Room 102—fig. 65). This doorway was widened to its present size, and French doors installed, circa 1920. The casings and rosette corner blocks have a mixture of ovolo and cavetto moldings reused from two or more doorways. Physical evidence preserved on the original floorboards may be helpful in determining the size and location of the original doorway.

Figure 65. Room 101: West doorway to Room 102, June 2007.

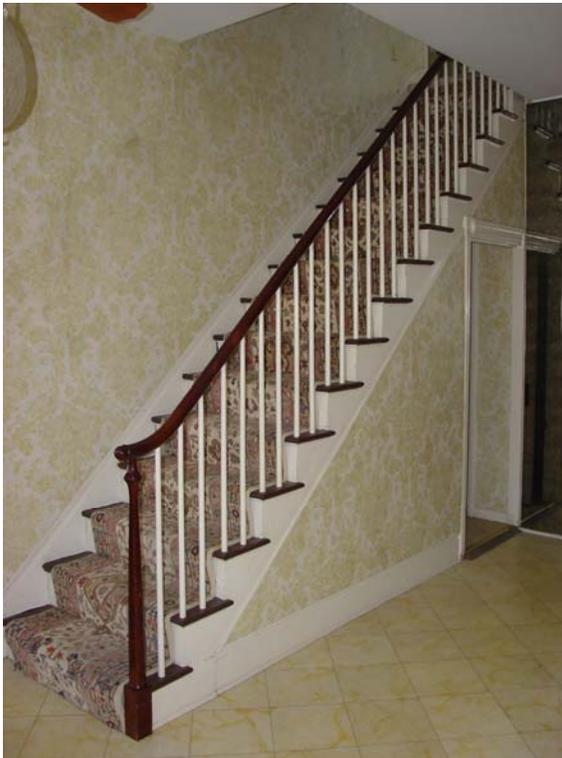
A stairway leading to the second story is an original feature of the lower hall (fig. 66). The stair is a straight run with a Federal-style railing and simple tapered balusters. The stair was described in Richard P. Hunt's probate inventory of 1856 as having a "Stair Carpet & Rods." These may have been the same "77 yds Carpet" and "1 1/3 doz Rod" purchased by Hunt from A. & E. S. Higgins of New York on May 7, 1841.³ A mechanical chair lift that was installed on the west side of the stair by the last owners is missing today.

Figure 66. Room 101: Stairway to the second story, June 2007.

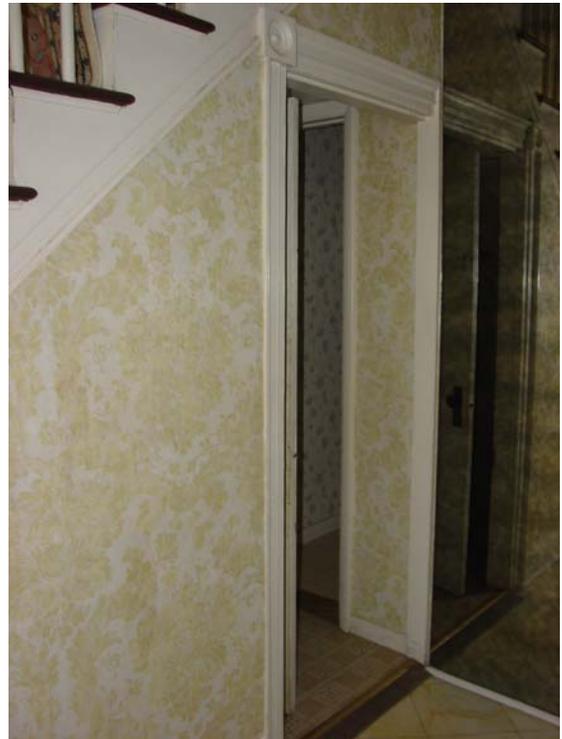
A closet located beneath the stair at the west wall was an original feature of the hall from 1828 until circa 1920. As previously mentioned in the section on "Doorways," this closet was referred to as the "Closet Under Stairs" in the 1856 probate inventory of Richard P. Hunt. Surviving physical evidence indicates that the framing of the stair was exposed in the closet historically. The closet's north and west partitions were removed around 1920 and the space incorporated as part of a new kitchen. The underside of the stair was finished at this time with the lath and plaster, which is furred out with pieces of reused painted woodwork. A cellar stair and access doorway were later installed by the Greenwoods circa 1950, beneath the hall stair in the south wall of the former closet. Plasterboard walls were erected at this time for a toilet room in the northeast corner of the kitchen, creating the existing narrow passage. All that remains of the hall closet today is the partial doorway opening and casing on the hall side (fig. 67). See "Doorways" for details.

Figure 67. Room 101: West doorway beneath the stair, June 2007.

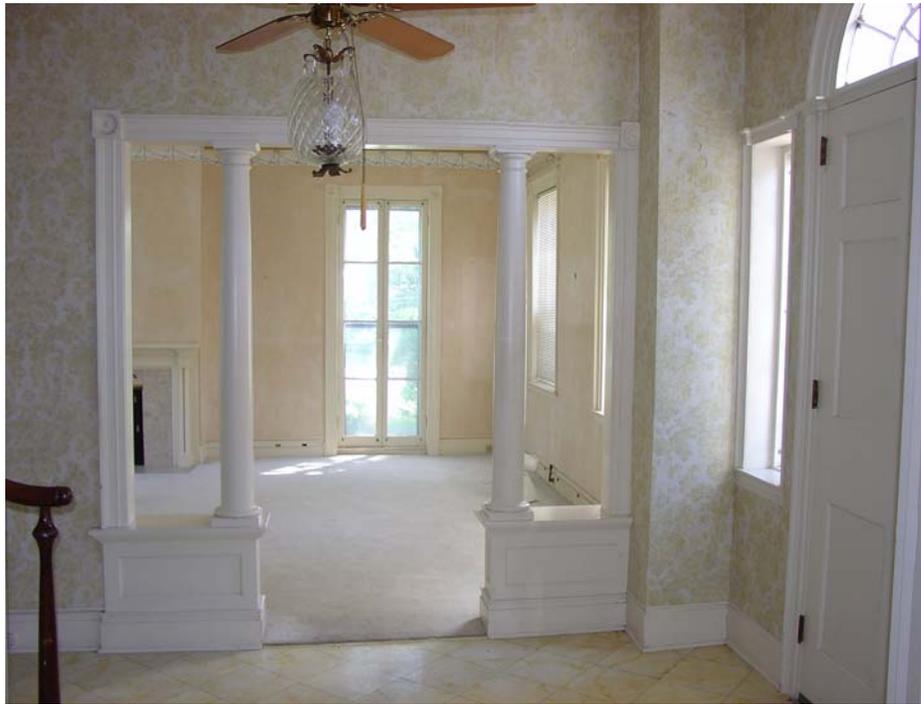
The first doorway on the right as one enters the house connects with the parlor, now called the living room (Room 106—fig. 68). This doorway was widened to its present size, and embellished with flanking columns on paneled bases, circa 1920. There are no doors. The casings and rosette corner blocks have a mixture ovolo and cavetto moldings reused from two or more doorways. Physical evidence preserved on the original floorboards may be helpful in determining the size and location of the original doorway.

Figure 68. Room 101: East doorway to Room 106, June 2007.

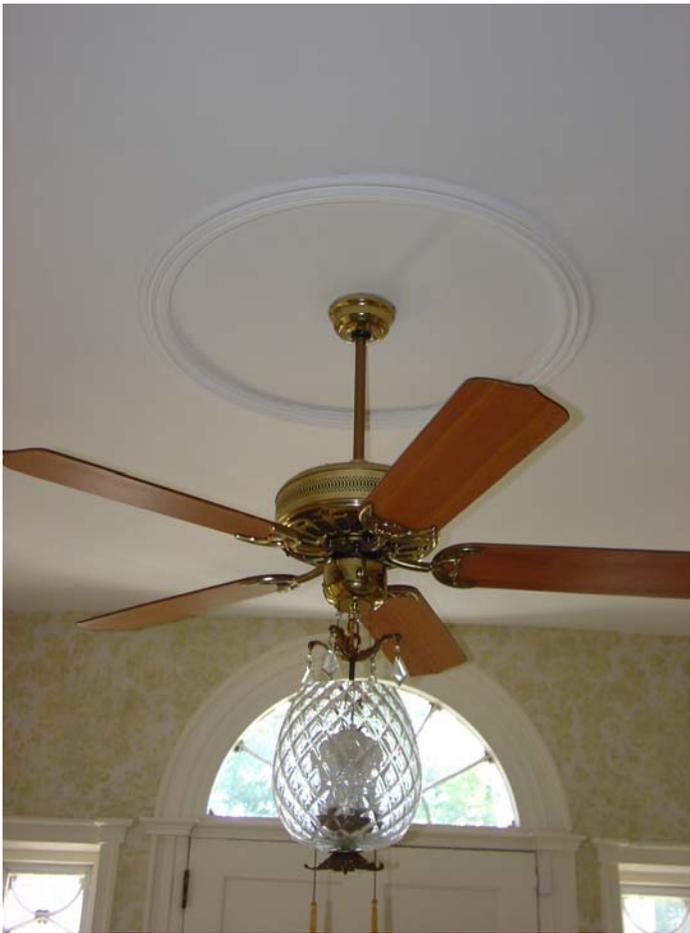
The ceiling measures 9' 9" high today, which is less than its historic height due to the buildup of later flooring and ceiling materials. The ceiling, like the walls, was finished with lime plaster applied to sawn lath originally. The extent of surviving original ceiling plaster in the lower hall is unknown, since most of the ceiling is still covered today with plasterboard installed in 1977. A round decorative ceiling molding in the front portion of the lower hall is presumably contemporary with the plasterboard (fig. 69).

Figure 69. Room 101: Detail of the ceiling looking south towards the front doorway, June 2007.

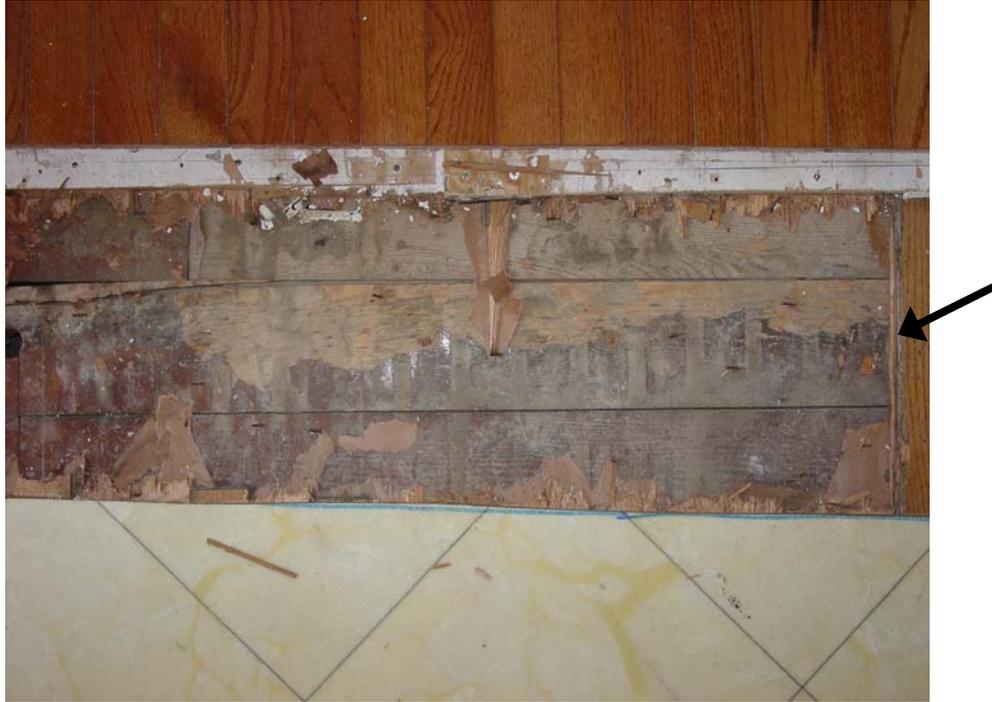
The original floor of the hall consists of a single layer of random-width, tongue-and groove floorboards (fig. 70). The floor was protected in 1856 with "1 Oil Cloth," according to Richard P. Hunt's probate inventory. The oil cloth was replaced by 1890 with "Abt. 25 yds carpet in lower hall" along with "2 door mats," as noted in Jane C. Hunt's probate inventory. Two layers of later flooring cover the original floorboards today. Oak floorboards over construction paper were installed circa 1920. Black-and-white vinyl tiles 9" square were removed in 1977 prior to installation of 12"-square vinyl tiles of faux marble design that cover the floor today. The circa-1950 black-and-white tiles were found preserved at the north end of the hall beneath the bathroom flooring (fig. 72).

Figure 70. Room 101: Detail of the floor at the west doorway to Room 102 showing original floorboards (at arrow) beneath later flooring, August 2007.

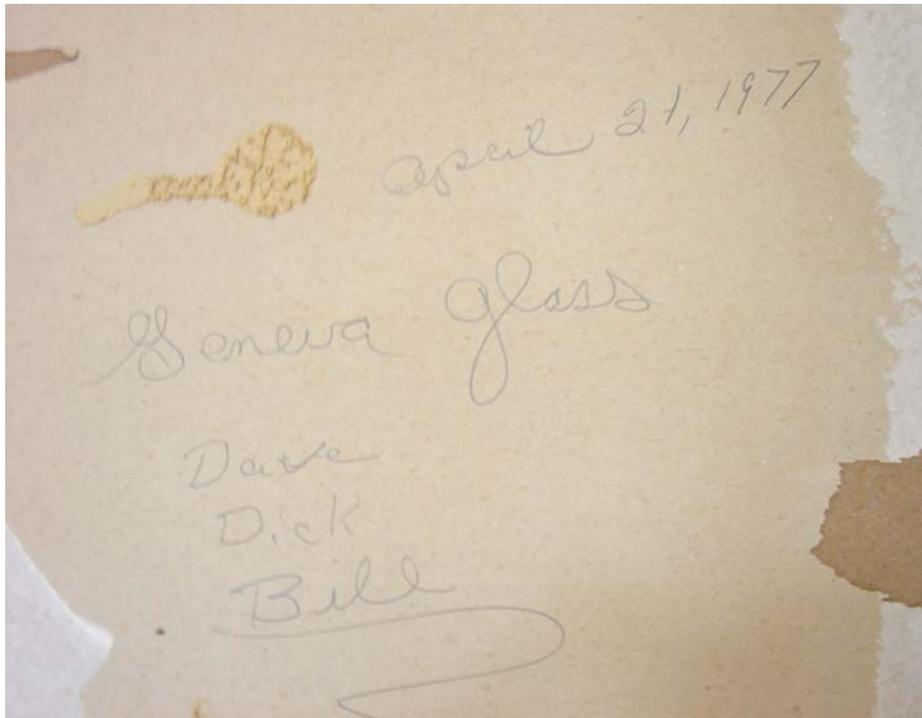
² A penciled note on the plasterboard beneath the mirror reads, "April 21, 1977, Geneva Glass, Dave, Dick, Bill" (fig. 71).

Figure 71. Room 101: Detail of writing on plasterboard at the later north partition beneath large mirror, August 2007.

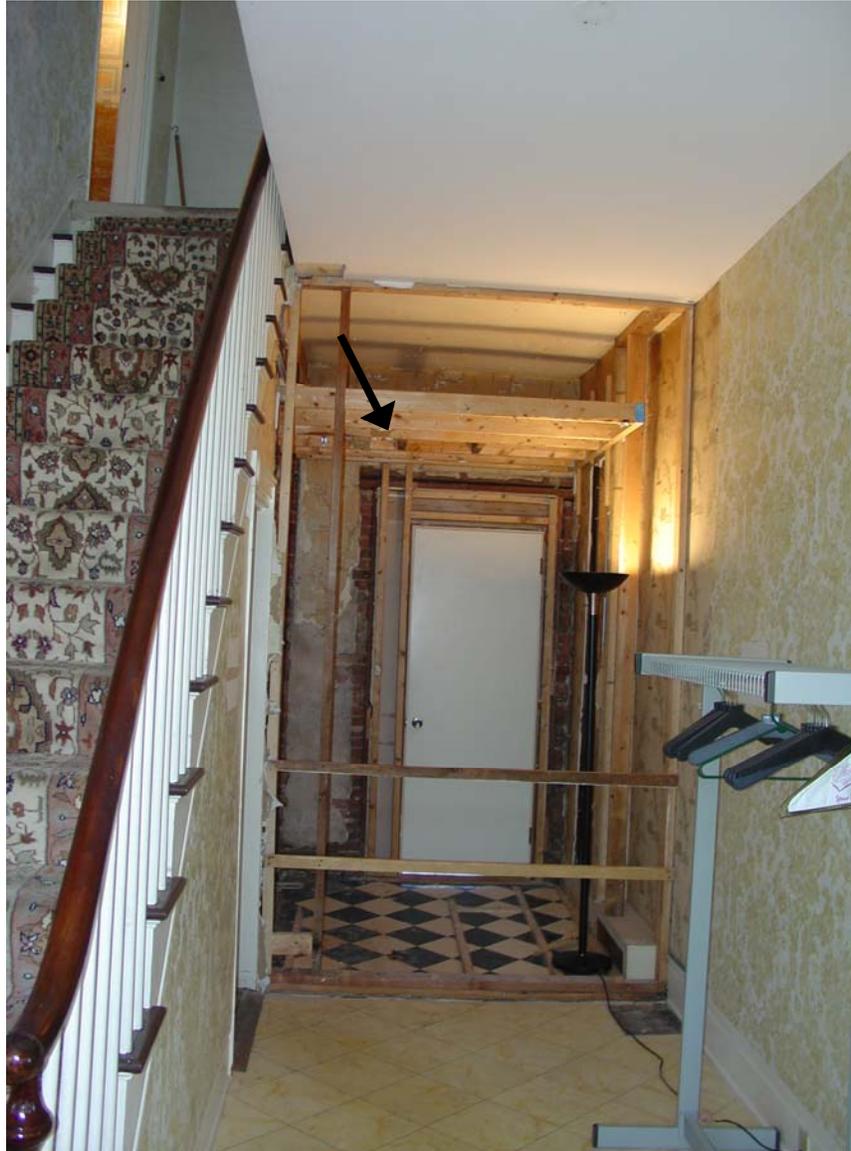
The back entrance to the house was in the north exterior wall of the lower hall. All that remains of this doorway is the opening itself and the door frame (fig. 72). Physical evidence indicates that this doorway had no sidelights or fanlight. It was converted to an interior doorway with the construction of the north addition around 1960. Access to the doorway from the hall was later completely blocked in 1977 when the north end of the hall was partitioned for a bathroom. This partition was removed by the National Park Service in 2008. The existing narrowed opening has a modern, hollow-core door.

Figure 72. Room 101: View looking north towards the original exterior back doorway at the end of the hall following removal of the bathroom partition, April 2008.

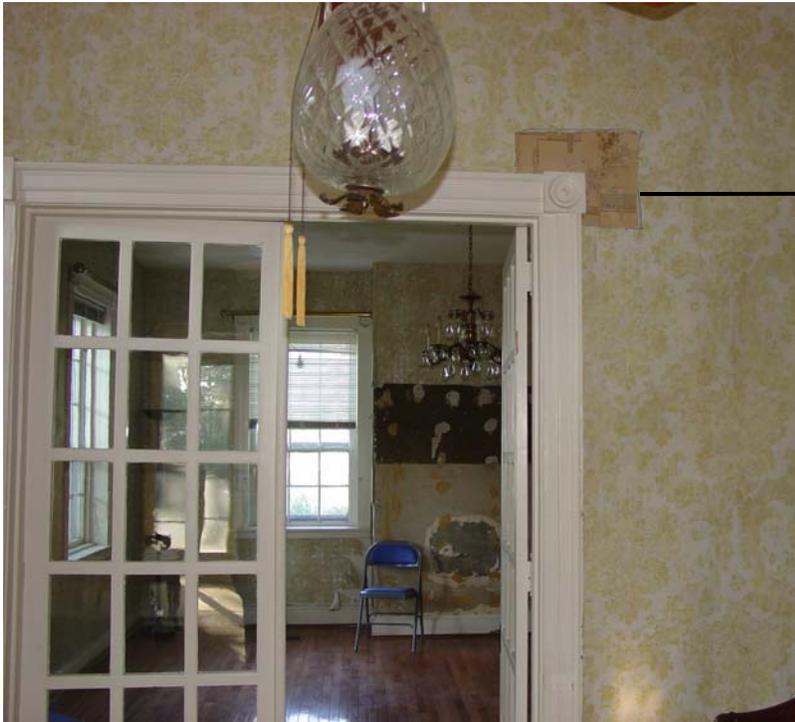
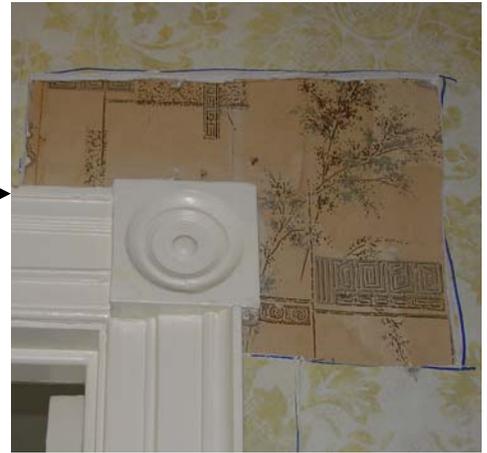
Figure 73. Room 101: Detail at west doorway to Room 102 showing circa-1960 wallpaper on plaster beneath existing plasterboard, August 2007.

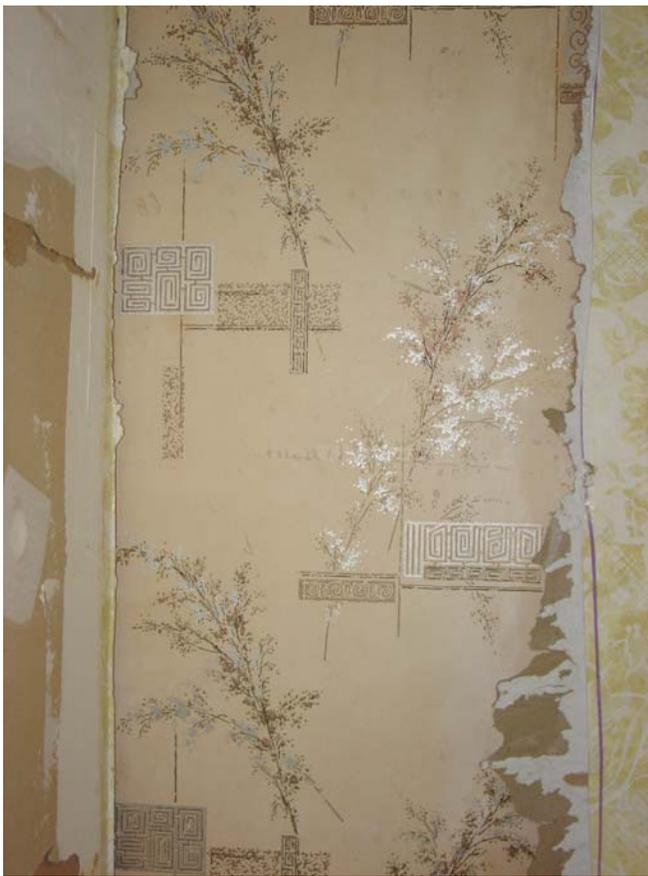
The last doorway on the right near the back end of the hall opened onto a small room called the "Hall Bed Room" in the probate inventory of Richard P. Hunt in 1856. This doorway was retained when the bedroom partition was removed to enlarge the parlor sometime before 1873 (circa 1860s). It was finally removed and the opening enclosed by the Greenwoods around 1960, based on a family photograph (fig. 25) and analysis of the paint on the baseboard patch. The location of this former doorway can be clearly discerned by patches in the baseboards and walls on the hall and parlor sides of the former opening (fig. 74).

Figure 74. Room 101: Detail of east plaster wall beneath plasterboard at former doorway to Room 106, August 2007.

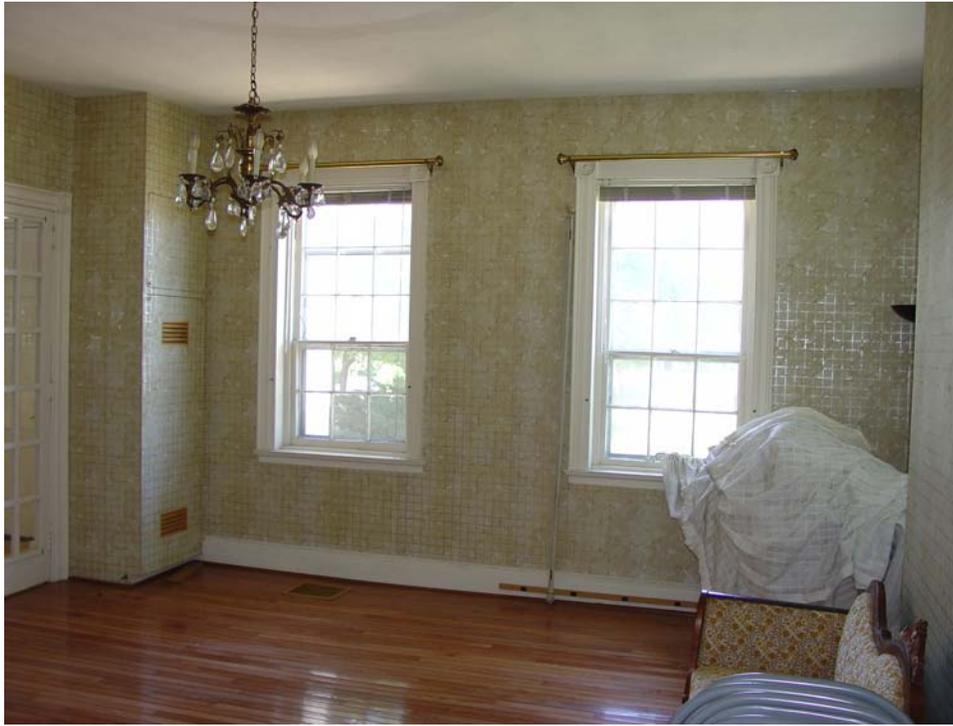
Three of the four existing windows in the dining room are historic. These are the two windows in the south wall (W101 and W102) and one to the left of the chimney breast in the west wall (W103)—see figs. 75 and 76. These windows retain their original 9-over-6 sashes and casings with cavetto edge molding and rosette corner blocks. Two of the windows, presumably at the south wall, were outfitted in 1890 with "2 curtains & cornices, shades & fixtures," according to Jane C. Hunt's probate inventory of that year. A fourth window (W104), on the right side of the chimney breast, replaced a circa-1841 doorway. Paint analysis indicates the window casing dates to circa 1920, while the 9-over-6 sashes were reused from some unknown location. Modern window elements include the sash locks and spring counterbalances that replaced the original sash cords and weights.

Figure 75. Room 102: South wall, June 2007.

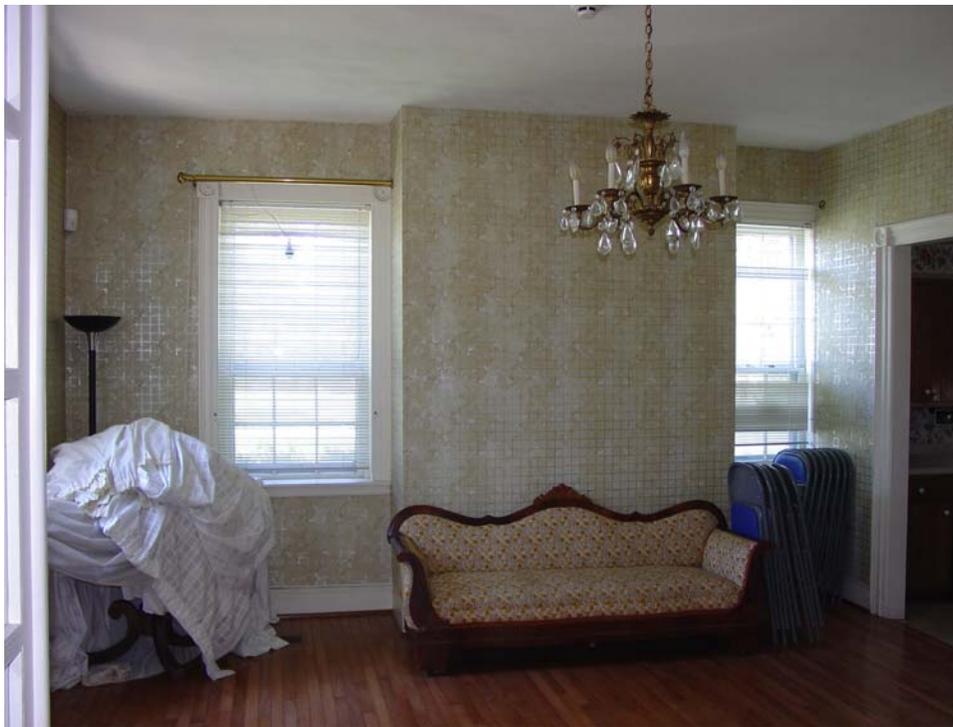
A chimney breast is centered at the west wall of the dining room (fig. 76). This is an original feature of the room that was constructed of brick and finished with a coat of plaster. The front face undoubtedly had a fireplace opening and mantel, but no physical evidence of either remains today. These are thought to have been removed and replaced by the existing coating of cement plaster around 1920. This modern plaster definitely existed by 1948, based on a penciled note from a local interior decorator of that date (fig. 81). The entire chimney breast was later covered by plasterboard panels glued to the plaster in 1977. The lower portions of plasterboard only were removed for the architectural investigation, revealing the plaster beneath.

Figure 76. Room 102: West wall, June 2007.

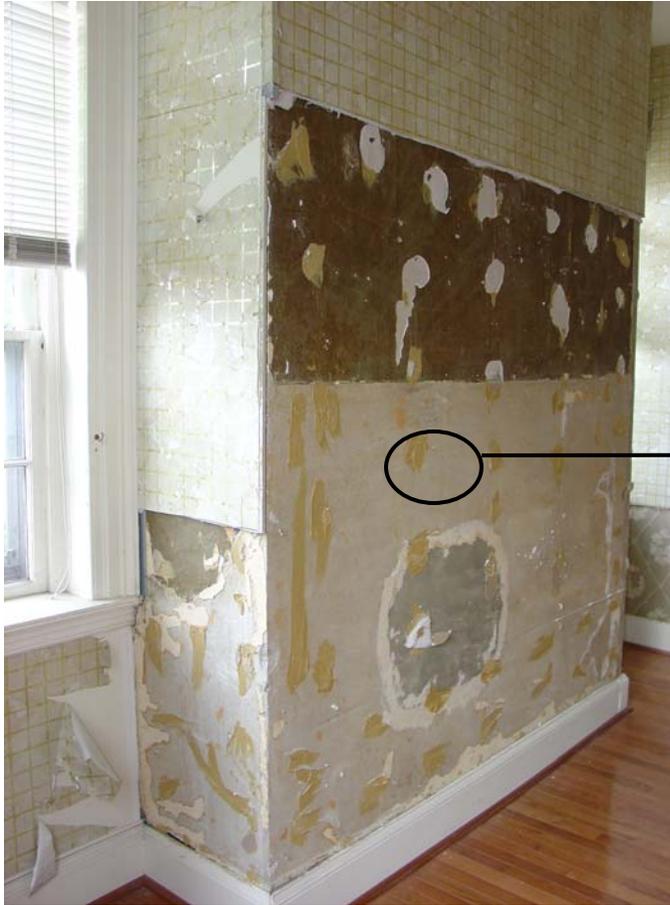
Figure 81. Room 102: Detail of chimney breast at the west wall following partial removal of plasterboard, August 2007. Pencil writing on the exposed plaster wall (below) reads "Oct. 1st 1948, O.C. Kidd, 19 Oak St., Waterloo N.Y., Interior Decorator."

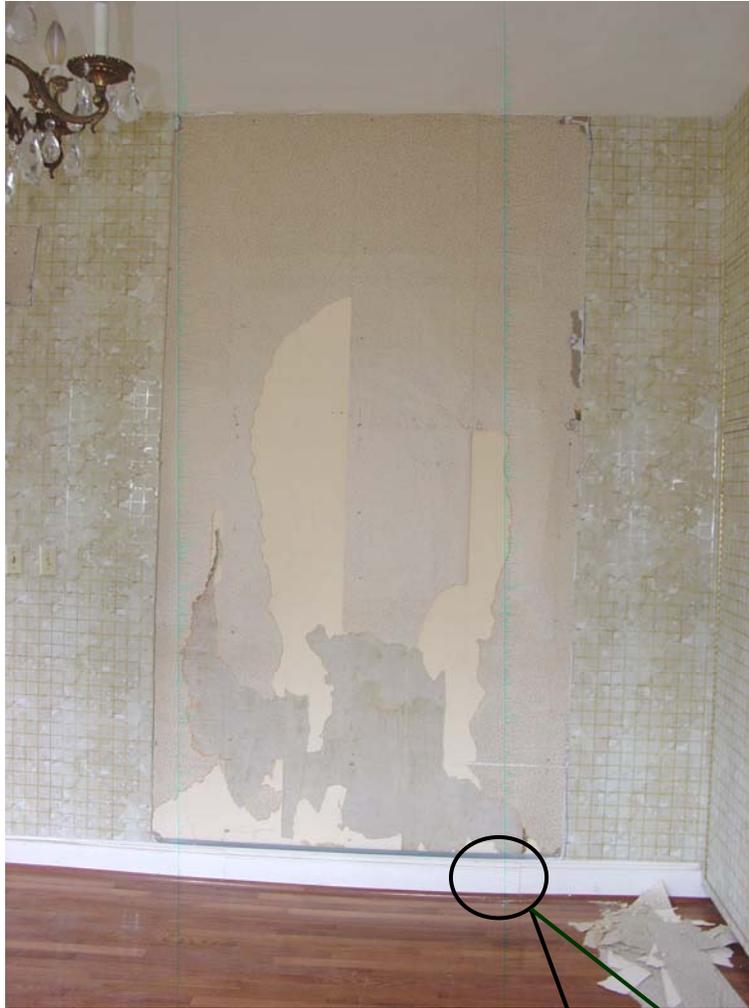
Figure 83. Room 102: Detail of the north wall at former doorway location, August 2007. Note baseboard patch (lower arrow) and gray plaster patch beneath the existing wallpaper (upper arrow) enclosing the former doorway opening.

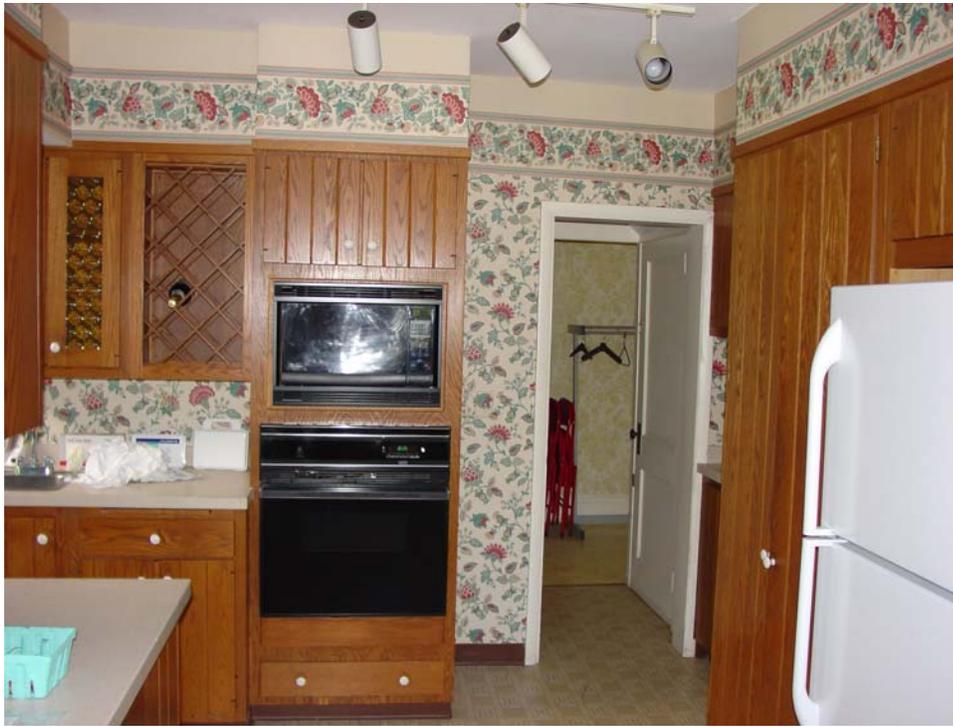
Most of the original east wall is missing today. The south portion of the wall, which comprised the partition for the hall closet, is believed to have been removed circa 1920 when the room was converted to a kitchen. The north portion of the wall probably remained in place when a toilet room was installed in the northeast corner of the kitchen circa 1950. It was not until 1977 that the wall was mostly removed to enlarge the toilet room to a full bathroom. Only the upper framing was left in place and concealed above a drop ceiling. The existing east wall of the kitchen therefore dates to the earlier installation of the toilet room about 1950. The wall is made of plasterboard attached to modern studs. The narrow passage to the hall and cellar doorway were also created about this time (fig. 84).

Figure 84. Room 103: View looking east, June 2007.

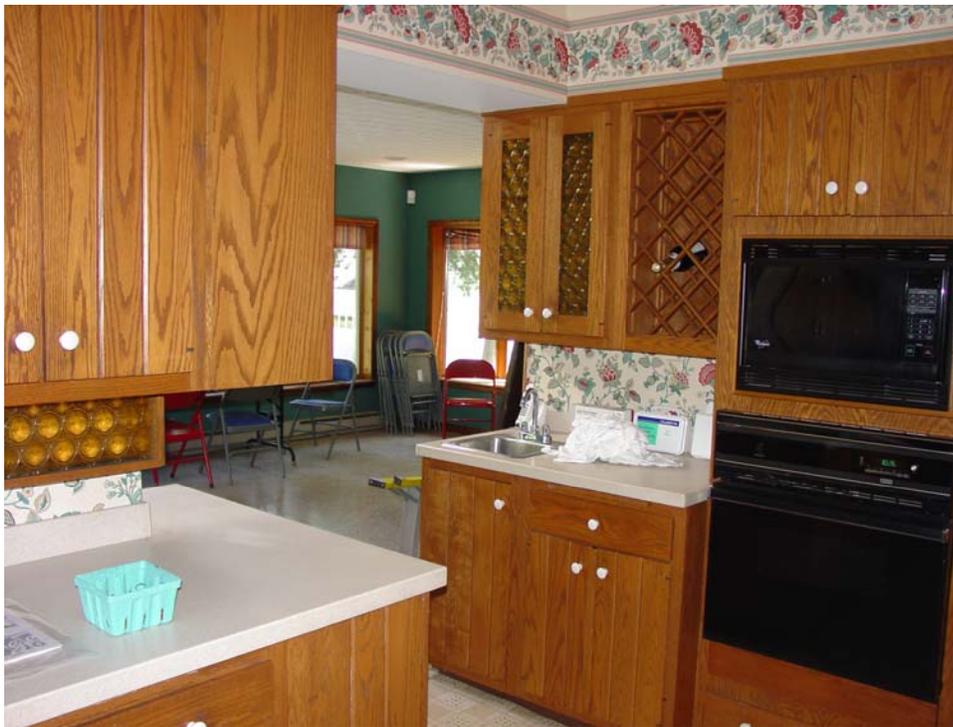
A doorway in the north wall of the kitchen/pantry communicated with the now missing north wing. This was an interior doorway that originally connected with the kitchen in the north wing, and later with the sitting room after the kitchen was moved to the west wing around 1841. The doorway became an exterior doorway when the north wing was removed circa 1920, and was remembered by the Greenwood children as a "door with a window." The doorway was completely removed when the existing north addition was built around 1960, based on Olmstead family photographs. The existing wide passage was created during a later remodeling of the kitchen by the Olmsteads in the 1990s (fig. 85).

Figure 85. Room 103: Northeast corner, June 2007.

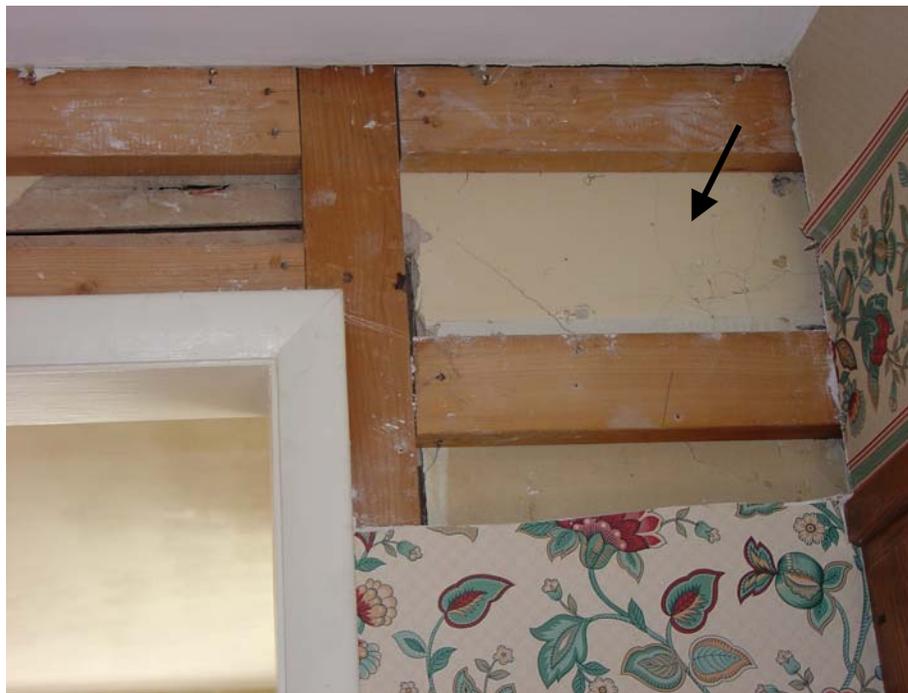
A doorway connecting with the dining room is at the west end of the south wall (fig. 88). This is an original doorway that was moved to its current location in the 20th century. Paint evidence in the dining room suggests this occurred around 1920. The original location of the doorway in the south wall is clearly visible on the dining room side of the opening, as indicated by a baseboard patch and plaster wall patch. The historic casings were preserved on the dining room side of the opening but were replaced by modern trim on the kitchen/pantry side. There is no door.

Figure 88. Room 103: Detail of upper southwest wall at the doorway to Room 102 revealing early plaster beneath plasterboard (at arrow), August 2007.

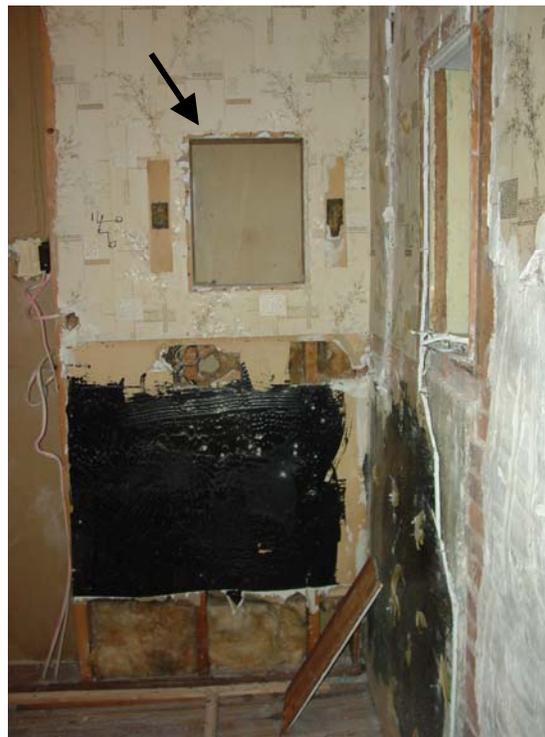
Figure 96. Room 105: Detail of north wall showing later wall niche (left arrow) and circa-1960 wallpaper (right arrow), December 2007.

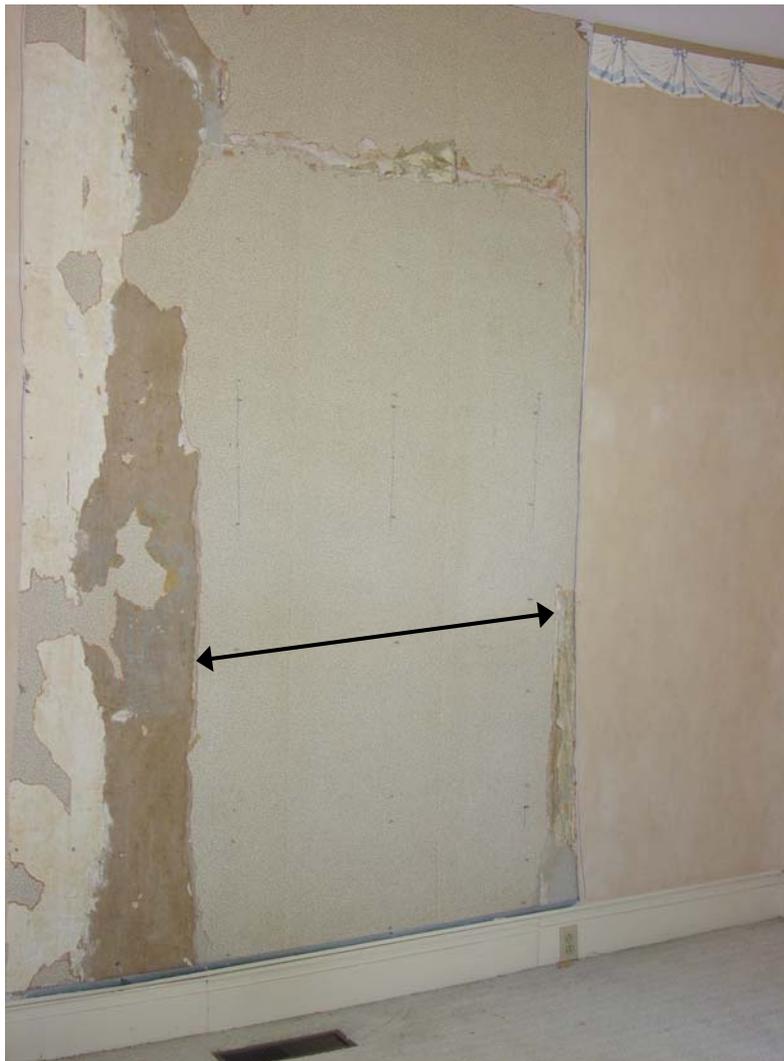
Figure 103. Room 106: Detail of west wall at former hall doorway, August 2007. The arrow delineates the width of the patch enclosing the former opening. (Also see fig. 25.)

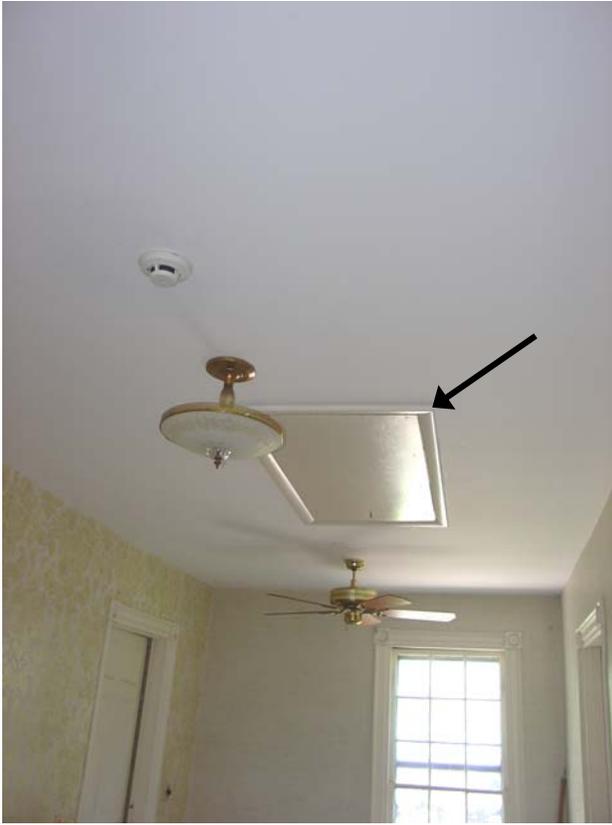
Figure 106. Room 201: Detail of ceiling looking north, June 2007. Folding attic stair is at ceiling hatch (at arrow).

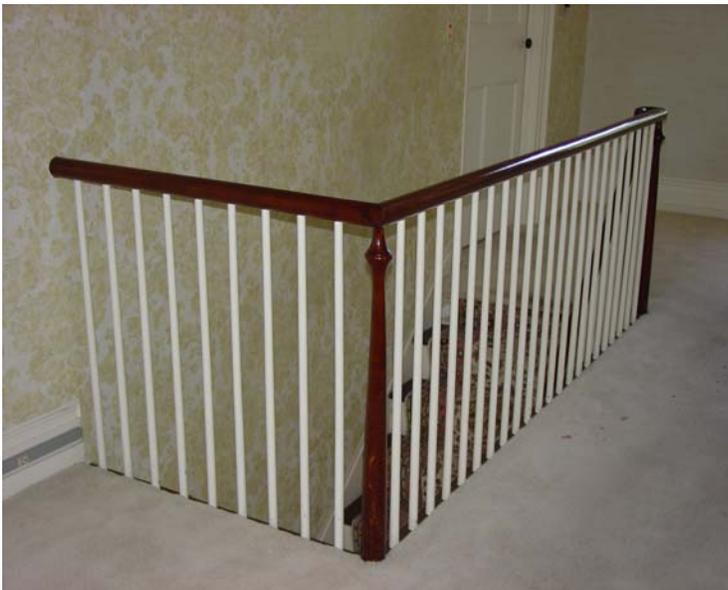
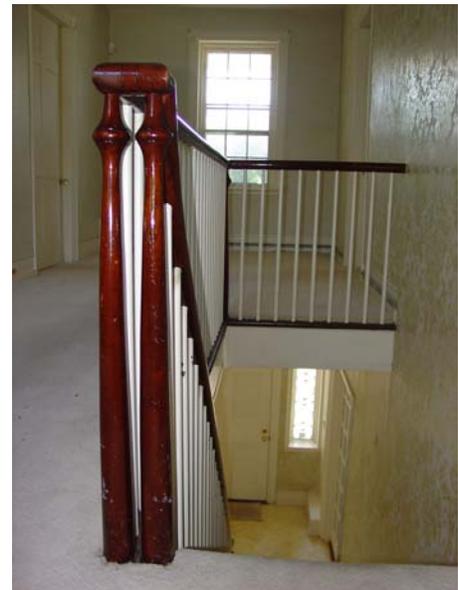
The stairway opening on the northwest side of the upper hall is bordered on the east and south sides by a wooden railing (figs. 108 and 109). This is an elegant railing of Federal design with simple turned newels and tapered balusters that most likely dates to the original construction of the house in 1828. Close examination of the railing reveals, however, that it has undergone some alterations. It appears that the railing was removed, trimmed, and

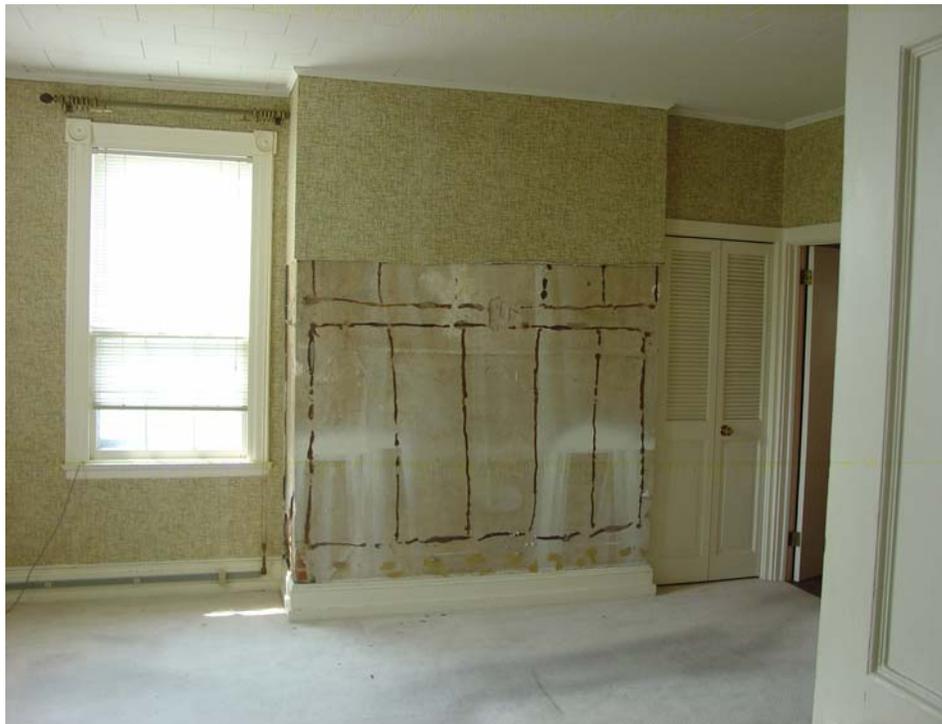
The projecting chimney breast at the west wall is an original feature of the room that was covered by plasterboard in 1977 (fig. 112). Removal of the plasterboard from the baseboard up to 6-feet high in 2007 revealed brickwork construction finished with a combination of original lime plaster and later cement plaster applied directly to the bricks. A later gray

Figure 115. Room 202: Original plaster revealed beneath the plasterboard at the chimney breast, August 2007. The brown lines are adhesive residue from the plasterboard. (Compare with pre-demolition photograph at fig. 112.)

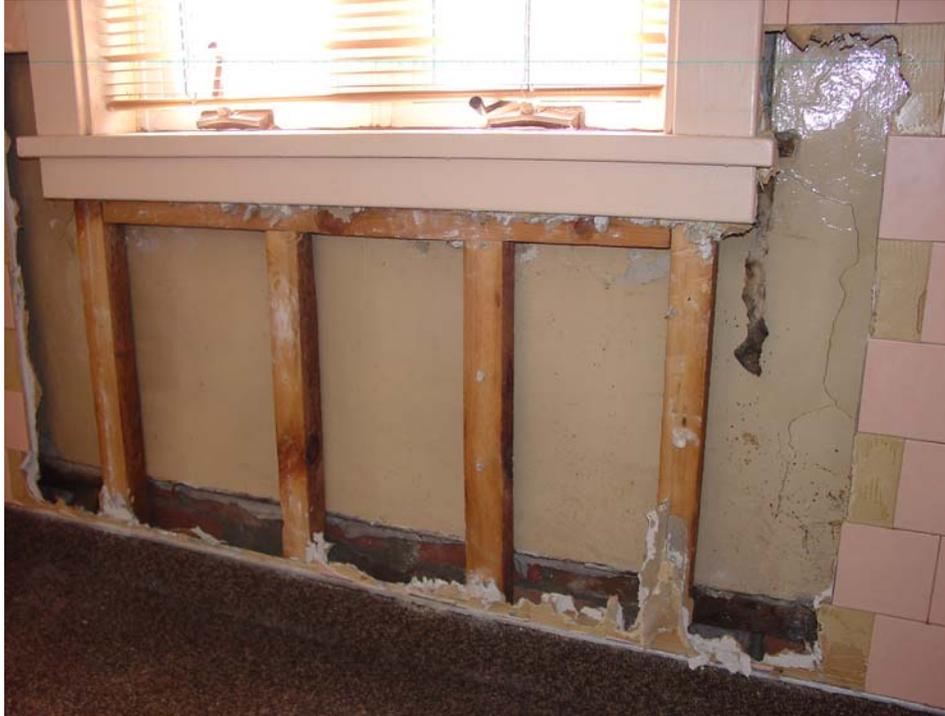
Figure 122. Room 203: West wall with pink-tiled plasterboard of 1950 vintage partially removed to reveal circa-1920 plaster, August 2007.

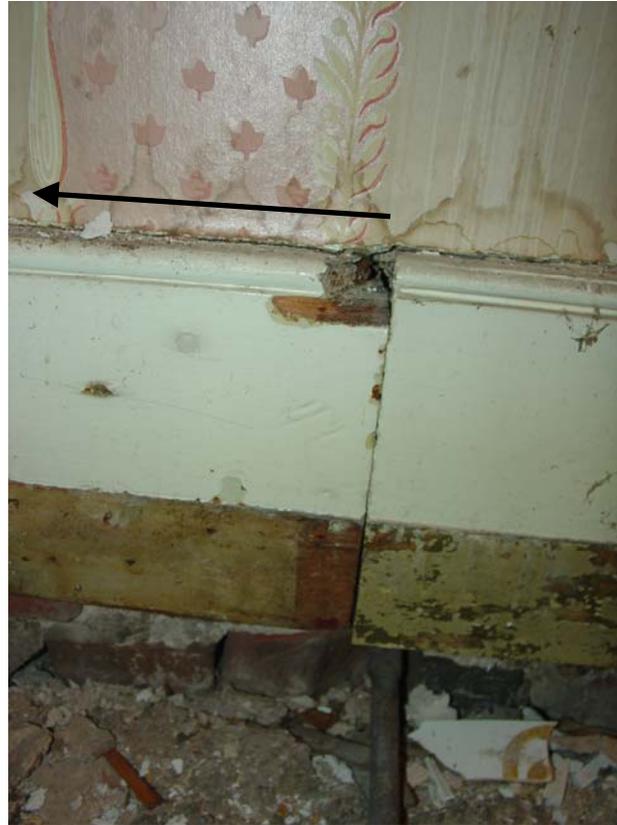
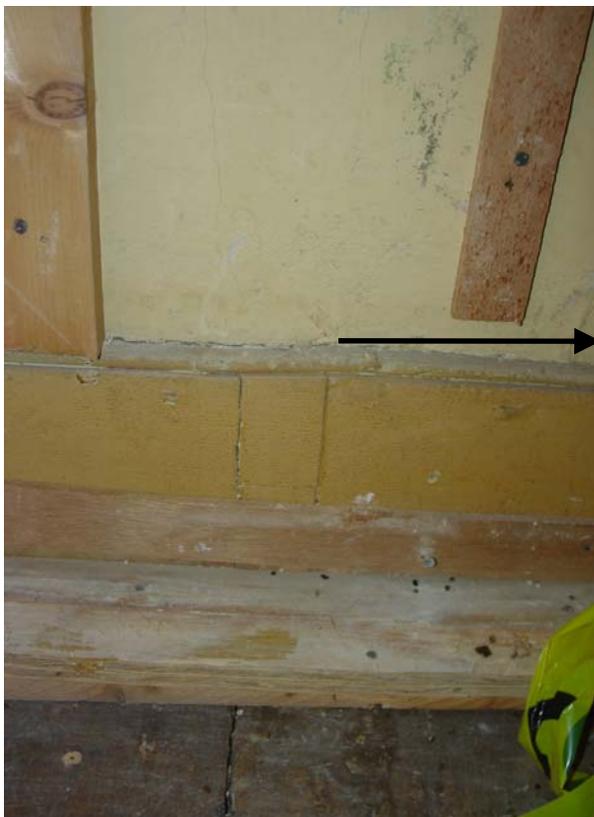
Figure 124. Room 204: Remnant of Room 203 baseboard (at arrow) preserved at the north wall of Room 204, April 2008. Note the area of missing paint on the lower baseboard formerly covered by the missing east partition, which was preserved beneath a lower trim board installed circa 1920.

Figure 125. Room 204: Remnant of Room 203 baseboard (at arrow) preserved at the south wall of the closet in Room 204, April 2008. Note the baseboard patch in the location of the original east partition.
