HUNT HOUSE

Women's Rights National Historical Park Seneca Falls and Waterloo, New York

Historic Structure Report

January 2009

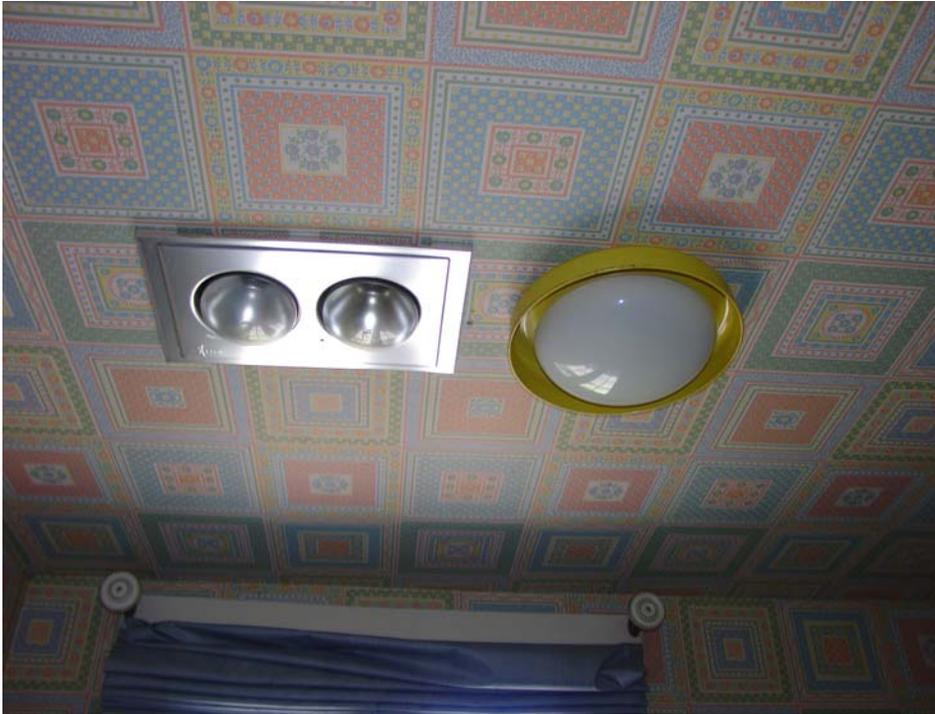
Figure 130. Room 204: Ceiling looking north, June 2007.

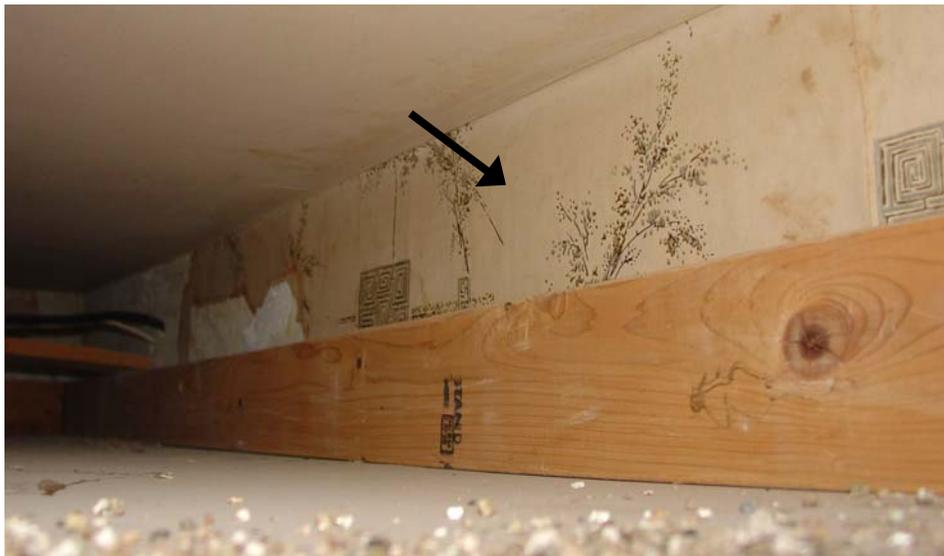
Figure 131. Room 204: East plaster wall and ceiling above existing plasterboard ceiling, June 2007. Note circa-1960 wallpaper (at arrow).

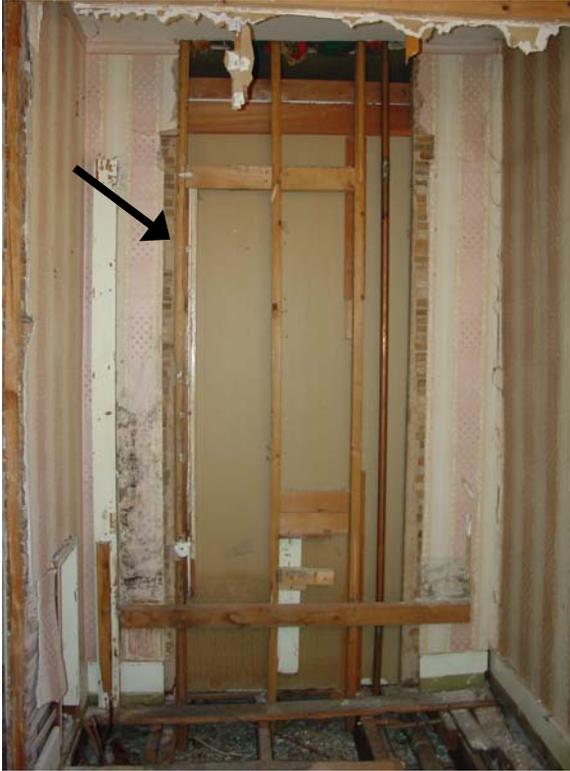
Figure 132. Room 204: Early doorway (at arrow) enclosed with later studs and plasterboard uncovered at the west wall of the former bathtub enclosure, April 2008. (Compare with pre-demolition photograph at fig. 126.)

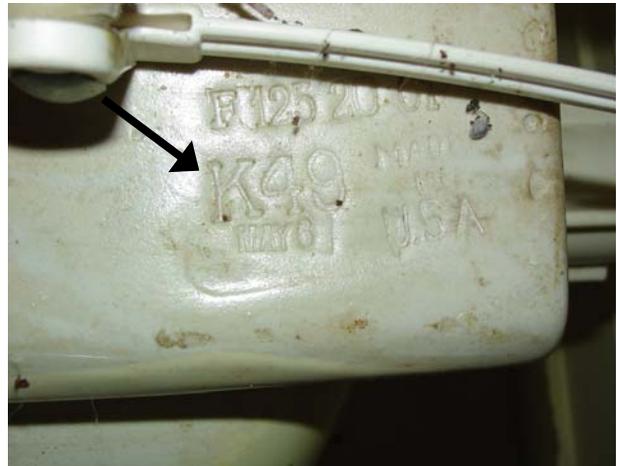
Figure 135. Room 204: Back side of the lavatory embossed with the date of manufacture, "K49, May 6" (at arrow), April 2008. (See intact lavatory at fig. 127.)

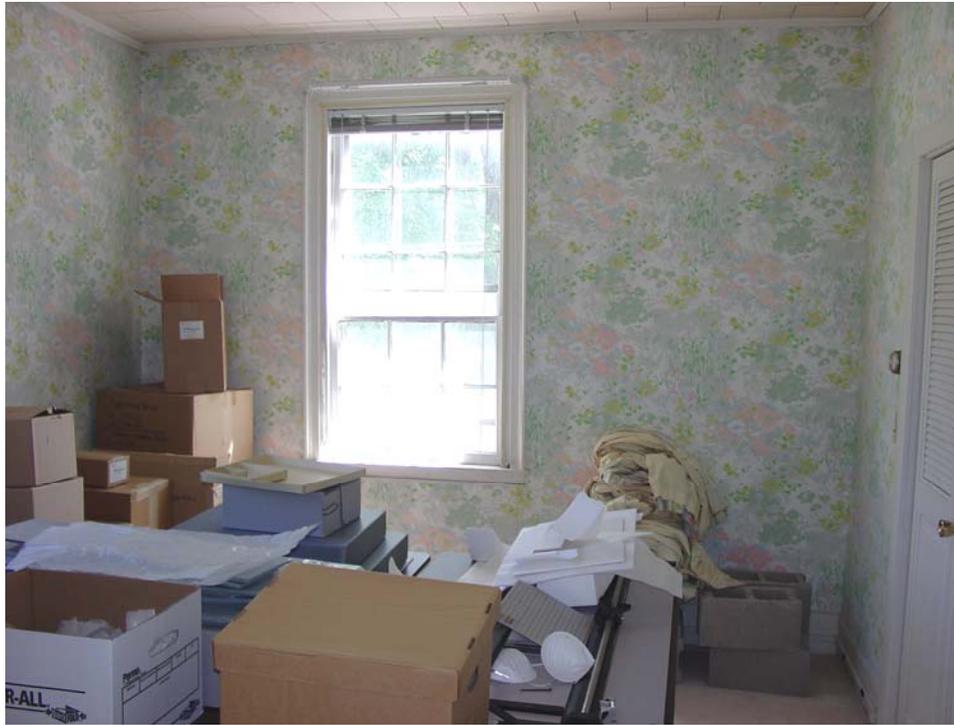
The window in the east wall is an original opening dating to 1828 (fig. 138). This window retains its historic casing with ovolo edge molding, mitered corners, and 9-over-6 sashes. Spring counterbalances have replaced the original sash cords and weights; there is no sash lock hardware.

Figure 138. Room 205: East wall, June 2007.

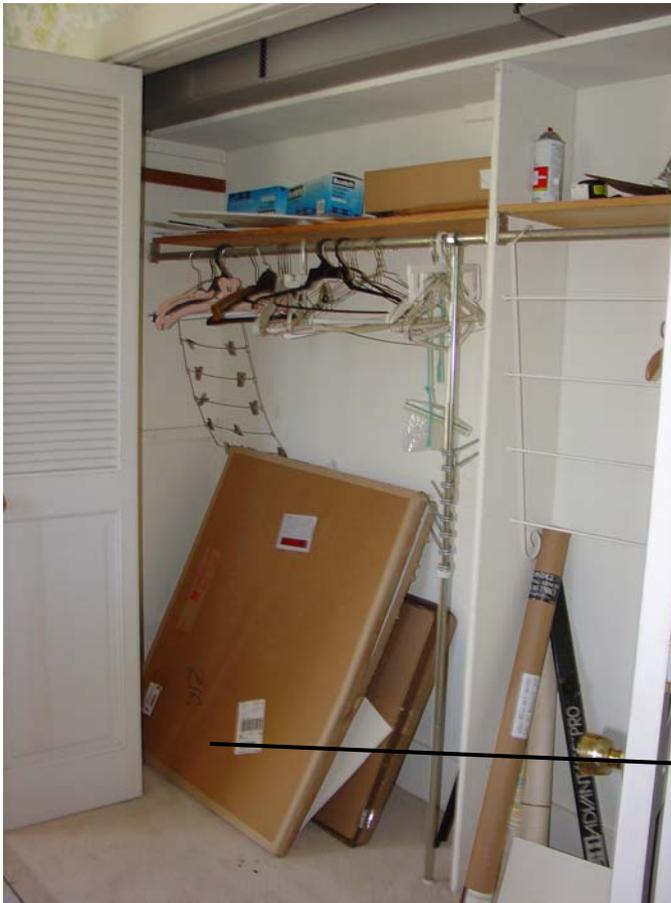
baseboard at the east wall of the closet matches that of the adjacent southeast bedroom (Room 206), in which it was originally located (fig. 141).

Figure 141. Room 205: Interior of closet at south wall, June 2007. Detail of the baseboard at the east wall of the closet (at arrow), which was originally in Room 206.

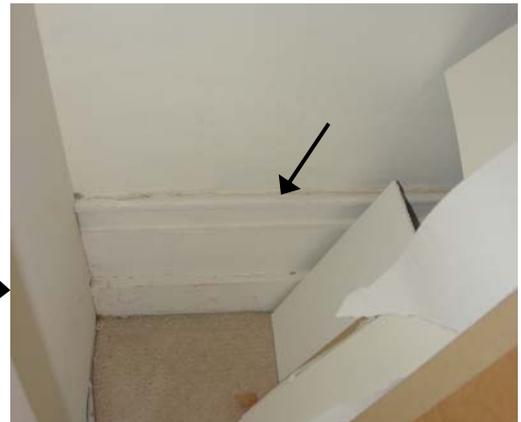
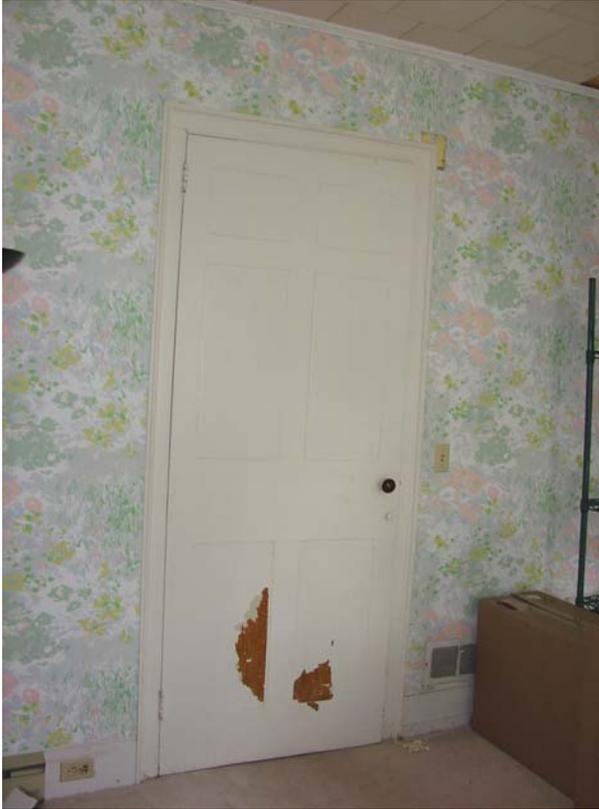
¹⁹ The graining was partially exposed on the door of the northeast bedroom in 2007 by shearing off the later paint layers with the blade of an X-Acto knife.

Figure 142. Room 205: West doorway showing graining partially exposed on the lower door panels, August 2007.

Figure 143. Room 205: Detail of graining exposed on the lower panel of the west door, August 2007.

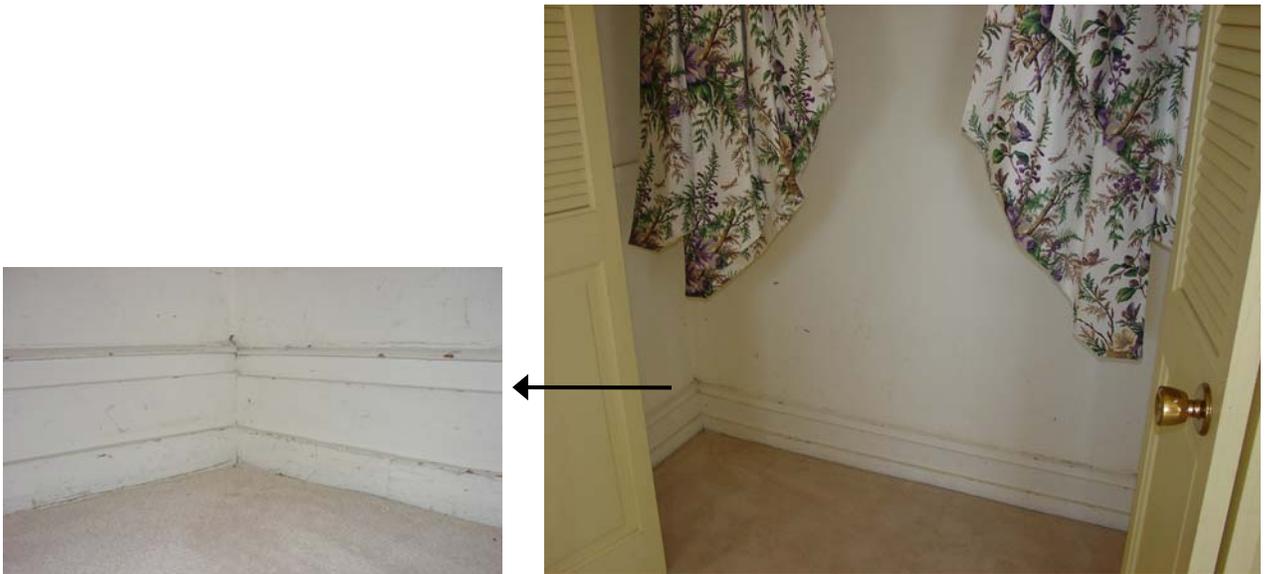
Original molded baseboards approximately 8+\" tall finish the lower walls of the room (fig. 149). These baseboards are identical in style to baseboards in the parlor (Room 106) and the lower and upper halls (Rooms 101 and 201). A later baseboard that is similar, but not identical, in style is attached to the front of the chimney breast at the east wall. It most likely dates to the removal of the fireplace mantel circa 1920. Plain trim boards attached to the

Figure 149. Room 206: Interior of north closet, June 2007. Detail of the room's original baseboard in the northwest corner of the closet is shown above (at arrow). The lower trim board was applied circa 1920.

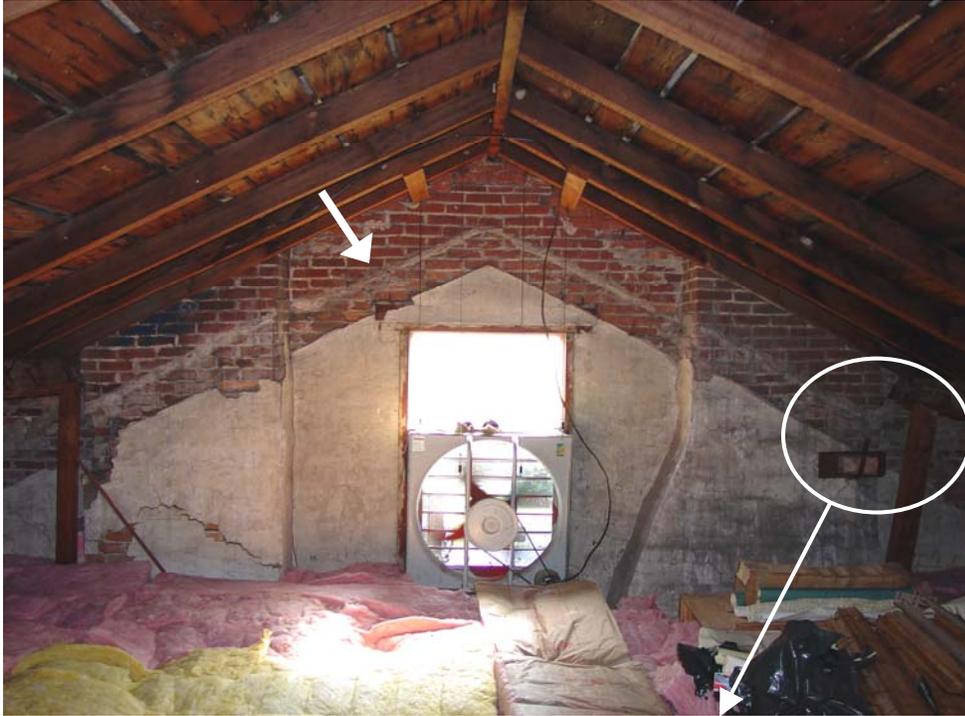
The brickwork walls of the attic were constructed in 1828 and circa 1841. The east and west end walls of the attic date to the original construction of the house in 1828 (figs. 151 and 153). They are particularly significant for the physical evidence they retain of the building's original features. Early lime plaster applied directly to the brickwork remains today, which clearly delineates the original lower roof height. Metal straps that secured the two roof purlins remain embedded in place the walls (fig. 152), made obsolete by repositioning of the

Figure 151. Attic:
View looking east,
June 2007. Note the
white plastered wall
and line of the
original lower roof
(at upper arrow).

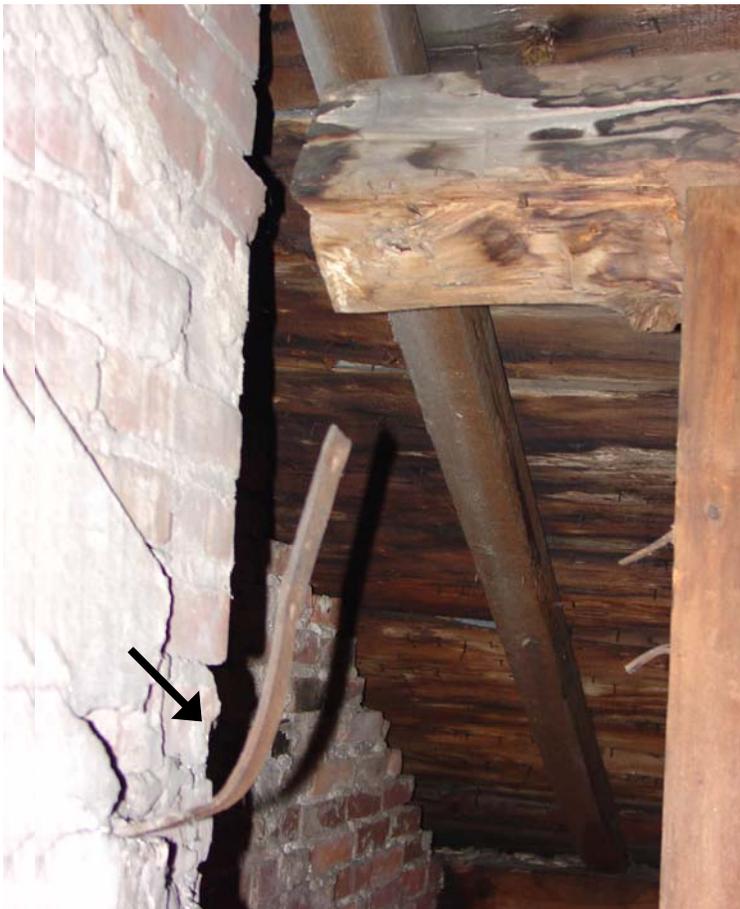
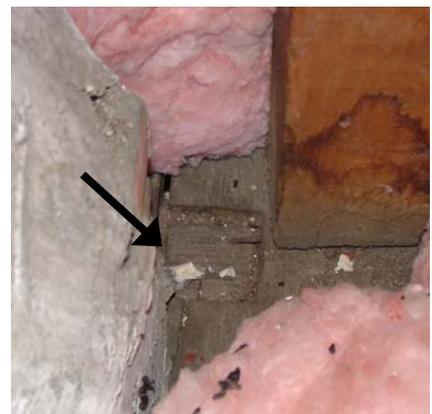
Figure 152. Attic Details:
Left: Southeast corner
showing the original reused
roof purlin and the iron strap
that formerly supported it (at
arrow).

Below: Indentation in the
floorboard beneath the iron
strap (at arrow) is evidence of
an early post that supported
the purlin.

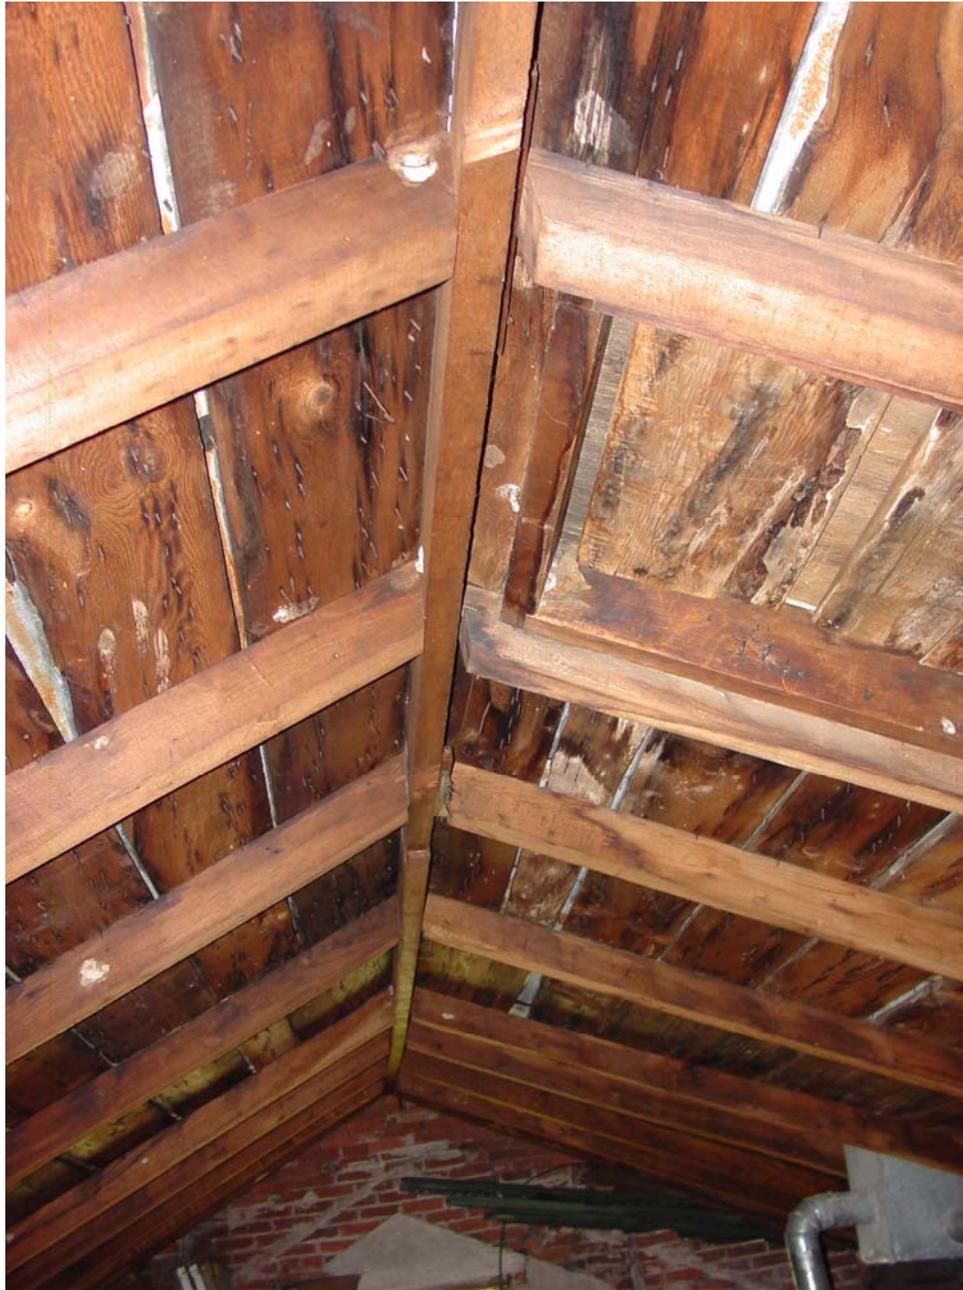
The ceiling of the attic consists of the exposed framing and sheathing boards of the roof (fig. 155). These elements appear to date to the construction of the house in 1828, including two hand-hewn purlins and reciprocal-sawn rafters and sheathing boards. The sheathing boards are of variable sizes, ranging in width from 12 to 16 inches. The roof has been raised approximately 2 feet, according to physical evidence of the original roof preserved at the east and west end walls (figs. 151 and 153). This consists of intact original plaster that clearly outlines the position of the original roof. Heightening of the roof is believed to have occurred during a remodeling of the house in 1841 to accommodate the existing wide cornice in the Greek-Revival style.

Figure 155. Attic: Roof framing, view looking west, June 2007.

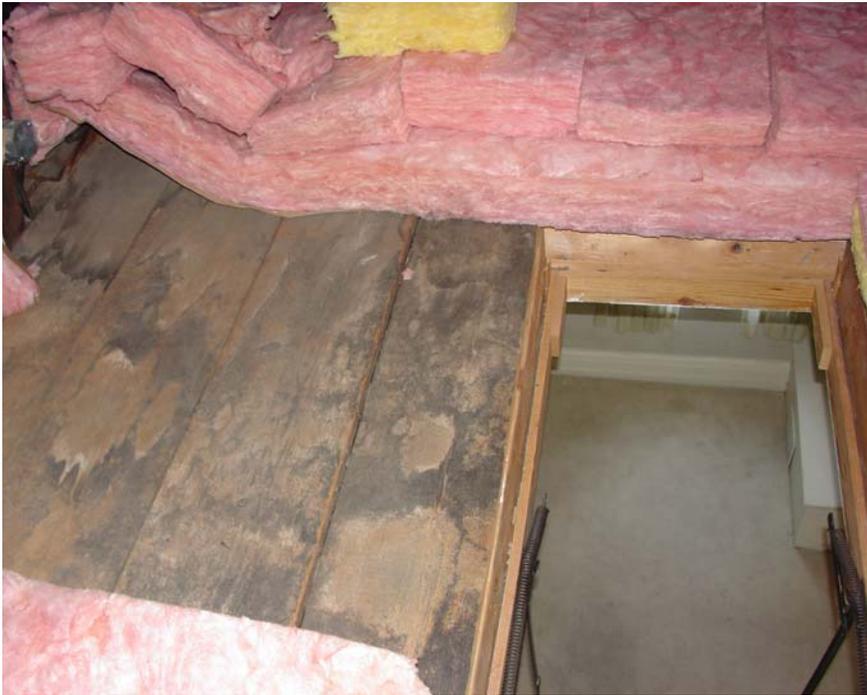
The floor of the attic is framed by two north-south floor beams that support floor joists oriented in an east-west direction. These are covered by a single layer of floorboards of variable width, from 12" to 16" wide (figs. 156 and 157). The floorboards are nailed to the floor framing and oriented in a north-south direction. They are plain boards with no tongue-and-groove interface on the sides. As mentioned above, the floorboards were covered with two layers of pink fiberglass insulation by the National Park Service in 2007.

Figure 156. Attic: Modern hatch with folding stair, view looking north, June 2007. The original wide floorboards can be seen to the left of the hatch.

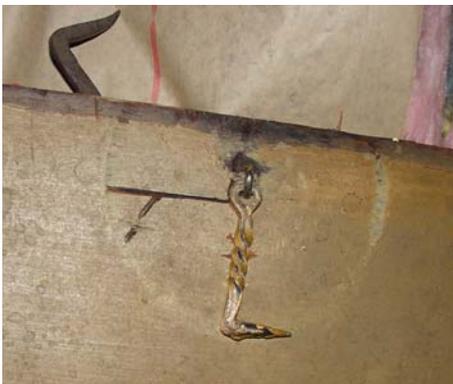
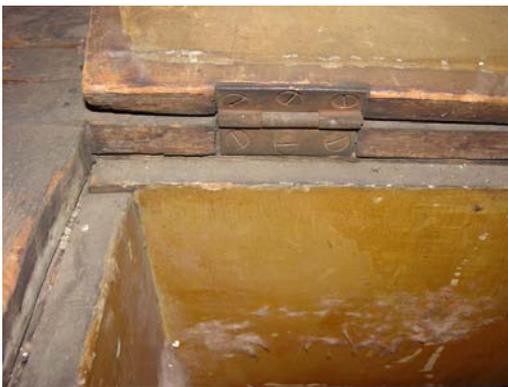
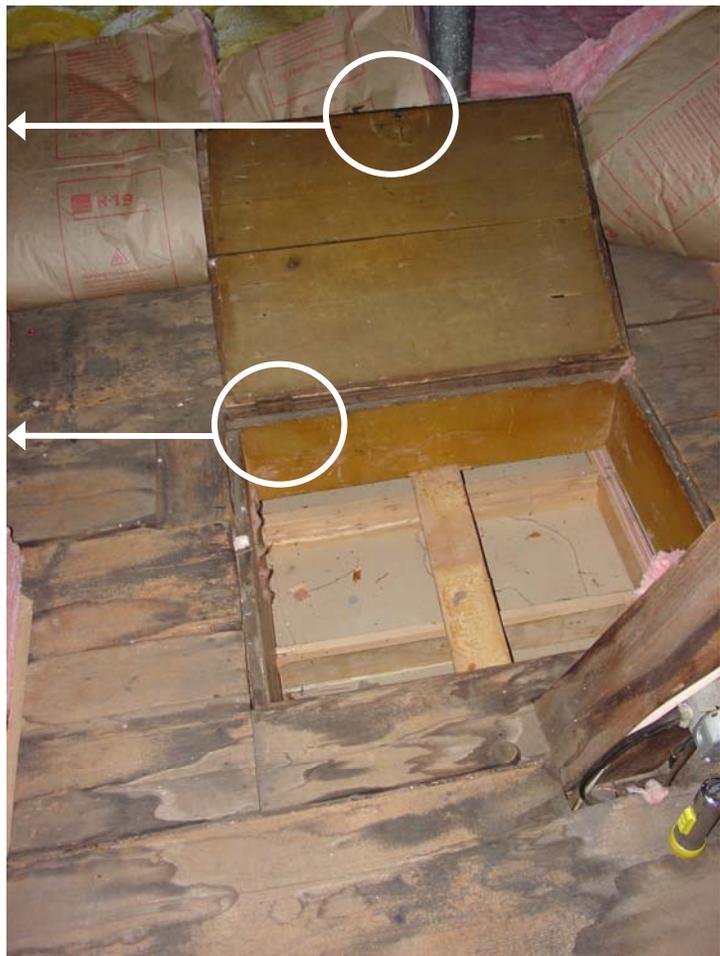
Original access to the attic was through a small hatch in the floor (fig. 157). The opening of this hatch, which remains today, measures approximately 3-feet long by 2-feet 3-1/2 inches wide. It has a deep wooden frame and a board-and-batten door made of two wide boards. Door hardware includes two early wrought-iron hooks (one on the attic side, the other on the room side) and two closed-butt hinges. The hatch was located in the ceiling of the entry off the northwest bedroom (Room 204) and had a steep ladder-style stair. It was closed off by a plasterboard ceiling in 1977. In its place was installed the existing large opening in the ceiling of the upper hall, equipped with a built-in folding stair (fig. 156). A hatch near the peak of the roof on the back (north) side also enables access to the roof from the attic. The date of this opening is not known.

Figure 157. Attic: The original attic hatch (right) retains its early hardware, including wrought-iron hook (above) and closed-butt hinges (below). June 2007.

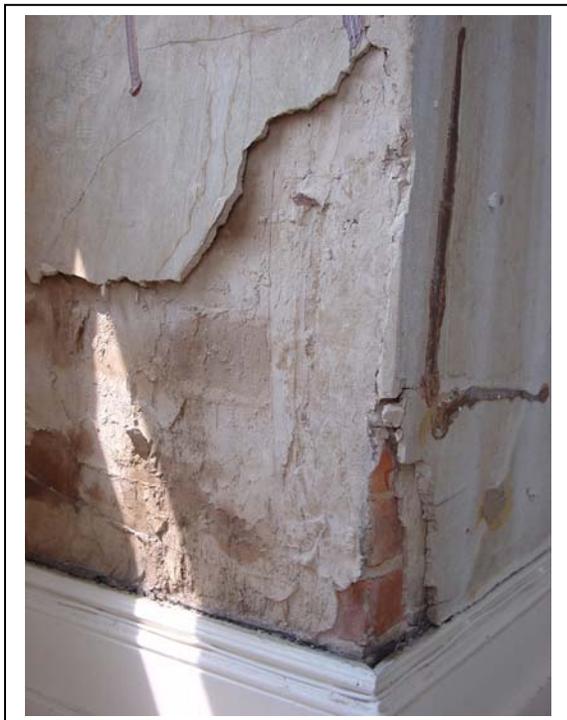
Figure B-2.
Detail of original plaster on the south side of the chimney breast in the southwest bedroom (Room 202). Note the pink-beige color of both the first scratch coat and the smooth finish coat. Photograph by Barbara Yocum, August 2007.

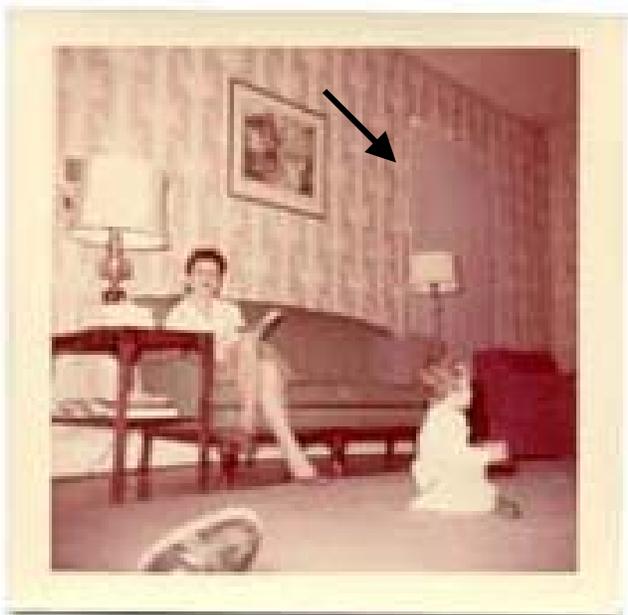
Figure B-4.
Circa-1960 snapshot of the living room (Room 106) showing gray plaster patch at the former hall doorway. Photograph courtesy of Joan Olmstead.

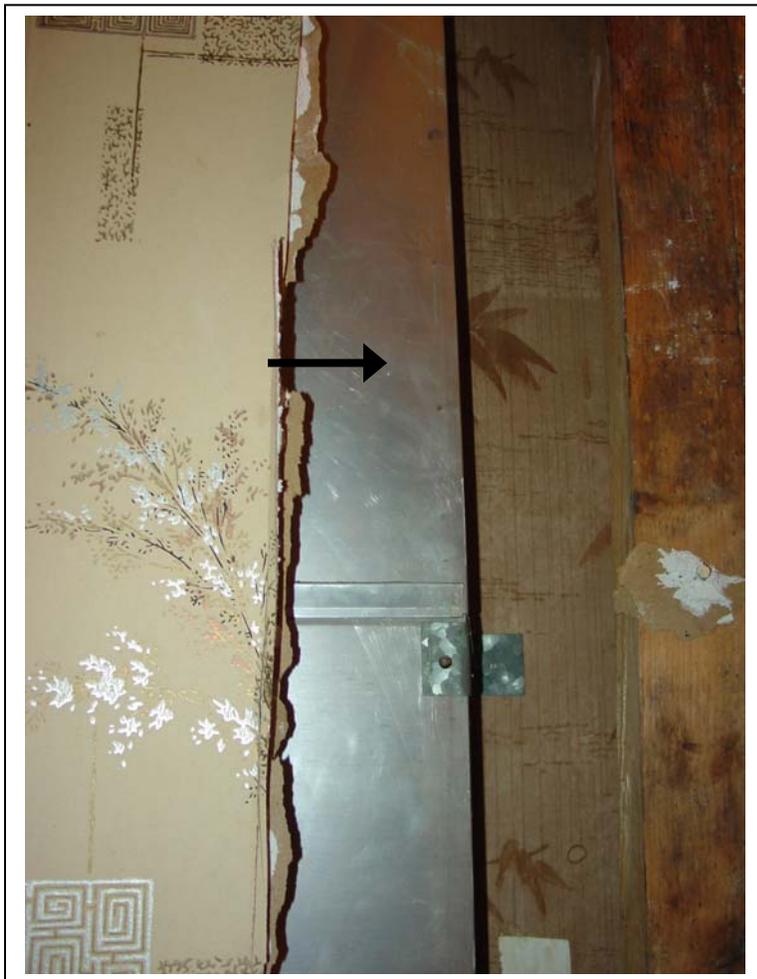
The earliest (circa-1930) wallpaper was discovered on the east wall of the lower and upper halls (fig. C-1). This paper was concealed behind chases for heating ductwork installed by the Greenwood family shortly after their purchase of the house in 1944. The pattern is a subdued design of brown leaves on a beige ground. It was most likely hung by the previous owner, Roy Brewster, who owned the house from 1930 to 1944. There appears to be only one layer of this wallpaper adhered to the plaster wall. A "dark yellow wallpaper," remembered by Joan Olmstead and Doris Depp as being in the dining room and living room when they moved to the house in 1944, was later removed by the Greenwoods.

Figure C-1. Circa-1930 wallpaper discovered behind a circa-1945 chase for heating ductwork at the east wall of the lower hall (at arrow). The gold-and-silver wallpaper on the left is dated circa 1960. Photograph by Barbara Yocum, April 2008.

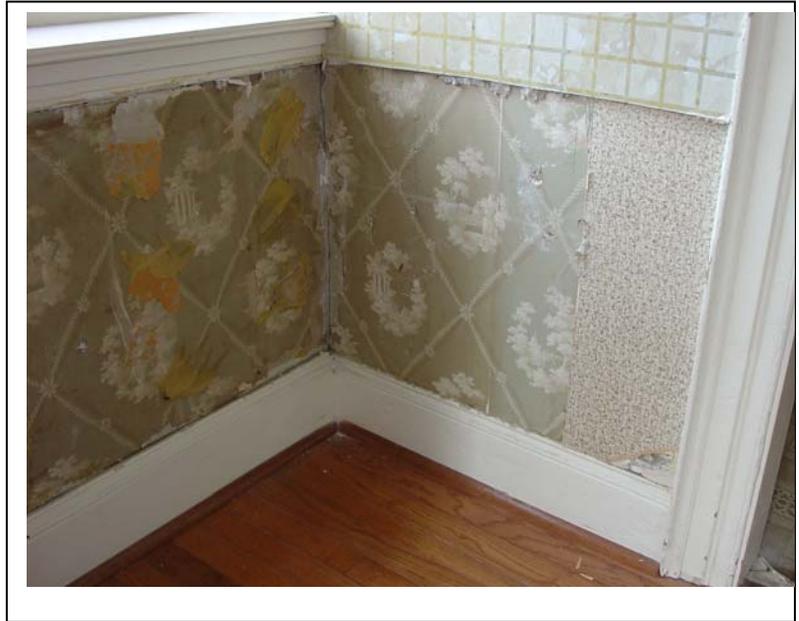
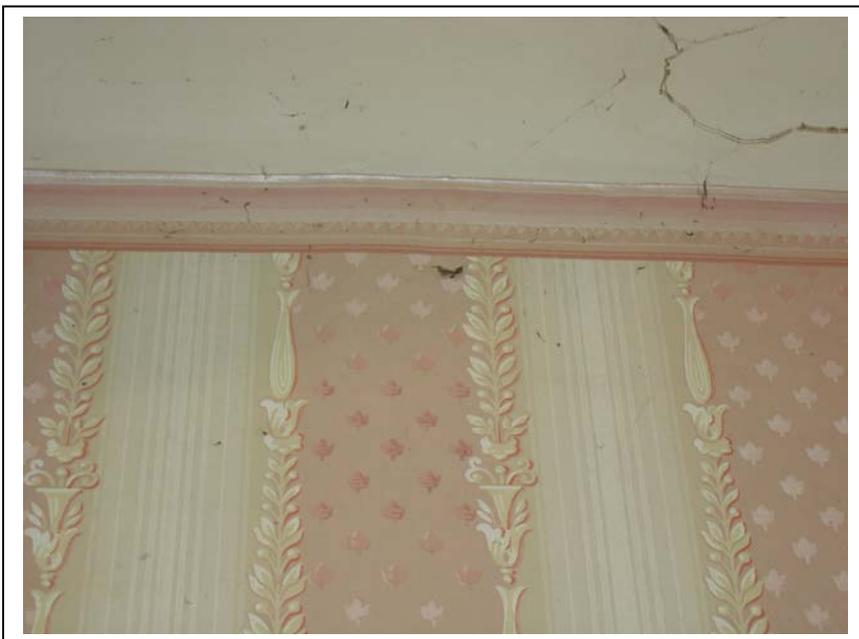
Figure C-2.

Two wallpapers hung in the dining room by the Greenwoods: the diamond-pattern on the left in 1948, and the abstract pattern on the right around 1960. The earlier paper is documented by a penciled note on the chimney breast dated Oct. 1, 1948, by O.C. Kidd of Waterloo, "Interior Decorator." The later paper is shown in a photograph of the room dated August 1968 (fig. 26 in the main report). Photograph by Barbara Yocum, August 2007.

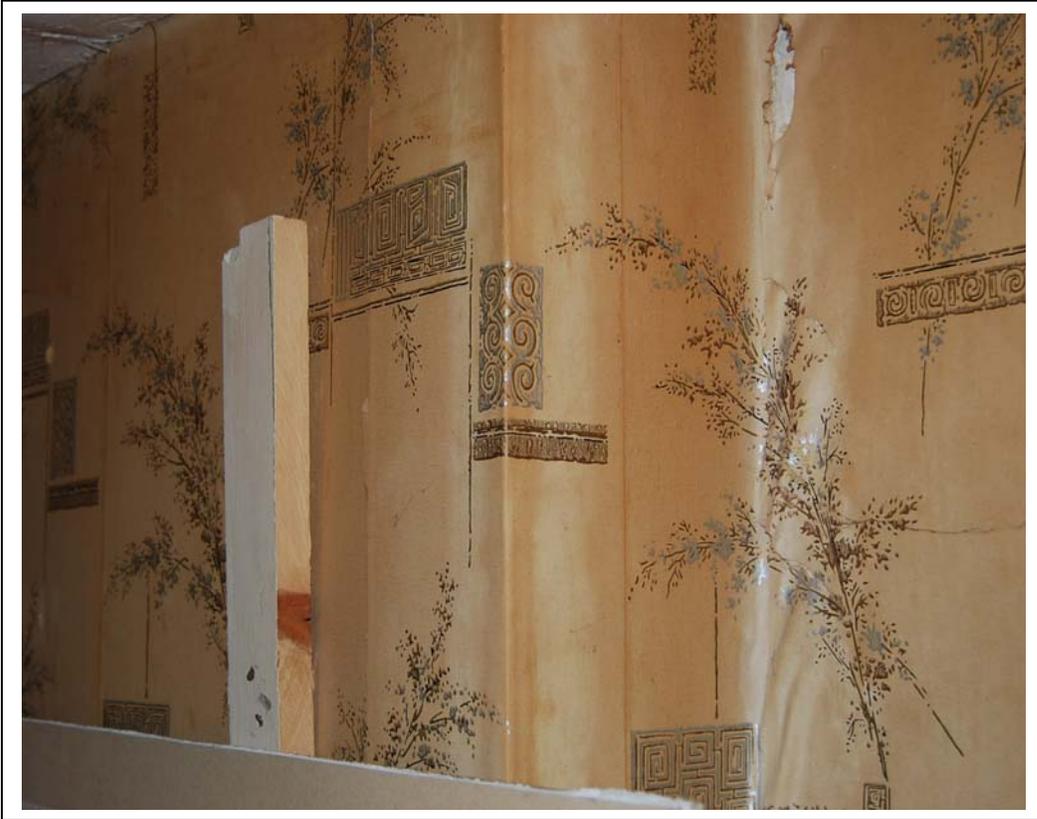
Figure C-6. Wallpaper hung circa 1960 in the center hall, downstairs toilet room, and hall bathroom. This photograph shows the north end of the upper east wall of the lower hall, where the wallpaper was concealed above a drop ceiling installed in 1977. Joan Olmstead's daughter, Robin, remembers that her grandparents hung this wallpaper "sometime in the 1960s." Photograph by Anne Derosie, September 2007.

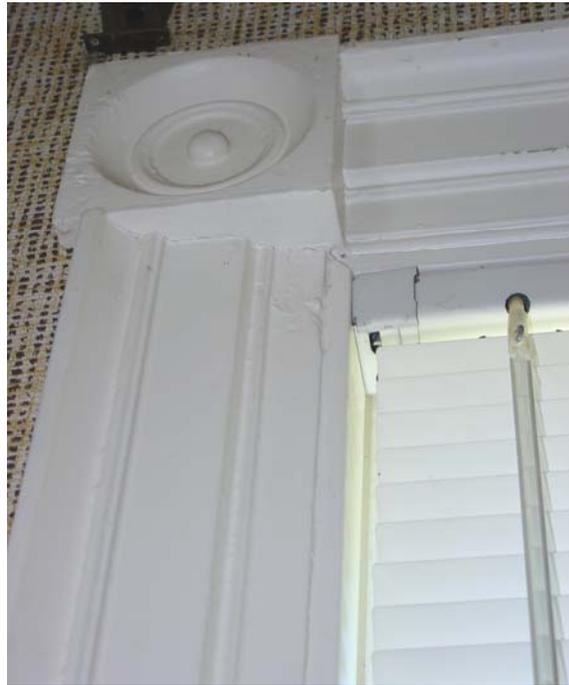
Two corner blocks were temporarily removed from the window casings of the front bedrooms by Guy ("Sparky") Hock, Jr., Maintenance Mechanic with Women's Rights NHP, in November 2008. The window casings and their corner blocks are of two different styles, with a covetto molding used at the perimeter of the casings in the southwest bedroom (Room 202 and an ovolo molding in the southeast bedroom (Room 206). See figures D-2 and D-3.

Figure D-2. Room 202: Detail of south window casing in the southwest bedroom. Photograph by Barbara Yocum, June 2007.

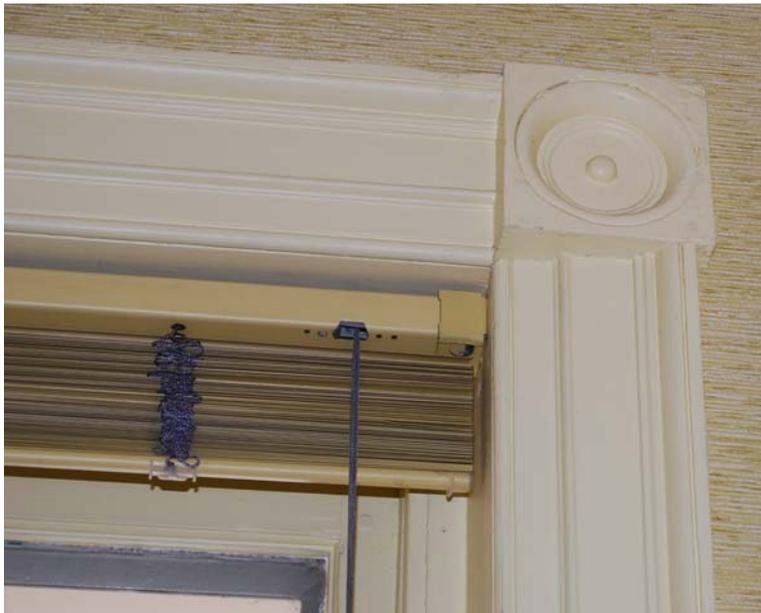
Figure D-3. Room 206: Detail of south window casing in the southeast bedroom. Photograph by Barbara Yocum, June 2007.

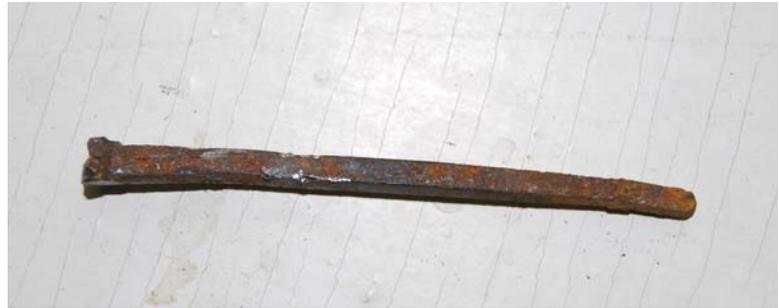
The corner blocks were found to be attached with machine-cut nails of a type typically manufactured from about 1815 through the 1830s. These nails have round points, as opposed to nails manufactured after 1840 that have flat, or sheared, points (fig. D- 4). Furthermore, no evidence was seen of previous nailings in the wood framework to which the casings and their corner blocks are attached. These wooden frames, also called plaster grounds, are original and unaltered, judging by the original lime plaster that abuts them (fig D-5).

Figure D-4. Room 206: Nail removed from south window corner block in the southeast bedroom. Note the round point, a feature of nails manufactured from circa 1815 through the 1830s. Photograph by Anne Derosie, November 2008.

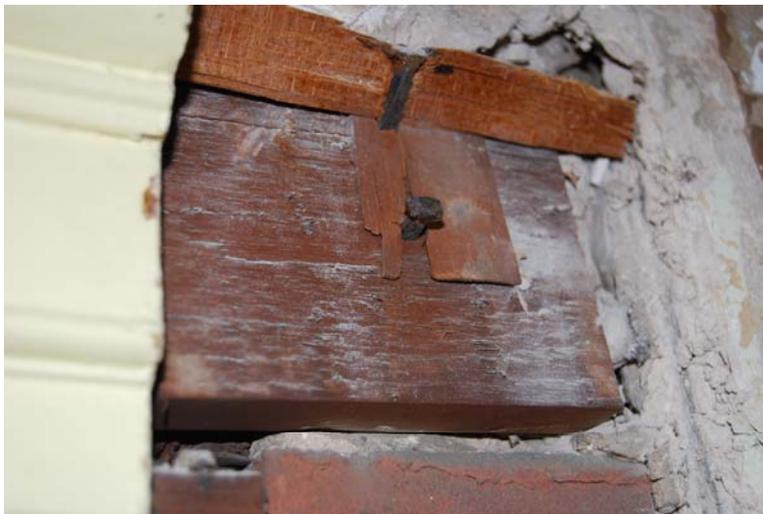
Figure D-5. Room 206: Detail showing the wooden frame, or plaster ground, to which the corner block was nailed in the southeast bedroom. Note the proximity of the original lime plaster to the right. Photograph by Anne Derosie, November 2008.
