WESLEYAN CHAPEL

Historic Structure Report

WESLEYAN CHAPEL
HISTORIC STRUCTURE REPORT
Women's Rights National Historical Park
Seneca Falls, New York

Written 1988
Published 1992

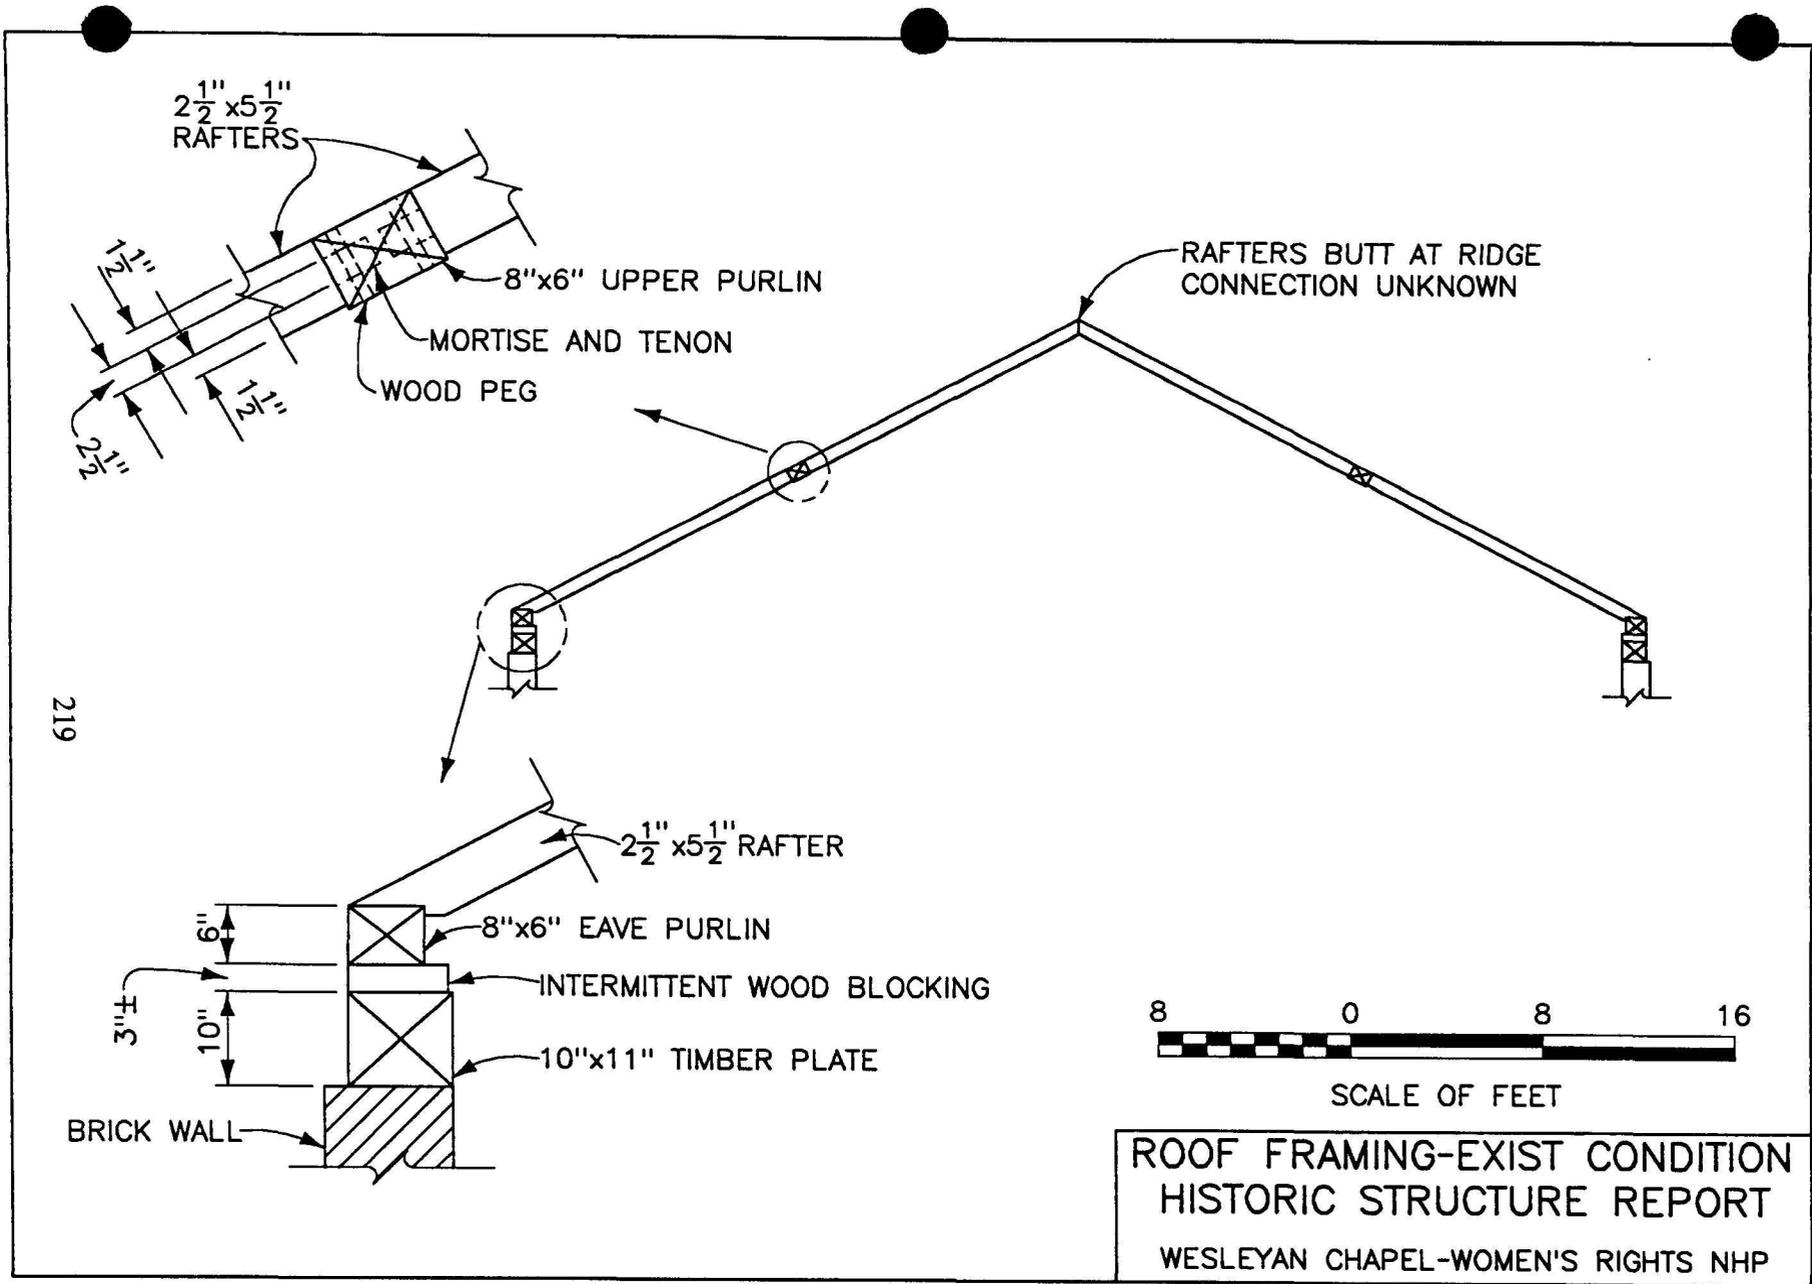
Figure 75. Wesleyan Chapel: Existing Condition, Roof Framing Connections, 1988.

The roof framing plan is shown in figure 74. A section through the roof-member connections is shown in figure 75. Typical truss member sizes are indicated in figure 76.
