Merced River Riparian Corridor Restoration in Yosemite Valley

Restoration Concept
Designs

March 2016

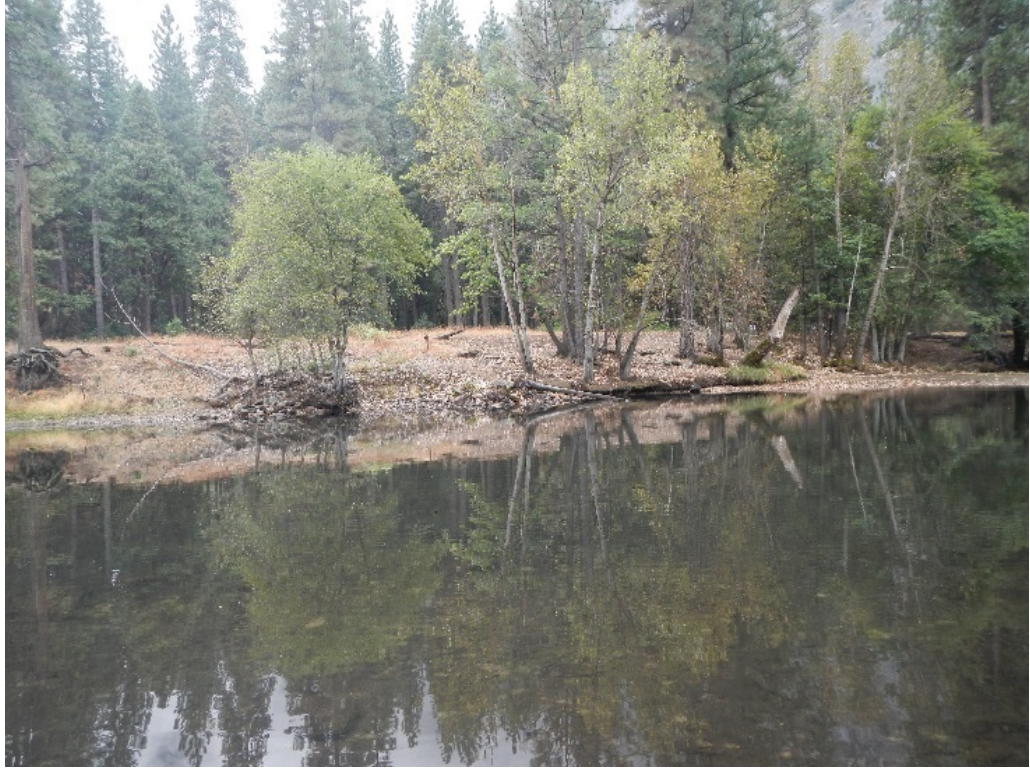
Location (River Miles)	<i>Photos and Caption</i> <i>Describing Problems, Opportunities, or Constraints</i>
1.05-1.16 (LB)

<p data-bbox="532 989 1349 1020">Analog for LWD at upstream end (left bank downstream of Stoneman Bridge)</p>
1.19-1.22 (LB)

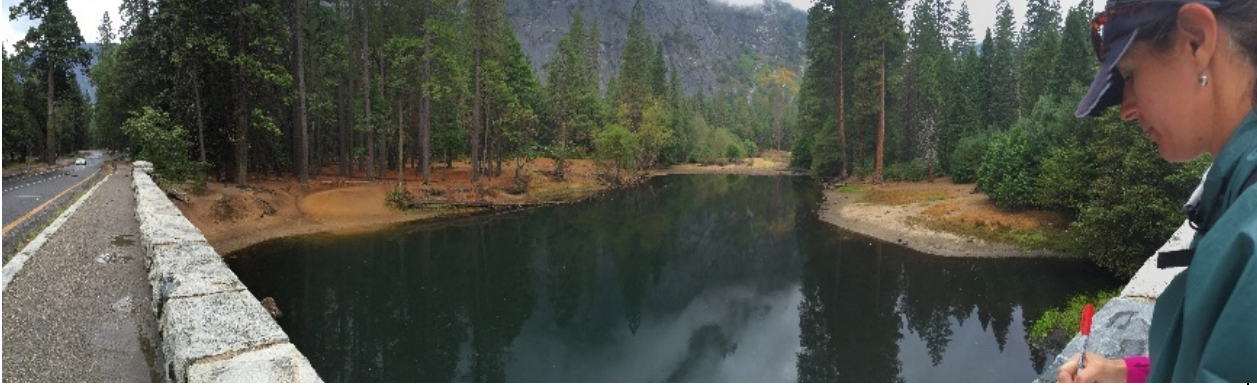
<p data-bbox="743 611 1138 636">DS panorama from Stoneman Bridge</p>
<p data-bbox="87 657 293 722">RM 1.22 – 1.51 1.24-1.51 (RB)</p>	<p data-bbox="328 657 1008 682">Reach 5 – Stoneman Bridge to Ahwahnee Bridge</p>

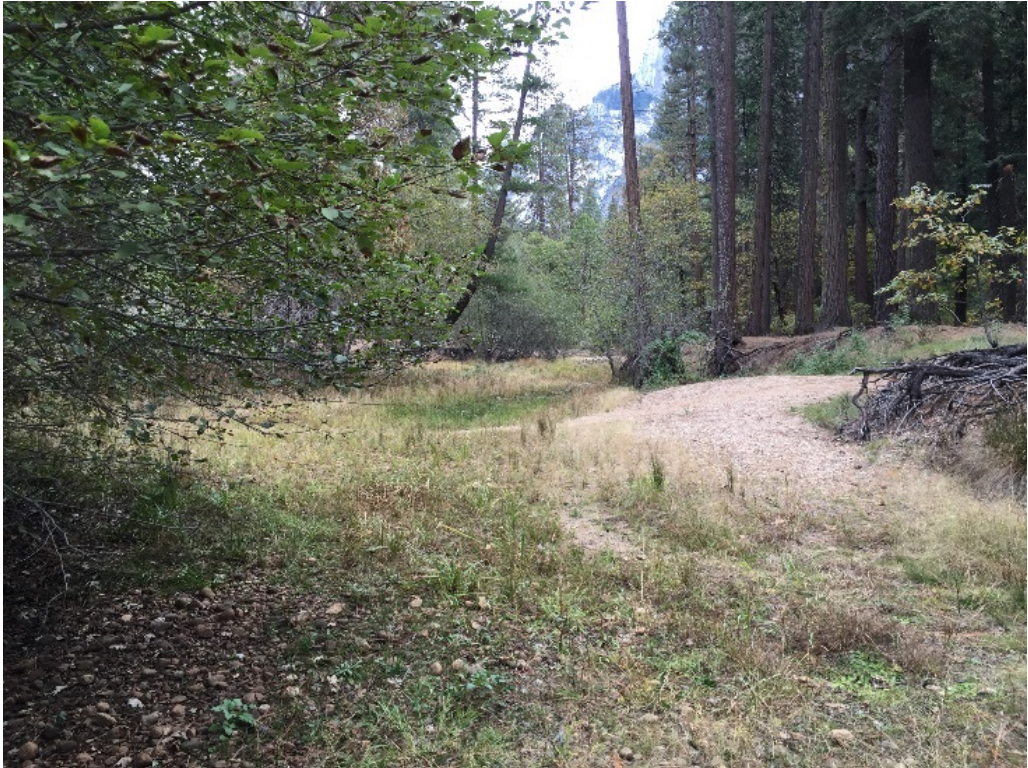
<p data-bbox="797 1837 1084 1864">View up LB overflow swale</p>
