Progressive failure of sheeted rock slopes: the 2009–2010 Rhombus Wall rock falls in Yosemite Valley, California, USA

Greg M. Stock,^{1*} Stephen J. Martel,² Brian D. Collins³ and Edwin L. Harp⁴

Earth Surface Processes and Landforms

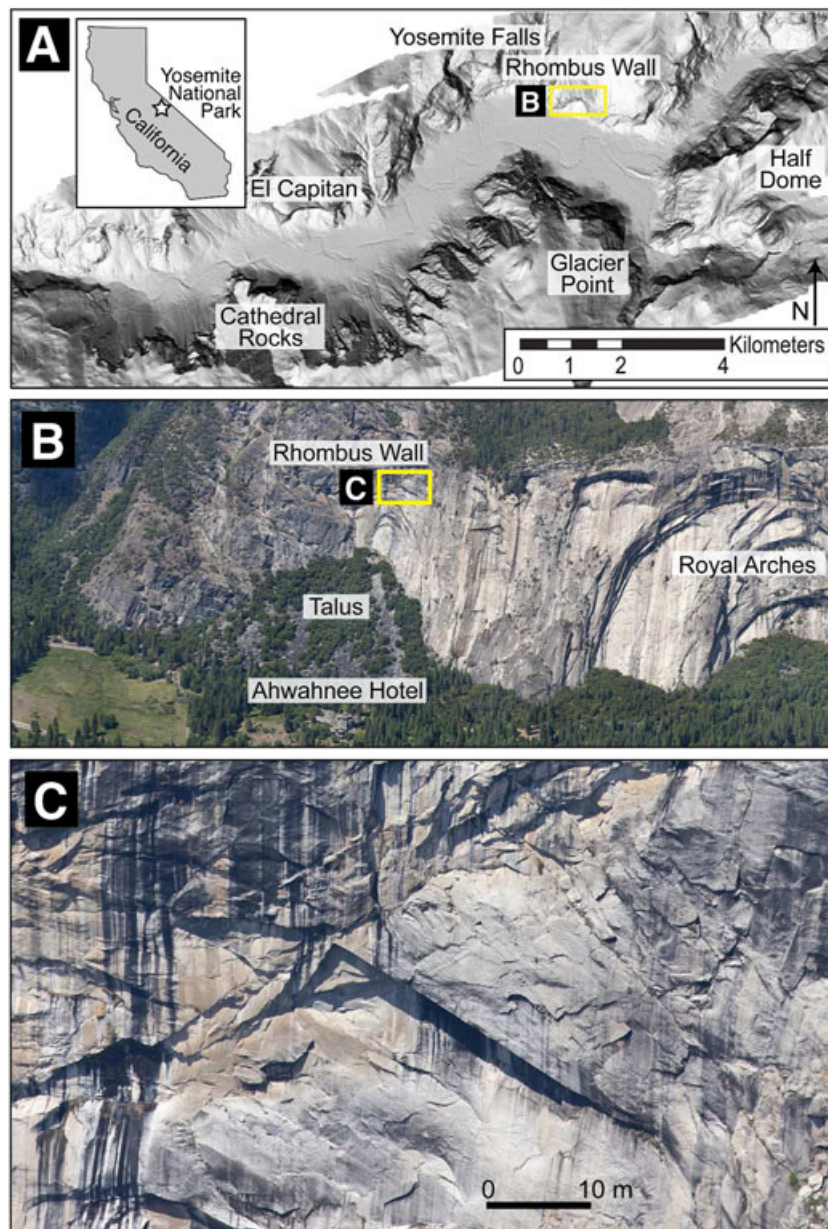
Figure 1. Rhombus Wall rock-fall source area. (A) Shaded relief map of Yosemite Valley, derived from a 1 m resolution lidar-based digital elevation model, showing location of Rhombus Wall (yellow box). Inset shows location of Yosemite National Park in eastern California. (B) Photograph of the Rhombus Wall, view to the north, showing the 2009–2010 rock-fall source area (yellow box). (C) Zoomed-in view of the source area prior to the 2009–2010 rock falls; the failures occurred above and left of the overhanging shadowed roof that extends from lower right to upper left in the center of the photograph (compare with Figure 5). This figure is available in colour online at wileyonlinelibrary.com/journal/espl

with the gigapixel panoramic images of the Rhombus Wall acquired prior to the rock fall (Figure 1(B), 1(C)) reveals that the failure occurred at the inside corner of an alcove roof beneath an overhanging rock slab (area 1a in Figure 5; Figure 6). Stress concentrations can be expected at corners such as this in rock (Holister, 1967; Muller and Martel, 2000; Barber, 2002). The failure surface showed mostly freshly broken rock with ragged edges and no clearly defined pre-existing structural discontinuities. Local water staining on the newly exposed surface, however, indicates that a fracture behind the rock mass was open and conducting water, and had partially detached the rock mass from the cliff prior to failure.

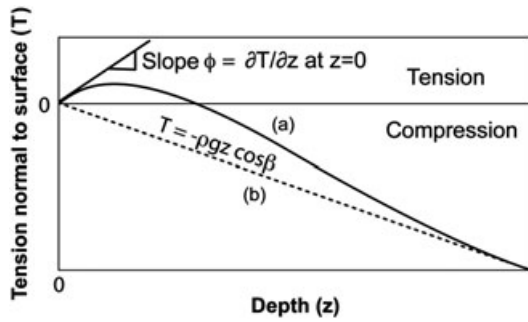
Figure 9. Schematic diagram showing possible variations in the normal stress T perpendicular to a traction-free rock surface as a function of distance into the surface z . The stress gradient ϕ is the slope of the T vs. z curve at the surface. (a) General form of stress profile required for sheeting joints, with a tensile stress at shallow depth and $\phi > 0$. (b) Linear stress profile for a constant gravitational stress gradient for a flat slope inclined at an angle $\beta < 90^\circ$, with $\pi < 0$. Tension is positive, compression is negative. Modified from Martel (2011).

negative), ρ is the density of the rock, g is gravitational acceleration (9.8 m/s^2), and β is the topographic slope angle in degrees (Martel, 2006). The gradient thus has contributions from both a curvature-stress term (kP) and a gravitational term ($-\rho g \cos \beta$). A tensile stress normal to a two-dimensional rock face will be present in the shallow subsurface (Figure 9) if

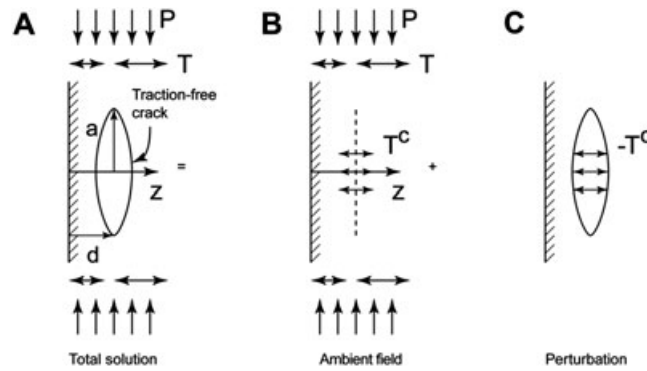
Figure 10. Superposition scheme for stresses around a sheeting joint parallel to a cliff face, showing the reference frame. The z-axis is normal to the slope, the y-axis points upward, parallel to the slope, and the horizontal x-axis points into the page. (A) Traction-free crack of half-length a at a depth d behind a traction-free rock face. (B) Assumed ambient stress state in the absence of a crack. The tensile stress T normal to the rock face is assumed to increase over a short distance from the face, and compressive stresses parallel to the rock face is P . The value of T at depth z is positive and equals T^c . (C) Pressurized crack, with an internal pressure $-T^c$; the minus sign is required because pressure is taken to be negative. The total stress field (A) is the sum of the ambient stress field (B) and the stress perturbation T due to the opening of the crack (C).

required traction-free boundary condition along the walls of the crack, the pressure in the crack must have the same magnitude as the tension in the ambient field at the depth of the crack, but the opposite sign (Figure 10(C)). Superposition of the two stress fields in Figure 10(B) and 10(C) thus describes the stress about a crack that is traction-free (Figure 10(A)). If the ambient tension at depth d is T^c , then the normal traction on the crack walls in the perturbation solution is $-T^c$ (Figure 10). For shallow depths beneath a traction-free surface, an approximate value for T^c is obtained by the product of the stress gradient, given in Equation (1), and the depth below the surface d (Figure 9):

We note that the stress intensity factor for a traction-free crack under tension (Figure 10(A)) can be the same as for a pressurized crack (Figure 10(C)). This is because the driving pressures can be the same, even though the stress fields far from the cracks can be very different. In other words, the conditions at the tips of a crack opening in tension can be indistinguishable from those at the tips of a pressurized crack. The behavior of a pressurized crack thus is useful in understanding propagation of a dry sheeting joint.

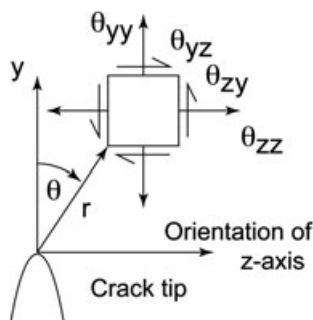
where σ_{ij} is the stress component acting on a plane normal to the i -direction, and acting in the j -direction, K_m is the stress intensity factor, r is a small distance from the fracture tip ($r < a$), and f_{ij} is a trigonometric function of the angle θ (Figure 11). Note that the stresses are singular (i.e. they approach infinite levels as $r \rightarrow 0$), and that the contribution

Figure 11. Reference frame for stresses near the tip of a crack. Positive stresses are depicted.

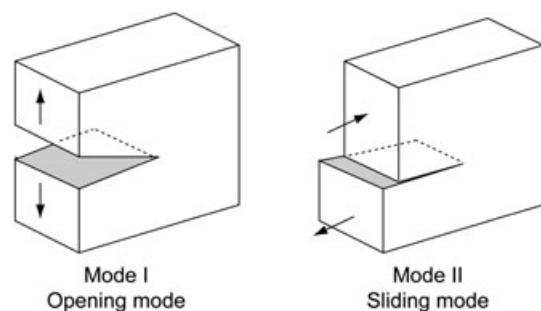
of the angular component of position θ is separable from that due to the radial component r . The subscript m denotes the mode of fracturing (i.e. the style of relative motion of the crack walls near the fracture tip), with $m=I$ for the opening mode, and $m=II$ for sliding modes (Figure 12). For a mixed-mode crack, both opening and sliding can occur. The displacement of the crack walls relative to one another Δu_m near the crack tip also can be expressed in terms of the stress intensity factor (Lawn, 1993)

Figure 12. The two modes of fracturing in plane strain.

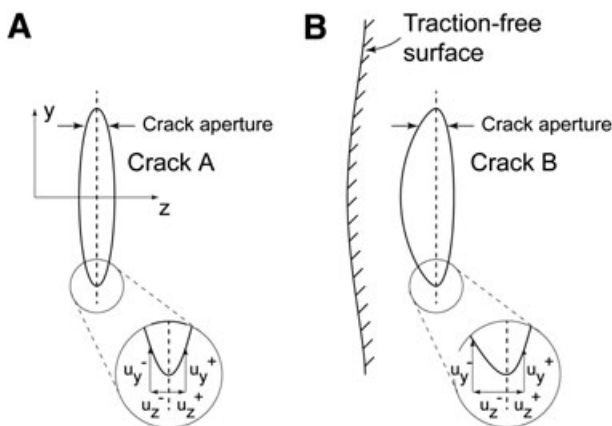
The mode II stress intensity factor K_{II} describes near-tip conditions in cases where crack walls slip by one another. For an isolated pressurized crack in an infinite body with no ambient stresses, $K_{II}=0$. This occurs even though tangential displacements do occur along the crack walls (Figure 13), but these displacements are matched such that no tangential displacement of the walls occurs *relative to one another*; the

displacements are symmetric about the plane of the crack. For a pressurized crack near a traction-free surface, however, the displacements are asymmetric (Figure 13(B)). The displacements normal to the plane of the crack are larger on the crack wall nearer to the free surface than along the opposing wall. Furthermore, the tangential displacements also are larger on the crack wall nearer to the free surface than along the opposing wall (i.e., $u_y^- > u_y^+$). This means a relative tangential displacement of the walls occurs because of a mechanical interaction between the crack and the traction-free surface. As a result, for a pressurized crack near a traction-free surface, $K_{II} \neq 0$. This has important ramifications for sheeting joint propagation.

Figure 13. Displacements of the walls of a uniformly pressurized crack (A) in an infinite body, and (B) in a half-space. The aperture is greater for crack B than for crack A owing to the proximity of the free surface. Crack opening includes displacement components (fine arrows in inset) tangential to the crack (u_y) as well as normal to the crack (u_z). The dashed line shows the walls of the crack prior to pressurization. The positive walls of the crack are to the right of the dashed line, the negative sides to the left. The asymmetry in the normal displacements for crack B is also associated with an asymmetry in the tangential displacements, with $u_y^- = u_y^+$ in (A), but $u_y^- > u_y^+$ in (B). The sense of slip at the upper end of the crack is opposite the sense of slip at the lower end.

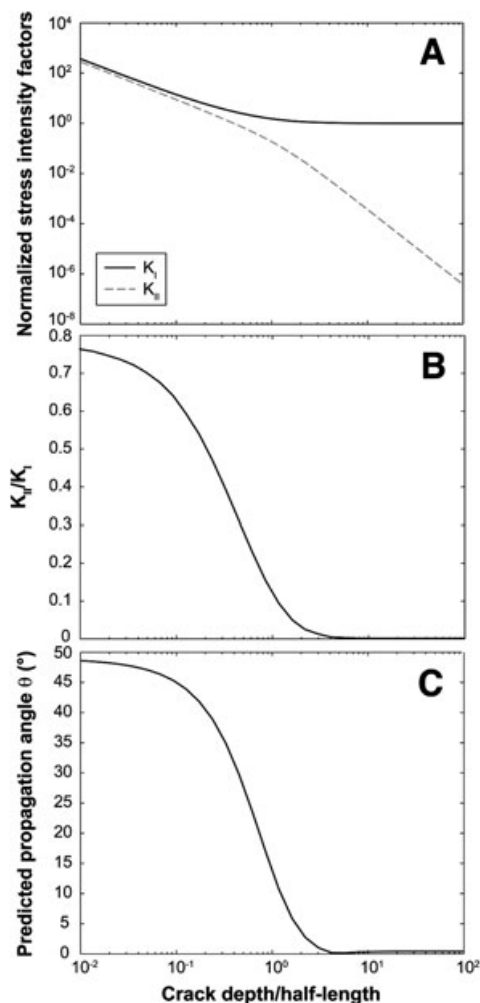
The influence of the proximity of a free surface on a pressurized crack can be quantified through the stress intensity factors. Dyskin *et al.* (2000) describe an asymptotic method for evaluating K_I and K_{II} for a two-dimensional pressurized crack parallel to a traction-free surface. In their procedure, the stress intensity factors (both K_I and K_{II}) for a crack parallel to a traction-free surface are normalized by the value of K_I for a crack of equal half-length in an infinite body. The right half of (Figure 14(A). shows that, for a half-length less than the depth, the normalized values of K_I effectively equal unity and the normalized values of K_{II} effectively equal zero. This means that sheeting joints essentially do not feel the effect of the traction-free surface if their shortest half-dimension is less than the depth of the crack below the surface. If a crack continues to grow, then the absolute value of K_I increases because the half-length a increases (see Equations 7). A positive feedback thus promotes further crack propagation. Moreover, the left half of Figure 14(A) shows that the normalized values of both K_I and K_{II} increase as the ratio of depth to half-length decreases, which will happen as the crack grows. This means a crack parallel to a traction-free surface would tend to propagate more readily than an isolated crack in an infinite body.

The ratio K_{II} / K_I provides a measure of the tendency of a fracture to deviate out of the plane tangent to the fracture at the fracture tip (Pollard and Aydin, 1984). If $K_{II} / K_I=0$, then the fracture is expected to propagate in the tangent plane, but if this ratio departs from zero, the fracture is expected to deviate out-of-plane if it propagates (Lawn, 1993). Figure 14(B) shows that as the depth to half-length ratio decreases, which would happen as a sheeting joint propagates, the ratio K_{II} / K_I increases; this increase is particularly pronounced as the depth to half-length ratio drops below a value of unity. Thus, sheeting joints with in-plane dimensions greater than the fracture depth can be expected to propagate out of plane, and to grow towards the surface (Erdogan, 1971; Pollard and Holzhausen, 1979). The general tendency is for the fractures to grow in a direction that minimizes the shearing stresses resolved across the tips and maximizes the so-called hoop stress, the normal stress perpendicular to a radial plane extending from the crack tip (Figure 14(C)). The crack tip thus re-orient itself to grow as a mode I fracture and minimize the value of K_{II} at the fracture tips (Lawn, 1993). This suggests that sheeting joints, as they grow, will tend to daylight (intersect the cliff face), completely separating a relatively thin sheet of rock from a slope; on a steep cliff face, this separation would result in a rock fall. Thus rock falls could occur without a sheeting joint propagating into pre-existing discontinuities to allow a rock mass to separate from a cliff. Although many of the Rhombus Wall failure surfaces did terminate along pre-existing regional discontinuities (Figure 8), there are also examples where failure surfaces appear to have daylighted on the cliff face (e.g. the 14 September 2009 and 12 November 2010 rock falls).

Figure 14. (A) Normalized stress intensity factors K_I (mode I) and K_{II} (mode II) for a uniformly pressurized two-dimensional planar crack parallel to a traction-free surface as a function of the depth/half-length ratio of the crack. The stress intensity factors are normalized by K_I for a uniformly pressurized crack in an infinite body. Stress intensity factors are calculated by the approach of Dyskin *et al.* (2000). (B) Ratio of K_{II} to K_I as a function of the depth/half-length ratio of the crack. (C) Predicted initial crack propagation angles as a function of the depth/half-length ratio of the crack. A value of zero corresponds to propagation in plane.

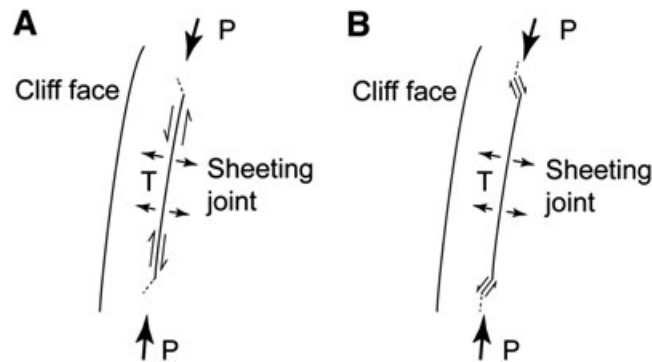
its tips due to a mechanical interaction with the cliff face (Figure 16(A)). Once a sheeting joint begins to propagate up towards the cliff face, however, a shear stress of the opposite sense is resolved across the new tip of the sheeting joint (Figure 16(B)); this occurs because the new tip is oblique to the ambient principal stresses P and T , which differ substantially in magnitude. As a result, the joint will tend to propagate back in a direction perpendicular to the most tensile stress (cf. Pollard and Aydin, 1984; Olson and Pollard, 1989). The strong anisotropy in the ambient stress field thus tends to 'steer' joints back to a path parallel to the cliff face. This anisotropy apparently is sufficient to allow sheeting joints to grow to lengths many times greater than their depth, as revealed by the failed sheets on the Rhombus Wall (Figure 5; Table I). This accounts for the characteristic tendency of slabs bounded by sheeting joints to be thin relative to their in-plane extent.

Figure 16. Schematic diagram showing sheeting joint propagation paths within a cliff. Dashed line shows the path of the sheeting joint during a subsequent stage of growth. (A) Sheeting joint propagates towards cliff face in response to shearing induced near joint ends as a result of mechanical interaction with the cliff face. (B) Sheeting joint propagates parallel to cliff face in response to shearing induced near new joint ends in response to the ambient principal stresses, defined by P and T .
