Subject: Adding Vehicular Entrances and Garage Doors to Historic Buildings

Applicable Standards: 2. Retention of Historic Character
9. Compatible New Additions/Alterations

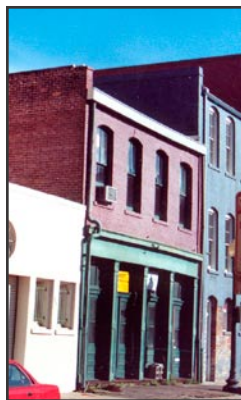
*Left:
Before rehabilitation
the ground floor of
the rear elevation
was divided into
four equal-sized
bays.*

Application 1 (*Compatible location/Compatible treatment*): This mid-19th century building was originally used as a warehouse on the first floor with the owner living above. The building is narrow and very deep, extending through the block from one street to another. The primary elevation with its cast-iron storefront faces a busy street while the rear faces a smaller street that is more like an alley in use and appearance. The shipping entrance at the rear was separated by decorative cast-iron piers into four bays of double doors.

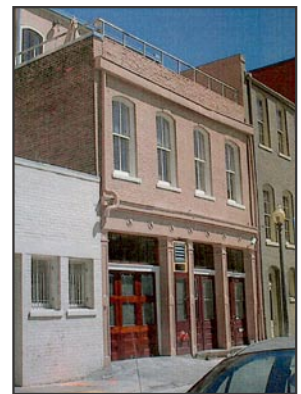
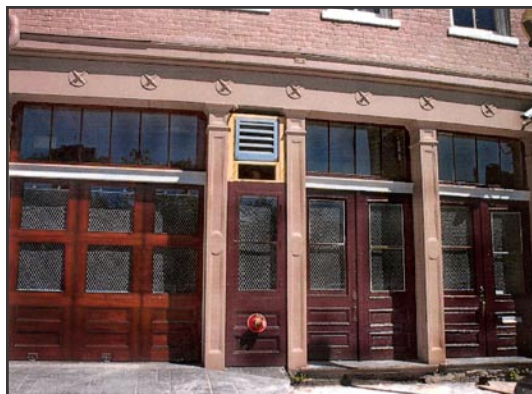
*Left and Upper Right:
The left bay was
enlarged to create a
vehicular opening
which is compatible
with the building's
historic character.*

The rehabilitation project proposed to return the upper floors to residential use. The first floor, which had little historic features or finishes remaining, was to be converted into an office in the front and parking in the rear. The rear of the building is a secondary elevation and using this portion for parking was determined to be compatible. Since no garage opening existed, the rear entrance had to be modified for vehicular access while retaining its historic character. One cast-iron pier was moved over several feet to create an opening wide enough for a car. Wood garage doors replicating the existing pedestrian doors were installed. Although moving the pier resulted in a slight change to the formerly symmetrical entrance, it did not negatively impact its historic character. The project met the Standards.

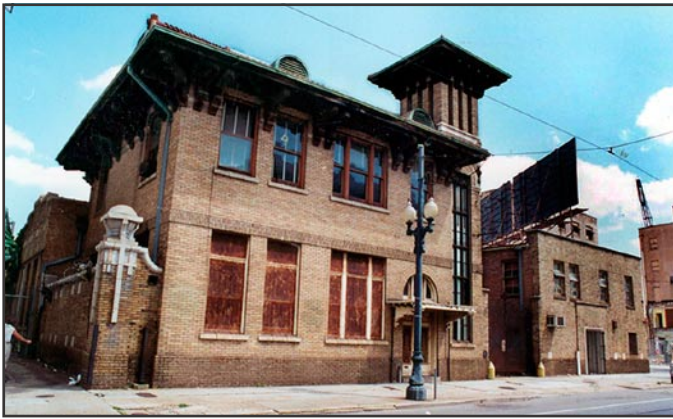
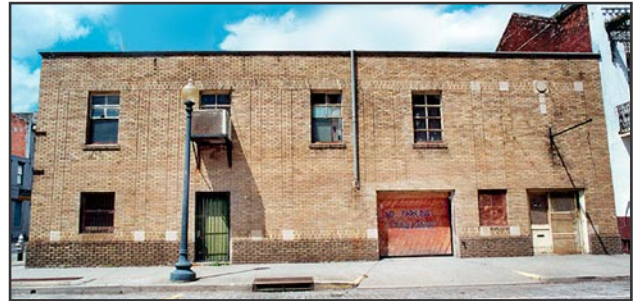
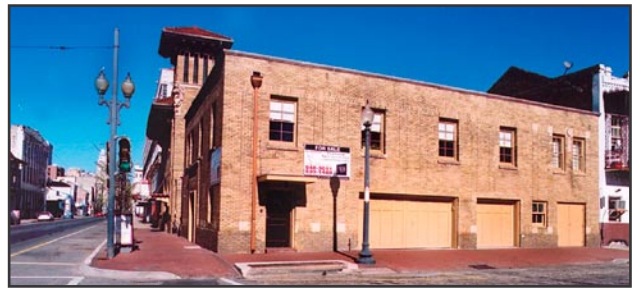
Below: A wing was added to the right side of the headquarters building several years after it was constructed in 1912. Because this wing had always been used for parking and had a garage door on the side elevation (right top), adding another garage door was determined to be a compatible treatment (right bottom).

Application 2 (*Compatible location/Compatible treatment*): This Tuscan Revival-style building was constructed in 1912 as regional headquarters for a national company. The property was to be rehabilitated for apartments. The first floor of the more utilitarian wing added later, which had been used for parking company vehicles, was proposed to be used as parking for the residents. Although one garage door already existed on the side of the addition, another, slightly wider opening was needed to allow incoming and outgoing cars to maneuver around cars parked inside.

Since the property is situated on a corner, this side of the building is clearly visible. But, it is a secondary elevation and of considerably less importance than the primary façade. In this case, the existence of a garage door on this elevation was a factor in determining that adding another garage door would not greatly change the character of the historic building. A simple opening was cut into this wall and traditional paneled wood garage doors were chosen to complement the early-twentieth century style of the building. The completed project met the Standards.

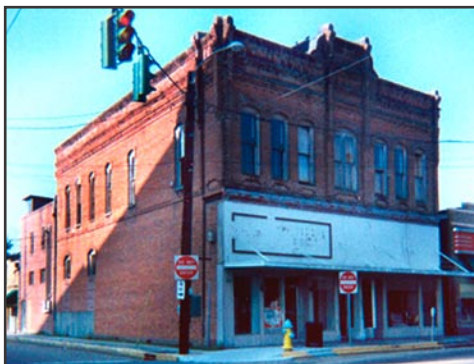
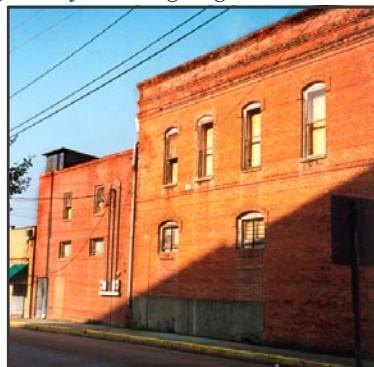
Left and Center: The front and side elevations of this building are shown here before rehabilitation.

Application 3 (*Compatible location/ Incompatible treatment*): This 1880s retail building, situated on a downtown corner, had been altered numerous times since its construction. The storefront had been remodeled and a rear addition had been constructed. The first floor of the building was to be rehabilitated for continued commercial use and the second floor for apartments. The rehabilitation included a compatible storefront design, and a proposal to cut a vehicular opening in the side wall of the non-historic addition so that the interior could be used for parking. Although the rear addition faces a street, it is a secondary elevation, and it was determined that adding a garage door in this location would not negatively impact the character of the historic building.

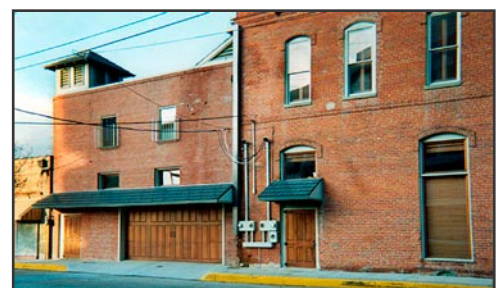
Right: The cumulative effect of the size, design and finish of the new garage door and the new pent roof overhang is a contemporary treatment that is incompatible with the historic character of the building.

Most treatments were completed as proposed. However, the new garage entrance differs from what had been proposed and approved. Two doors, varnished rather than painted as they would have been traditionally, are installed in a very large opening. A large pent-roof overhang which spans the entire length of the addition, extending from the garage to the back door, is also incompatible with the building's historic character. The garage entrance treatment did not meet the Standards and the project was denied certification.
