THE HISTORY AND ARCHITECTURE OF THE POINT REYES LIGHT STATION

Historic Structures Report
Point Reyes National Seashore

NATIONAL PARK SERVICE
1990

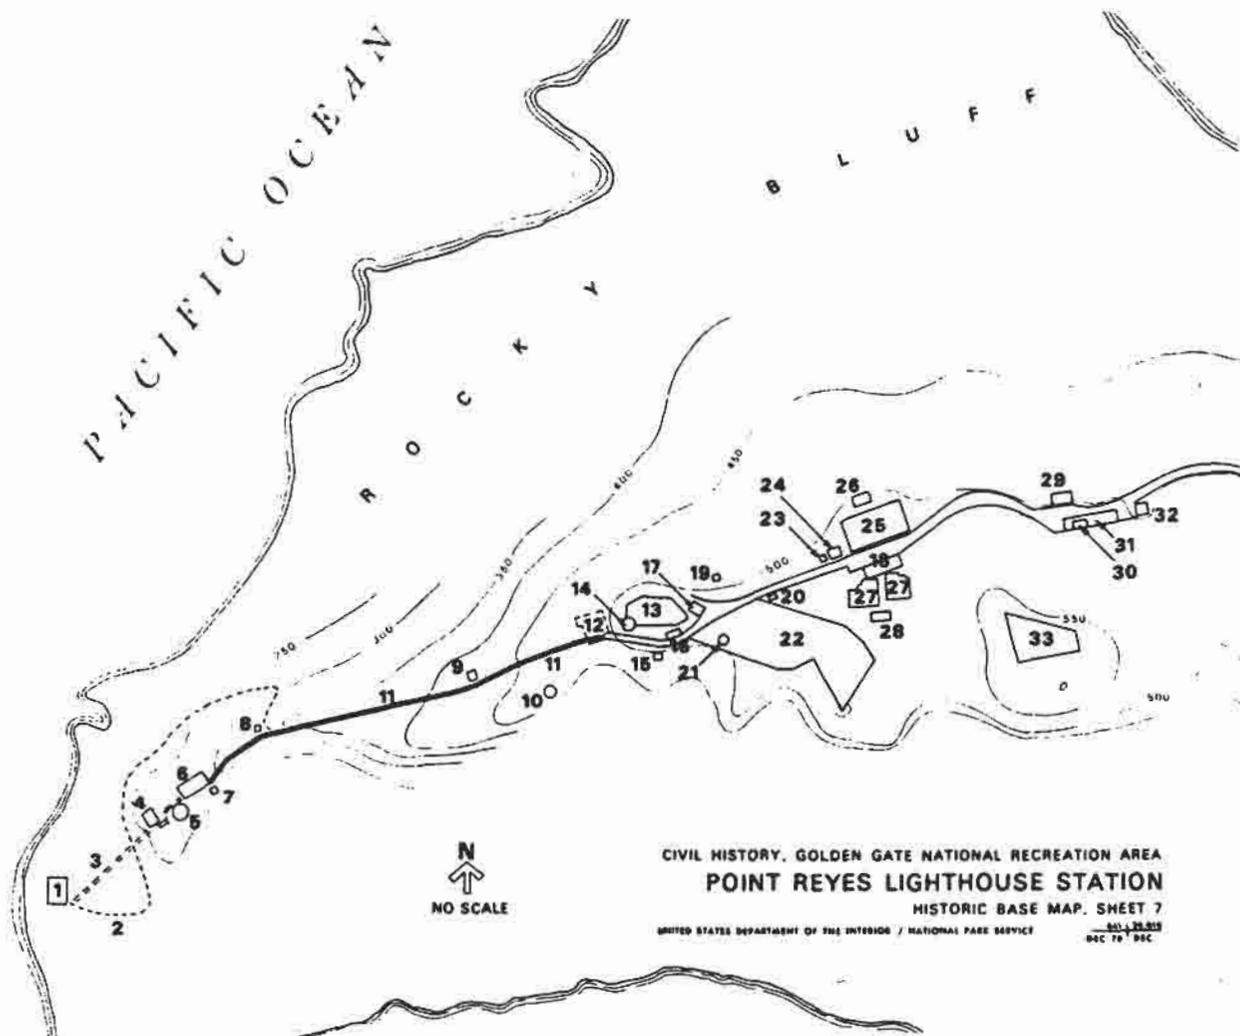
C. HISTORIC BASE MAP from Toogood

| <ol style="list-style-type: none"> 1. Fog signal (site, 1871-1934) 2. Trail/stairs to fog signal 3. Route of coal chute 4. Modern light station/site of fog signal

1934-1974 5. Lighthouse, 1870 6. Equipment building, 1928 7. Transformer building (old oil house), 1910 8. Fuel tank (site) 9. Gasoline storage building (site) 10. Wooden 42,000 gal. water tank (site) 11. Stairway, 1959 (site of original wooden stairs) 12. Weather Bureau/keepers dwelling,
1902-c.1960 (site) 13. Rainshed, site of storm warning pole
& flag pole 14. Cistern, 1898 15. Washhouse (site) 16. Single garage, fuel shed (site) | <ol style="list-style-type: none"> 17. Visitor center (ex-garage) 18. Planked terrace (site) 19. Pump house, 1934 20. Fuel and paint storage building, c. 1900 21. Cistern, 1871 22. Rainshed, 1871-1900 23. Paint shop (site) 24. Coal house (site) 25. Double keepers quarters, 1870-1960 (site),
apartments, 1960 26. Outhouses, sheds, laundry & store buildings
(sites) 27. Keepers cottages, 1885-1960 (site) 28. Fuel and store building (site) 29. Barn, 3-car garage (site) 30. Modern pumphouse, site of gas storage building 31. Stable, barn (site) 32. One-car garage, 1933 (site) 33. Upper rainshed, 6,000 square feet, 1900 (site) |

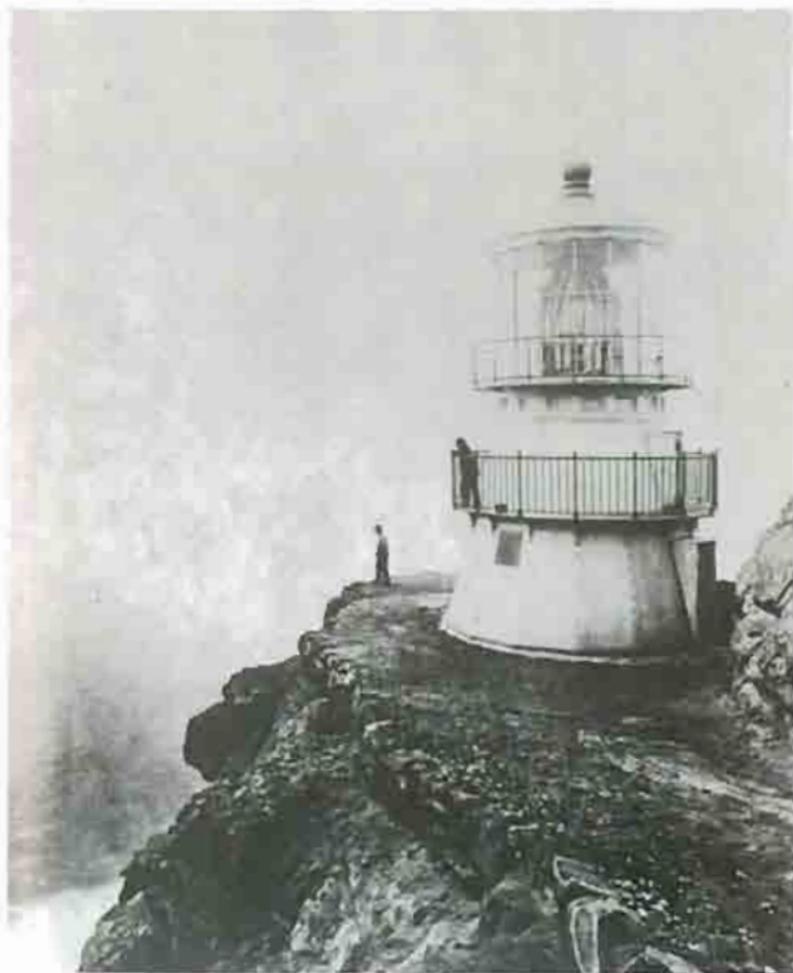
Figure 3 - Point Reyes lighthouse when new, probably taken in late 1870 or early 1871. Note the light color of lantern. Eadweard Muybridge photograph, Records of the United States Coast Guard, National Archives.

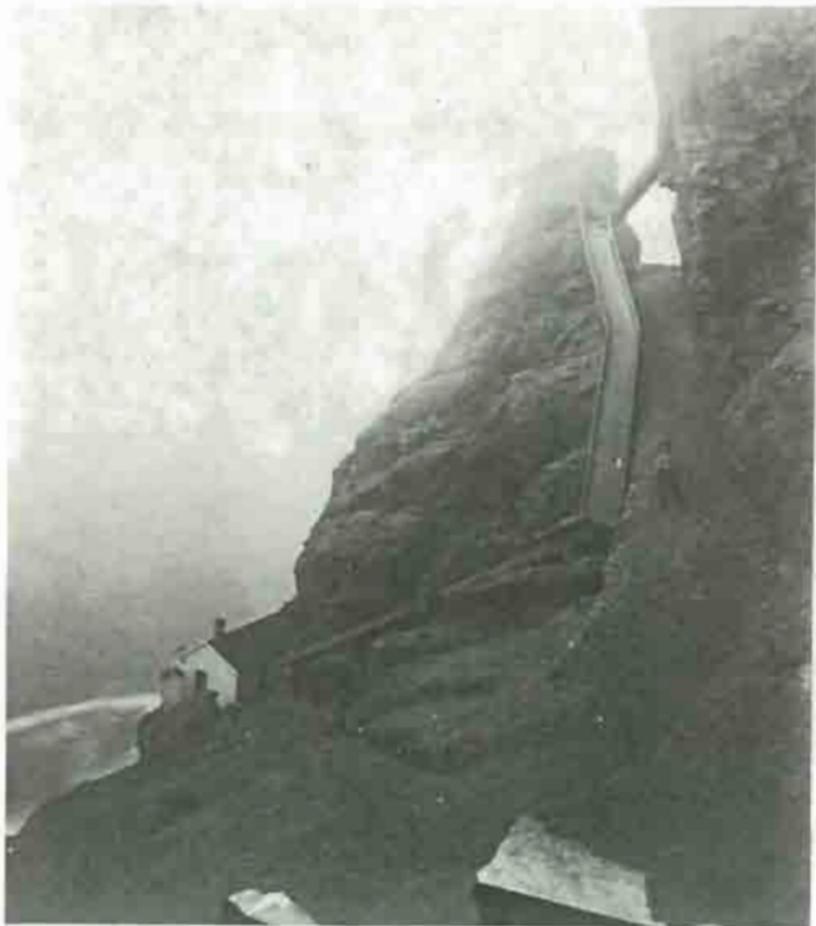
Figure 4 - Newly built coal chute and fog signal, ca. 1871.
Eadweard Muybridge photograph courtesy of Bancroft Library.

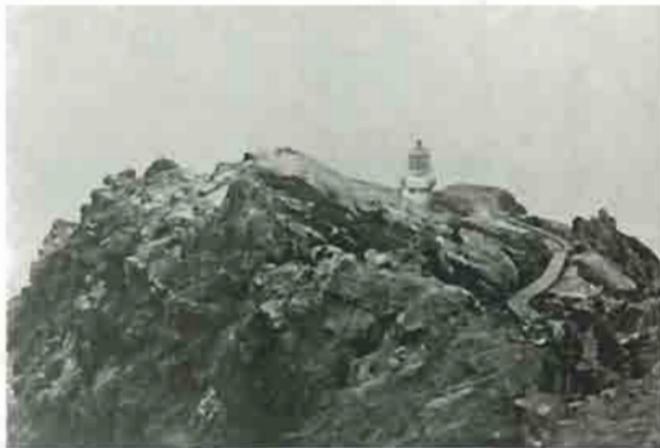
Figure 7 - View down stairs under construction, probably late 1870. Note that future site of equipment building has been graded. Eadweard Muybridge photograph, United States Coast Guard.

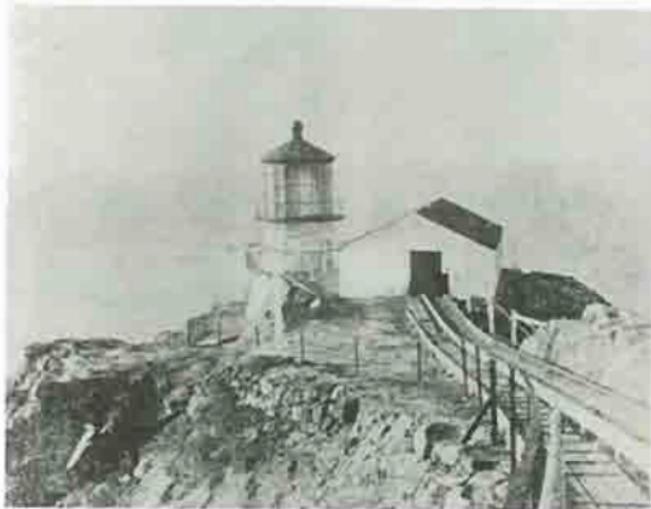
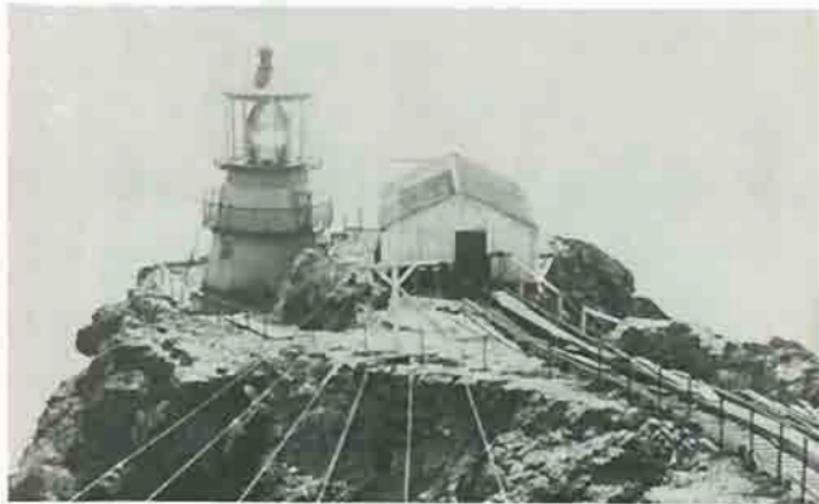
Figures 8 and 9 - Two views of the lighthouse and coal shed, before 1880. National Park Service.

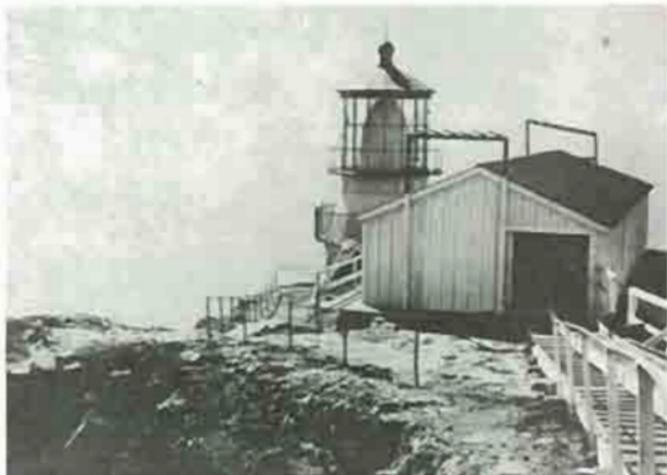
Figure 10 - Lighthouse and second coal storage building, ca. 1900. Jack Mason Museum.

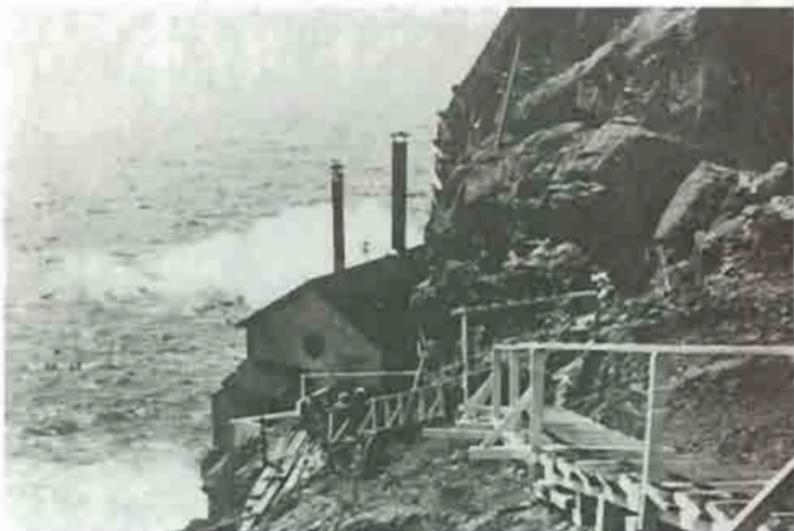
Figure 11 - Fog signal building, ca. 1900. Jack Mason Museum.

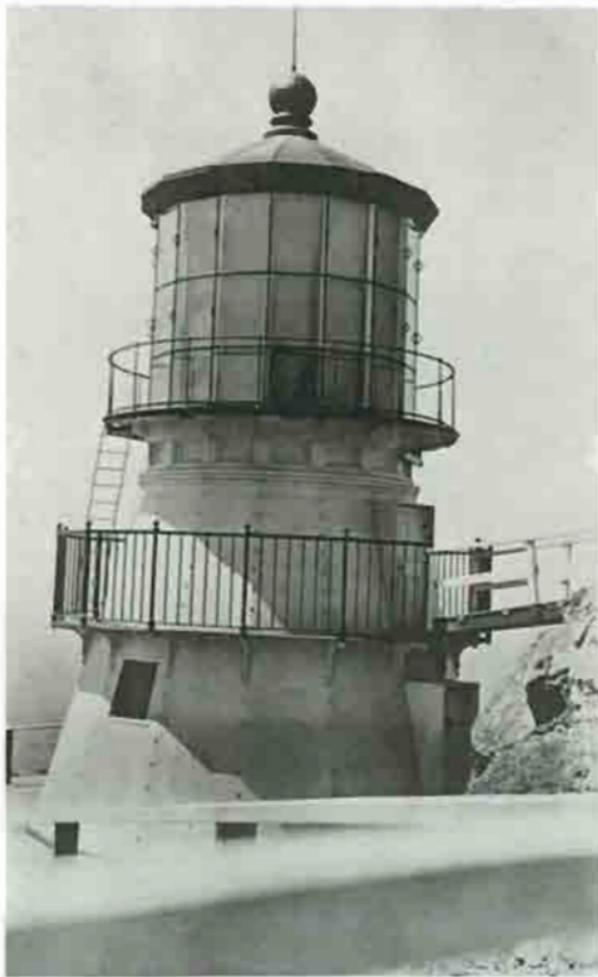
Figure 12 - Lighthouse ca. 1910. Note concrete sidewalk around tower. Jack Mason Museum.

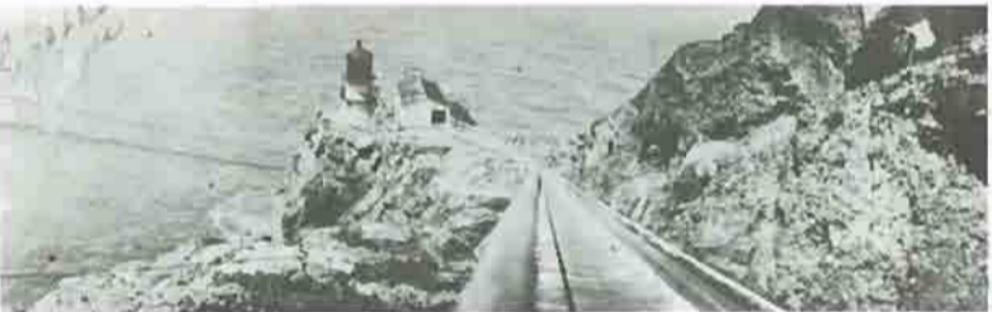
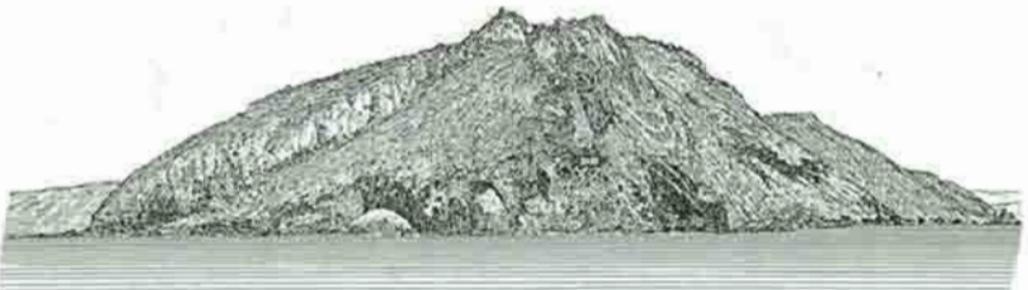
Fog-horn.
Water-tank, Light-house,
Point Reyes Light-house and Fog-horn, E. $\frac{1}{2}$ N., 1 mile.

Figures 13 and 14 - Lighthouse complex from stairs, before 1910 (left), Jack Mason Museum.
Drawing of Point Reyes from sea (right), from 1889 Coast Pilot.

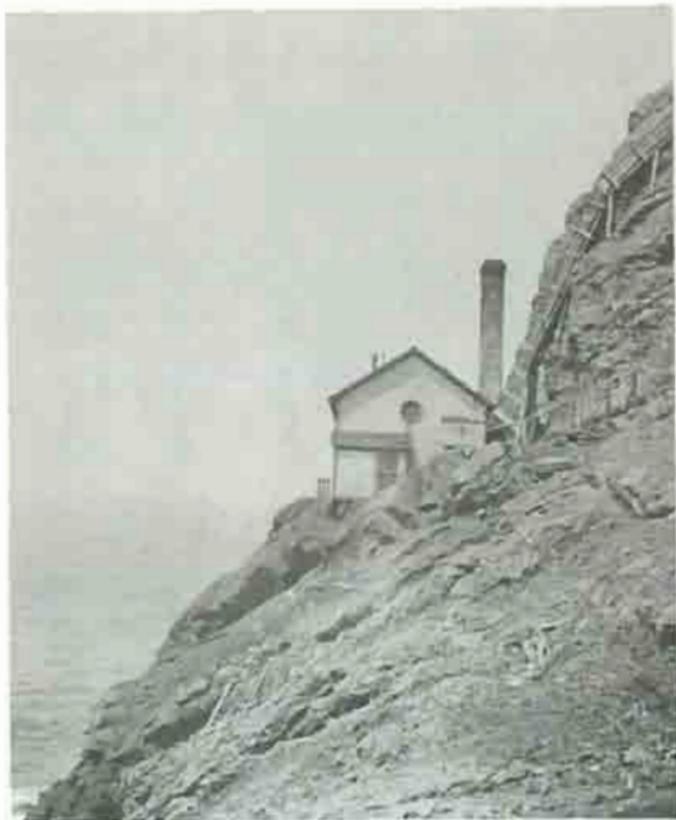
Figure 15 - Fog Signal building ca. 1915, National Park Service.

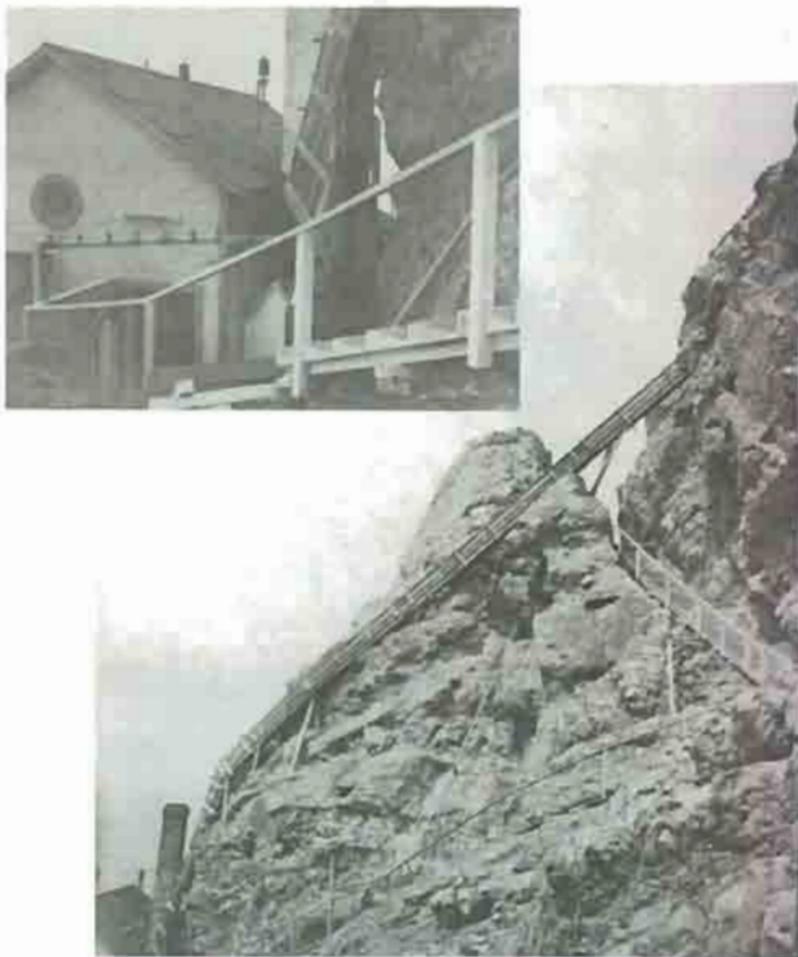
Figure 16 - Stairs and chute, fog signal, ca. 1915; detail of fog signal building ca. 1915 (inset).
National Park Service.

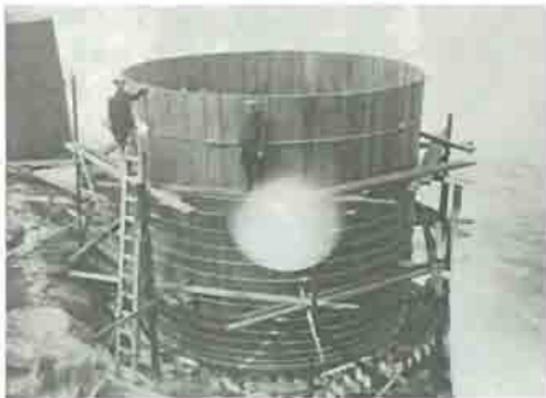
Figure 17 - Construction of new water tank near top of stairs, ca. 1915. National Park Service.

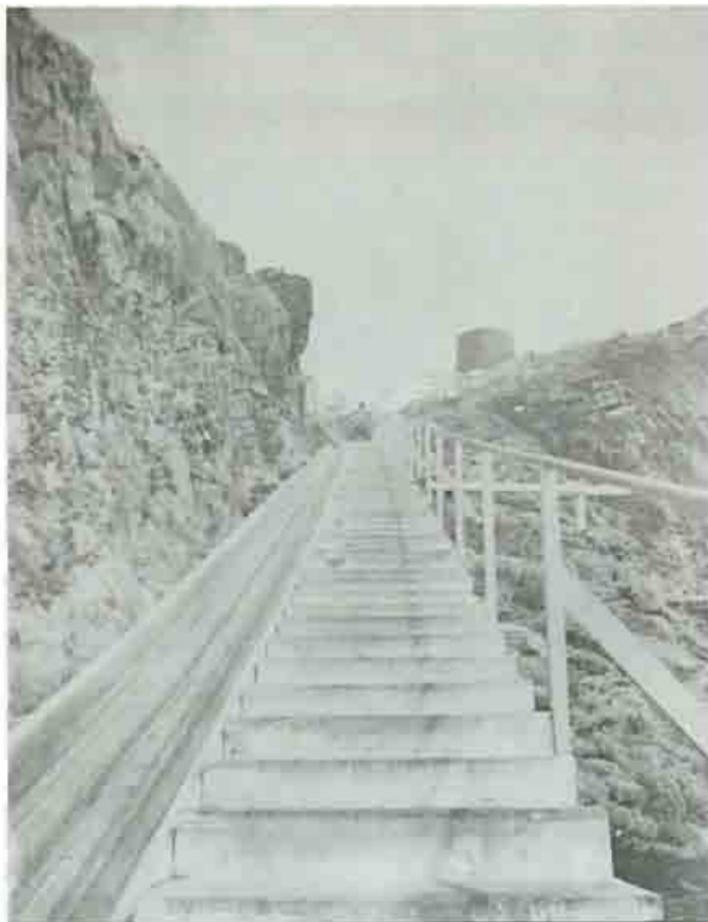
Figure 19 - Looking up wooden stairs, ca. 1915. National Park Service.

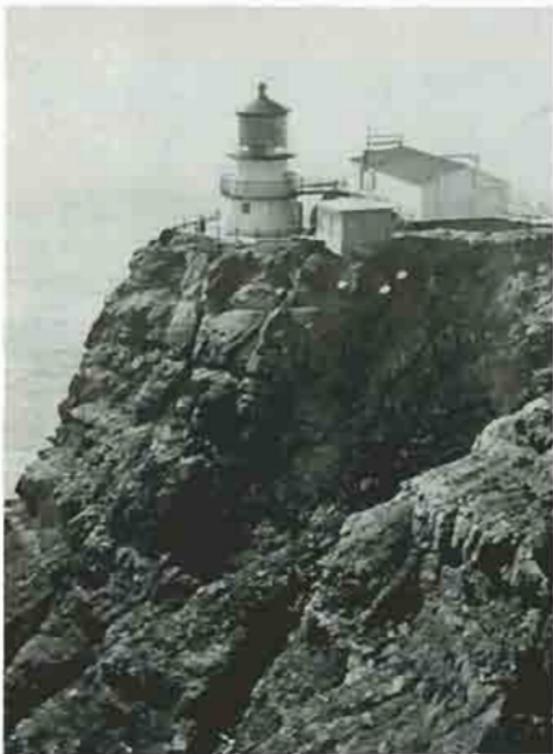
Figure 20 - Lighthouse, oil storage building, coal shed, 1927. Within a year the shed will be replaced by the equipment building. National Park Service, courtesy of Fred V. Kreth.

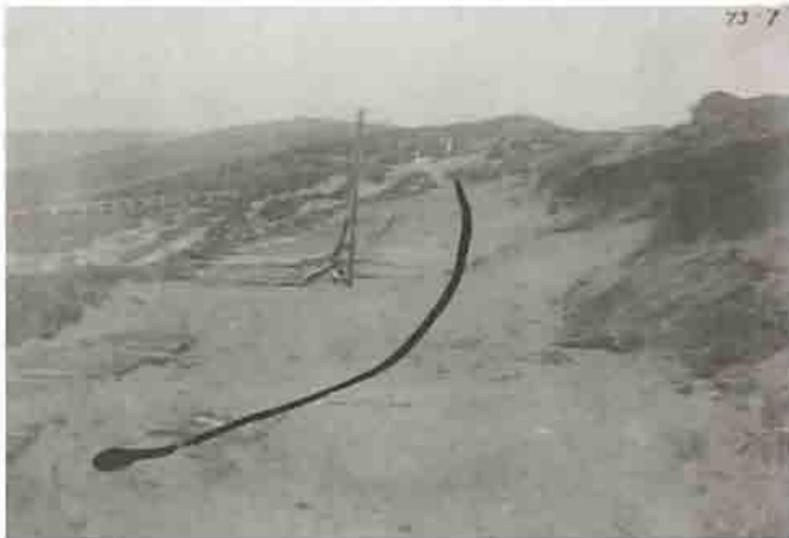
Figure 21 - Road in eastern part of reservation before repairs, 1921; line marks proposed bypass of plank road on left. National Park Service.

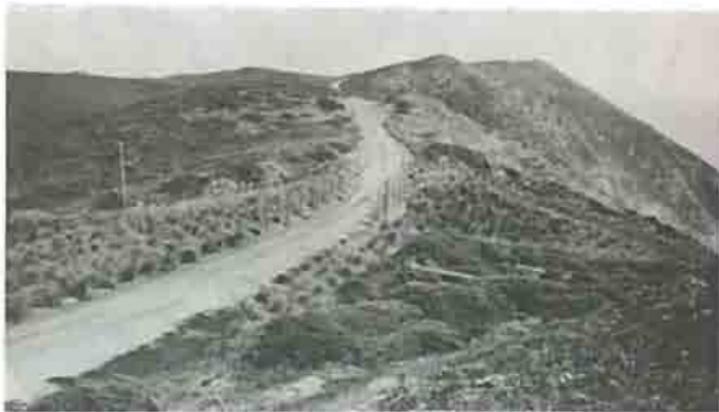
Figure 22 - Road after repairs, 1934. Notice vegetation planted to stabilize dune. National Park Service.

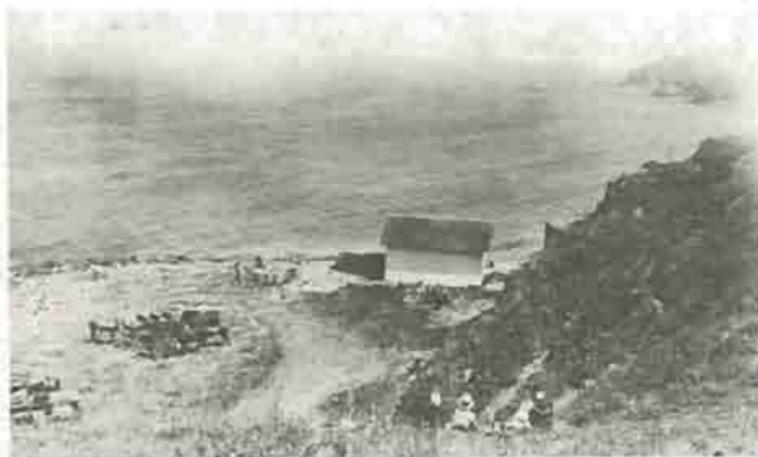
Figure 23 - Lighthouse landing at Drakes Bay, ca. 1915. San Francisco Maritime National Historic Park.

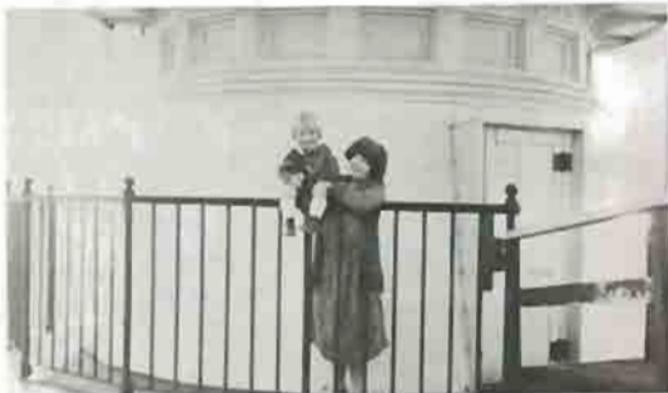
Figure 29 - Lighthouse balcony showing original door to first gallery, taken about 1922. Smith family album, Jack Mason Museum.

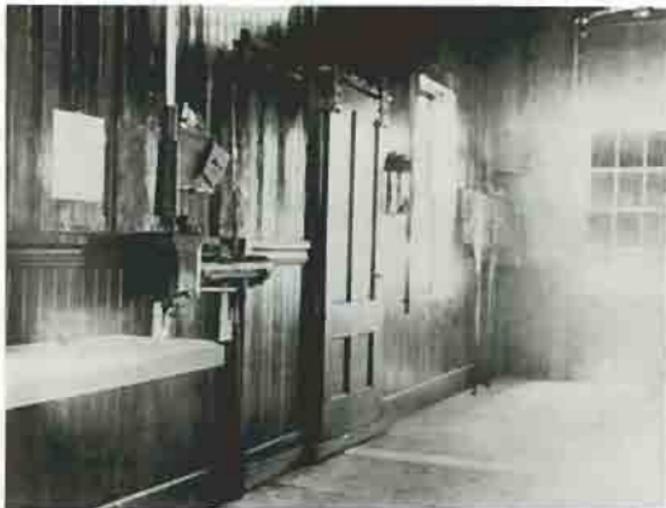
Figure 31 - Interior of fog signal building, 1915. Note similar appearance to later equipment building interior. National Park Service.

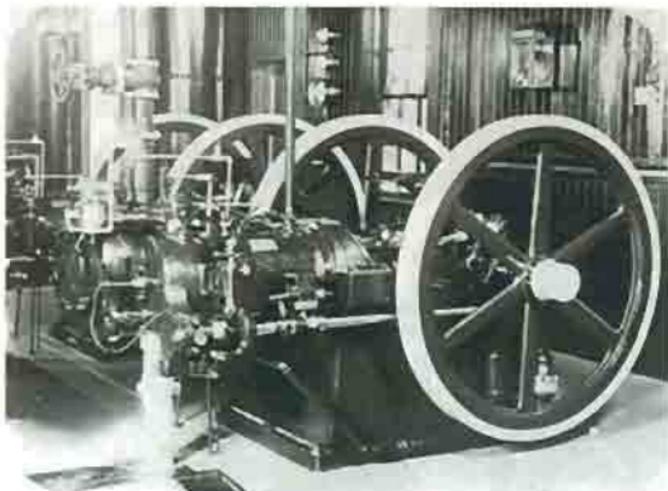
Figure 32- Doak gasoline engines, fog signal building, 1927. National Park Service.

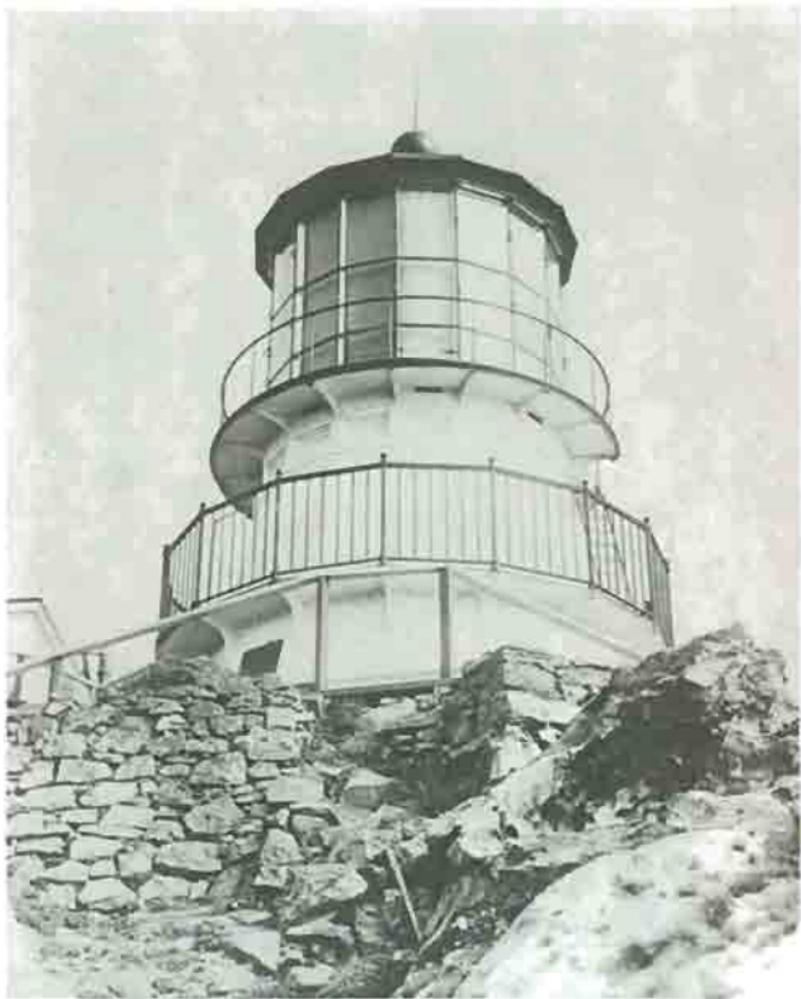
Figure 33 - Lighthouse tower from cliff below, 1927. National Park Service.

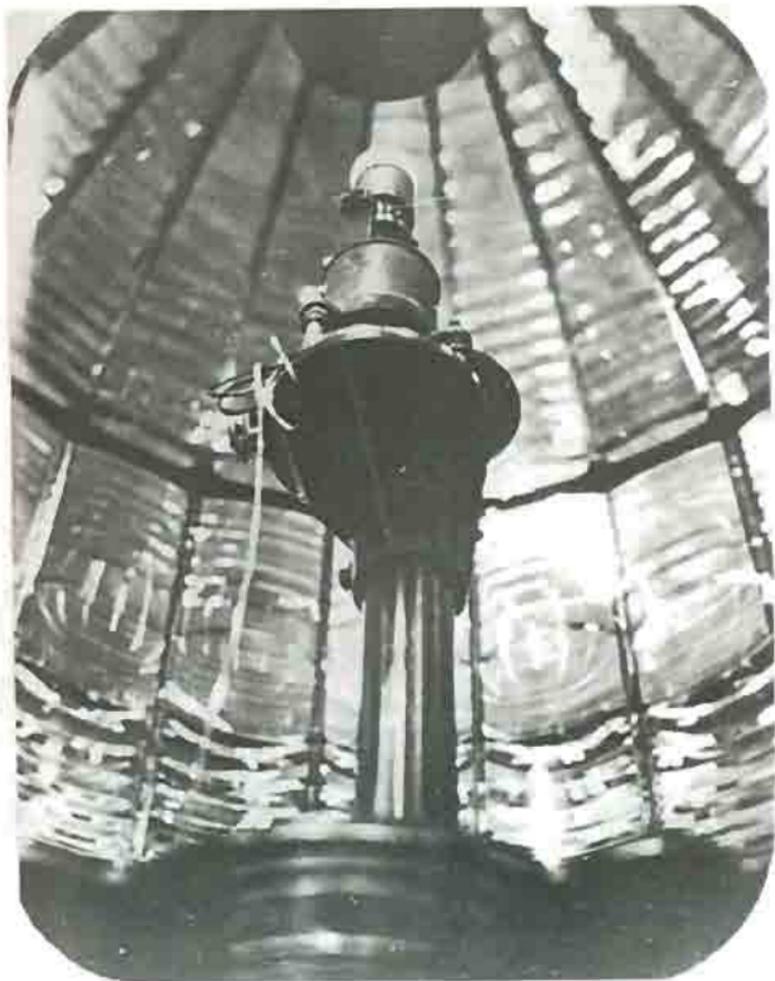
Figure 34 - Illuminating apparatus, 1927. National Park Service.

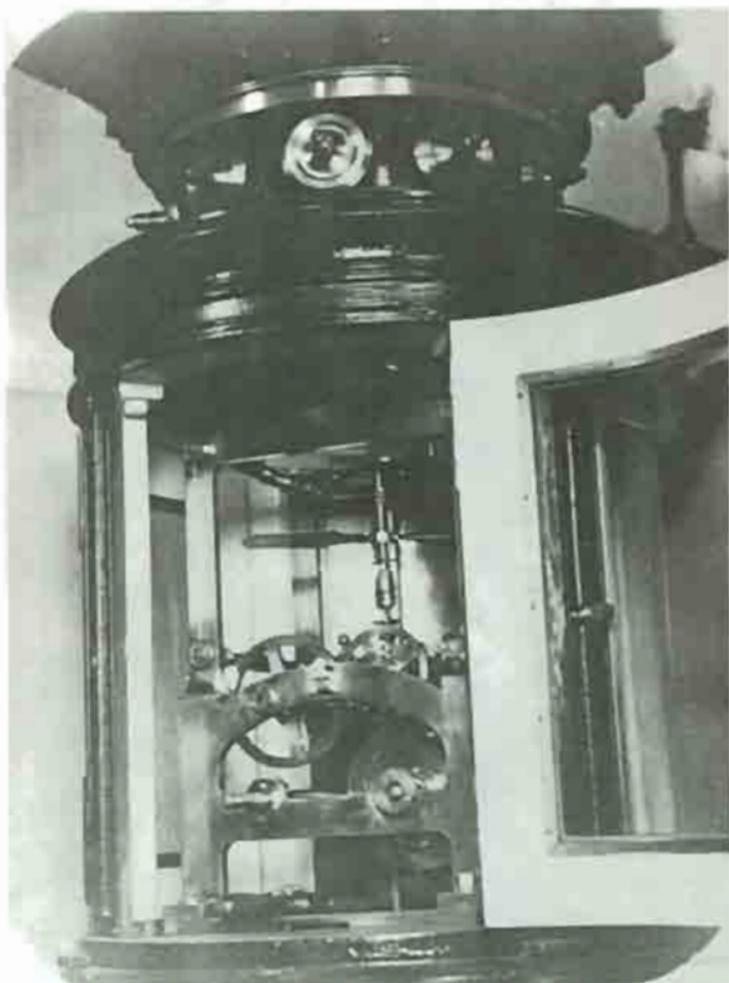
Figure 35 - Clockwork apparatus and lens pedestal, 1927. National Park Service.

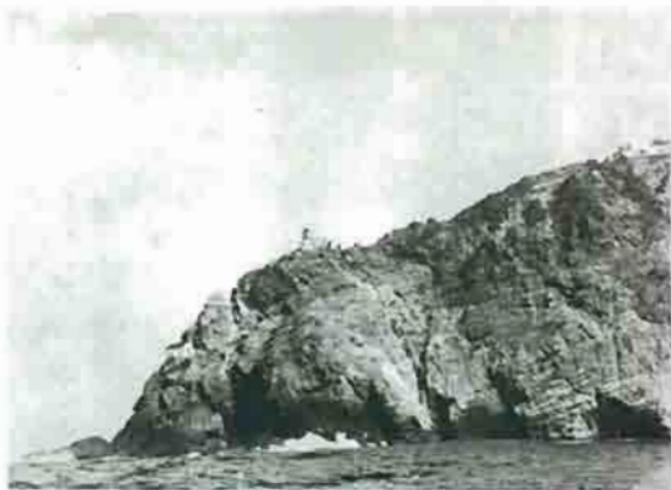
Figure 38 - Point Reyes Lighthouse from sea, looking north; newly built equipment building behind tower, February 1929. National Park Service.

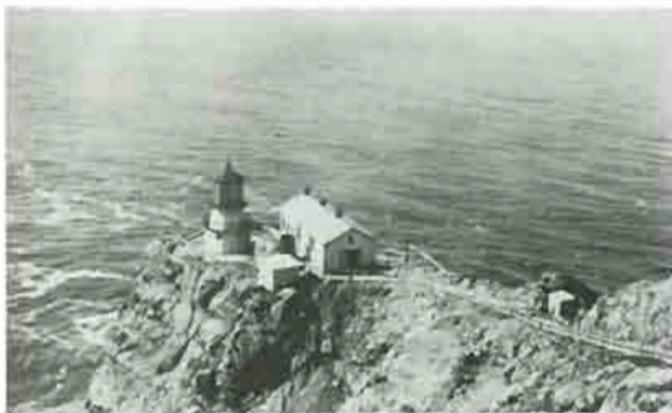
Figure 39 - Lighthouse complex with new fog signal equipment building, January 1, 1929. Photo marked by photographer, "New fog signal building at Pt. Reyes showing circulating water tank [next to building] and distillate sump tank [on right]. National Park Service, courtesy of Fred V. Kruth.

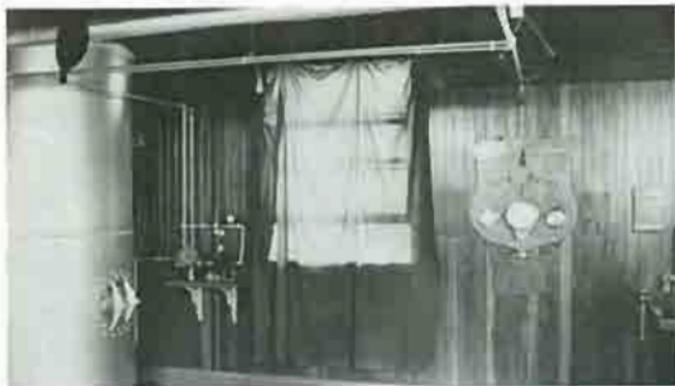
Figure 40 - Interior of fog signal equipment building in 1935, showing compressed air holding tank on left and gauge board on wall, both still extant. National Park Service.

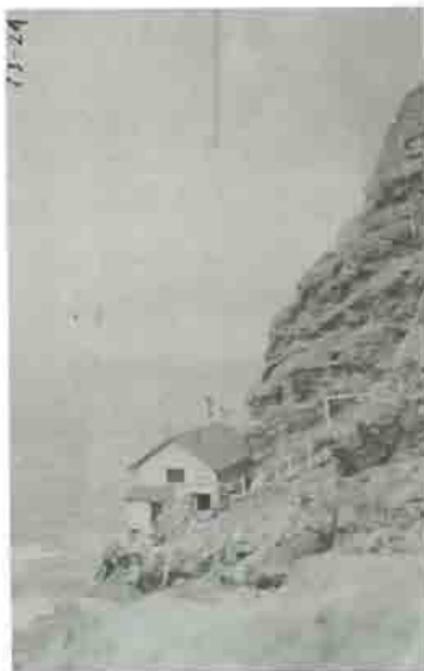
Figure 41 - Fog signal building ca. 1915-1925, before signals were moved up to the lighthouse complex.
National Park Service,

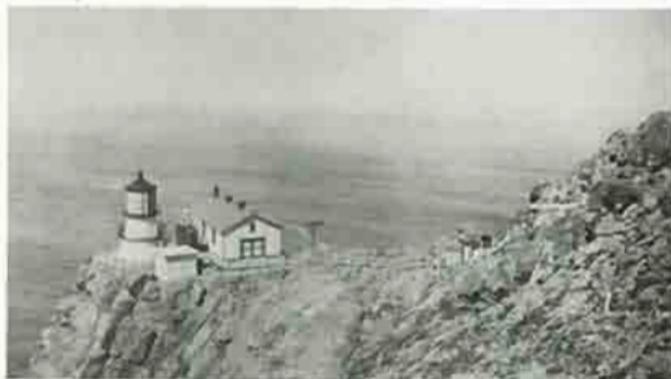
Figure 42 - Lighthouse complex in 1935, after fog signal was moved to lighthouse level. National Park Service.

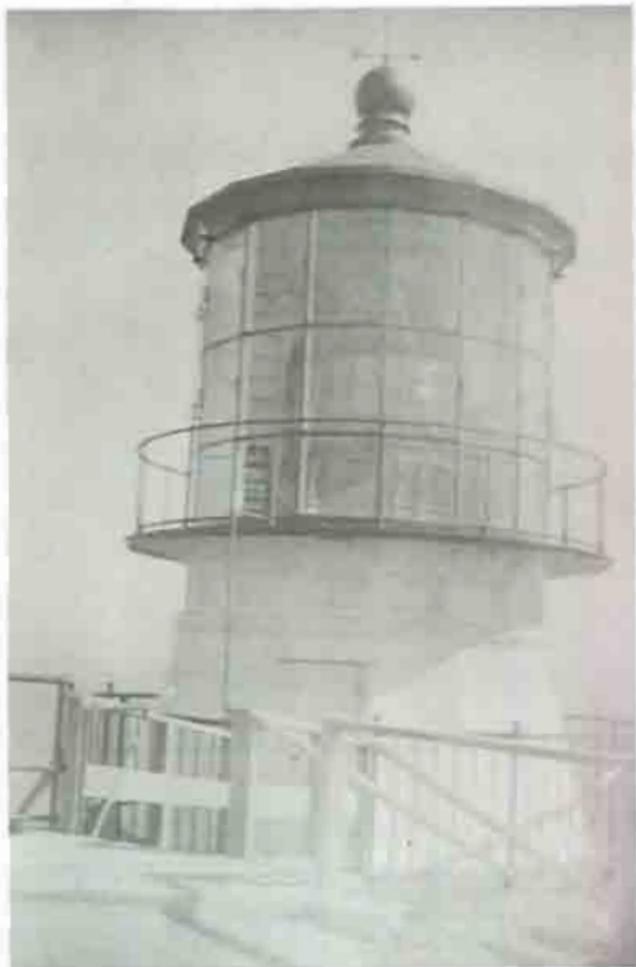
Figure 44 - Lighthouse tower, 1935. Note weathervane above the ventilator hall. National Park Service.

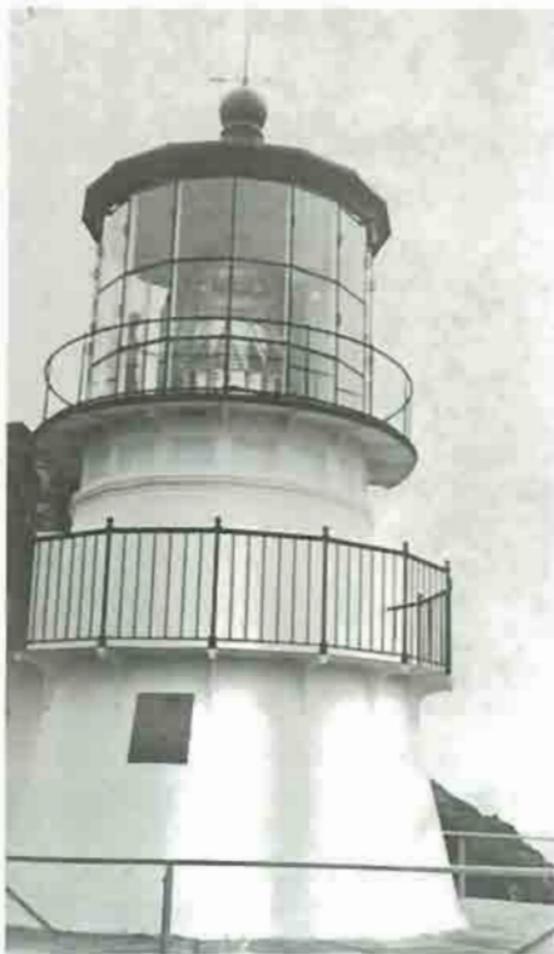
Figure 45 - Lighthouse tower, April 1941. Note weathervane. U.S. Coast Guard.

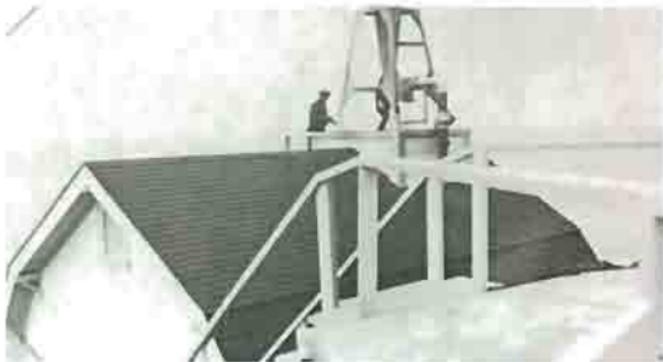
Figure 47 - Fog signal building, April 1941. Man is standing at base of diaphones. U.S. Coast Guard.

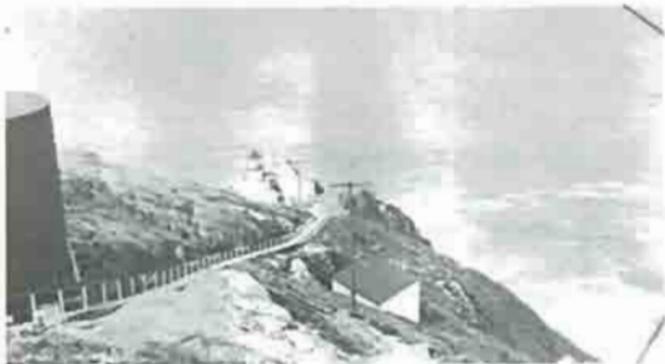
Figure 49 - Looking down lighthouse stairs, April 1941. Overflow water storage tank on left, gasoline storage shed in center foreground. U.S. Coast Guard.

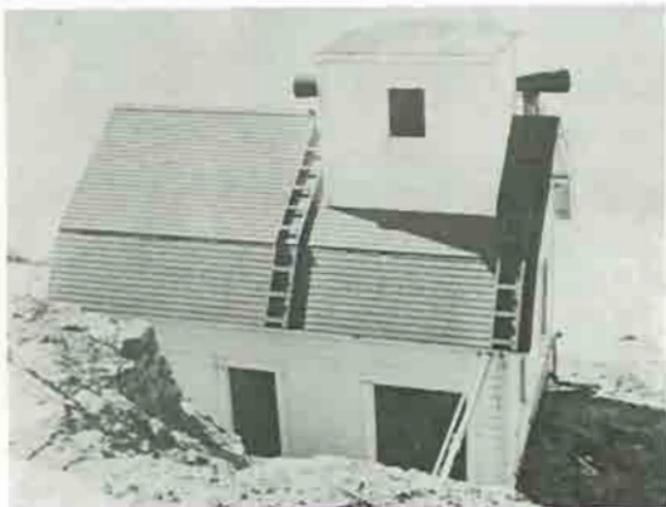
Figure 63 - Fog signal building with F2T horns, ca. 1950. U.S. Coast Guard.

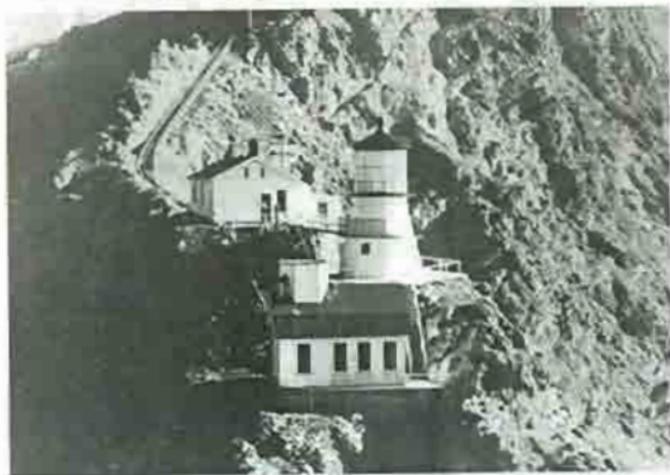
Figure 64 - Lighthouse complex, ca. 1950, shows F2T horn on fog signal building, light tower, equipment building, transformer house. National Park Service.

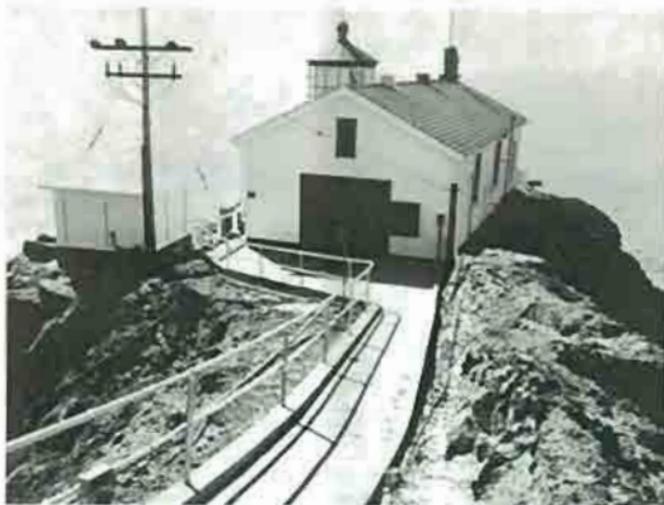
Figure 68 - Equipment building and new ramp from stairway, ca. 1960. National Park Service.

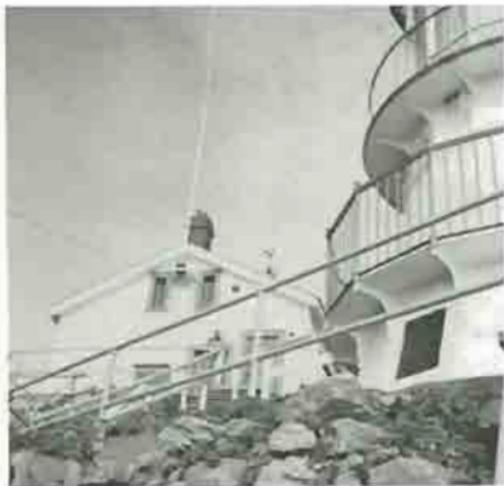
Figure 72- Equipment building and lighthouse tower from fog signal building, February 1971; note the whip antenna on the equipment building. National Park Service photo by Thomas Mulhern.

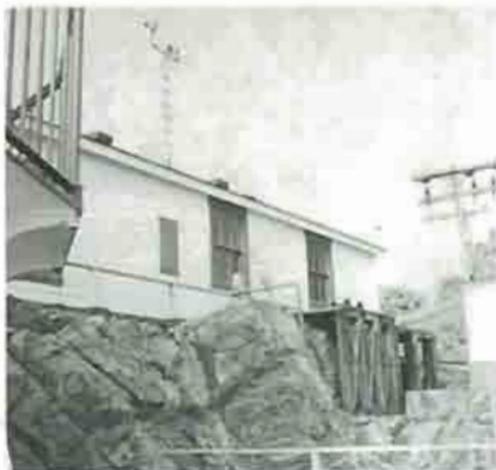
Figure 73 - South elevation of equipment building, February 1971; supports for water tanks have since been removed. National Park Service photo by Thomas Mulhern.

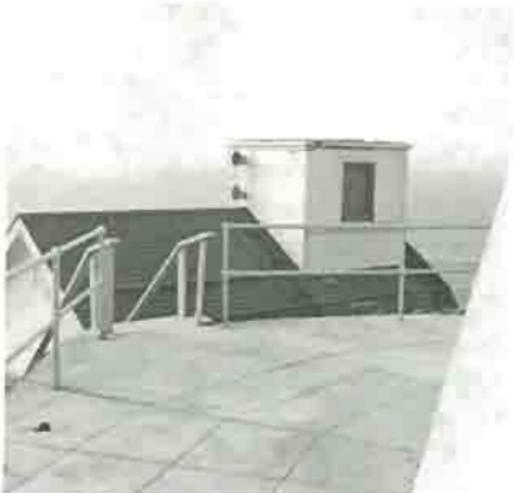
Figure 74 - Fog signal building showing previous location of super typhon fog horns, February 1971. National Park Service photo by Thomas Mulhern.

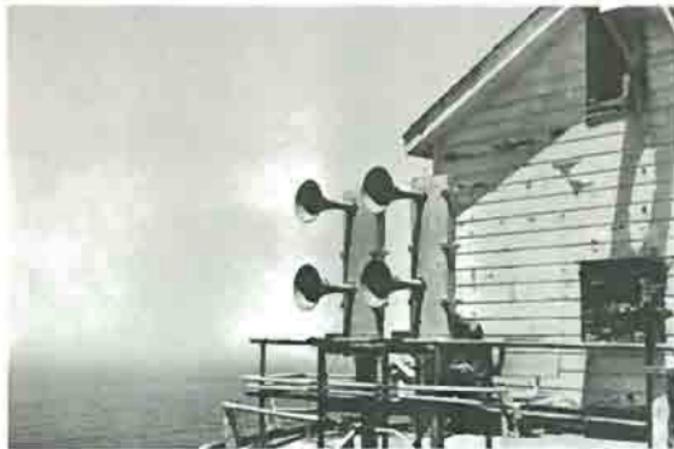
Figure 75 - Super typhon fog horns temporarily mounted outside of equipment building, 1976. Note poor condition of building during its last year of use. National Park Service.

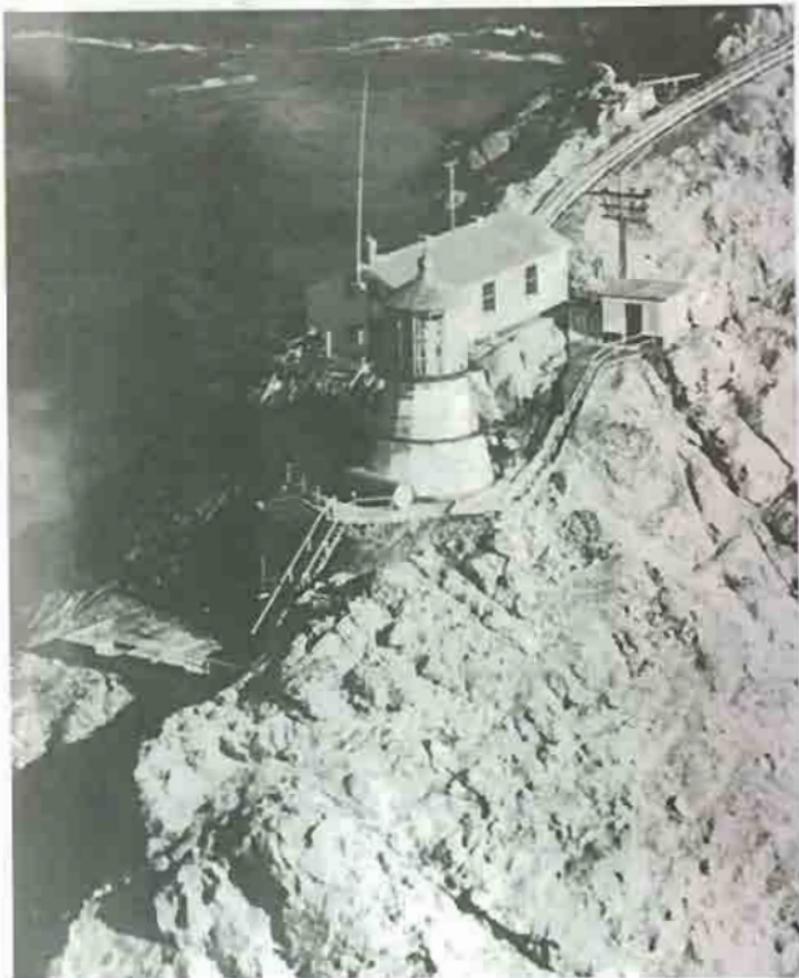
Figure 76 - Aerial view of lighthouse, 1975. Ramp is being constructed for access to fog signal site, where the new automated aids building will be constructed. National Park Service.

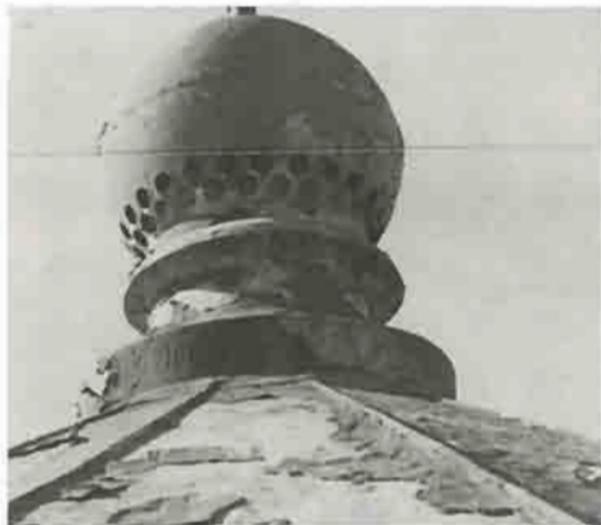
Figure 77 - Detail of lighthouse ventilator hall and roof prior to stabilization, November 29, 1979. National Park Service photo by Robert M. Cox.

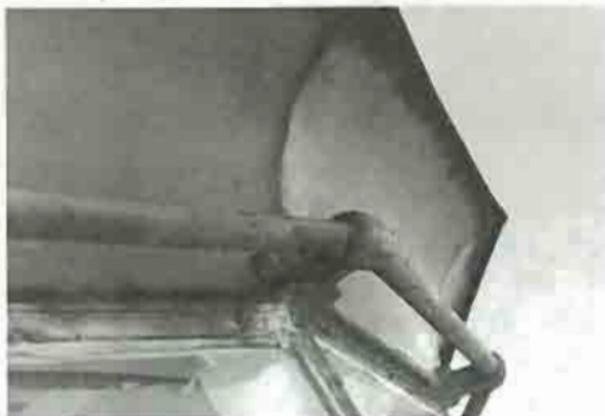
Figure 78 - Detail of lantern cornice and ladder rail prior to stabilization, November 29, 1979. National Park Service photo by Robert M. Cox.

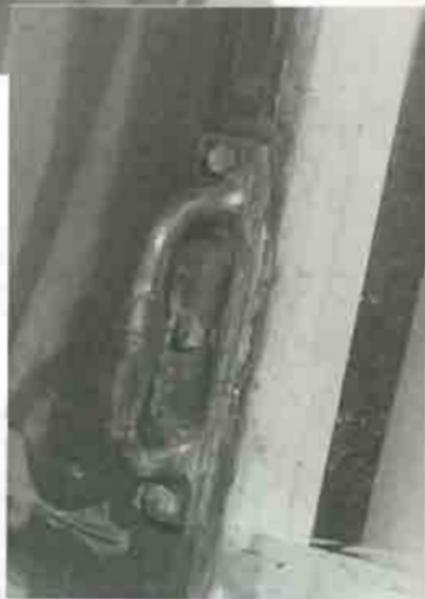
Figures 79 and 80 - Details of bronze astragal hand grip and transom cleat after white paint has been stripped off. There is visible evidence of what appears to be red lead on these pieces despite cleaning. November 29, 1979. National Park Service photos by Robert M. Cox.

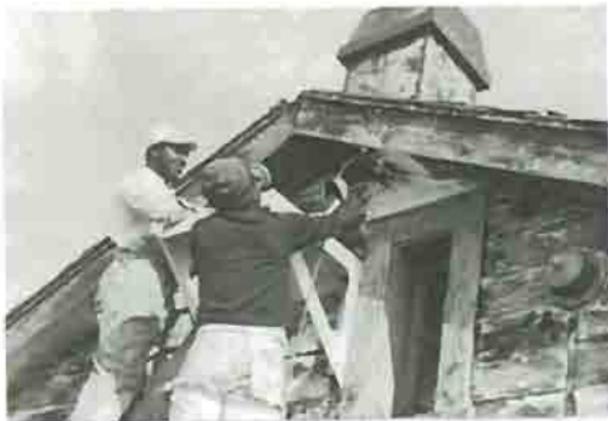
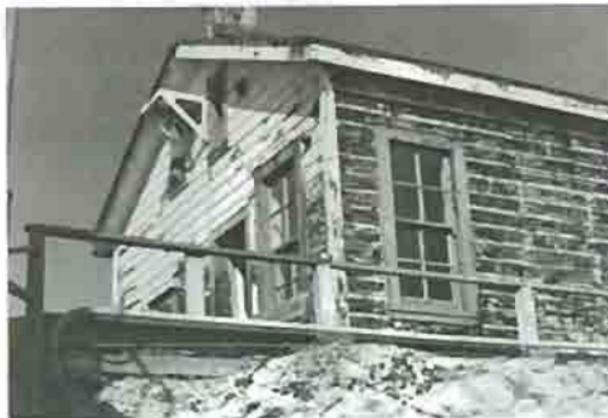
Figures 81 and 82 - Equipment building in the process of having the paint removed, November 29, 1979.
National Park Service photos by Robert M. Cox

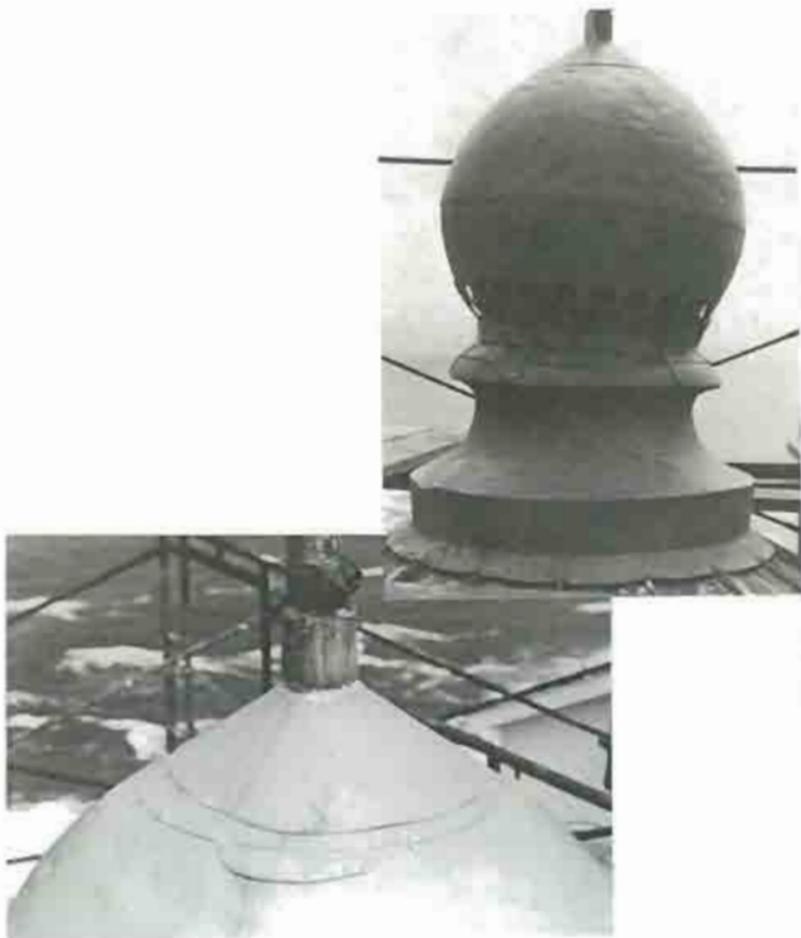
Figures 83 and 84 - Lighthouse vent ball after stabilization, April 24, 1990. Note rusted mounting bracket for weathervane base. National Park Service photos by Robert M. Cox.
