THE HISTORY AND ARCHITECTURE OF THE POINT REYES LIGHT STATION

Historic Structures Report
Point Reyes National Seashore

NATIONAL PARK SERVICE
1990

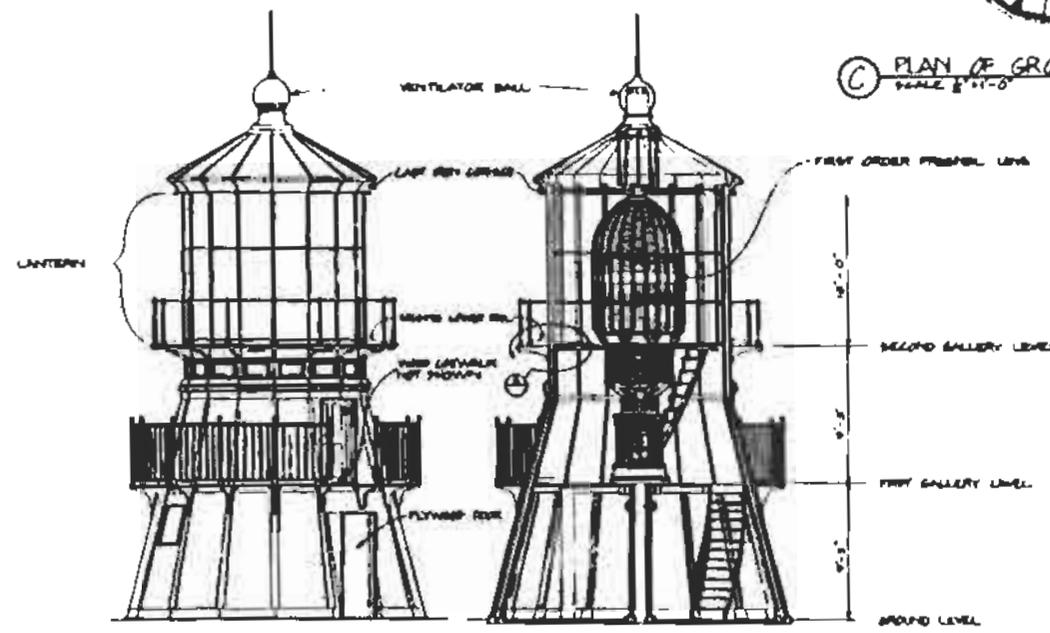
(A) EAST ELEVATION
SCALE 1/4" = 1'-0"

(B) SECTION
SCALE 1/4" = 1'-0"

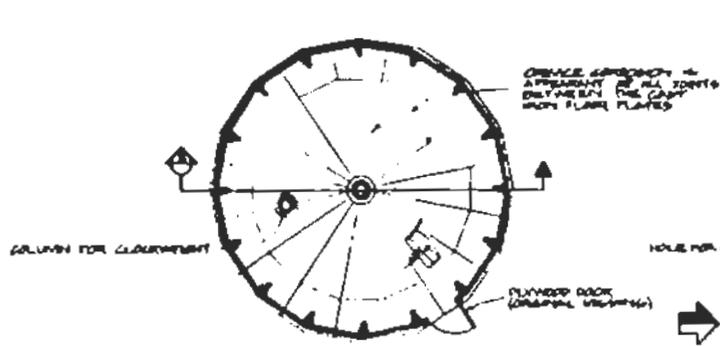
(C) PLAN OF GROUND LEVEL
SCALE 1/4" = 1'-0"

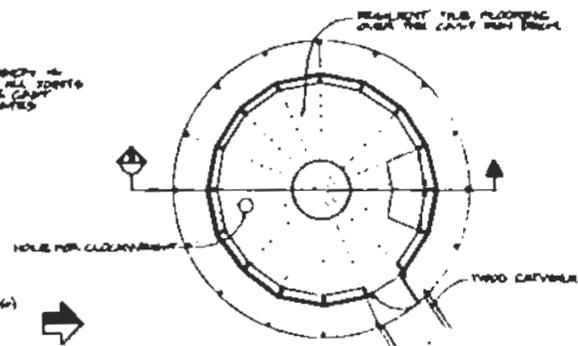
(D) PLAN OF FIRST GALLERY LEVEL
SCALE 1/4" = 1'-0"

3. The gallery deck is ringed by heavy iron balusters, railings and posts. Posts and balustrades are round, the railing rectangular, the tops of the posts capped by spherical iron finials (fifteen, one is missing); all of these elements are painted gloss green. There are sixteen segments of actual decking.

4. A simple ship-type ladder has been removed (for obvious safety reasons) from the first-level gallery. The missing deck plate on the second-level gallery indicates the location of this feature.

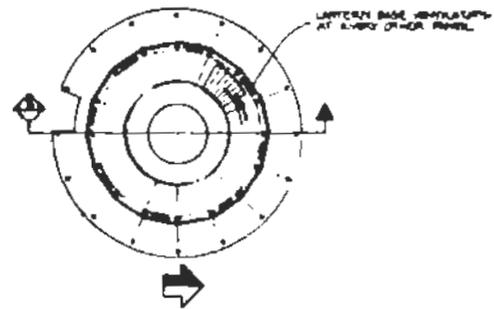
(E) PLAN OF SECOND GALLERY LEVEL
SCALE 1/4" = 1'-0"

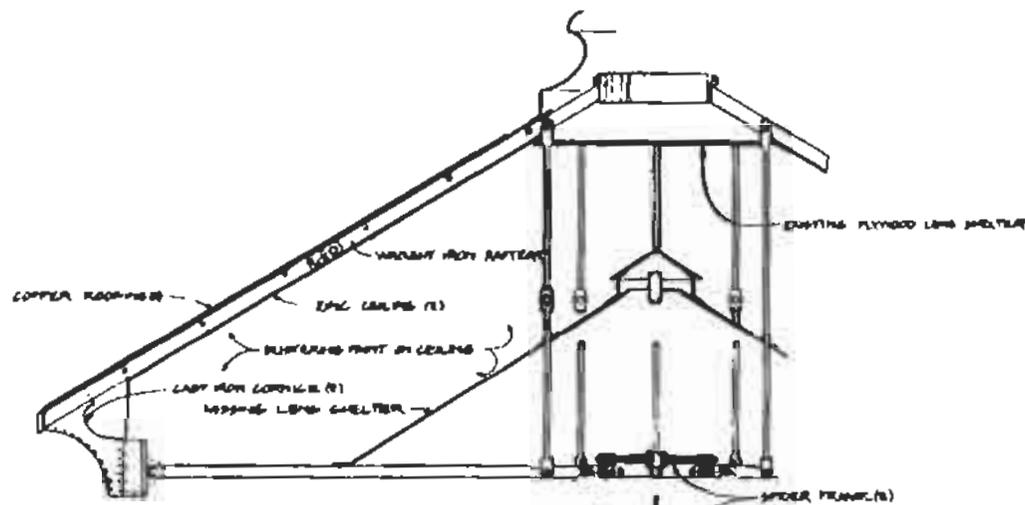
(C) ROOF AND CORNICE SECTION
SCALE 1/4" = 1'-0"

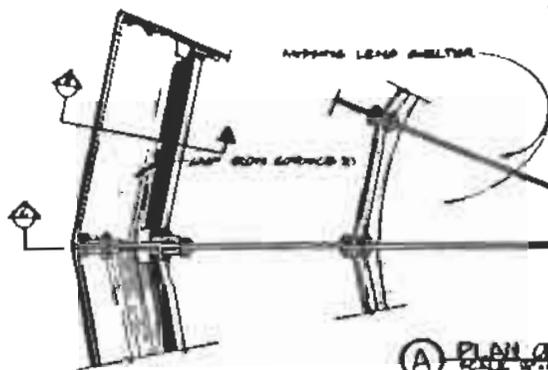
(A) PLAN OF CROWN PIECE AND CORNICE (1)
SCALE 1/4" = 1'-0"

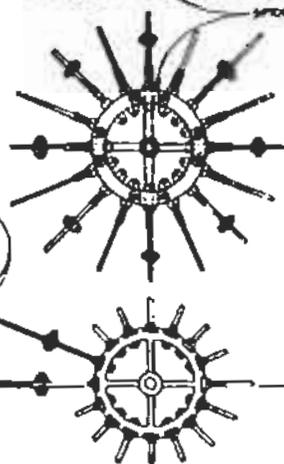
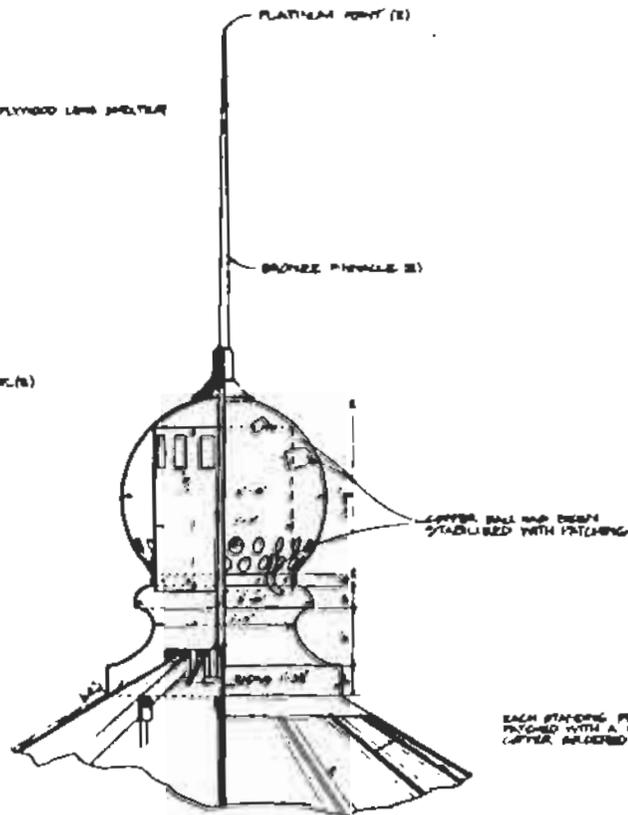
(B) SECTIONAL ELEVATION OF VENTILATOR (1)
SCALE 1/4" = 1'-0"

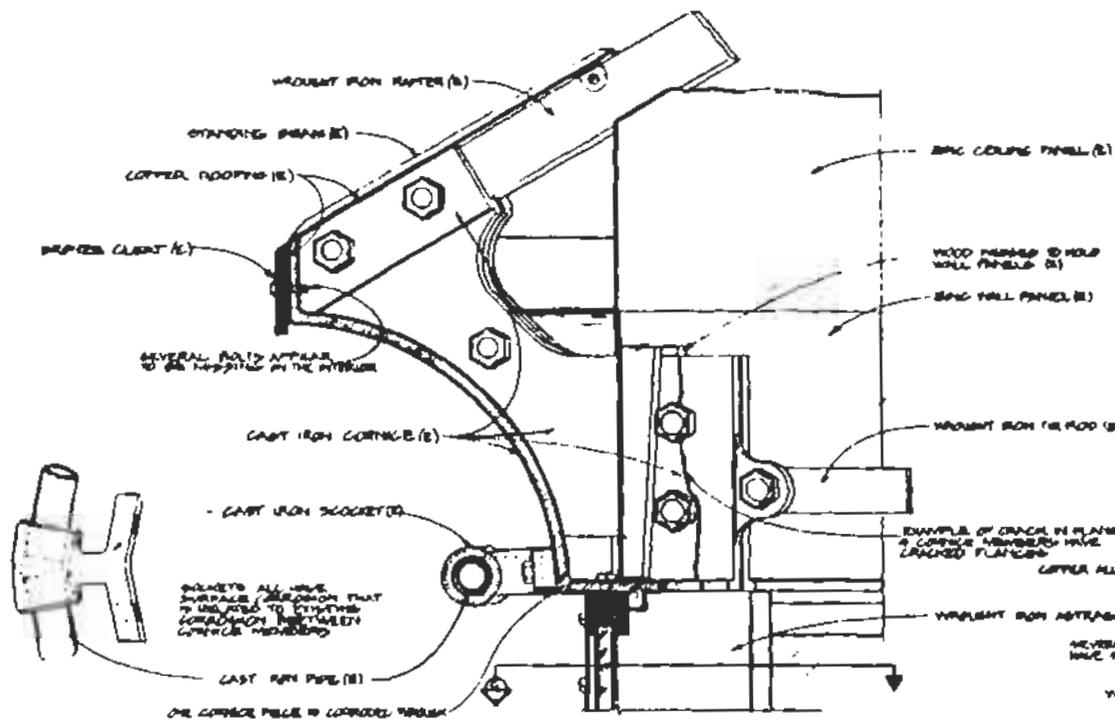
A SOCKET DETAIL
SCALE 3/4" = 1'-0"

B CORNICE SECTION
SCALE 3/4" = 1'-0"

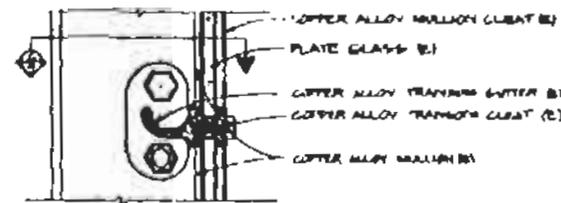
D SECTION OF TYPICAL TRANSOM GUTTER
SCALE 3/4" = 1'-0"

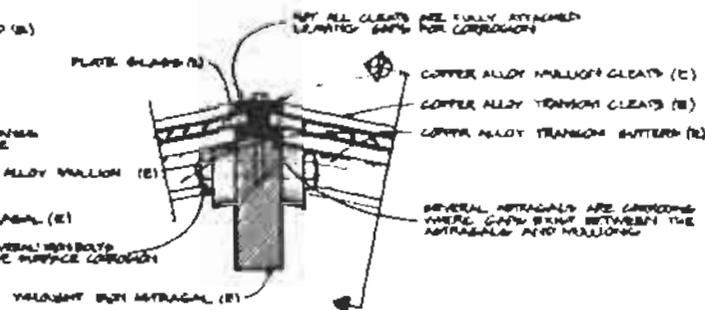
C SECTION OF ASTRAGAL MULLION & CLEAT
SCALE 3/4" = 1'-0"
1 2 3 4 FEET

seal these cleats and bolts. There may be gaps in this material, leading to leaks.

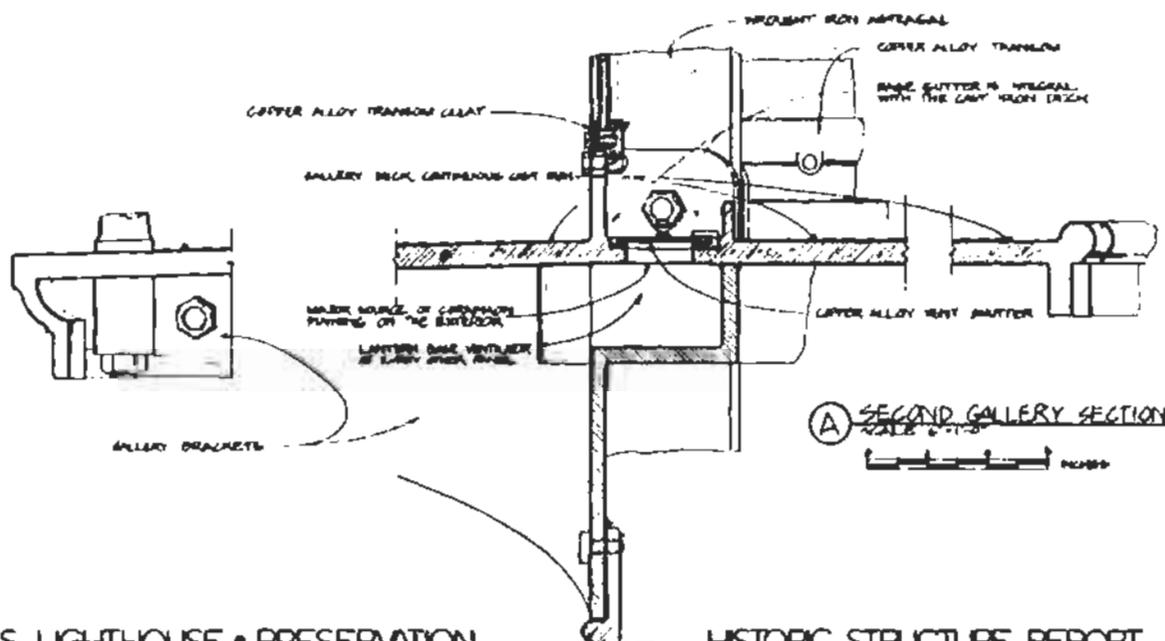
(A) SECOND GALLERY SECTION
SCALE 2"-1"=0

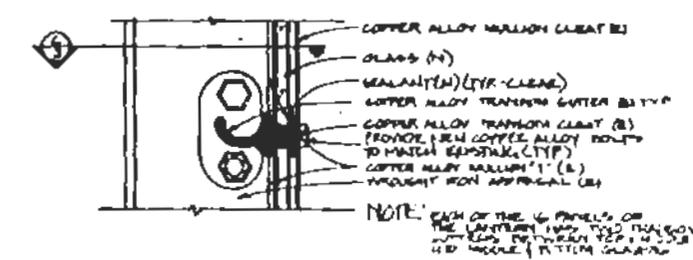
SECTION OF TYPICAL TRANSOM GUTTER
 SCALE 1/4"

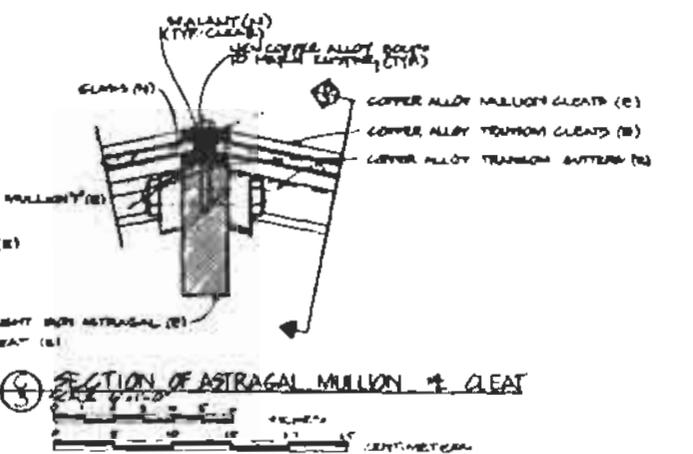
SECTION OF ASTRAGAL MULLION & CLEAT
 SCALE 1/4"

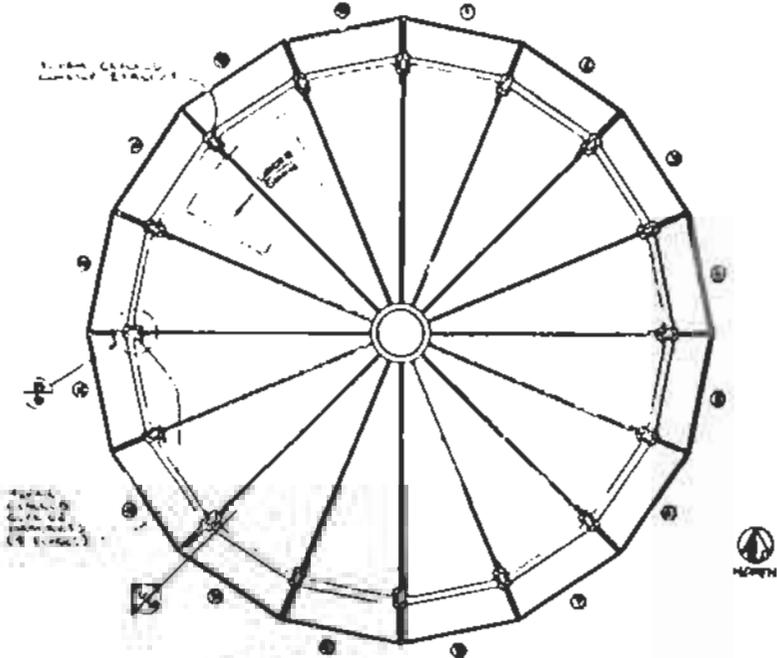
(A) SPLICE FRAME PLAN
SCALE 1/2" = 1'-0"
CENTIMETERS

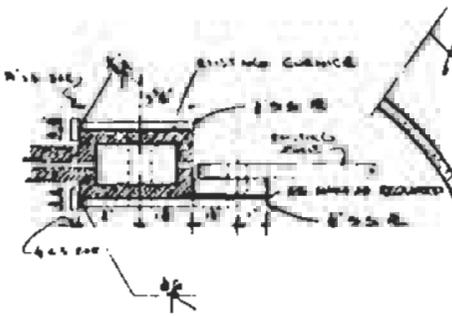
NOTE: HAVE EXISTING INDICATIONS LEADER TO EXISTING USED WORKING TO SHOW WHERE NEW CORNICE BRACKET IS TO BE PLACED

(B) PLAN OF NEW CORNICE BRACKET
SCALE 3/4" = 1'-0"
CENTIMETERS

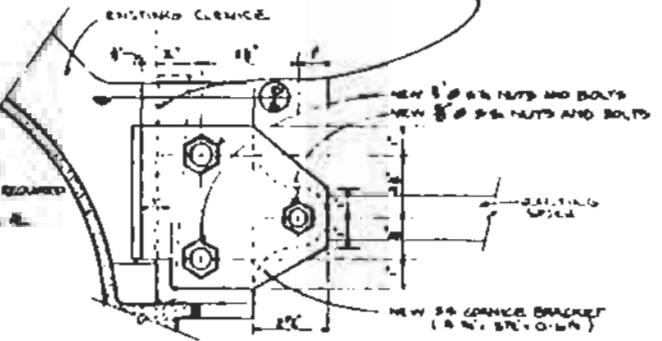
(C) CORNICE BRACKET ELEVATION
SCALE 3/4" = 1'-0"
CENTIMETERS

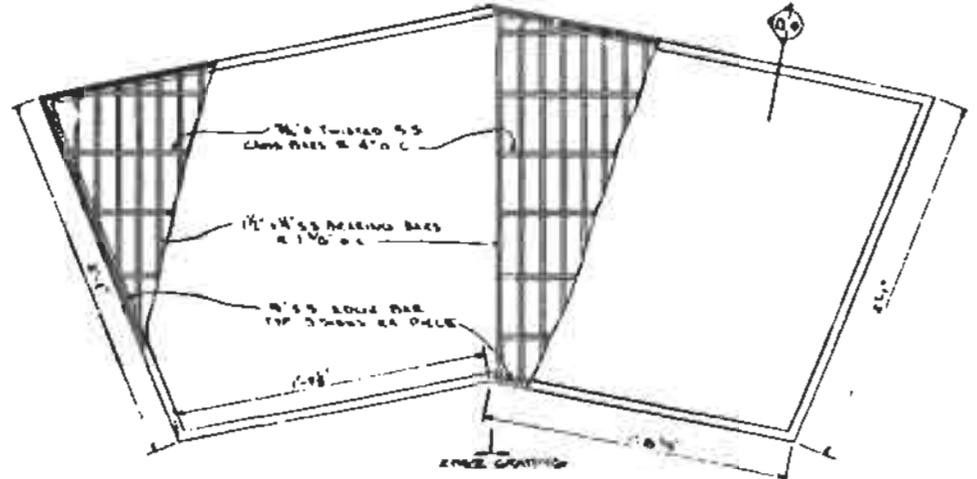
(E) FIRST GALLERY LEVEL HATCH GRATE (N)
SCALE 3/4" = 1'-0"
CENTIMETERS

NOTE: GRATE MUST BE BRACKETED TO FLOOR TO CLOSE HATCH

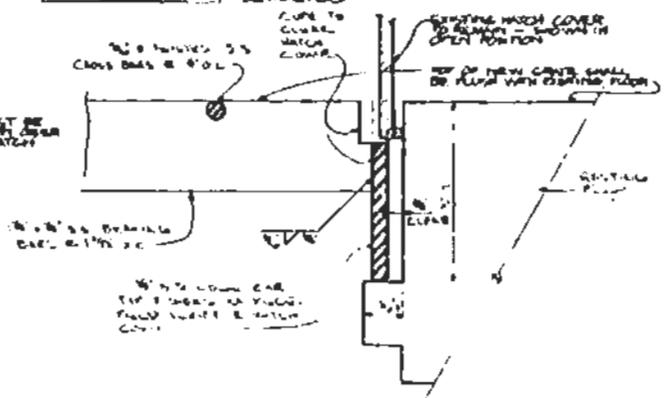
(D) TYPICAL SECTION OF HATCH COMBING
SCALE 1/2" = 1'-0"
CENTIMETERS

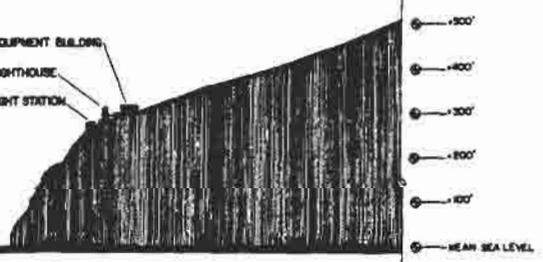
IMMEDIATE SITE SECTION
SCALE 3/4" = 100'-0"

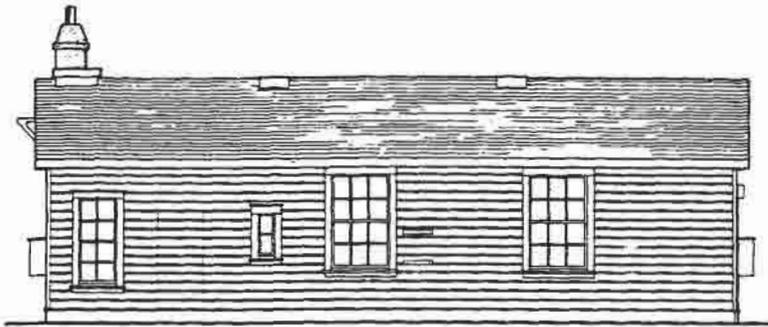
SOUTH ELEVATION
SCALE 1/4" = 1'-0"

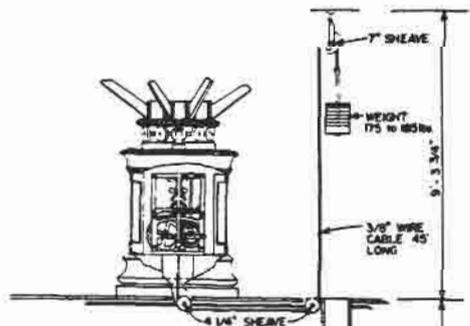
ARRANGEMENT OF CLOCKWORK, CORD, SHEAVES, DRIVING WEIGHT, AND FALL

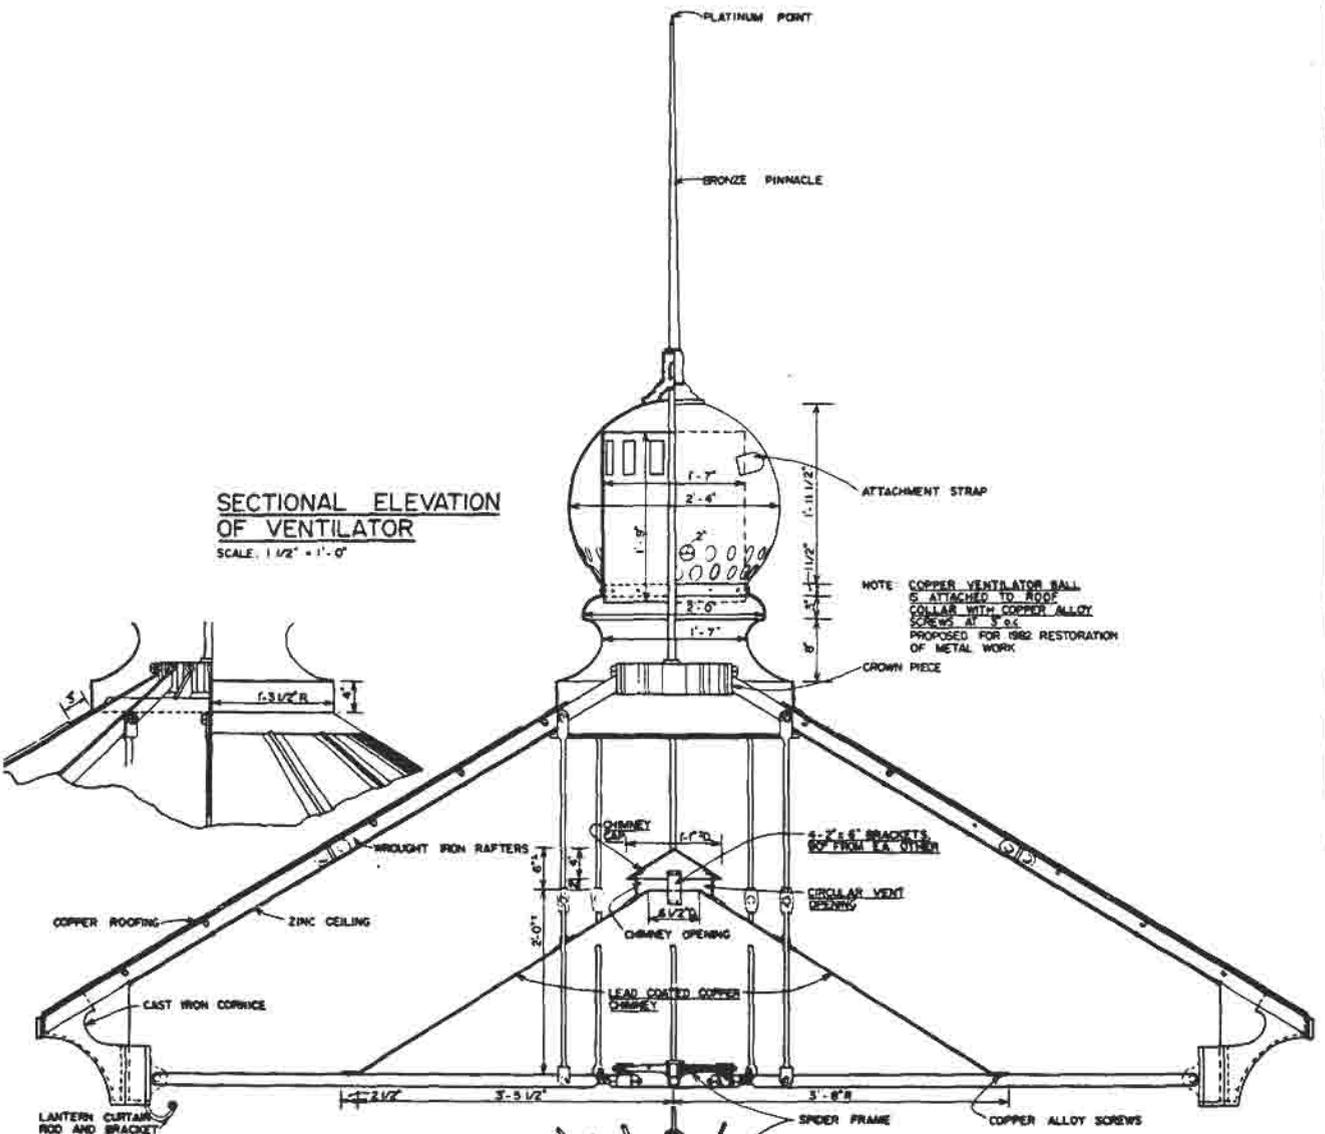
SECTIONAL ELEVATION OF VENTILATOR
SCALE: 1/2" = 1'-0"

NOTE: COPPER VENTILATOR BALL IS ATTACHED TO ROOF COLLAR WITH COPPER ALLOY SCREWS AT 3 O.C. PROPOSED FOR 1982 RESTORATION OF METAL WORK

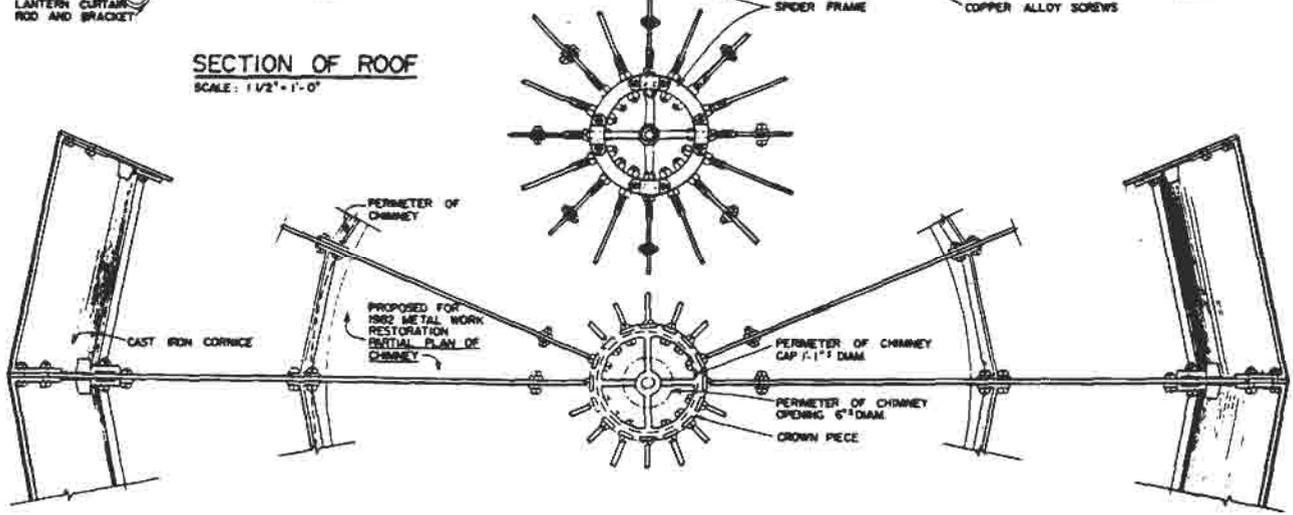
SECTION OF ROOF
SCALE: 1/2" = 1'-0"

PLAN OF CROWN PIECE AND CORNICE
SCALE: 1/2" = 1'-0"

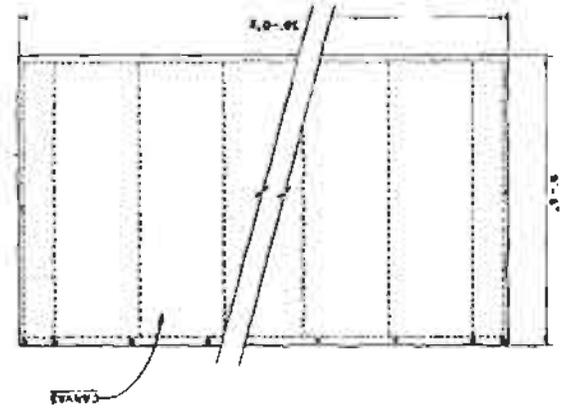
LANTERN CURTAIN HOOK FOR WALL RESTORATION
 SCALE: 1/2" = 1'-0"
 SCALE: FULL SIZE

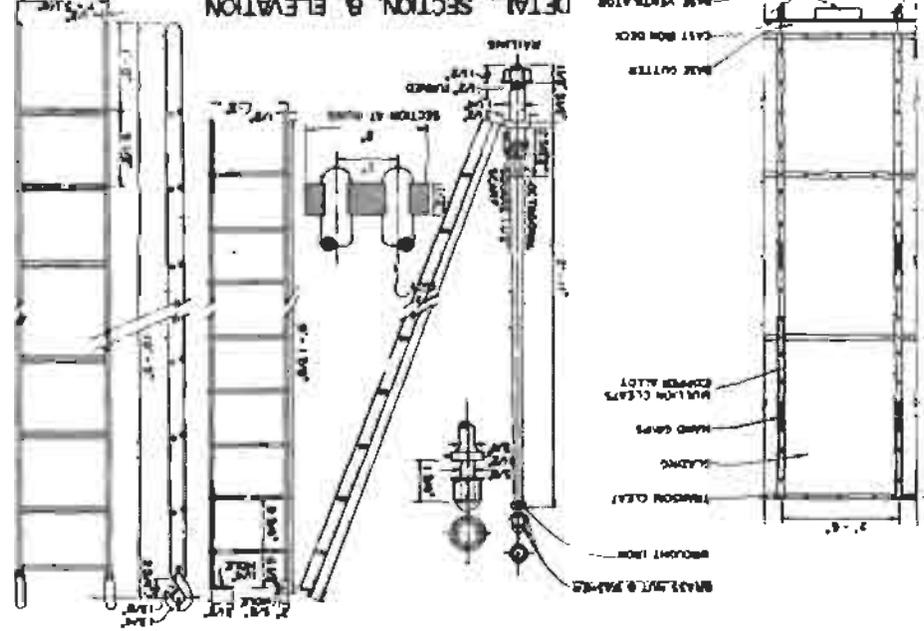
GLAZED PANEL
 SCALE: 3/8" = 1'-0"
 DETAIL SECTION & ELEVATION OF PARAPET LADDER & LANTERN LADDER
 (SHOWING GALVANIZED METAL)
 NOT TO SCALE

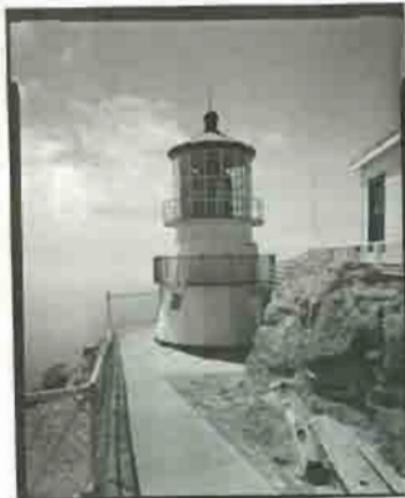
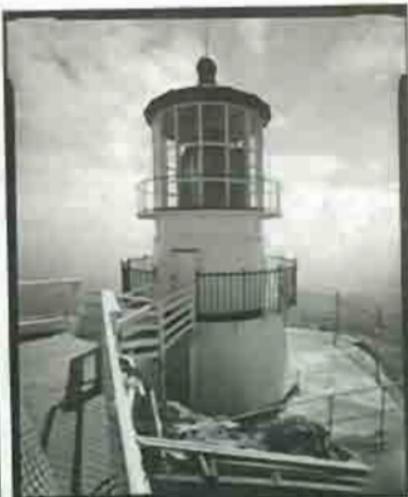
- 2 and 3. Lighthouse, east elevation (left), north elevation (right).

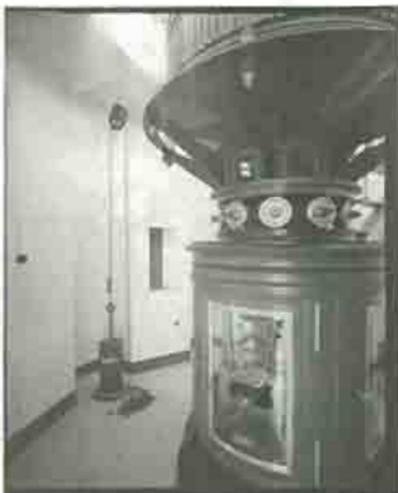
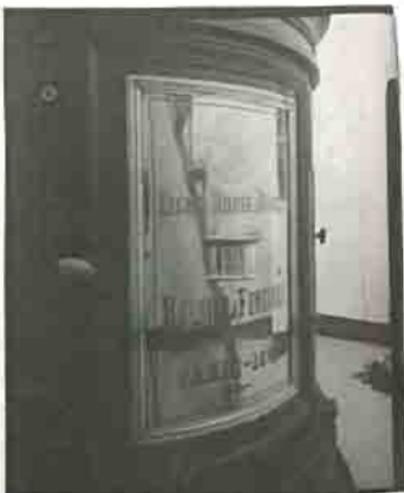
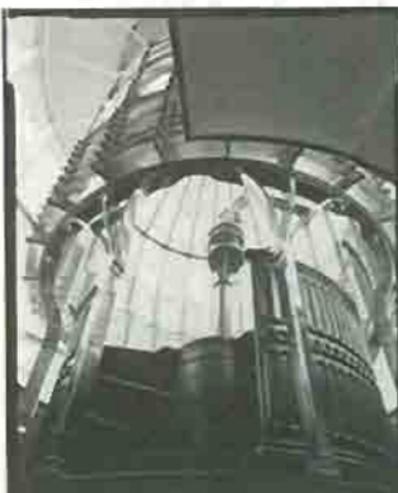
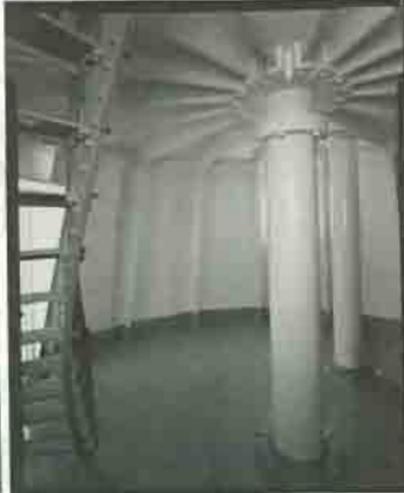
4, 5, 6, 7. Lighthouse interiors (clockwise from upper left): pedestal and weight system, builder's plaque, watch room or ground level, lens and light source.

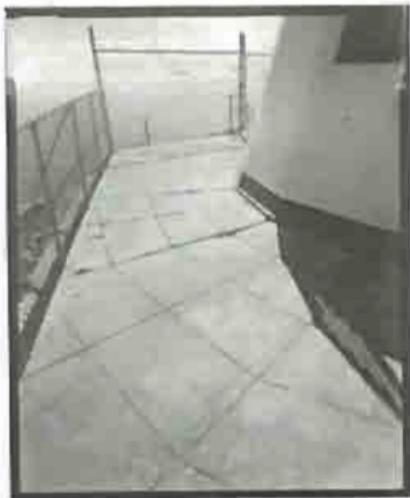
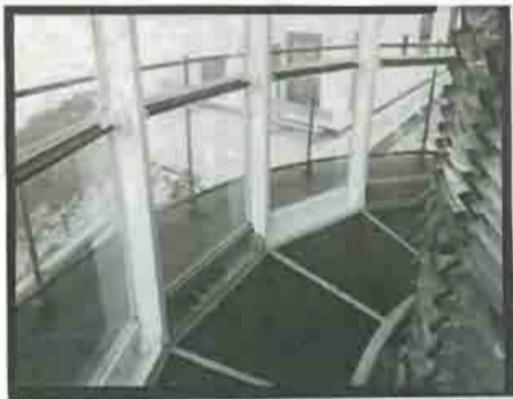
8, 9. Lighthouse details: concrete pattern (top), lantern interior (bottom).

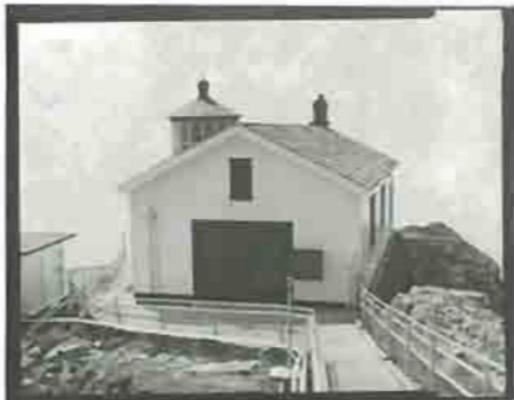
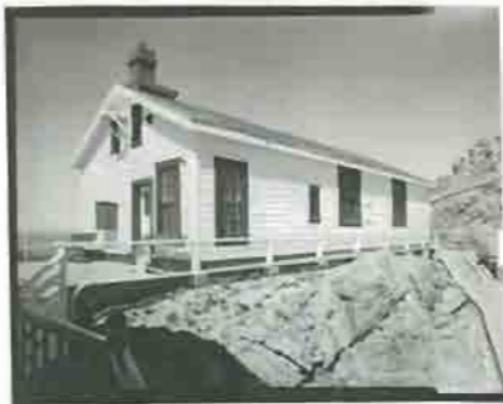
10, 11. Exteriors, equipment building: east elevation (top), south and west elevations (bottom).

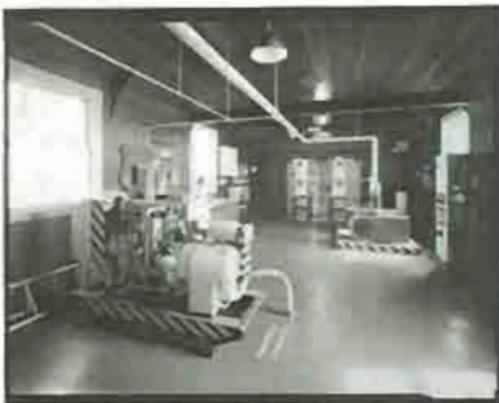
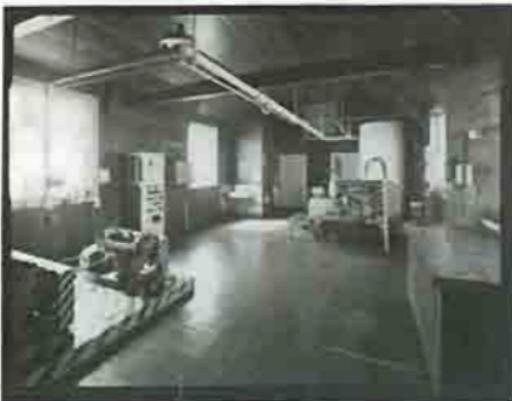
12, 13. Interiors, equipment building: view to east wall (top), view to west wall (bottom).

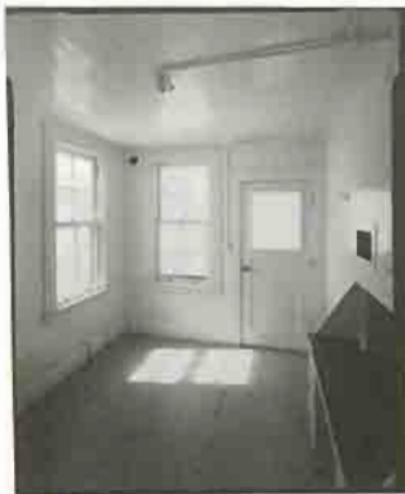
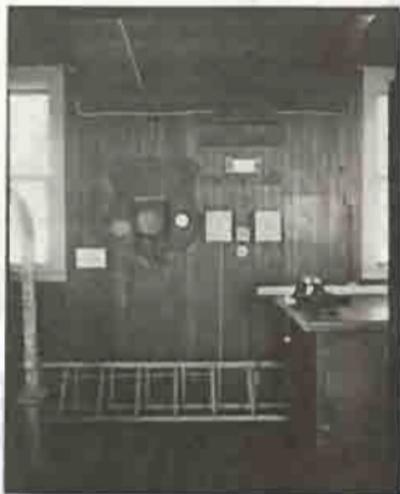
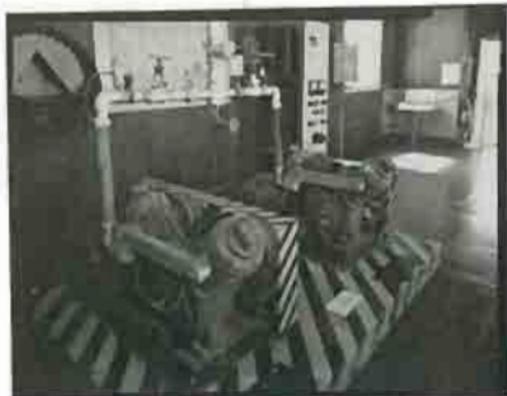
14, 15, 16. Interiors, equipment building: watch room (upper left), gauge board and work bench on north wall (upper right), compressors, (bottom).

Gauge Board: It is recommended that the historic gauge board, located on the north wall, be restored to its original appearance (which is accurately documented in a 1935 historic photograph). This would require removal of the two existing instruments, refinishing of the wood plaque, with repair and replacement of the pressure gauges. The missing gauge to the west should be replaced with one that matches the missing one as closely as possible in appearance.

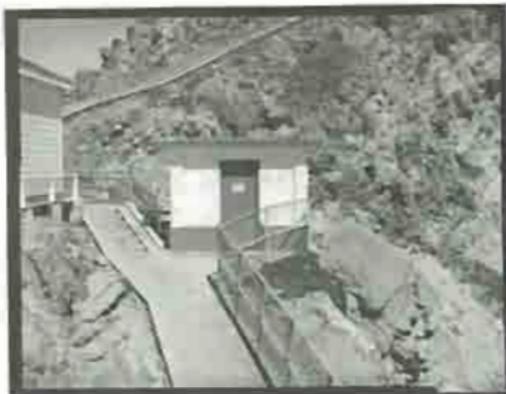
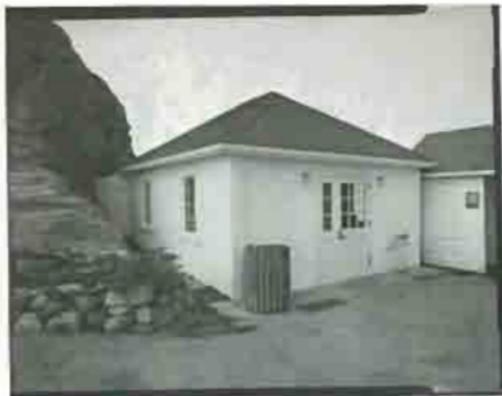
17, 18. Transformer building west elevation (top), visitor center (old garage) south and west elevations (bottom).

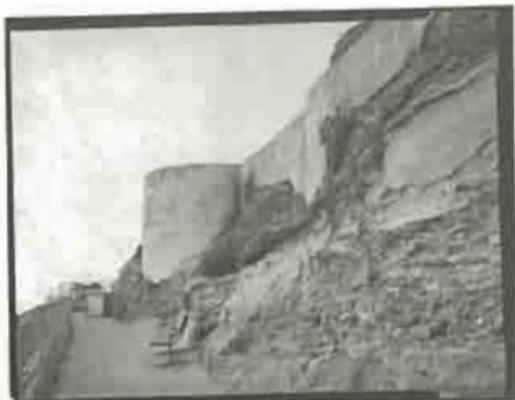
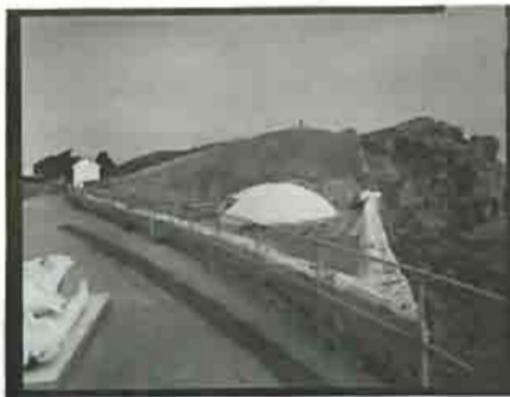
19, 20. Cisterna: west cistern (top), large original cistern (bottom).

The cistern for the Keepers dwelling is probably cracked from the earthquake as the water is lowering at the rate of one inch in 48 hours. As the cistern is nearly full it is inadvisable to try to do anything until it is empty, so as not to waste the water.

The cistern of the 3rd assets dwelling leaked considerable after the earthquake but is now practically tight, as the water has lowered but $\frac{1}{2}$ " in 48 hours including water for household use.

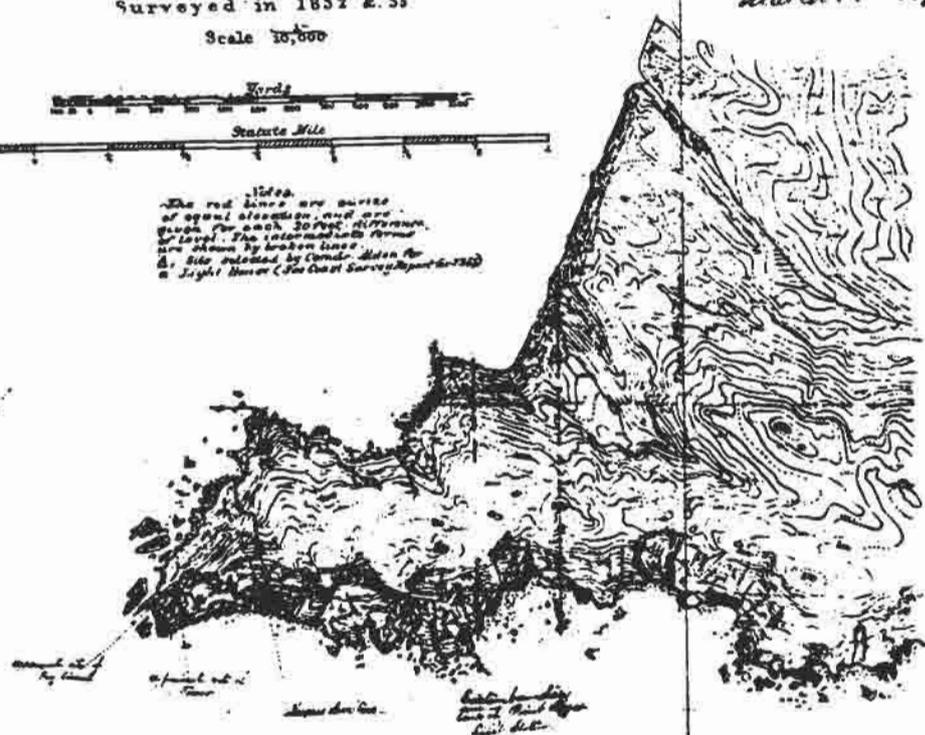
Position of *Thomas*
Ketchikan Dwelling and Flag
Signal at
POINT REYES
CALIFORNIA
Surveyed in 1852 & '53
Scale 10,000

The red lines are series
of equal elevation, and are
drawn for each 50 feet difference
of level. The intermediate forms
are shown by broken lines
A site indicated by *Comdr. Allen* for
a Light House (See Coast Survey Report No. 1362)

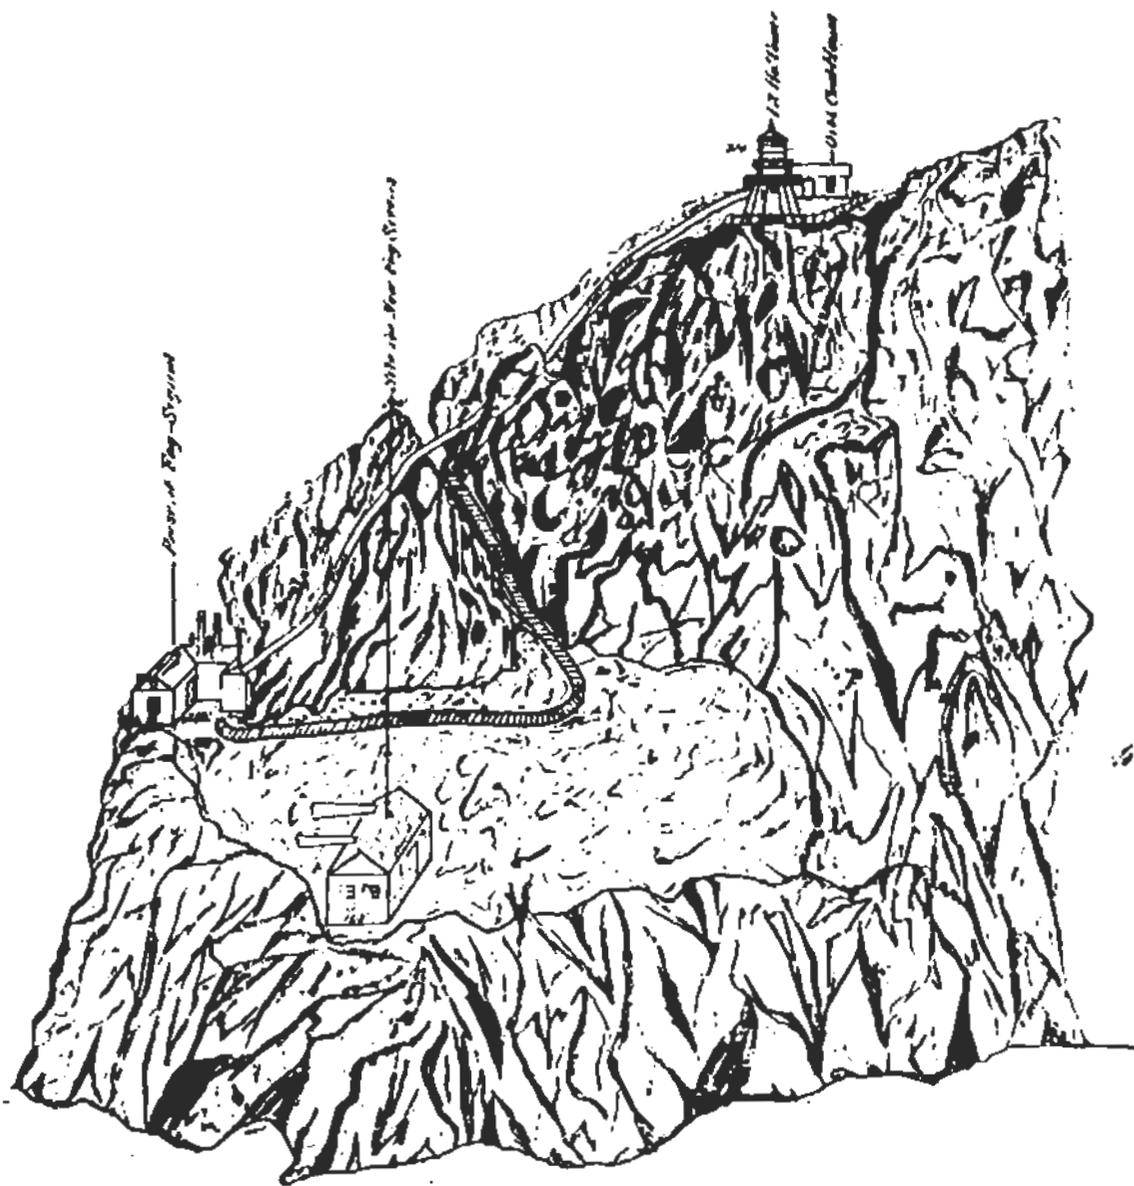
*Sketch of Point Reyes Light Station
 as shown in Report, dated Nov 30, 1850.
 Elevation given in sketch.*

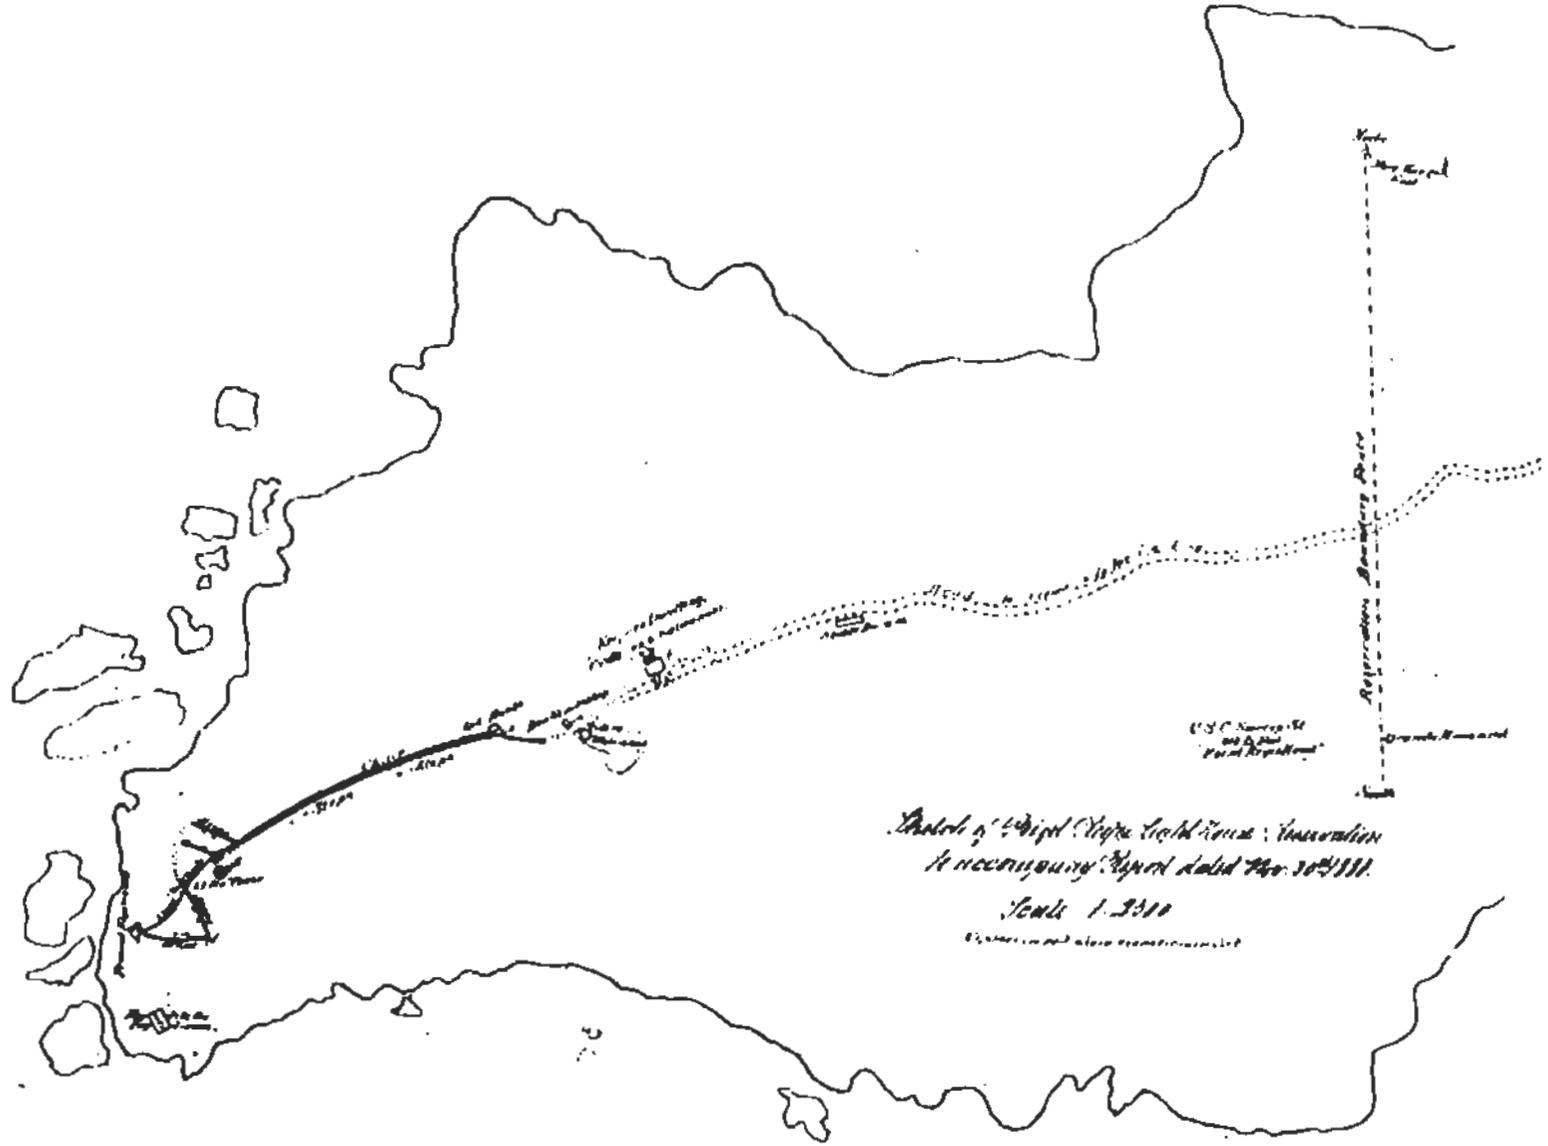
Sketch of Point Reyes Light Station, San Francisco, California,
 Report dated Apr. 30, 1911.
 Scale 1:2500
 Elevation in feet above sea level.

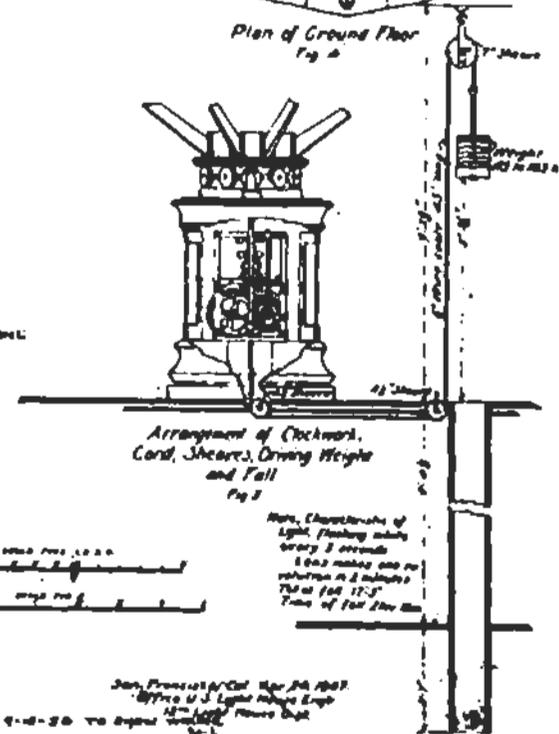
Arrangement of Clockwork, Card, Shears, Driving Weight and Fall Fig. 5

Note, Characteristics of Light, Flashing white every 3 seconds
 1000 revolutions and revolution in 2 minutes
 7500 ft. fall 12-5
 Time of fall 200 sec

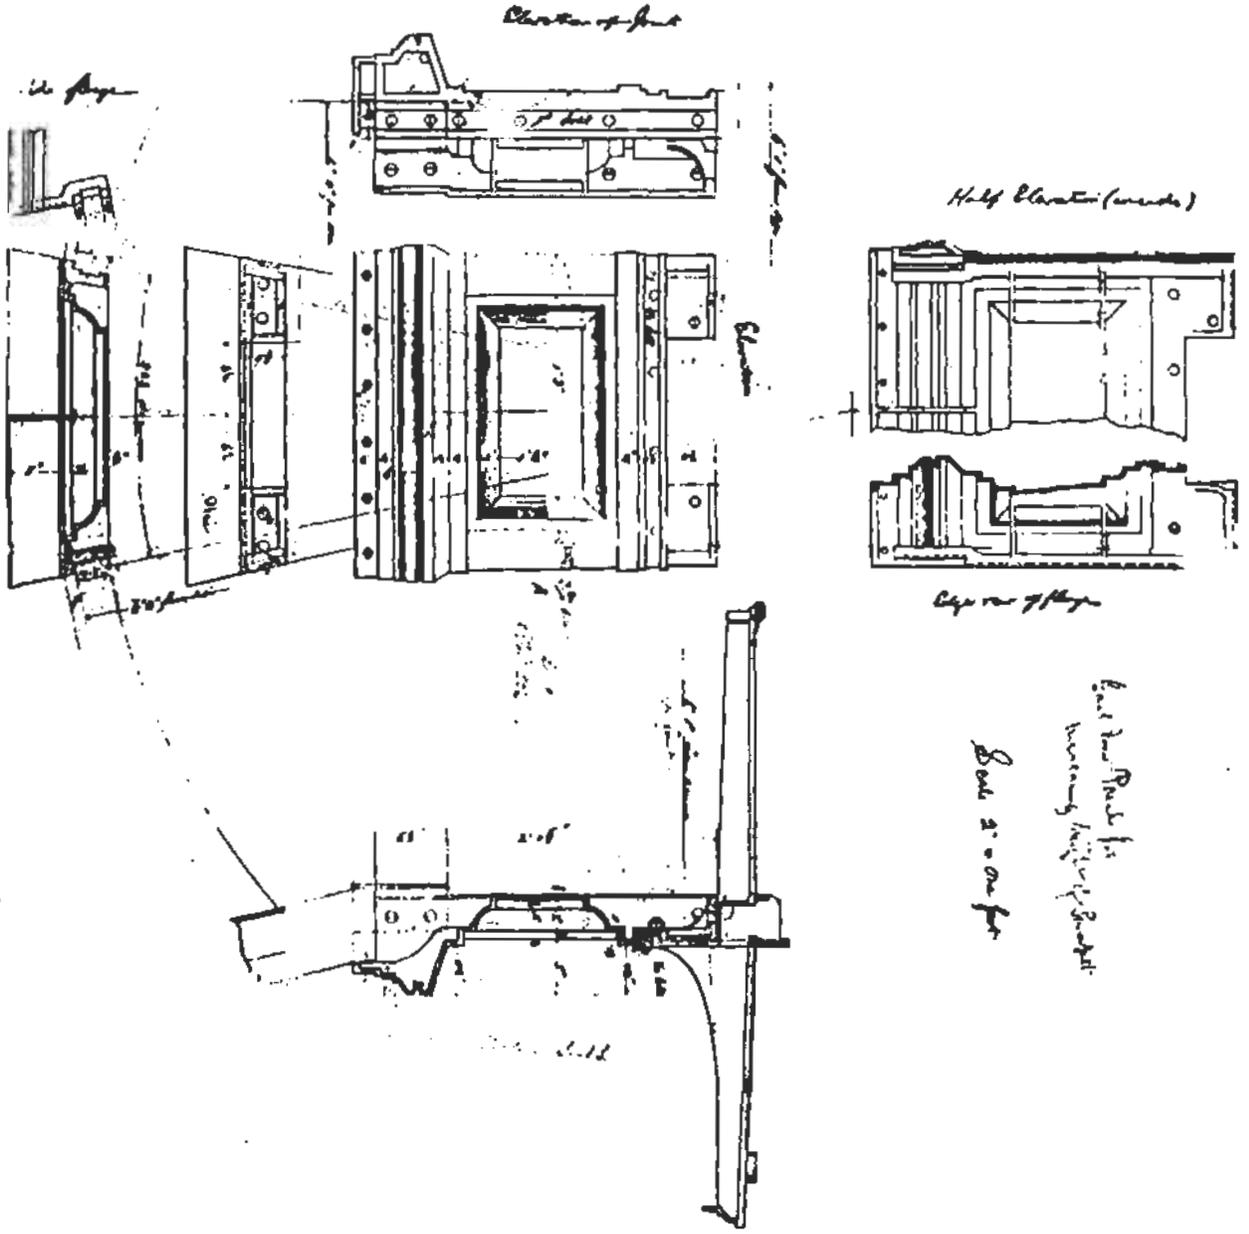
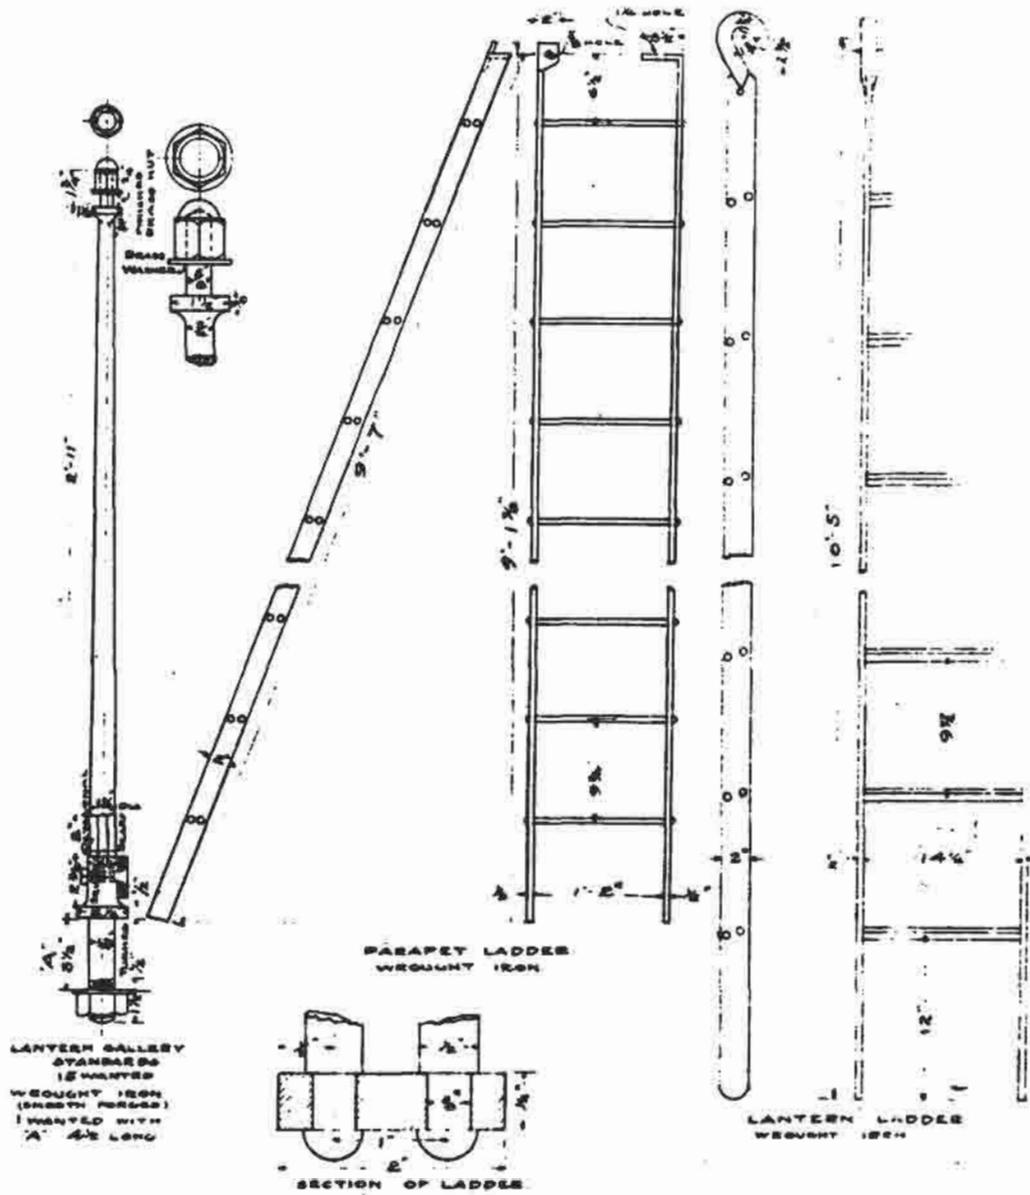
FIRST ORDER LANTERN PARTS.
POINT REYES LIGHTSTATION, CAL.
NO SCALE.
