THE HISTORY AND ARCHITECTURE OF THE POINT REYES LIGHT STATION

Historic Structures Report
Point Reyes National Seashore

NATIONAL PARK SERVICE
1990

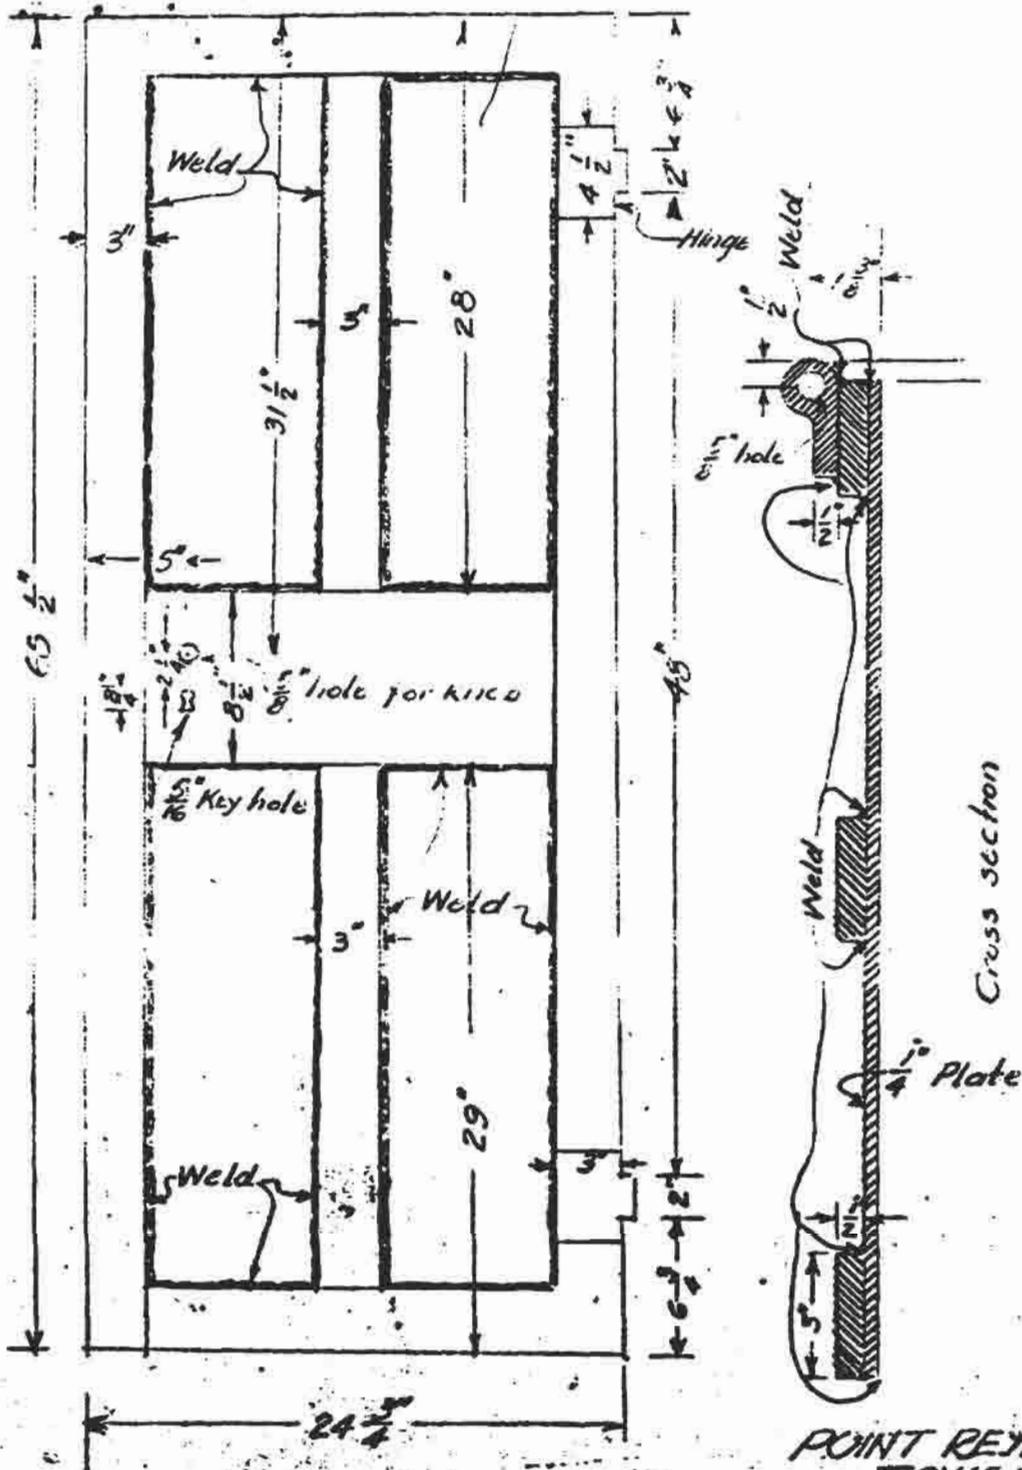
All welding to be continuous

POINT REYES LIGHT STA
TOWER DOOR

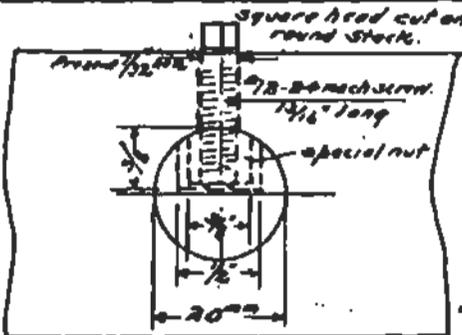
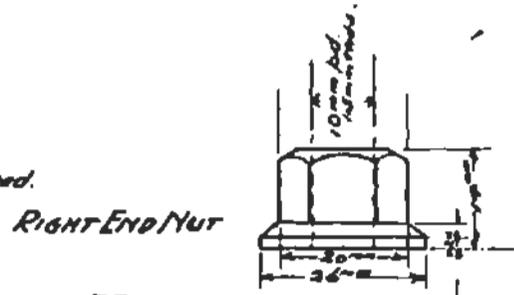
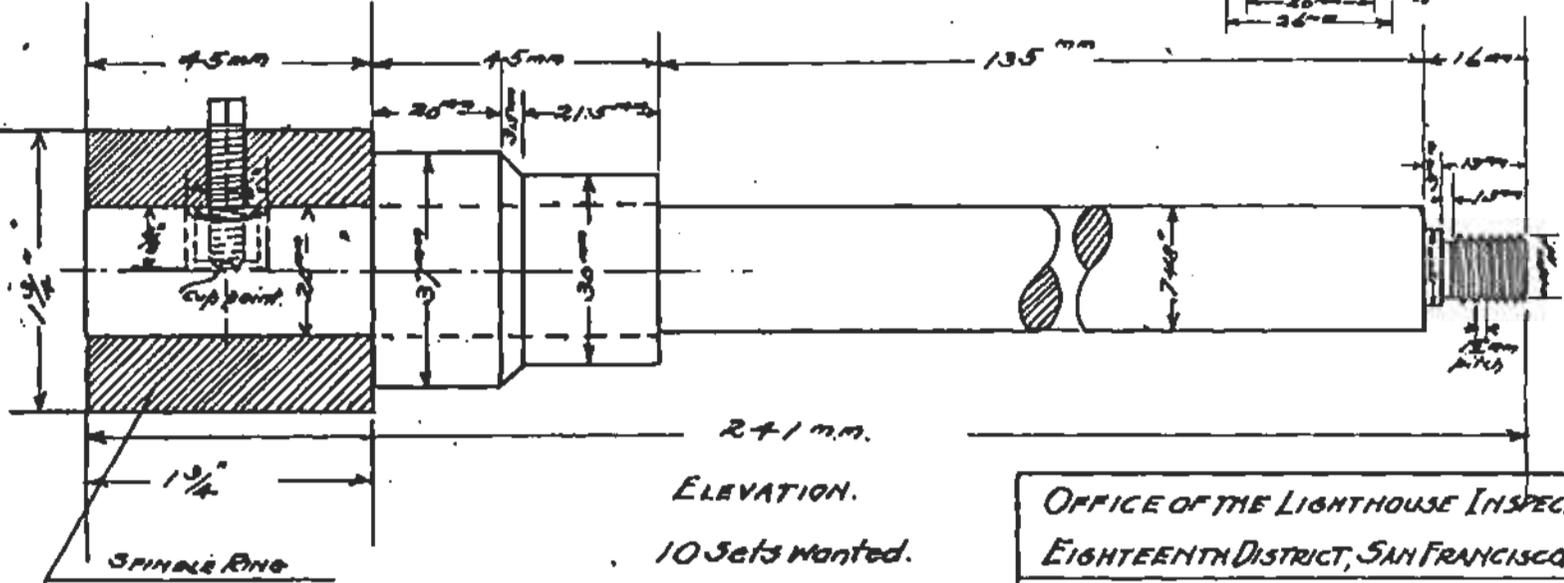
LEFT END ELEVATION.

RIGHT END NUT

OFFICE OF THE LIGHTHOUSE INSPECTOR
 EIGHTEENTH DISTRICT, SAN FRANCISCO CAL.
 CHARIOT WHEEL SPINDLES.
 POINT REYES LIGHTSTATION, CAL.
 SCALE: - FULL SIZE APPROVED 4/8/17
 G. J. Oster. H. W. Thodes.
 SUPERINTENDENT INSPECTOR
 DRAWN R.P.P.
 TRACED J.R.J. NO 1106
 CHECKED R.P.P. Pt Reyes B.B.

The only damage to this apparatus is the bending of the upper and lower guide-roller spindles; also the displacement, inside of the lens, of the lamp stand, together with the steps and balustrade, (all being riveted together making practically one solid piece) which was doweled to the pedestal with dowels 7⁸" long and about 7" apart.

By referring to exhibit A it will be seen that on account of the guide projecting through the ring, the spindle nuts are inaccessible and cannot be touched with an ordinary wrench, and it is recommended a socket wrench be made of "double X" gas pipe, about three feet long, to insure against injury to the lens, in removing the old spindles and replacing the new ones. There are six spindles in each set, one of each set being sent for a sample to have the new ones made from. The spindle having a nut on one end and a hole for a spring cotter at the other, belongs to the upper set. Of this set only the spindles are to be renewed.

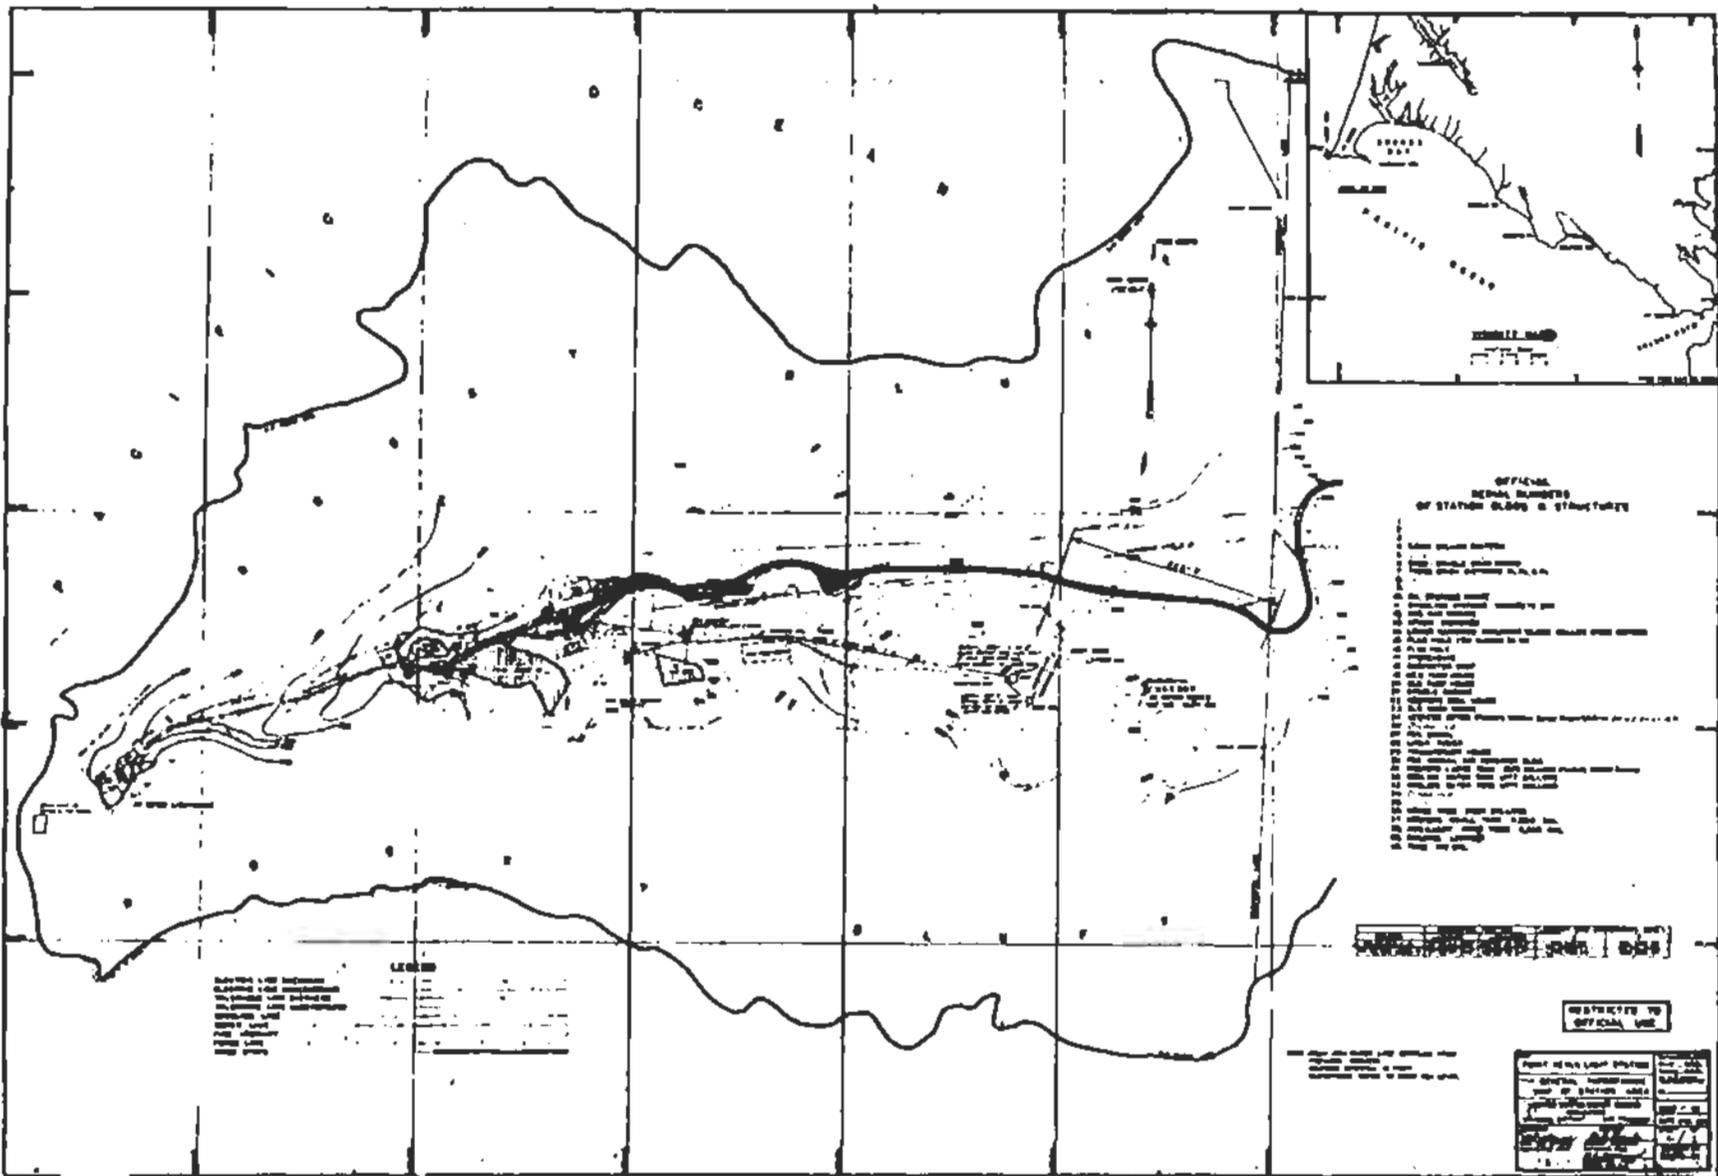
DATE	10/1/77
BY	D. M. J.
PROJECT	POINT REYES LIGHT STATION
DESCRIPTION	LOG SIGNAL MACHINERY BUILDING
SCALE	1/4" = 1'-0"
NO.	101
DATE	10/1/77

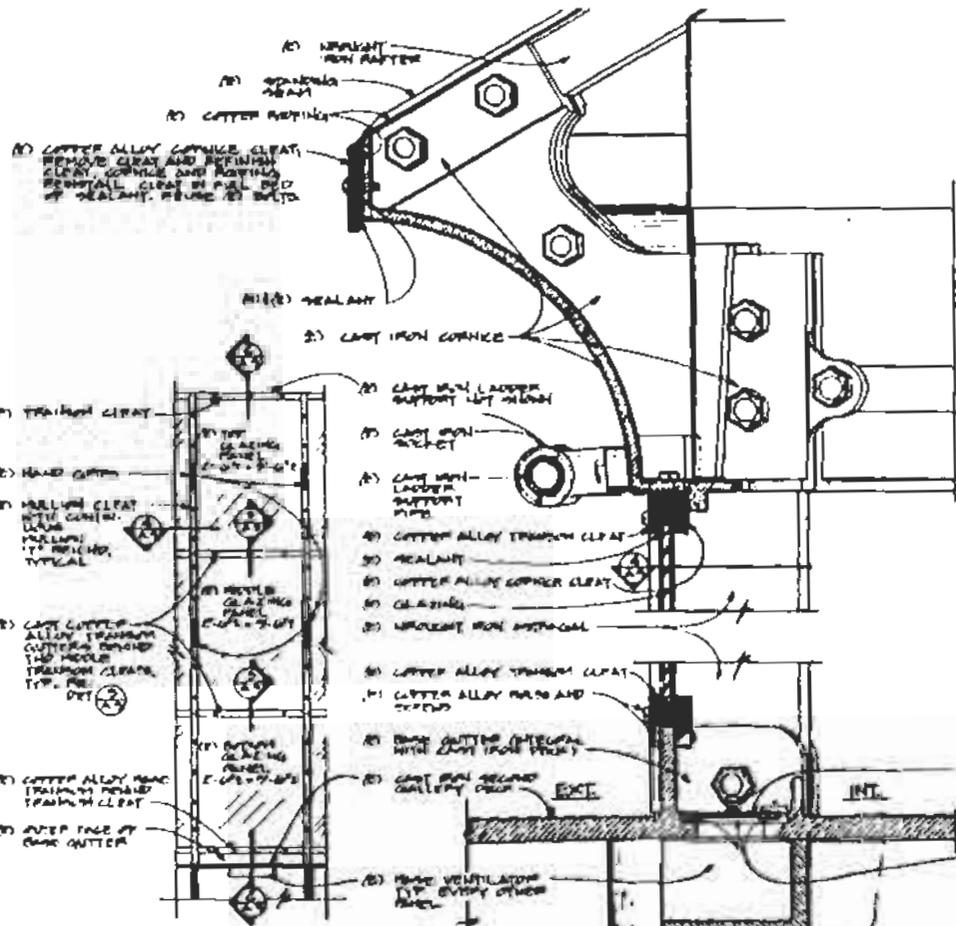
1 EXTERIOR ELEVATION
TYPICAL GLAZED
LANTERN PANEL
SCALE: 3/4" = 1'-0"

2 LIGHTHOUSE LANTERN SECTION
SCALE: 1/2" = 1'-0" (HALF-SIZE)

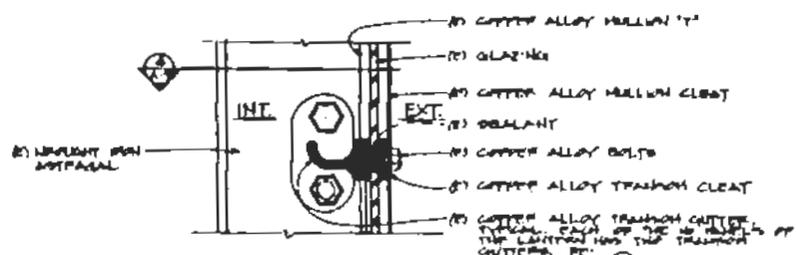
3 TYPICAL TRANOM GUTTER SECTION
SCALE: 1/2" = 1'-0" (HALF-SIZE)

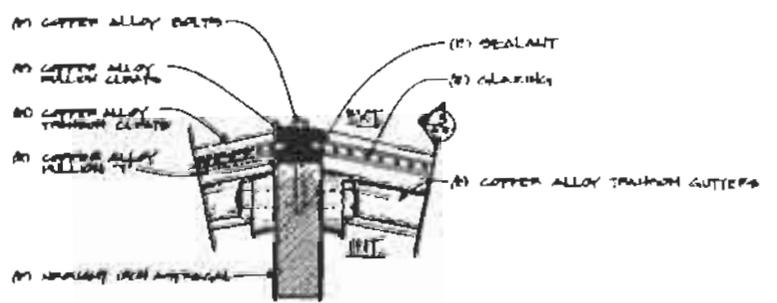
4 ASTRAGAL, MULLION & CLEAT SECTION
SCALE: 1/2" = 1'-0" (HALF-SIZE)

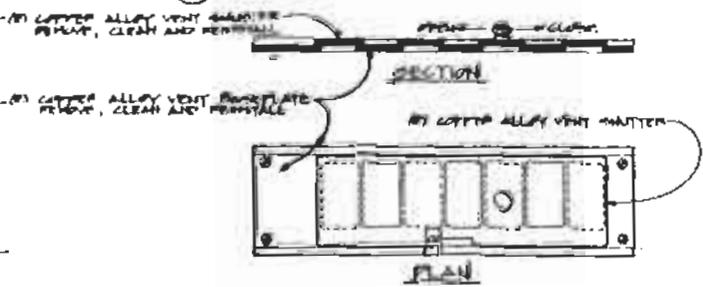
5 VENTILATOR SHUTTER DETAILS
SCALE: 1/2" = 1'-0"

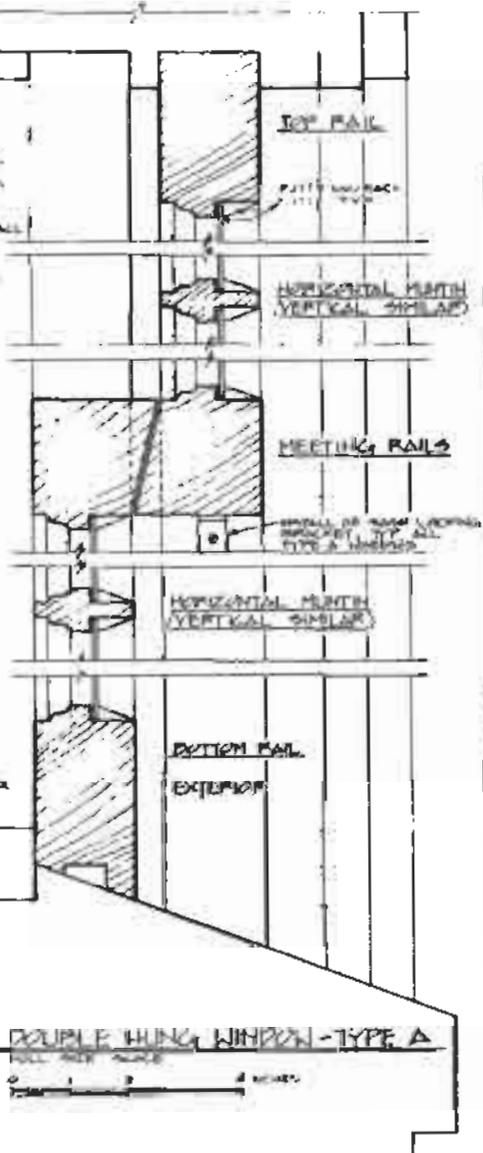
② DOUBLE HUNG WINDOW - TYPE A
ALL METAL
0 1 2 4 INCHES

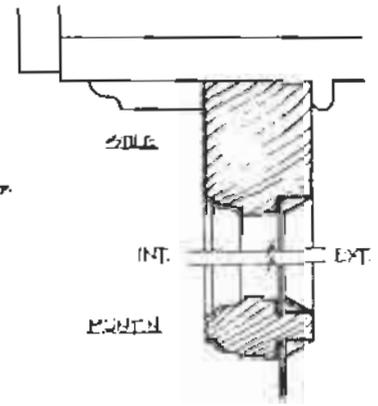
④ SASH PROFILE - TYPE B
ALL METAL

③ EXISTING CONDITION DETAILS - TYPES A & B
ALL METAL

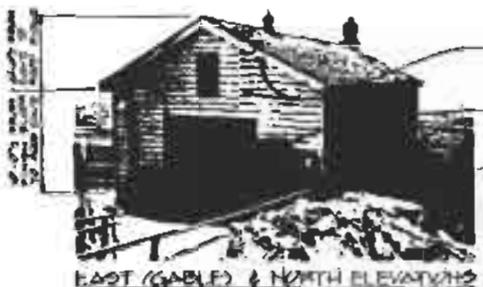
EAST (GABLE) & NORTH ELEVATIONS

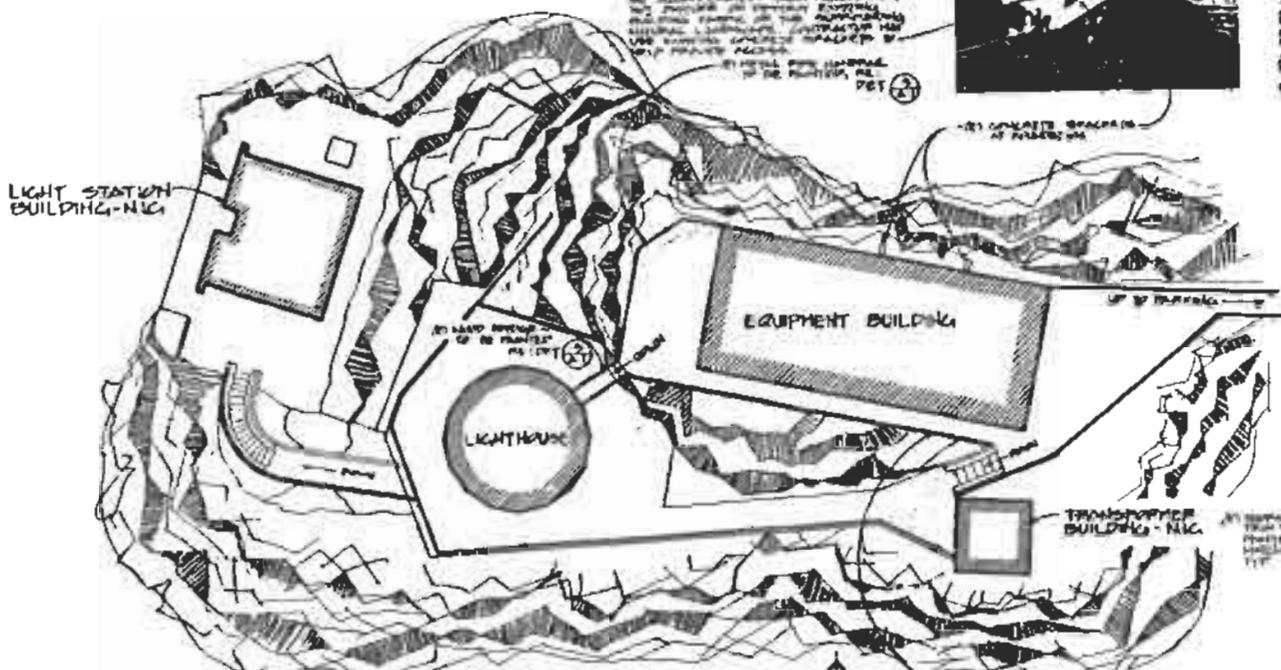
1 SITE PLAN
 SCALE: 1" = 100'
 100 0 100 200 FEET

2 EQUIPMENT BUILDING ELEVATIONS
 NO SCALE
