Many Glacier Hotel Historic Structure Report

Glacier National Park
Montana

July 2002

Prepared by
National Park Service

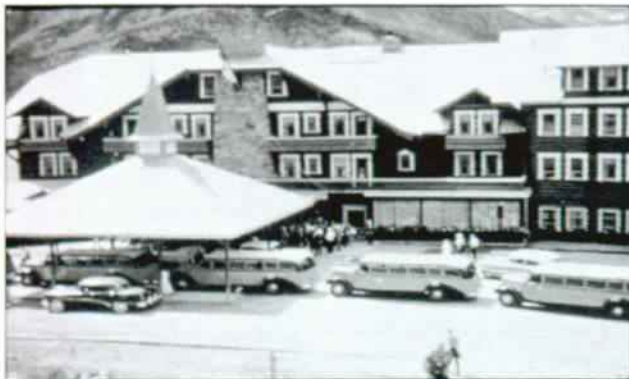
Porte Cochere developed at main entry to hotel to protect guests from "the elements."
Courtesy Glacier National Park Archives

The Many Glacier Hotel site began changing when a larger number of guests began to travel to the hotel in their own automobiles in the late 1920s. This new means of transportation resulted in development of vehicle parking and site design to separate horse and vehicle traffic. An entrance porch to the lobby was added in 1932, and in 1957 a porte cochere was added to provide a protected drop-off zone for visitors arriving by automobile and bus.

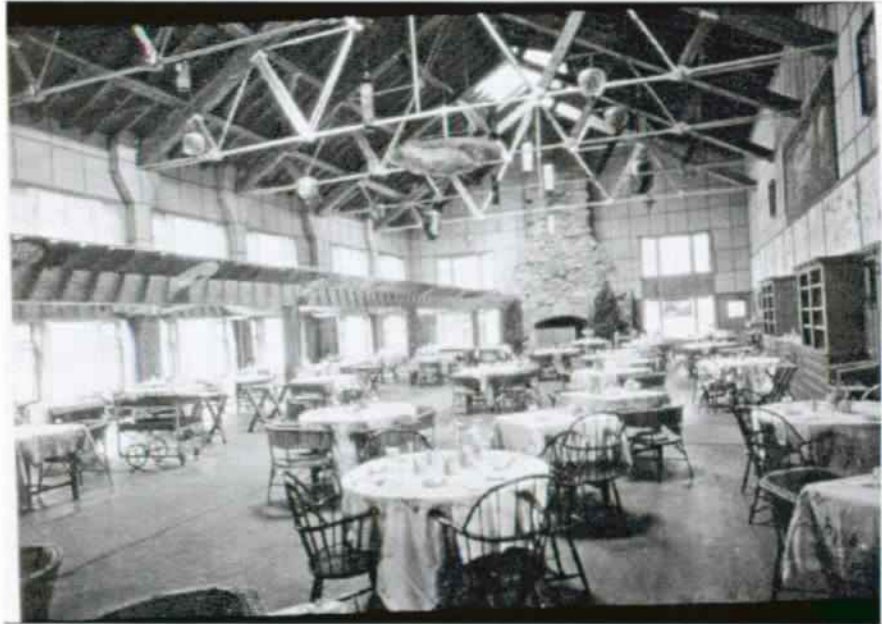
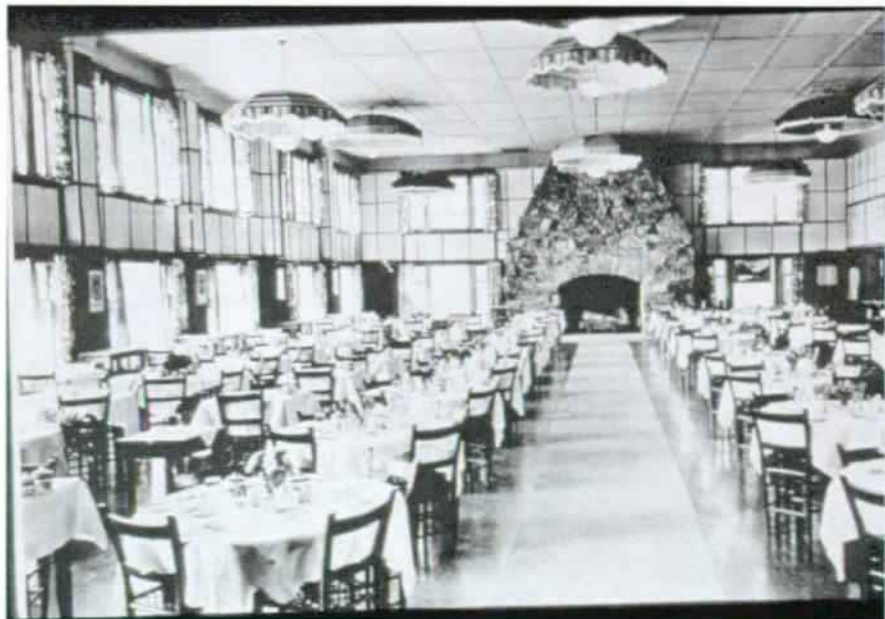
Above left: Original dining hall with exposed roof trusses. Note pergola and decorative Oriental umbrellas left, Blackfeet pictographs right, and evergreen trees at stone fireplace. Furniture included 36 hardwood chairs, 122 Japanese wicker chairs, square homemade tables, round tables, homemade sideboards, tray stands, Japanese lanterns, blue willow ware china and one tea tray wagon. *Left:* Following 50's remodel, dining hall after ceiling was dropped below bottom of trusses, wood floor covered with linoleum.

A second major rehabilitation of the historic fabric occurred in the early 1980s. Guestrooms were refurbished. The gift shop was expanded further into the lobby. The former pool area was retrofitted for use as employee quarters. The exterior was painted. The dining room windows, which dated to the 1950s, were replaced, and the dining room ceilings were suspended below the trusses.

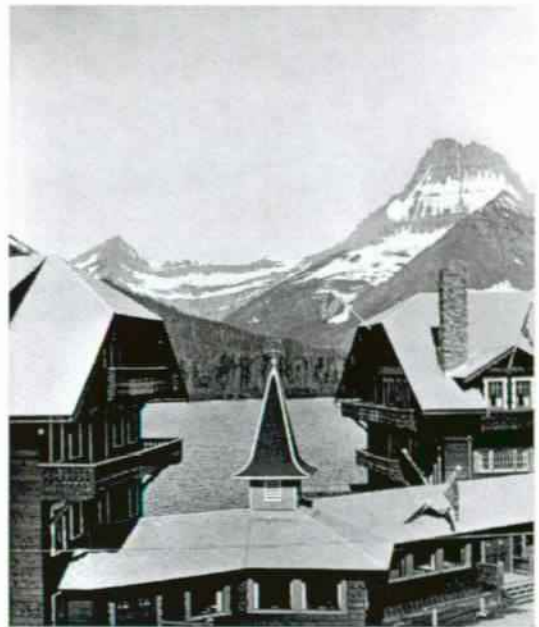
Annex 2, left, and connecting south bridge with spired cupola constructed in 1917. The spire was likely inspired by the first set of drawings submitted by Kirtland Cutter but rejected by Louis Hill. *Courtesy Glacier National Park Archives*

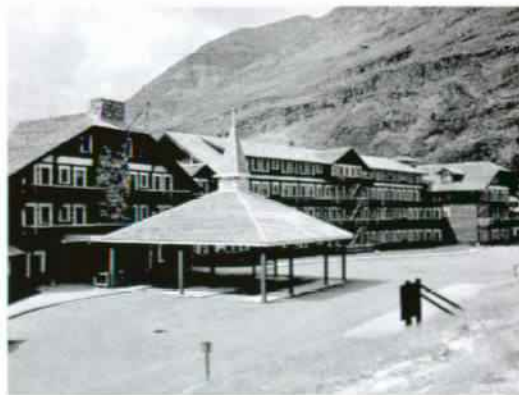
Porte Cochere added in 1957 to protect arriving and departing guests from the weather. *Courtesy of Glacier National Park Archives*

- Bus platform and entrance canopy added (porte cochere topped with spire)
- Wall added to separate cocktail lounge from bridge
- New guestrooms added above gift shop
- Compressor room added
- Convention hall and women's toilet added
- Reservation desk and office built
- Green linoleum laid down on lobby floor
- Steel supports added to Lucerne Room
- New bathrooms installed in rooms 115 and 315
- Boiler room piping added
- Spiral stairway from lobby to basement removed and

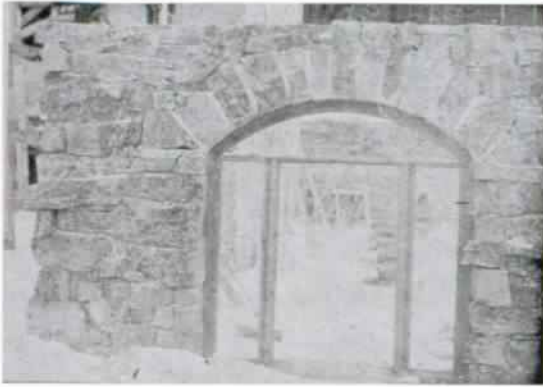
The stone segments creating the arched windows were constructed from locally quarried stone. *Courtesy of Minnesota Historical Society*

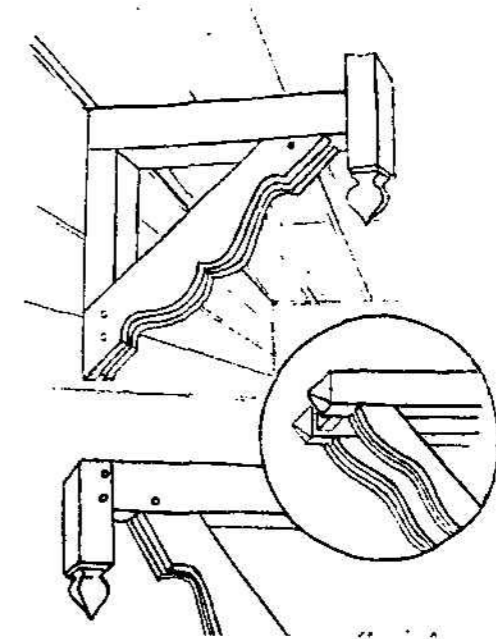
Decorative knee braces and pendants. Artwork Shaila Sorensen 1999

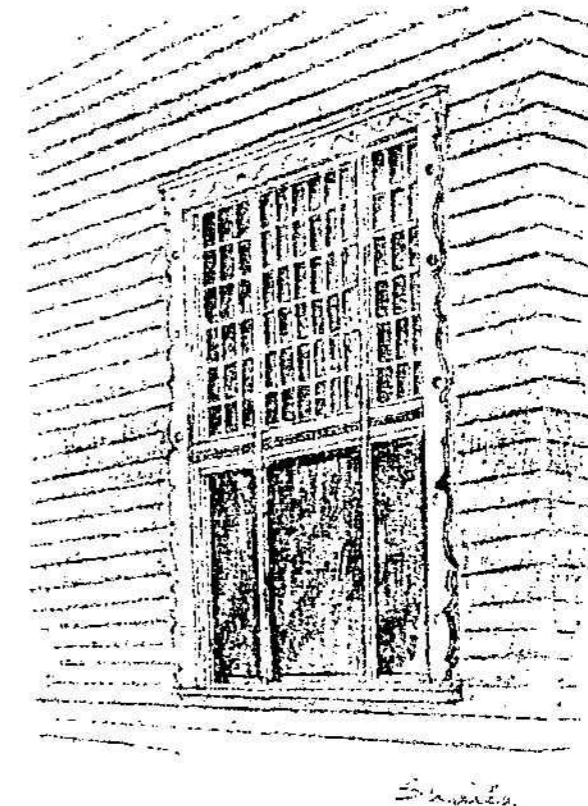
Main lobby windows. Artwork: Shaila Sorensen 1999

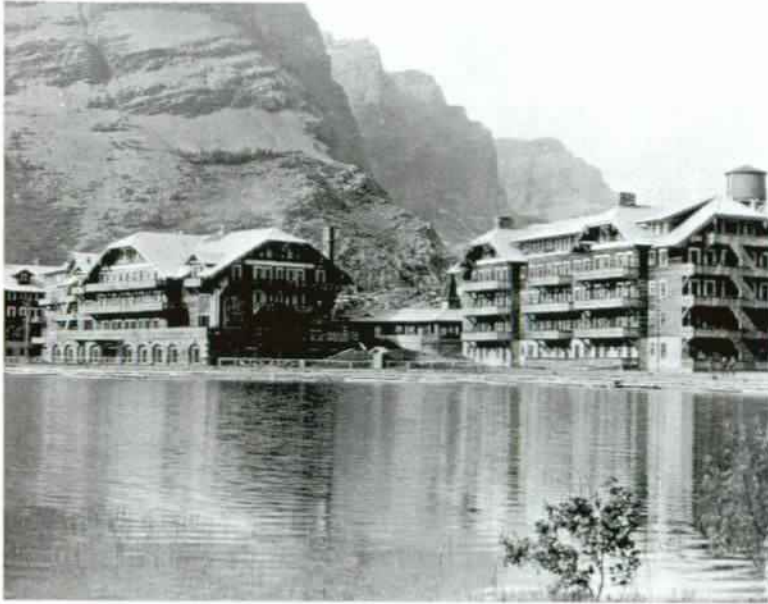
View of many glacier hotel from west side of Swiftcurrent Lake. Note pergola over entry to lake level of main building (no longer exists), original water tower (foundation remains today), fence along walk between hotel and lake. *Courtesy Glacier National Park Archives*

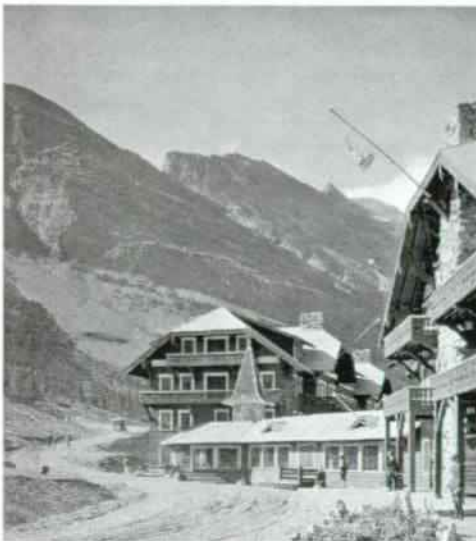
South end of Many Glacier Hotel. Annex 2 in background with spired South Bridge in middle of photo connecting the annex and main lobby building to right. Note flagpole supports. *Courtesy Glacier National Park Archives*

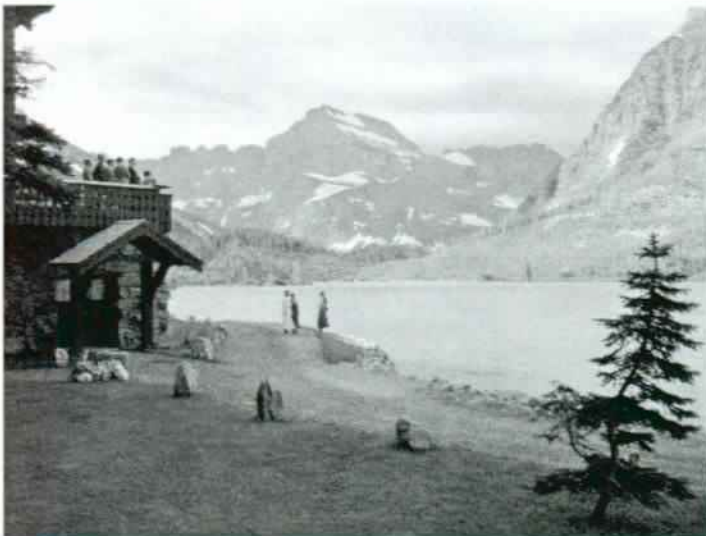
Visitors on front veranda off of lobby, 1933. Mt. Gould in distance. Note original gable-covered entry (no longer exists) to lower level Grill Room (original Soda Fountain was next to this entryway). *Courtesy Glacier National Park Archives*

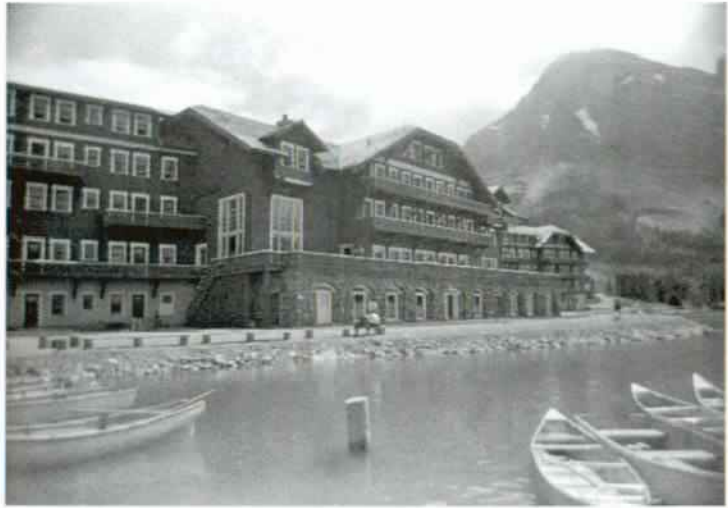
South end of main building.
Note arched window and doors
heads composed of segments
of locally quarried stone.
*Courtesy Glacier National Park
Archives*

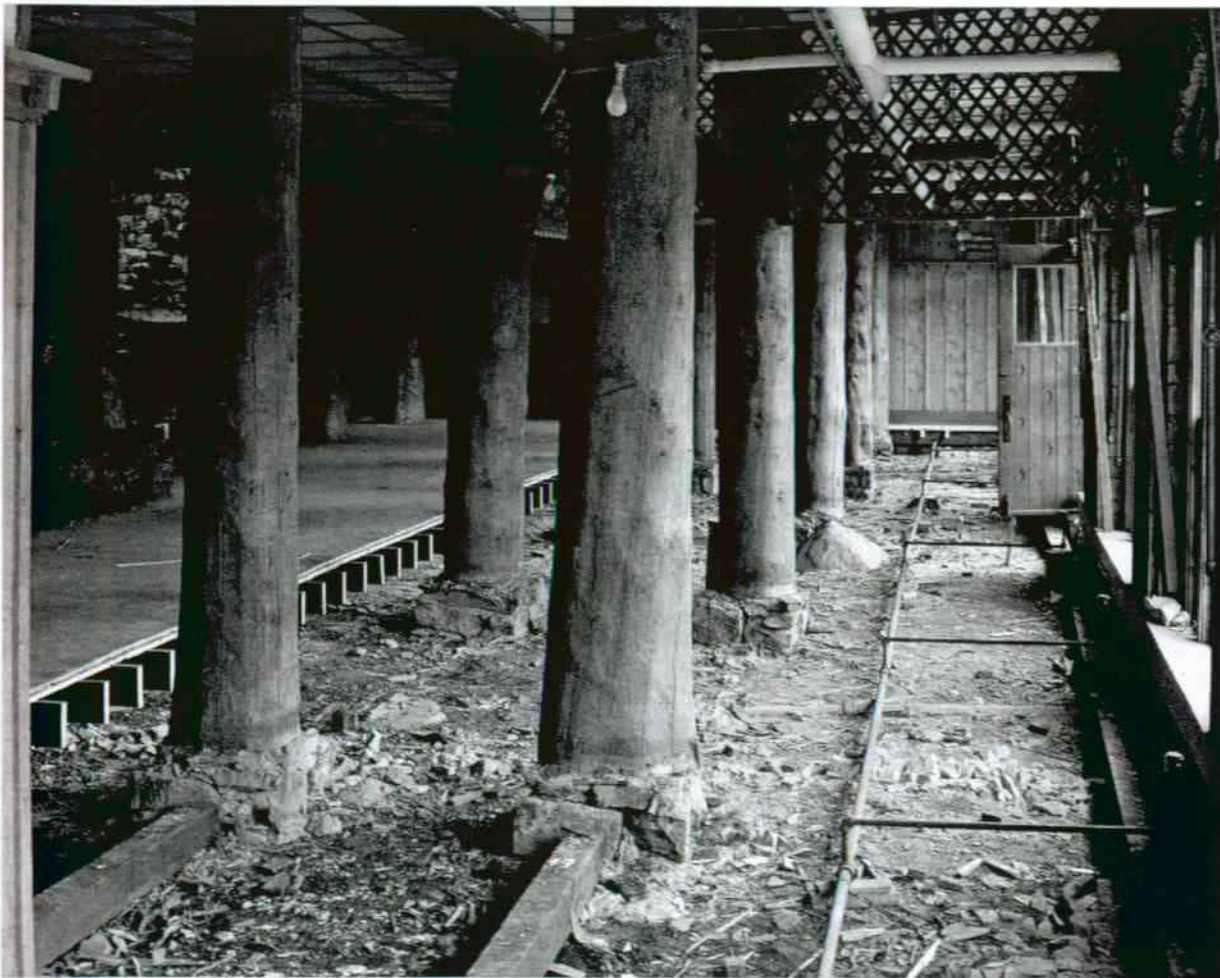
Base of original log columns set in main building. The typical peeled log column measured approximately 36 inches at its base and reduced to approximately 30 inches at its peak. This photo shows the floor of the Grill Room opened for repair work to bad concrete bases under log columns in 1952. *Courtesy Glacier National Park Archives*

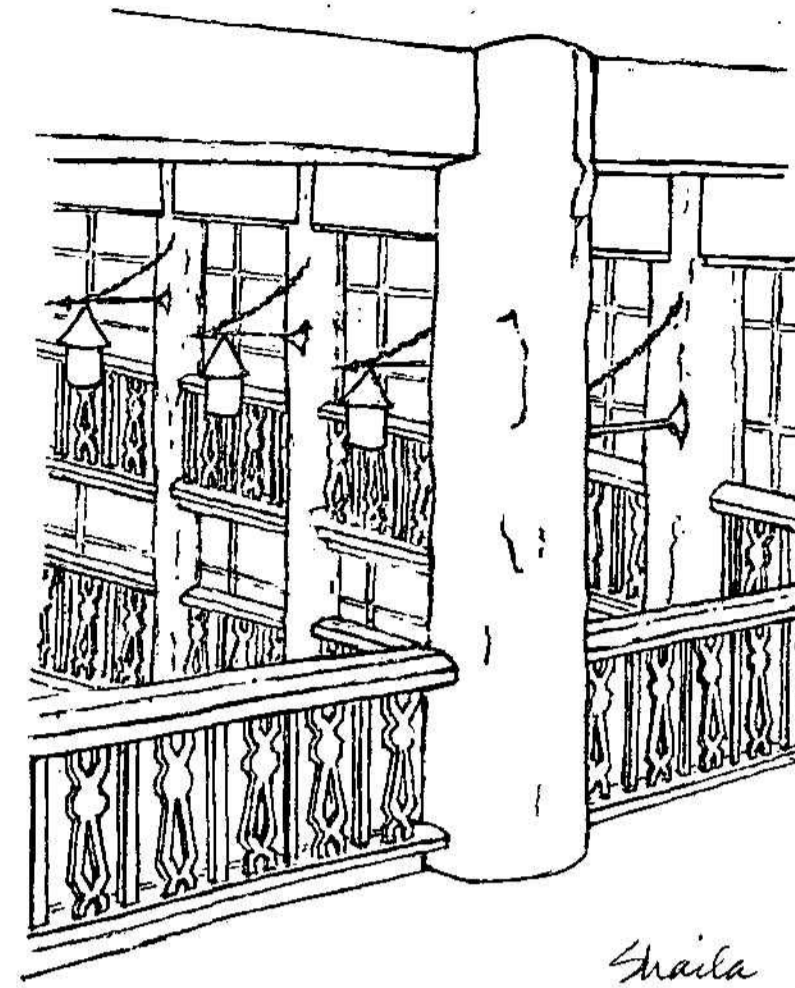
Above: Interior balcony log columns and balustrades

Below: Log column capital typical in lobby

Doric-like columns and capitals are found in the lobby of the main building and the Interlaken Lounge. These columns are full heights high, unfluted, and without bases, giving them an unbroken verticality. They are constructed of natural bark-off log with a stain varnish or shellac finish. The wooden components that form the echinus and abacus blocks are curve-edged and mitered square blocks of increasing size laid on top of the columns with a neck transition. The larger upper blocks support the round log beams that surround the atrium-like space of the lobby.

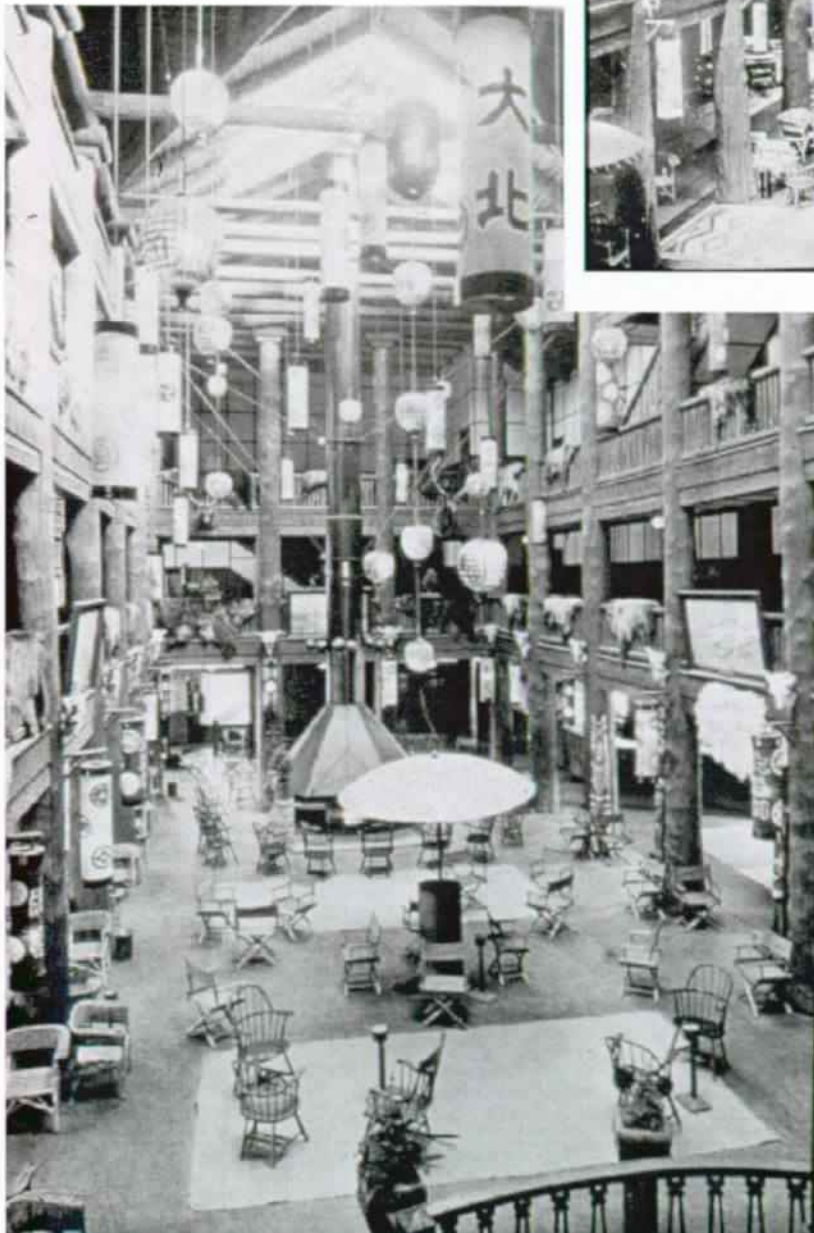
The fireplace hood was designed after the Sibley hood that the U.S. Army used in tents. It was made out of cast iron and was raised and lowered with counterweights. Courtesy Minnesota Historical Society

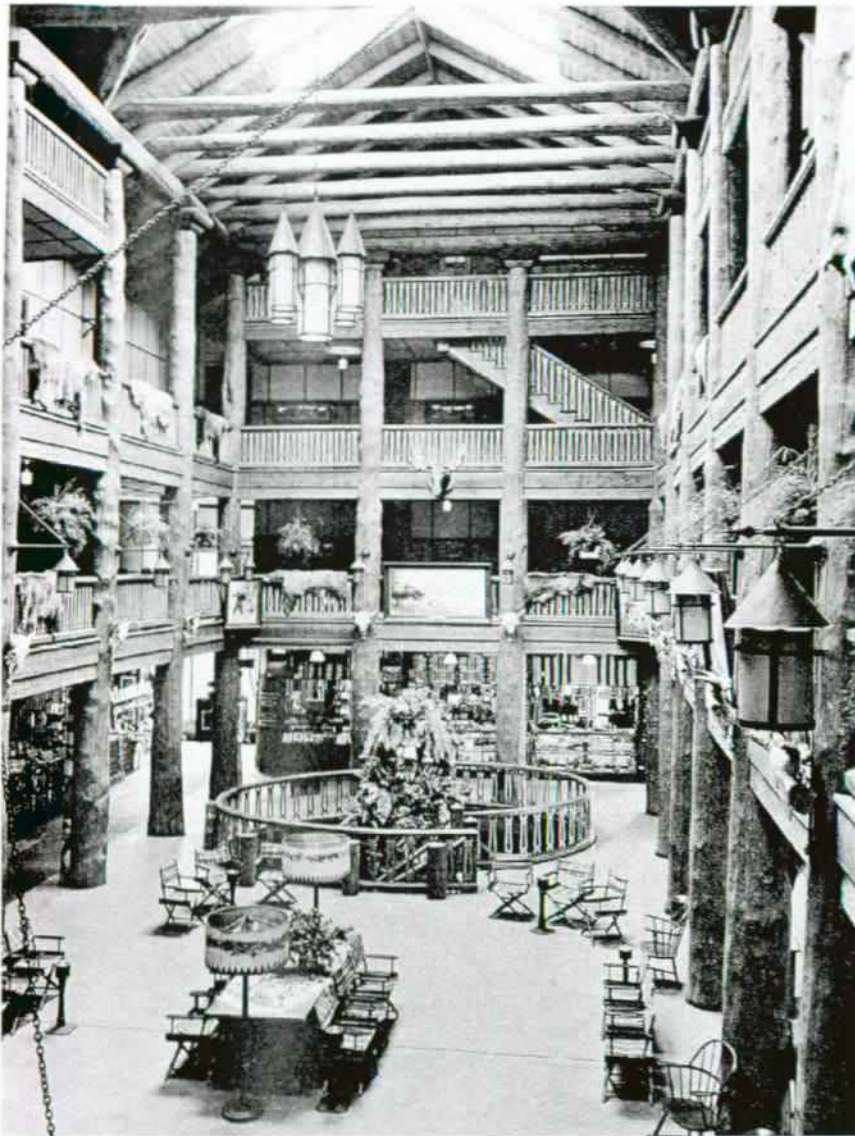
Hotel lobby looking south towards gift shop, circa 1920. Note lights, bear skin rugs, staircase, smaller gift shop, furnishings. *Courtesy Glacier National Park Archives*

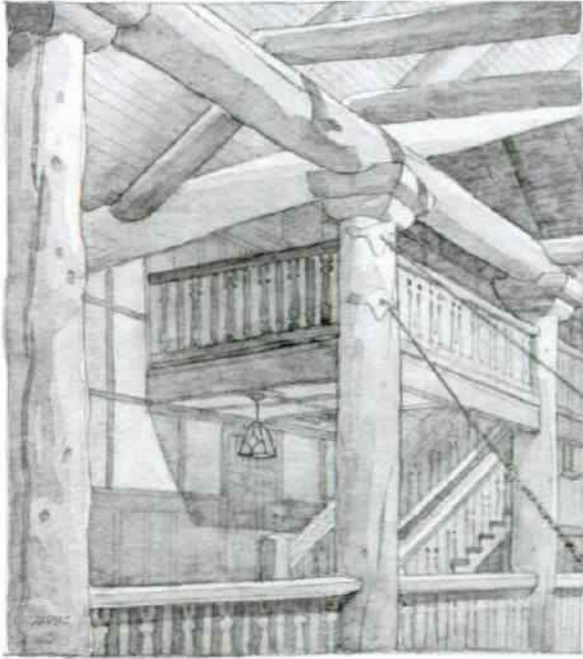
Painting of interior log structure: log columns with capitals, log beams and trusses. Original crafted balustrades. Patterned batten boards over Sackett board above wood wainscoting. Artwork Henry Sorensen 1999

The wainscoting found throughout the hotel consists of rough sawn 1x10 vertical boards with 1x2 wood trim battens over the joints. A chair rail composed of three trim pieces caps the wainscoting. The effect is a three-dimensional pattern covering two thirds of the wainscoted walls. The top third of these walls and the ceiling is gypsum wallboard, referred to as Sackett wallboard because of the original specification. The Sackett wallboard is accented with a regular pattern of 1x2-batten strips whose color historically matched the wainscot. The spacing of the batten strips responds to scale of the space (e.g. dining hall battens are spaced further apart than the guestroom battens).

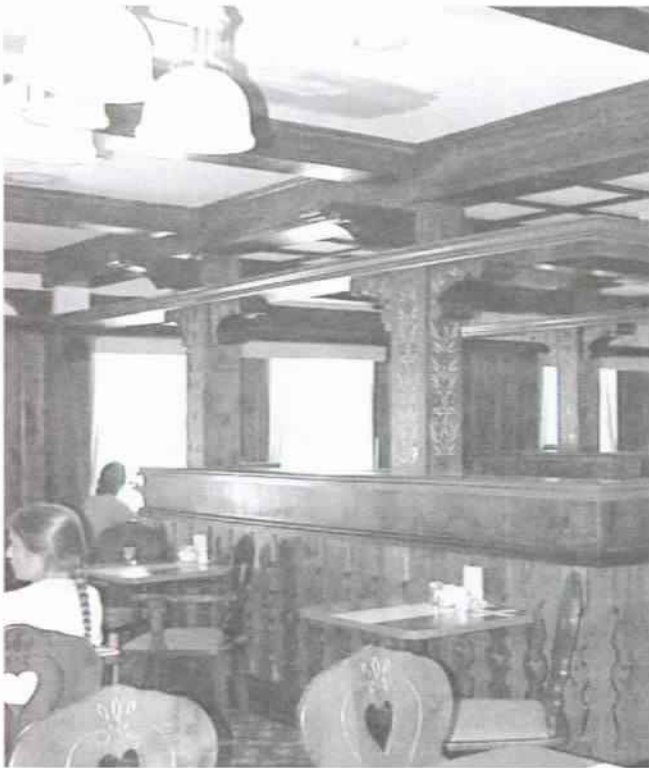
Interior Swiss Lounge, 2001. Courtesy Glacier National Park

lounge - the Swiss Lounge. The Swiss Lounge, constructed adjacent to the north bridge of annex 1 between 1953 and 1954, presented architectural detailing with less rustic and more Swiss motif. Details included a lowered ceiling resting on dimensional wood beams supported by highly decorative columns and corbels.

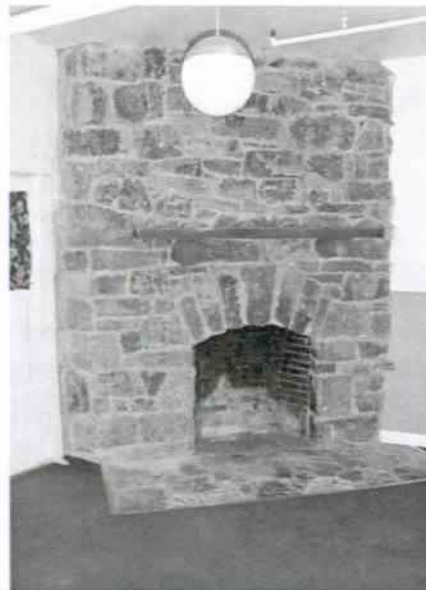
Corner fireplace in Deluxe Guestrooms. Note obtrusive contemporary light fixture. 2001 Courtesy Glacier National Park

Lesser fireplaces and chimneys are found in the lounges, the hallway openings, and the luxury guestrooms. However, many of the smaller fireplaces and their chimneys have been removed over time. A comparison of the historic photos of the east façade with that façade today reveals the regrettable decrease of a feature that was not only functional but an essential part of the designer's palette for using native materials and old world masons' craftsmanship.

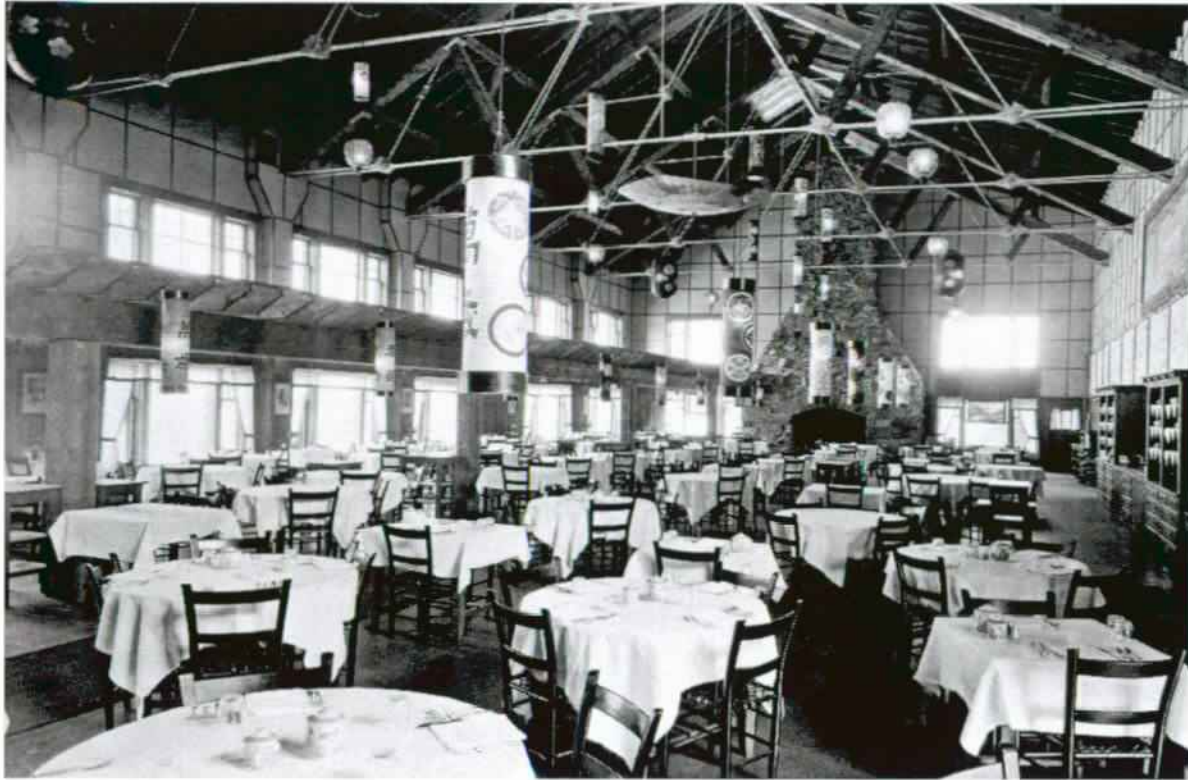
Many Glacier Hotel dining room, CIRCA 1940. Note fireplace on far end of room, tables prepared for guests. Chinese lanterns light the room. In 1949, a typical dinner menu consisted of baked Columbian River salmon, tartar sauce, fried half spring chicken a la Maryland, braised loin of pork dressed, applesauce, omelet, escalloped potatoes, snow potatoes, buttered string beans, cauliflower in cheese sauce, angel food cake, chocolate sundae, and chilled cantaloupe. *Courtesy Glacier National Park Archives.*

A drop ceiling was added to the dining room in 1937, and the pergola was removed. The finish on the new ceiling was similar to other battened ceilings throughout the building. The architectural detailing in the dining room has not changed since, but the rustic character has been lost due to the painting out of details such as the battens on the walls and ceiling. Windows were replaced in 1984 based on the 1950s designs.

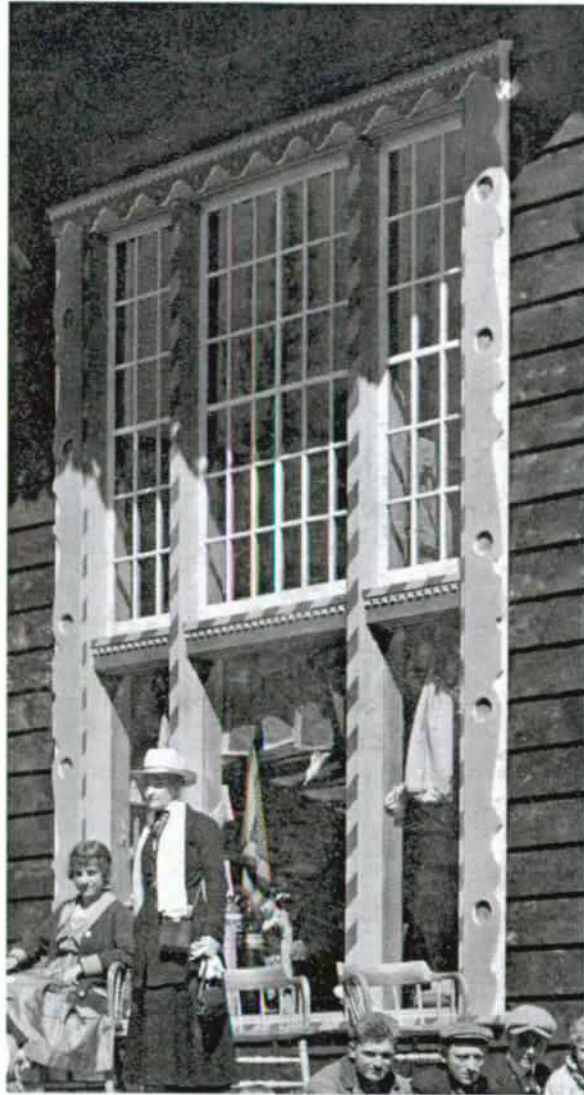
Lobby window. Note diagonal striping on vertical trim. Cut-out circles in perimeter trim were originally designed and in fact believed to be painted blue in color. *Courtesy of Glacier National Park Archives*
