A REPORT ON THE GROUNDS SURROUNDING THE SECOND BANK OF THE UNITED STATES
WITH EMPHASIS ON CONDITIONS DURING THE PERIOD FROM 1819 TO 1836

By James G. Kiryakakis
Landscape Architect

19 AUGUST 1955

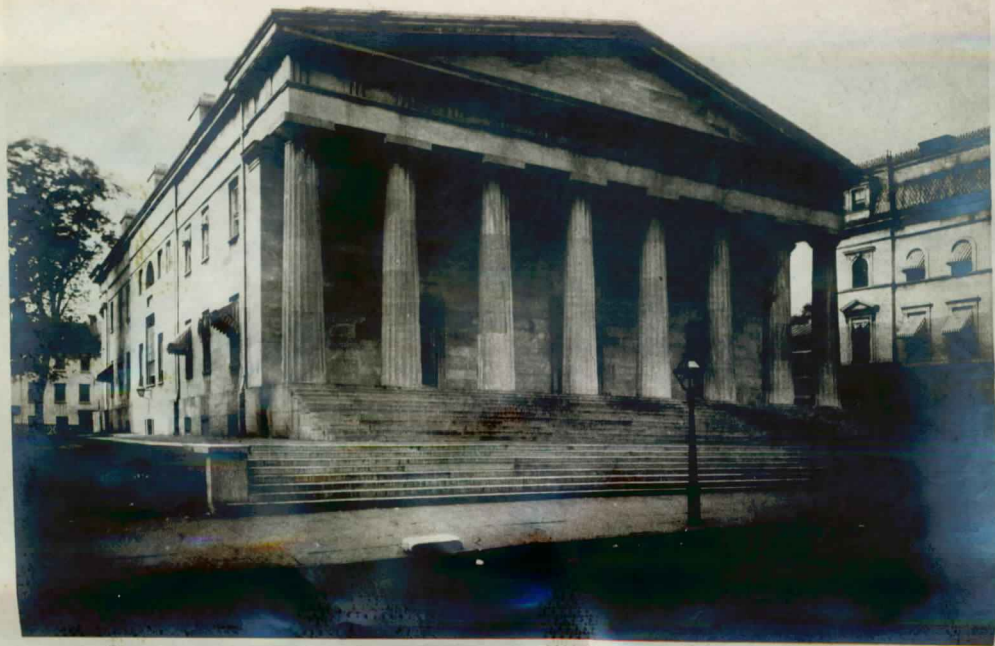
FIGURE 1. Elevation of the Bank of the United States,
designed by William Strickland Arch. "Port
Folio" 1821 Plate 150

1. Elevation of the Bank of the United States, designed by William Strickland Arch. "Port Folio" 1821 Plate 150 (*fence never put on Chestnut street side*)

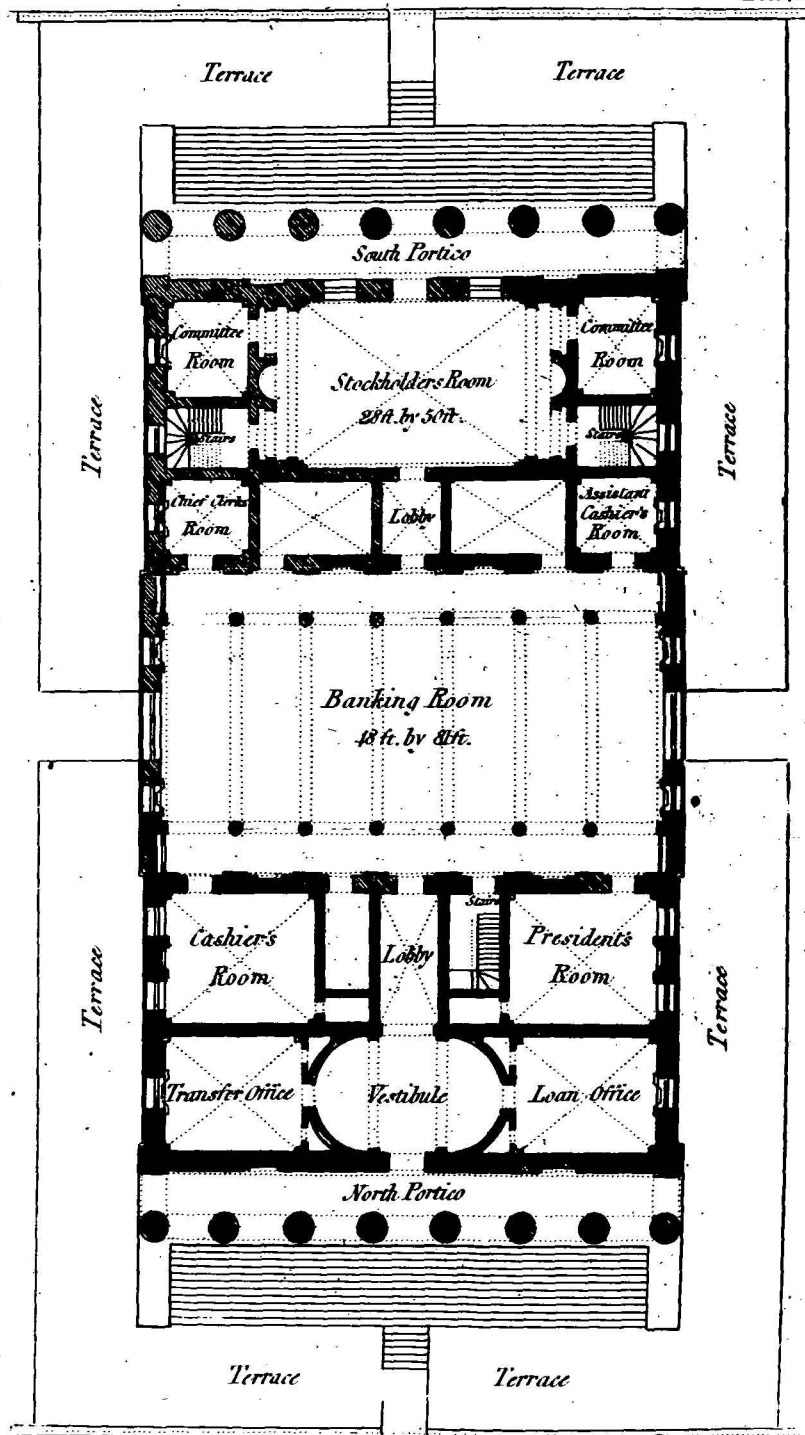
PLAN OF THE BANK OF THE UNITED STATES.

FIGURE 2. Plan of the Bank of the United States
designed by William Strickland Arch.
"Port Folio" 1821 Plate 149

2. Plan fo the Bank of the United States, designed by William Strickland Arch. "Port Folio" 1821 Plate 149 (*direct approach on Chestnut street never built*)

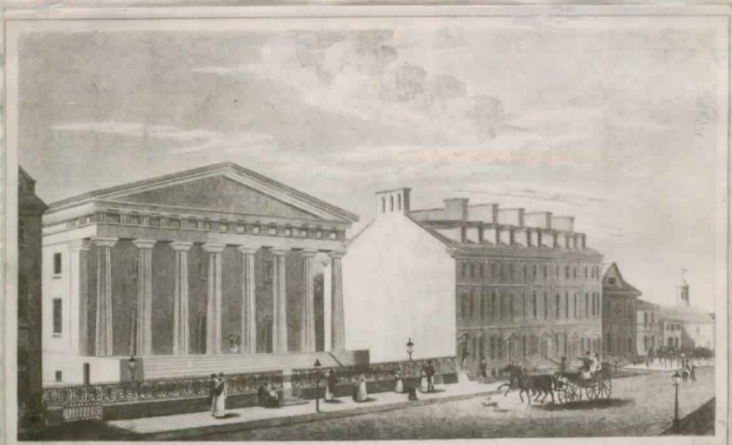
FIGURE 3. United States Bank, Chestnut Street, Phila.
Strickland Del. Tucker Sc. (most probably
an early sketch of the building since fence was never
built in this manner on chestnut Street.)

A street lamp once stood along the curb on Chestnut Street east of the center of the building, about 60 feet from the east property line. (See figures 3, 5, 17, and 19.)

A drawing of a view of Chestnut Street by Strickland (figure 3) shows two lamps attached to the top of the fence on that side of the building. While it is known the fence was never constructed as such on Chestnut Street, the drawing does suggest the possible location of the lamps on the fence along Library Street. Inspection of the existing section of fence along Library Street indicated that a lamp might have been attached to the fence at the point where the terrace walls end and the wing walls begin. Two bolts can be seen at this point (bolts larger than those used to connect the fence sections) spaced the proper distance apart for attaching a wrought iron lamp to the fence. (See footnote 1.) However, as the terminal points of the side terrace walls are not shown in any of our views of the Library Street facade of the building, we are without any photographic record to support our inclination toward this conclusion.

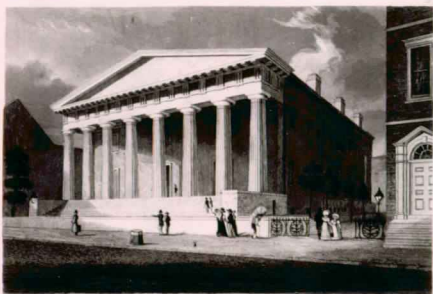
FIGURE 4. United States Bank at Philadelphia, 1831,
Burton (copy at American Phil. Soc. Library)

Another lamp was located inside the east passageway south of the steps leading up to the terrace. (See figures 4, 5, and 12.)

A third lamp was located on the section of the cast iron fence attached to Norris Row. The design of this lamp may be found in "Colonial Iron Work in Philadelphia" (footnote 1). The lamp was attached to the top of the cast iron fence between an arrowhead. (See figures 4, 9, 12, and 17 and footnote 1.)

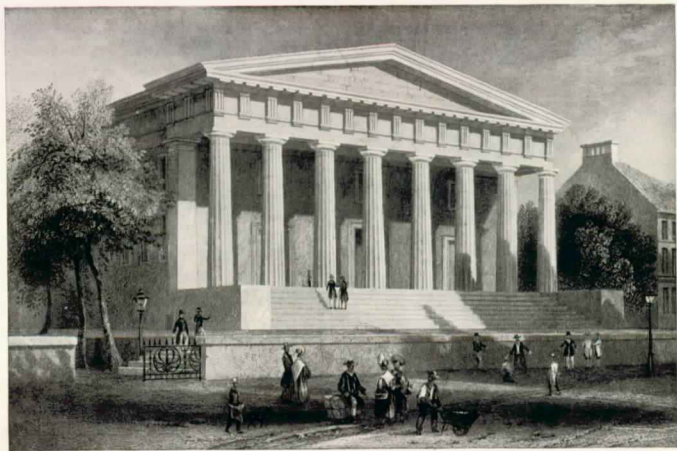
FIGURE 5. Second Bank of the United States, J. Tingle
after W. H. Bartlett, "Historical Philadelphia"
(Vol 43, pt. 1, 1953) American Phil. Soc. 1839

design to the one which stood on Chestnut Street from 1827 to 1839. The lamp was located 10 to 12 feet west of the center of the building along the curb on Library Street. (See figures 5, 7, 18, and 19.)

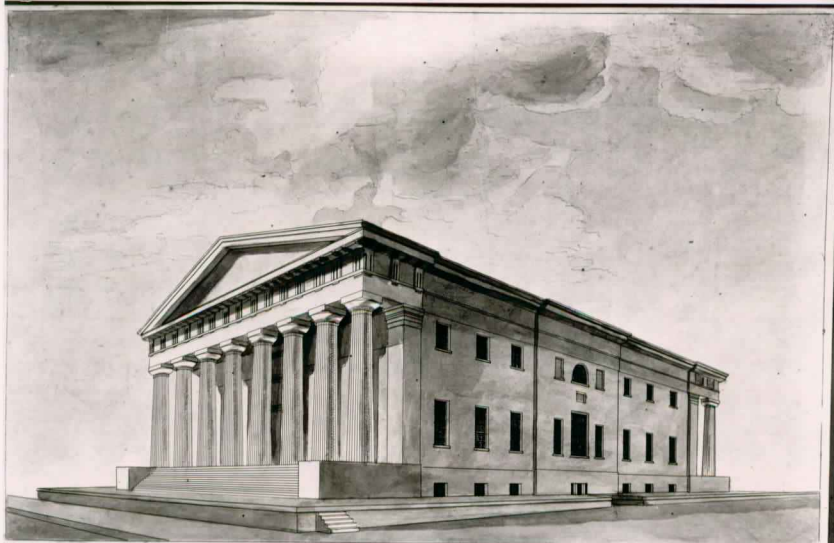
FIGURE 7. Bank of the United States, Chestnut Street, Phila.
George Strickland del. Thos. Birch publisher 1827

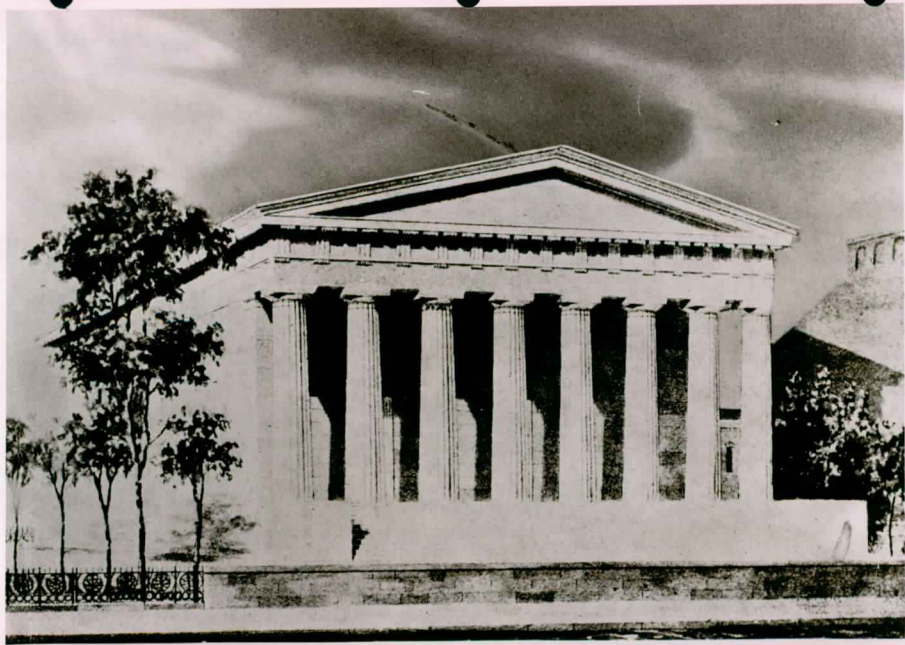
FIGURE 8 The Custom House, Alexander Jackson Davis,
"American German Review", April 1940

The sidewalks in front of the building and in back of the building along the terrace walls were paved with large blocks of flagstones jointed together. (See figures 4, 8, 11, 13, 15, and 17 through 20.) To substantiate this statement there is a record of checks (in research files, "Second Bank of U.S." INHPP) made payable as follows: to "Samuel Haines for regulating curb stone 4.50" dated June 15, 1821; to "George G. Leiper for 150 ft curb stone @ 75¢ 112.50" dated August 24, 1821; to "Flag Stone Cutters 44.86½" dated October 13, 1820; and to "Nicholas Struck portorage of flagging, marble, poles, etc, 66.37" dated November 10, 1820. The 150 feet of curb stone is the frontage of the property along Chestnut Street.

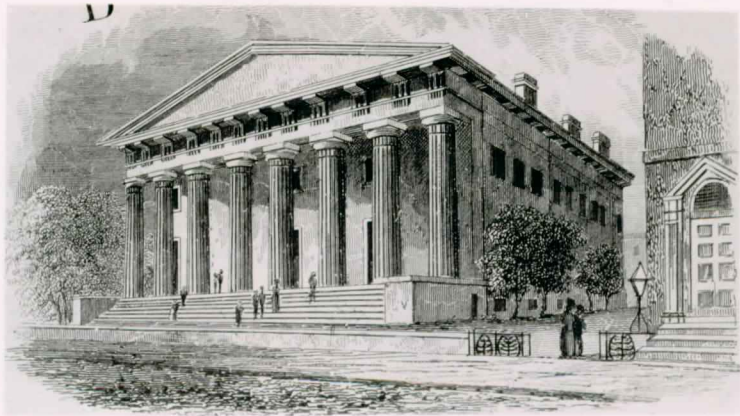
FIGURE 9. United States Bank, Philadelphia 1840
from Map 205A P.L. Phillips 1552B

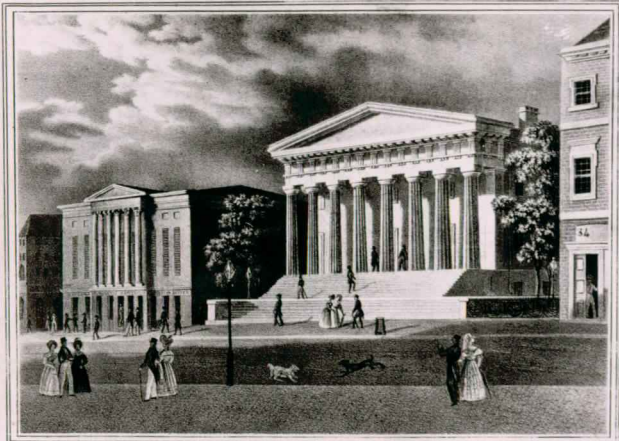
FIGURE 12. United States Bank, Philadelphia
Lithograph by J. C. Wild 1838

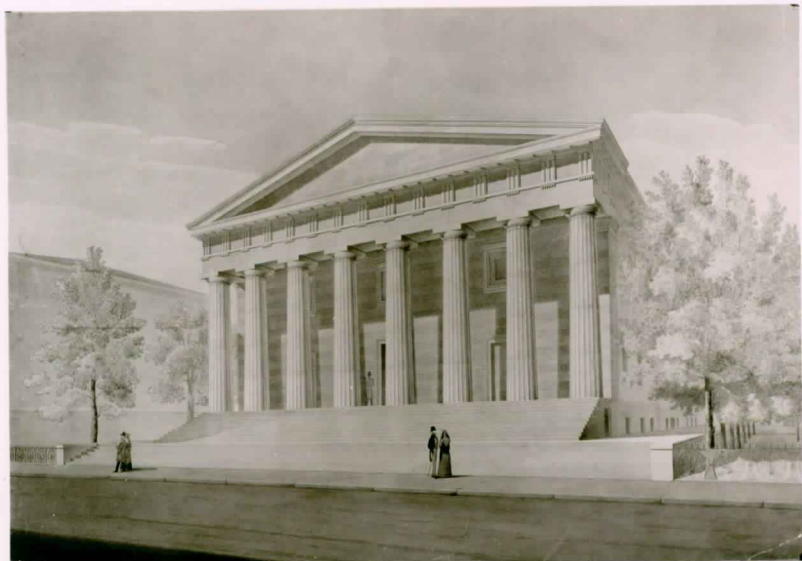
FIGURE 13. Drawing of the Second Bank of the United States
attributed to Wm. Strickland , dates post 1838
Phila Hist. Soc.

Trees lining the passageway were out about 3 feet from the base of the terrace walls. (See figures 5, 10, 13, 14, 16, 17, 18, and 19.)

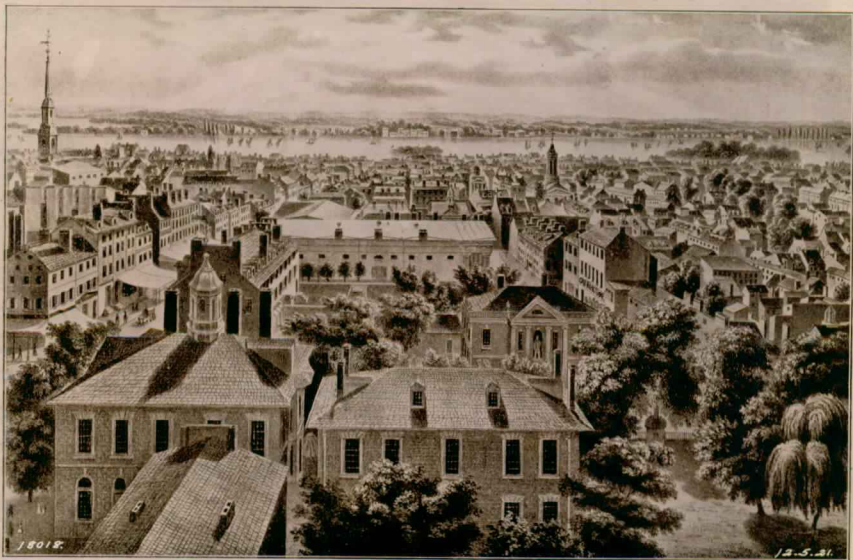
FIGURE 14. Panarama of Philadelphia from the State House Steeple, Looking East 1838. (Horace W. Sellers Collection)

A brick wall with a marble coping was built in 1820 on the west side of the property line on the property of Mr. H. Kuhn on Norris Row. This wall was 133 feet 9 inches long (footnote 6). From the Horace Wells Sellers collection (figure 14) we observe that a brick wall enclosed part of the back yards of the Norris Row building. By measuring from the Library Street Freestanding Wall with the cast iron fence 133 feet 9 inches, we come to a point approximately 26 feet from the rear of the Norris Row build-

ing. This is also the same approximate point of intersection as shown in figure 14. It is believed that the wall immediately to the rear of Norris Row was in existence at the time the Second Bank was being built and that the Bank obtained permission to build the wall on Mr. Kuhn's property for the purpose of enclosing the passageway completely.

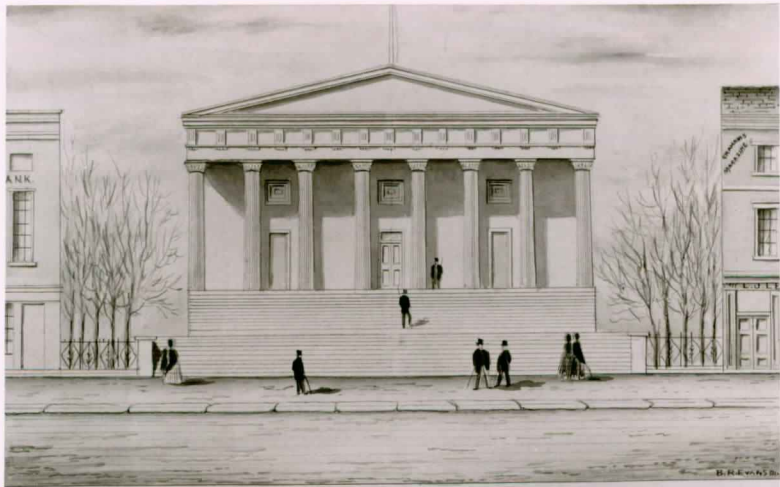
FIGURE 15. Custom House, South side Chestnut St. between
4th and 5th sts. 1851 B. R. Evans del.

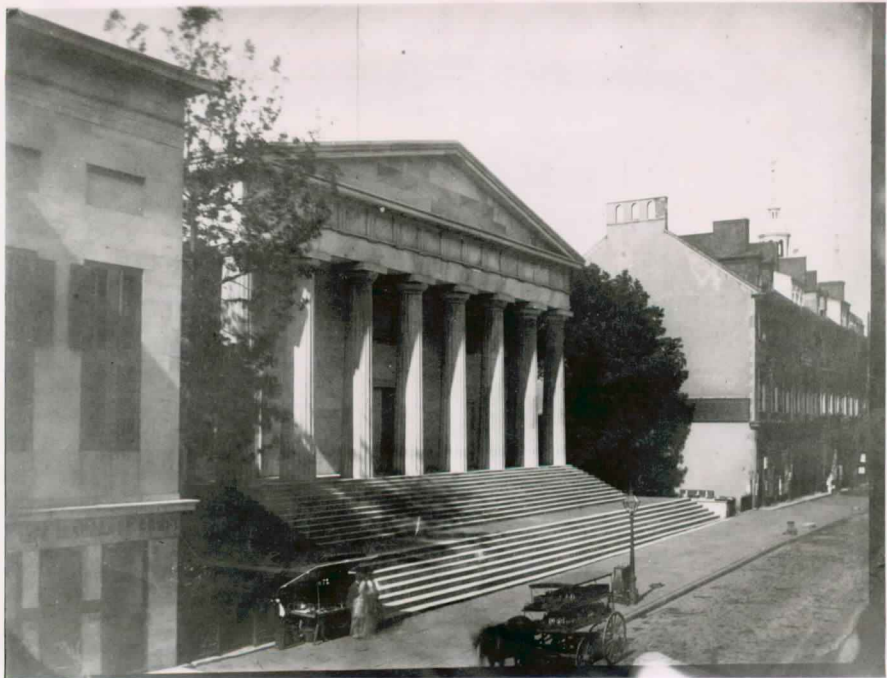
FIGURE 17. Custom House, Old Photo dates between 1850
and 1863

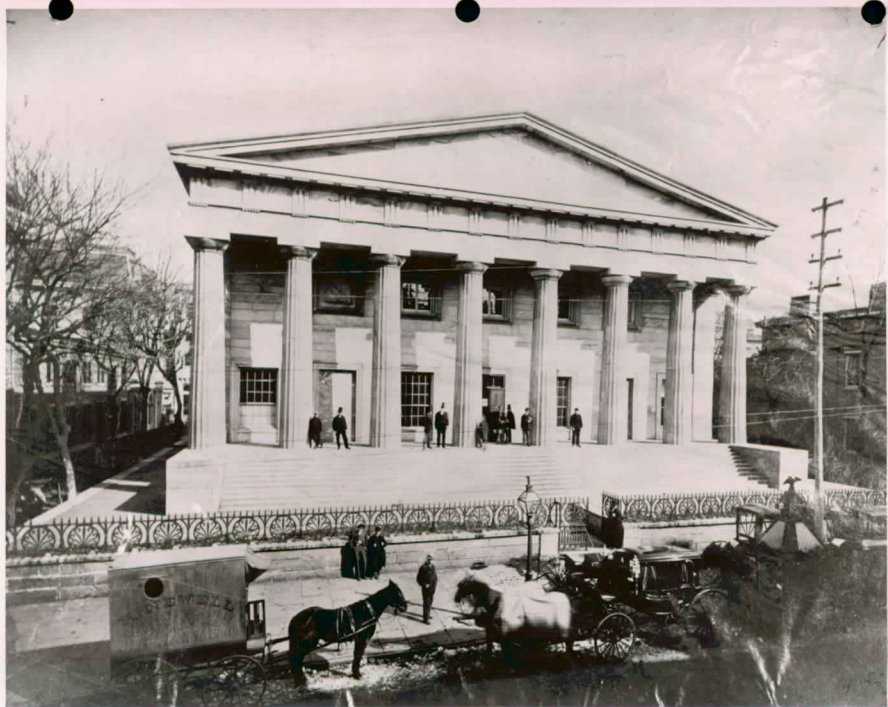
FIGURE 18. Custom House, old photo. probably by Rinewell
Landscape Photographer, dates between 1863
and 1881

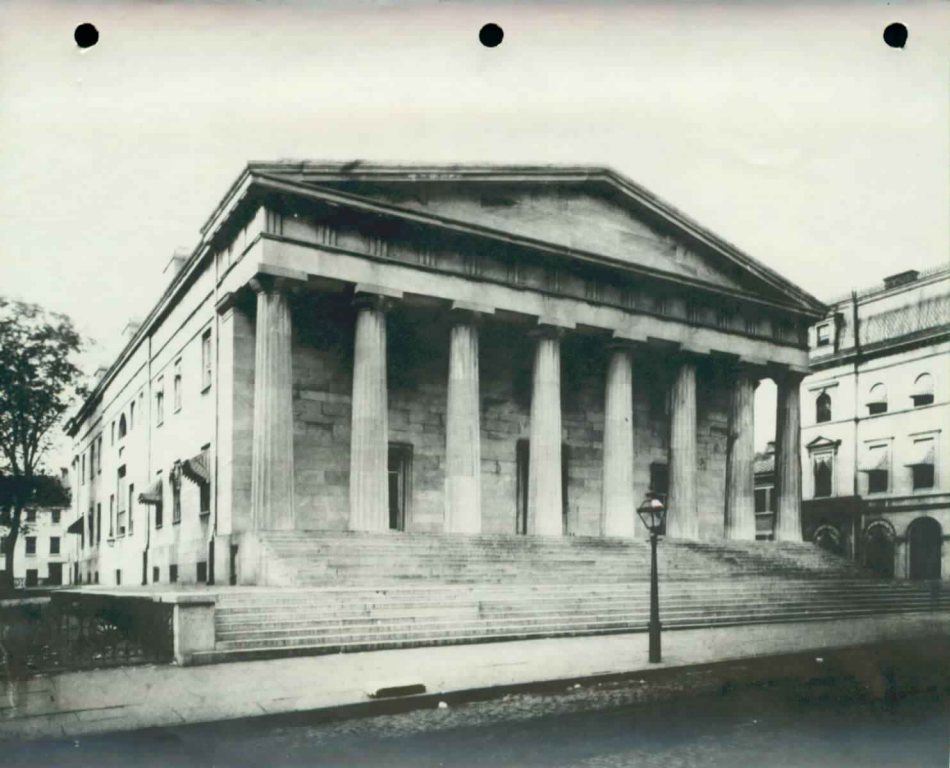
FIGURE 19. Custom House, photo taken between 1863 and 1888

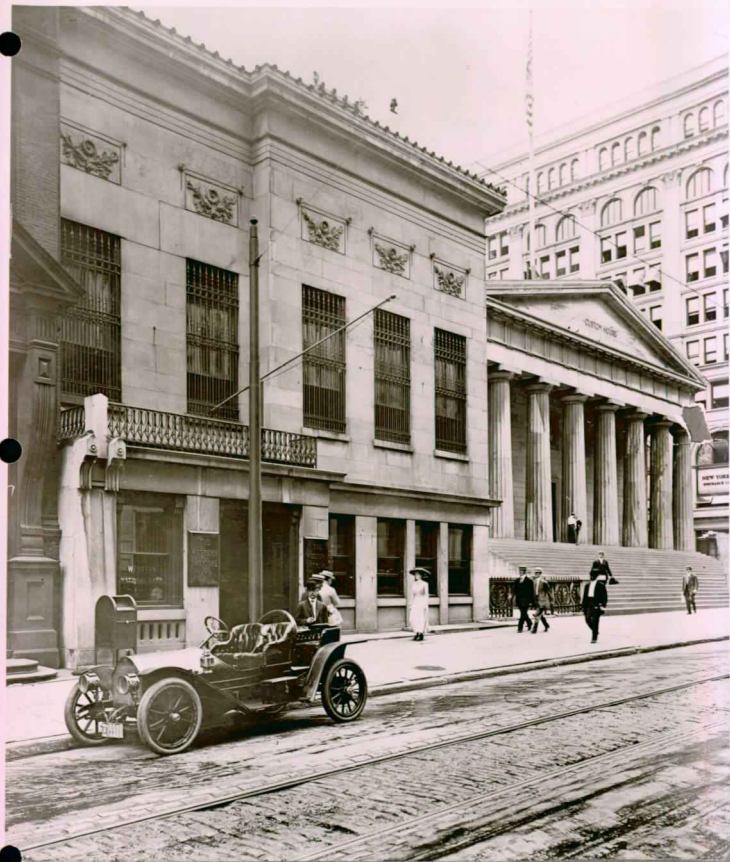
FIGURE 20. Custom House, Photo dates areound 1910
Lutz collection

West half - Philadelphia Bank after remodelling - Old photograph - Gift of Mr. Lutz
to American Philosophical Society - Lutz Collection - Rec. 5/19/53
