**Archeological Investigations at the  
Harriet Dean House (11SG272),  
Lincoln Home National Historic Site,  
Springfield, Illinois**

National Park Service - Midwest Archeological Center

Enclosed are seven copies of a report entitled "Archeological Excavations at the Harriet Dean House (11SG272), Lincoln Home National Historic Site, Springfield, Illinois," by Vergil E. Noble. This report describes the results of archeological test excavations conducted at the Cook House prior to its restoration and adaptive reuse.

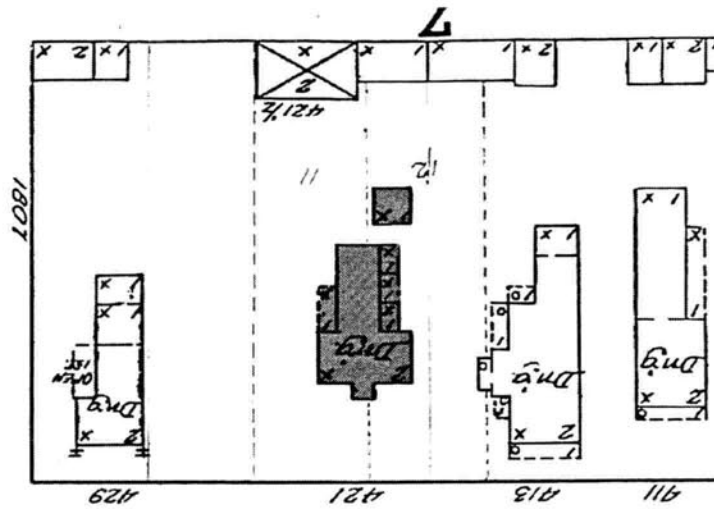
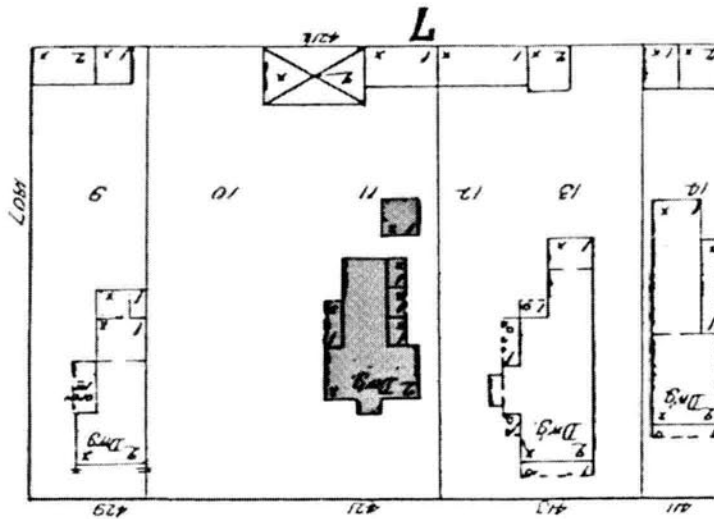
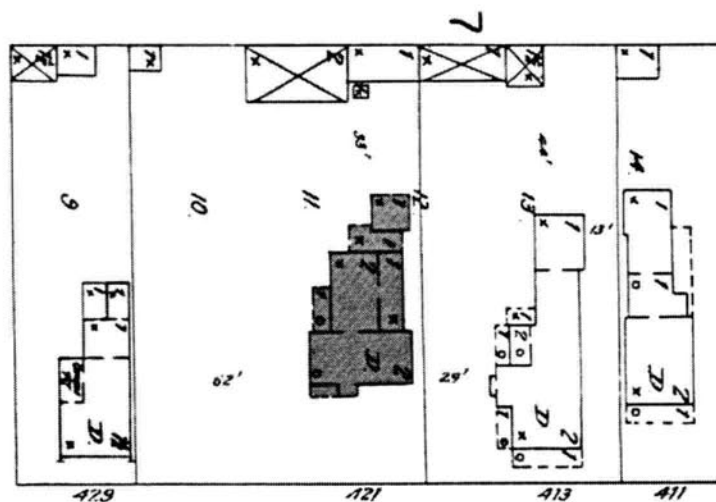
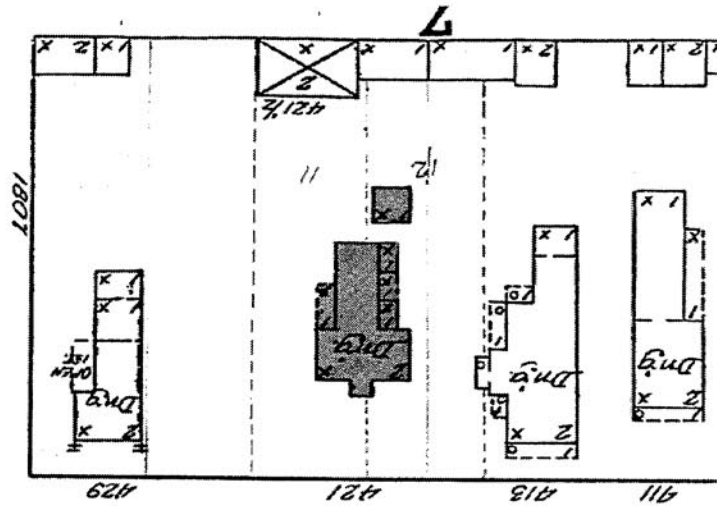
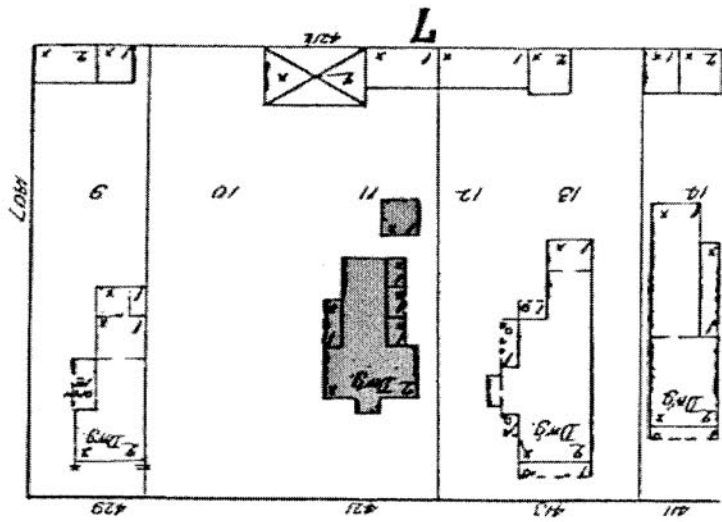
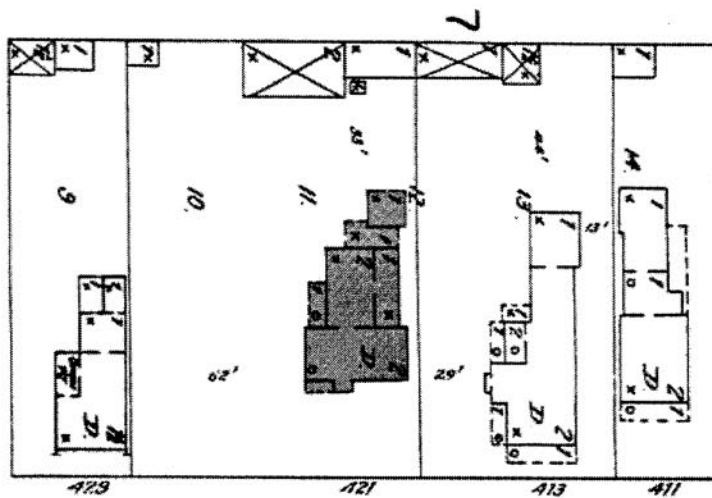
Figure 8. Six annotated details from Sanborn fire insurance maps (1884–1952), illustrating changes in the configuration of the Harriet Dean House and surrounding property (continued on following page).

This is consistent with plan views of the Dean House appearing on Sanborn insurance maps published in 1896, 1917, 1941, and 1952 (Figure 8). The porch does not appear south of the Dean House vestibule on the 1884 and 1890 Sanborn maps of Springfield. Nevertheless, there does seem to be a small porch immediately left of the vestibule in a bird's-eye-view depiction of the Dean House in 1873 (Figure 7). It is not known why the small section of decking should be absent from the 1884 and 1890 Sanborn maps.

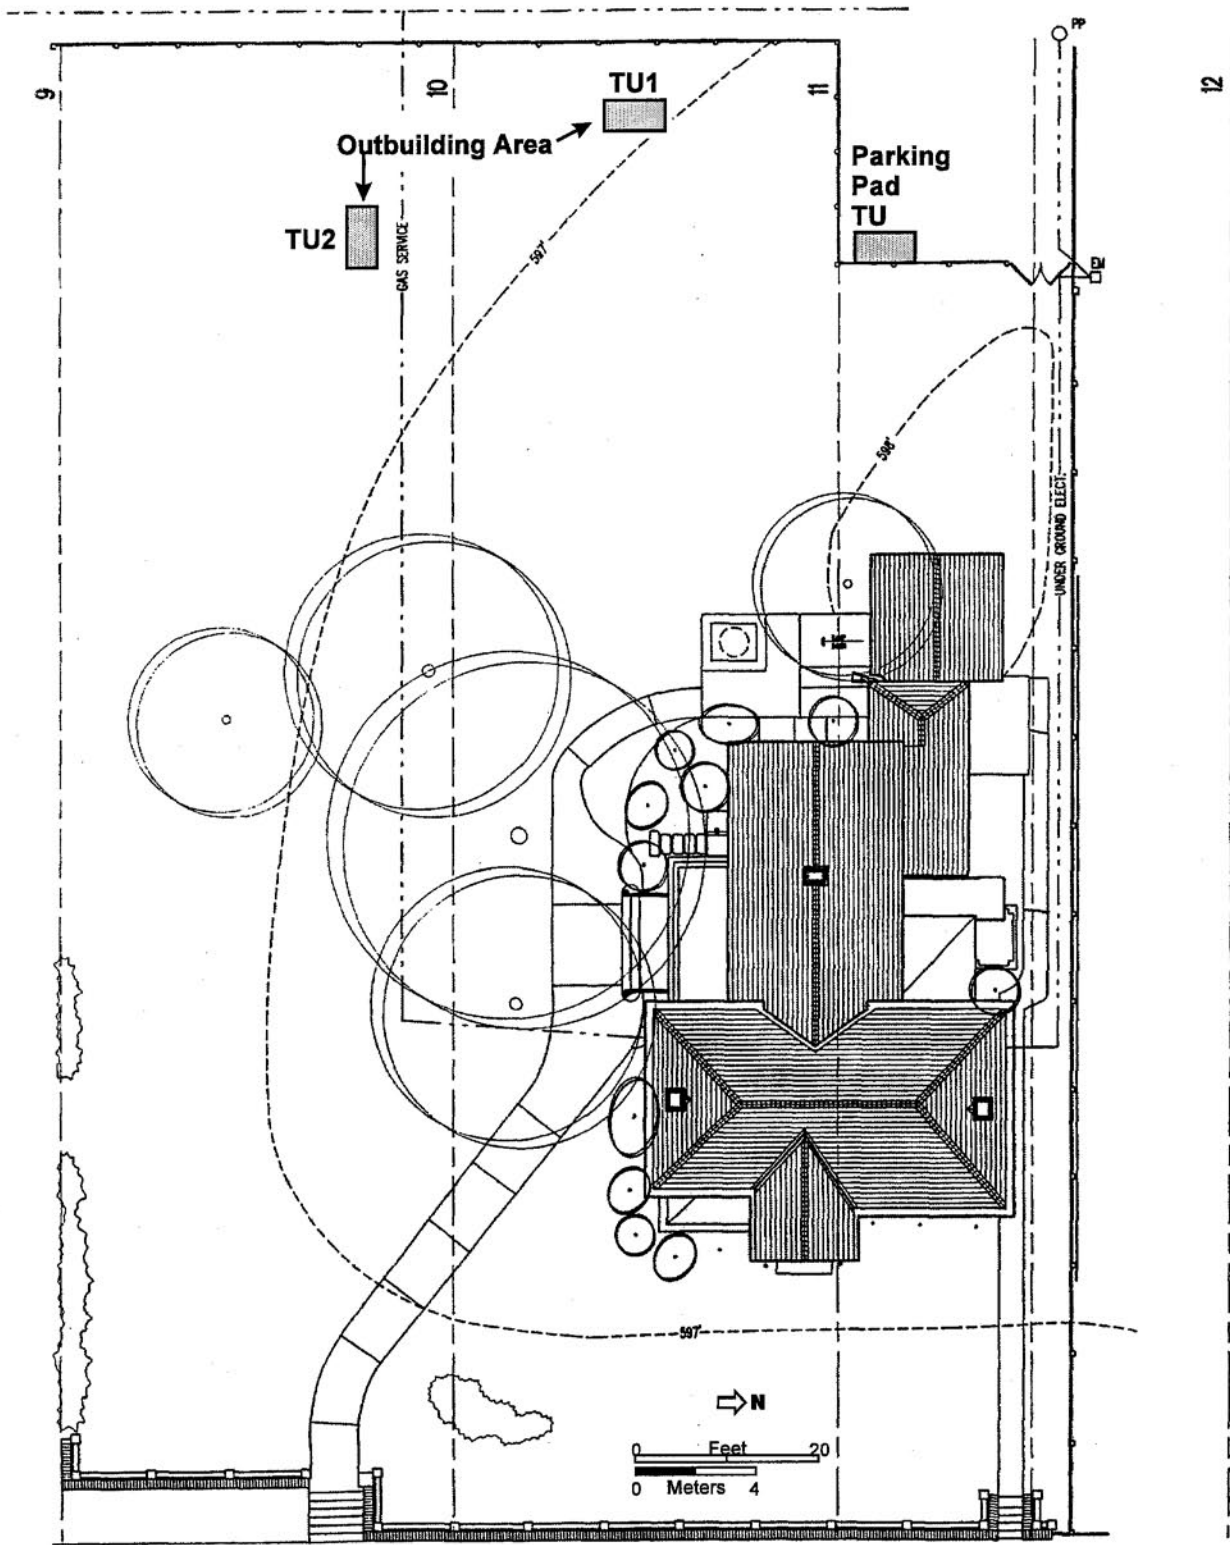
Figure 9. Harriet Dean House and lot showing the location of excavation units in the backyard.

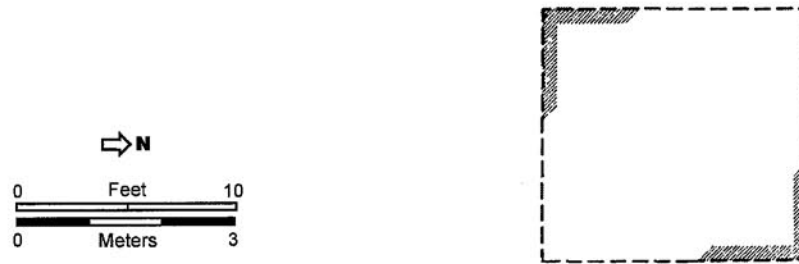
Figure 11. Basement floor plan of the Harriet Dean House and location of excavation units.

Much of the Dean House is underlain only by a crawlspace, which could not be readily investigated by archeologists at any time before or during the restoration project. There is a partial basement divided into two large rooms, however, beneath the south parlor and dining area. During the 1992 Dean House field season it was learned that demolition activities in the basement would afford the archeological crew an opportunity to perform controlled excavations in certain areas underneath an existing concrete floor. The three basement test units measured 50 cm square (Figure 11).

Located in the southwest corner of the basement, immediately adjacent to the foundation walls (Figure 11), the unit revealed a course of bricks that formed a spread footing at the base of the foundation. The line of bricks extended approximately 7 cm into the unit along both the west and south foundation walls. The rest of the unit consisted of a light tan clay apparently typical of sub-basement soils in this neighborhood. No artifacts were found on or in the clay, and the unit was declared sterile after the excavation of two 10-cm levels.

Located 150 cm east of the northwest corner of the basement and 100 cm south of the north foundation wall (Figure 11), a deposit of light tan clay was again present immediately underneath the removed concrete floor. The unit yielded very few materials out of Level 1 (0-10 cmbs) and nothing more after that (Table 15). There was no indication of any cultural features through two 10-cm levels.

Located 100 cm away from the south foundation and 125 cm west of the basement stairway (Figure 11), paving bricks were present in the unit's southwest corner immediately below the concrete floor. No artifacts occurred on this apparent former floor surface, however, nor in the compacted light tan clay present in the remainder of the unit.

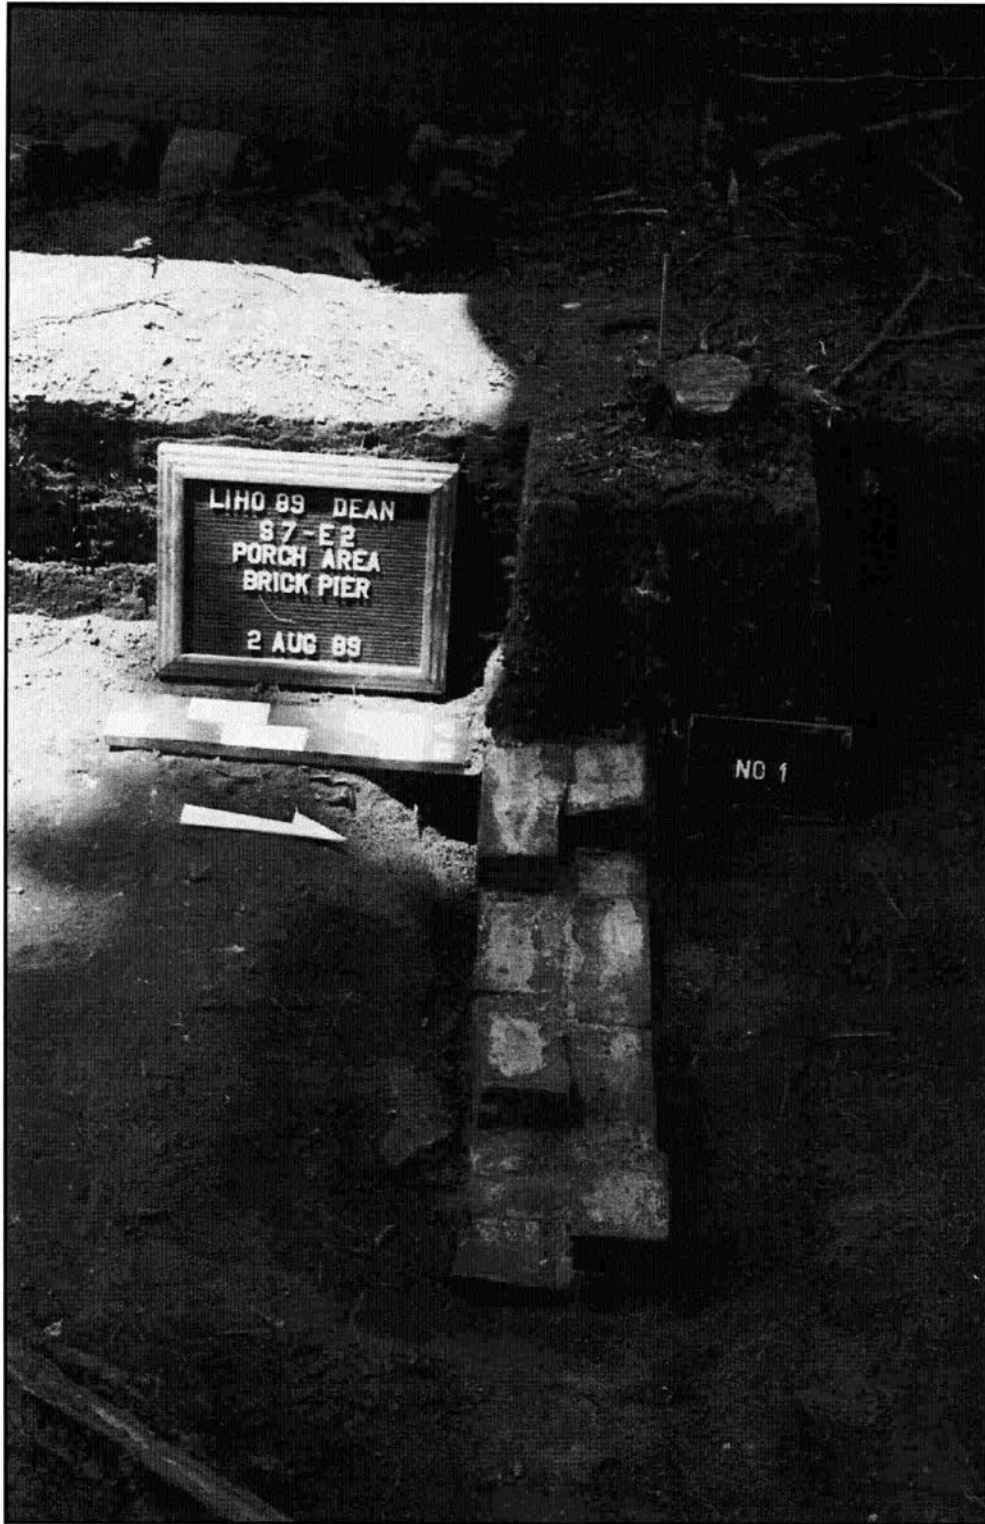
Figure 14. Front porch area and the north brick alignment, looking west toward the entry of the Harriet Dean House.

The paired brick features run slightly more than 5 ft out from the vestibule foundation and are laid up in courses that are two bricks thick. The north (No. 1) brick alignment (Figures 14 and 15) measures approximately 163 cm (64 in) long, and the south one is about 166 cm (65.5 in). There is no indication on the distal end of either element that any bricks had been removed to shorten the length of the alignments, suggesting the original length was intended to extend about 5 ft from the house foundation. The rather inconsequential differences in length perhaps can best be attributed to minor irregularities in individual brick sizing and small variances in the mortared spacing between the coursed brick.

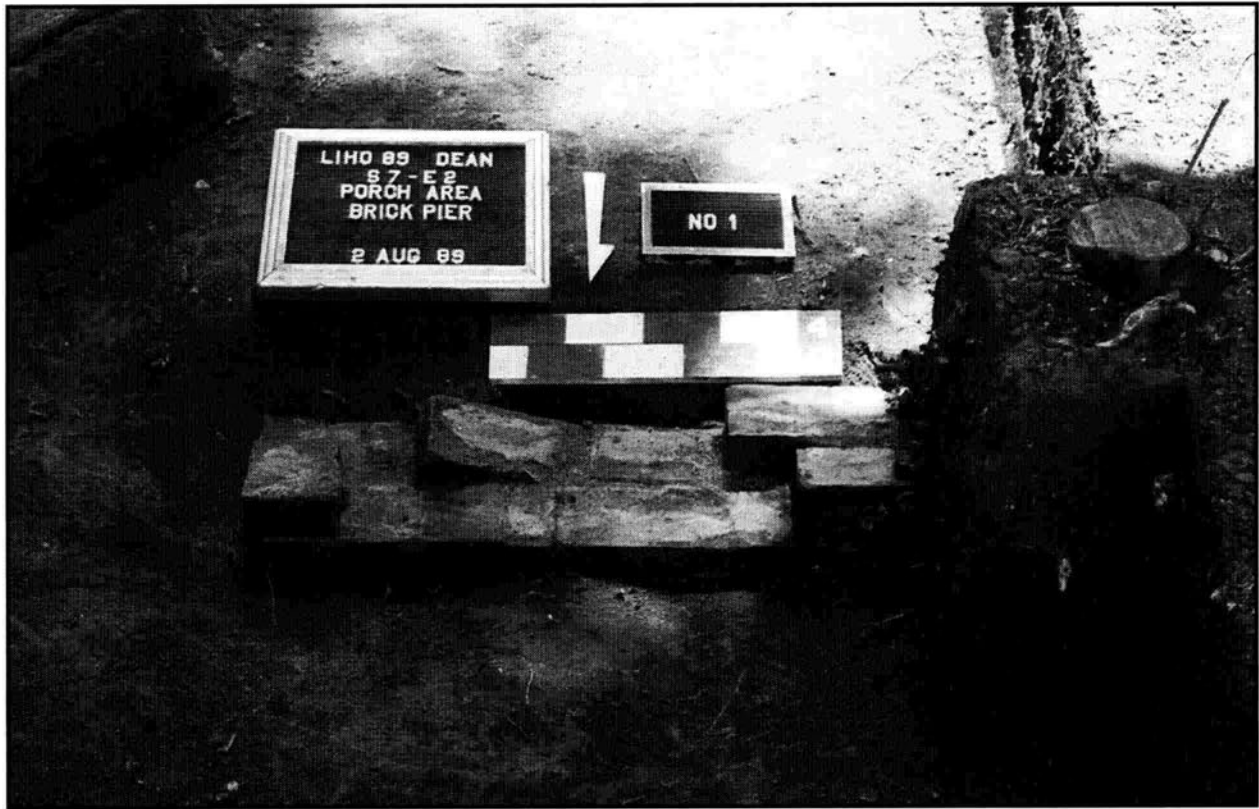
Figure 15. Front porch area and profile of the north brick alignment.

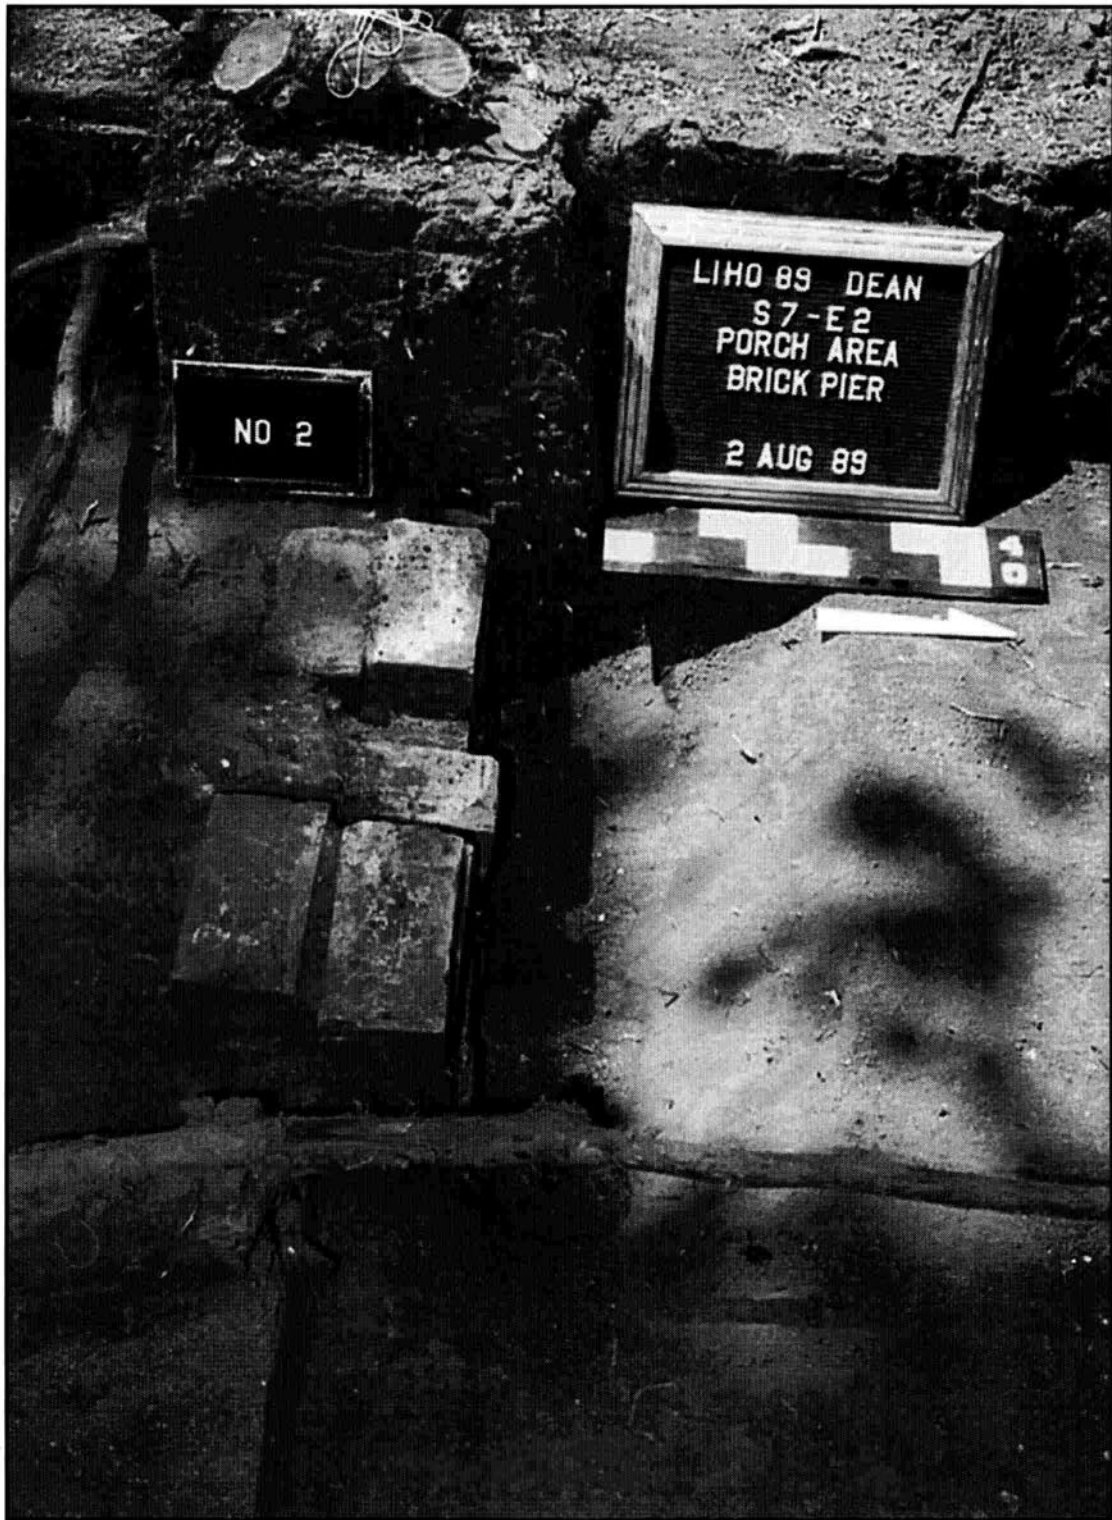
Figure 16. Front porch area and the south brick alignment, looking west toward the entry of the Harriet Dean House.

As many as six courses of brick were still present in the south (No. 2) alignment when that feature was exposed in 1989 (Figures 16 and 17). The uppermost course clearly was not the true top of the structure, however, since the superior surface of those bricks also exhibited residual mortar, indicating that at least one more course above that had been removed. It is also worth noting that the south element was covered by approximately 30 cm (12 in) of soil, and the north element, which had fewer surviving courses, averaged about 60 cm (24 in) below grade in 1989. Unfortunately, it could not be determined by examining the soil deposits if the grade present at the front of the Dean House in 1989 conformed to the grade when those structural elements were built. Excavations around many other houses in the neighborhood have consistently shown changes in grade dating from the time of original construction. This is generally attributed to the spreading of earth removed from the basement cavities across the ground surface, which eliminated the need to haul that material away, or from subsequent modifications in more recent times. Brick walkways associated with such neighborhood structures as the Julia Sprigg House and Henson Robinson House, for example, have been discovered at varying depths below their adjacent ground surfaces today.

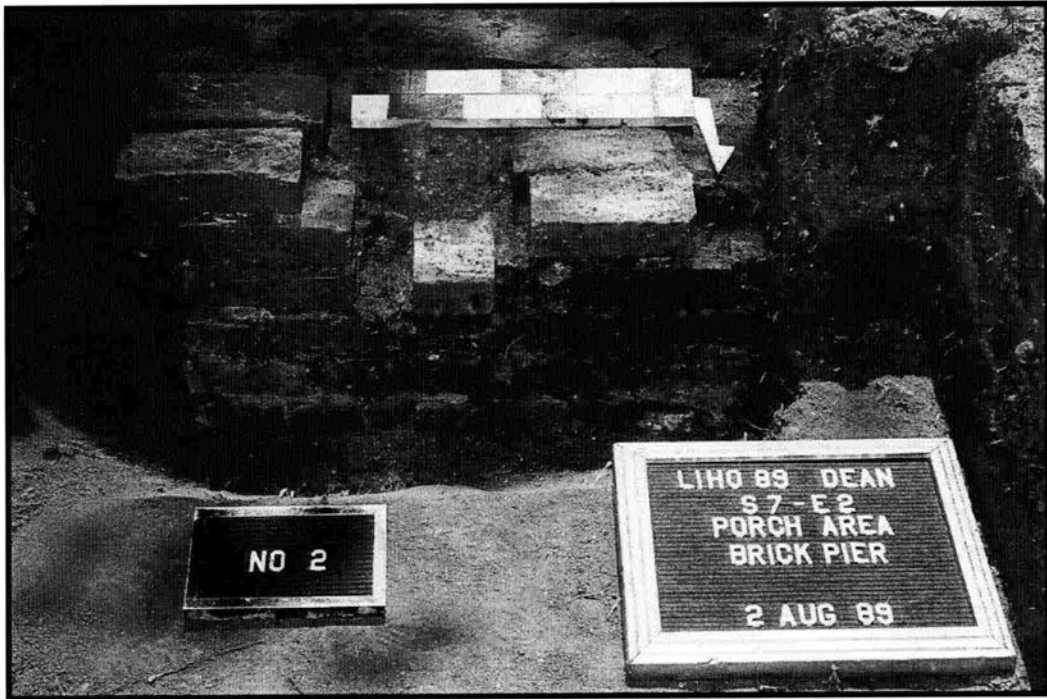
Figure 17. Front porch area and profile of south brick alignment.

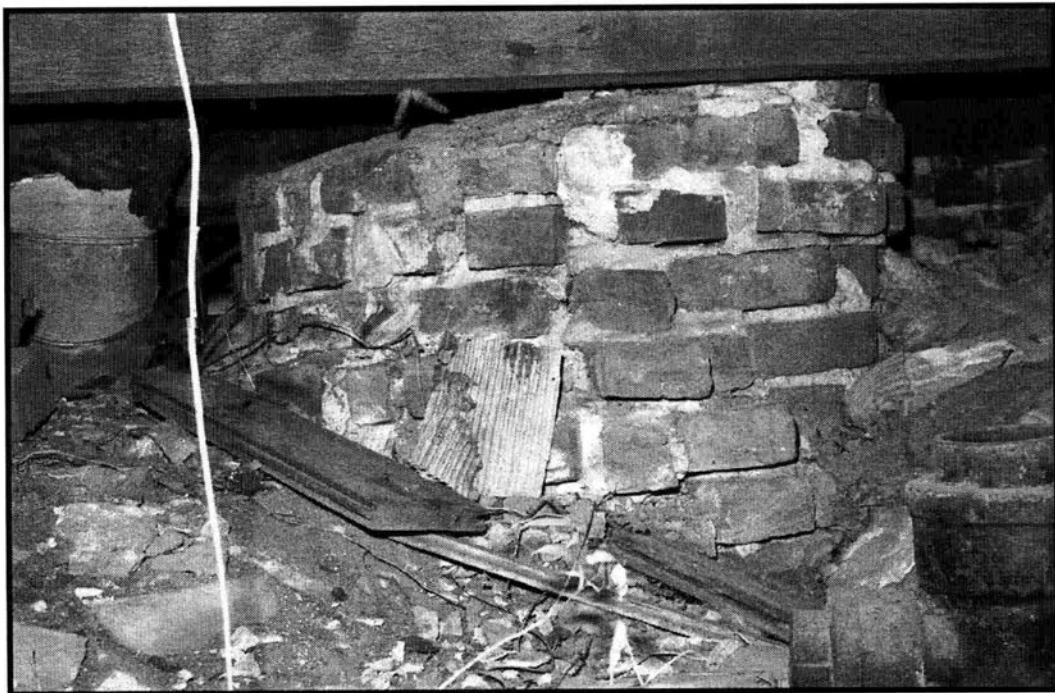
Figure 18. Cistern in Harriet Dean House crawl space.

During earlier field investigations at the Dean House, park staff had directed our attention to the presence of what was believed to be a large well or cistern beneath flooring in the northwest quarter of the building (Figure 18). That feature had apparently been rendered useless when the house was expanded over it. Access to the feature was not possible, however, until floorboards were pulled up as part of demolition activities inside the house. A concrete plug had been poured into the opening, which was removed by dismantling the brick collar after it was recorded. It soon became clear that the feature was an abandoned cistern, probably once associated with a former porch now enclosed as a room. The cistern cavity was empty, except for some silt in the bottom and a discarded light bulb of relatively modern manufacture. The bell-shaped reservoir measured approximately 10 ft (ca. 3 m) in diameter with the floor about 10 ft below the oculus.
