# **CULTURAL LANDSCAPE REPORT, AQUATIC PARK**

## **SAN FRANCISCO MARITIME, NATIONAL HISTORICAL PARK**

**NATIONAL PARK SERVICE**  
**PACIFIC WEST REGION**  
**2010**

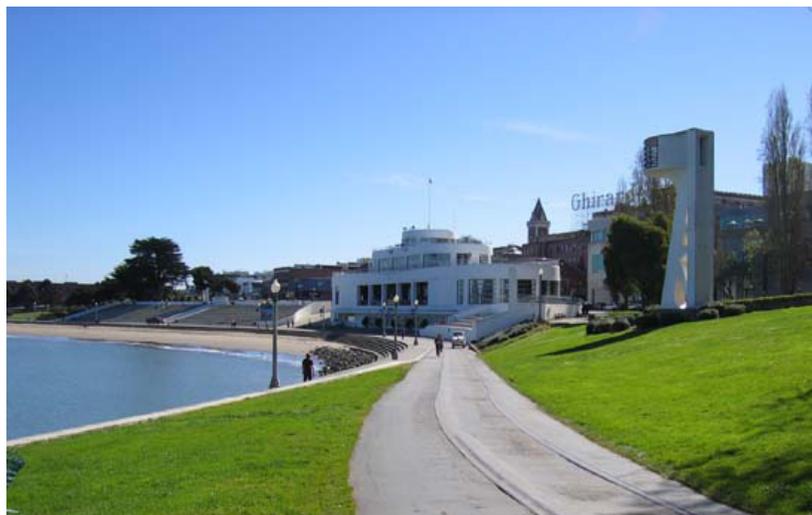
**Figure 1.** View from the west end of the park, looking toward the West Speaker Tower, Bathhouse, and bleachers. (NPS, 2007)

Today Aquatic Park is a historic designed landscape, significant in the area of community planning and development by the Works Progress Administration and the Federal Art Project during the 1930s. Additionally, Aquatic Park is an outstanding example of the Streamlined Moderne style applied to the design of both the buildings and grounds that make up the park. Today, the park remains a unique recreational and cultural resource along the San Francisco waterfront. (Figure 1)

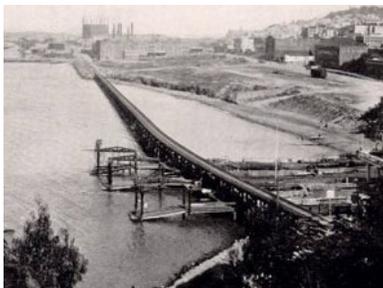
**Figure 6.** The State Belt Railroad trestle across Black Point Cove, ca. 1915. Future site of Aquatic Park in on the right. View looking east. (Courtesy of the San Francisco History Center, San Francisco Public Library AAA 6723)

that the opportunity to establish a park was slipping away, the San Francisco Recreation League petitioned the San Francisco Board of Supervisors to obtain an order to stop the dumping. In addition, the Recreation League and the South End Rowing Club—who by then had a boathouse at the foot of Van Ness Avenue, tried to arrange an exchange between the Southern Pacific Railroad with a parcel at the foot of Van Ness Avenue and land owned by the City of San Francisco on the southern waterfront. By March 1914, after the State Belt Railroad completed construction of a trestle across the cove and a tunnel under Black Point, several other rowing clubs joined the San Francisco Recreation League to protest additional filling of the cove at the north end of blocks 33, 36, and 37 (located on either side of today’s Jefferson Street). Filling operations in the cove ended in 1914, although the city continued dumping into the following year. The damage to the cove was tremendous; the sand beach was gone, covered with tons of rubble, mud, and rock, and much of the former cove was now dry land. Moreover, the railroad trestle interrupted access to the water for swimmers and rowers. Community concern eventually reached a critical point when public support galvanized and key officials for both the army and city became involved and supported the movement to construct a public park.<sup>14</sup> (Figure 6)

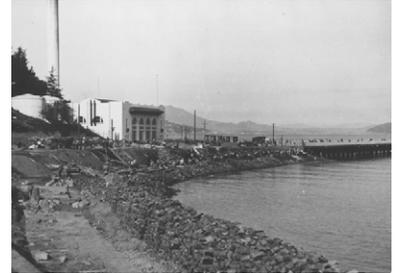
**Figure 9.** Large amounts of debris and rubble dumped along the shoreline of the cove were used to construct a crude seawall. (*San Francisco Maritime NHP, Historic Documents, Photograph Collection, P88-035.00033*)

grade, and prepare the shoreline area below Beach Street. After receiving approval for the government to build on the site, the army contracted to remove and rebuild the wharf at the city's expense. The former seawall and small walkway around the east side of Black Point were slowly filled in by thousands of cubic yards of fill, placed to form a broad platform for an extension of Van Ness Avenue out towards the pier. In addition, 47 truckloads and 12 railroad cars full of cobblestones salvaged from reconstructed San Francisco streets were hauled to the site and stockpiled in the park.<sup>21</sup> A crude seawall was constructed around the shoreline to hold the unconsolidated fill material. (Figure 9)

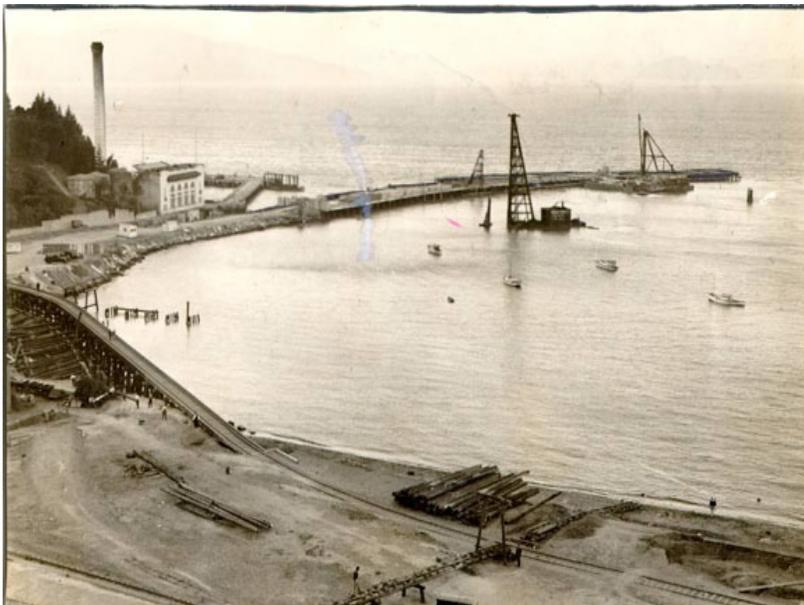
**Figure 10.** Municipal Pier under construction in 1932. Note the realigned State Belt Railroad trestle in the foreground. (*Courtesy of the San Francisco History Center, San Francisco Public Library, AAC 2288*)

At the same time the grading and filling was in full swing, casting for concrete pilings of the pier were underway. In July 1931, the city contracted to build approximately 636 feet or about one-third of the eventual length of the new pier. Construction of the support pilings began in August of 1931, and by the middle of 1933 the pier extended its full 1,850-foot length. (Figure 10) Concrete curbing, benches, and parapet wall along the pier were added in October 1933. Work on the pier ended in March of 1934.<sup>22</sup> Construction of Municipal Pier and preparatory hand grading for the proposed park proceeded with small amounts of money from the city. Work was completed with borrowed tools and salvaged materials, such as the lumber used for cribbing and the tons of granite cobblestones hauled to the site. It was soon clear

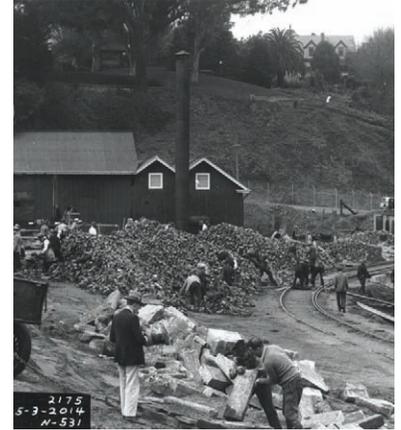
**Figure 11.** Collected from city improvement projects, a variety of salvage materials were brought to the site and used as fill material. View looking west. (*San Francisco Maritime NHP, Historic Documents, Photograph Collection, P88-035.00027*)

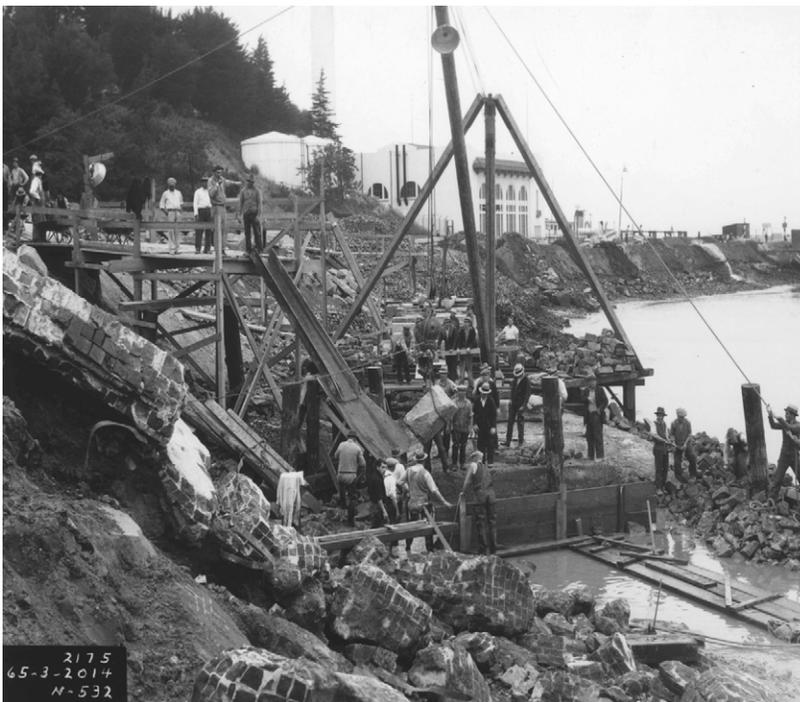
**Figure 12.** Detail of WPA photograph showing work crews using derricks, pulleys, and other devices to place large stone for the foundations of structures built around the cove. Note the building debris dumped on the slope for use as fill. View looking west. (*San Francisco Maritime NHP, Historic Documents, Photograph Collection, P88-035.00007*)

In early 1936, 782 WPA laborers arrived at the site to begin construction of Aquatic Park.<sup>26</sup> One of the initial projects for the crews was construction of a new concrete and stone seawall along the shore of the cove. The new seawall was designed to follow a gentle curve around the cove, and also to create a structurally stable area south of the excavations for construction of the new Bathhouse at the foot of Polk Street. Masons laid thousands of basalt blocks, hauled to the site between 1931 and 1933. These materials were collected from city streets that were being modernized and widened to accommodate better vehicle access to the new Golden Gate and Bay bridges. Other fill came from the excavation for the Bathhouse and rubble collected on the beach. (Figure 11) Work on the wall progressed gradually, rising and curving along the shoreline until it reached the base of Municipal Pier. The former rubble and concrete seawall haphazardly constructed near Municipal Pier in 1931 was torn down, and the base of the structure reused as the foundation for the new wall. Debris, along with the rubble from the beach and other site grading was used to backfill the seawall. (Figure 12)

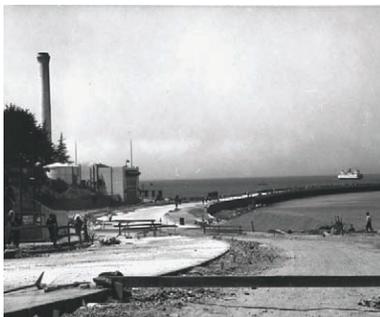
**Figure 13.** WPA photograph showing the extension of Van Ness Avenue down to the Municipal Pier, July, 1936. (*San Francisco Maritime NHP, Historic Documents, Photograph Collection, P88-035.00048*)

Once the seawall was completed, additional excavations including cuts, fill, and overall grading for the park began. Fill was added along the west side of the park to allow for the extension of Van Ness Avenue to the Municipal Pier. Headstones from city cemeteries (closed throughout the city in the late 1920s) were cut and shaped to make a flat plug between the original 1911 military seawall and the new WPA seawall, closing a gap between the two structures. Van Ness Avenue was graded and paved all the way to the pier providing access for construction trucks and other vehicles. (Figure 13)

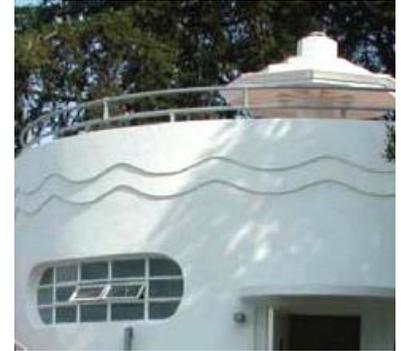
**Figure 14.** Architectural details such as wavy lines, metal railings, and nautical-style windows are characteristic of the Streamlined Moderne style expressed in the structures and grounds at Aquatic Park. (NPS, 2008)

of airplanes and ships constructed using aerodynamic engineering principles. Nautical references to luxury liners found their way into the design components of many buildings during the 1930s, including those of Aquatic Park. (Figure 14) Press releases from the WPA played on both the nautical and modern aspects of Mooser’s design and described the Bathhouse as:

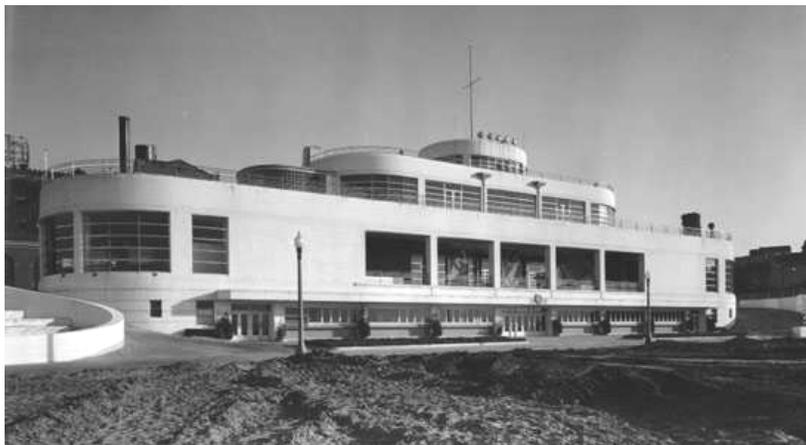
**Figure 15.** The Aquatic Park Bathhouse designed by William Mooser Jr. displayed many architectural components of the Streamlined Moderne style. (Courtesy of the San Francisco History Center, San Francisco Public Library, AAA 6748)

*...streamlined and modern to the last degree . . . with rounded ends, set-back upper stories, porthole windows and ship rails, its resemblance to a luxurious ocean liner is indeed startling.*<sup>30</sup> (Figure 15)

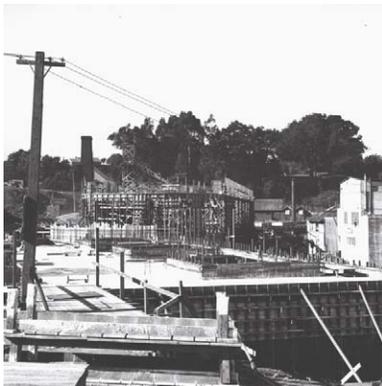
**Figure 18.** By February 1937, crews were framing and completing concrete work for the upper floors of the Bathhouse. (*San Francisco Maritime NHP, Historic Documents, Photograph Collection, P88-035.00074*)

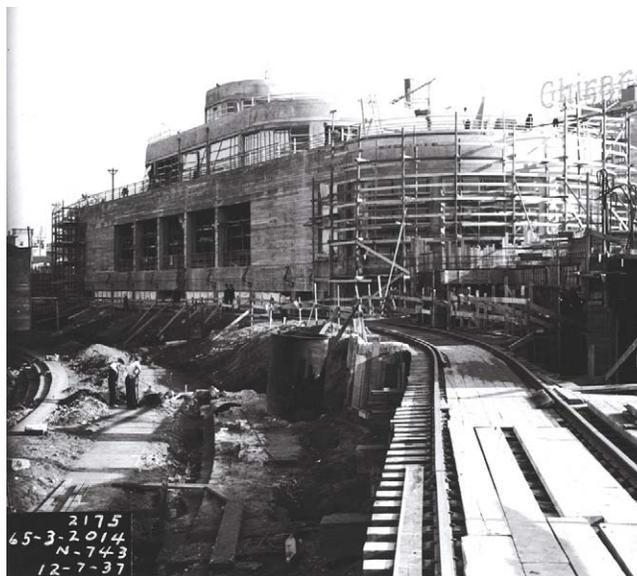
**Figure 19.** WPA photograph showing the relocated State Belt Railroad tracks, extent of excavations, and by the end of 1937, progress on construction of the Bathhouse. View looking southeast. (*San Francisco Maritime NHP, Historic Documents, Photograph Collection, P88-035.00106*)

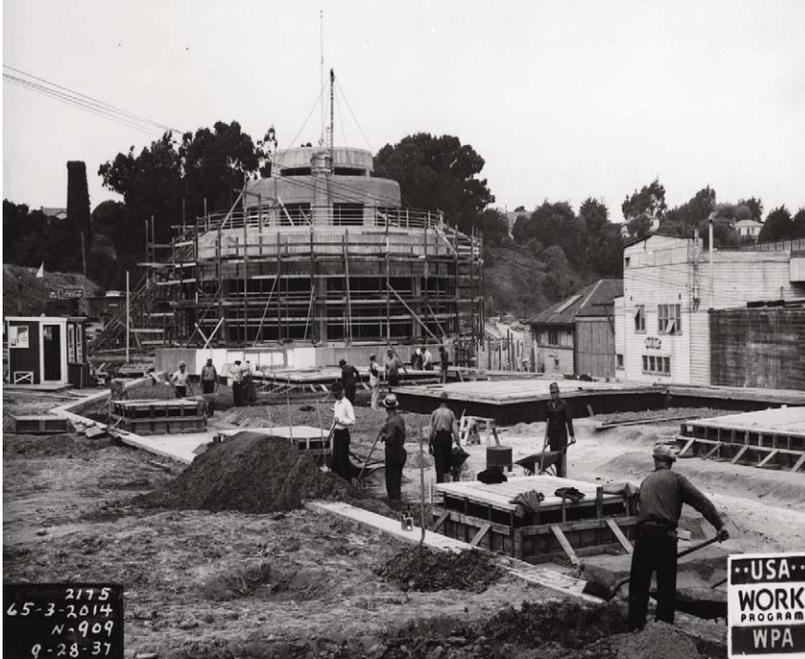
**Figure 20.** Site work and rough grading east of the Bathhouse moved quickly through the fall of 1937. View looking west. (*San Francisco Maritime NHP, Historic Documents, Photograph Collection, P88-035.00087*)

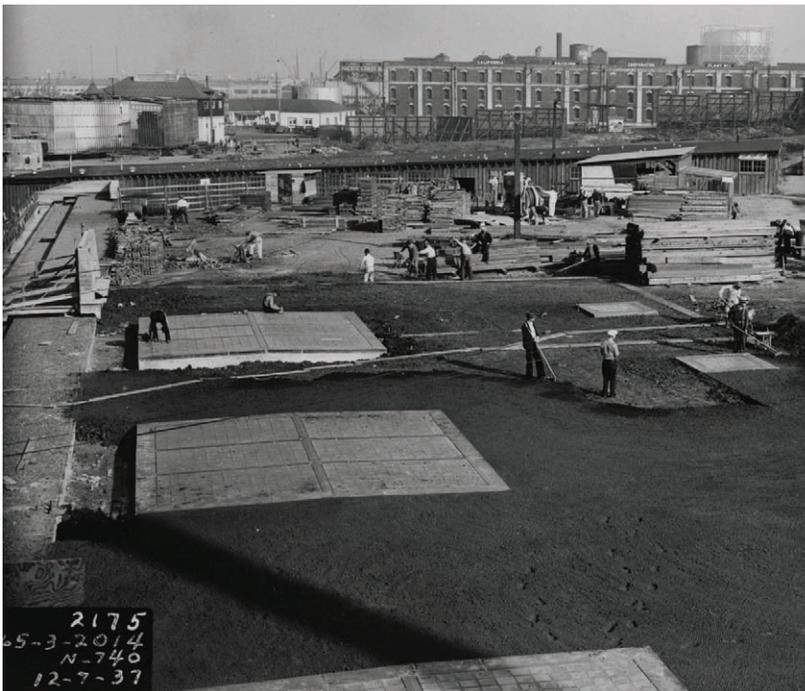
**Figure 21.** By December, 1937, finish grading around the skylights provided the level area needed for the establishment of turf grass and planting beds east of the Bathhouse. View looking east. (*San Francisco Maritime NHP, Historic Documents, Photograph Collection, P88-035.00102*)

**Figure 22.** Detail of WPA photograph showing progress towards completion of several structures in Aquatic Park including the West Convenience Station, the West Speaker Tower, the West Bleachers, the final alignment of the State Belt Railroad tracks, and the Seawall around the cove. May, 1938. (*San Francisco Maritime NHP, Historic Documents, Photograph Collection, P88-035.00139*)

WPA work at the park and construction of the park structures was relatively concentrated into a two-year period of year-around activity. In early 1936, excavations for the Bathhouse were underway and before the fall, concrete foundations were poured. The extent of the excavations for the building required relocation of the State Belt Railroad tracks, moved once already, farther south toward Beach Street. By October 1936, framing of the lower portion of the Bathhouse was nearing completion, and work began on the upper stories. (Figures 18, 19) While work was proceeding with the Bathhouse, grading and site work around the structure was also underway. Within the year and by the spring of 1937, framing for the Bathhouse was complete and grading and site work around the skylights and bleachers was nearing completion. (Figure 20) During the winter of 1937, construction was accelerating on the west side of the park, and finish grading of the terraces on the east side of the Bathhouse was completed and prepared for planting. (Figure 21)

speaker towers at each end of the park, and work was nearing completion on two of the three convenience stations. Along the cove, gravel was placed as a foundation for the concrete sidewalks behind the seawall, as well as for a large concrete wall required to retain the slope between Van Ness Avenue and Fort Mason. (Figure 22)

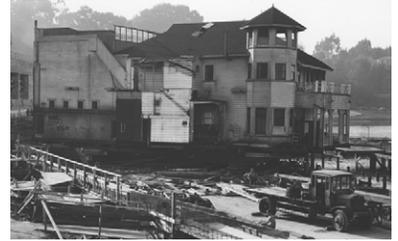
**Figure 24.** Detail of a WPA photograph showing construction and waterproofing of the East Bleachers. View looking east. (*San Francisco Maritime NHP, Historic Documents, Photograph Collection, P88-035.00140*)

In April 1938, work began on the concrete bleachers over the men’s dressing rooms on the east wing of the Bathhouse and the women’s dressing rooms on the west wing. The following month, waterproofing on the East Bleachers was underway and the West Bleachers were nearing completion. (Figure 24)

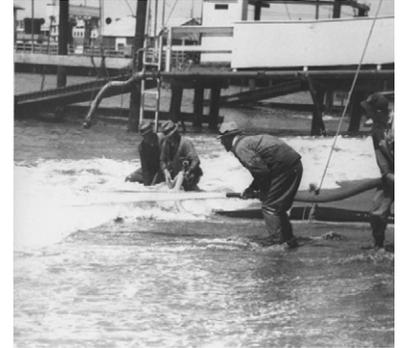
**Figure 26.** Agitating with hoses to redistribute sand and replenish the beach, 1939. (Courtesy of the San Francisco History Center, San Francisco Public Library, AAA 6708)

Mieldazis also noted that the beach was “inadequate” for recreation and remedial action by the city was required to prevent scouring of the beach by high tides. The memo went on to note that maintenance and repair of the beach was the city’s responsibility.<sup>36</sup> (Figure 26) The beach was initially stabilized using wood breakwaters. Then in July 1941, 80 million cubic feet of sand (excavated during construction of the Union Square Parking Garage) was hauled to Aquatic Park and used to supplement and re-contour the beach. (Figure 27) Only three years later, erosion continued and tidal action began to undermine the sea wall, at which point additional sand was brought in and wood groins were placed in the sand to mitigate future erosion.<sup>37</sup>

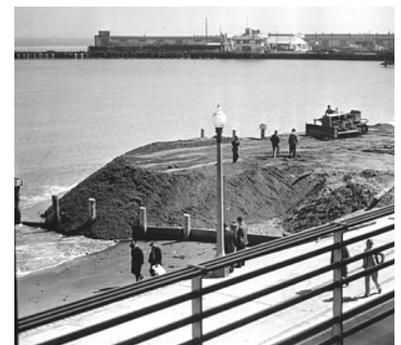
**Figure 27.** Sand brought to supplement the eroding beach, 1941. View looking east. (Courtesy of the San Francisco History Center, San Francisco Public Library, AAA 6691)

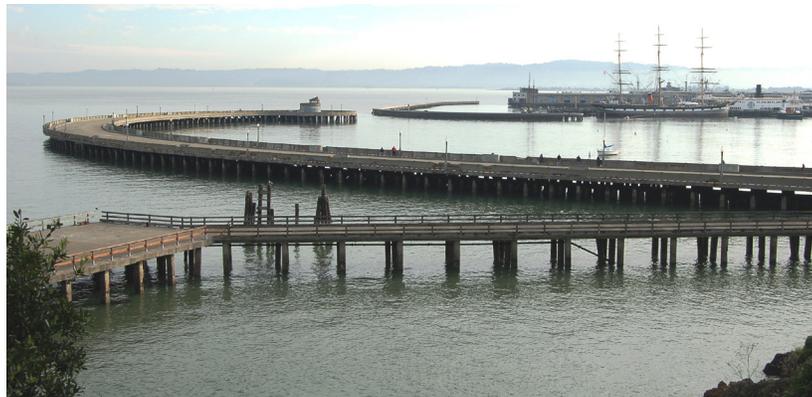
**Figure 43.** View to the Municipal Pier as it arcs around Aquatic Park Cove. Fort Mason Pier 4 in the foreground. View looking northeast. (NPS, 2007)

The primary historic structures in Aquatic Park are located around the shoreline of the cove and are oriented towards the water and the Beach Promenade, which follows the shoreline from the east boundary of the park to Van Ness Avenue. (Figure 42) The Municipal Pier extends out along the northwest side of the cove. It is used by park visitors for a variety of recreational activities such as sightseeing, photography, strolling, and fishing. (Figure 43)

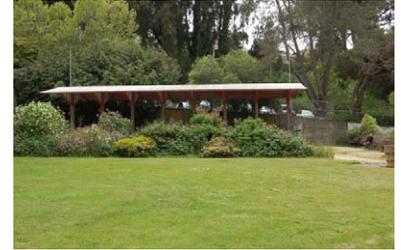
**Figure 44.** View of the overhead structure covering the Bocce Ball Courts located in the southwest corner of the park. (NPS, 2007)

Structures associated with the bocce ball courts are situated in the southwest portion of Aquatic Park including two courts and a small wood-frame building used by the Aquatic Park Bocce Ball Association as their clubhouse. (Figure 44)

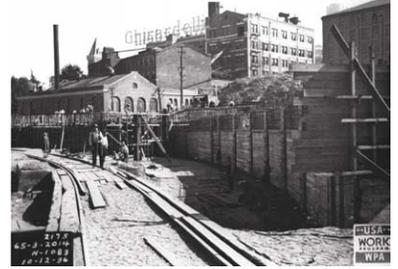
**Figure 49.** WPA photograph showing the retaining structures required prior to relocation of the State Belt Railroad tracks. (*San Francisco Maritime NHP, Historic Documents, Photograph Collection, SAFR-N-2-26*)

landscape graded so that the main entry to the building would meet grade at Beach Street, and the entry on the north side of the building was at the same grade as the Beach Promenade. Some fill was added along Beach Street for a parking area. The excavation and grading for the Bathhouse was the central topographic influence on subsequent grading and the placement of structural retaining walls at the park. (Figure 49)

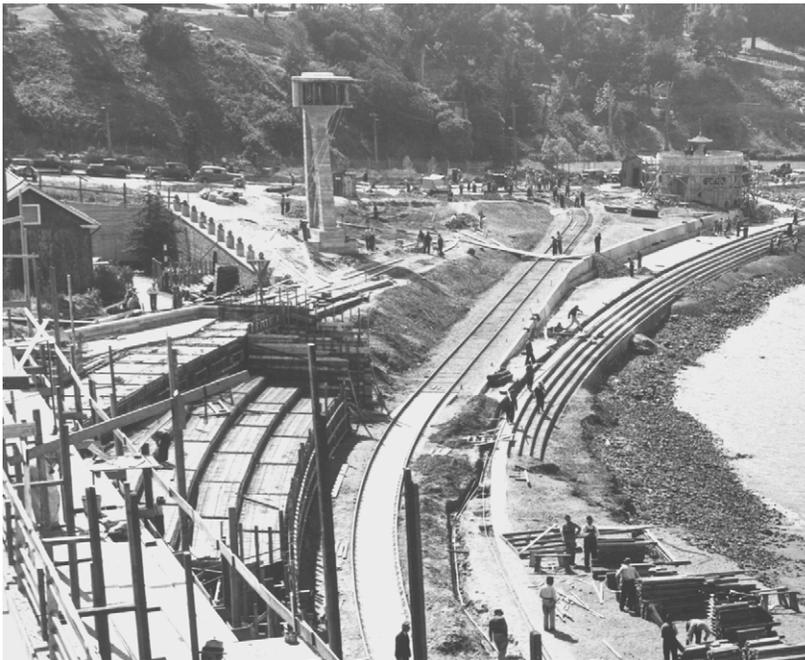
**Figure 50.** Detail of WPA photograph showing the number of topographic modifications to the slope around the cove that were part of the site design and construction of Aquatic Park, 1938. (*San Francisco Maritime NHP, Historic Documents, Photograph Collection, P88-035.00139*)

In addition to the seawall, which defined the shoreline of the park, retaining walls were used throughout the site to create a stepped grade around the cove, and topographic transitions from the cove to Beach Street. A concrete retaining wall was built on the south side of the Beach Promenade and a basalt block retaining wall was built just north of the Black Point Pump House. Fill was added between these two walls, and the slope graded so that the elevation decreased from the basalt block wall to the Beach Promenade wall, tapering towards the west side of the park, where the grade met the edge of Van Ness Avenue. In 1938, the large structural terraces on both sides of the Bathhouse were leveled and seeded with grass. Sloping walkways and steps were used to create transitions and allow pedestrian access between the terraces and down to the Beach Promenade. (Figure 50)

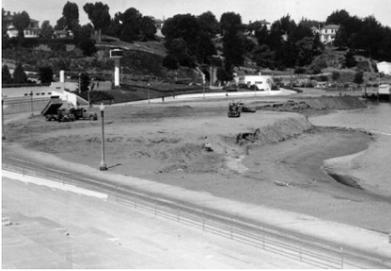
**Figure 51.** Sand distributed on the bathing beach in Aquatic Park, 1941. View looking west. (Courtesy of the San Francisco History Center, San Francisco Public Library, AAA 6701)

In order to create a gently sloping recreational beach along the cove, 24 railcar loads of sand (from beaches in Monterey) were added to the shoreline north of the seawall. Within several years however, a severe storm removed all of this sand, and in July 1941, 80 million cubic feet of sand from construction excavations of the Union Square Parking Garage were hauled to the Aquatic Park beach, further extending the shoreline into the cove.<sup>5</sup> This fill reestablished a broad, clean sandy beach in place of the exposed rubble-filled shoreline. (Figure 51)

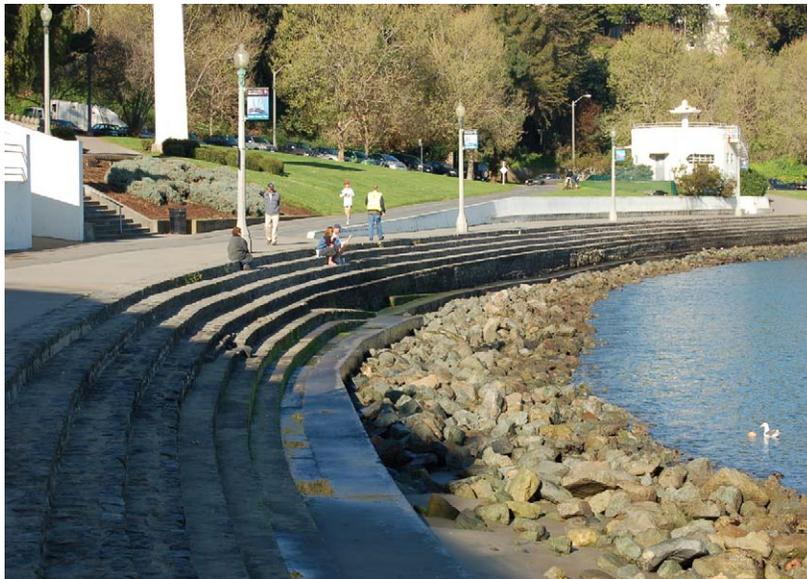
**Figure 52.** Current view of Seawall around the cove stepping to the Beach Promenade and the slope above to the Upper Promenade. View looking west. (NPS, 2006)

stabilized by constructing retaining walls and adding fill to create level terraces and sloping planes. Pedestrian movement through the park was structured by transitions between these terraces and grade changes, using ramped walkways and steps. (Figure 52)

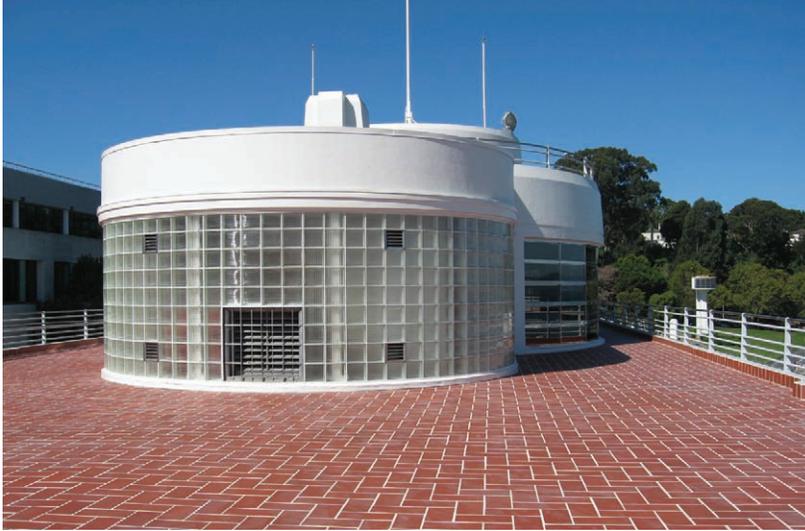
**Figure 55.** Rehabilitation work at the Bathhouse in 2008 included the installation of a new stainless steel window system; and a modern waterproofing system for the building roofs with new roof tiles to match the historic ones that could not be salvaged. The rehabilitated glass block pantry is now the elevator lobby on the 3rd floor. (NPS, 2008)

The most recent renovations to the building include replacement of 90 percent of the windows and doors in the building with a new system that preserves the appearance of the original design and conservation of the wall mural in the lobby. (Figure 55)

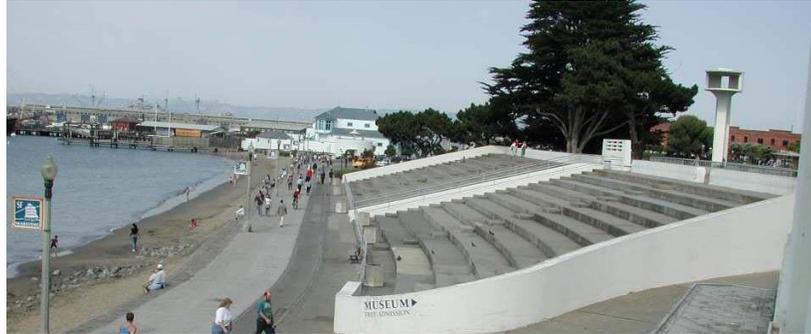
**Figure 56.** East Bleachers prior to rehabilitation work. View looking east. (NPS, 2007)

Concrete bleachers flank the east and west sides of the Bathhouse and beneath them are the former shower and locker rooms that create a continuous ground floor with the lowest level of the Bathhouse. Streamlined Moderne style details are incorporated into the bleacher wing walls. The East Bleacher structure, which measures 65 x 250 feet and with 11 rows for seating, is the larger of the two structures. It is composed of two parts separated by a driveway and entries into the structures below, and is generally known as the center and east bleachers for clarity's sake. The space under the center bleachers was originally the men's and boy's

shower facility. It is now used for the park’s exhibit staff office, workshop, and storage. The space under the East Bleachers includes the original hospital that was used by the NPS as a lifeguard station and now as an office for the facility management division. The rest of the space under the East Bleacher is used for a metal shop, machine shop, and facility maintenance storage. The West Bleacher measures 30 x 100 feet and comprises four rows of seats. The space beneath the West Bleacher is used as a ceramics studio by the Senior Center and was formerly office, work and storage space for the park’s grounds crew. Once the bleachers are rehabilitated, grounds crew will move into the East Bleachers and their former space will become offices for park rangers. (Figure 56 )

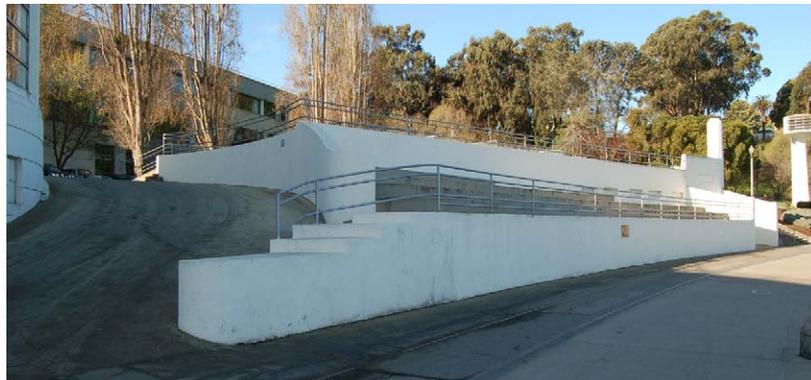
**Figure 57.** West Bleachers prior to rehabilitation. Note the ramp between the bleachers and the Bathhouse. View looking southwest. (NPS, 2007)

Between the Bathhouse and the bleachers, vehicular ramps lead from Beach Street to the Beach Promenade. (Figure 57) These ramps curve around the east and west ends of the Bathhouse, and repeat the elliptical forms characteristic of the complex of buildings and structures in Aquatic Park. Metal handrails, similar to those forming the Bathhouse parapet rails, separate the bleachers from the Beach Promenade and line the entryway, in the center of the east bleachers to the Bathhouse changing rooms.

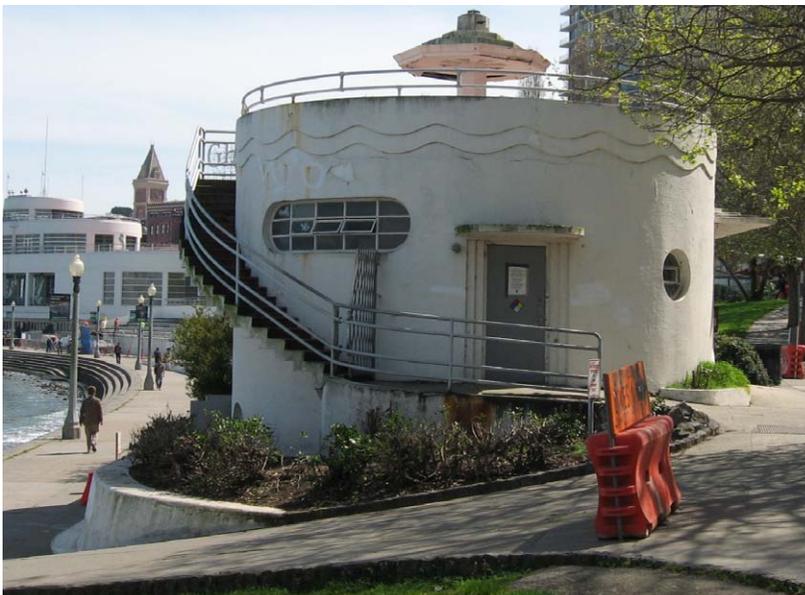
**Figure 58.** West Convenience Station. View looking east. (NPS 2010)

The West Convenience Station is located on the west side of the park near Van Ness Avenue and the approach to the Municipal Pier. The building originally contained a concession stand and restrooms. Today the concession stand is not used and the restroom fixtures have been removed so that the building can be used to store facility management supplies and materials during the bleacher rehabilitation project. The building was constructed by the WPA and architecturally reflects nautically inspired Streamlined Moderne style elements similar to other park buildings. (Figure 58) The two-story building measures 27 x 30 feet and is embellished with two bands of a wave design along the upper portion of the exterior walls. The fixed metal sash windows in the restroom are shaped like portholes. The building also contains a partial basement that is used for storage. Changes to the building since the period of significance include

construction of a new concrete floor, addition of new kitchen equipment and a stainless steel counter, as well as the addition of an awning over the counter and serving windows in the concession stand. A stairway leading to the roof and observation deck wraps around the exterior of the building. The deck has built-in benches and a small unfinished shelter, designed to provide lookouts for lifeguards. The roof deck includes a metal rail parapet, similar to the metal parapet on the Bathhouse.

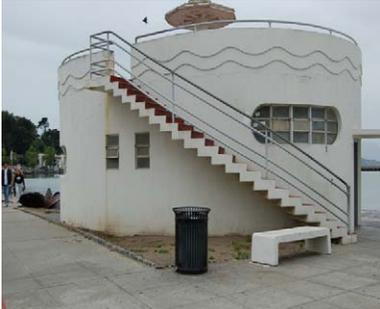
**Figure 59.** East Convenience Station. View looking west. (NPS, 2007)

The East Convenience Station is adjacent to the Rowing Club buildings at the end of Jefferson Street. The building was completed and opened to the public in 1944. The oval-shaped building has a white stucco exterior, similar to the West Convenience Station. Its principal design elements are stylistically consistent with the other buildings in the park with an elliptical form, banded wave designs, and a staircase that wraps around the exterior. (Figure 59) The roof of the building was also designed for use as a lifeguard station. Like the West Convenience Station, restroom fixtures have been removed and the building is currently used for storage.

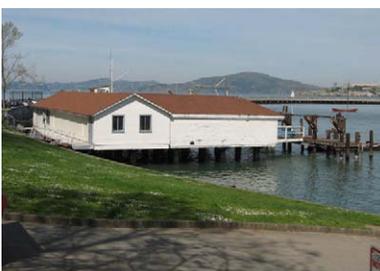
**Figure 60.** Sea Scout building at the west end of the cove. View looking north (NPS, 2010)

While the army was using Aquatic Park (1941-1948), it constructed a small landing wharf at the west end of the cove near the West Convenience Station and the end of the Municipal Pier. The facility, including a concrete pier and small wood-frame building, was built between 1943 and 1944, and was later expanded and remodeled. It now serves as the Sea Scout Building. Constructed on pilings, access to the one-story, wood-frame building, is by narrow concrete stairs from Van Ness Avenue. (Figure 60) The building contains many small rooms used for storage, offices, and classrooms. It also features a docking and boat repair facility for the Sea Scout organization. The WPA plans for development of the park included a building in this location for rowing clubs, and a similar building to be used by the Sea Scouts and the Unified School District was planned for the east side of the cove; neither was built due to a lack of funding. The park intends to extend the use of this building to include more park activities and partner education classes in the near future, making this building the core of the Maritime Heritage Learning Center.

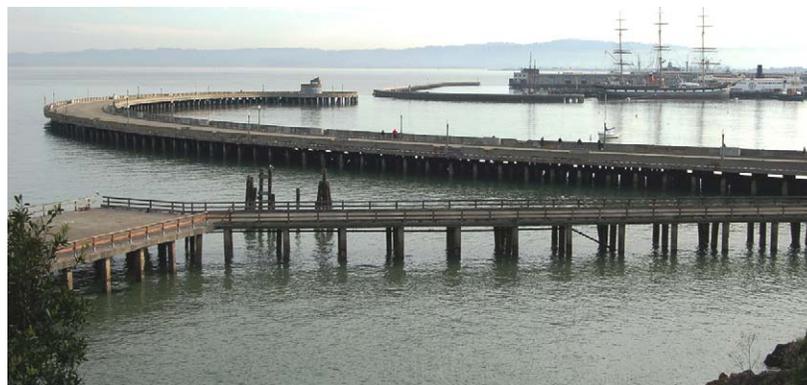
**Figure 63.** The Municipal Pier with Fort Mason Pier 4 in the foreground. View looking east. (NPS, 2007)

The baffles incorporated into the pier structure serve as a breakwater. Some riprap has been added over the years to act against scouring at the mud line. The pier is curvilinear in plan with a round, bulb-like end.

(Figure 63) The reinforced concrete and jacketed wood pilings support a concrete deck. Concrete curbs along the outer edges of the roadway serve both as a conduit for utility pipes and as a divider between vehicles and pedestrians. Concrete benches and streetlights are located at even intervals along the length of the pier. Most of the original streetlights function, but in some cases fixtures have been broken or removed and only the poles remain. The pier railing was designed to accommodate the placement of the concrete benches. Notches in the railing opposite the benches provide easier access for fishing and improve views to the water while seated.

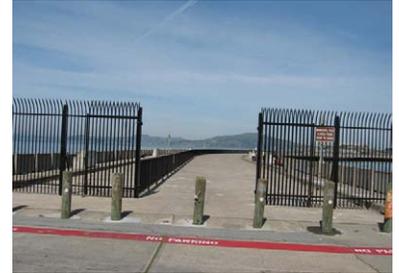
**Figure 64.** Fencing was added to the Municipal Pier in 2008 and 2009 to enhance safety until structural improvements can be completed. View looking north. (NPS, 2010)

Today the pier is in very poor condition due to saturation by seawater and deterioration of metal rebar. In 2008, the park installed a fenced gate at the entrance to the pier for safety reasons, and in 2009 most of the west (bay) side of the structure was also fenced to prevent access to the most deteriorated portion of the structure. The National Park Service is in the process of planning a major rehabilitation project to repair and stabilize the structure. (Figure 64)

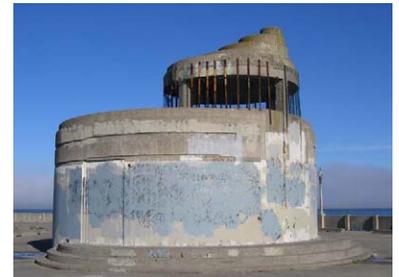
**Figure 65.** The unfinished convenience station at the end of the Municipal Pier. (NPS, 2007)

The convenience station and lifesaving station at the end of the pier was less than 50 percent complete when the WPA turned the project over to the city. These structures remain unfinished today. The circular building was designed to match the other two convenience stations in Aquatic Park. Only the rough concrete exterior was constructed. Access to the unfinished building is by bolted hatches on the roof. The interior rooms are currently filled with rubble and water. (Figure 65)

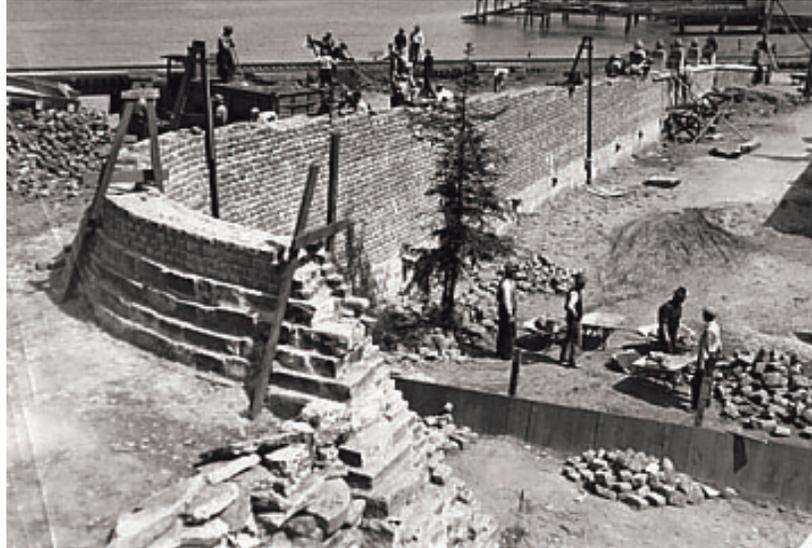
**Figures 66.** Constructed in 1936, the stone masonry retaining wall located on the west end of the park, was a significant structure, stepping down from the highest point near Van Ness Avenue. View looking east. (Courtesy of the San Francisco History Center, San Francisco Public Library AAA 6725)

station pre-dates most of the park construction by the WPA. The stone wall and much of the fill material used to construct this wall came from cemeteries located in the Richmond District and Laurel Hill sections of the city, when the graveyards were moved to Colma in the early part of the 20th century. The wall has concrete coping with granite piers and acorn finials on top. This wall was significantly altered during construction of Aquatic Park. The original wall was longer and the western end had a curve. The eastern end was also either angled or curved. Today, with the

exception of a single acorn finial, the east section of the wall is largely buried and the west side, including the curved portion of the wall, was removed at an unknown date. (Figures 66, 67)

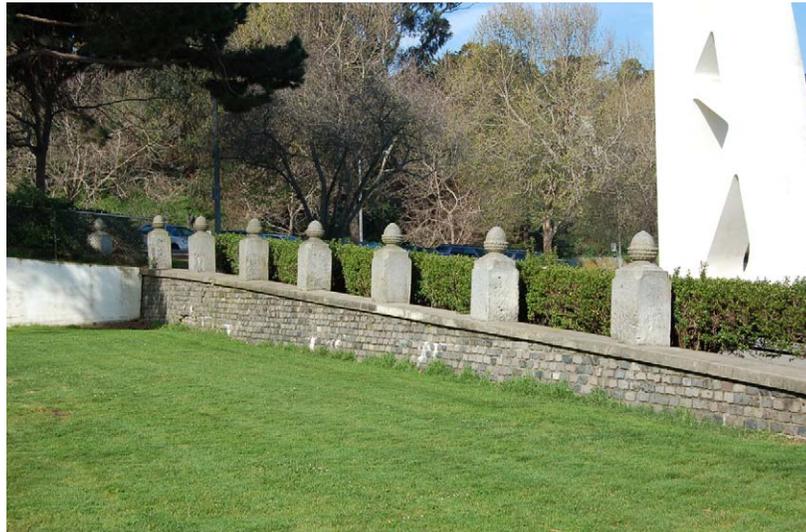
**Figures 67.** Stone masonry retaining wall as it appears today near the Bocce Ball Courts. A considerable amount of backfilled was used after the pumping station was removed to create a level grade on the south side of the structure. View looking west towards Van Ness Avenue. (NPS 2007)

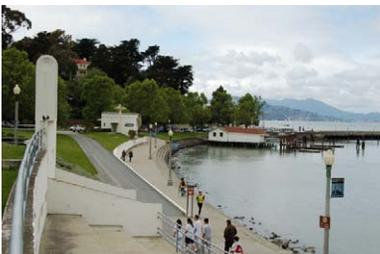
**Figure 68.** Beach Promenade in front of the Bathhouse, view looking west. (NPS, 2007)

The Beach Promenade is paved with concrete and has a uniform width of approximately 15 feet. In the early site plans for Aquatic Park, city engineer John Punnett used the term “promenade” for the walk along the water, suggesting that this primary pedestrian route was designed to be somewhat grand. The Beach Promenade begins at the east end of the seawall, adjacent to the East Convenience Station, and continues west along the cove to Van Ness Avenue. It provides access to the beach, the convenience stations, the bleachers, the Bathhouse, Van Ness Avenue, and the Municipal Pier. The Beach Promenade connects Jefferson Street on the east with Van Ness Avenue on the west, paved walkways near the east and west bleachers, and the two concrete ramps that curve around the Bathhouse. (Figure 68)

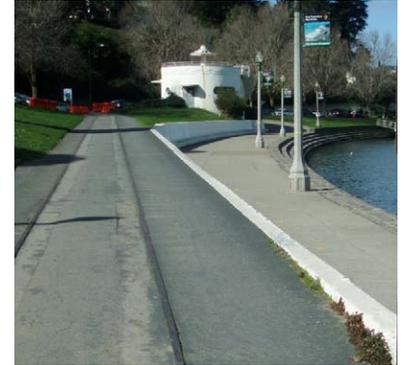
**Figure 69.** Asphalt walkway located between the Beach Promenade and the slope up to the Upper Promenade with the tracks at grade. (NPS, 2007)

The initial design for Aquatic Park incorporated the alignment of both the State Belt Railroad tracks and the Municipal Pier into the overall circulation system. The State Belt Railroad was originally constructed as a single standard-gauge track on a trestle over the lagoon in 1914. These tracks were relocated (in 1925 and again in 1936) and incorporated into the Beach Promenade during development of the park. The State Belt Railroad of California was renamed the San Francisco Belt Railroad (ca. 1969). Crossing Aquatic Park from east to west, the trains ran infrequently and generally at night. The tracks historically extended from the Embarcadero through the Fort Mason tunnel, eventually reaching lower Fort Mason and on to the Presidio. Within Aquatic Park, the portion of track between the stairs west of the West Bleachers and Van Ness Avenue appears to have been paved in the late 1970s when the railroad was no longer used. Over the years, the area between the rails has been backfilled with asphalt to reduce hazards for pedestrians and bicyclists. In spite of these changes the tracks remain in the same location as they were during the period of significance.<sup>13</sup> (Figure 69)

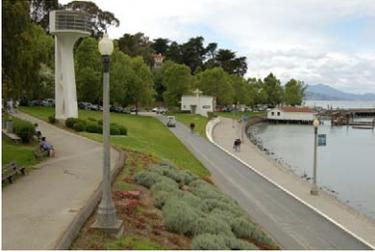
**Figure 71.** View of three components of the pedestrian circulation system in Aquatic Park. The Beach Promenade along the shoreline, the State Belt Railroad tracks (asphalt), and a portion of the Upper Promenade as it passes the West Speaker Tower. (NPS, 2008)

The first contributing portion of this system is the Upper Promenade, an asphalt-paved walk approximately 10 feet wide, extending from Van Ness Avenue past the West Speaker Tower. Off of this alignment, a stairway comprised of 19 concrete steps, 12 feet wide with a central round metal railing, connects pedestrians with the Beach Promenade. From the top of these steps, the Upper Promenade continues to the west end of the Bathhouse, where it meets the Beach Street sidewalk. (Figure 71)

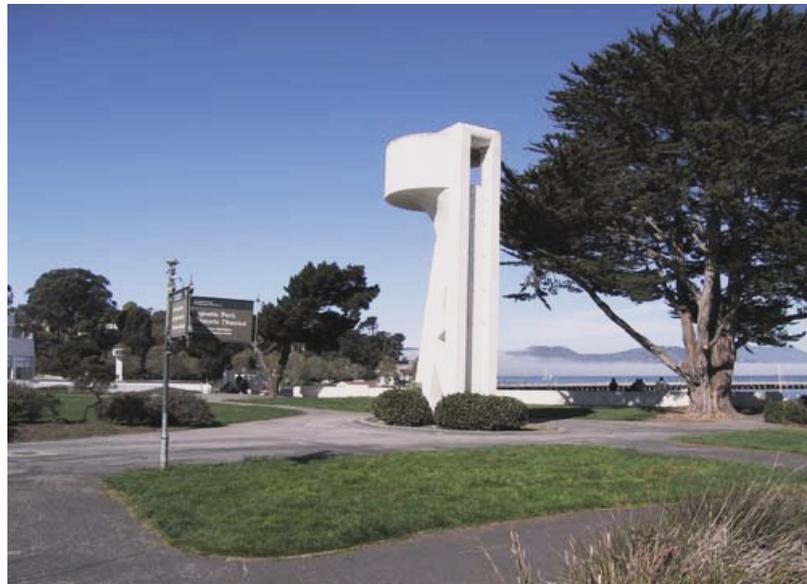
**Figure 72.** View of the East Speaker Tower and walkways looking northwest from edge of Victorian Park. (NPS, 2007)

The second contributing section of pedestrian walkways begins on the east side of the Bathhouse, at the intersection of the east vehicle ramp and the Beach Street sidewalk. From this intersection, the walkway extends diagonally toward the East Speaker Tower. Midway along this walkway, a short spur provides a connection to the center of the East Bleachers. The walkway forks at the East Speaker Tower, with one walk leading to the east end of the bleachers and the other section continuing into Victorian Park. A third section of this walkway spurs south to connect with the Beach Street sidewalk. (Figure 72)

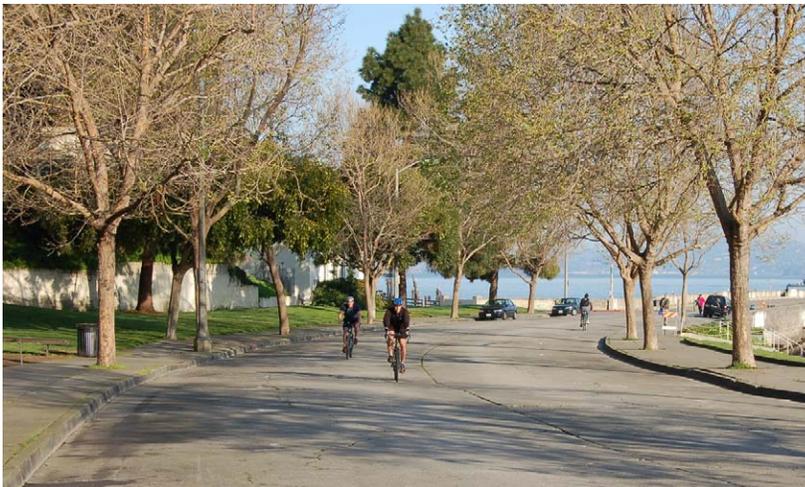
**Figure 73.** The extension of Van Ness Avenue in 1936 historically linked the city with the Municipal Pier and created a defining edge to the new park. (NPS, 2007)

Very early in the development of Aquatic Park, the City of San Francisco extended Van Ness Avenue as it formed the west boundary of the park, northward along the base of the Black Point. This extension was designed over extensive fill in order to provide access to a new recreational pier proposed for Aquatic Park. To meet the pier, Van Ness Avenue was extended approximately 150 feet north along the base of the point. Prior to extending Van Ness Avenue, several rowing clubs located on the western shore of the cove were relocated to the east side of the water. Sidewalks were added to both sides of Van Ness Avenue to allow pedestrian access to the Municipal Pier, while the road itself provided access and parking for automobiles. This area continues to function as originally designed. (Figure 73)

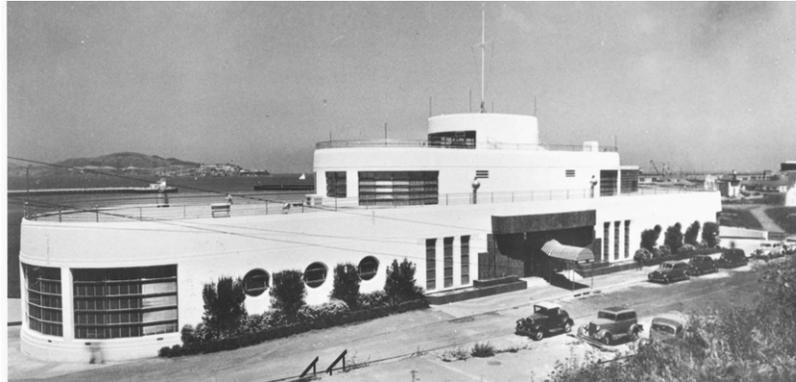
**Figure 74.** Plantings were established on both sides of the Bathhouse entrance, adding a degree of formality to the front facade of the building, ca. 1940. (*San Francisco Maritime NHP, Historic Documents, Photograph Collection P81-073.2n*)

The formal entry to the Bathhouse along Beach Street historically included two planting beds along the foundation of the building, on either side of the doorway. These beds, installed by 1938 (and removed after 1952), were planted with small trees, shrubs, and perennials. Based on historic photographs, the configuration, species, and even the pruning style changed at least once during the period of significance. Today, these beds are paved over with asphalt. (**Figure 74**)

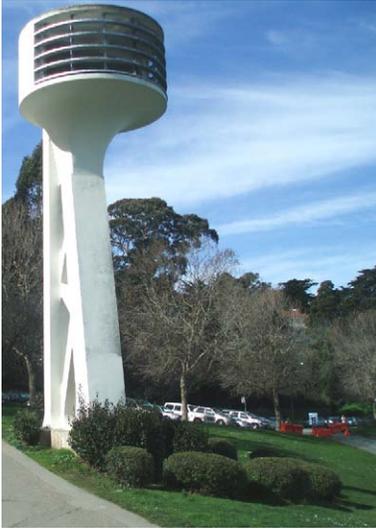
**Figure 76.** Grecian laurels (*Laurus nobilis*) remaining around the West Speaker Tower. View looking west. (NPS, 2008)

Between 1939 and 1941, Grecian laurels (*Laurus nobilis*) were planted around the foundation of the West Speaker Tower and were pruned to form vase-shape shrubs. This planting bed, surrounded by grass, extended down slope about 24 feet, narrowing to a point. After the military occupation of the park, the laurel shrubs were allowed to grow into more of a free-form tree shape. In 2000 NPS maintenance staff cut the laurel back to stumps in an effort to reduce their size and restore their form as shrubs. Today, the laurels are returning to a shrub form and are maintained in the original bed along with a dwarf variety of *Escallonia* around the laurels. (Figure 76)

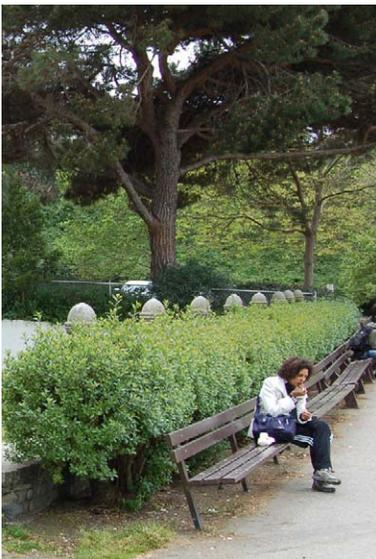
**Figure 77.** *Escallonia* hedge on the north side of the masonry wall along the Upper Promenade. (NPS, 2008)

Immediately south of this area, a hedge of *Escallonia* follows the path along the entire length of the masonry wall. It is not clear that there was a hedge in this location during the period of significance. The hedge does appear in a photograph from the late 1940s. (Figure 77)

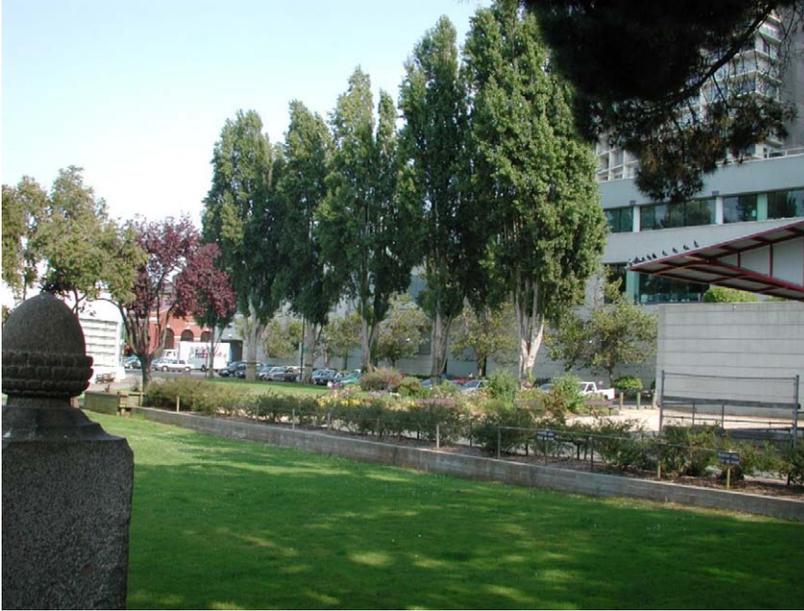
**Figure 78.** Area northeast of the Bocce Ball Courts prior to the bleacher rehabilitation project. This area was used as a staging area during construction and was significantly altered in 2009. (NPS, 2007)

East of the Bocce Ball Courts, the open grass area was originally used as an unpaved parking lot for Aquatic Park. John Punnett's 1938 site plan specified a shrub and tree border surrounding an open lawn on the south and west, creating a boundary between Aquatic Park, a proposed playground, and Beach Street. A single Acacia tree is depicted on a 1952 plan of the park and is visible in an aerial photograph. Today, a planting bed defines the north side of the Bocce Ball Courts; a similar bed on the east side was removed in 2008. These beds contained a mixture of small shrubs, perennials, blackberry, and ivy. A plum tree is planted in the west end of the bed along the north side. Three *Pittosporum sp.* (tree form) are located along the west side of the Bocce Ball Court area (next to the concrete retaining wall). A row of seven English laurel are located in the raised bed in the southwest corner of the Bocce Ball Court area. The area immediately south of the acorn retaining wall was covered with sand until the early 1980s, when it was planted with grass. (Figure 78)

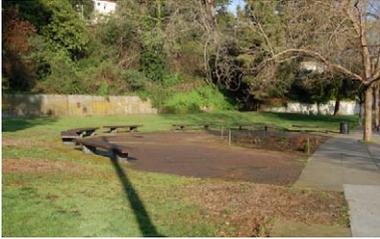
**Figure 81.** View looking north into Pocket Park along Van Ness Avenue, prior to removal of the benches and paving materials from the 1975 design. (NPS, 2007)

Plant species identified in the plan include 12 sweet gums trees (*Liquidambar styraciflua* ‘Palo Alto’), nine Canary Island pines (*Pinus canariensis*), and at least one weeping willow tree (*Salix babylonica*). A semi-circular brick paved area with benches around the perimeter of the paving was also proposed, with eight sweet gum trees in a semi-circle on the west side of the brick plaza. The interior of this area was planted with fortnight lily (*Moraea iridiodes*). This 1975-76 design extended from the railroad tracks (at the tunnel) to the path leading up the stairs to Fort Mason. A planting bed was added along the base of the east wall of the Pumping Station No. 2 at this time. (Figure 81)
