# **CULTURAL LANDSCAPE REPORT, AQUATIC PARK**

## **SAN FRANCISCO MARITIME, NATIONAL HISTORICAL PARK**

**NATIONAL PARK SERVICE**  
**PACIFIC WEST REGION**  
**2010**

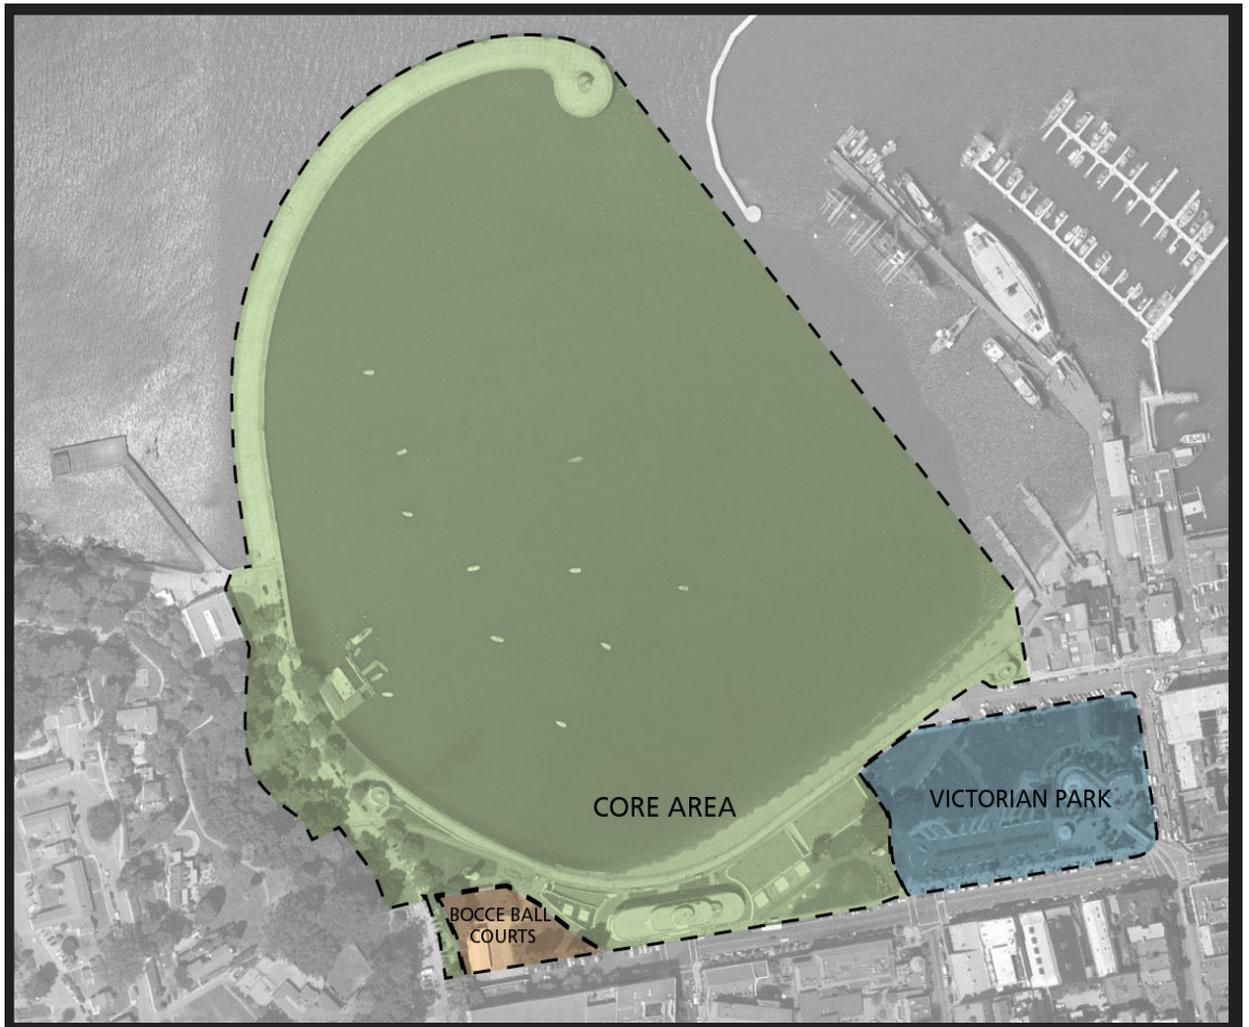
Figure 85

# Treatment Plan (Schematic)

Symbols depicting materials and locations for plant materials are schematic. Placement and general concepts are presented as a way to amplify and illustrate written recommendations in the *Cultural Landscape Report, Aquatic Park*.

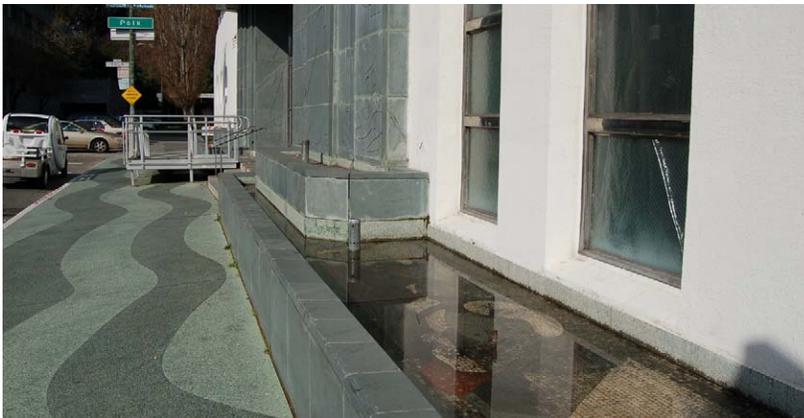
**Figure 86.** Front façade of the Bathhouse. View looking north. (NPS, 2006)

- Restore and maintain the historic slate façade on the south side of the building as the primary entrance to the building. (Figure 86)
- Restore the historic planting beds on both sides of the entry (see the section, “Recommendations: Vegetation, Bathhouse Plantings”).

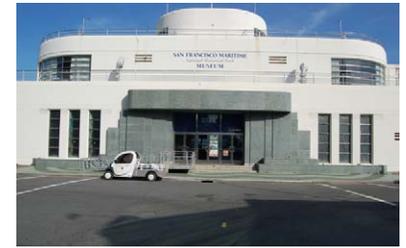
**Figure 87.** One of the two fountains that flank the entrance to the Bathhouse and could be restored as part of an overall landscape rehabilitation. (NPS, 2006)

- Complete rehabilitation of the fountains on the front (south) façade of the building and complete conservation of the stone and mosaics. (Figure 87)

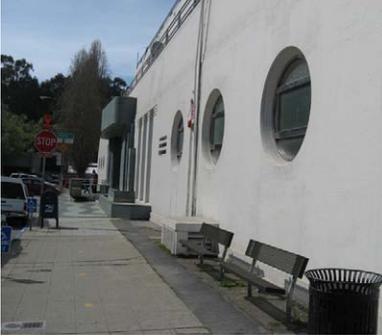
**Figure 88.** Northeast side of the entrance to the Bathhouse with a variety of non-compatible features such as benches, trash cans, city street signs, utilities, and public mailbox. (NPS, 2010)

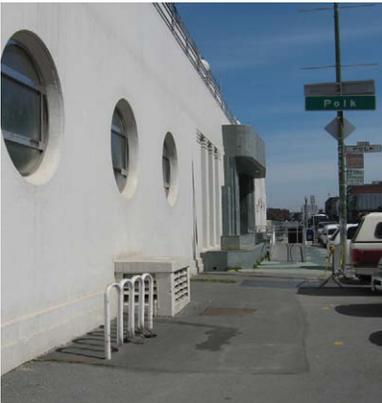
**Figure 89.** On the west side of the front entrance to the Bathhouse, a bicycle rack, accessibility ramp, and various small-scale features and utilities create a cluttered appearance. Note asphalt paving where planting bed was originally located. (NPS, 2010)

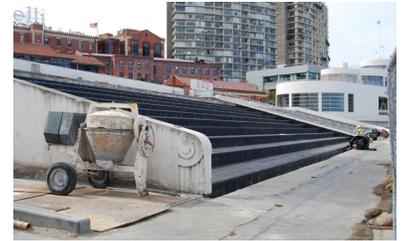
**Figure 90.** View of the East Bleachers showing new waterproofing material applied during rehabilitation. Note mildew on the concrete wall. Cleaning and repainting this portion of the structure is important to the character of the structure, and should be integrated into overall maintenance. (NPS, 2009)

- Inspect the bleachers annually to ensure the surfaces of the structure remain in good condition.
- Remove vegetation growing in cracks and breaks in the concrete. Repair and paint damaged concrete surfaces as needed using appropriate materials. (Figure 90)
- Maintain pedestrian access to the bleachers from adjacent areas and walkways.

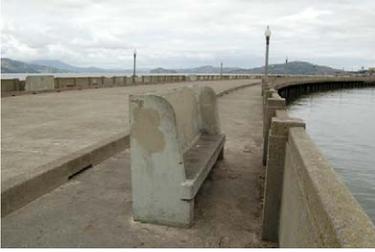
**Figure 91.** Historic concrete bench, parapet walls and curbing, light standards, and other site features associated with the Municipal Pier. (NPS, 2007)

- Consideration should be given to restoring and/or rehabilitating site furnishings along the decking of the Municipal Pier based on the preferred treatment for the structure. Replacement of these features with replica or “period” furnishings is not recommended. (Figure 91)

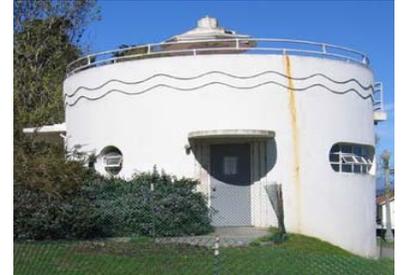
**Figure 92.** Staining on the exterior of the West Convenience Station. (NPS, 2007)

- Conduct inspections of exterior fixtures, railings, windows, and window sashes. Clean and repair as needed. The use of rust-resistant hardware is encouraged where possible and appropriate to reduce maintenance. Undertake replacement of external building fixtures and repairs to the concrete façade of both buildings in consultation with a historical architect. (Figure 92)

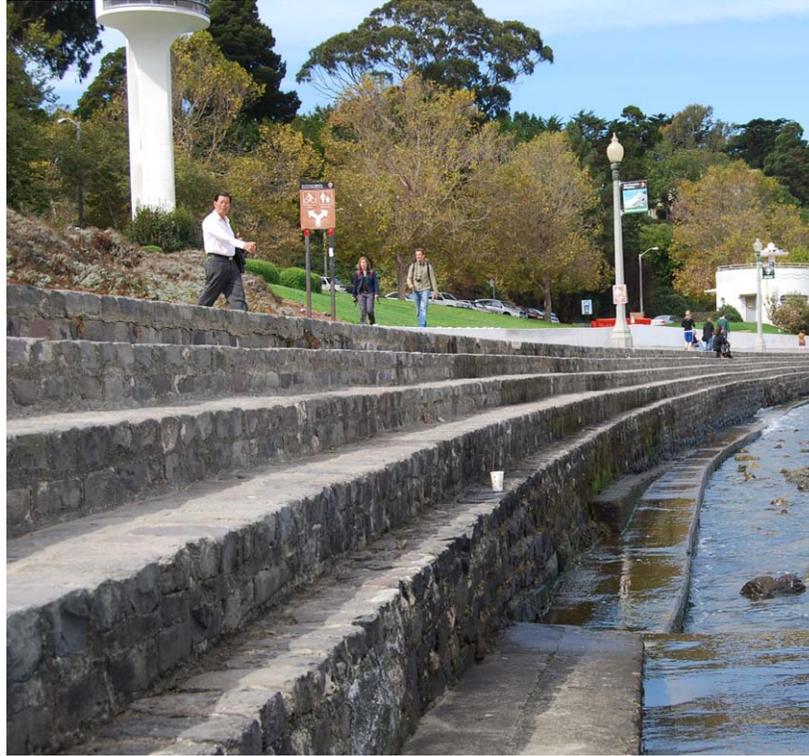
**Figure 93.** One of the earliest structures built during the historic period, the Seawall around the cove is in relatively stable condition. (NPS, 2009)

The Seawall and steps that extend the entire length of the cove from the East Convenience Station to the Municipal Pier are generally in good condition, with just a few cracked and missing basalt blocks. Stone curbs throughout the site are also in relatively good condition. Exceptions are a missing section of curb near the Sea Scouts building and damaged curbs near the West Convenience Station. Recommendations address repair and replacement. (Figure 93)

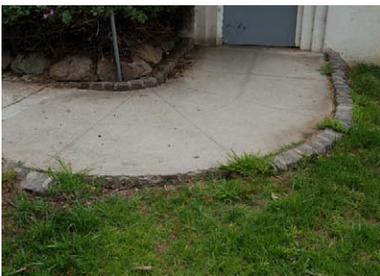
**Figure 94.** Missing block curbing at the West Convenience Station should be repaired using in-kind materials. (NPS, 2007)

- Replace the missing portion of the stone curbs as needed using compatible materials and appropriate restoration techniques. (Figure 94)
- Repairs to all historic stonework should be done in consultation with a historical architect or preservation mason.

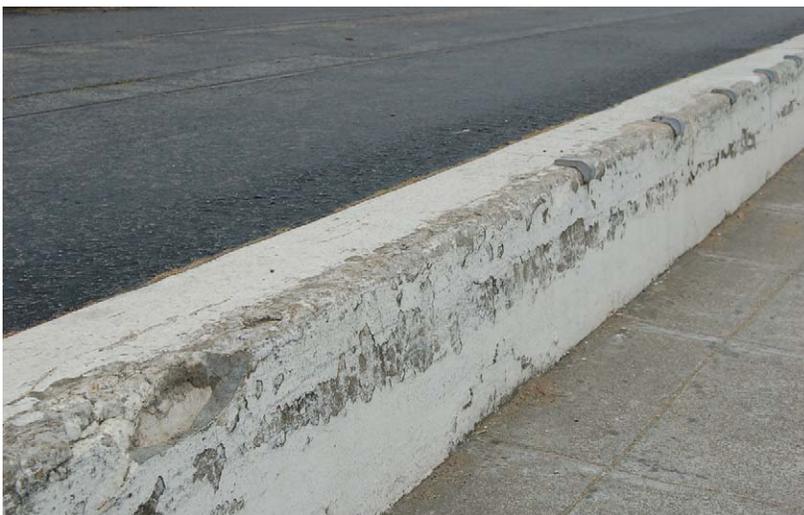
**Figure 96.** Flaking and loss of material along the concrete wall occurs as deterrent bolts fail and water penetrates the under layers of the concrete. Repair may require patching, reapplication of a skim-coat, or some combination. View of the east end of the wall, looking west. (NPS, 2007)

- Repair damaged portions of the wall where deterrent bolts have broken or given way. Replace bolts as needed along repaired portions of the wall. (Figure 96)

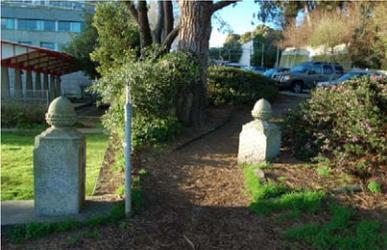
**Figure 97.** Remnant features of the original stone retaining wall as it wrapped around the park to Van Ness Avenue. View looking south. (NPS, 2008)

The stone retaining wall that borders the Bocce Ball Courts was one of the earliest structures built during initial construction of Aquatic Park. It was built to accommodate site grading for the extension of Van Ness Avenue and the State Belt Railroad grade. Based on historic photographs, the original wall was considerably longer than it is today and the grade difference from one side of the wall to the other appears to have been as much as 20 feet. The city water pumping station was located on the lower side of the wall where the Bocce Ball Courts are today. Photographs indicate that the wall was shortened in 1937 when additional grading was done to accommodate construction of new park buildings. Around 1942 the pumping station was removed and the area on the south side of the wall was backfilled, leaving only approximately 4 feet above grade at its highest end. The wall remains distinctive today for its stone construction and the granite acorn bollards on top of the wall. (Figure 97,98)

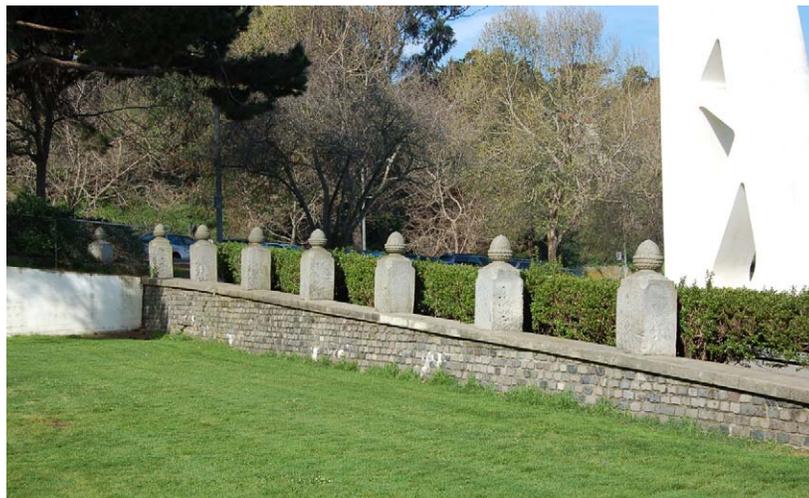
**Figure 98.** View of the stone retaining wall looking northwest from the lawn near the Bocce Ball Courts. The amount of exposed wall visible in the park today generally slopes to the east based on fill added to even the grade when the pump house was removed in the 1940s. (NPS, 2008)

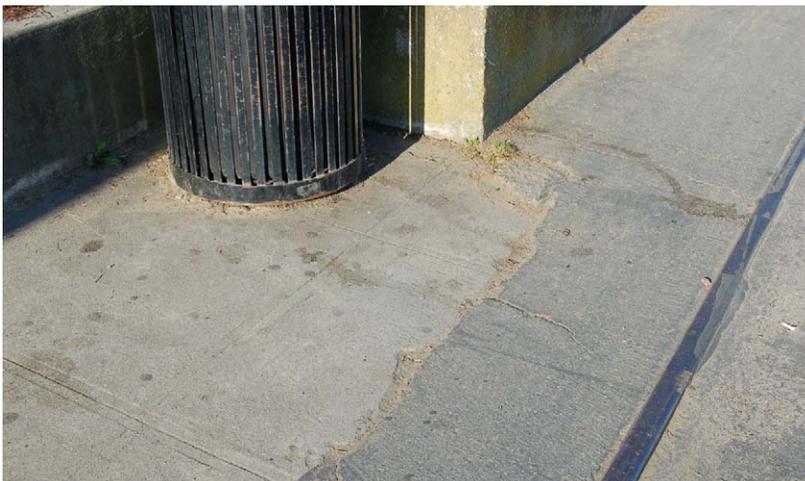
**Figure 100.** In some areas walkways have been resurfaced with paving added over existing layers creating a patchwork of materials. (NPS, 2008)

- paving material. (Figure 100)
  - Remove excess paving material in places where past repairs have altered the historic width, alignment, material, edge treatments, or character of the historic walkway.

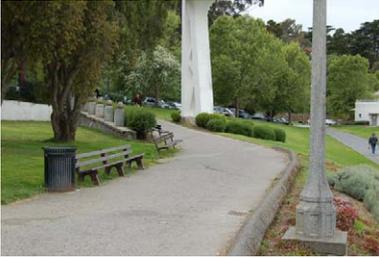
**Figure 101.** Rolled asphalt curbing along the Upper Promenade. View looking west. (NPS, 2008)

- Remove the raised asphalt and pre-formed concrete curbs around the East Speaker Tower and along the Upper Promenade. If curbs are currently needed to control water run-off and drainage, a low, narrow profile concrete curb is more compatible with the historic character and should be used in place of rolled asphalt curbs or pre-form concrete. (Figure 101)

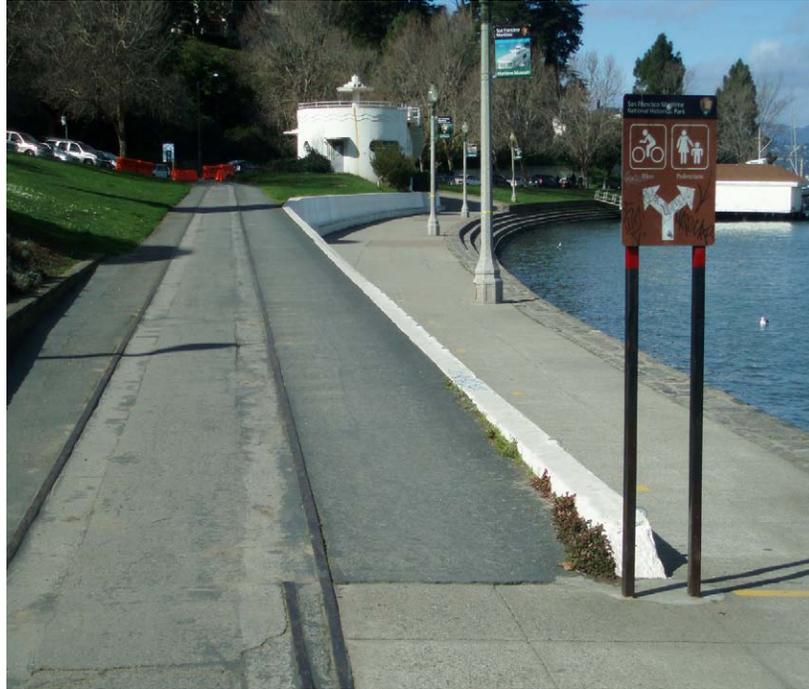
**Figure 102.** In most cases the separation between bicycles routed on the upper walkway and tracks (left) and pedestrians along the shoreline on the Beach Promenade helps mitigate potential pedestrian/bicycle conflicts. Over the years, asphalt paving and patching around the tracks has created uneven surfaces and in some cases, presents safety hazards. This view looking west. (NPS, 2005)

The elastic nature of the asphalt paving has a tendency to make it sag and separate around the rails. Today the uneven character of the rails and the asphalt bedding around them has the potential to create safety issues for bicyclists and other users of the park. Heavy truck traffic and frequent patches to the asphalt exacerbate the safety issue and create an adverse visual impact. (Figure 102)

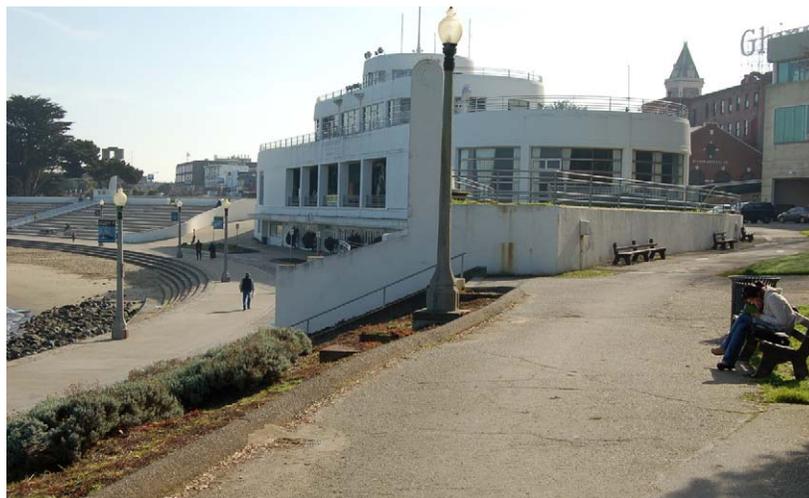
**Figure 104.** View of the Upper Promenade showing the rolled curb along the edge of the walkway and planting bed (left), and the patching and expansion of paving leaving a relatively undefined edge on the right side. (NPS, 2006)

- Rehabilitate areas where asphalt, gravel, or compacted earth have migrated beyond the edge of the promenade and are preventing vegetation growth. (Figure 104)
- Ensure that any future park development affecting the historic character of the Upper Promenade, such as development of a streetcar stop in this area, is considered and evaluated within the context of the historic designed landscape and potential impacts to the NHL district.
  - Assess potential adverse effects of new park development affecting the historic design of the Upper Promenade and develop appropriate mitigation measures in consultation with a historical landscape architect and/or cultural resource staff.

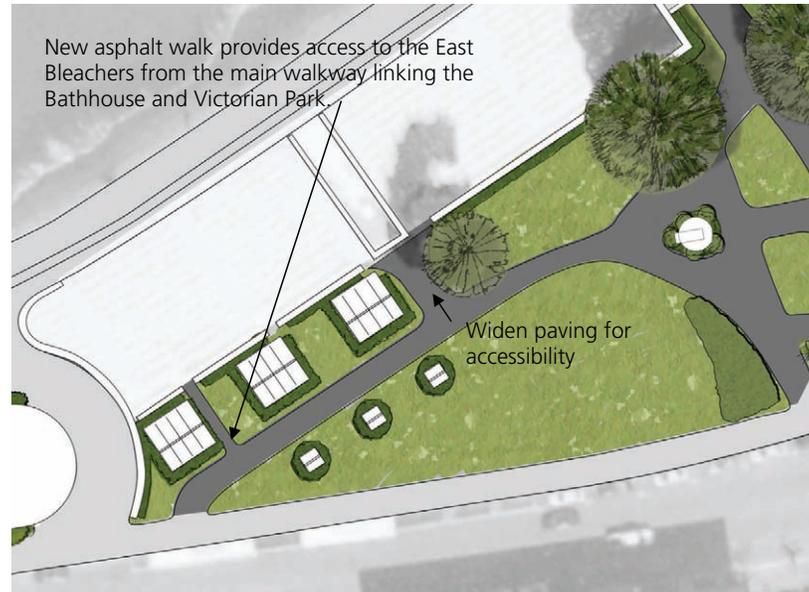
**Figure 105.** Plan view showing the areas behind the East Bleachers. (NPS, 2007)

- Restore the historic configuration, alignment, and width of walkways behind the East Bleachers as part of the rehabilitation of the East Bleachers.
  - Add a new access walkway on the west side of the East Bleachers between the skylights. (Figure 105)

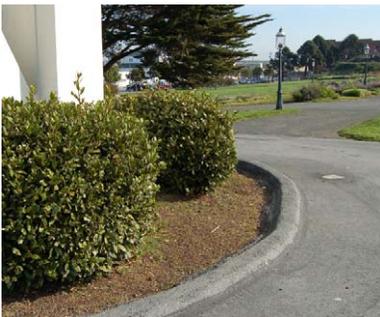
**Figure 106.** Raised asphalt curb around the East Speaker Tower planting bed. (NPS, 2008)

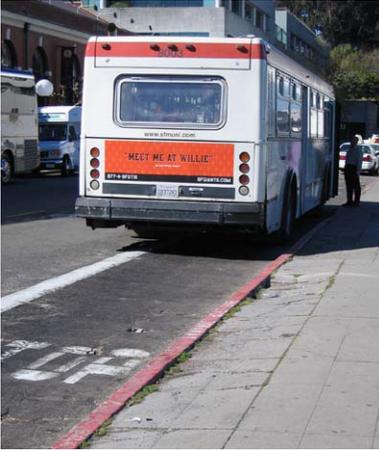
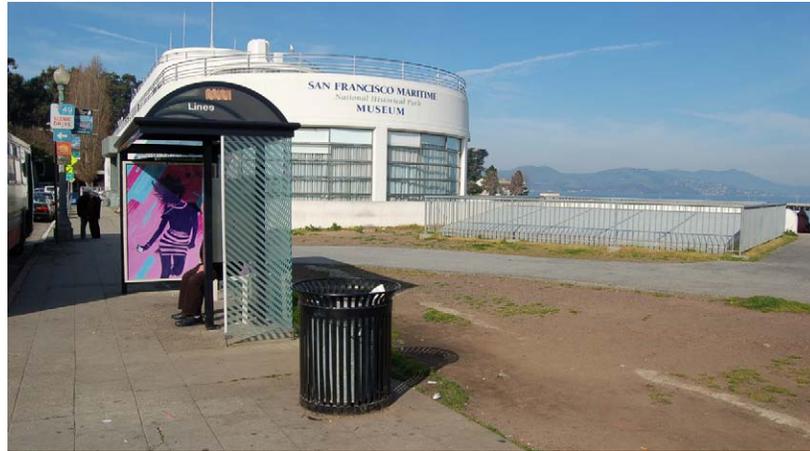
**Figure 107 a&b.** The bus stop located on the east side of the Bathhouse is an area significantly impacted by heavy use in a relatively compact zone. Overall, the combination of degraded concrete sidewalks, denuded vegetation, damaged concrete curbs, visually incompatible structures, and a diverse variety of small-scale features create an adverse impact to the NHL district. View from the shelter looking east along Beach Street. (NPS, 2006)

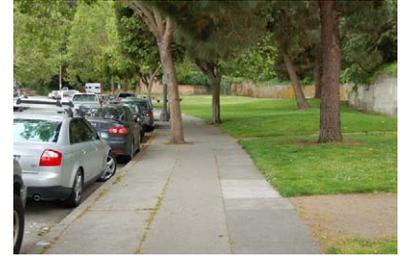
**Figure 108.** Displaced, cracked, and patched sidewalk along Van Ness Avenue next to Pocket Park. At a certain point, rather than patching, a holistic approach to rehabilitation of the sidewalk will assure a more uniform character. View looking south. (NPS, 2008)

- Ensure that repairs made to the surface of the extension use concrete that matches the color and finish of the existing material. Date-stamp new concrete surfaces to differentiate them from existing pavement.
- Ensure that sidewalks along Van Ness Avenue are repaired and maintained in good condition. Work with an arborist or horticulturist as needed to determine appropriate treatments for areas of sidewalk pavement displaced by tree roots. All repairs should be made using compatible materials and finishes. (Figure 108)

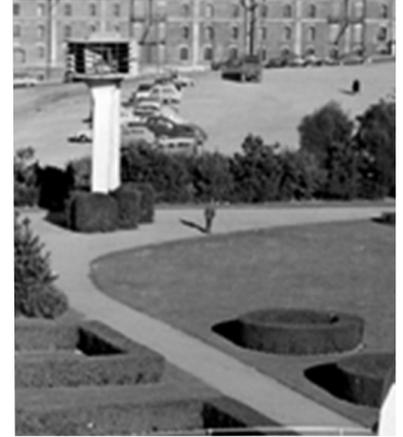
**Figure 112.** Detail of photograph showing the historic character of the hedges planted around the skylights on the east side of Aquatic Park, 1953. (San Francisco Maritime NHP, *Historic Documents, Photograph Collection, A12.17,546.1*)

Hedges were an integral component of the overall planting design in Aquatic Park. Used primarily to create, define, or enhance the edges of structures including walls and skylights. Major hedge planting was located along the Upper Promenade stone retaining wall, behind the east and west bleachers, and around the skylights. Although all hedges were pruned to maintain a specific height, only those around the skylights were pruned to have a formal, manicured appearance. From historic photographs these hedges appear to have been composed of a leafy evergreen shrub and were neatly clipped to 3-4 feet in height. (Figure 112) As part of the

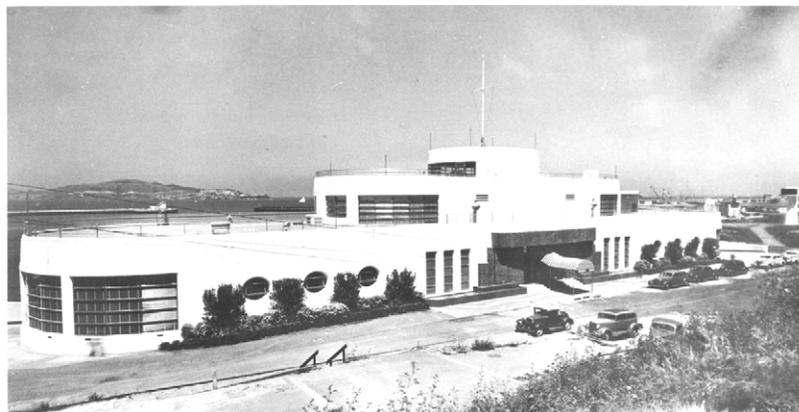
**Figure 117.** View of the Bathhouse from the hill north of Beach Street, showing the vegetation and character of plantings across the front façade of the building. View looking northeast, ca. 1940. (*San Francisco Maritime NHP, Historic Documents, Photograph Collection, P81-073,2n*)

During the historic period ornamental plantings were used in front of the Bathhouse, along Beach Street, and along the north side of the building, facing the cove. In front, two planting beds extended along the foundation of the building on each side of the entrance. (Figure 117) While plantings within the beds changed at least once during the historic period, the character of the beds remained the same. <sup>6</sup>By the mid 1940s each bed was composed of four tall, upright shrubs with an open form planted between the round porthole windows. Below these, shrubs were planted in a continuous row. A low hedge, not more than 18 inches high, lined the sidewalk in front of the shrubs. These beds

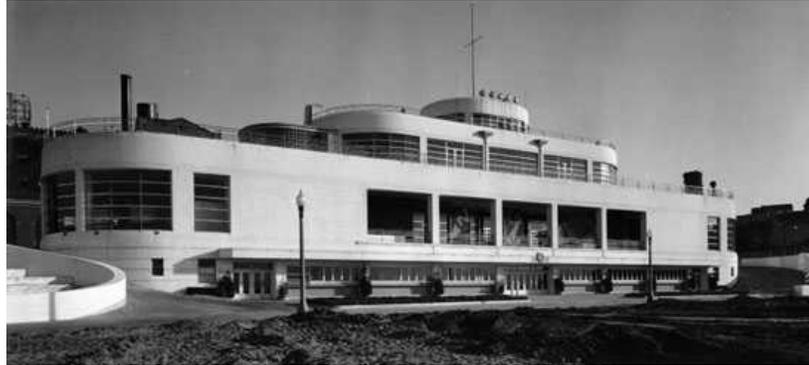
**Figure 119.** Historic view of the north side of the Bathhouse showing the placement of juniper plants in the planters along the foundation of the building. View looking southwest, n.d. (Courtesy of the San Francisco History Center, San Francisco Public Library AAA 6748)

On the north side of the Bathhouse, individual shrubs were planted in small planters between each set of windows. (Figure 119) Eight semicircular planters each contained one juniper shrub, maintained in an upright, irregular conical form. A longer bed was located at each end of the building. There is no indication that these planters ever contained more than a single shrub each. Today, six of the original eight junipers remain in the planters near the building; two of the junipers have been removed and their planters paved over with concrete. The long planting bed on the west end of the Bathhouse contains hebe shrubs, while the bed on the east side is empty. It is unknown if this material was used historically, but it is compatible with the historic design. Today the junipers appear in poor condition from either a lack of light in the shade of the building, or a lack of water due to the small planters and overhanging structure.

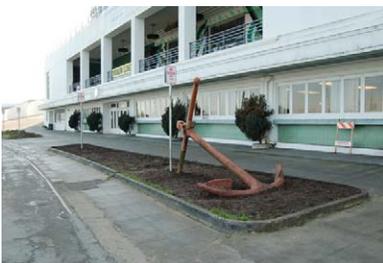
**Figure 120.** View of the existing juniper plants on the north side of the Bathhouse. View looking south east. (NPS, 2008)

Also on the north side of the Bathhouse are two, low median planting beds. (Figure 120) These beds are approximately 6-inches high and defined by a concrete curb. During the historic period, these beds contained vegetation, although the historical record is insufficient to determine the specific plant materials. Historic photos suggest that the planting beds may have contained very low shrubs or a low hedge around the edge of the beds, with lawn or groundcover in the center. Today the beds do not contain any vegetation.

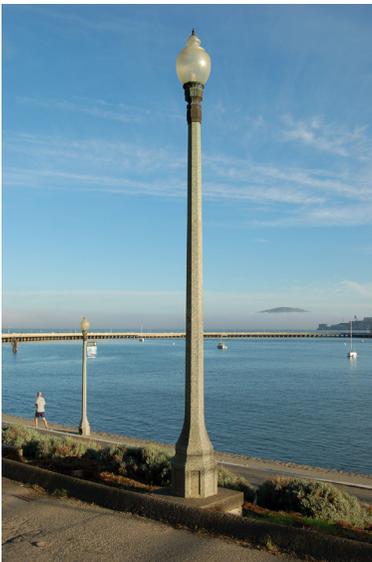
**Figure 123.** Historic lampposts remain in Aquatic Park along the Beach Promenade and Municipal Pier. (NPS, 2007).

- Preserve and maintain small-scale historic site features that contribute to the character of the NHL District.
  - Retain and repair as needed historic lampposts located along the Beach Promenade and in other areas throughout the park. (Figure 123)
  - Repair and reestablish as possible, the historic drainage features including grates and manhole covers.
  - Ensure that the historic basalt block curbing located along walkways is preserved and maintained in kind through the Facility Maintenance Software system (FMSS).
  - Document the historic small-scale features such as benches and light standards on Municipal Pier. Consider restoration of these features in the future rehabilitation and/or reconstruction of the structure.

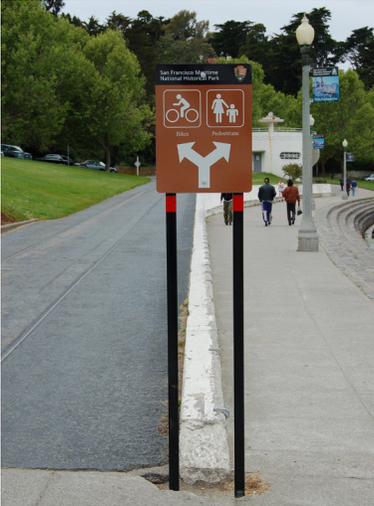
**Figure 126.** Placed at a height that allows cyclists to see it, this sign clearly denotes directional information as a way to reduce potential conflicts between bicycles and pedestrians, and is a useful model, compatible with standards for the NPS messaging system. (NPS, 2007)

- The addition of new signs within the NHL District is generally discouraged with the exception of safety, wayfinding, and interpretive signs.
  - Assure that materials for new signs are compatible with the Streamlined Moderne style. The use of a contemporary and consistent design vocabulary for all signs is encouraged. (Figure 126)

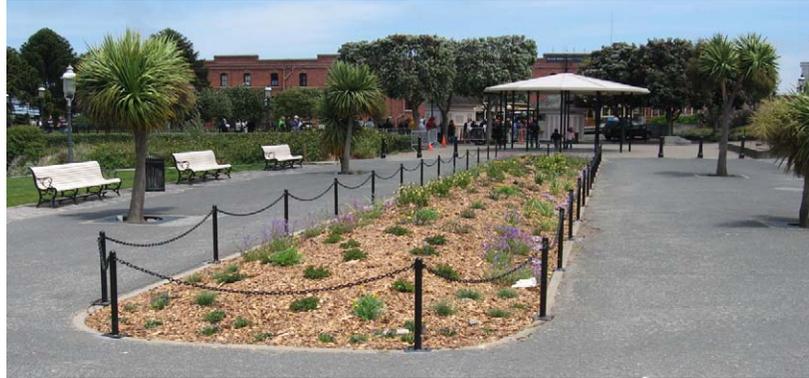
**Figure 127.** Using funds from a First Bloom grant, the park worked with Boys and Girls clubs in the city to replant the planting bed in the center of the Victorian Park. pedestrian plaza The grant program emphasizes the opportunity to engage urban youth in garden projects where they can learn about the use of native plants in the landscape. (NPS, 2010)

- Remove plants currently in the planter down the center of the plaza and replace with low-growing materials and ground cover similar in character to *Juniperus*, *Cistus*, *Lantana*, Rosemary, *Hebe*, *Santolina*, and *Pelargonium*.
  - Consider installing a low profile (22 inches high) post-and-chain barrier around the plant beds to prevent pedestrian shortcuts and social trails through the beds.
- Plant low-growing shrubs, groundcover, or turf in the raised beds along Beach Street to improve overall conditions that result from the inappropriate use of these areas by the public. (Figure 127)

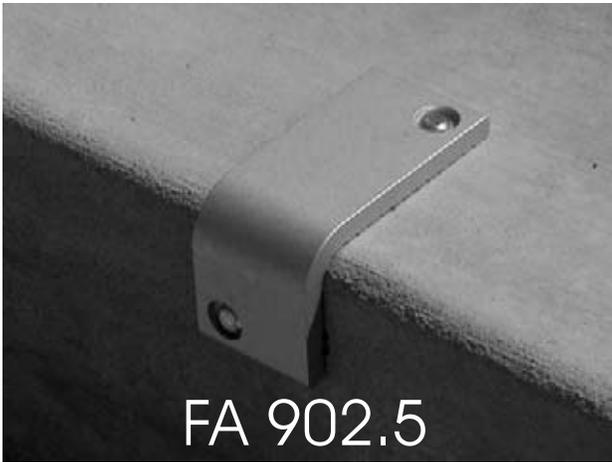
FA 902.5

This patented part is designed for 90° edges with a 1/2" radius. Most commonly used on poured cement applications.

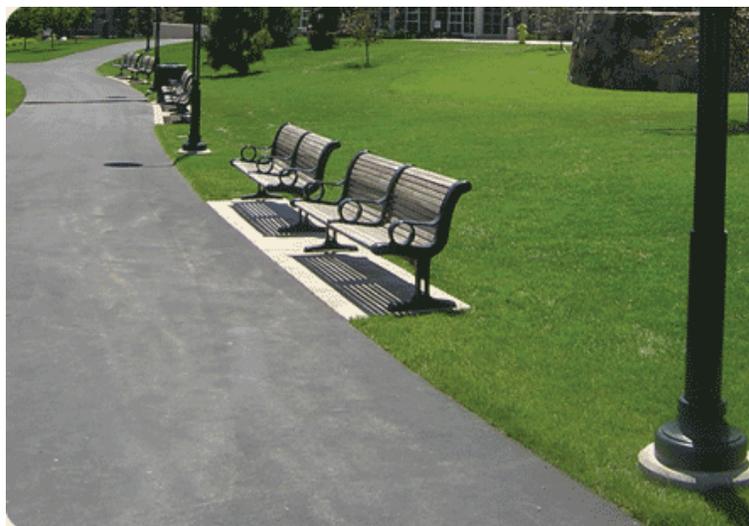
AsphaltEdge™ is a line of flexible, L-shaped aluminum asphalt restraints. One of the biggest drawbacks of asphalt compared to concrete and brick is an inconsistent edge. With Permaloc AsphaltEdge, you get a strong, uniform 90-degree edge. It installs quickly and easily, making your work stand out and providing a “finished look” - an excellent compliment to any asphalt installation.

- Engineered to extend the life of asphalt pavement by helping to prevent broken edges, providing uniform thickness throughout the pavement surface, and providing a finished, maintainable look along the asphalt border.
- Permaloc's patented AsphaltEdge is the only product specifically designed to be installed and perform as an integral restraint system for asphalt.
- AsphaltEdge is designed for asphalt over aggregate, asphalt overlay, and asphalt over concrete, including residential, commercial and industrial applications.

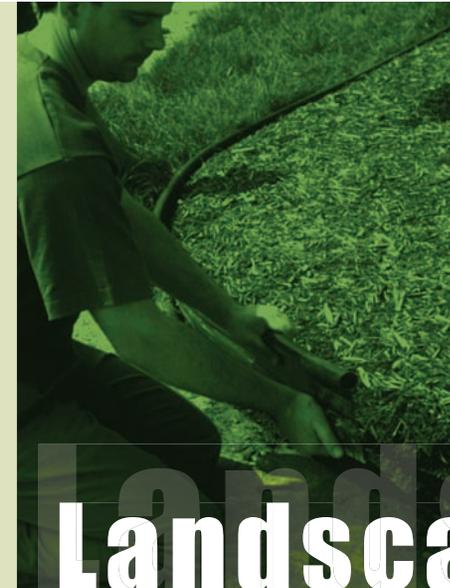
### 90 Degree Connectors

Corner connections for EdgePro® Professional or EdgePro® ProLip Landscape Edging are made easy with plastic 90-degree connectors.
