Merced River and Riparian Vegetation Assessment

June 2012

Prepared For
Yosemite National Park, National Park Service

Cardno ENTRIX
2300 Clayton Road, Suite 200, Concord, CA 94520
Tel 925 935 9920 Fax 925 935 5368 Toll-free 800 368 7511
www.cardnoentrix.com

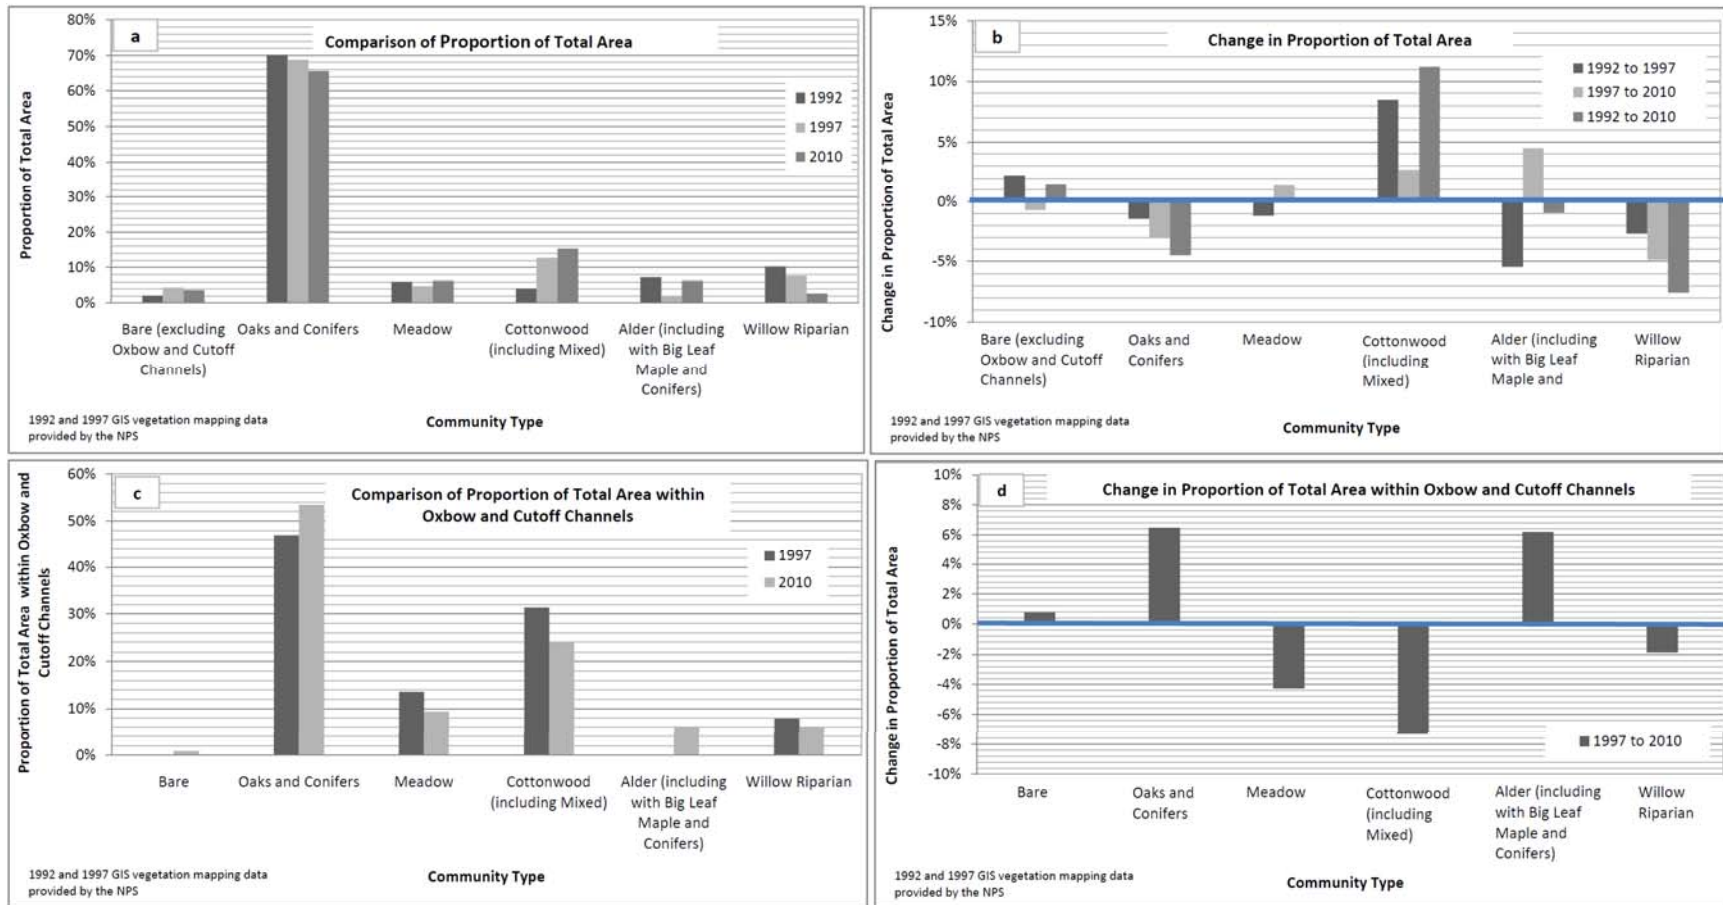
Figure 3-1. Comparison of the Proportion of Total Area of Each Community Type(a) and Change in the Proportion of Each Community Type (b) within the Merced River Corridor (1992, 1997, and 2010) and within Oxbow and Cutoff Channels (c and d)¹.

Oak and conifer communities dominated the study reach in all three years (66 to 70 percent of total area), decreasing slightly (5 percent from 1992 to 2010 (Figure 3-1 and Appendix A [1992 to 1997 and 1997 to 2010 Riparian Vegetation Map Series]). The proportion of meadow vegetation within the riparian corridor remained similar from 1992 to 2010, while black cottonwood forest communities increased in area by nearly 10 percent, and the area of willow-dominated communities decreased by 8 percent. Bars and channel margins with established willow communities in 1992 were mapped as bare in 1997 and 2010, likely reflecting scour by the January 1997 flood (Appendix A, 1992 to 1997 Riparian Vegetation Map Series Map 4). Prescribed burns in the Upper, Inter-, and Lower Meadows reaches in the early 1990's that burned through the riparian corridor may also resulted in the decrease in the proportion of willow communities, particularly with more severe burns. The oxbow and cutoff channels (about 10.4 ha in total within the study reach) were vegetated primarily with oak and conifer communities and black cottonwood, including mixed with willow in both 1997 and 2010 (78 percent). The proportion of each vegetation communities mapped within the oxbow and cutoff channels were similar in 1997 and 2010 (Figure 3-1)¹².

The majority of the riparian corridor within the study reach is dominated by community types comprised of different combinations of late seral species, including conifers, oaks, and incense cedar (Figure 3-1). These communities generally occur in fairly long continuous corridors along the stream banks (Appendix A, 2010 Riparian Vegetation Map Series). The proportion of these community types decreased slightly between 1992 and 2010 (4.5 percent) (Appendix A, 1992 to 1997 and 1997 to 2010 Riparian Vegetation Map Series). The proportion and distribution of meadow and herbaceous communities have also remained relatively constant over time. The proportion of bare areas decreased by less than 1 percent between 1997 and 2010¹⁵. The proportion of alder dominated communities has remained similar between 1992 and 2010 (1 percent decrease). The proportion of bare areas increased between 1992 and 1997, likely caused by scouring of vegetation by the January 1997 flood (a 2.2 percent increase). Some of these areas have been naturally revegetated (0.7 percent).

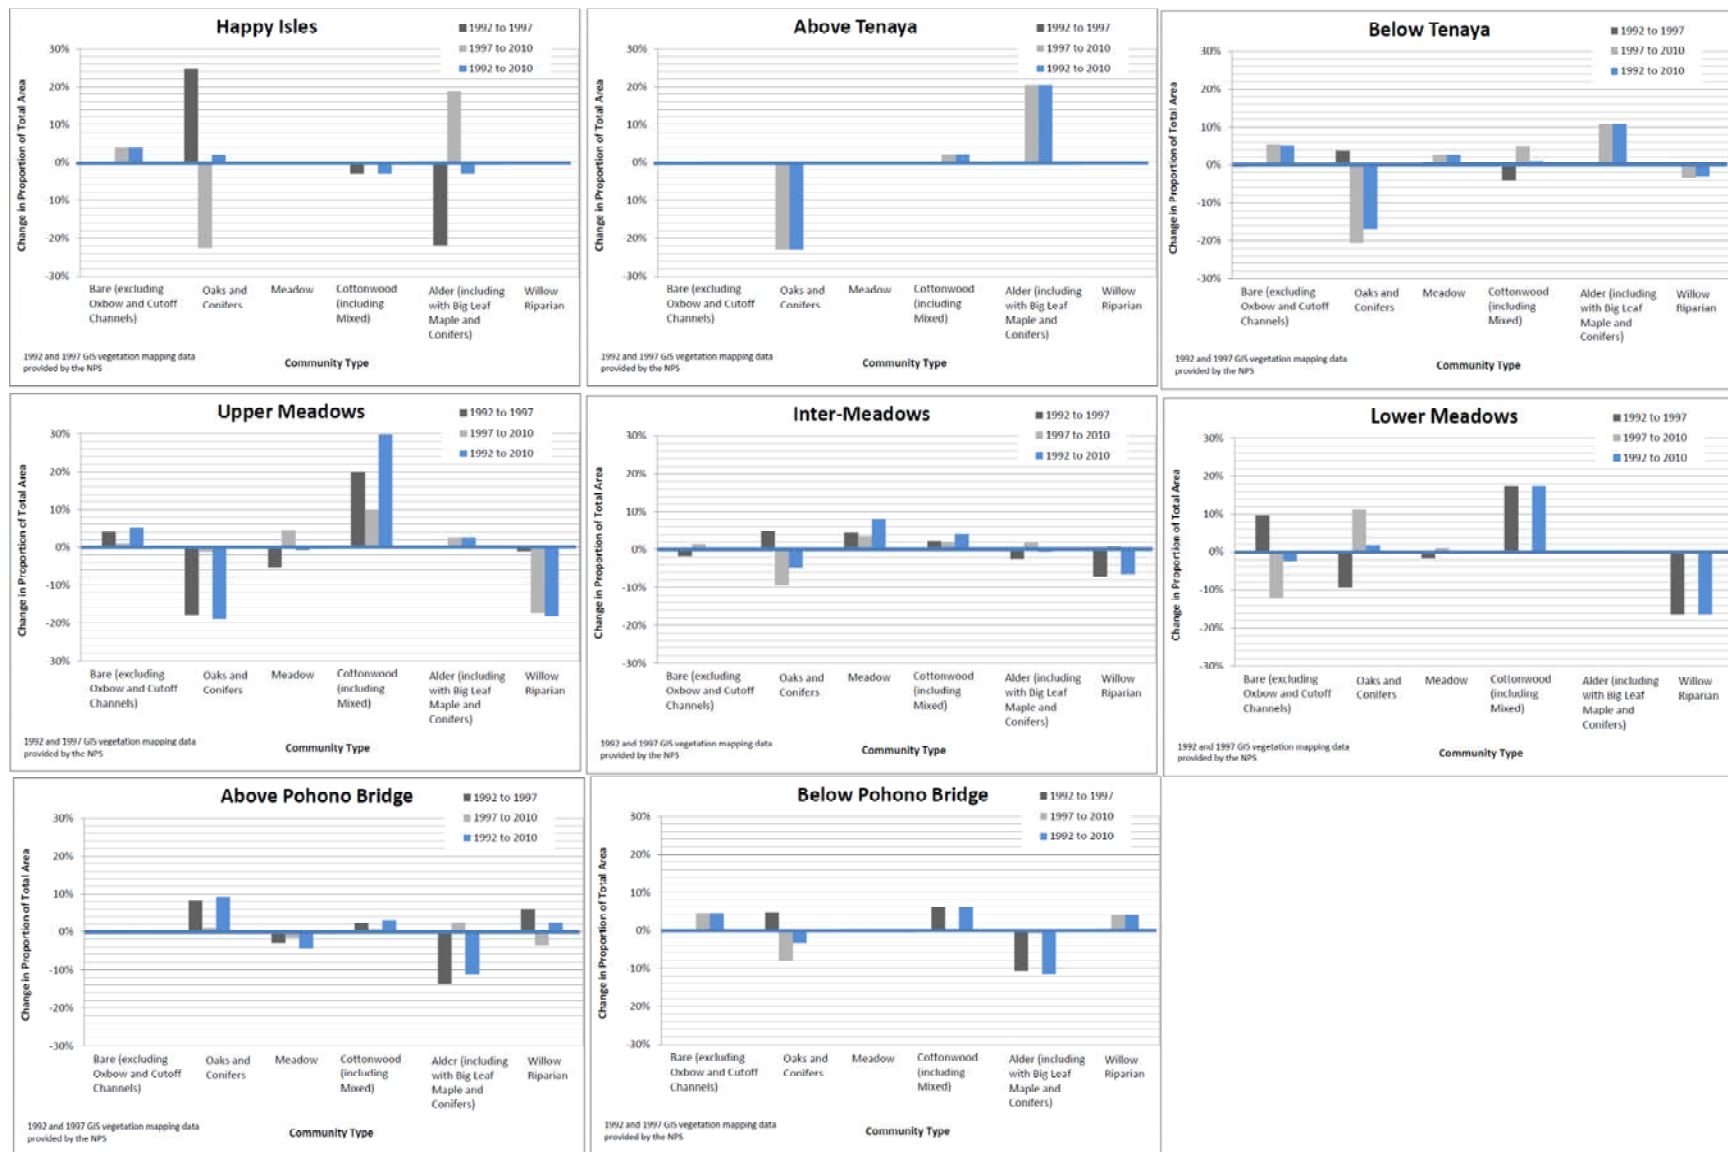
Figure 3-2 Change in the Proportion of Each Community Type by Geomorphic Reach within the Merced River Corridor (1992, 1997, and 2010)¹

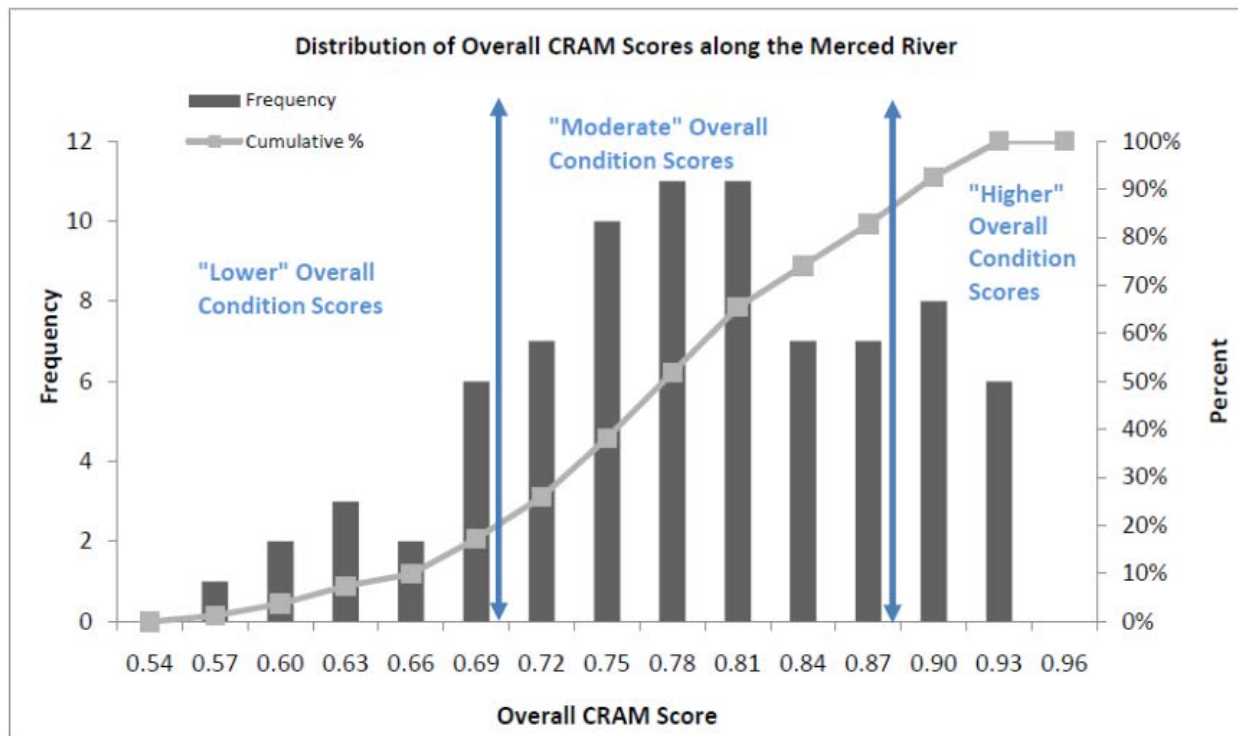
Figure 3-4. Distribution of Overall California Rapid Assessment Method Scores along the Merced River

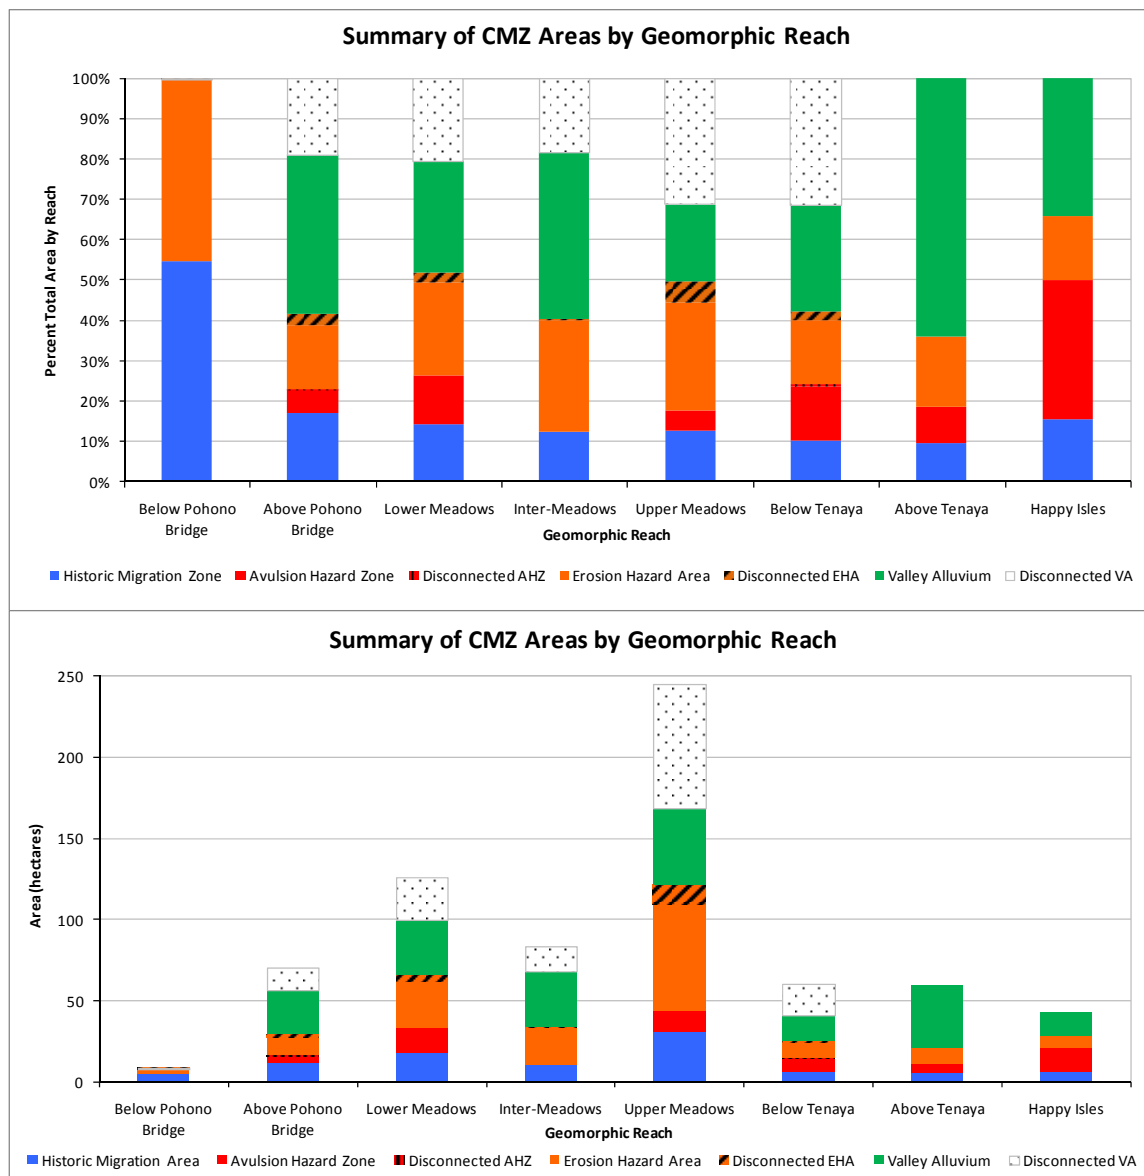
Figure 3-7. Summary of Area for All CMZ Zones Delineated by Geomorphic Reach

The relative percent (top) and total area (bottom) of each CMZ category by geomorphic reach are provided in Figure 3-7. The Happy Isles reach (most upstream) had considerably more AHZ by percent area (34 percent) compared to the geomorphic reaches downstream (Figure 3-7, top). No AHZ occurs within either the Below Pohono Bridge or Inter-Meadows reaches, primarily due to their straight and entrenched character. The Below Pohono reach had the greatest proportion of EHA compared to the reaches upstream. The percent area EHA is similar within the three

upstream reaches (16 percent), and increases by approximately 10 percent through the Meadows (Upper, Lower, Inter-) reaches. The Lower and Upper Meadows, and Below Tenaya reaches have similar distributions of CMZ types.

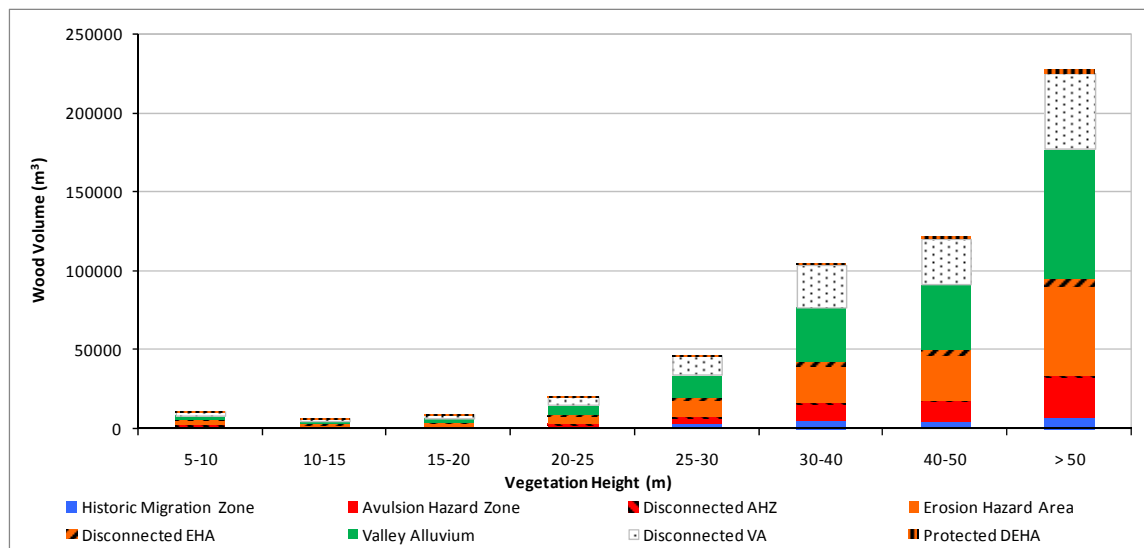
Figure 3-12. Potential LWD Recruitment Volumes for Each CMZ Area by Tree Height Class

The quantity of potential LWD recruitment (wood loading) within each of the CMZ zones by vegetation height class for the entire study reach is summarized in Figure 3-12. Larger trees, by volume, will contribute more to LWD loading within the river system than the smaller trees.

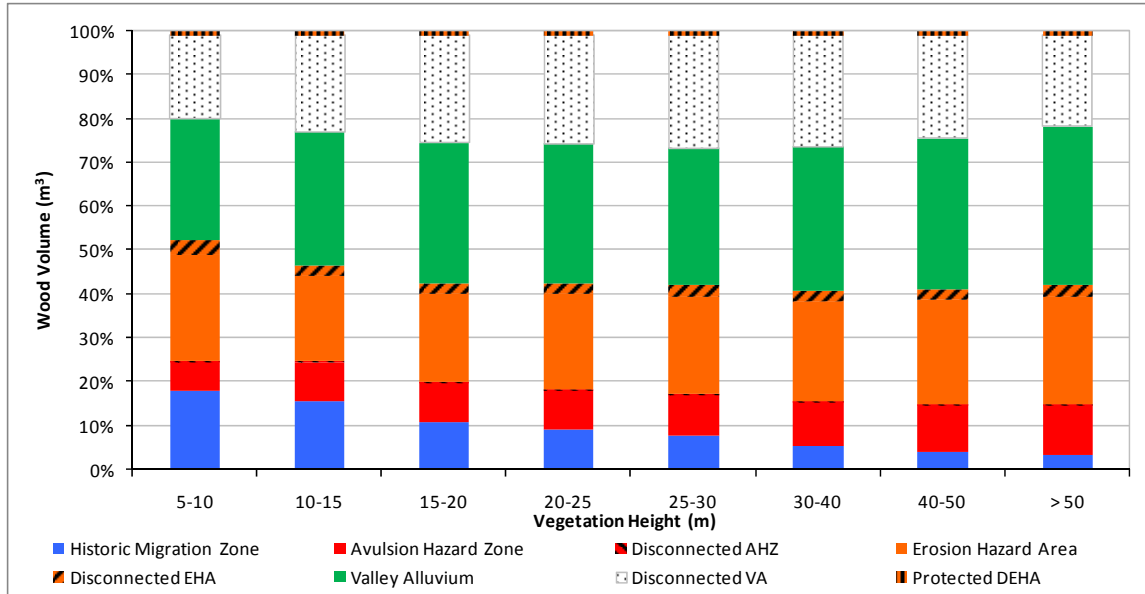
Figure 3-13. Relative percent of potential LWD Recruitment Volume for Each CMZ Area by Tree Height Class

The relative percent of potential wood volume within each CMZ area is similar for each tree height class, particularly within the EHA, DAHZ, DEHA, DVA, and PDEHA areas (Figure 3-13). The relative percent of potential LWD volume within the low risk CMZ areas (VA and DVA) and AHZ increases with increasing tree height class (from 47 percent to 57 percent and 7 percent to 12 percent, respectively). In comparison, within the HMZ, the relative percent of potential LWD volume decreases with increasing tree height (from 18 percent to 3 percent).

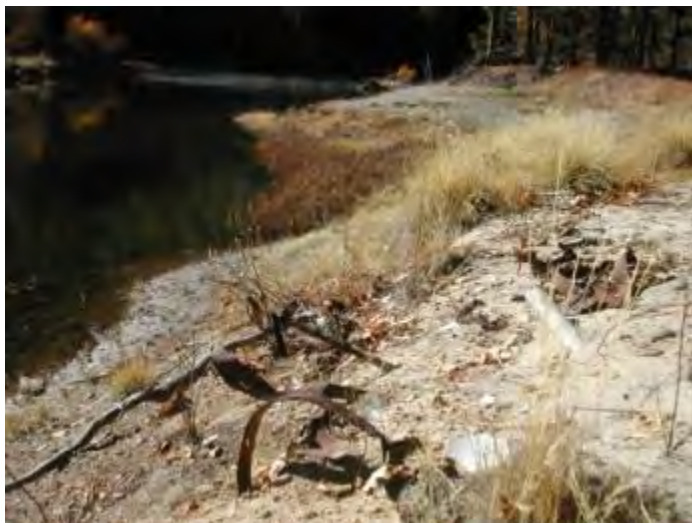
Figure 1: Exposed materials at El Capitan Dump.

The historic dump was used between 1880 and the 1960's. Exposed material consisted of metal pieces, glass, and ceramic shards, all of which posed a threat to visitors at the picnic area and had a high potential for being transported into the river (Figure 1). The El Capitan Dump Restoration Project was conducted in 1991 by restoration and archeology staff. The project sought to remove exposed surface materials from the site to mitigate potential hazards.

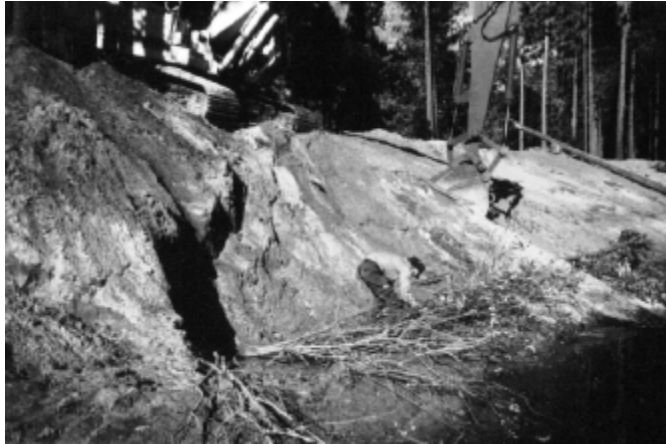
Figure 1: Crew member planting willow and cottonwood cuttings with the aid of the excavator

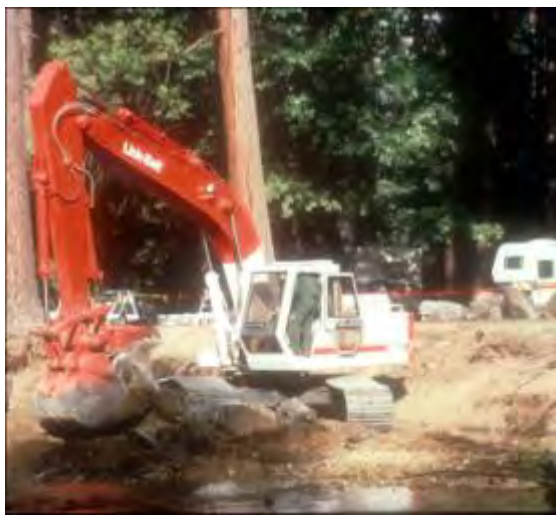
Figure 2: Restoration staff using excavator to remove riprap at Lower River Campground.

In October of 1991, restoration staff used a small excavator to remove all riprap from the channel (Figure 2). On the terrace, they removed the asphalt parking pads, cement curbs, and campground boundary rocks from the nine former campsites. Approximately 230 cubic yards of boulders and 20 cubic yards of asphalt were removed from the site with a loader operated by maintenance personnel. This heavy equipment phase lasted 4 days, from October 7-10.

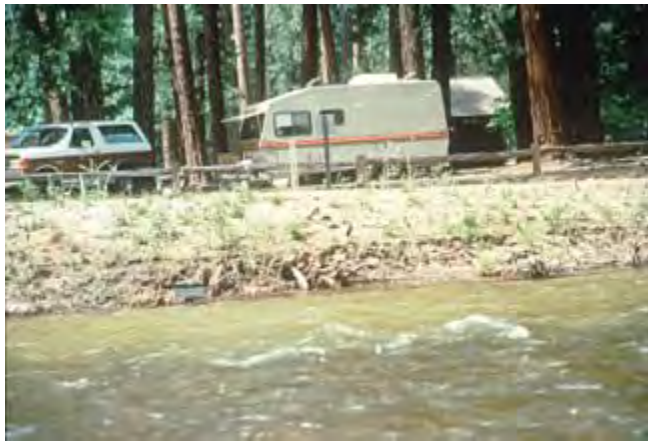
Figure 3: Lower River Campground 1 year after restoration.

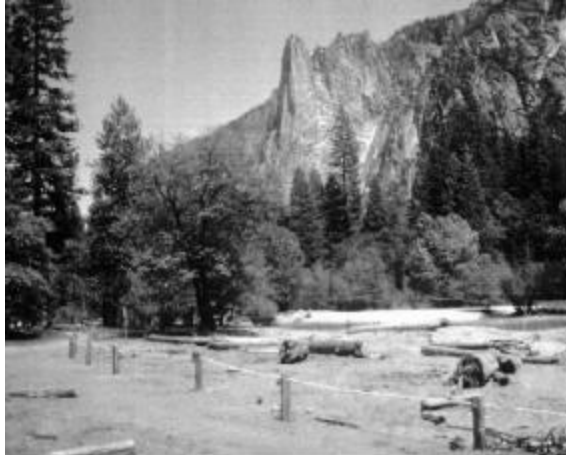
Figure 3: Post and cable fencing at the El Capitan Picnic Area restoration site.

Staff installed a post and cable fence and connected it to the El Capitan Dump project fence. They also moved Valley Loop Trail signs to direct hikers along the fenced perimeter (Figure 3).

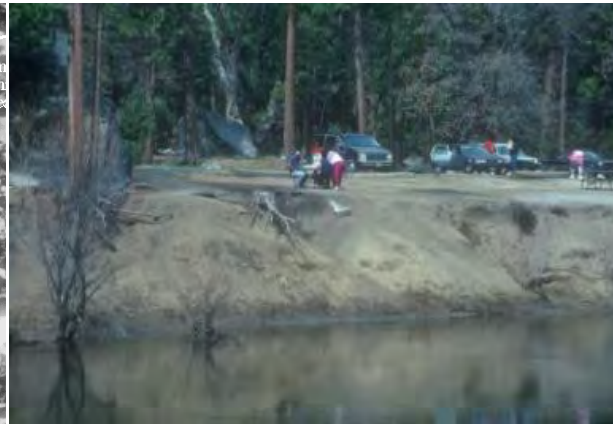
Figure 2: Riverbank at Devil's Elbow picnic area before restoration.

Devil's Elbow is a section of the Merced River located just 0.2 miles upstream of El Capitan Crossover Bridge (Figure 1). The site has a long history as a popular picnic area and river access point for visitors. Up until 1984, it served as the main raft take-out location for the concessionaire, resulting in extreme erosion of the bank (Figure 2).

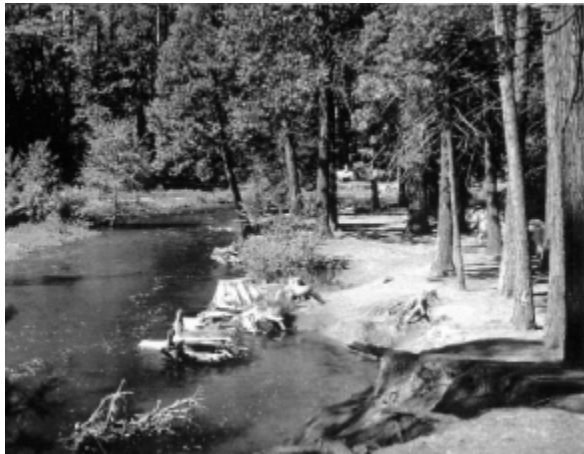
Figure 1: Denuded Bank of Tenaya Creek at North Pines Group Camp prior to restoration.

North Pines Group Camp is located at the east end of Yosemite Valley adjacent to Tenaya Creek. The campground experiences intensive visitor use during the summer months and as a result, a section of riverbank between the creek and the campground became denuded of vegetation and heavily eroded (Figure 1).

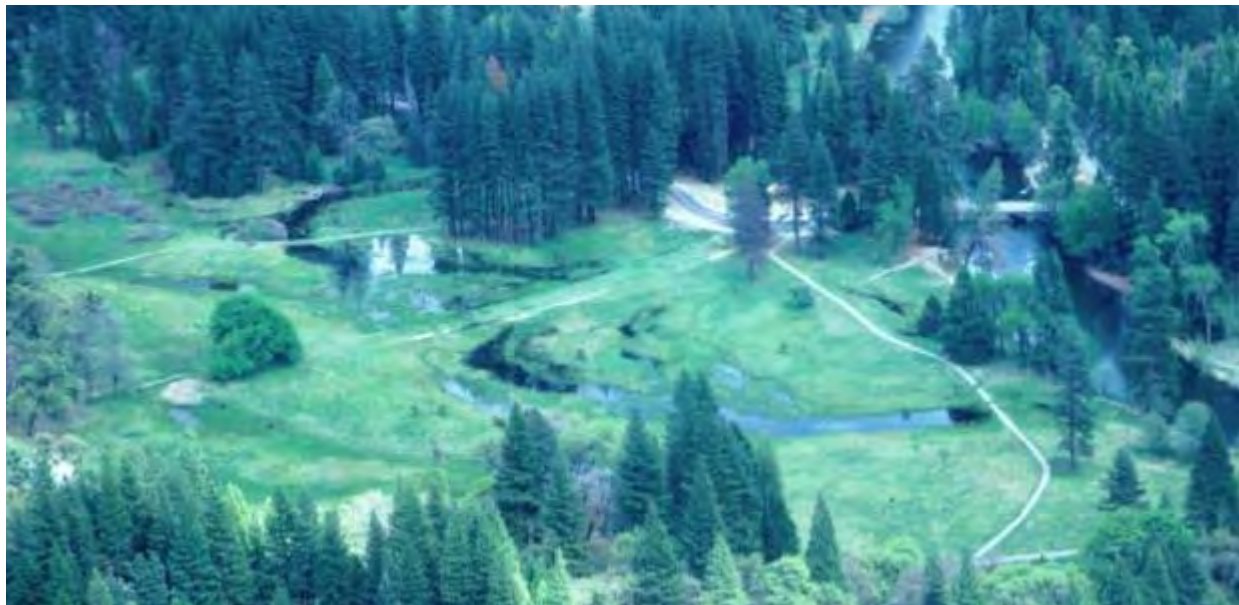
Figure 1: Cook's Meadow with paved trails (left and right) and historic roadbed (center), 1993.

The hydrology of Cook's Meadow was significantly altered in the 1800s when settlers drained certain parts of the meadow with ditches and culverts in order to maintain drier land for pastures and agricultural purposes. A road was also built through the center of the meadow, compacting the soil and impeding the flow of surface water across the land. The subsequently drier soils also promoted the proliferation nonnative upland grass species as well as conifer encroachment into the meadow. In later years, paved interpretive trails were established throughout the meadow as well (Figure 1).

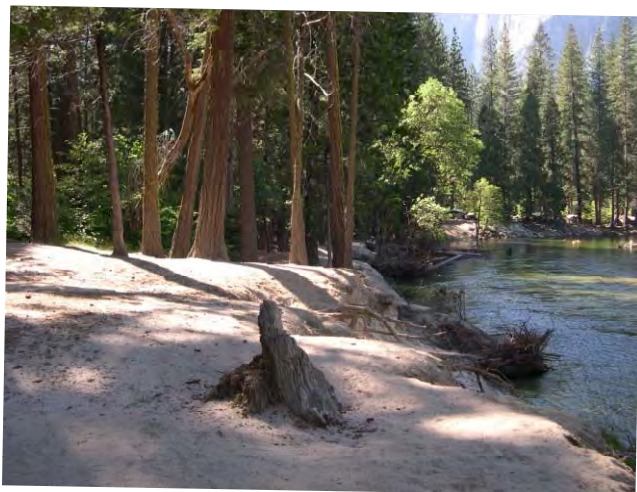
Figure 33: Eroding bank on river left between Stoneman Bridge and Housekeeping Camp.

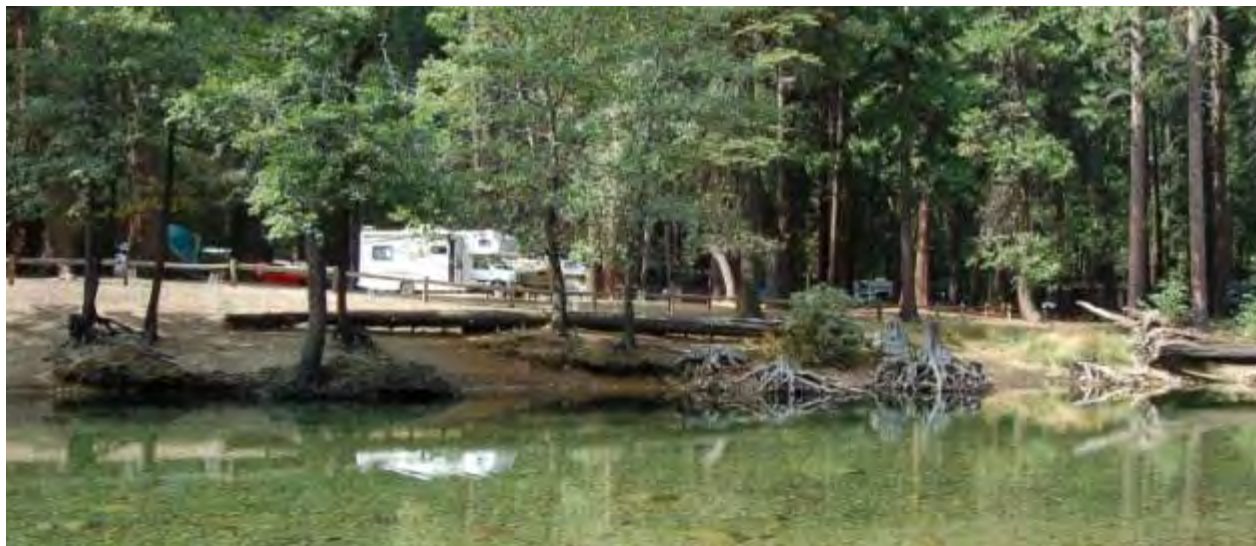
Figure 1: Exposed tree roots in Lower Pines Campground (river left).

In 2006, the reach of river below Clark's Bridge at the North Pines and Lower Pines Campgrounds, was targeted for restoration based on the condition of the riverbanks and exposure to high levels of visitor use. The campgrounds are situated opposite each other along approximately 1,750 feet of the Merced River beginning at Clark's Bridge and extending down to the confluence of Tenaya Creek. The banks and terrace on both sides of the river are denuded of most understory vegetation and tree roots are largely exposed (Figure 1).

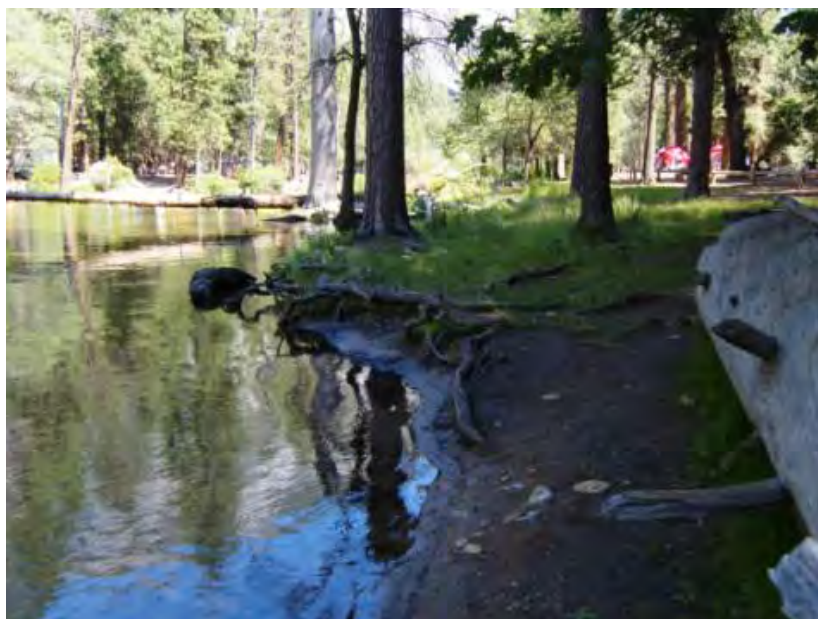
Figure 3: Vegetation establishment in Lower Pines Campground 2 years after fence installation.

They constructed two sections of fencing, totaling 1,200 feet, in Lower Pines Campground with a designated river access point between them (Figure 2). Staff also planted the two enclosed areas with herbaceous and shrub seedlings in the more highly denuded zones. Figure 3 shows vegetation establishment 2 years after fence installation in Lower Pines Campground.

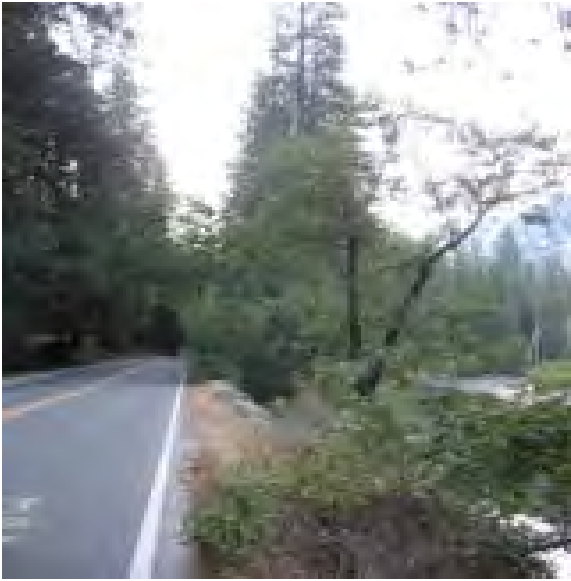
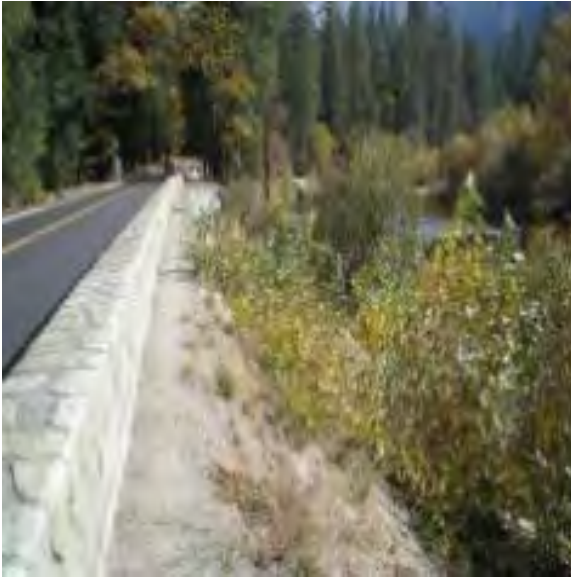
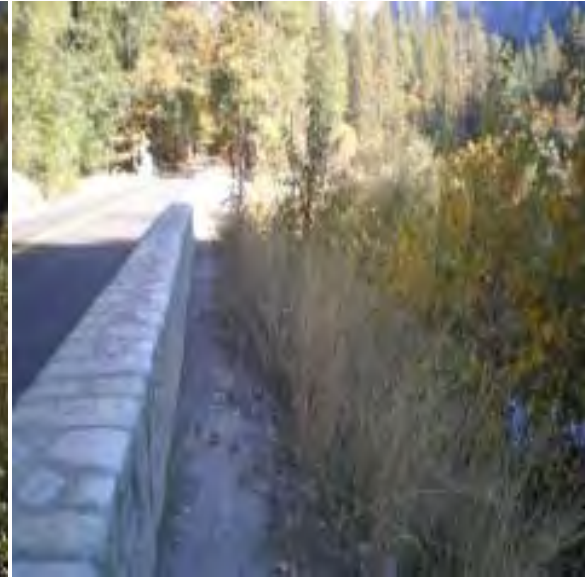
Figure 1: Vegetation recruitment at the Narrows: pre-construction and 3 years post-construction.

Two years following the completion of the project, park ecologists have determined that the mitigation planting was a success. The number of woody vegetation stems and clumps, as well as the basal cover and height of these stems and clumps, has increased each year following planting (Figure 2). Survival of planted species is well over 75 percent, with significant volunteer recruitment. No further mitigation efforts are needed and the next monitoring site visit will occur in the late fall or early winter of 2011.

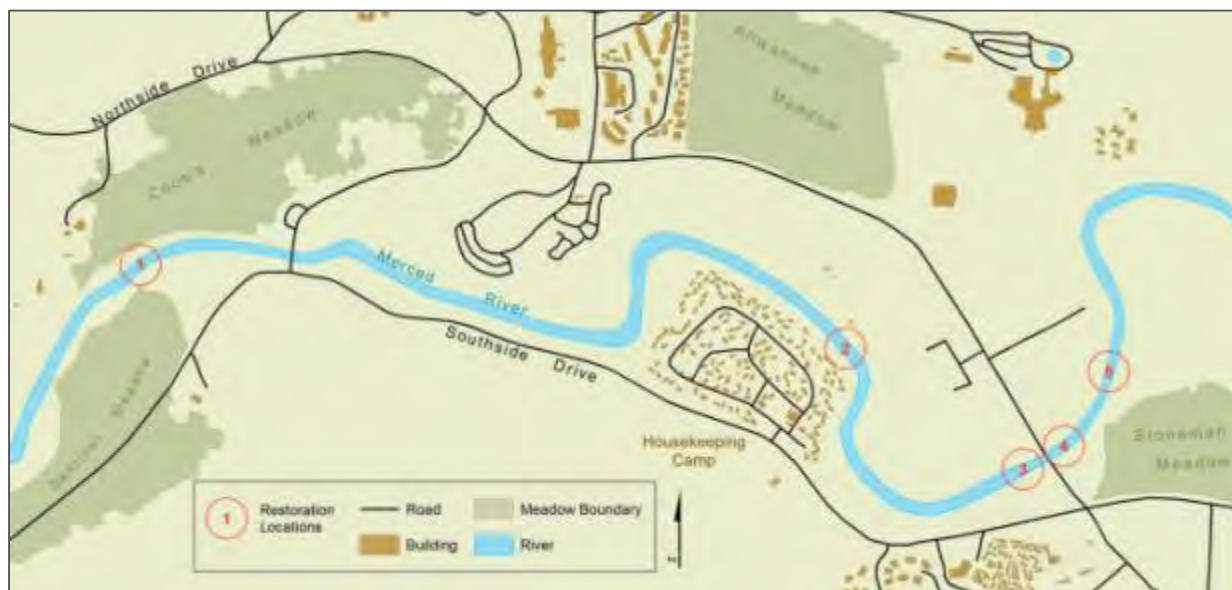
Figure 1: Utility removal restoration locations in Yosemite Valley, 2010.

In 2010, the National Park Service and a contractor removed eight utility line crossings from the Merced River, five of which required restoration action in order to stabilize the banks on one or both sides of the river (seven bank locations in all). Figure 1 shows the five general locations requiring restoration action. The site locations that required restoration are described as follows: (1) upstream of Superintendent's Bridge, south side of river; (2) downstream of Housekeeping Bridge, both sides of the river; (3) downstream of Stoneman Bridge, south side of the river; (4) upstream of Stoneman Bridge, south side of the river; and (5) the reach of river at Stoneman Meadow, both sides of the river.
