Tech Notes

WINDOWS

NUMBER 9

Interior Storm Windows: Magnetic Seal

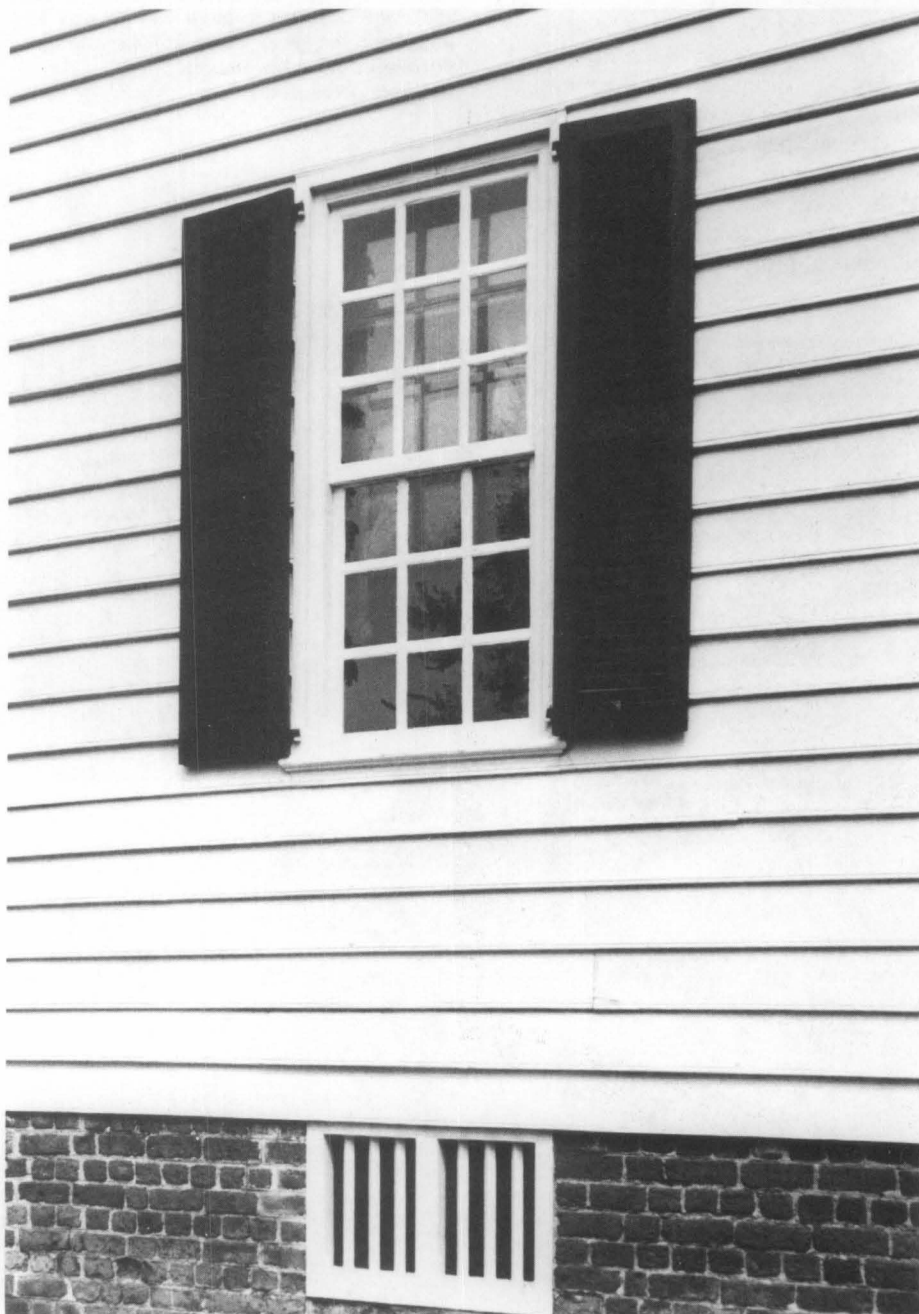
Figure 8. The unobtrusive interior storm window required no physical damage or exterior visual alteration to the original window. Photo: Tom H. Taylor.

The unobtrusive nature of these storm windows is an advantageous feature, along with the fact that no physical damage or alteration to the original window is required (see figure 8).
