Subject: Altering the Character of Historically Finished Interiors

- Applicable Standards:**
2. Retention of Historic Character
 5. Preservation of Distinctive Features, Finishes and Craftsmanship
 6. Repair/Replacement of Deteriorated or Missing Features Based on Evidence

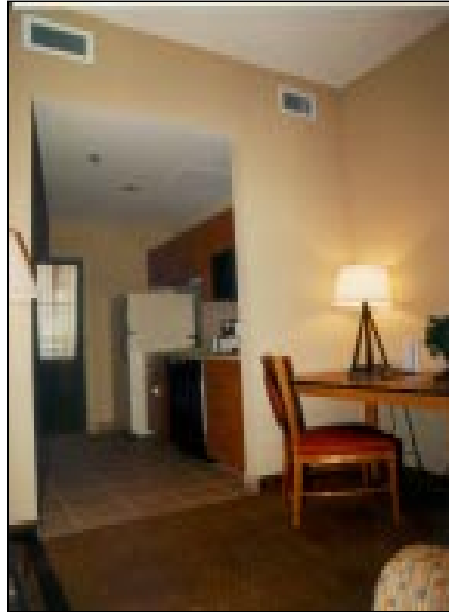
The lowered ceiling in the kitchen area conceals mechanical and other equipment in this rehabilitated 1927 office building.

Application 2 (*Compatible Treatment*): A similar conversion of another early 20th century office building for new housing use illustrates a much more sensitive rehabilitation approach where a previously installed suspended ceiling was removed. In this case, a new ceiling finish was applied directly to the underside of the flat concrete floor slab overhead. In order to minimize the impact of the new mechanical systems, they were concealed above a lower ceiling over the kitchen and bathroom areas. Locating these functions in the secondary spaces, away from the perimeter wall, made it possible to avoid dropping the ceiling below the top of the windows and to retain the sense of volume and proportion of the original space in the primary living areas. Furthermore, the finished quality of the space was maintained.
