Interpreting The Secretary of the Interior's Standards for Rehabilitation

Subject: Completing Never-Built Portions of a Historic Building

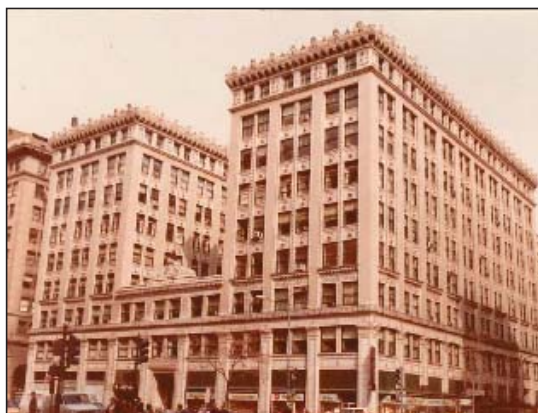
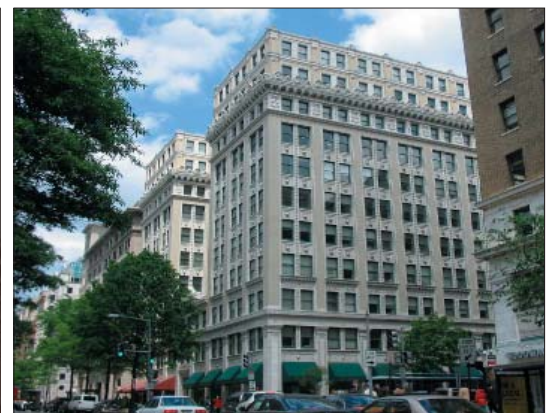
Above is an elevation of the original design concept; the shaded areas indicate the two stories which were never built. To the right is the building as originally constructed, and to the far right, the building after the two-story addition was built.

Extensive research into the history of the building clearly showed that the architect's original design envisioned an eleven-story building rather than the nine-story structure that was eventually built. This was documented in the historic structural drawings, original promotional material, and in the structural support for the future addition found on the roof. Such documentation, however interesting, was of little relevance since the historic character of the building was defined by what had actually been constructed, that is, a nine-story structure with a very distinctive cornice. Accordingly, constructing the proposed two-story rooftop addition, even though it followed the never-built design, was not a compatible treatment because it changed the height and proportions of the building, diminished the prominence of the cornice and, thus, negatively impacted the building's historic character. The project did not meet the Standards.

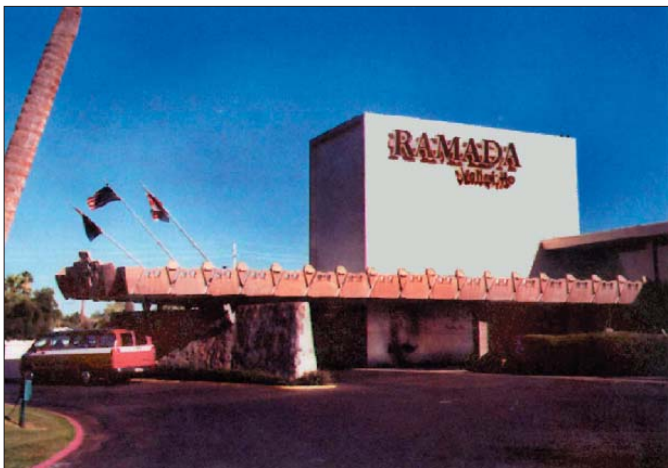
The image at the top is an architectural rendering of the original design for the hotel from 1957, which includes a tower element. Below this image is a postcard showing the main entrance to the complex as completed in the 1950's. As can be evidenced in these illustrations, the proportions of the three-story tower pylon highlighted by the long horizontal lines of the surrounding construction are part of the complex's distinctive visual character. The third image from the top shows the tower and porte-cochere before rehabilitation. While the tower's original architectural finish concrete has been covered with stucco and the original sign has been removed and replaced, its primary form remains as it was originally constructed.

Application 2 (Incompatible treatment): Another rehabilitation project which included a proposal to add a never-built feature on to a historic building involves a much different type of resource in terms of setting and appearance. In this case, the historic resource is a well-preserved resort hotel constructed in 1956, which embodies all the modern conveniences catering to the automobile-oriented leisure traveler of that era. Among the character-defining features of the hotel are the sprawling two-story guest wings informally arranged around a landscaped pool area. A cantilevered porte-cochere and a three-story rectangular block fitted with an illuminated sign established the presence of the hotel from afar.
