## Interpreting The Secretary of the Interior's Standards for Rehabilitation

### Subject: Designing Compatible Replacement Storefronts

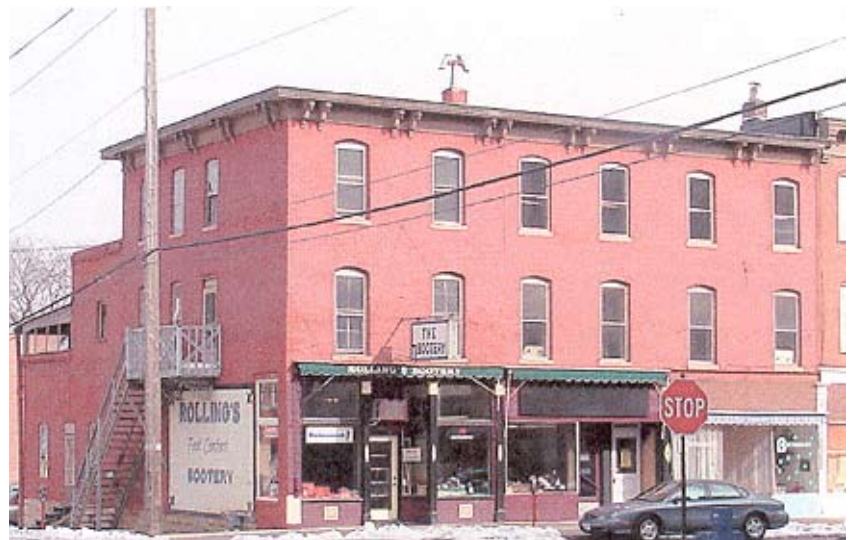
*The three buildings prior to rehabilitation.*

**Application 1 (Compatible treatment):** These three buildings constructed in 1868 are part of a three-story commercial block. The storefronts had been remodeled prior to rehabilitation, each somewhat differently, although the original cast iron pilasters that separated the storefronts remained and all the entrance doors were in their original locations.

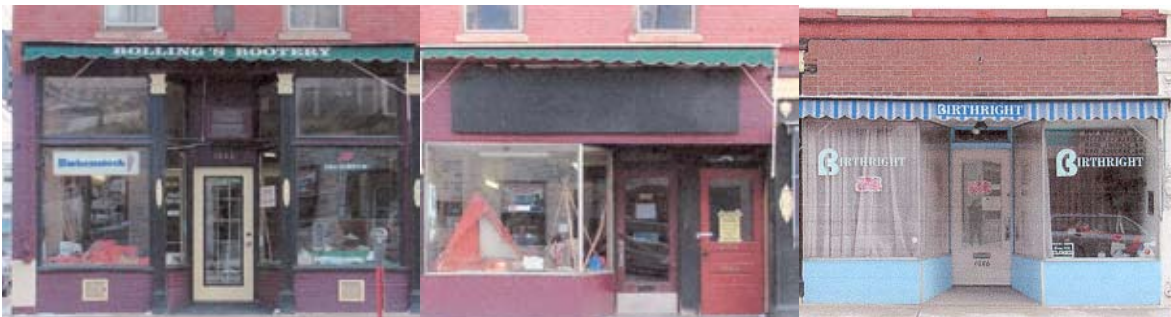
*Details of existing storefronts prior to rehabilitation.*

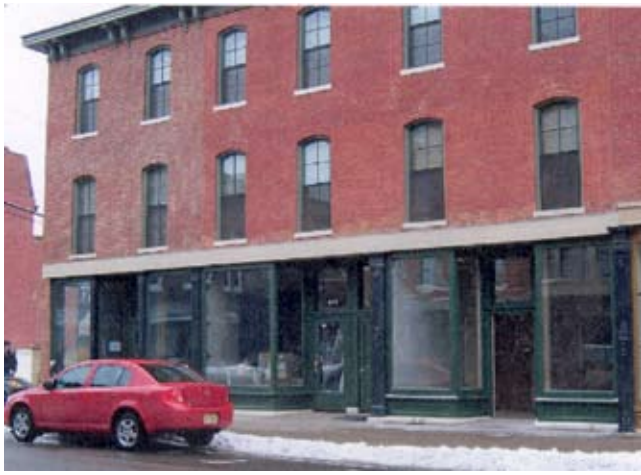
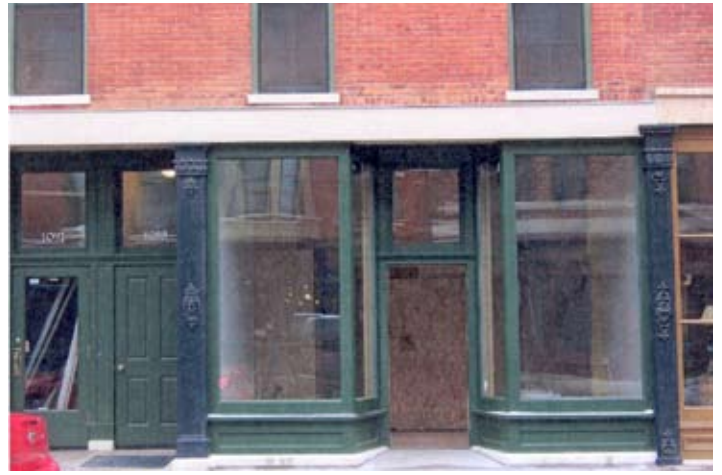
The buildings with compatible new storefronts after rehabilitation with detail of new storefronts.

The rehabilitation of these buildings for retail/commercial use on the first floors and residential use on the upper floors included installing compatible new storefronts. As part of the rehabilitation the original cast iron pilasters were retained and repaired. The new replacement storefronts are painted wood and consist of a lower panel and large glass display windows. The new doors are simple in design and feature transoms above. Although the original storefront windows could have included transoms, the new full height, undivided showcase windows without transoms are compatible with the historic character of these buildings. Accordingly, this rehabilitation project meets the Standards.

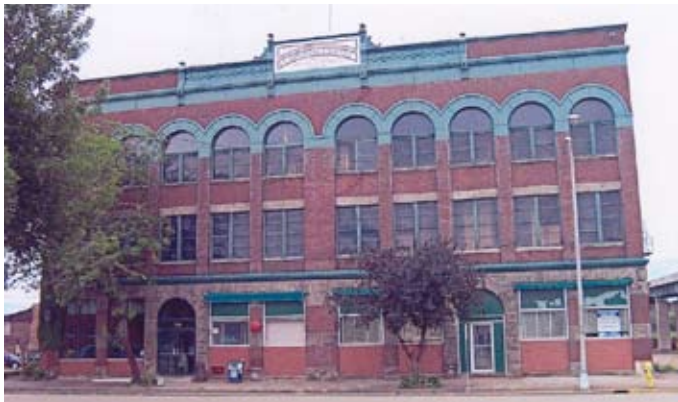
Above: The warehouse storefronts had been changed prior to rehabilitation.

**Application 2 (Compatible treatment):** This 1912 hardware warehouse was rehabilitated for low-income housing. Over the years, the first floor storefront openings had been altered. A single door, surrounded by green spandrel glass sidelights and transom, filled in the entrance. Brick infill had reduced the size of the window openings, especially those on the right side of the façade. The historic storefront windows themselves had been replaced with smaller unpainted aluminum windows with green spandrel glass transoms.
