7 PRESERVATION BRIEFS

The Preservation of Historic Glazed Architectural Terra-Cotta

de Teel Patterson Tiller

U.S. Department of the Interior National Park Service
Preservation Assistance Division Technical Preservation Services

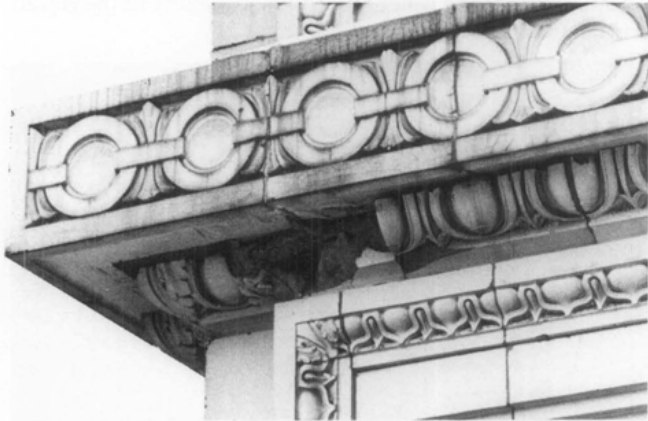
Figure 7. Material Spalling. Excessive expansion of the porous tile body caused by water and freezing temperatures produces major material spalling, a situation often difficult to repair.

Material spalling is a particularly severe situation. Not only is the visual integrity of the detailing impaired, but a large area of the porous underbody, webbing and metal anchoring is exposed to the destructive effects of further water entry and deterioration (Fig. 7). Both glaze and material spalling must be dealt with as soon as possible.

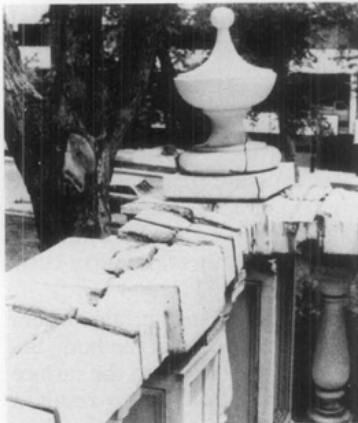
Figure 8. Deterioration of Exposed Detailing. Exposed or freestanding terra-cotta detailing (parapets, urns, balusters, etc.) have traditionally been subject to the most severe vicissitudes of deterioration as a result of freezing temperatures and water. (Colorado State Historic Preservation Office)

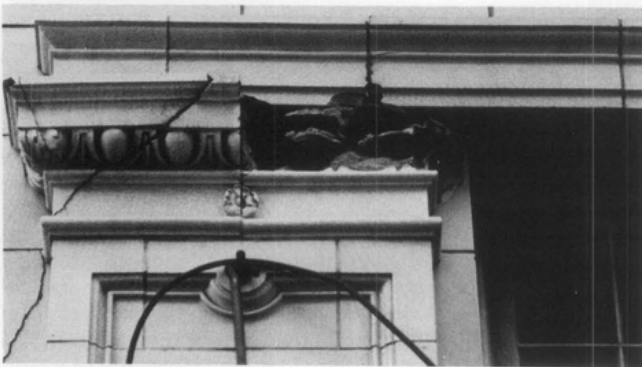
Figure 10. Structural Cracking. Structural cracking, whether static (nonmoving) or dynamic (moving or active), should be caulked to prevent water entry into the glazed architectural terra-cotta system. Note the exposed webbing.
