# 11 PRESERVATION BRIEFS

## Rehabilitating Historic Storefronts

H. Ward Jandl

U.S. Department of the Interior  
National Park Service  
Cultural Resources  
Heritage Preservation Services

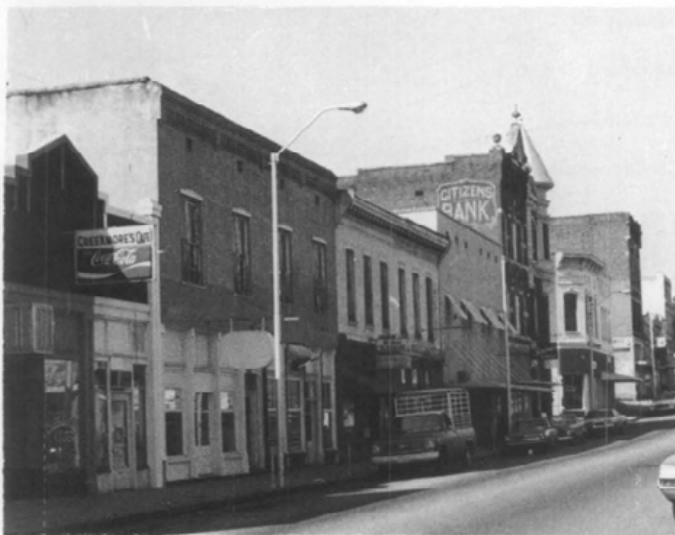
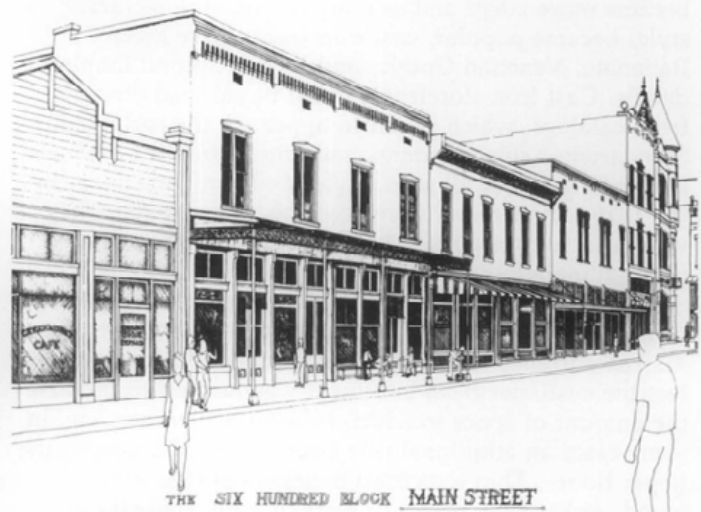
Figure 1. Inappropriate storefront alterations over the years—metal cladding, oversized signs and canopies—have detracted from the character of this historic district in Van Buren, Arkansas. A carefully considered rehabilitation plan for Main Street, including the removal of poorly designed signs, false fronts and the selection of an appropriate exterior paint color palette, serves to enhance the visual environment and preserves the district's sense of time and place. Photo above: Bob Dunn; Drawing, David Fitts

As more and more people come to recognize and appreciate the architectural heritage of America's downtowns, however, a growing interest can be seen in preserving the historic character of commercial buildings. The sensitive rehabilitation of storefronts can result not only in increased business for the owner but can also provide evidence that downtown revitalization efforts are succeeding (see figure 1).

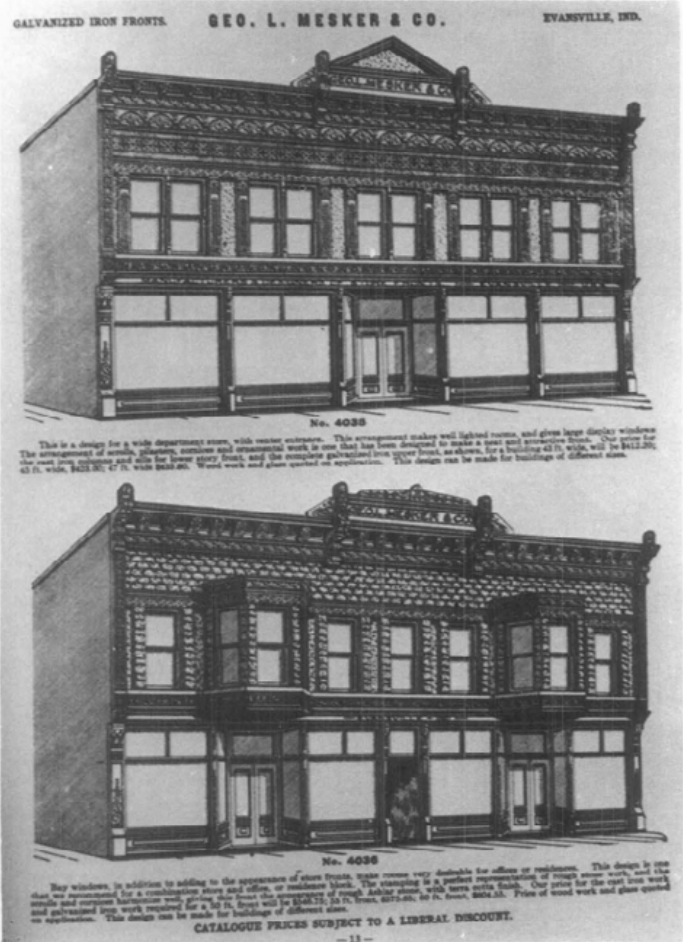
Figure 2. These 19th century galvanized iron storefronts could be purchased from George L. Mesker & Co. in Evansville, Indiana.

The first cast iron fronts were simple post-and-lintel construction with little decoration. As iron craftsmen became more adept and as more ornate architectural styles became popular, cast iron fronts were given Italianate, Venetian Gothic, and French Second Empire details. Cast iron storefronts could be selected directly from catalogs, which began to appear in the early 1850's. Standardized sills, columns, and lintels could be arranged to create fronts of all sizes, styles and configurations. In the 1870's sheet metal storefronts became popular; they were also sold in standardized sizes and configurations through manufacturers' catalogs (see figure 2).

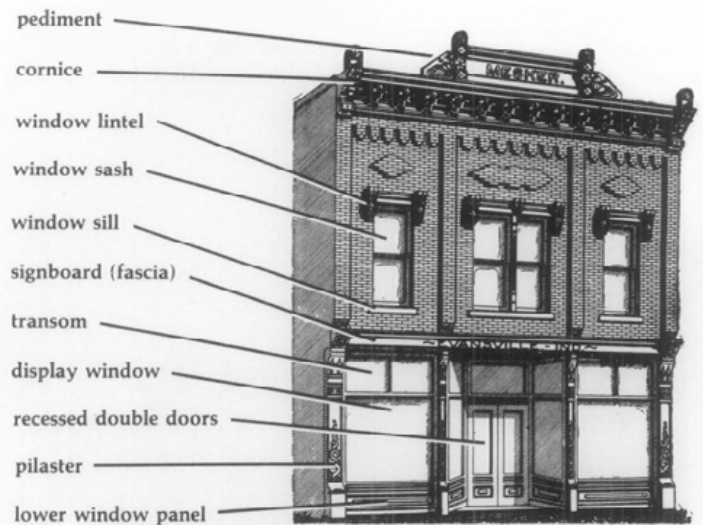
Figure 3. Become familiar with the architectural features typical of historic commercial buildings. A close look at a storefront's construction materials, features and relationship to the upper stories will help in determining how much of the original facade remains.

This particular storefront is No. 4016 in the George L. Mesker and Company catalog of 1905. One of Mesker's most popular designs, it featured cast-iron sills, columns and lintels, galvanized iron lintel and main cornice, window caps and pediment.

The typical 19th century storefront consisted of single or double doors flanked by display windows (see figure 3). The entrance was frequently recessed, not only to protect the customer from inclement weather but to increase the amount of space in which to display merchandise. In some cases an additional side door provided access to the upper floors. Thin structural members of cast iron or wood, rather than masonry piers, usually framed the storefront. The windows themselves were raised off the ground by wood, cast iron or pressed metal panels or bulkheads; frequently, a transom or series of transoms (consisting of single or multiple panes of glass) were

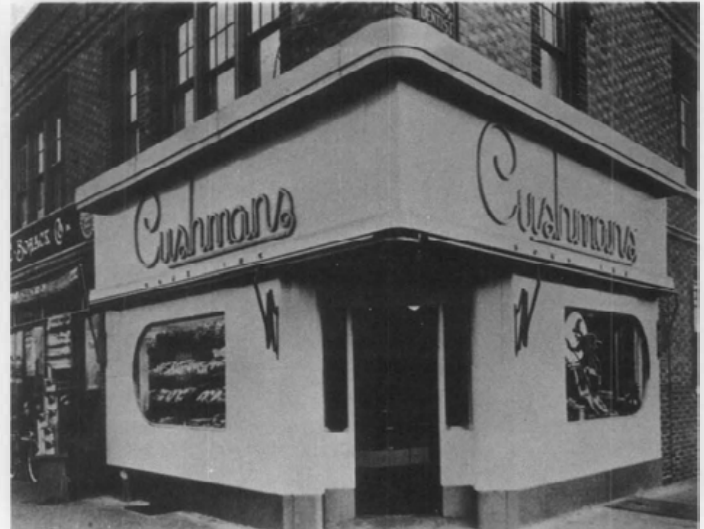
Figure 4. This storefront in New York City designed by Raymond Loewy typifies the streamlined look of the 1930's. Added to an earlier building, the front utilizes glass, stainless steel and neon to make a modern statement. This is a good example of a later storefront which has acquired significance and should be retained in any rehabilitation.

The first decades of the 20th century saw the growing use of decorative transom lights (often using small prismatic glass panes) above display windows; in some cases, these transoms could be opened to permit air circulation into the store. Electric incandescent lights enabled storeowners to call attention to their entrance and display windows and permitted nighttime shopping. In the 1920's and 1930's a variety of new materials were introduced into the storefront, including aluminum and stainless steel framing elements, pigmented structural glass (in a wide variety of colors), tinted and mirrored glass, glass block and neon. A bewildering number of proprietary products also appeared during this period, many of which went into storefronts including Aklo, Vitrolux, Vitrolite, and Extrudalite. Highly colored and heavily patterned marble was a popular material for the more expensive storefronts of this period. Many experiments were made with recessed entries, floating display islands, and curved glass. The utilization of neon lighting further transformed store signs into elaborate flashing and blinking creations. During this period design elements were simplified and streamlined; transom and signboard were often combined. Signs utilized typefaces for the period, including such stylized lettering as "Broadway," "Fino" and "Monogram." Larger buildings of this period, such as department stores, sometimes had fixed metal canopies, with lighting and signs as an integral component of the fascia (see figure 4).

In evaluating whether the existing storefront is worthy of preservation, recognize that good design can exist in any period; a storefront added in 1930 may have greater architectural merit than what is replaced (see figure 4). In commercial historic districts, it is often the diversity of

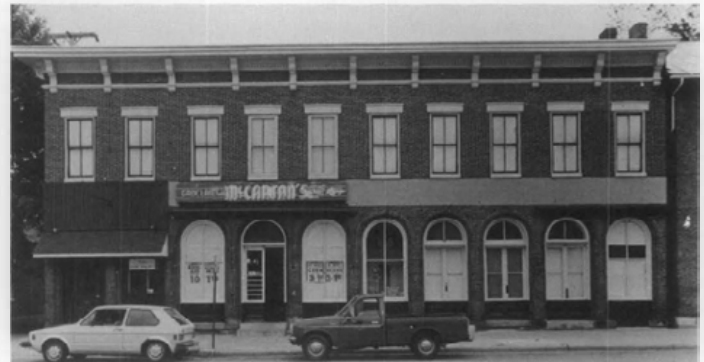
Figure 5. In some cases, as in the storefront on the extreme left, it is a simple matter to determine original appearance by looking at neighboring storefronts. Removal of the board and batten fasciaboards, pent roof, and "colonial" style door, all of which could be undertaken at minimal cost, would restore the original proportions and lines of the building. Photo: Day Johnston

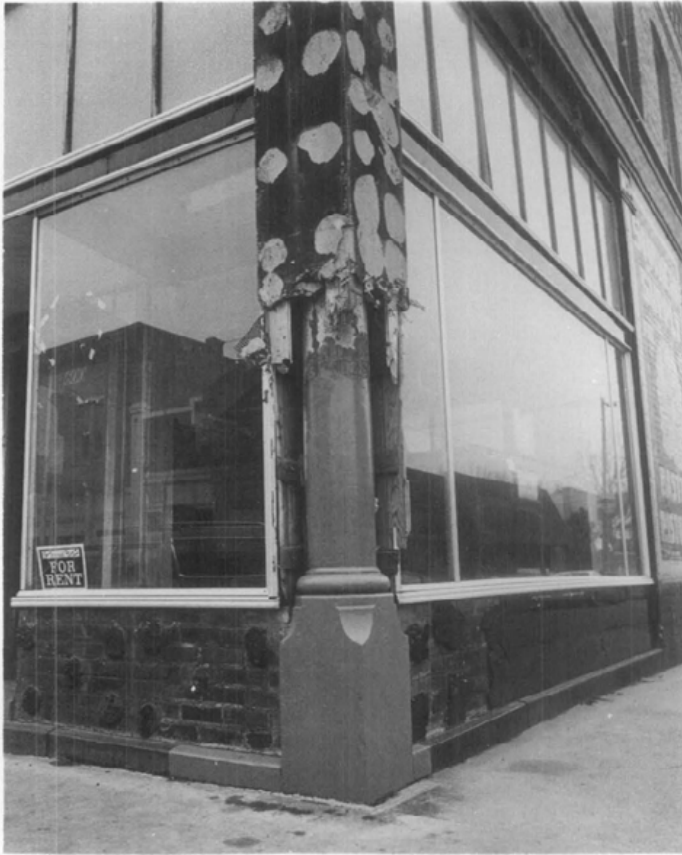
Figure 6. Storefronts of the 1940's, 50's, and 60's were frequently installed by attaching studs or a metal grid over an early front and applying new covering materials. If the existing storefront is a relatively recent addition with little or no architectural merit, begin by removing the covering materials in several places as was done here. If this preliminary investigation reveals evidence of an earlier front, such as this cast-iron column, carefully remove the later materials to assess the overall condition of the historic storefront. The black mastic visible on the lower masonry panels was used for installing pigmented structural glass. Some attachment methods for modern facings, such as mastic or metal lath, may have seriously damaged the original fabric of the building, and this must be taken into account in the rehabilitation process. Photo: Bob Dunn

tent and nature of rehabilitation work needed (see figure 6). In most cases, this examination is best undertaken by a qualified professional.

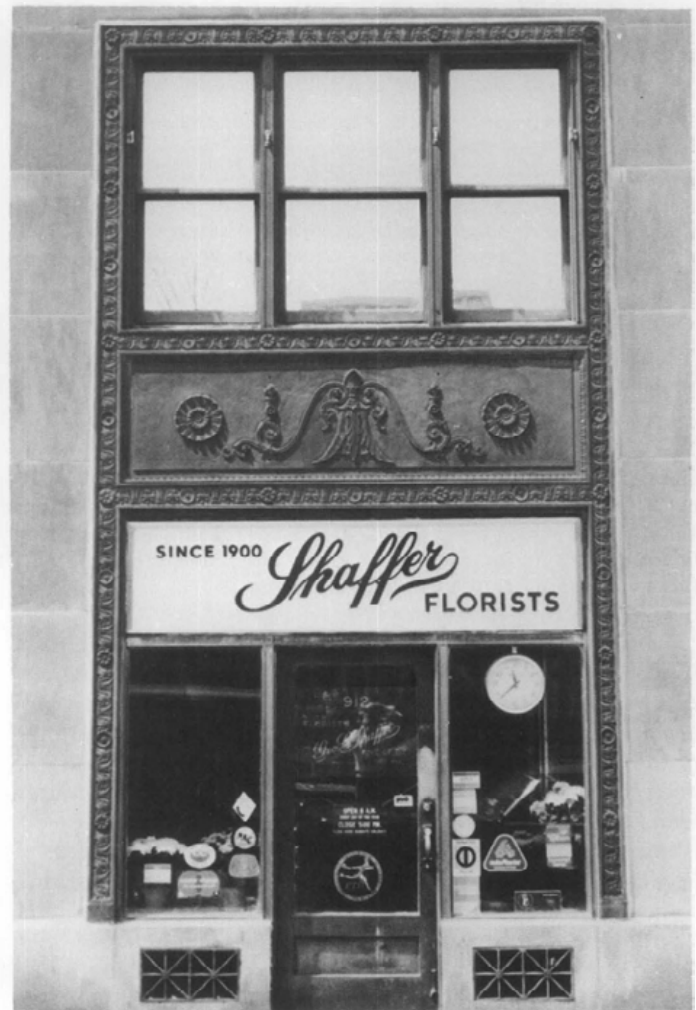
Figure 7. Part of a large office building constructed in Washington, D.C. in 1928, this finely detailed bronze storefront is typical of many constructed during this period. It should be noted that the original grilles, spandrel panel and window above are all intact. Photo: David W. Look, AIA

**Bronze and brass**—nonmagnetic, abrasive-resistant alloys combining copper with varying amounts of zinc, lead, or tin. These copper alloys, more commonly found in office buildings or large department stores, range in color from lemon yellow to golden brown to green depending on their composition and are well suited for casting (see figure 7).

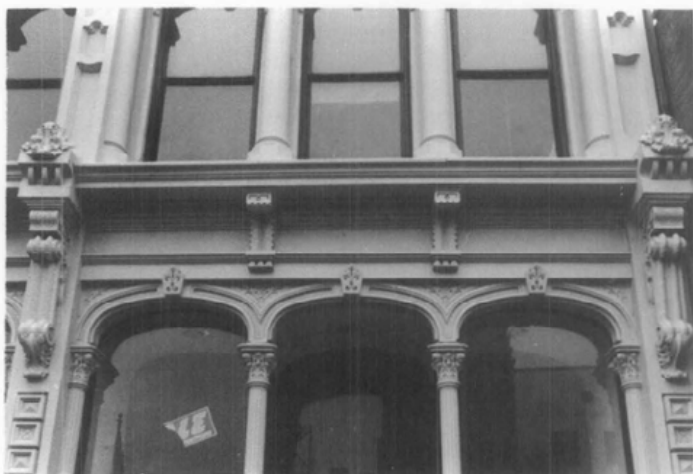
Figure 8. When the Grand Opera House in Wilmington, Delaware, was rehabilitated, missing cast-iron columns were cast of aluminum to match the original; in this particular case, because these columns do not carry great loads, aluminum proved to be successful substitute. Photo: John G. Waite

If metal components have deteriorated to a point where they have actually failed (or are missing), replacement is the only reasonable course of action. If the components are significant to the overall design of the storefront, they should be carefully removed and substituted with components that match the original in material, size and detailing (see figure 8).

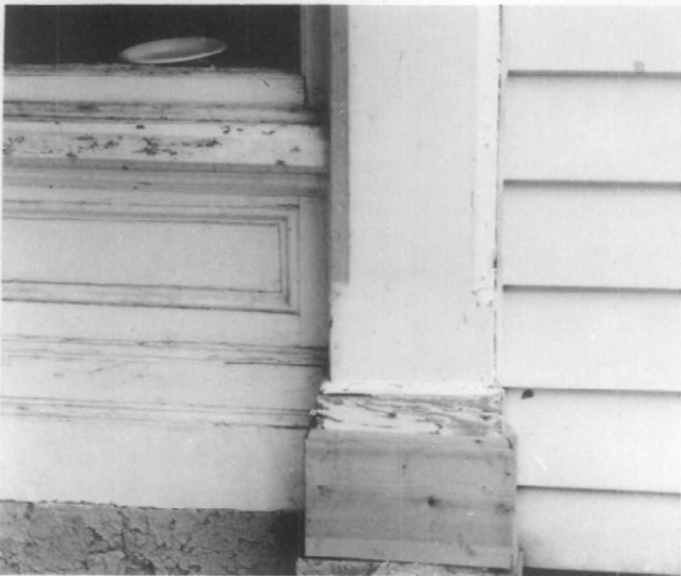
Figure 9. Rather than replace an entire wooden storefront when there is only localized deterioration, a new wooden component can be pieced-in, as seen here in this column base. The new wood will need to be given primer and top coats of a high quality exterior paint—either an oil-base or latex system. Also wood that is flaking and peeling should be scraped and hand-sanded prior to repainting. Photo: H. Ward Jandl

Where components of wood storefronts are so badly deteriorated that they cannot be stabilized, it is possible to replace the deteriorated parts with new pieces (see figure 9). These techniques all require skill and some expense, but are recommended in cases where decorative elements, such as brackets or pilasters, are involved. In some cases, missing edges can be filled and rebuilt using wood putty or epoxy compounds. When the epoxy cures, it can be sanded smooth and painted to achieve a durable and waterproof repair.

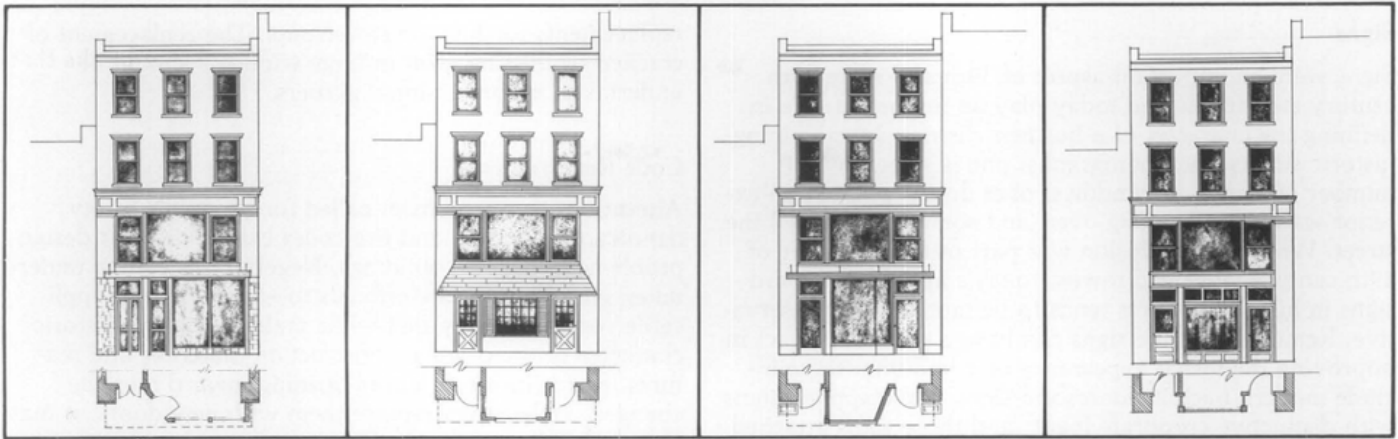
Figure 10. (A) This existing storefront, added in the 1950's to a late 19th century brick building, extends beyond the plane of the facade; faced with anodized aluminum and permastone, it does not contribute to the architectural and historic character of the building. (B) This replacement design uses "lumberyard colonial" detailing, such as barn-type doors, shutters, small paned windows, and a wood shake pent roof. The design, detailing, and choice of materials are clearly inappropriate to this commercial building. (C) This replacement design retains the 1950's projecting canopy but symmetrical placement of the doors relates well to the second floor windows above; this contemporary design is compatible with the scale and character of the building. (D) This replacement design accurately restores the original appearance of the building; based on historical research and physical evidence, it too is an acceptable preservation approach. Drawings: Sharon C. Park, AIA

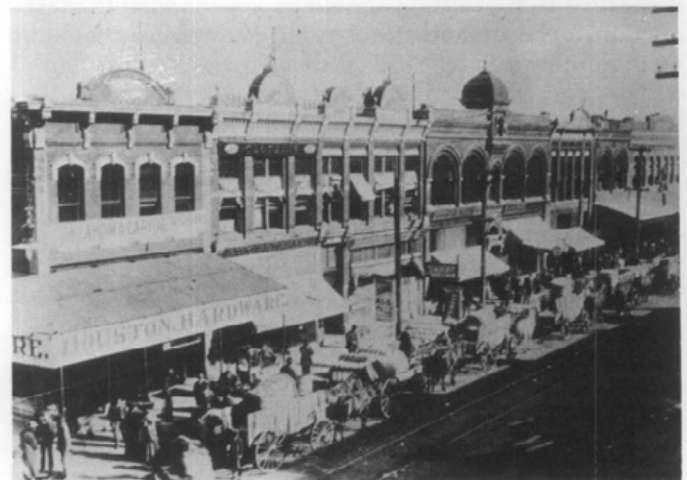
Figure 11. Try to locate old photographs or prints to determine what alterations have been made to the storefront and when they were undertaken. Awnings were common elements of storefronts at the turn of the century. They can be equally useful today.

Where based on historic precedent, consider the use of canvas awnings on historic storefronts (see figure 11).

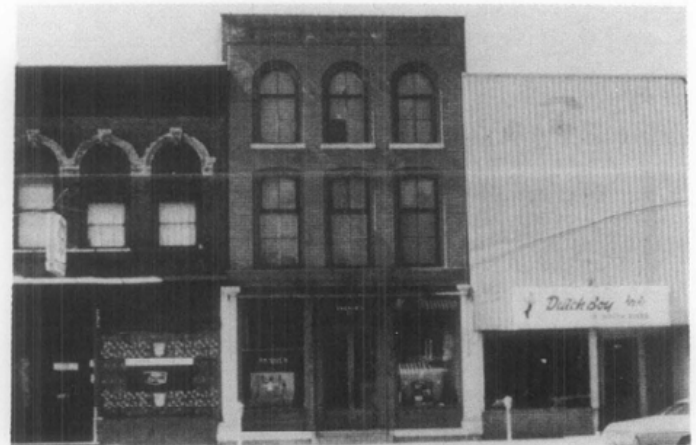
Figure 12. This photograph of three late 19th century commercial buildings clearly shows the impact of preserving and rehabilitating storefronts. The one on the right has been totally obscured by a "modern" front added in the 1950's. Although inappropriate alterations have taken place on the left storefront, it is still possible to determine the original configuration of the doors and display windows. The storefront in the middle has remained intact. Although in need of some minor maintenance work, the appeal of the original design and materials is immediately apparent.

A key to the successful rehabilitation of historic commercial buildings is the sensitive treatment of the first floor itself (see figure 12). Wherever possible, significant storefronts (be they original or later alterations), including windows, sash, doors, transoms, signs and decorative features, should be repaired in order to retain the historic character of the building. Where original or early storefronts no longer exist or are too deteriorated to save, the commercial character of the building should nonetheless be preserved—either through an accurate restoration based on historic research and physical evidence or a contemporary design which is compatible with the scale, design, materials, color and texture of the historic building. The sensitive rehabilitation of historic storefronts will not only enhance the architectural character of the overall building but will contribute to rejuvenating neighborhoods or business districts as well.
