**VOLUME I OF VI: INTRODUCTION AND OVERALL
DEVELOPMENT HISTORY**

**APOSTLE ISLANDS NATIONAL LAKESHORE
LIGHT STATIONS OF MICHIGAN ISLAND, OUTER ISLAND, DEVILS ISLAND,
LONG ISLAND AND SAND ISLAND**

**CULTURAL LANDSCAPE REPORT, HISTORIC STRUCTURE REPORT
AND
ENVIRONMENTAL ASSESSMENT**

prepared by
Anderson Hallas Architects, PC
Golden, Colorado

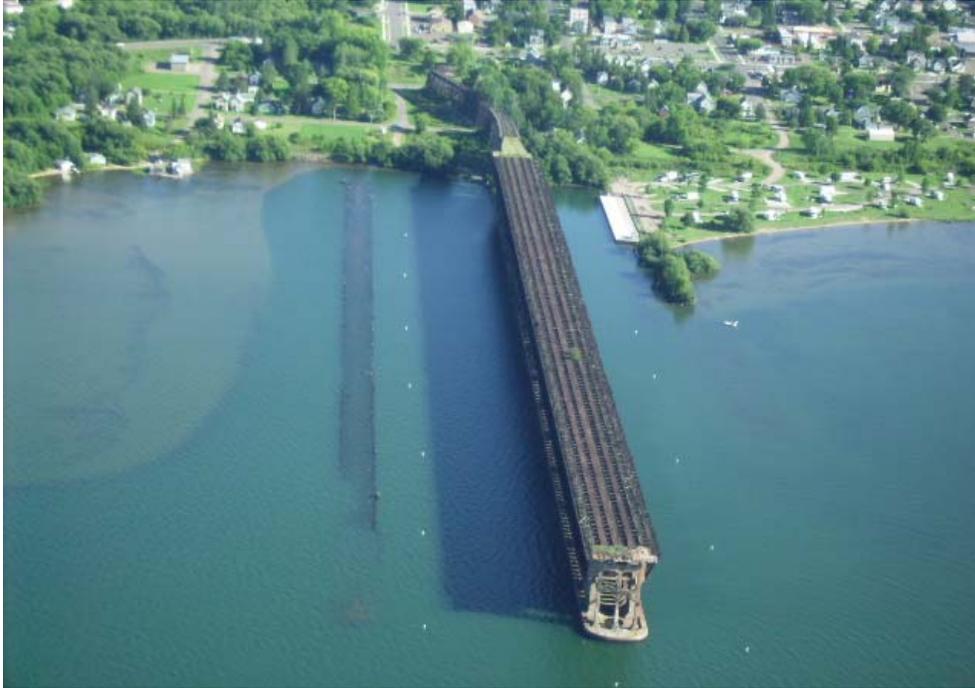
Trains dumped their load into chutes that loaded into waiting freighters at the Ashland ore docks. The first ore docks were installed in 1885. These are the third docks and were constructed in 1915-1917. Over a billion tons of iron ore was shipped from this dock during World War II. The last iron ore shipment was in 1965. The docks are scheduled for demolition.

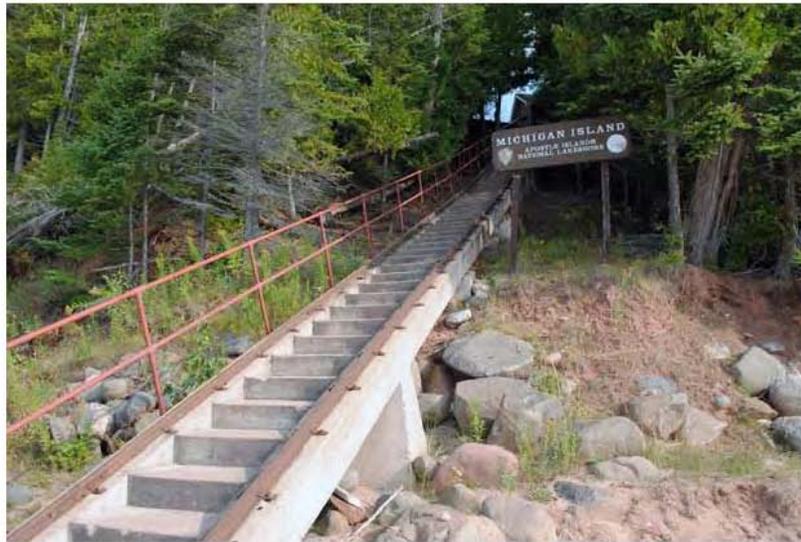
Michigan Island Tramway

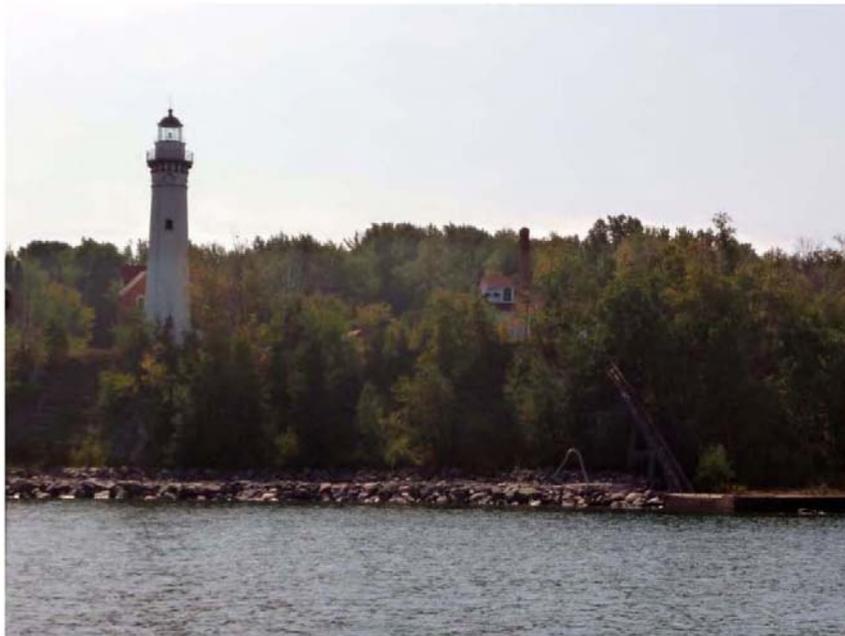
Outer Island Light Station and Tramway

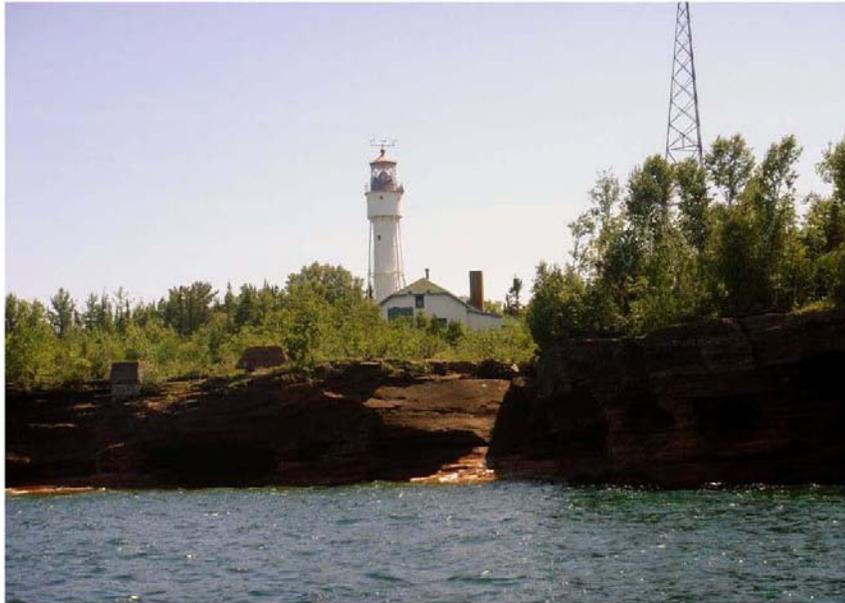
Devils Island Rocky Cliffs and Light Station

Physical access - Physical access to the Light Station, including its buildings and structures, is limited due to the topography of the site, rocky cliffs at the boat landings near the Light Station and steps leading into and through the structures. When the existing pit toilet is replaced, an accessible vault toilet will be installed.
