HIGHLAND LIGHTHOUSE AND KEEPER'S DWELLING

HISTORIC STRUCTURE REPORT

North Truro, Massachusetts

The Building Conservation Branch, Cultural Resources Center
North Atlantic Region, National Park Service
U.S. Department of the Interior
Lowell, Massachusetts

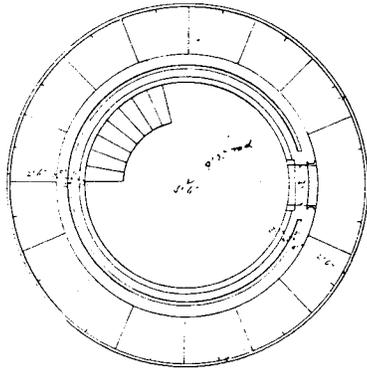
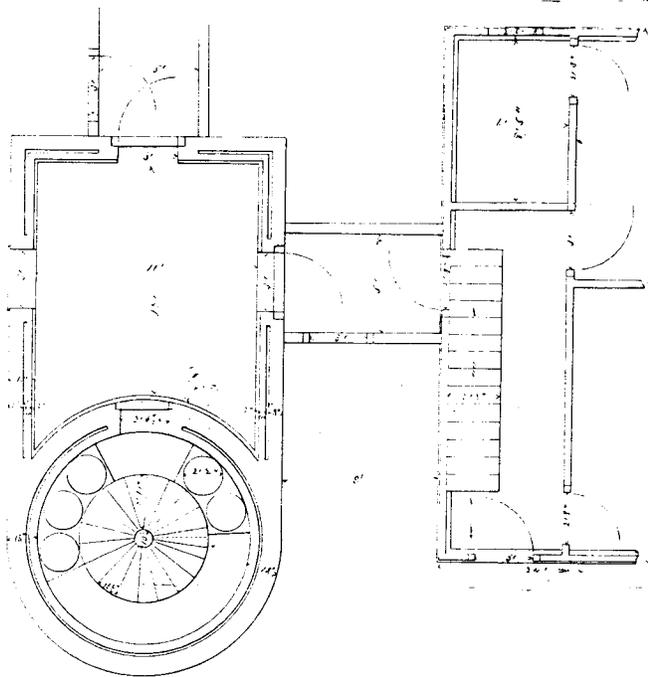
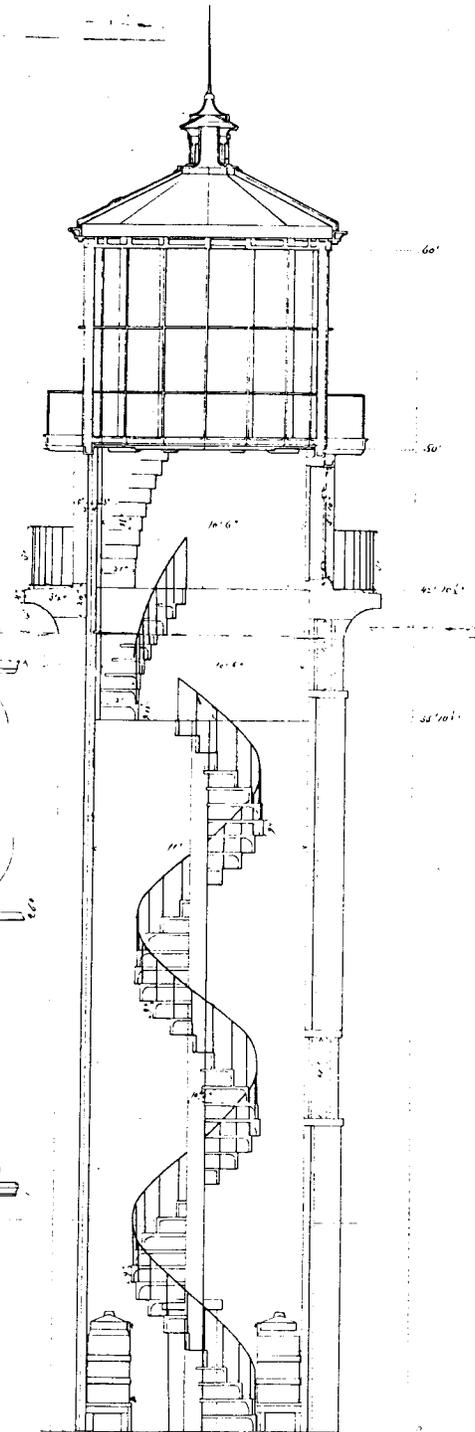
Figure 3. Design for Light House Tower at Highlands, Truro, Cape Cod (no date).

*Design for Light House Tower
at the Highlands, Truro, Cape Cod.*

*Plan of Balcony.
Modified as by Fig. 1. Plate II.*

*Ground Plan.
Modified as by Fig. 2. Plate II.*

*Vertical Section thru Centre.
Modified as by Fig. 3. Plate II.*

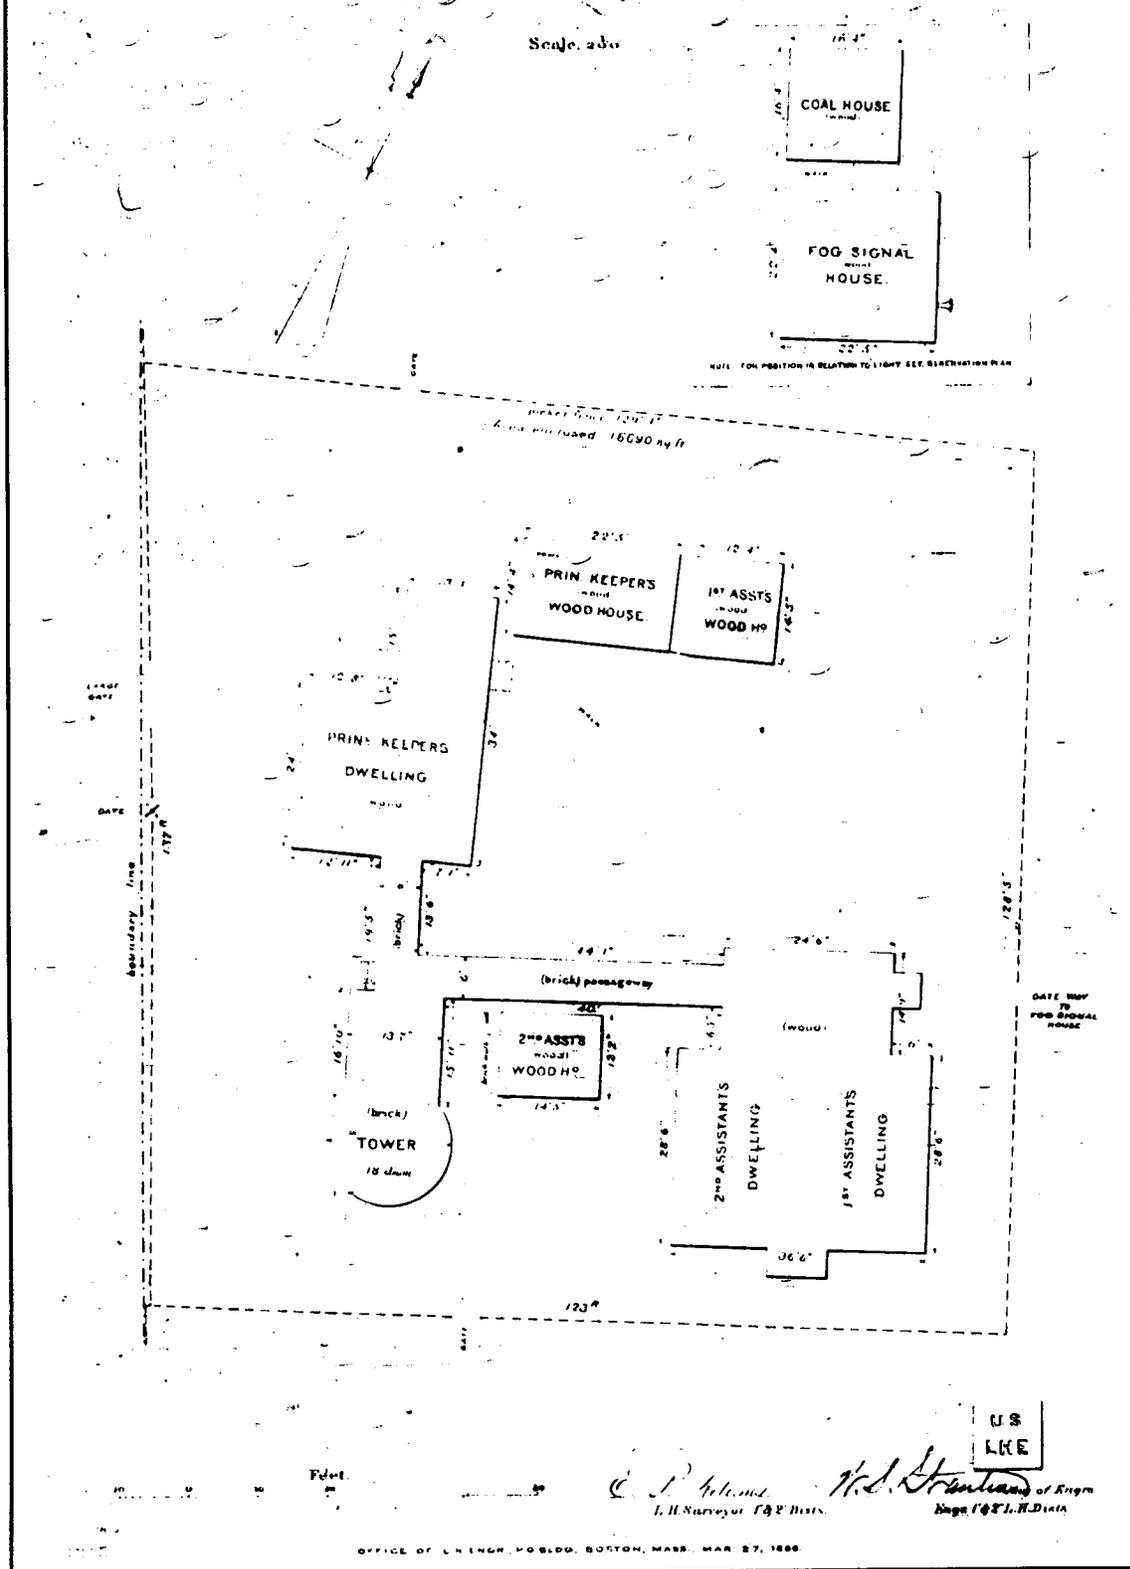
Figure 8. Cape Cod Light Station, 1885 survey.

Buildings Surveyed Dec. 18 & 19, 1885, by E. PADAMS, C.E., L.H. Surveyor.

Unspecified repairs were made to the buildings by 1873.⁵⁷ By 1880, conditions had gotten so bad that a recommendation was made to rebuild the keepers' dwellings.⁵⁸ Apparently the Lighthouse Board took notice: documentation from 1881 stated that the dwelling (singular) had been refloored, shingled, and clapboarded; new doors were fitted; and old doors and windows were repaired. Subsequently, it was reported that "The station is now in excellent condition."⁵⁹ The replacement of the original vertical board-and-batten siding on both dwellings with clapboards is confirmed by a historic photograph dated September 13, 1886 (fig. 8).

One of the drawings (fig. 8) details the immediate area around the main buildings; it also shows the more distant fog-signal building and coal house (engine house) in an inset block. A note in the inset directs that "for position [of the buildings] in relation to [the] 'light' see reservation plan." This note refers to the other drawing of the survey (fig. 9), which is a plot plan. This drawing was found in two separate archives. While the clearer of the two images is included in the body of this report, some of its notations have disintegrated; the second copy is included in Appendix K.

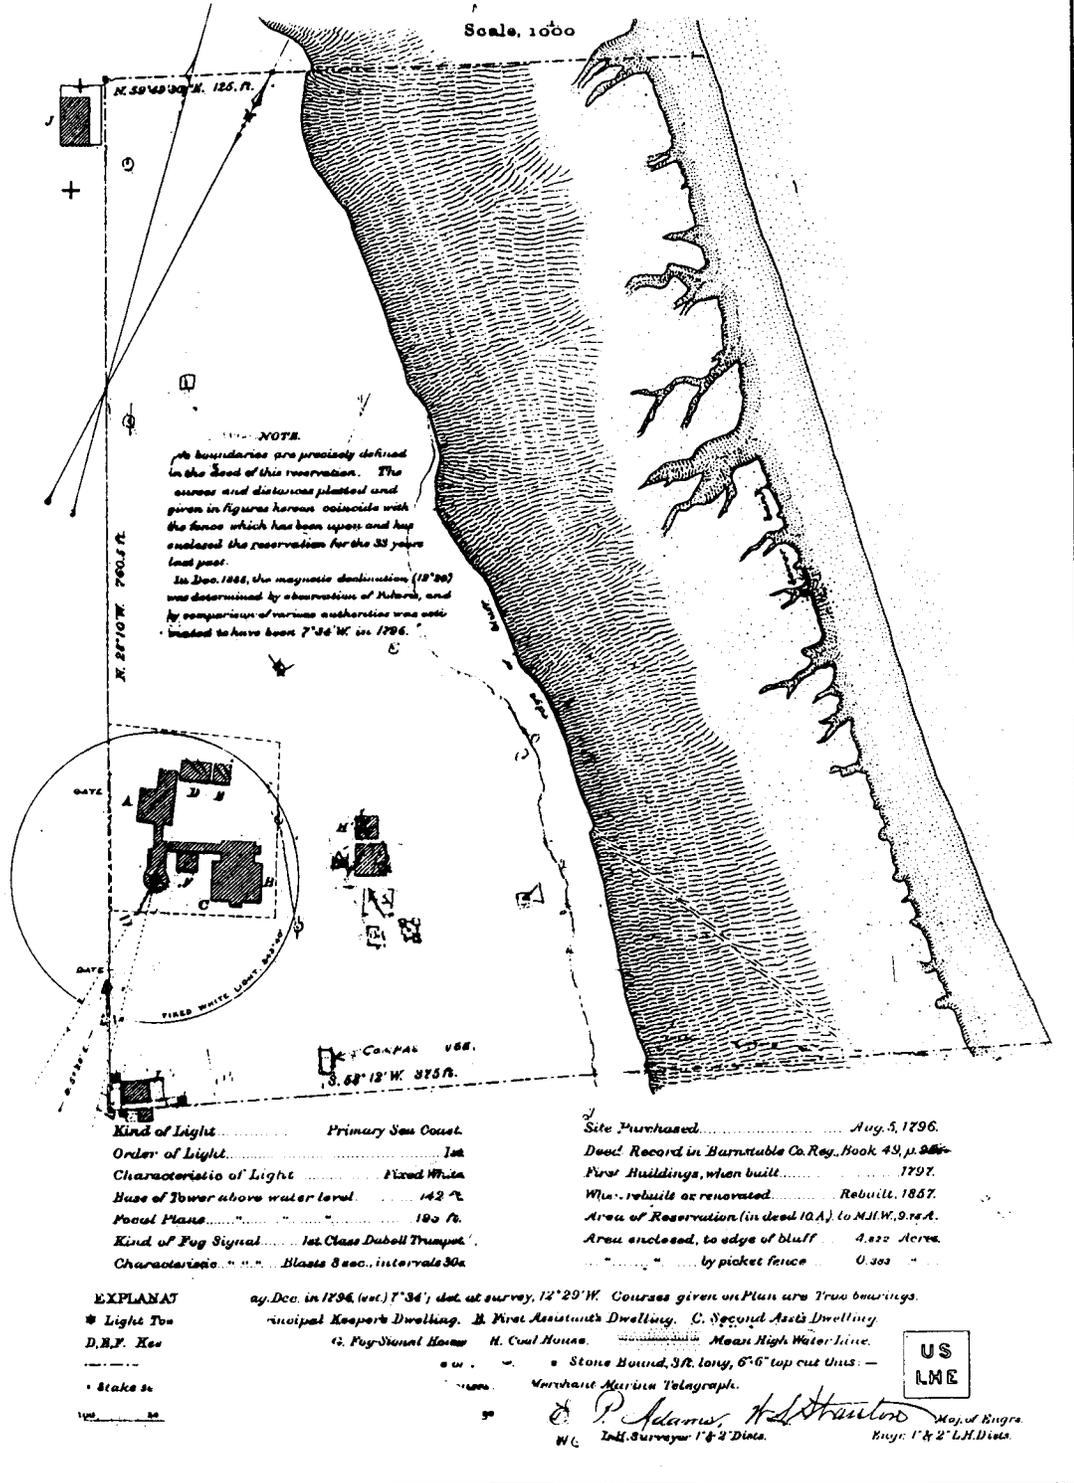
Figure 9. Cape Cod Light Station, 1885 survey.

Reservation Surveyed Dec. 18 to 23, 1885, by E.P. ADAMS, C.E., I.H. Surveyor.

A property survey conducted in 1885 (see fig. 10) shows that the location of the three structures was as close to the west property line as possible, and near the south corner. This site selection was no doubt based on the need to keep the buildings as far away from the eroding cliffs as possible, so the necessity for relocating or rebuilding the structures would be postponed for as long as possible.

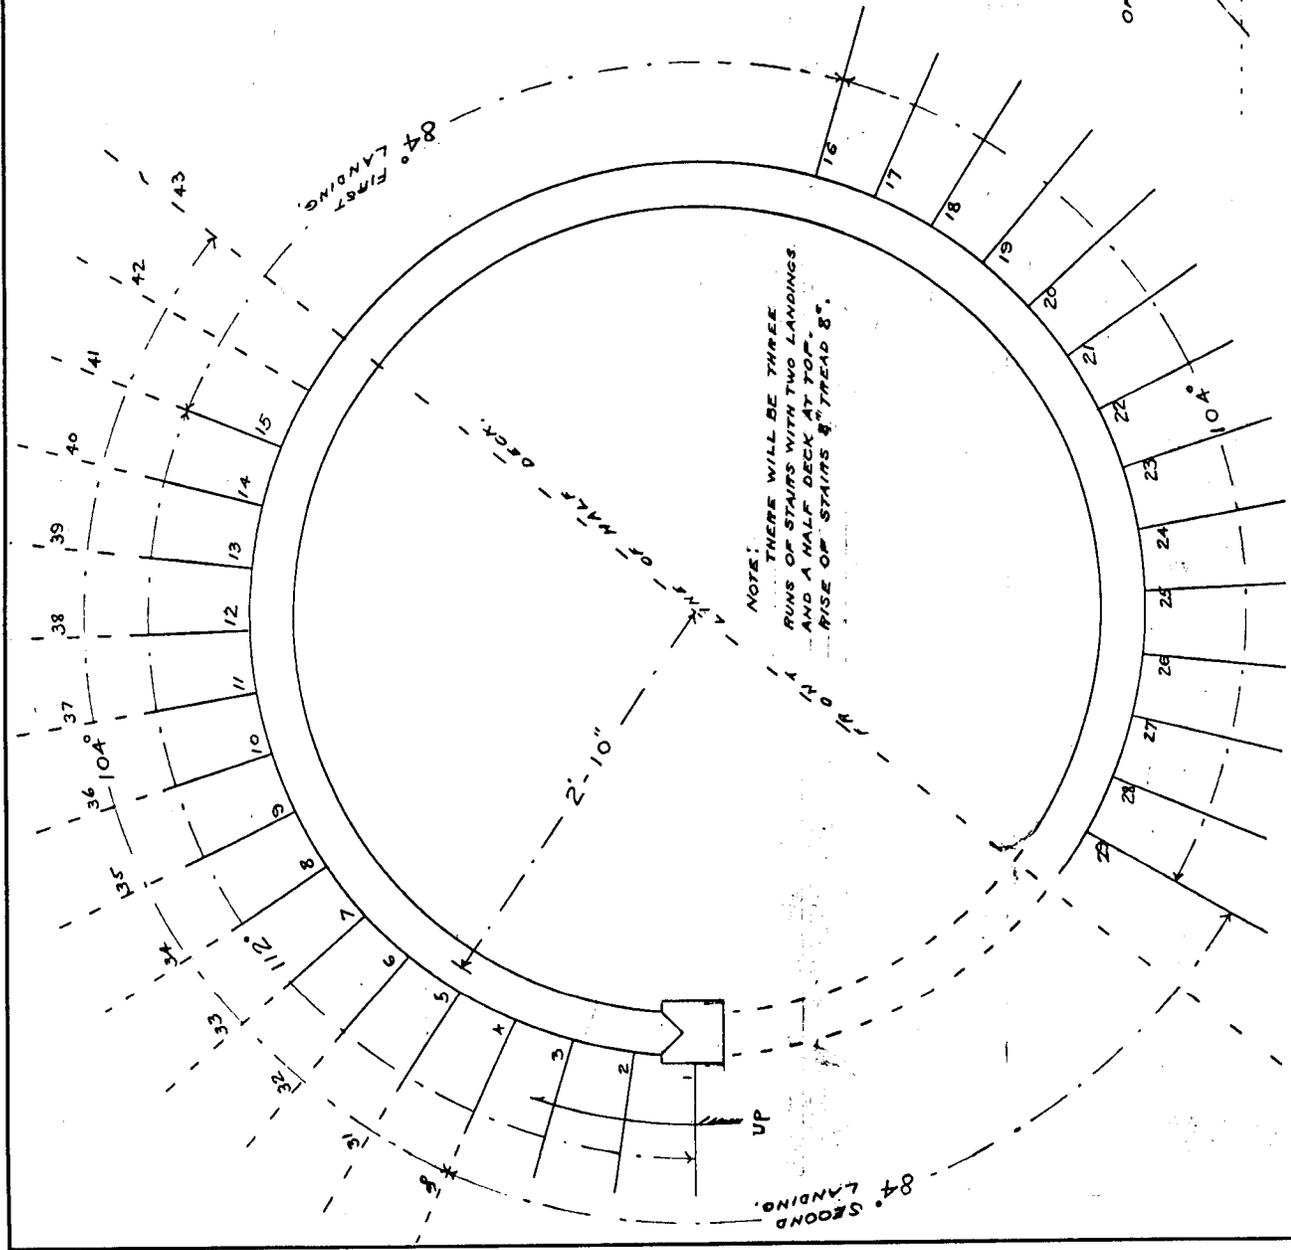
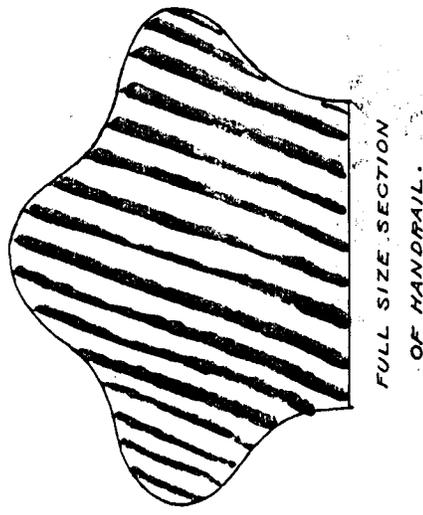
Figure 20. Handrail for Cape Cod Light Tower, April 4, 1903.

FULL SIZE SECTION
OF HANDRAIL.

HANDRAIL FOR CAPE COD
LIGHT TOWER.

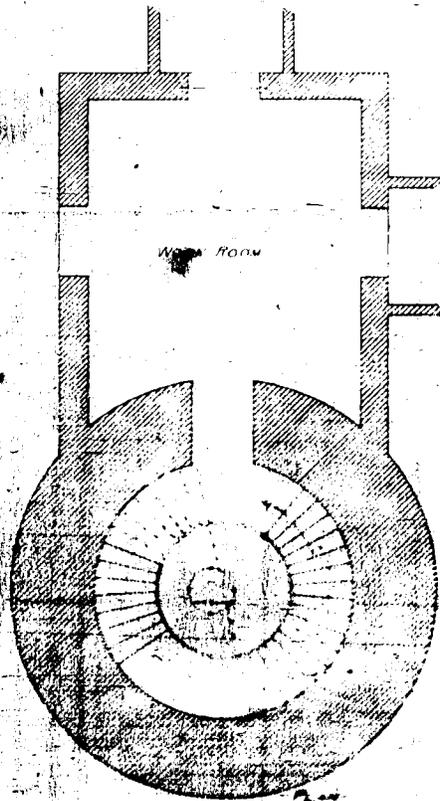
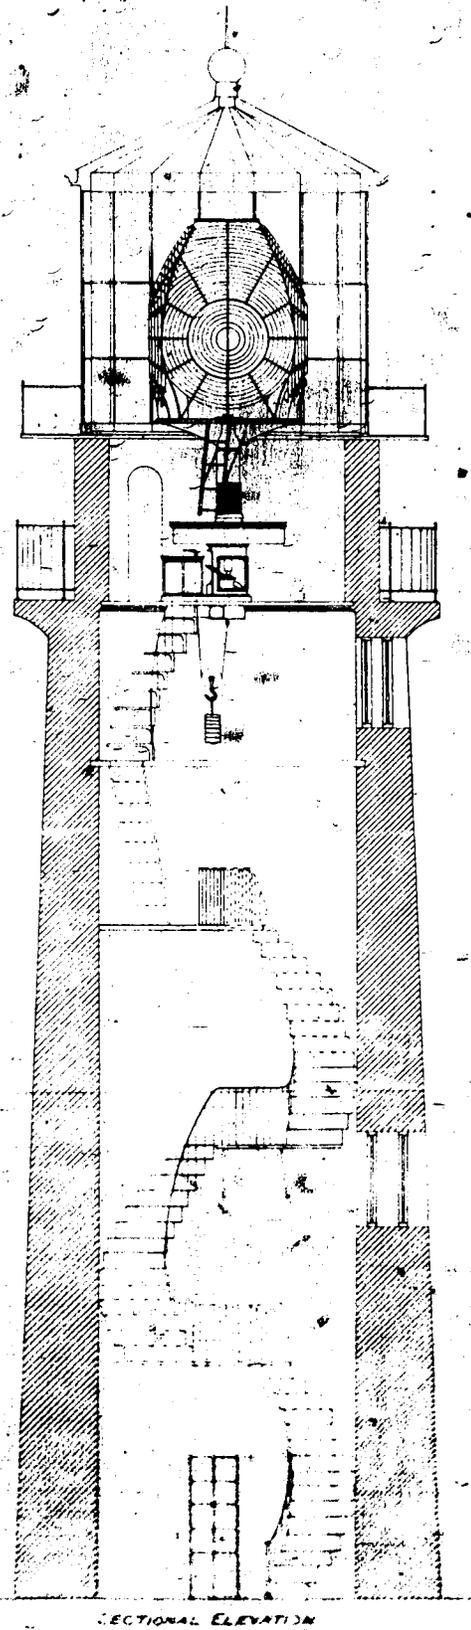
Figure 21. Cape Cod Light Station, Showing Illumination Apparatus, March 1907.

CAPE COD LIGHT STATION MASS
SHOWING ILLUMINATING APPARATUS

SECTIONAL ELEVATION

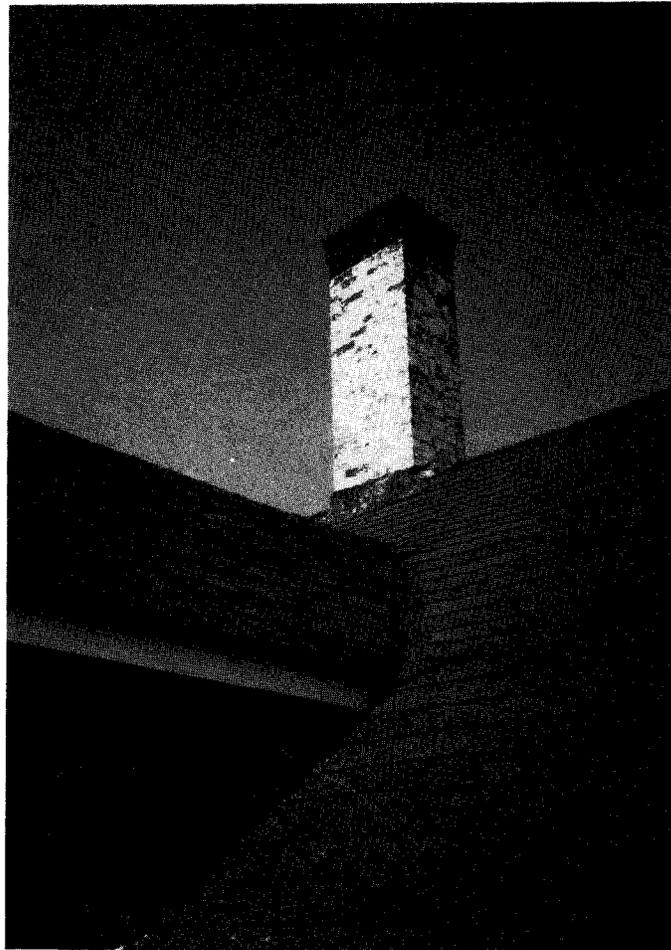
Figure 39. Keeper's Dwelling, brick chimney with date of 1857.

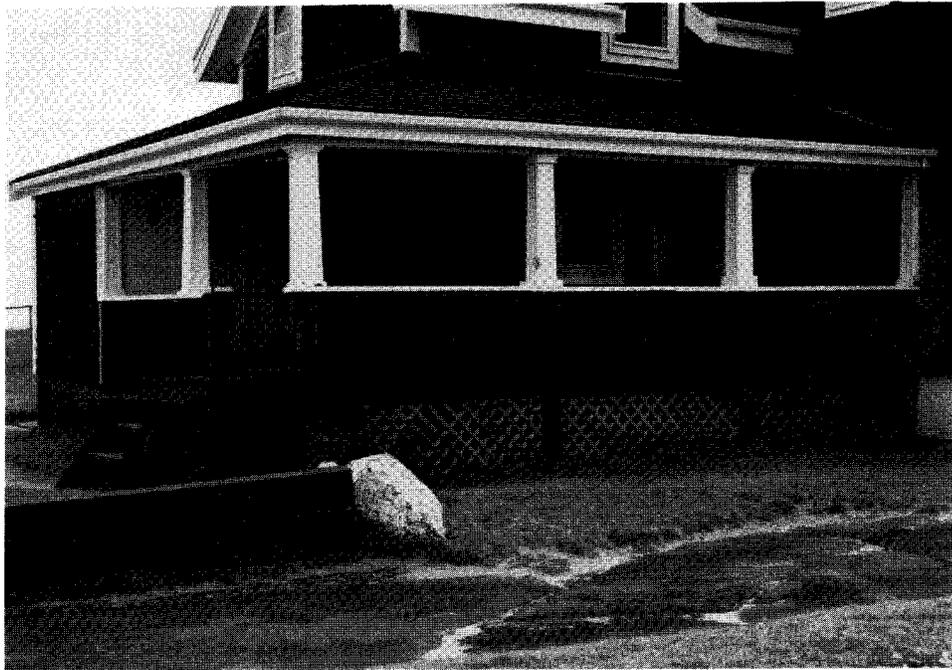
Figure 40. Wraparound porch on Keeper's Dwelling ell.

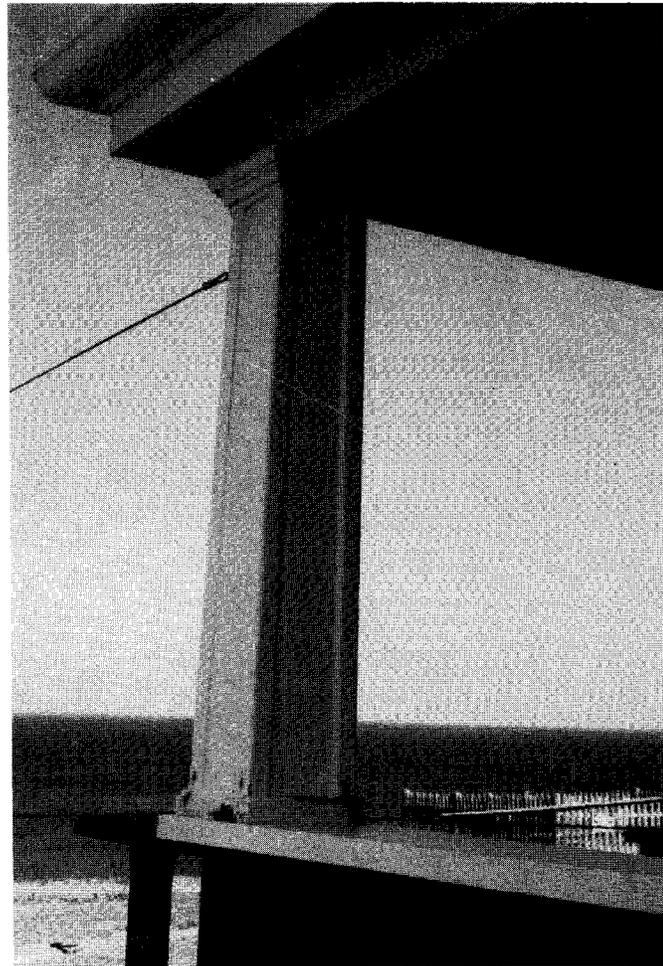
Figure 41. Detail of porch column.

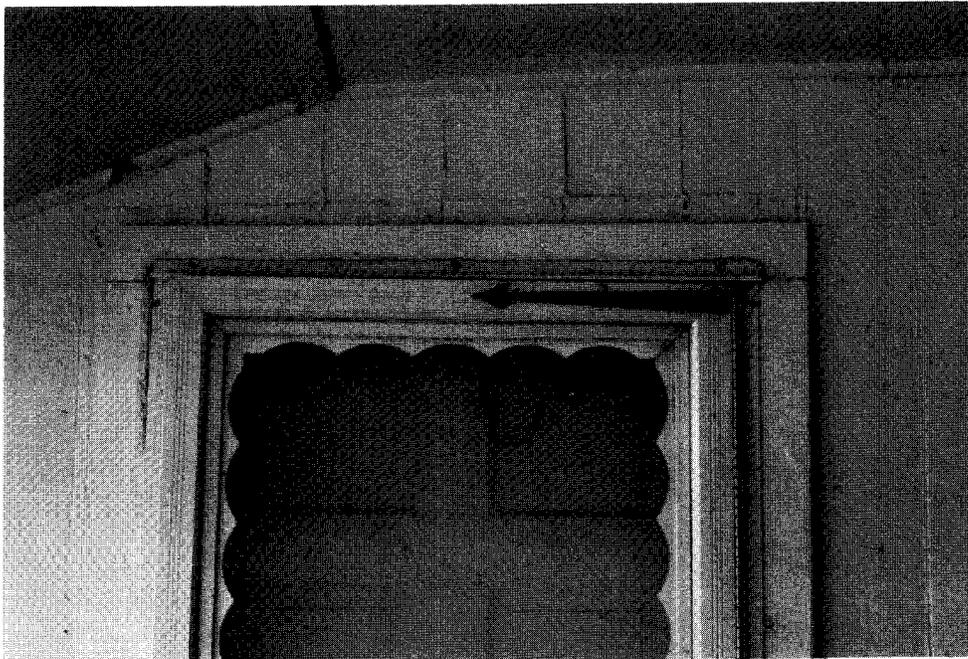
Figure 42. Keeper's Dwelling ell, west exterior elevation of north vestibule.

The west exterior wall of the north vestibule (fig. 42) is covered with vertical beaded boards 6 inches wide and painted white. It contains a doorway leading into the interior of the vestibule. The main door here is wood, six-paneled, and painted white; it is covered by an aluminum storm door. A paint ghost around the doorway frame suggests that its trim is a replacement.

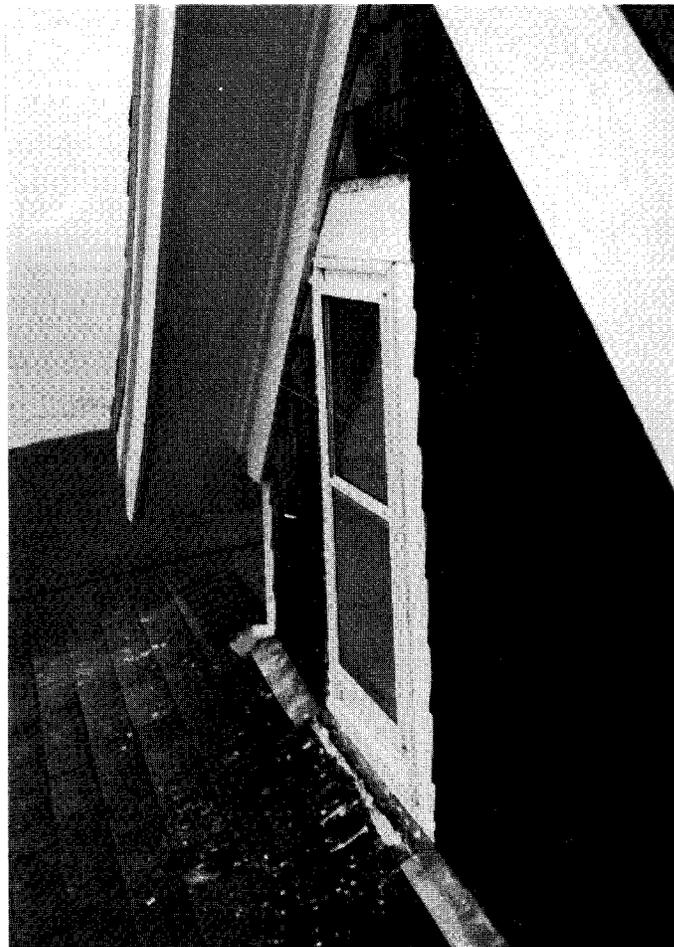
Figure 43. Keeper's Dwelling, second story of north elevation.

A window with double-hung, one-over-one sashes and an aluminum storm sash is located at second-story level, toward the east end of the wall. The raking end of the ell roof (fig. 43) has an overhang of about 12 inches here, and is trimmed with two plain, overlapped boards painted white.

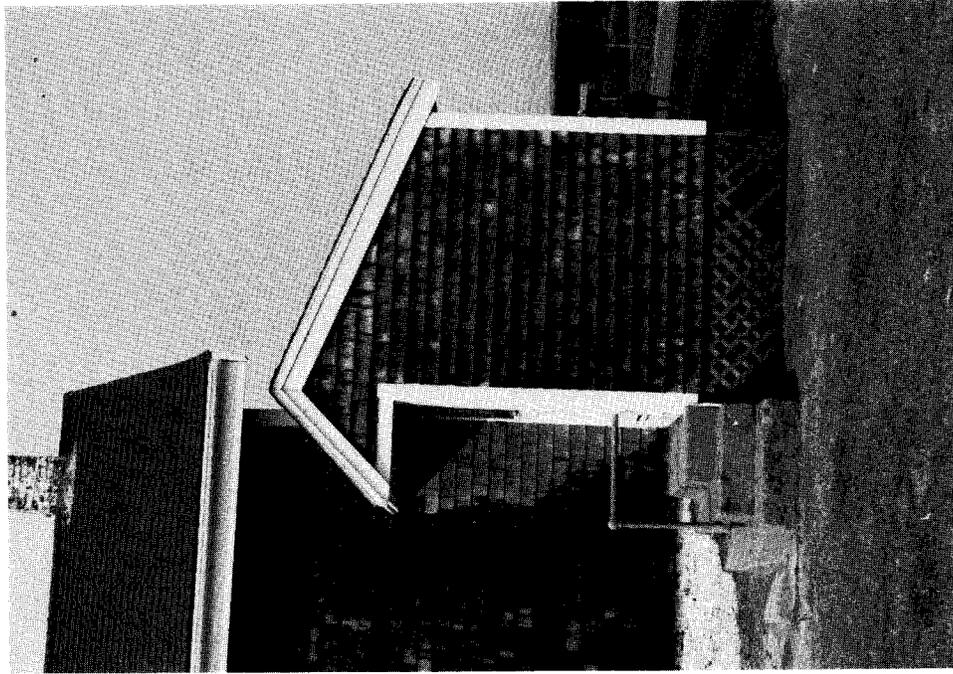
Figure 45. Keeper's Dwelling ell, east exterior elevation of north vestibule.

At the north end of the ell's east wall, the north vestibule (fig. 45) projects eastward. The foundation of the vestibule consists of wood posts covered with pressure-treated lattice panels. The walls of the vestibule are shingled and trimmed with plain, white-painted corner boards. There is a doorway in the south wall of the vestibule. It is accessed by three green-painted concrete steps with a pipe railing. A brass or bronze disk is embedded into the east corner of the bottom step (fig. 46). It is embossed with a date and the words: "U.S.COAST & GEODETIC SURVEY BENCH MARK - FOR INFORMATION WRITE TO THE DIRECTOR, WASHINGTON, D.C. - \$250 FINE OR IMPRISONMENT FOR DISTURBING THIS MARK- TB M-NO16-RESET 1958." The doorway (fig. 47) is covered by a white aluminum storm door. The main six-panel door is of wood painted an off-white color. The gable roof of the vestibule is asymmetrical: the short south slope projects to protect the south doorway, while the long north slope covers the remainder of the vestibule. The east gable end has typical white-painted rake trim. The soffit of the south roof slope is a white-painted plywood panel that covers three rafters that extend from the entry ridge. The plywood is cut around the rafter ends.

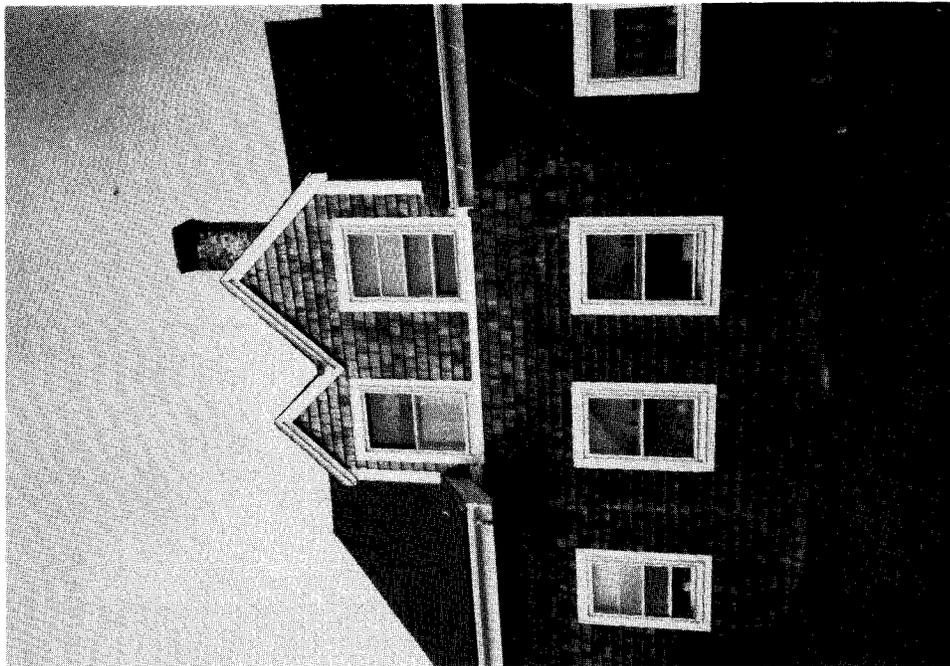
Figure 44. Keeper's Dwelling, east elevation.

The east elevation above foundation level (fig. 44) is clad with unpainted wood shingles and trimmed with plain corner boards painted white. There are three windows at the first-story level. They are trimmed in the usual way, and contain double-hung, one-over-one sashes with storm sashes.

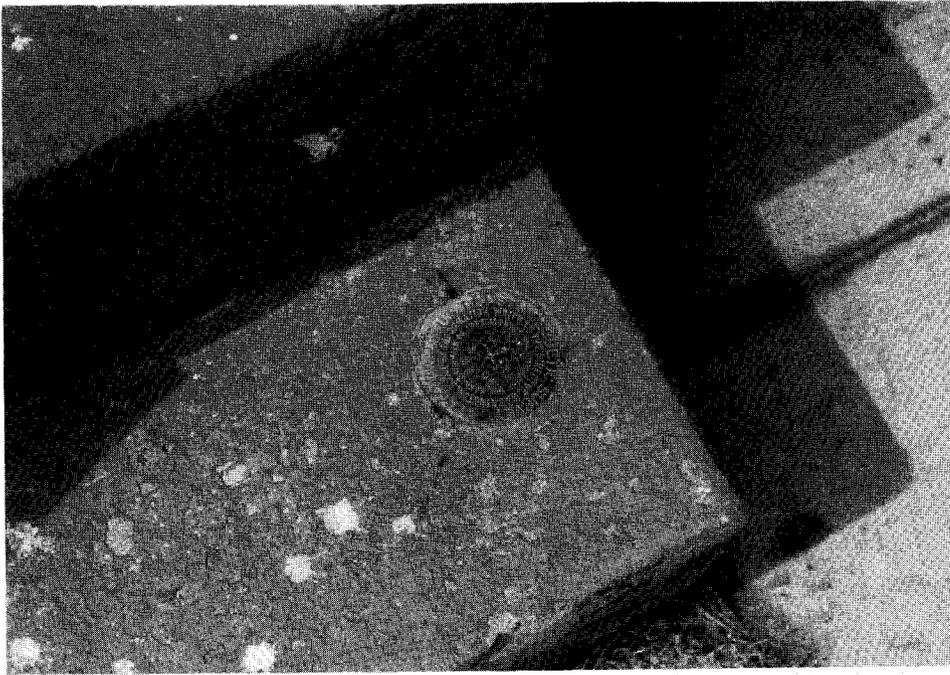
Figure 46. Keeper's Dwelling ell, north vestibule, concrete steps with embedded disk.

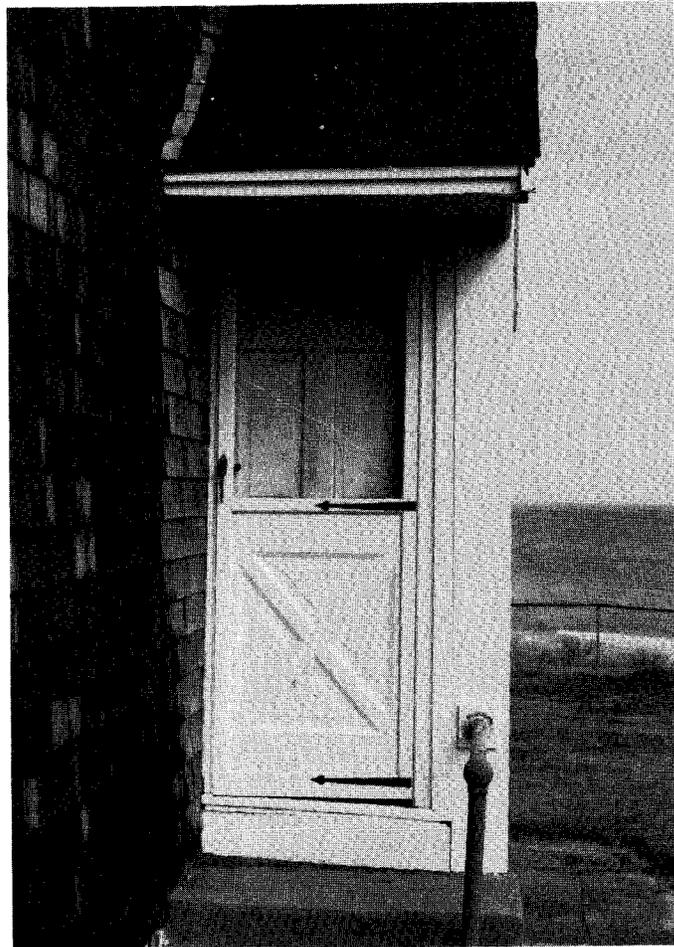
Figure 47. Keeper's Dwelling ell, exterior south doorway of north vestibule.

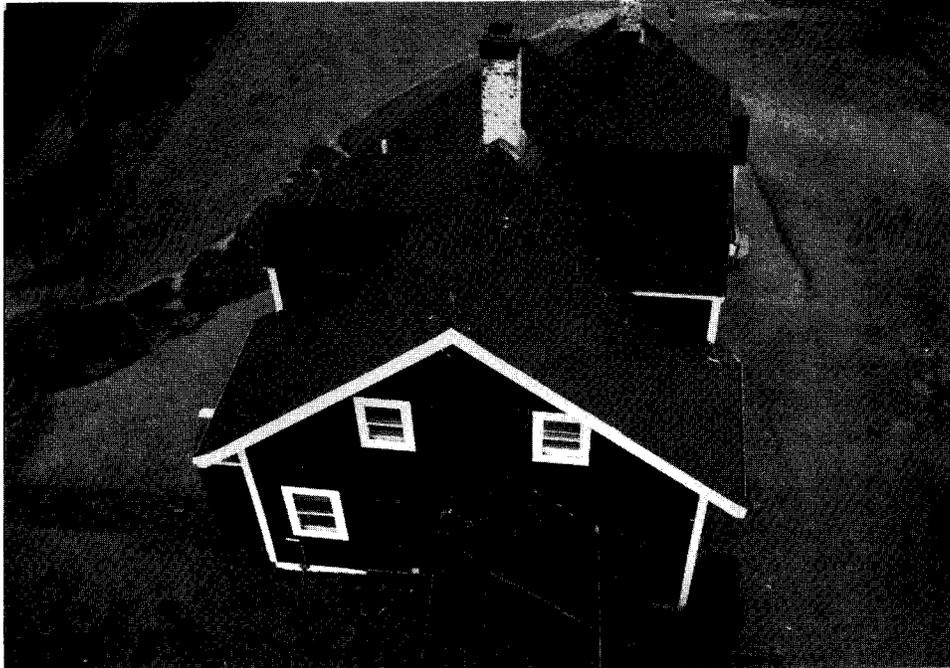
Figure 48. Keeper's Dwelling, south elevation, seen from Tower.

The south elevation of the main house (fig. 48) abuts the Connector at the Keeper's Dwelling. The foundation is of white-painted brick. A bulkhead with red metal doors is located near the center of the exposed foundation wall. The bulkhead leads to the basement of the Keeper's Dwelling. An electrical meter, water pipe, and metal bracket are at the base of the south elevation, near the west end.

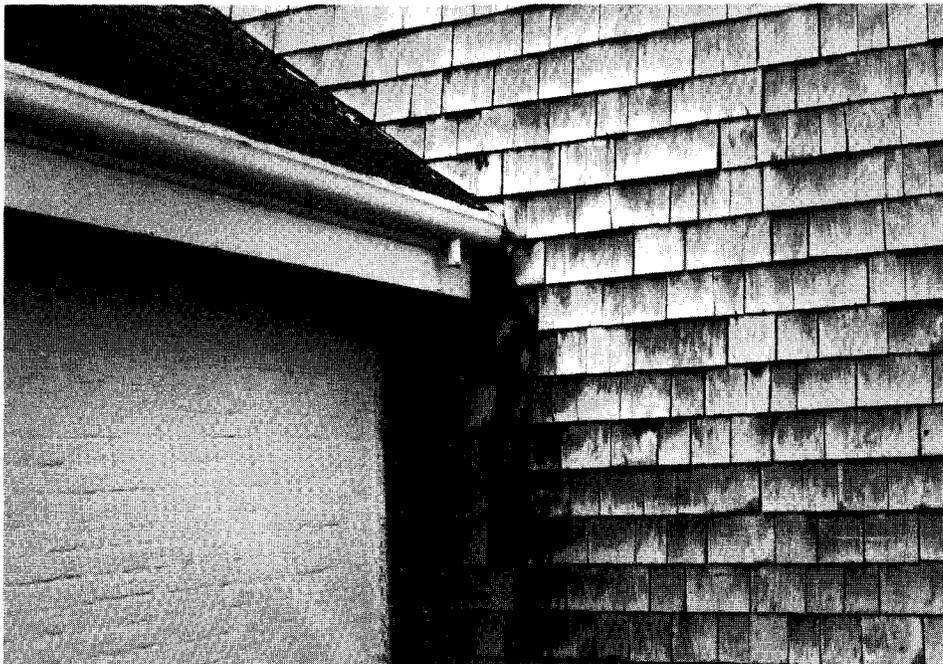
Figure 49. Keeper's Dwelling, south elevation, bracket for missing downspout.

One bracket for a downspout remains on this elevation, indicating that a gutter extended along the cornice of the adjacent Keeper's Connector (fig. 49).

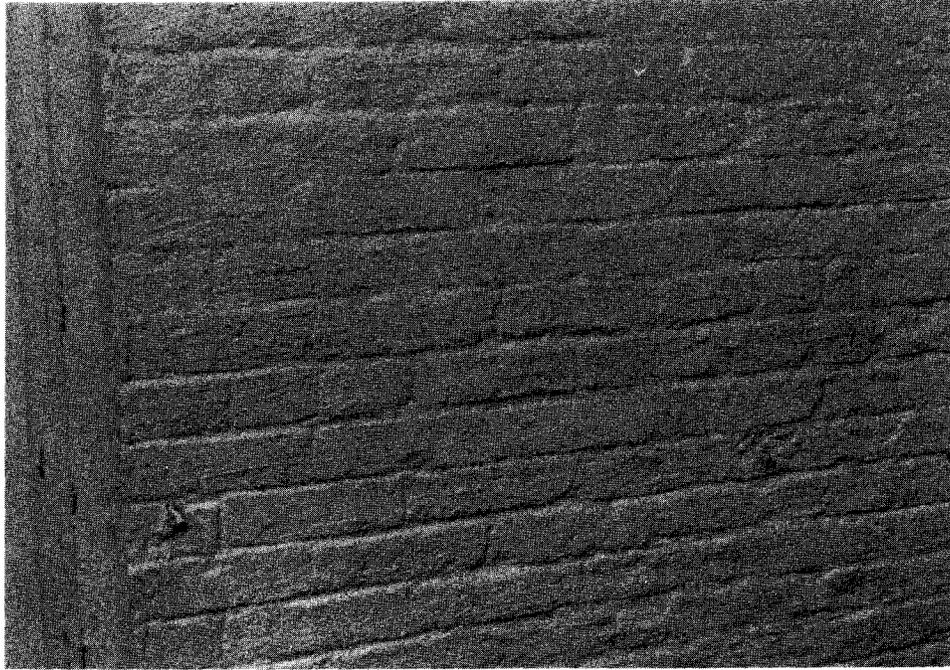
Figure 50. Connector at the Keeper's Dwelling, brick sizes and brush marks on east elevation.

The Connector at the Keeper's Dwelling is a simple rectangular brick building, whose north side is attached to the Keeper's Dwelling, and whose south side is attached to the Tower Connector. (See the interior description of Rooms 107-111). The angle of the Connector relative to the Keeper's Dwelling is 5 degrees towards the east (see app. A). It sits lower than the Keeper's Dwelling by approximately 10 inches. The size of its bricks is 7 1/2 by 2 1/4 inches. Only the 17th course of brick was laid as all headers. The bricks have been painted with a thick coat of cementitious wash. This coating was applied with a type of stiff bristle brush: horizontal brush marks are visible on the brickwork (fig. 50).

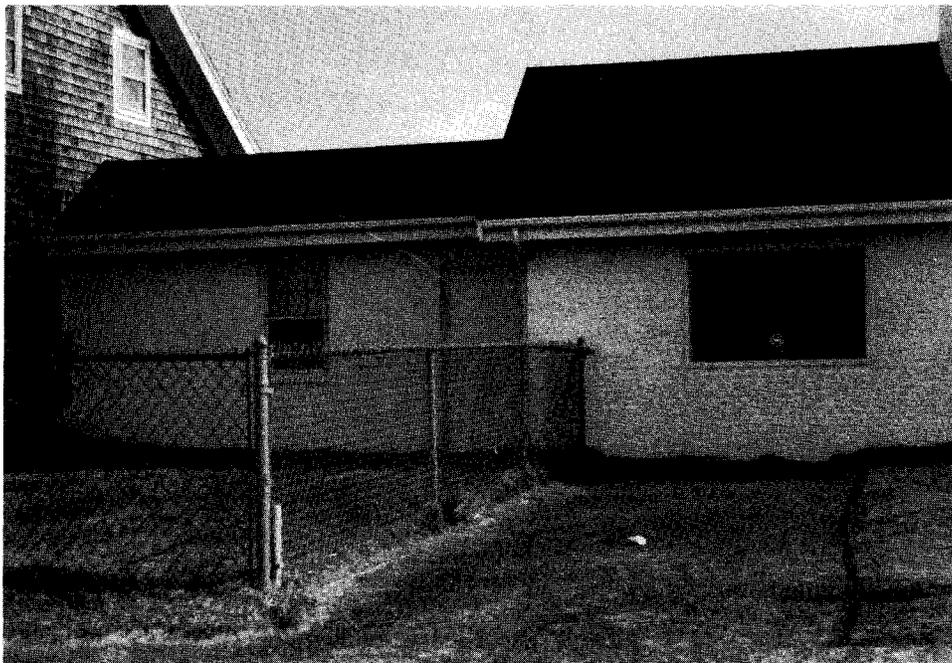
Figure 51. Connector at the Keeper's Dwelling and Tower Connector, west elevation.

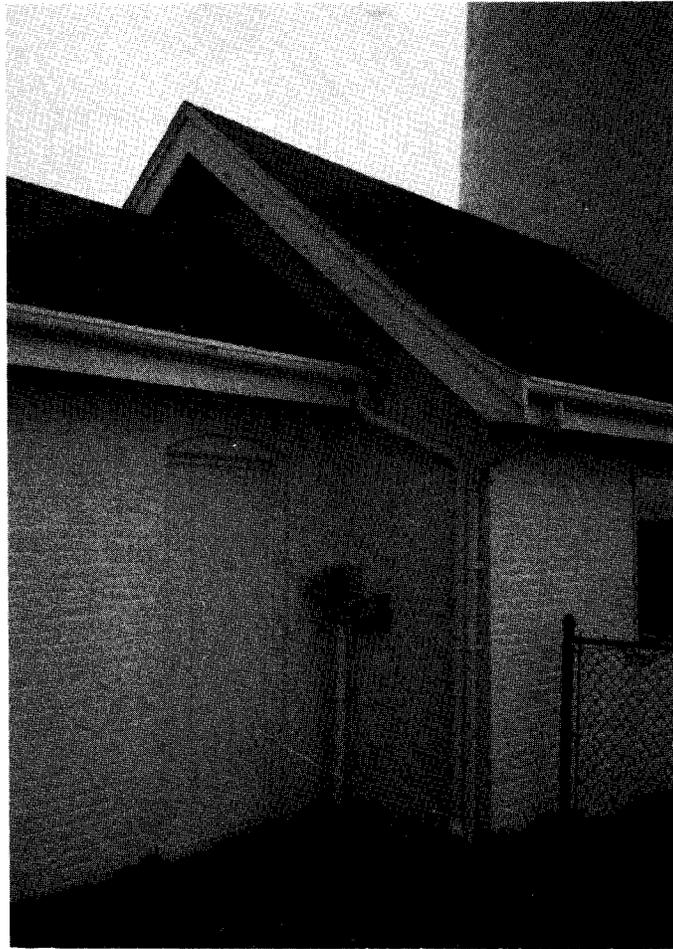
Figure 52. Connector at the Keeper's Dwelling and Tower Connector, west elevation: blocked entryway, outlet tubes, and downspouts.

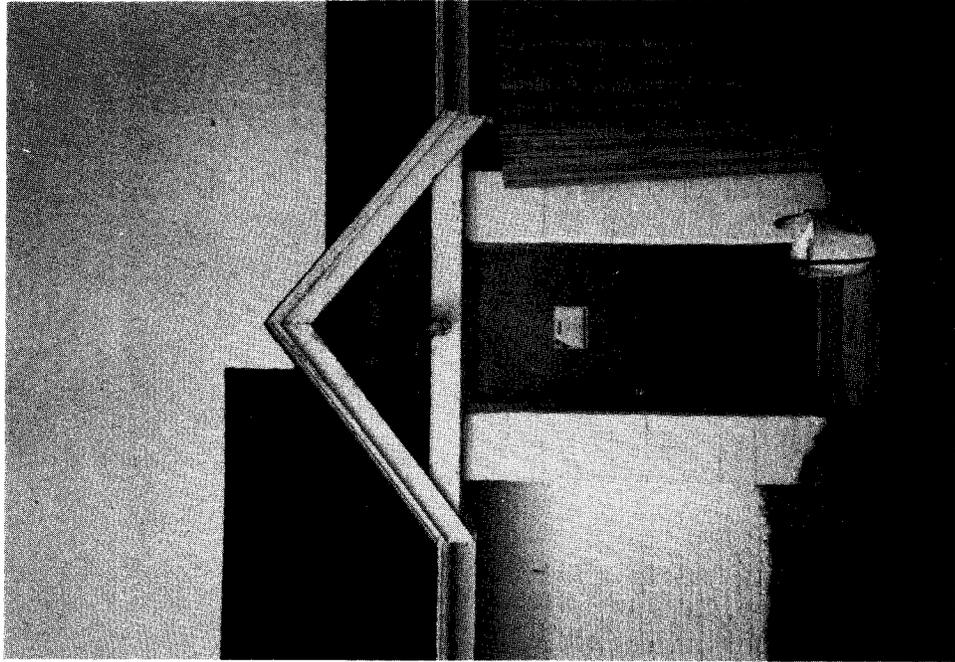
Figure 53. Concrete-block entry at junction of Connector at Keeper's Dwelling and Tower Connector, east elevation.

There is one doorway, on the east wall where the Tower Connector abuts the Connector at the Keeper's Dwelling. It is protected by a concrete-block entry (fig. 53). Above the doorway is a triangular pediment covered in weathered wood shingles and trimmed with plain boards painted white. A single-bulb metal outdoor light fixture is located above the door. The doorway opening contains a steel door that leads into the tower entry (Room 109). The concrete step at the exterior of the entry was installed in 1900. The east wall also has a segmentally arched window opening that was filled in with brick in 1987 (fig. 54). This infill is recessed 4 inches from the plane of the wall; its bricks are also painted white, but are of a larger size than the wall bricks. On the west elevation of the Tower Connector, an original window opening was enlarged and a single plate glass window was inserted in 1987 (fig. 55).

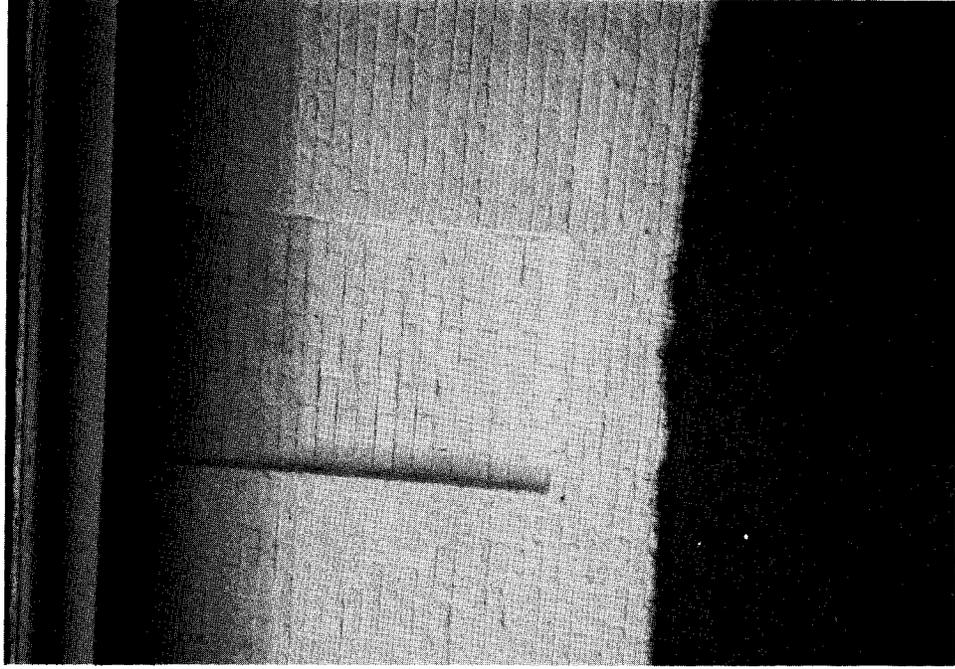
Figure 54. Tower Connector, blocked window on east elevation. Note larger brick size.

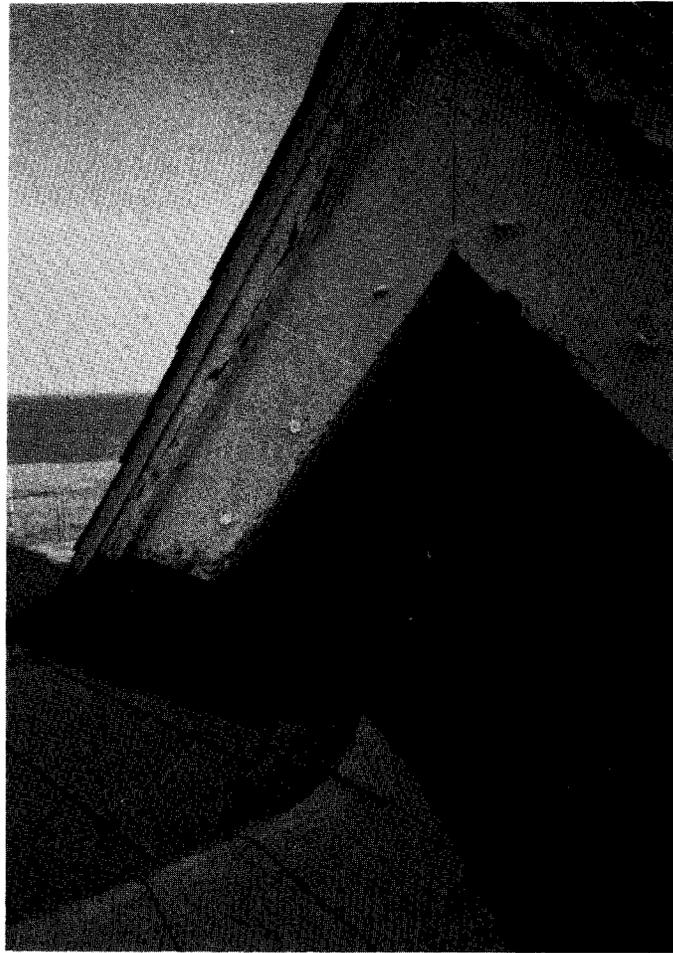
Figure 56. Tower Connector, roof overhang at junction with Connector at Keeper's Dwelling.

The roof of the Tower Connector is covered in red three-tab asphalt shingles. The north end of the roof overhangs the lower roof of the Connector at the Keeper's Dwelling. Its raking eaves are trimmed with the usual plain white overlapped boards. The lower rake board has a series of eye screws in it. They begin just above the ridge of the Keeper's Connector roof line; their function is undetermined. The east-side raking eave intersects the roof ridge of the concrete-block entry. The north slope of the entry roof extends under the rake to abut the face of the north wall (fig. 56).

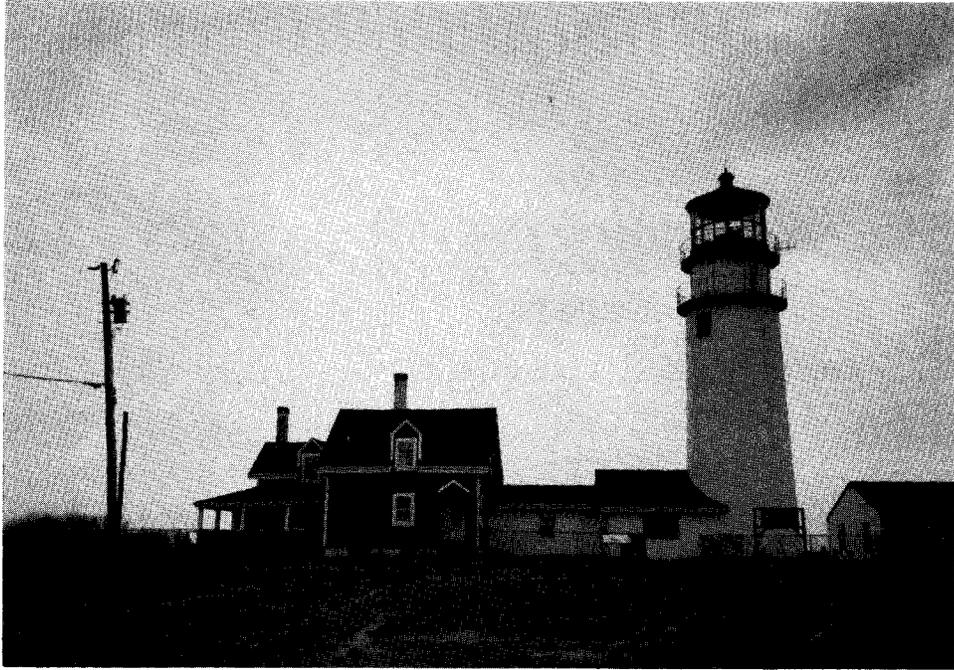
Figure 57. Highland Light Station, west elevation.

The Tower is located at the south end of the Tower Connector (fig. 57). It is 66 feet high to the top of the lantern house vent ball, excluding the spike. The Tower consists of three sections: the long, tapering, cylindrical shaft; the straight-sided Watch Deck and Watch Gallery; and the straight-sided Lantern and Lantern Gallery.

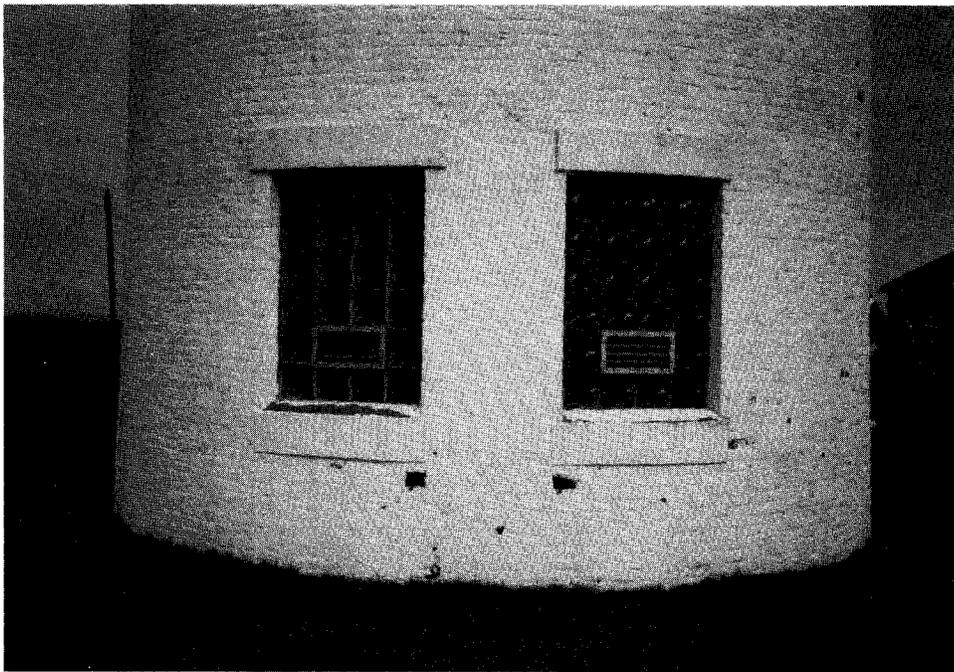
Figure 58. Tower, windows on south elevation.

The south elevation of the shaft has two window openings located approximately 10 brick courses above grade. They measure 3 feet wide by 4 feet high (fig. 58). Each has a granite sill and lintel, both painted white. Cement parging on the top exposed surface of the sills slopes to the exterior. Both window openings are filled with 6-inch square glass blocks in panels four units wide by six units high. Gray mortar fills the joints between the glass blocks. In the second row of glass blocks, vents replace the two center blocks. These vents are made of unpainted metal and are fixed in place by screws on the exterior. There is a third window on the northwest elevation of the shaft (fig. 60), immediately below the Watch Gallery (at the level of the interior Weight Deck). The size of the opening and glass-block panel is similar to those of the south-elevation windows.
