HIGHLAND LIGHTHOUSE AND KEEPER'S DWELLING

HISTORIC STRUCTURE REPORT

North Truro, Massachusetts

The Building Conservation Branch, Cultural Resources Center
North Atlantic Region, National Park Service
U.S. Department of the Interior
Lowell, Massachusetts

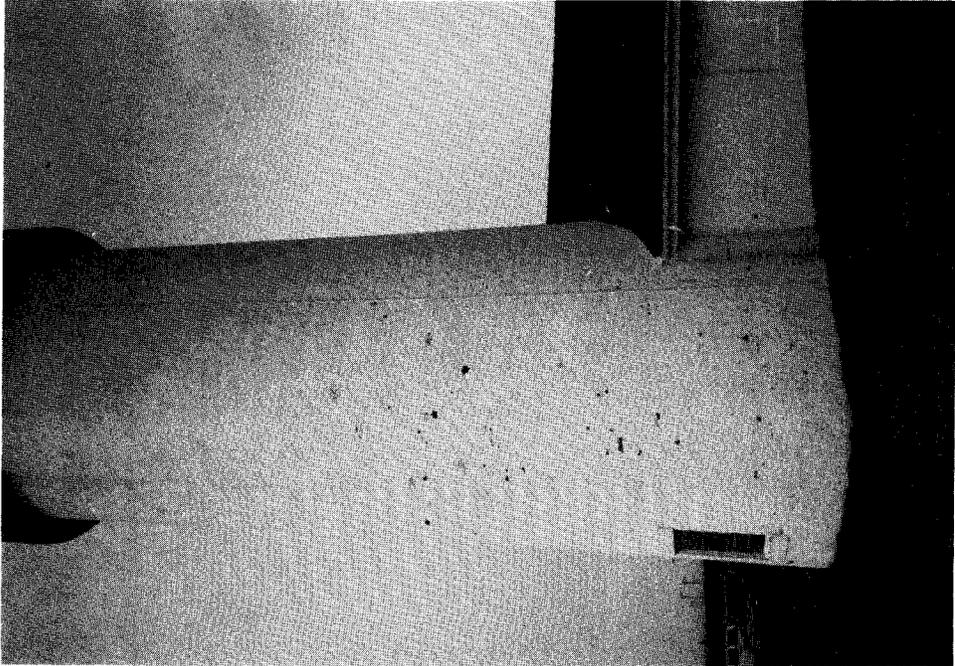
Figure 59. Tower, east elevation.

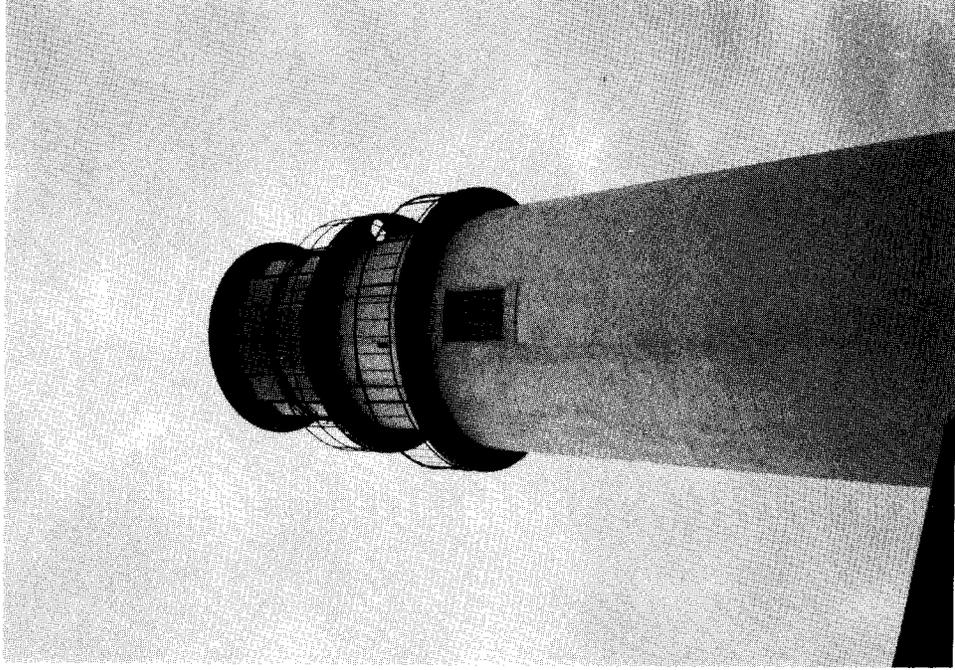
Figure 60. Tower, northwest elevation.

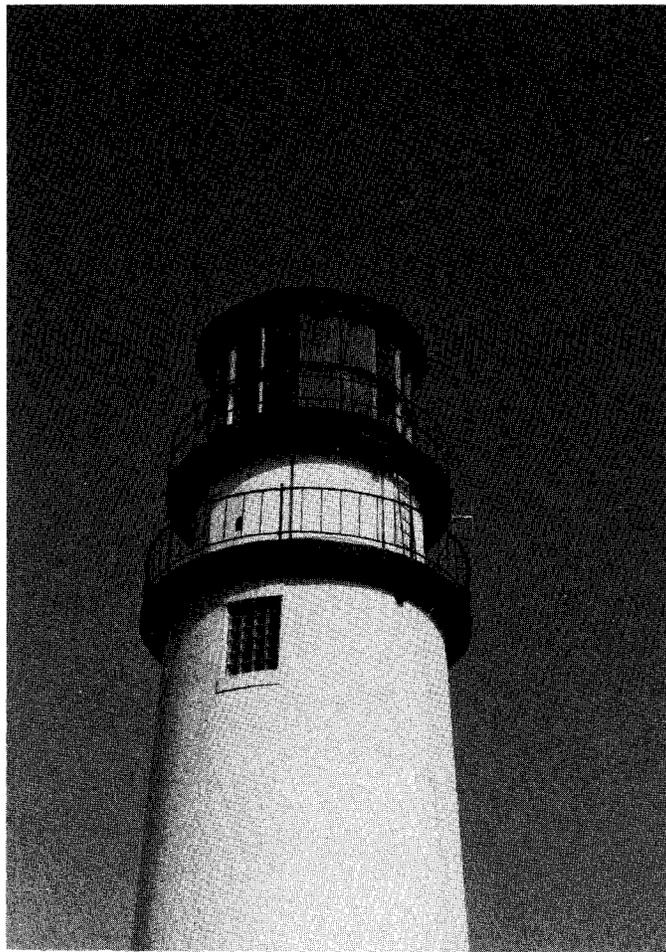
Figure 61. Tower, northwest elevation.

The exterior wall of the Watch Deck is 7 feet 1 1/4 inches high. It is also of white-painted brick. It is surrounded by the Watch Gallery, which is the lower of two observation decks (fig. 61).

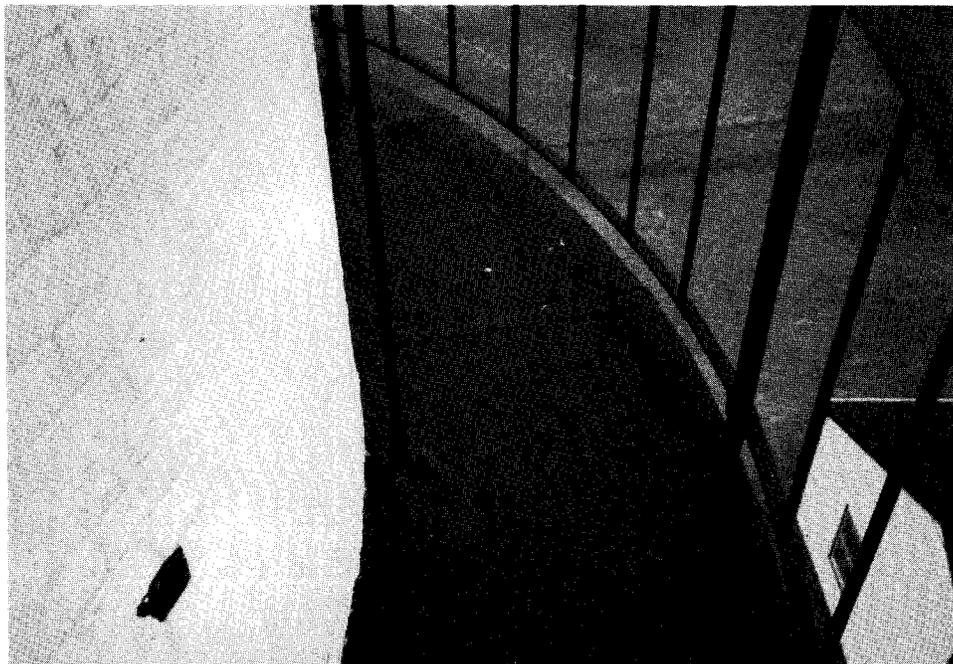
Figure 62. Tower, detail of joints in granite-block floor of Watch Gallery.

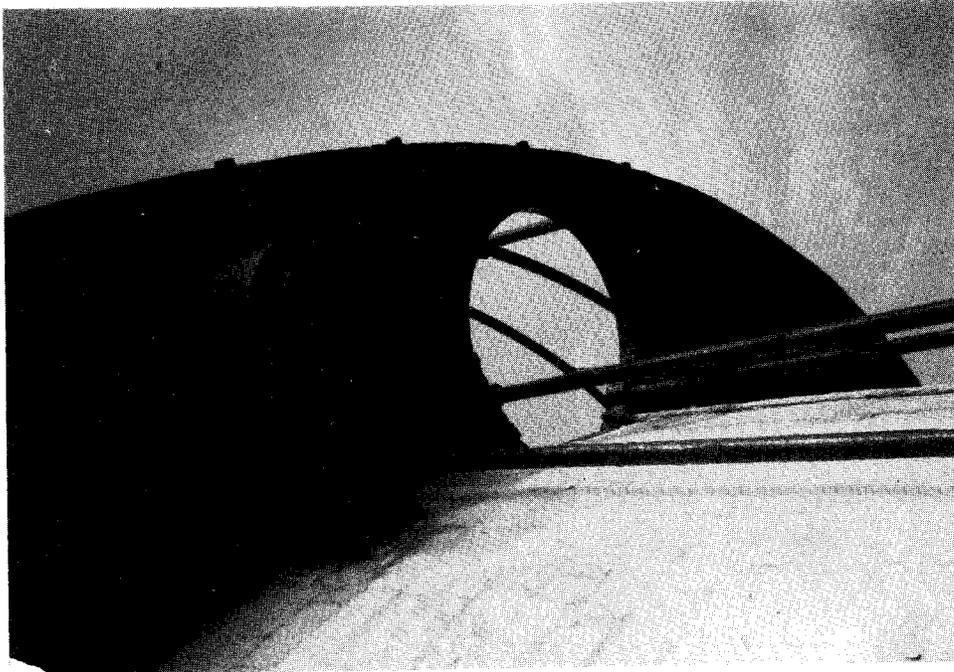
Figure 63. Tower at Watch Gallery: pipe support, tie rod, and underside of Lantern Gallery, showing ladder opening.

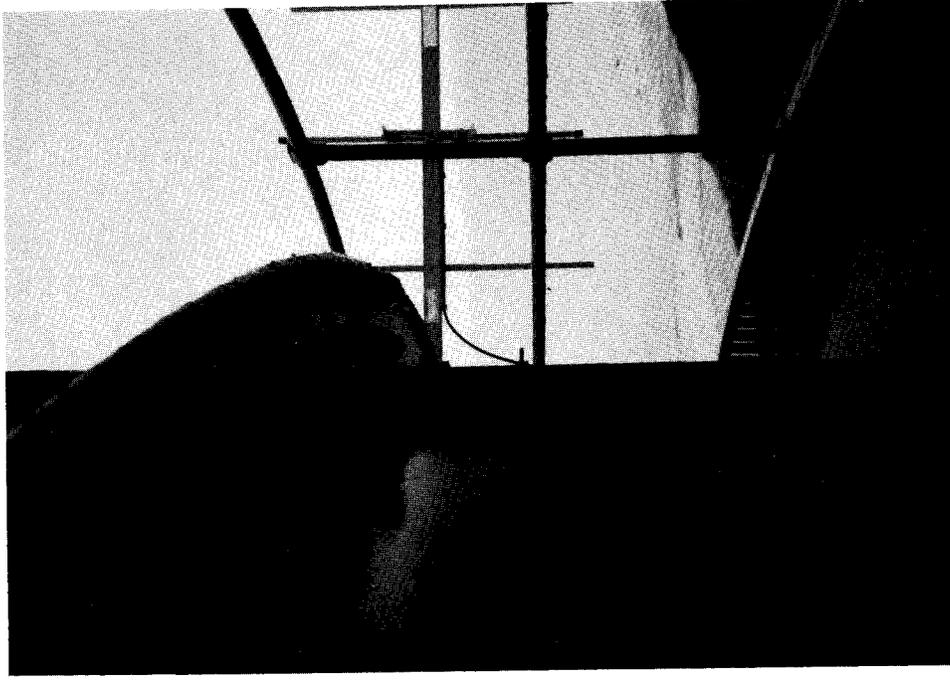
Figure 64. Tower, railing of Lantern Gallery.

The floor of the Lantern Gallery is composed of four cast-iron sections that have been bolted in place, which are continuous with the floor at the interior. A slotted lip 5 inches high runs around the Lantern Gallery where a pipe railing has been installed (fig. 64). The entire assemblage is painted black. A radio or other antenna is attached to the railing on the south side of the gallery.

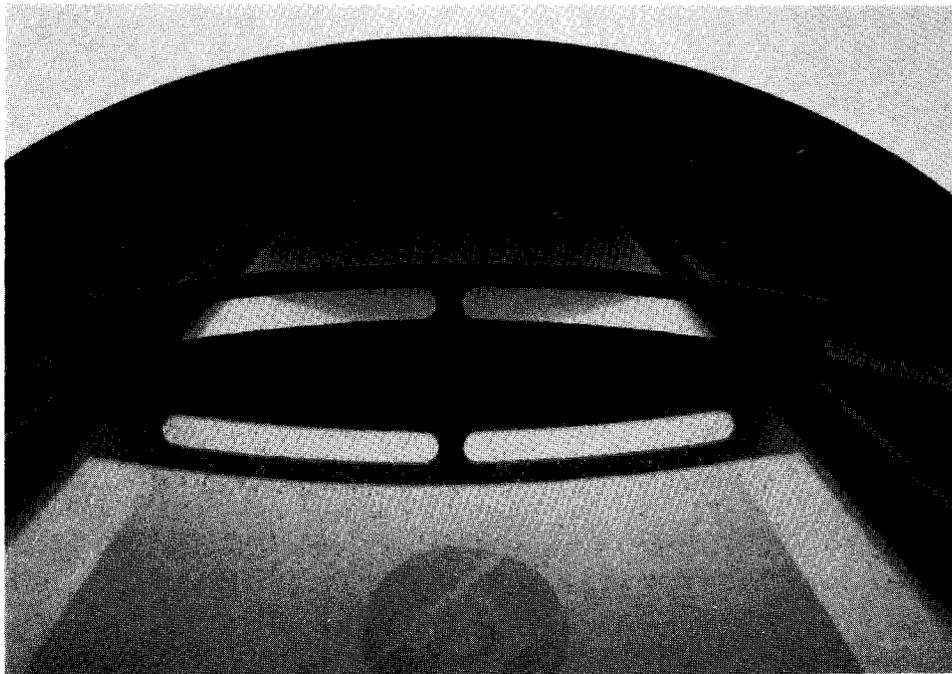
Figure 65. Tower, detail of handrail along horizontal mullion of Lantern Gallery window wall.

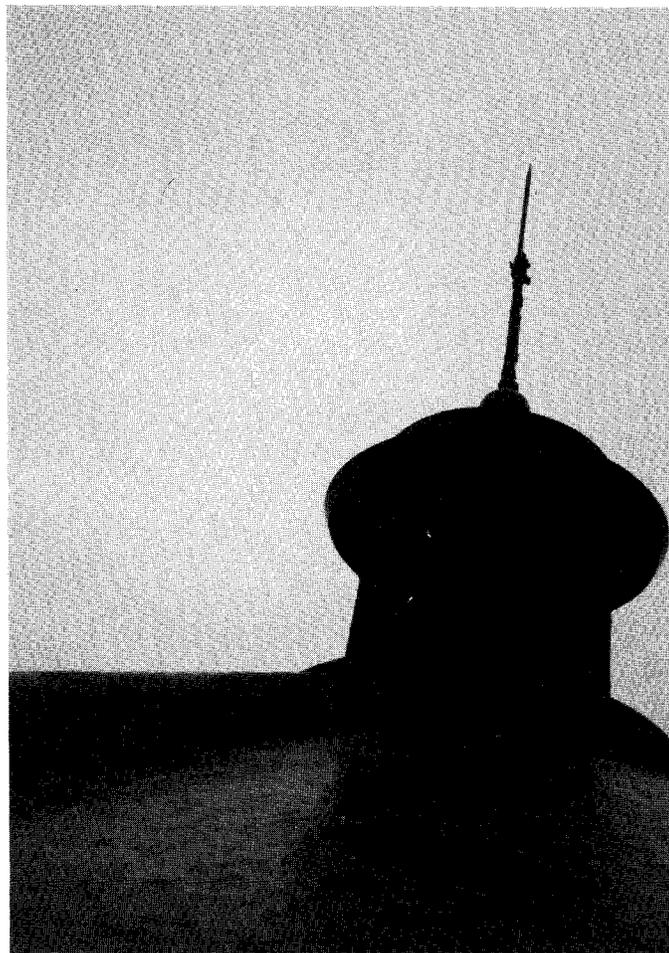
Figure 66. Tower, vent cupola of Lantern.

The cap of the Lantern consists of eight metal sections bolted together (fig. 66). The peak of the roof is capped by a slotted ventilator for the Lantern Deck. The lantern cap is painted black.
