Building Number: 621
Area: West Barracks
Date of Construction: 1907
Period of Significance: 1900-1919
 (per HSR Part One)
Historic Use: Hospital Corps
 Sergeant's Quarters
Current/Recent Use: Quarters

Task One: Conditions Assessment

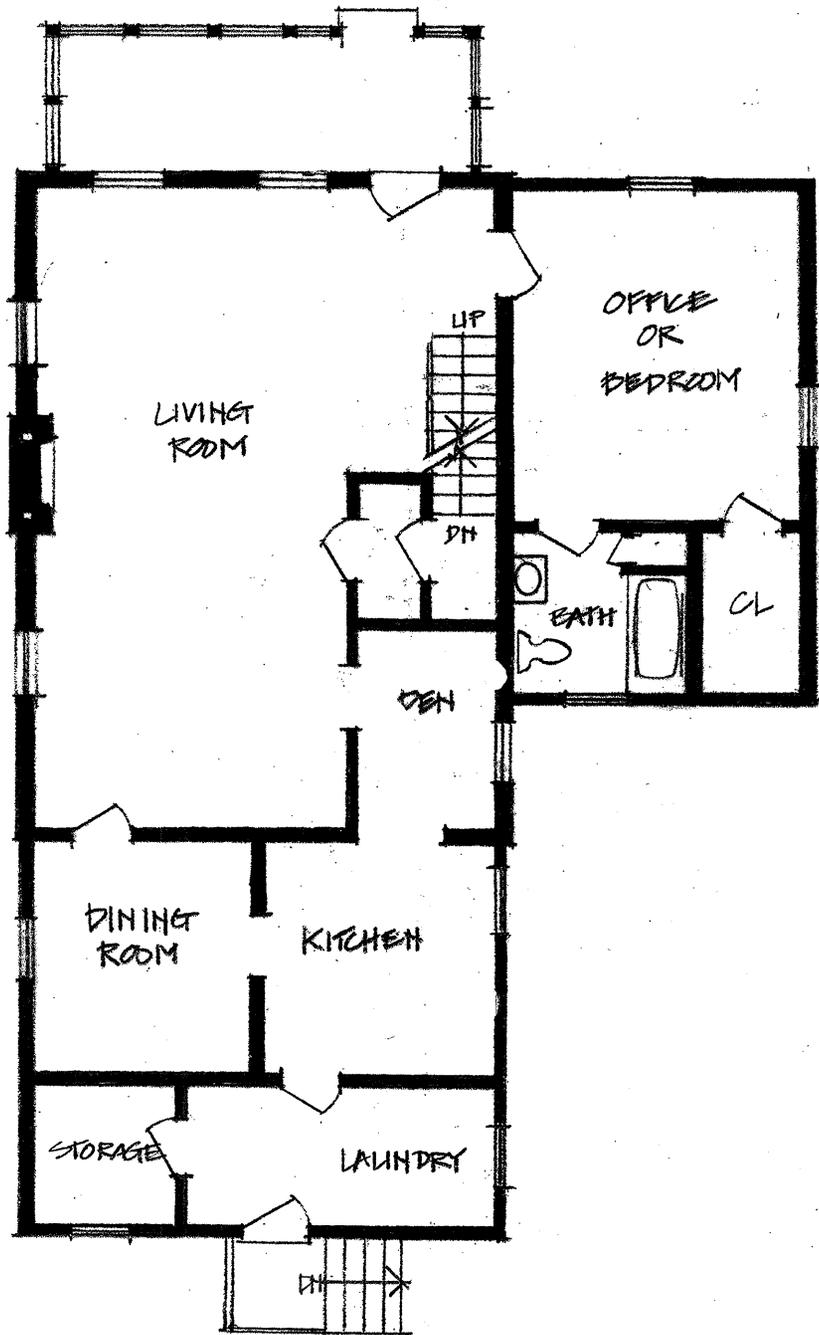
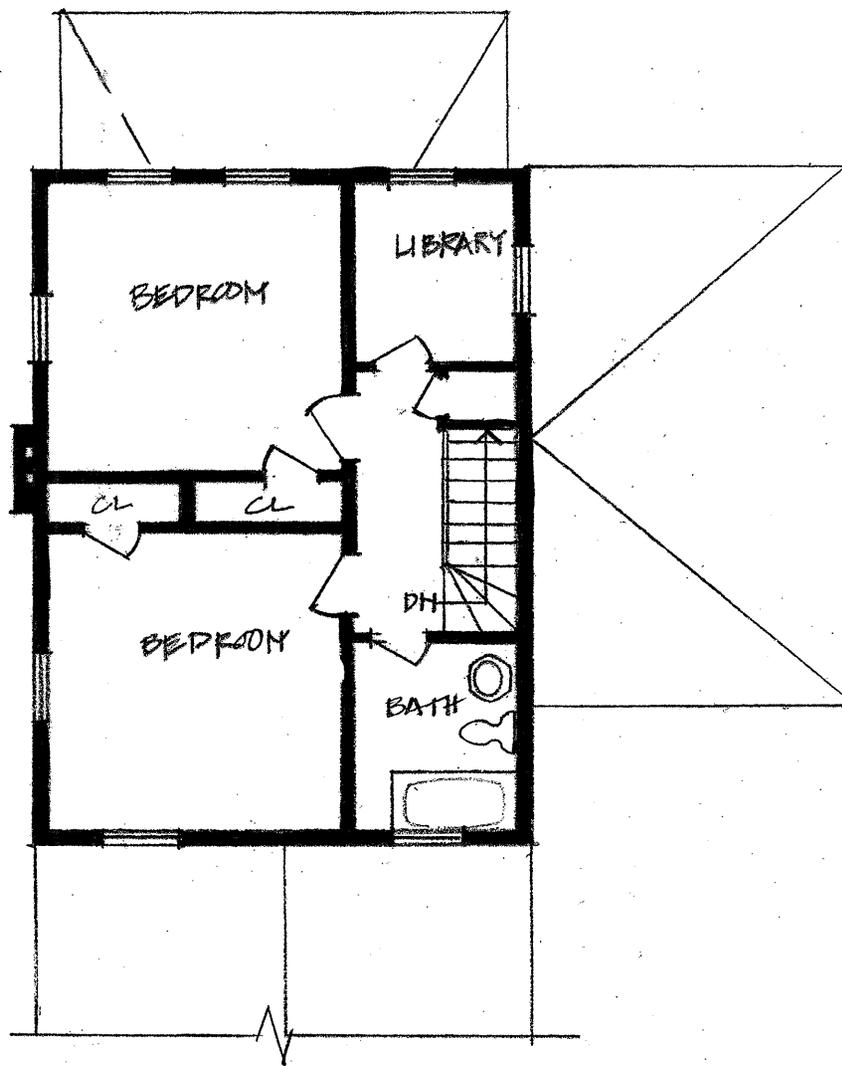
BUILDING 621
 SCALE: 1/8" = 1'0"

The Hospital Steward's Quarters (Building #621) is a good candidate for exterior restoration according to the *Secretary of Interior's Standards* and interior rehabilitation. The *West Vancouver Barracks Reuse Plan* suggests that residential use combined with an in-house office or business (live/work) would be the most appropriate re-use of the building (See Plan). Very little work is necessary to bring this building to a point where it can be leased.
