# Fort Mason Officers Club

## Historic Structure Report

## *Historic Structure Report*

**May 2005**

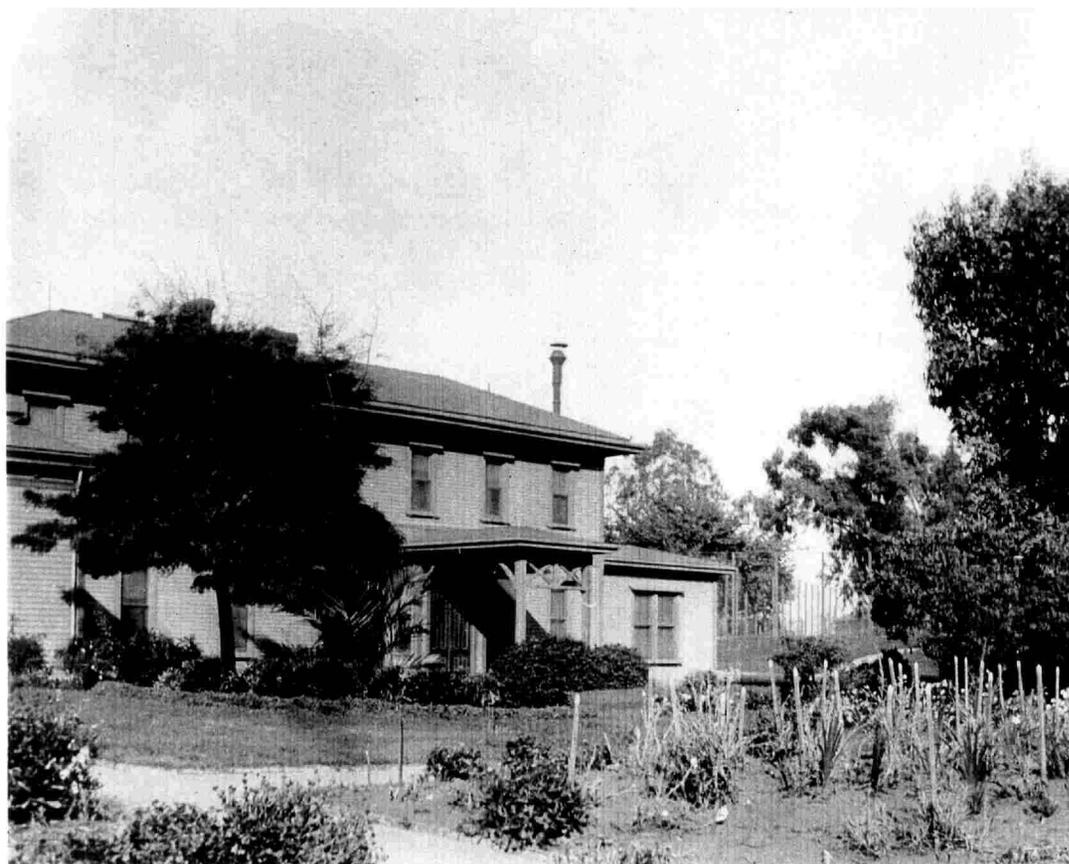
Quarters 1, circa 1900. Note the original wooden front doors and immature vegetation in front of the building. (GOGA 2316)

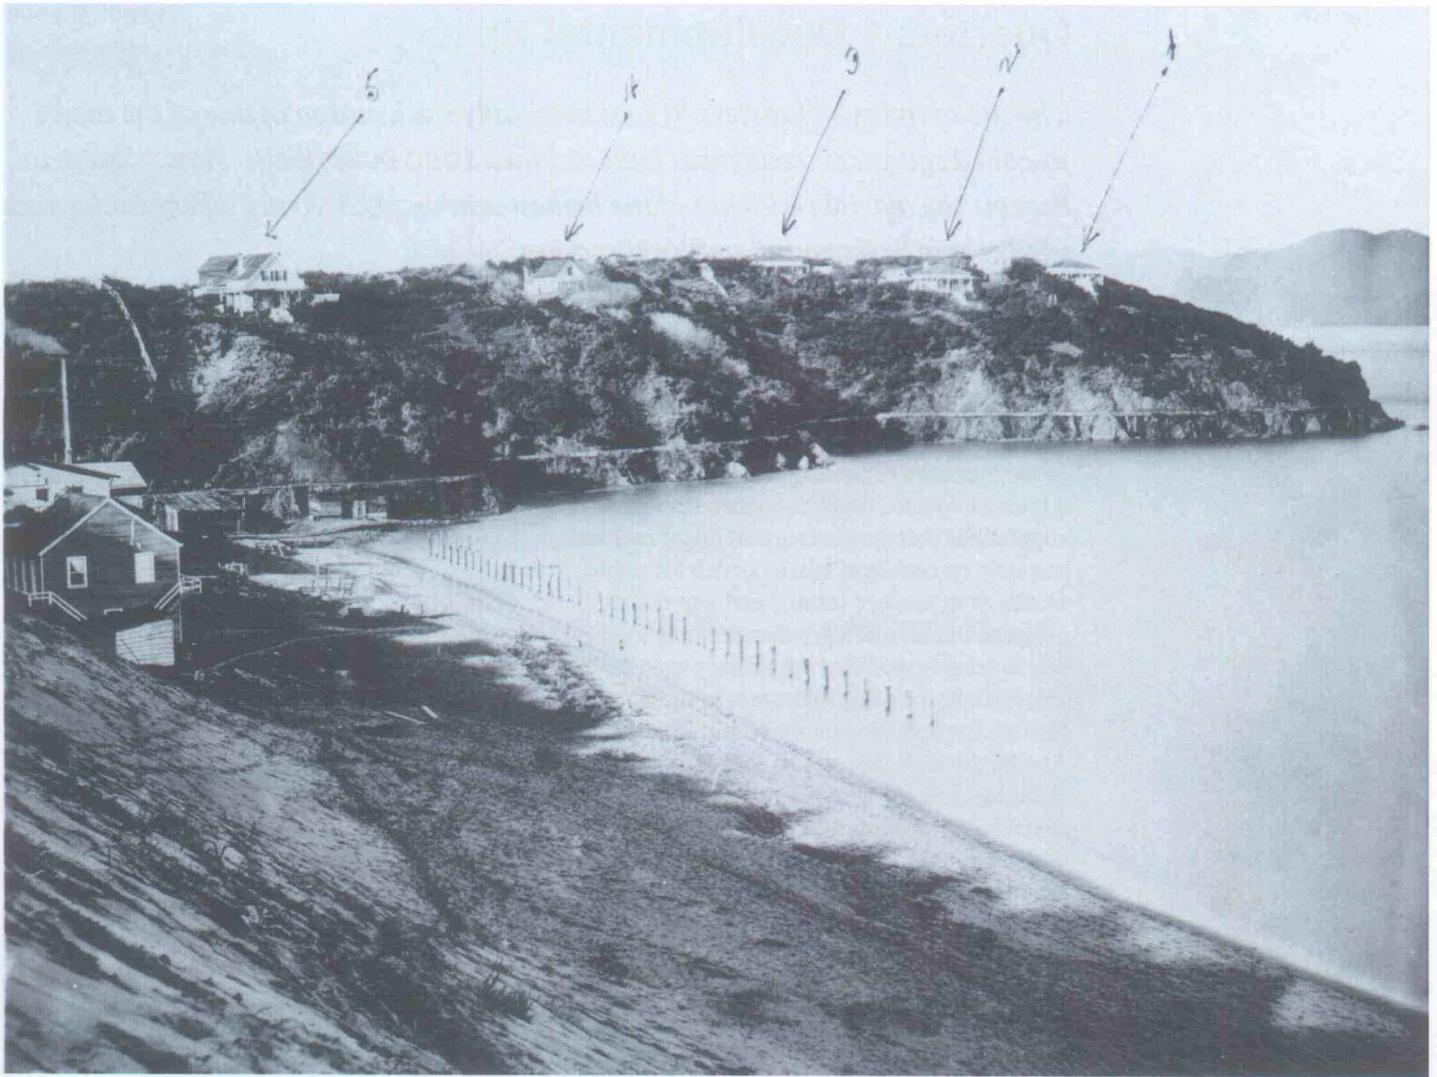
Figure 2 - Black Point in 1863 showing squatters residences. The earlier 1855 building, which was demolished in 1877 to make way for the current Quarters 1, is identified as building #5. (PARC-GOGA 78-c-55)

The most spacious home at Black Point was located at the southerly end of the row of private homes on the approximate location occupied today by Quarters 1 (see figure 2). Originally constructed around 1855, it was a rambling structure, with Stick and Queen Anne style decorative elements, with a gable-roofed 1½ story tall central portion and several single-story additions. James Brooks, the editor of the newspaper *Golden Era*, built the house and lived in it for a time. He later sold the house to the banking firm of Haskell and Company, who in turn sold it to Mr. Charles Cook of Palmer, Cook and Company, another banking firm. Its last owner was Mr. Emil Grisar, a wool merchant, who bought the house near the start of the Civil War. Photographs of Black Point taken in the early 1860s show the Grisar house to be a large, gable ended house with a porch along its east facade overlooking the bay, with small wings on its north and south sides,

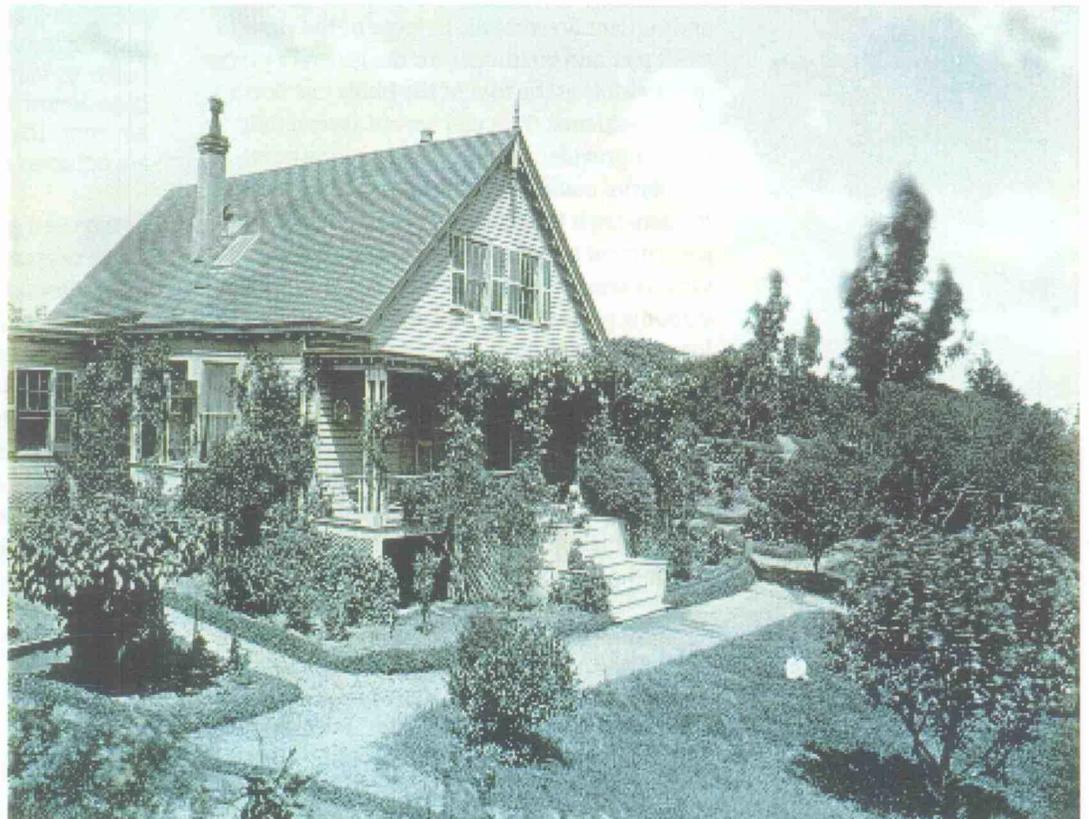
Figure 3 - This 1869 photo of the original Commanding General's house shows decorative elements such as, overhanging eaves with exposed rafter ends and the a carved wooden spire at the roof's ridge edge. (Bancroft Library)

A series of photograph taken about this time by the photographer Eadweard Muybridge show the Commanding General's house in some detail, surrounded by lush lawns, manicured gardens and verdant flowerbeds. In some of the views, a small pier and boathouse for the general's private use is visible at the foot of the bluffs just north of his residence. This pier served several functions: it provided a place where visiting naval dignitaries could land at the point when visiting the general; it functioned as a stopping place for government steamers plying the bay between the various army posts; and it served as a convenient stopping place for civilians arriving at Point San Jose who found travel by boat more convenient than taking a carriage over the city's unpaved streets. (See figures 3 & 4)

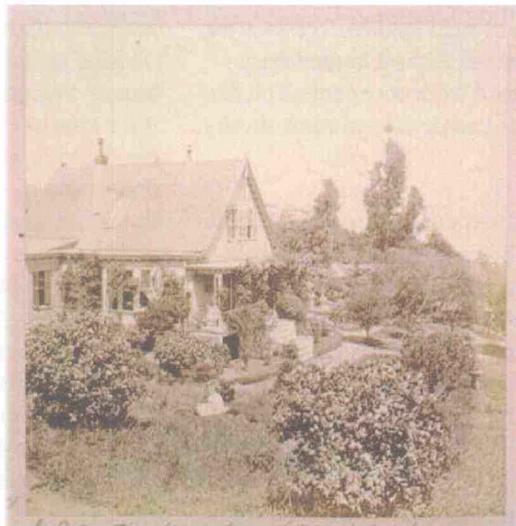
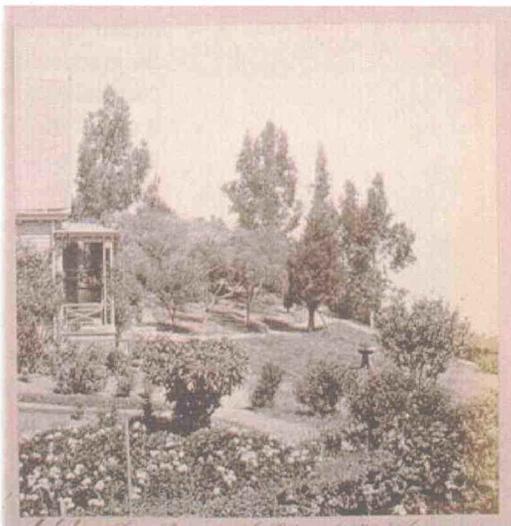
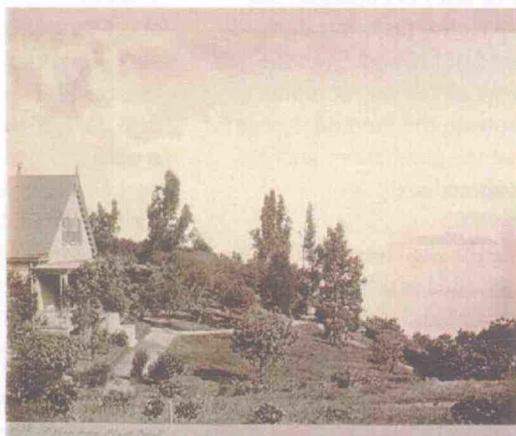
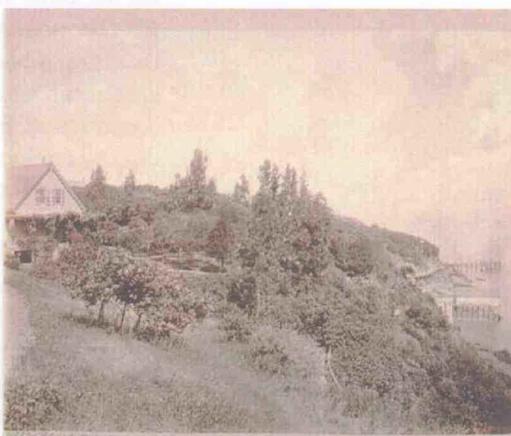
Figure 4 - Series of Eadweard Muybridge photos showing the Commanding General's house at Black Point, 1869. Note the private pier in the lower right image, which was used by visiting dignitaries. (Bancroft Library)

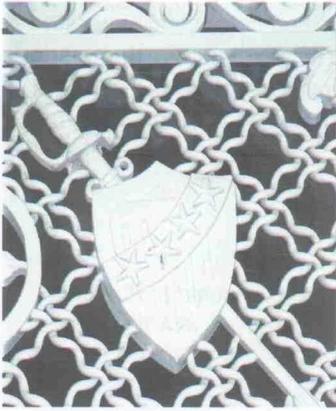
Sword and shield in screen above doorway from Reception room to Conservatory. (John Martini)

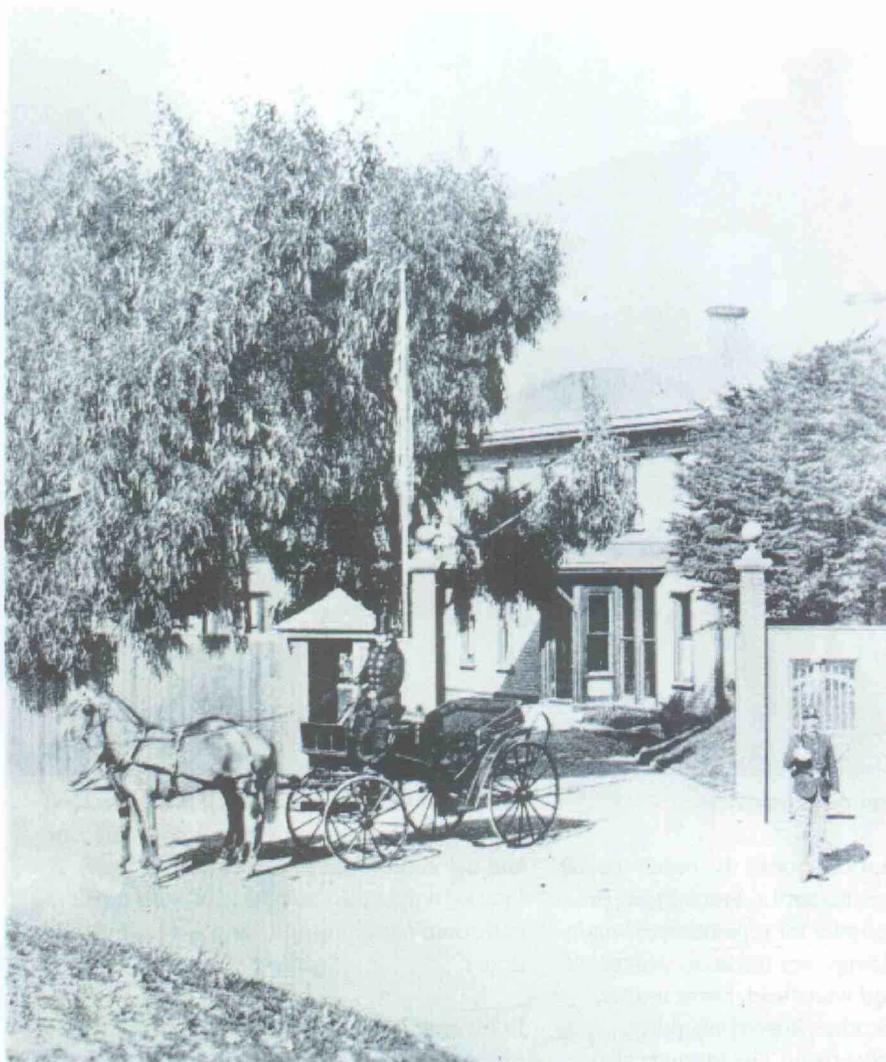
Figure 5 - Earliest known photograph of the new general's house, 1877. (HABS)

The earliest known photograph of the new general's house was taken around the time of Howard's occupancy. It shows the sentry mentioned by the general standing outside the carriage way leading to the front entrance, while a carriage and liveried driver wait just outside the gate. What's impressive about the scene is how little the front of the building has changed since the photo was taken. Aside from new gateposts and substantial tree growth, the residence looks virtually unchanged today. (See figure 5 and the front cover photograph)<sup>19</sup>

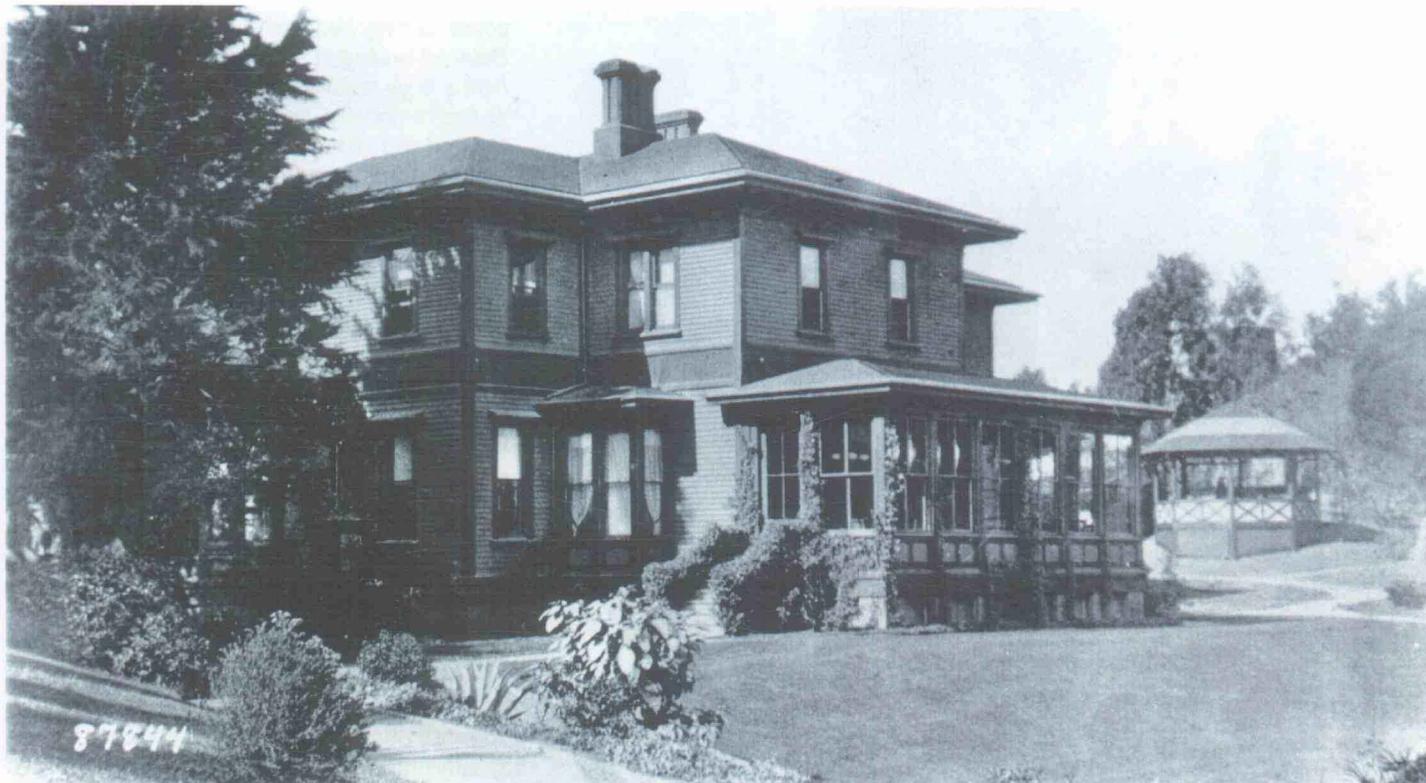
Figure 6 - Quarters 1, circa 1885. The east elevation of this building has experienced much change. Note that in 1885 there was a bay window at the first floor and the Conservatory was rectangular shaped with a wall of glazing. (77-C-293)

Another photograph taken around the same time shows the east façade of the house – a view that would change dramatically over the next 120 years. In this photo the original exterior of this side of the building is still evident, unchanged by later dining room additions and window redesigns. Especially prominent are the ivy covered conservatory wing and the original second-floor window arrangements. In the distance, a tiny bandstand sits atop a gentle knoll separating the general's house from Quarters 2 (see figure 6).

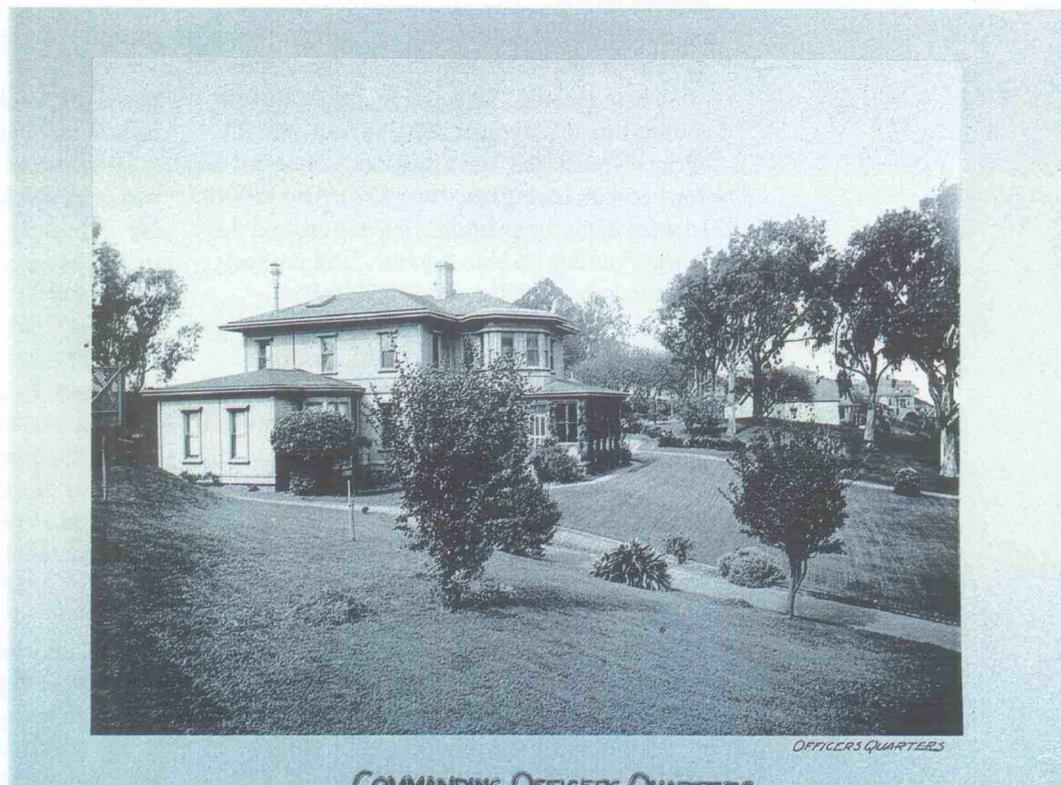
Figure 7 - Quarters 1, 1893. By 1893, modifications and improvements had occurred to the building, including the construction of projecting bay windows, probably at the general's 2nd floor bedroom. (RG92)

In 1893 the Quartermaster Department prepared photographic surveys of army buildings in the San Francisco area, and two views were made of the Commanding General’s house and grounds at Fort Mason. The first view (figure 7) shows the east side of the building from a perspective similar to the view taken circa 1885. In this view, though, a large bay window has appeared at the corner of the bedroom directly over the parlor, which, given its location in the house, was likely the general’s bedroom. The other view (see fig-

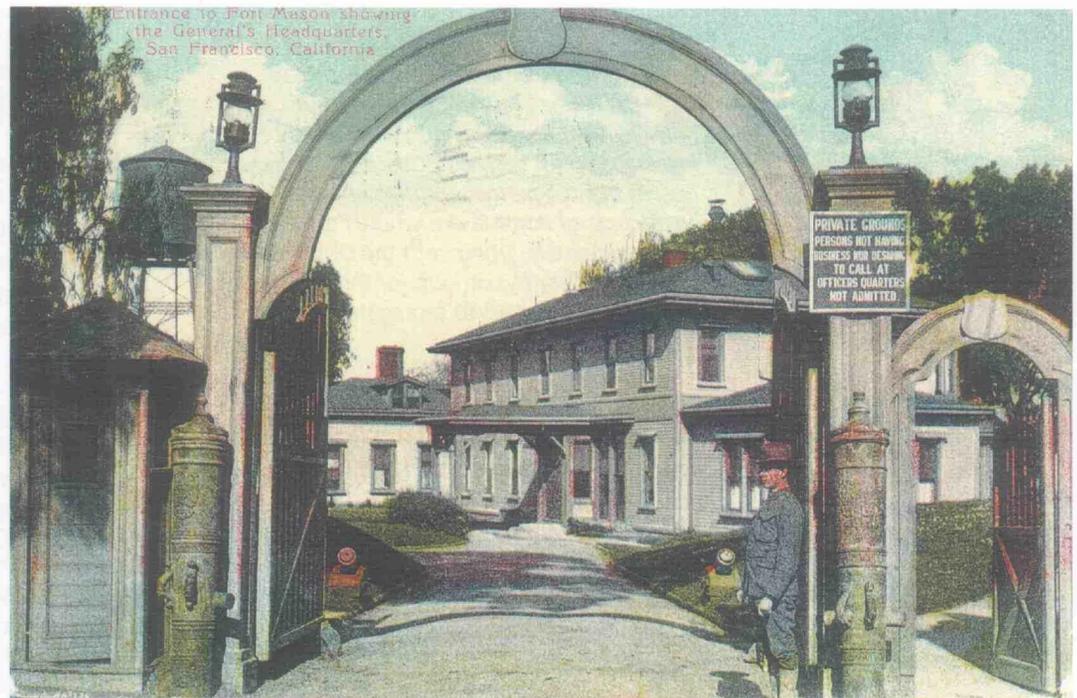
Figure 13 - Quarters 1, circa 1907. This image from an old postcard shows the sentry box at the left, the cannons flanking the entrance, and the arched entryway, guarded by a soldier. (John Martini collection)

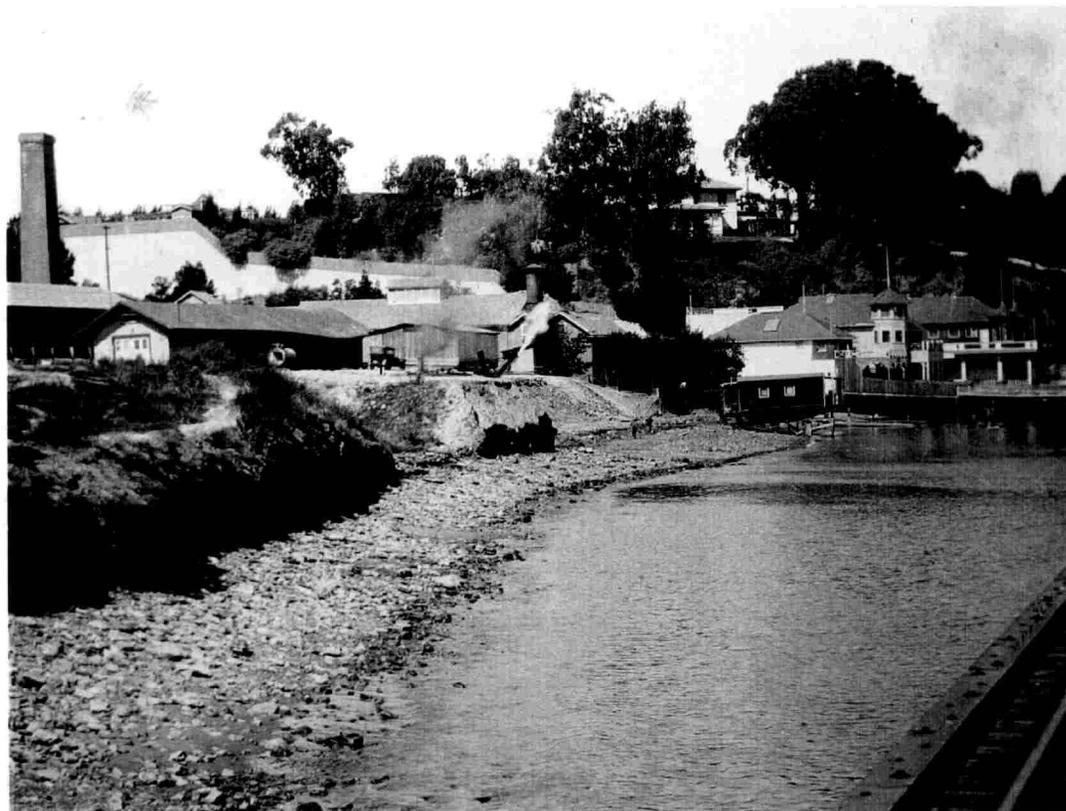
Figure 14 - Fort Mason viewed from Aquatic Park, January 14, 1919. Quarters 1 is in the center of the photo up on the hill and the still rectangular conservatory is visible. (SFPL DPW 6134)

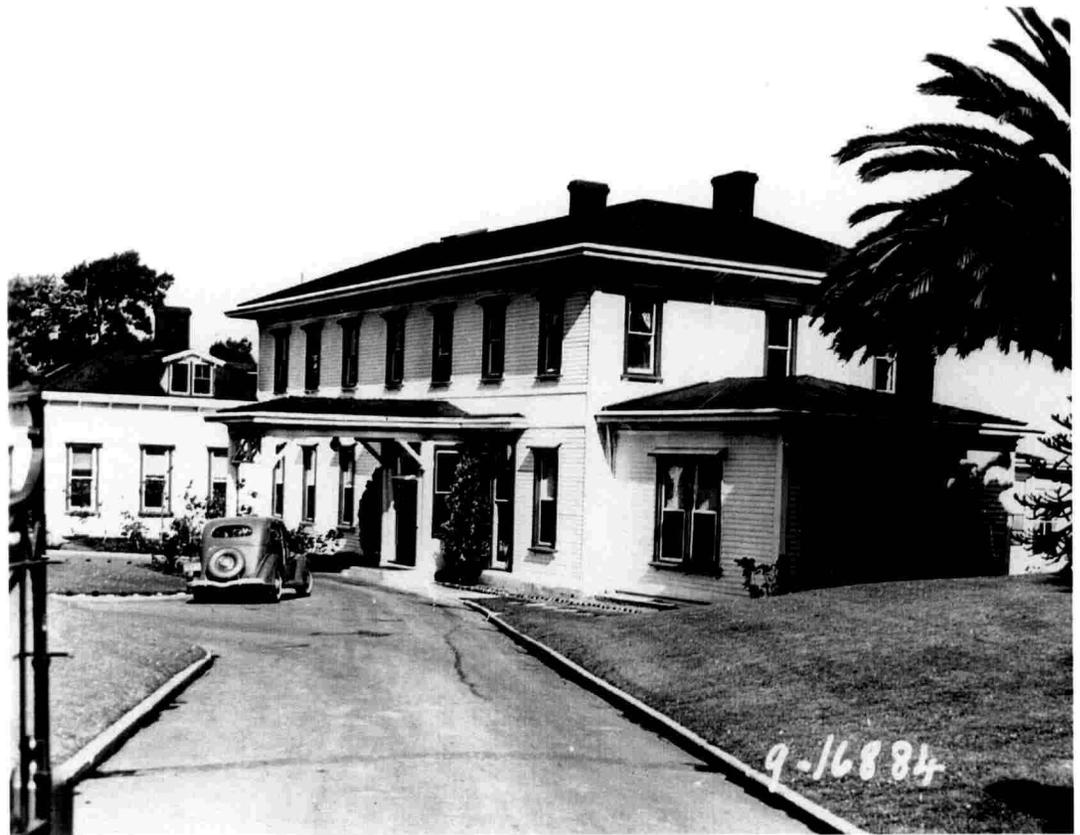
Figure 15 - This photo of Quarters 1 in 1941 shows the new chimney at the library wing, the functional porte-cochere and the original kitchen wing with a hipped roof. (75-C-41)

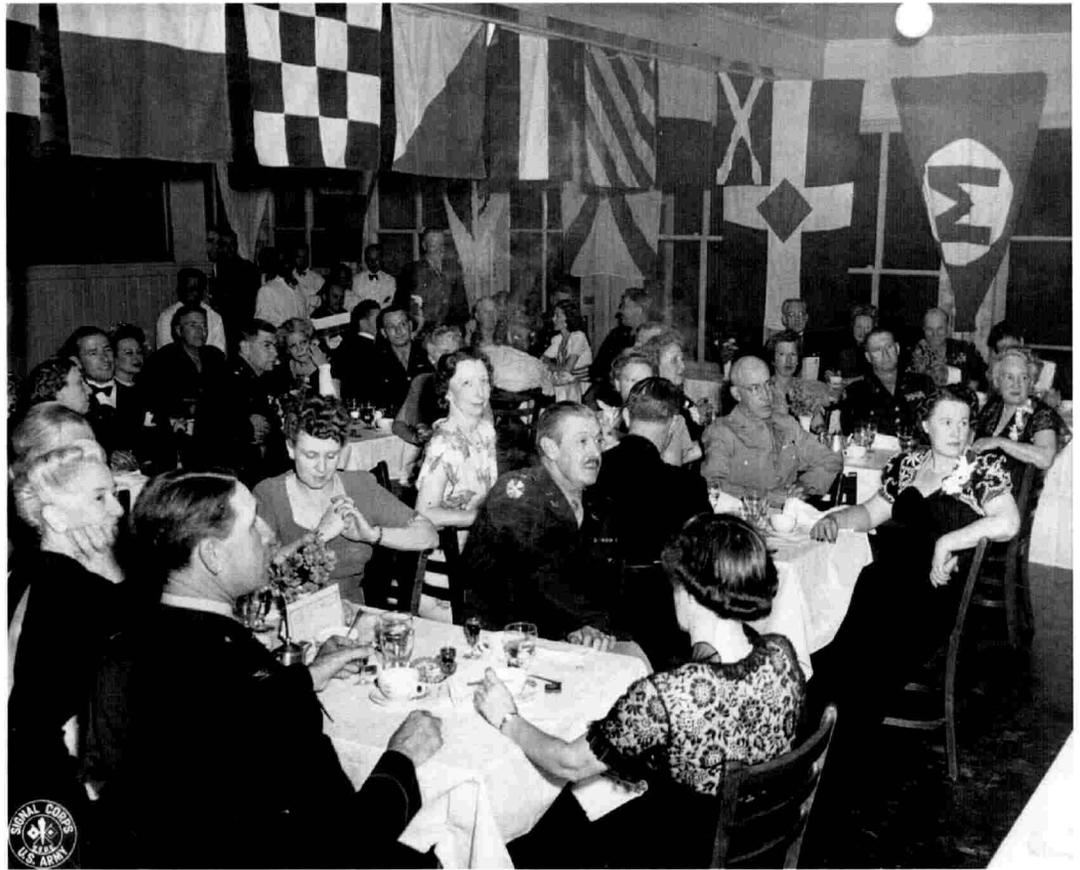
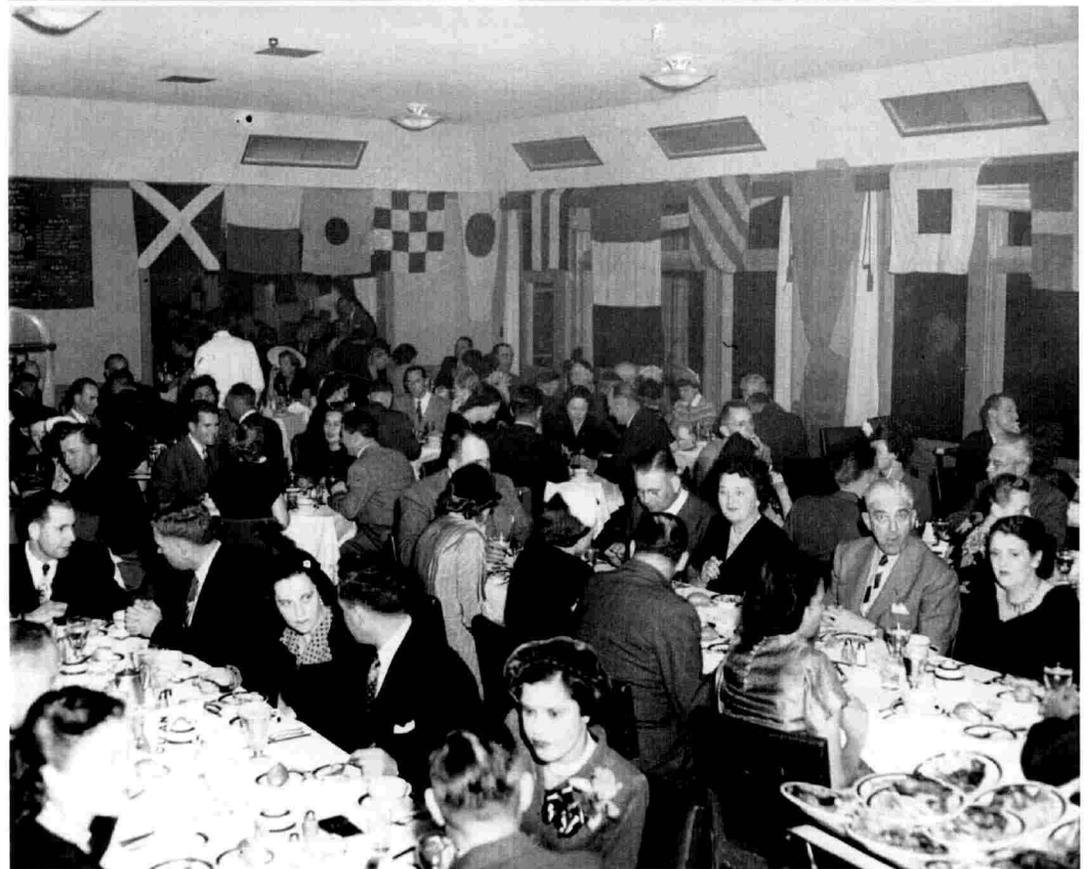
Figures 16 & 17 - Social events in the new Officers Club in 1947 and 1948. The top photo shows an event in the Circle Room (formerly the Conservatory); the bottom photo shows a function in the newly constructed Social Hall. (GOGA 32475)

Figure 20 - By the 1960s, with the Transient Dining Room constructed, the Conservatory was free to be transformed into the Cocktail Lounge. Note the dramatic change from figure 16 & 18 - the windows were replaced, light cans were installed into new ceiling tiles and the decor was lighter, more open and more "modern". View looking northwest, circa 1960s. (GOGA 2316)

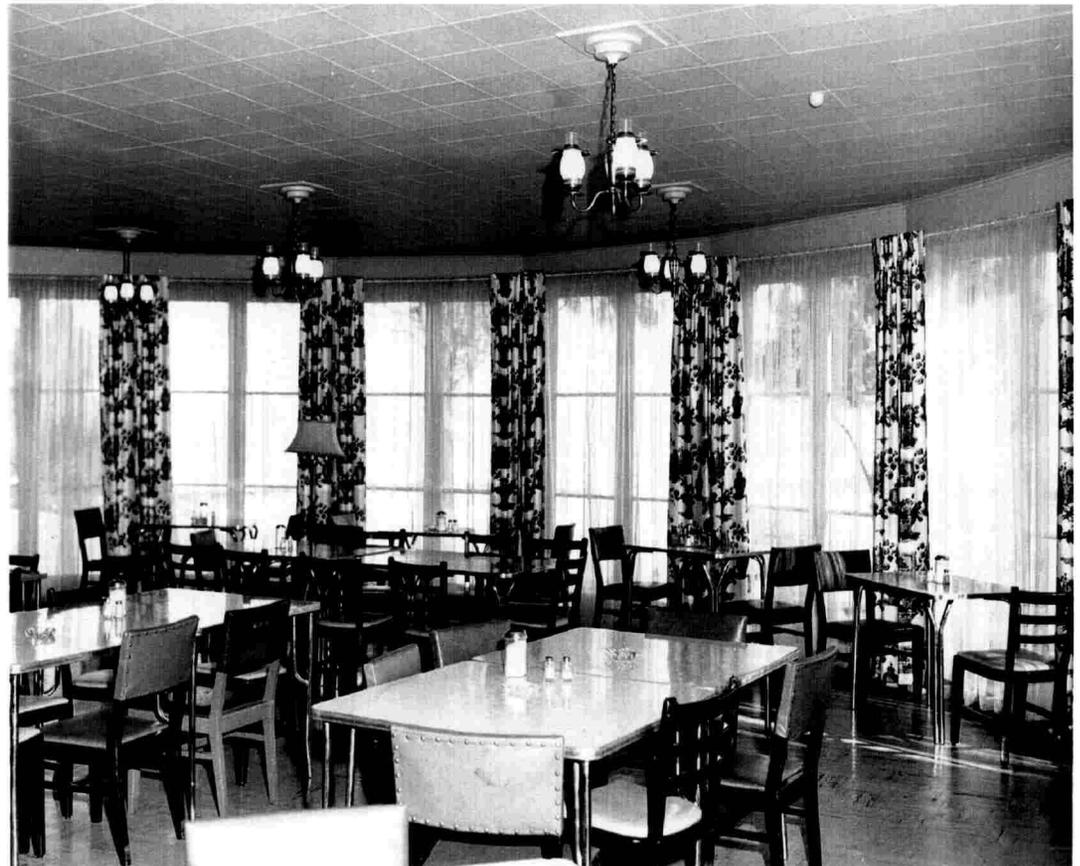
**Figure 18 -** By the 1950s the Officers Club was cramped for space. Before the Dining Hall was constructed in 1960 the Conservatory was pressed into use as a dining room. Note the 1950s decor, with the long floral drapes and the formica table tops. View looking east, 1955. (GOGA 2316)

The next major modification to Quarters 1 occurred in 1958-1959, not as an effort to modernize the building but rather to provide additional dining space for the membership as well as for military personnel traveling through the Bay Area (see figure 18). This latter group, referred to by the Army inelegantly as “transients,” often included military families passing through San Francisco on their way to and from Pacific bases.

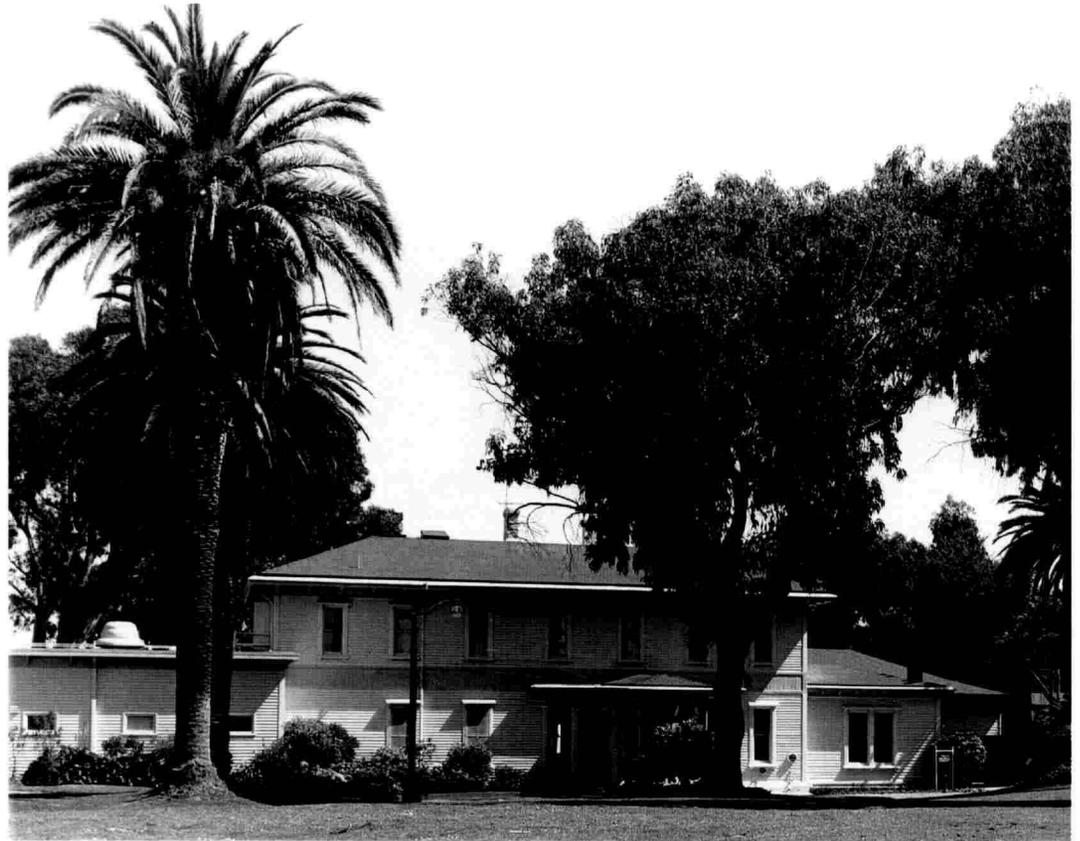
Figure 21 - This photo from 1971 shows the west elevation as it stands today, with the new, flat-roofed kitchen addition at the left hand side. View looking west. (GOGA-2316)

Construction continued throughout 1959 and was apparently completed in early 1960, and a set of plans dated February 1 that year show in detail the new Transient Dining room, cafeteria, and rebuilt kitchen wing (see figure 21). The same plans also reveal that the former Conservatory had been converted from a dining area to a bar called the “Circle Room” (see figure 20), and that the historic general’s office on the first floor served as a library.<sup>78</sup>

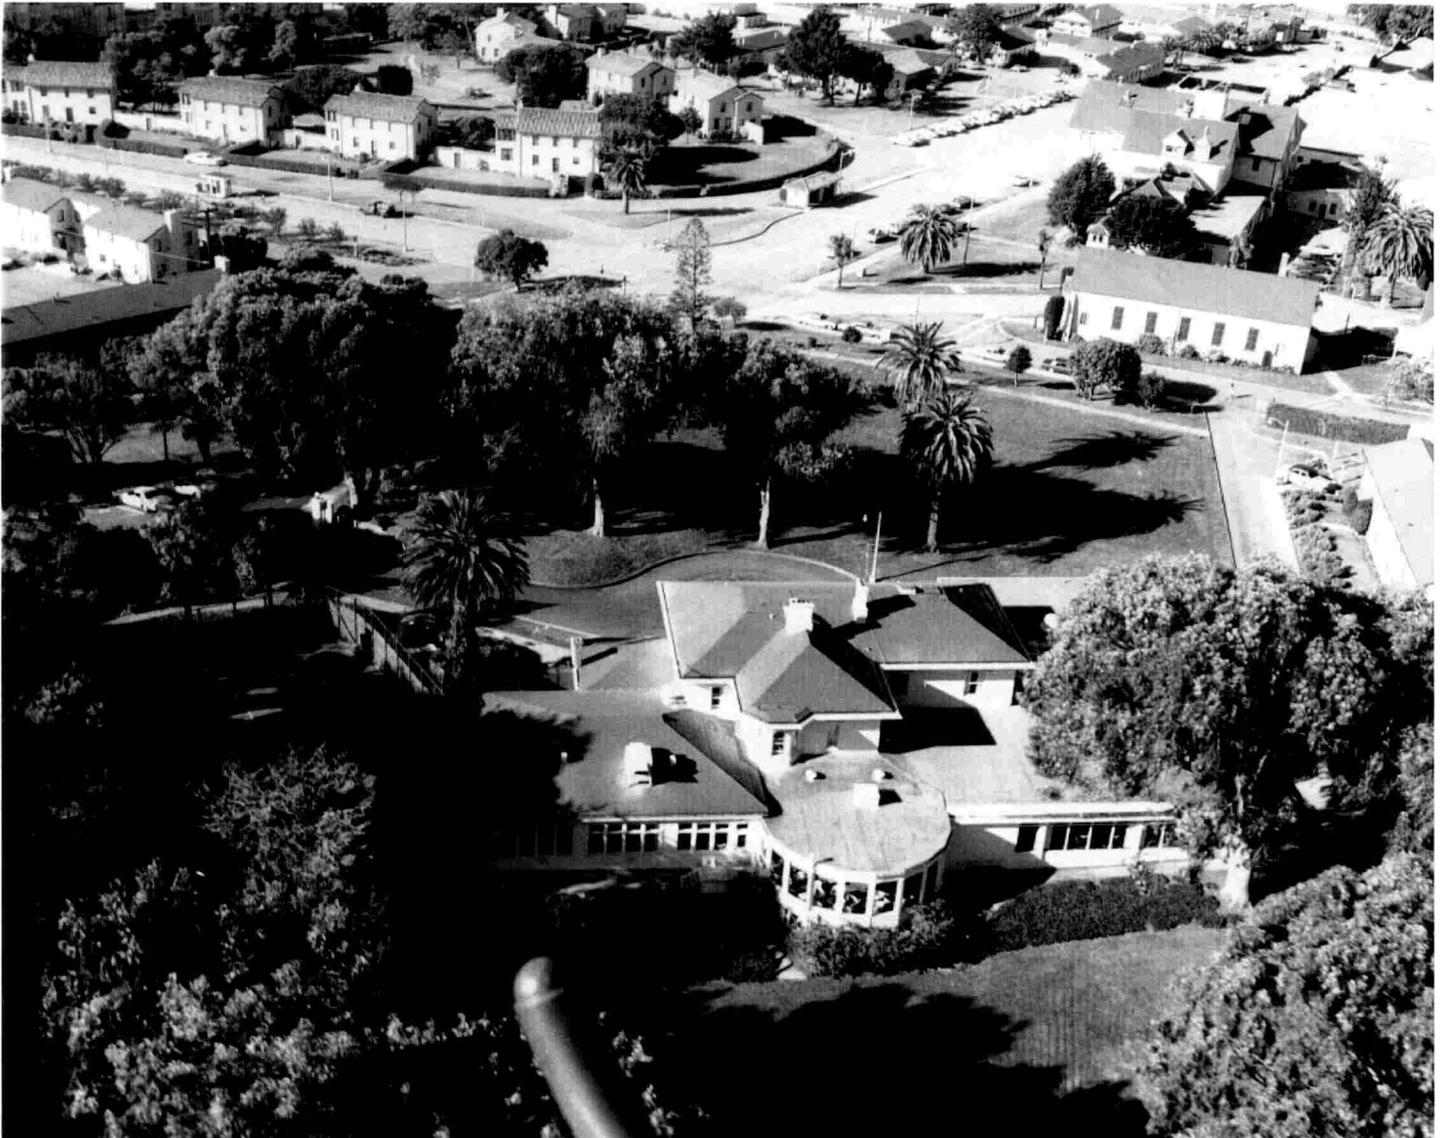
Figure 22 - Aerial view of Officers Club and Fort Mason, March 1970. This photo shows the building as it stands today. (GOGA 2316)

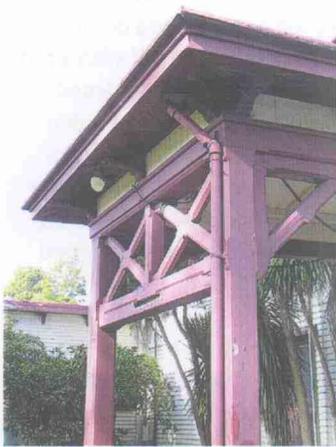
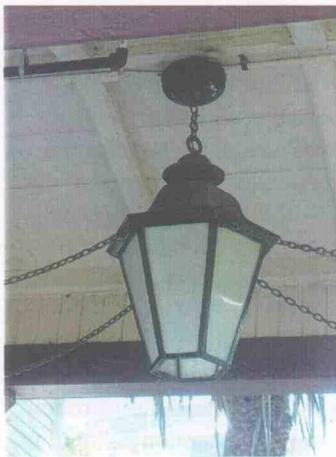
Upper photo: Detail of porte-cochere framing. (John Kalucki, 2002)

Lower photo: Light fixture in porte-cochere. (Lehman, 2004)

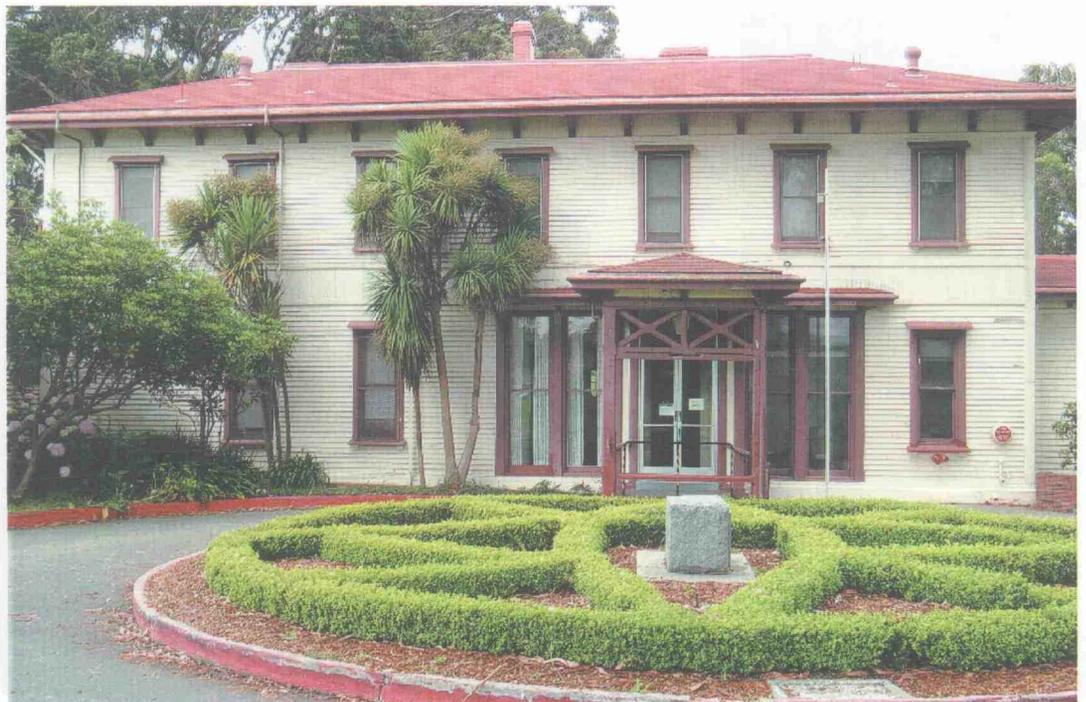
Photo at right: Front elevation of Officers Club. (Martini, 2004)

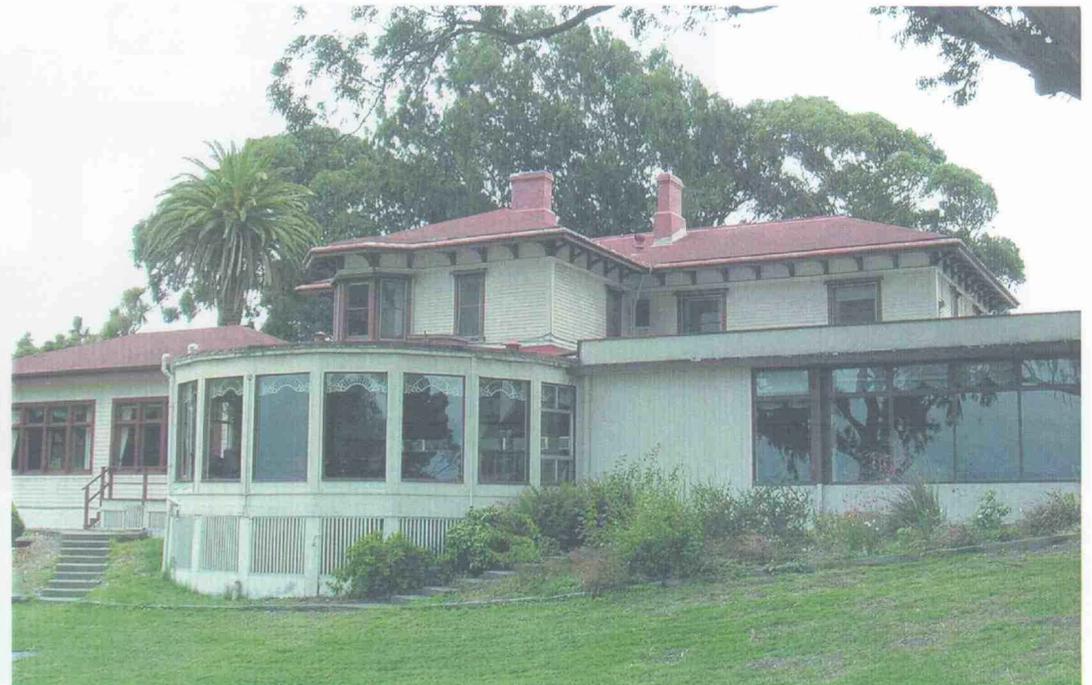
Photo at right: East elevation of Officers Club. (Lerner, 2004)

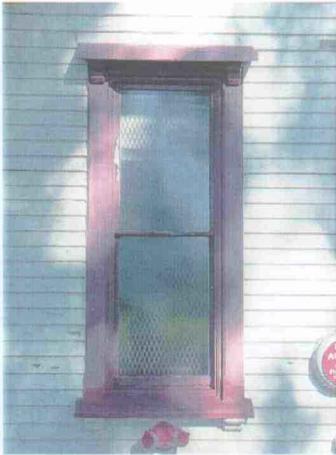
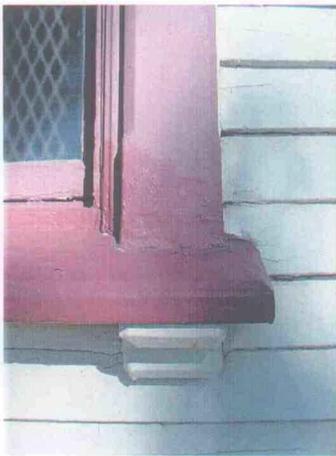
Upper photo: Typical original double-hung window. (Lehman, 2004)

Lower photo: Small decorative brackets supporting window sills. (Lehman, 2004)

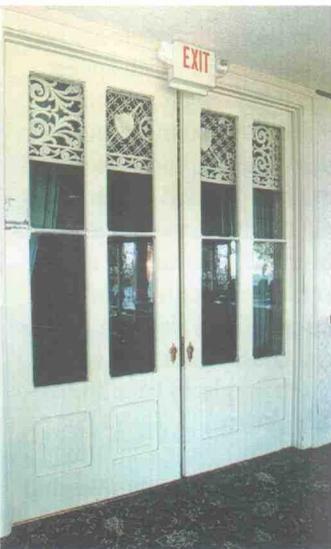
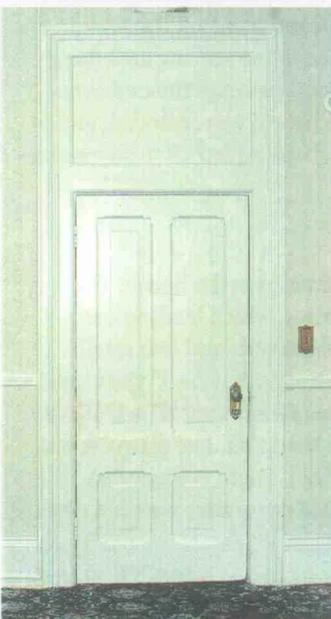
Lower photo: Brass hardware on Conservatory doors. (Martini, 2004)

Upper photo: Original pocket doors into Conservatory. (Martini, 2004)

Lower photo: Original style wood doors. (Martini, 2004)

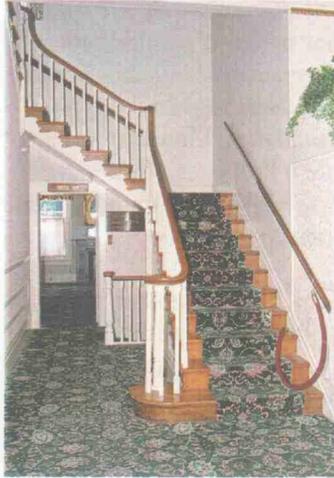
Upper photo: Detail of plaster crown moulding in Library, 2004. (John Martini)

Lower photo: Main staircase in Reception Hall, 2004. (John Martini)

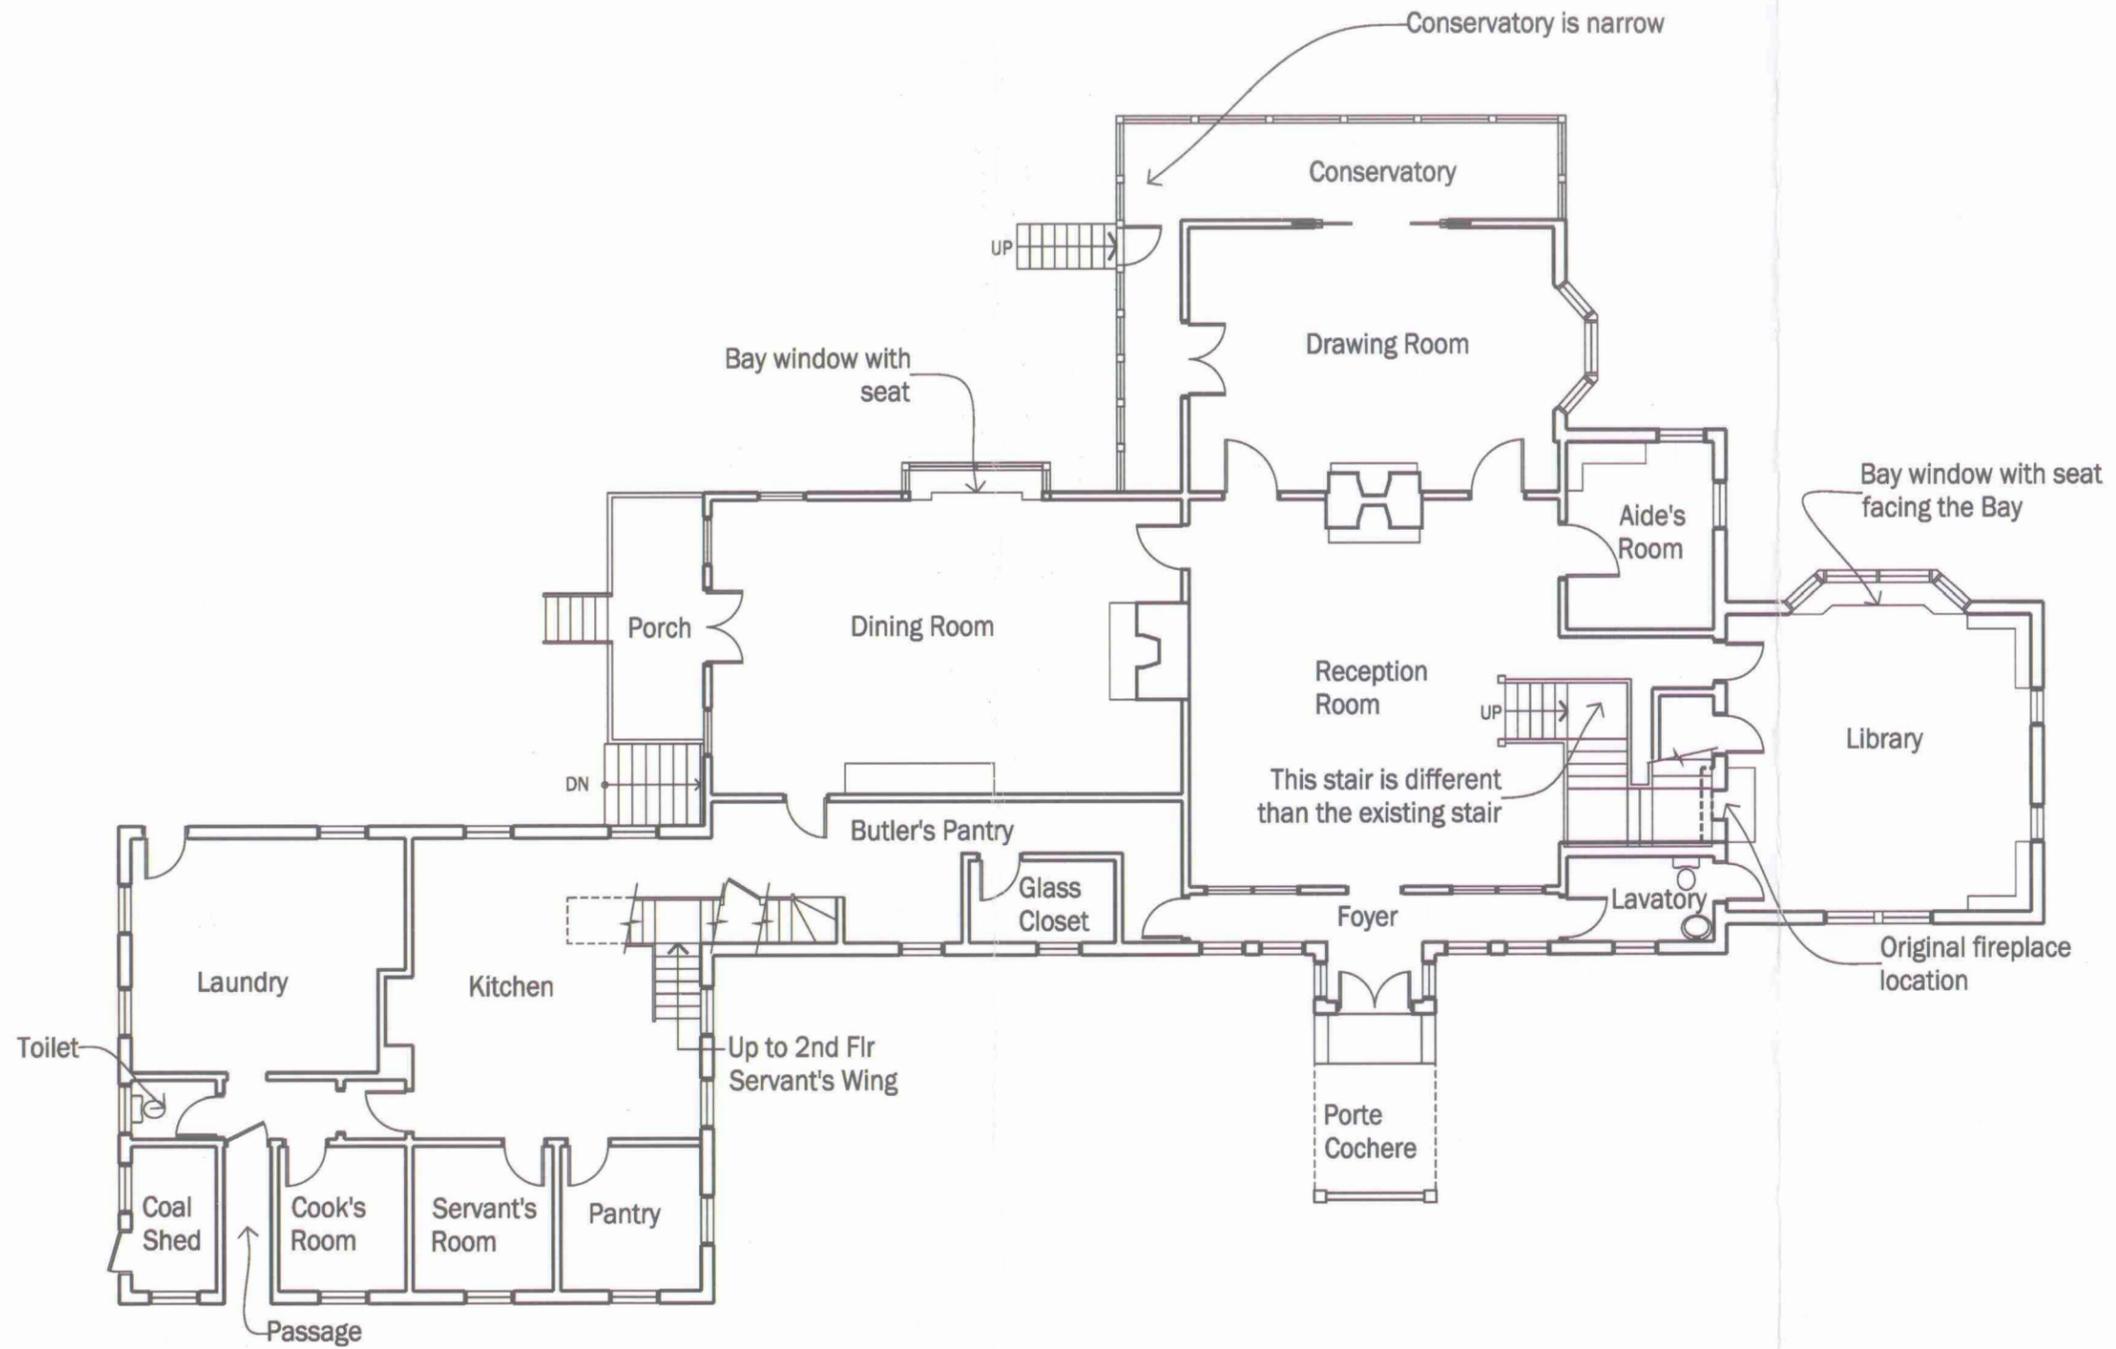
FIRST FLOOR PLAN ca. 1884

NOTE: Although based on information obtained from primary and secondary historical sources, these building plans contain conjectural and projected information, and are for the purpose of illustrating the building's evolution. These drawings are not "as-built" layouts of spaces, fixtures and other building components.
