# Fort Mason Officers Club

## Historic Structure Report

## *Historic Structure Report*

**May 2005**

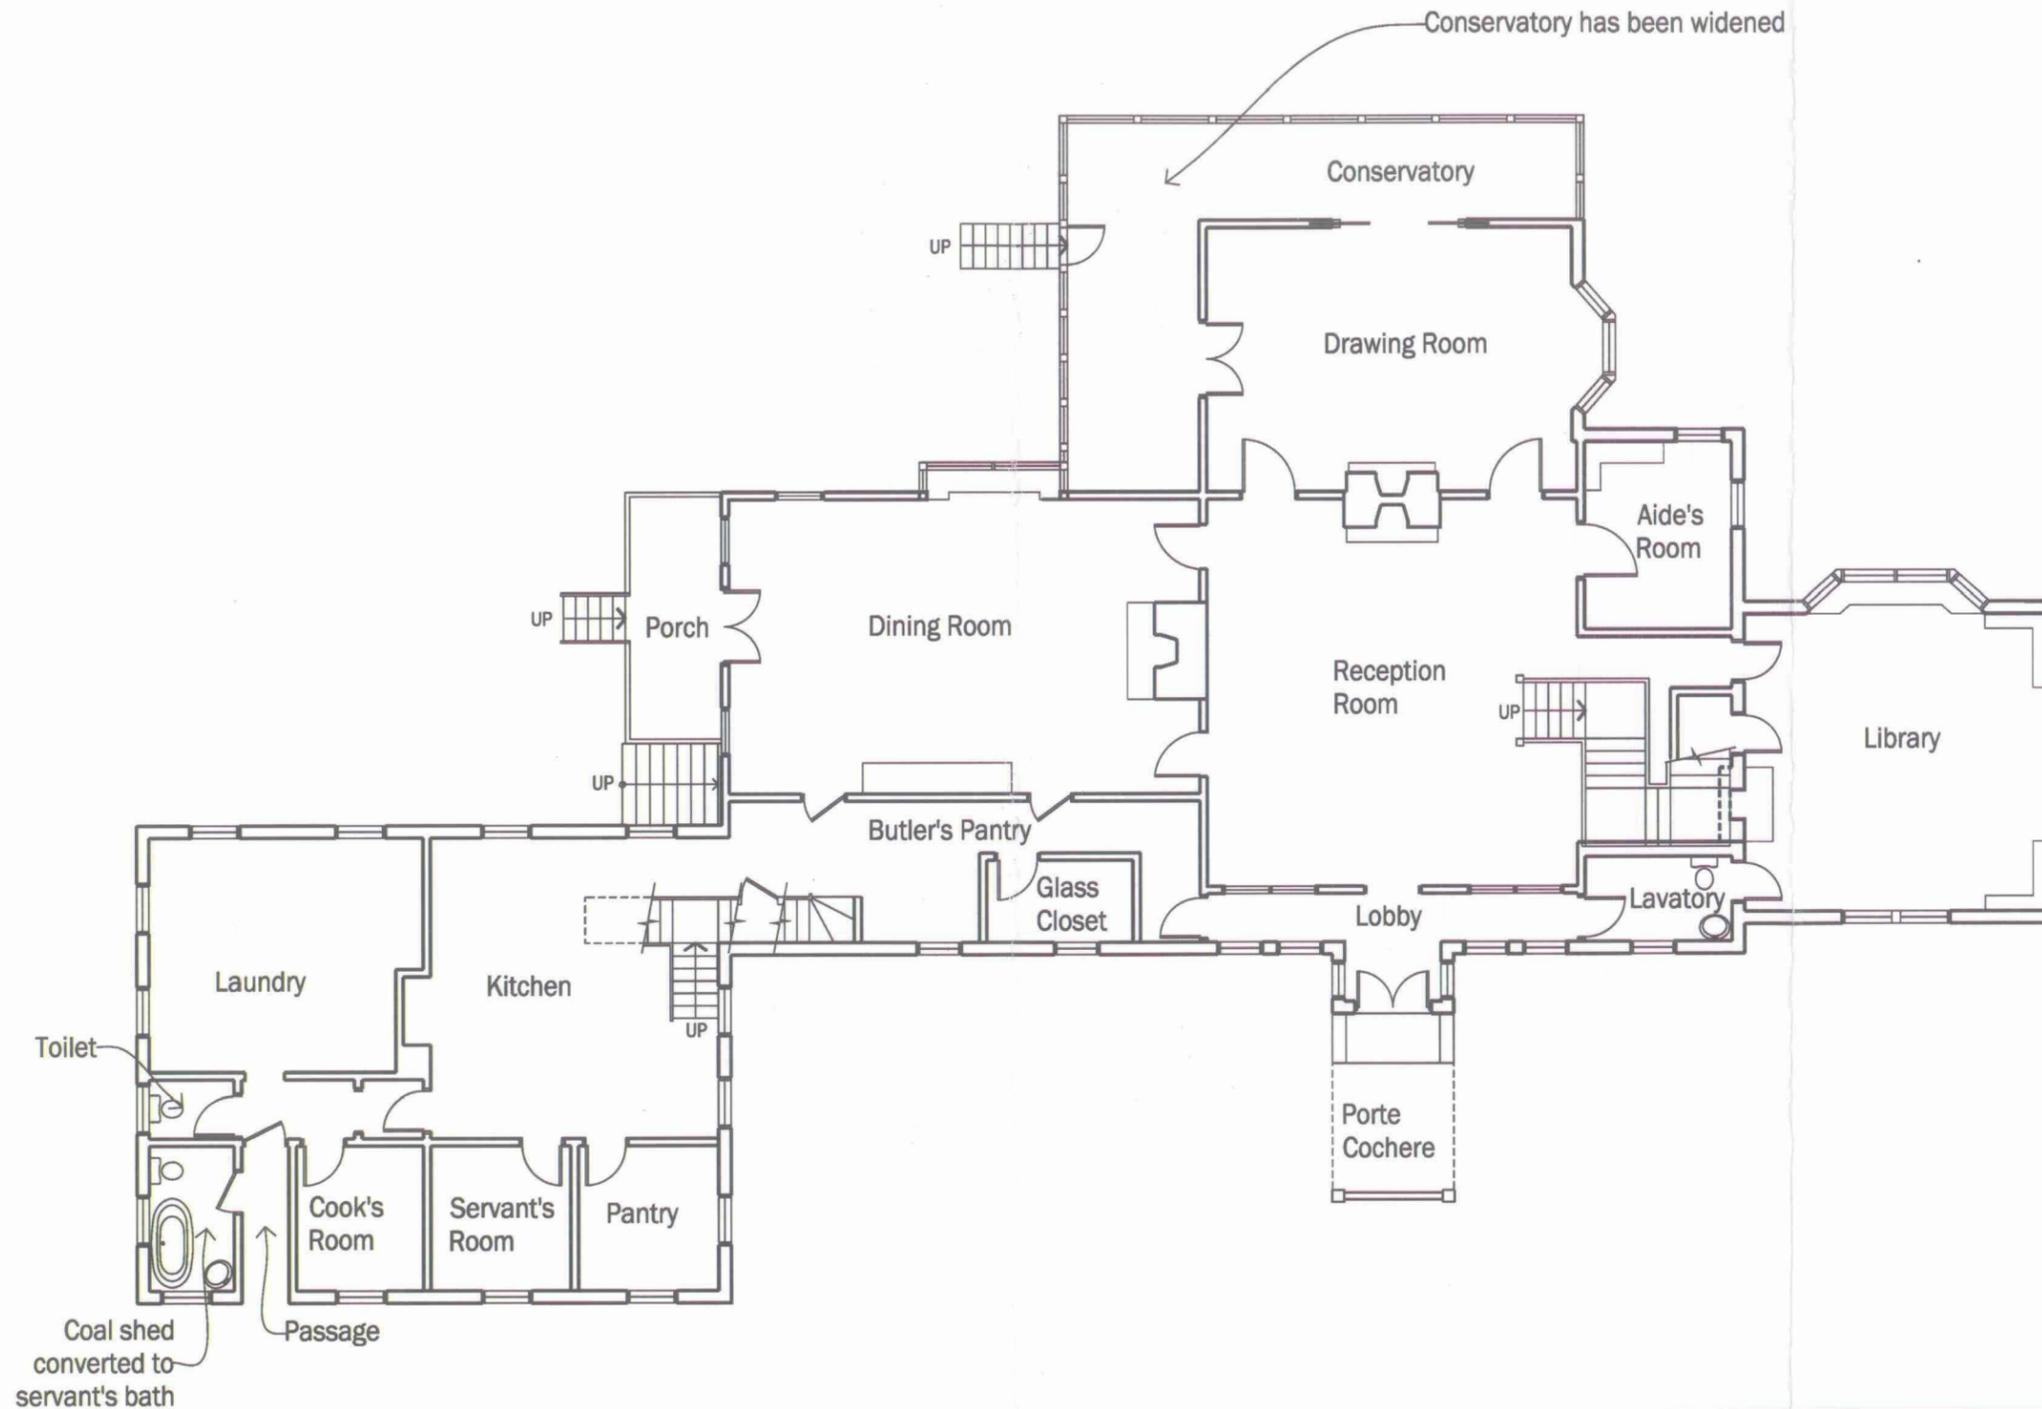
FIRST FLOOR PLAN ca. 1912

NOTE: Although based on information obtained from primary and secondary historical sources, these building plans contain conjectural and projected information, and are for the purpose of illustrating the building's evolution. These drawings are not "as-built" layouts of spaces, fixtures and other building components.

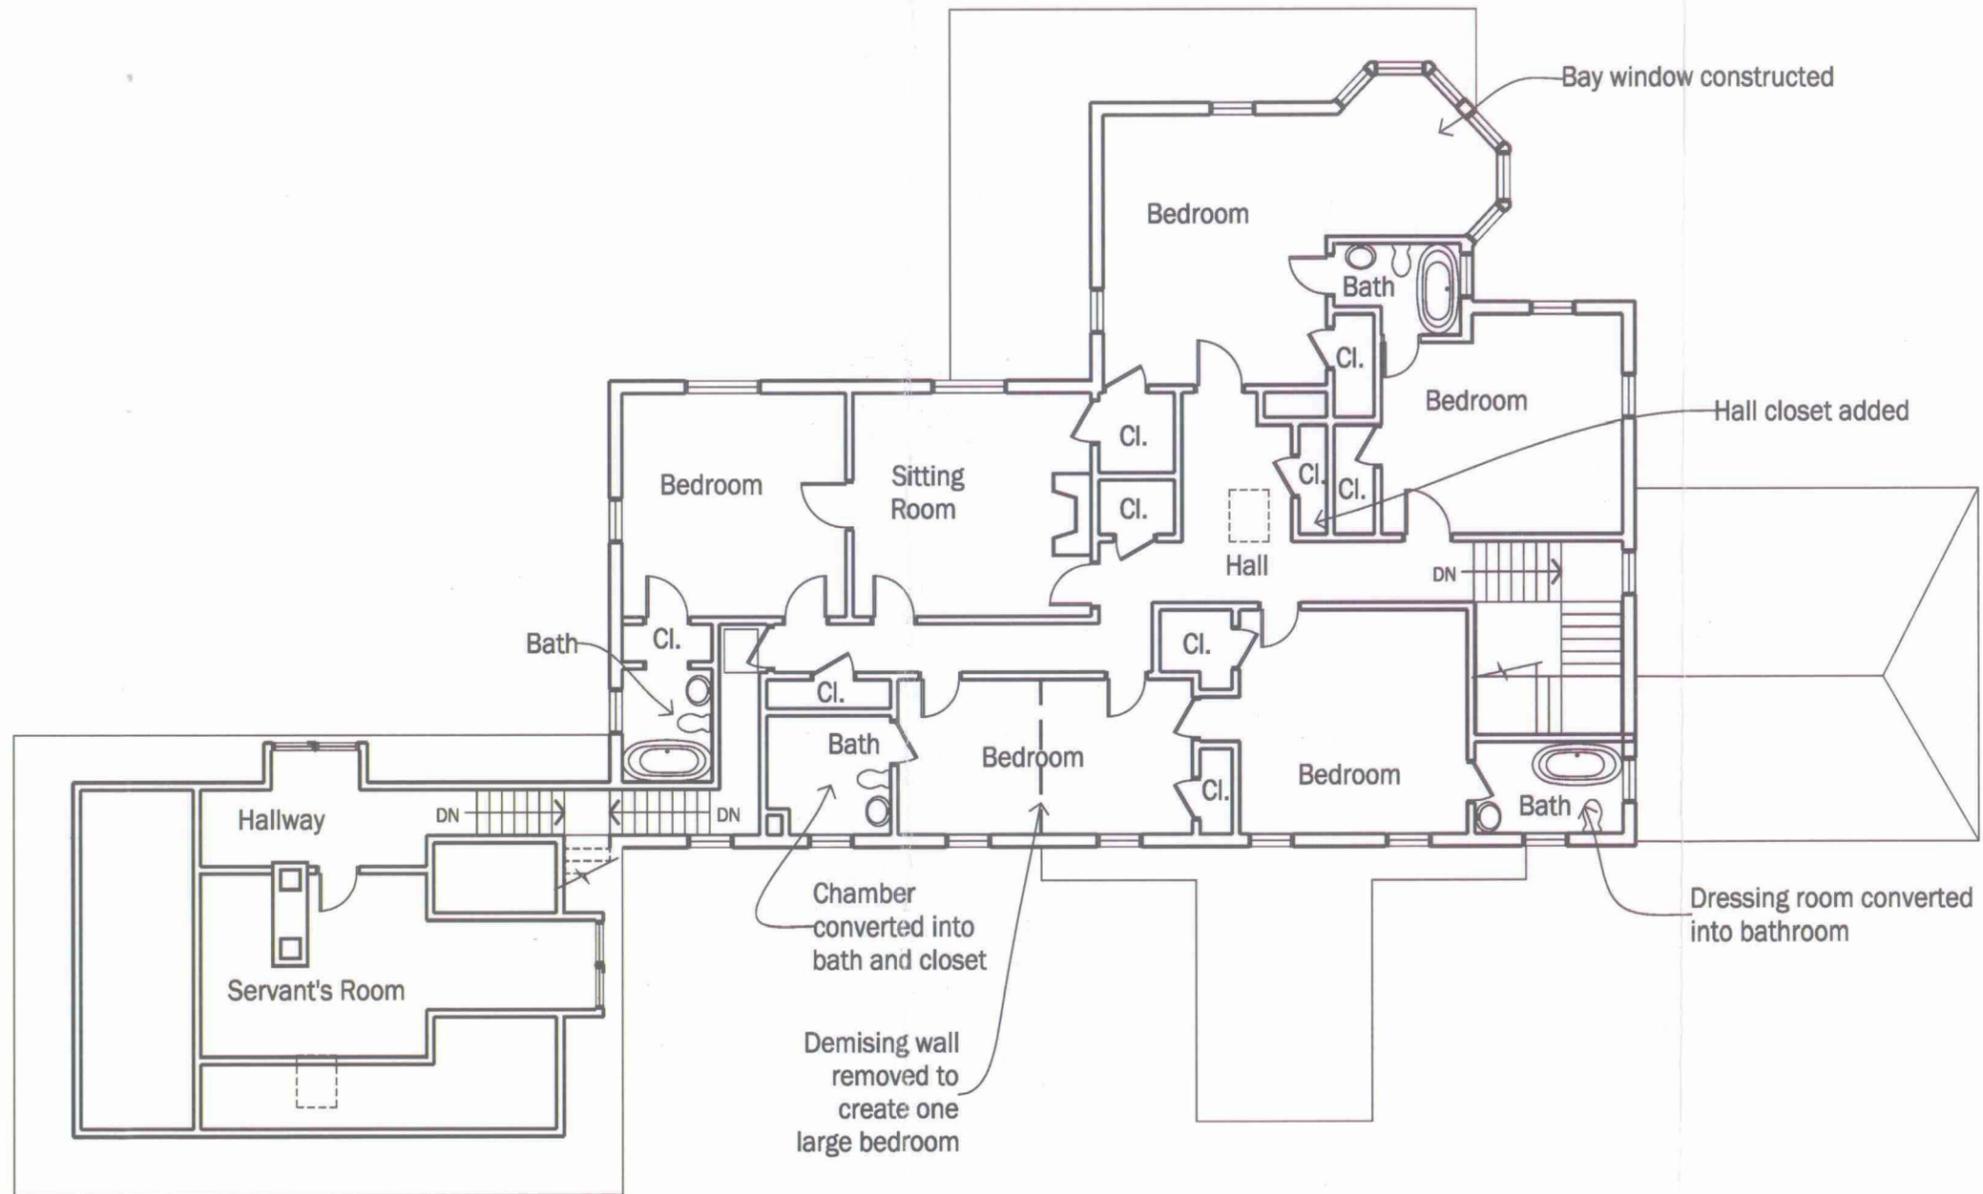
SECOND FLOOR PLAN ca. 1912

NOTE: Although based on information obtained from primary and secondary historical sources, these building plans contain conjectural and projected information, and are for the purpose of illustrating the building's evolution. These drawings are not "as-built" layouts of spaces, fixtures and other building components.

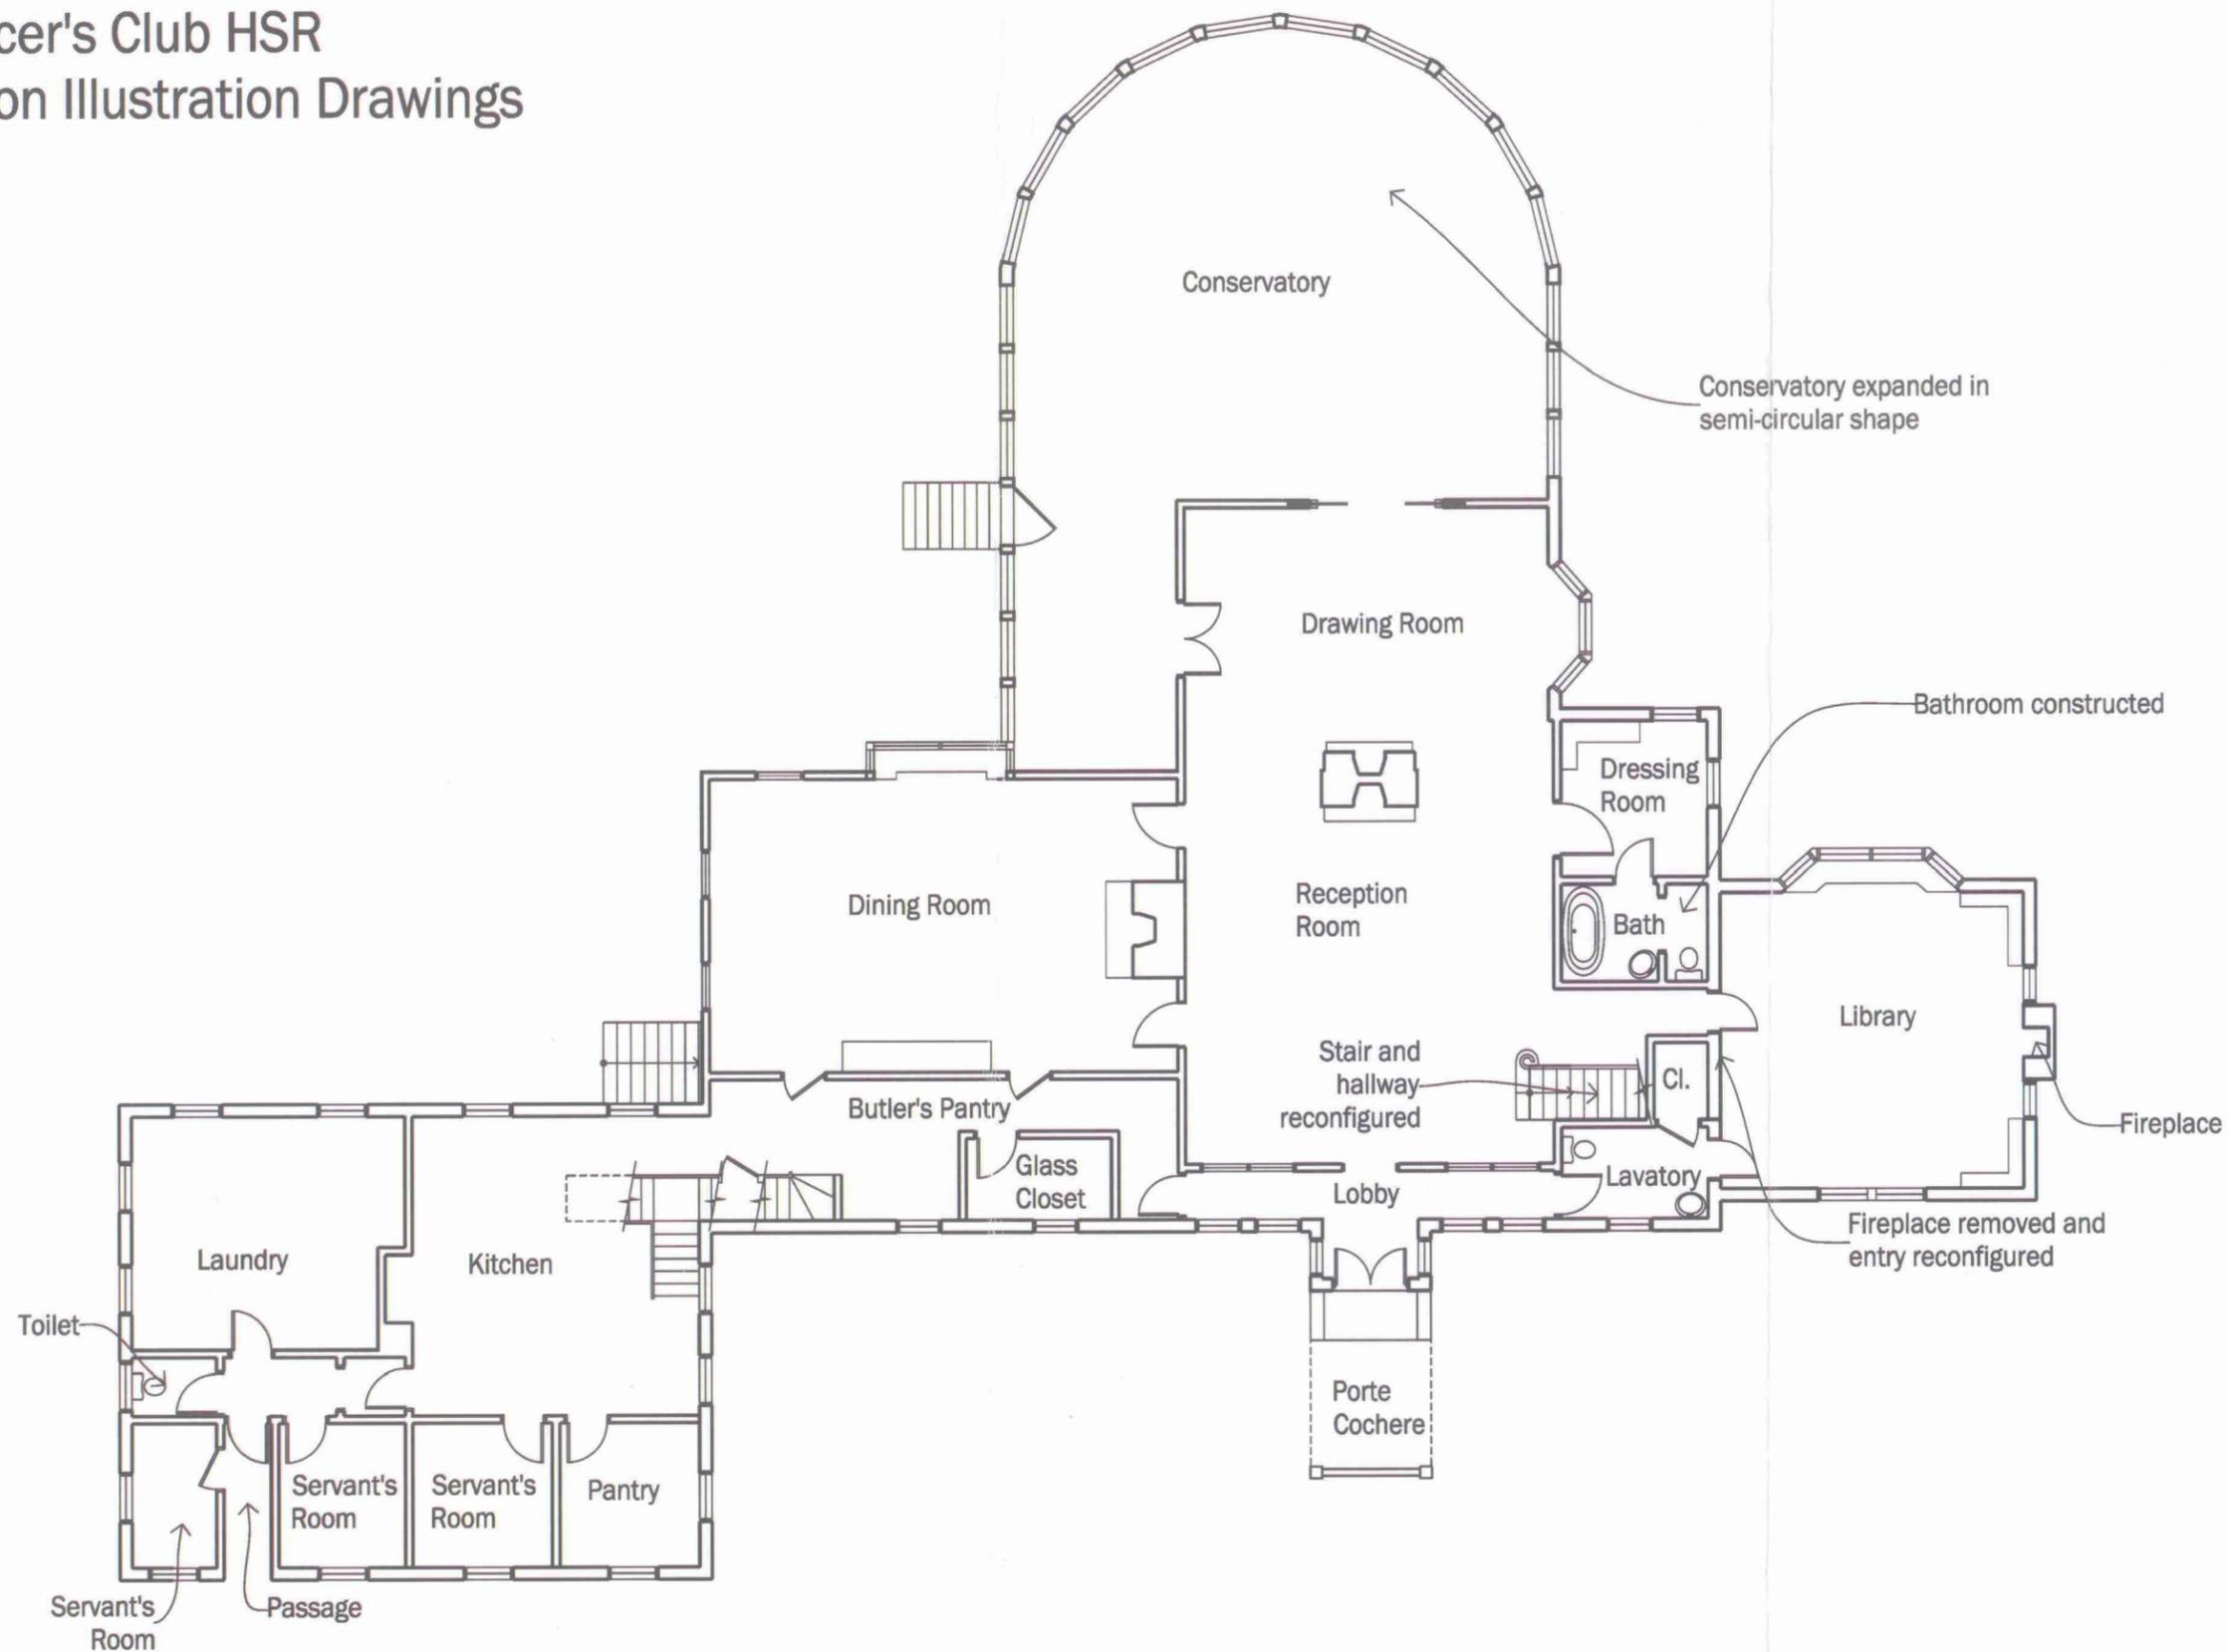
FIRST FLOOR PLAN ca. 1922 to 1938

NOTE: Although based on information obtained from primary and secondary historical sources, these building plans contain conjectural and projected information, and are for the purpose of illustrating the building's evolution. These drawings are not "as-built" layouts of spaces, fixtures and other building components.

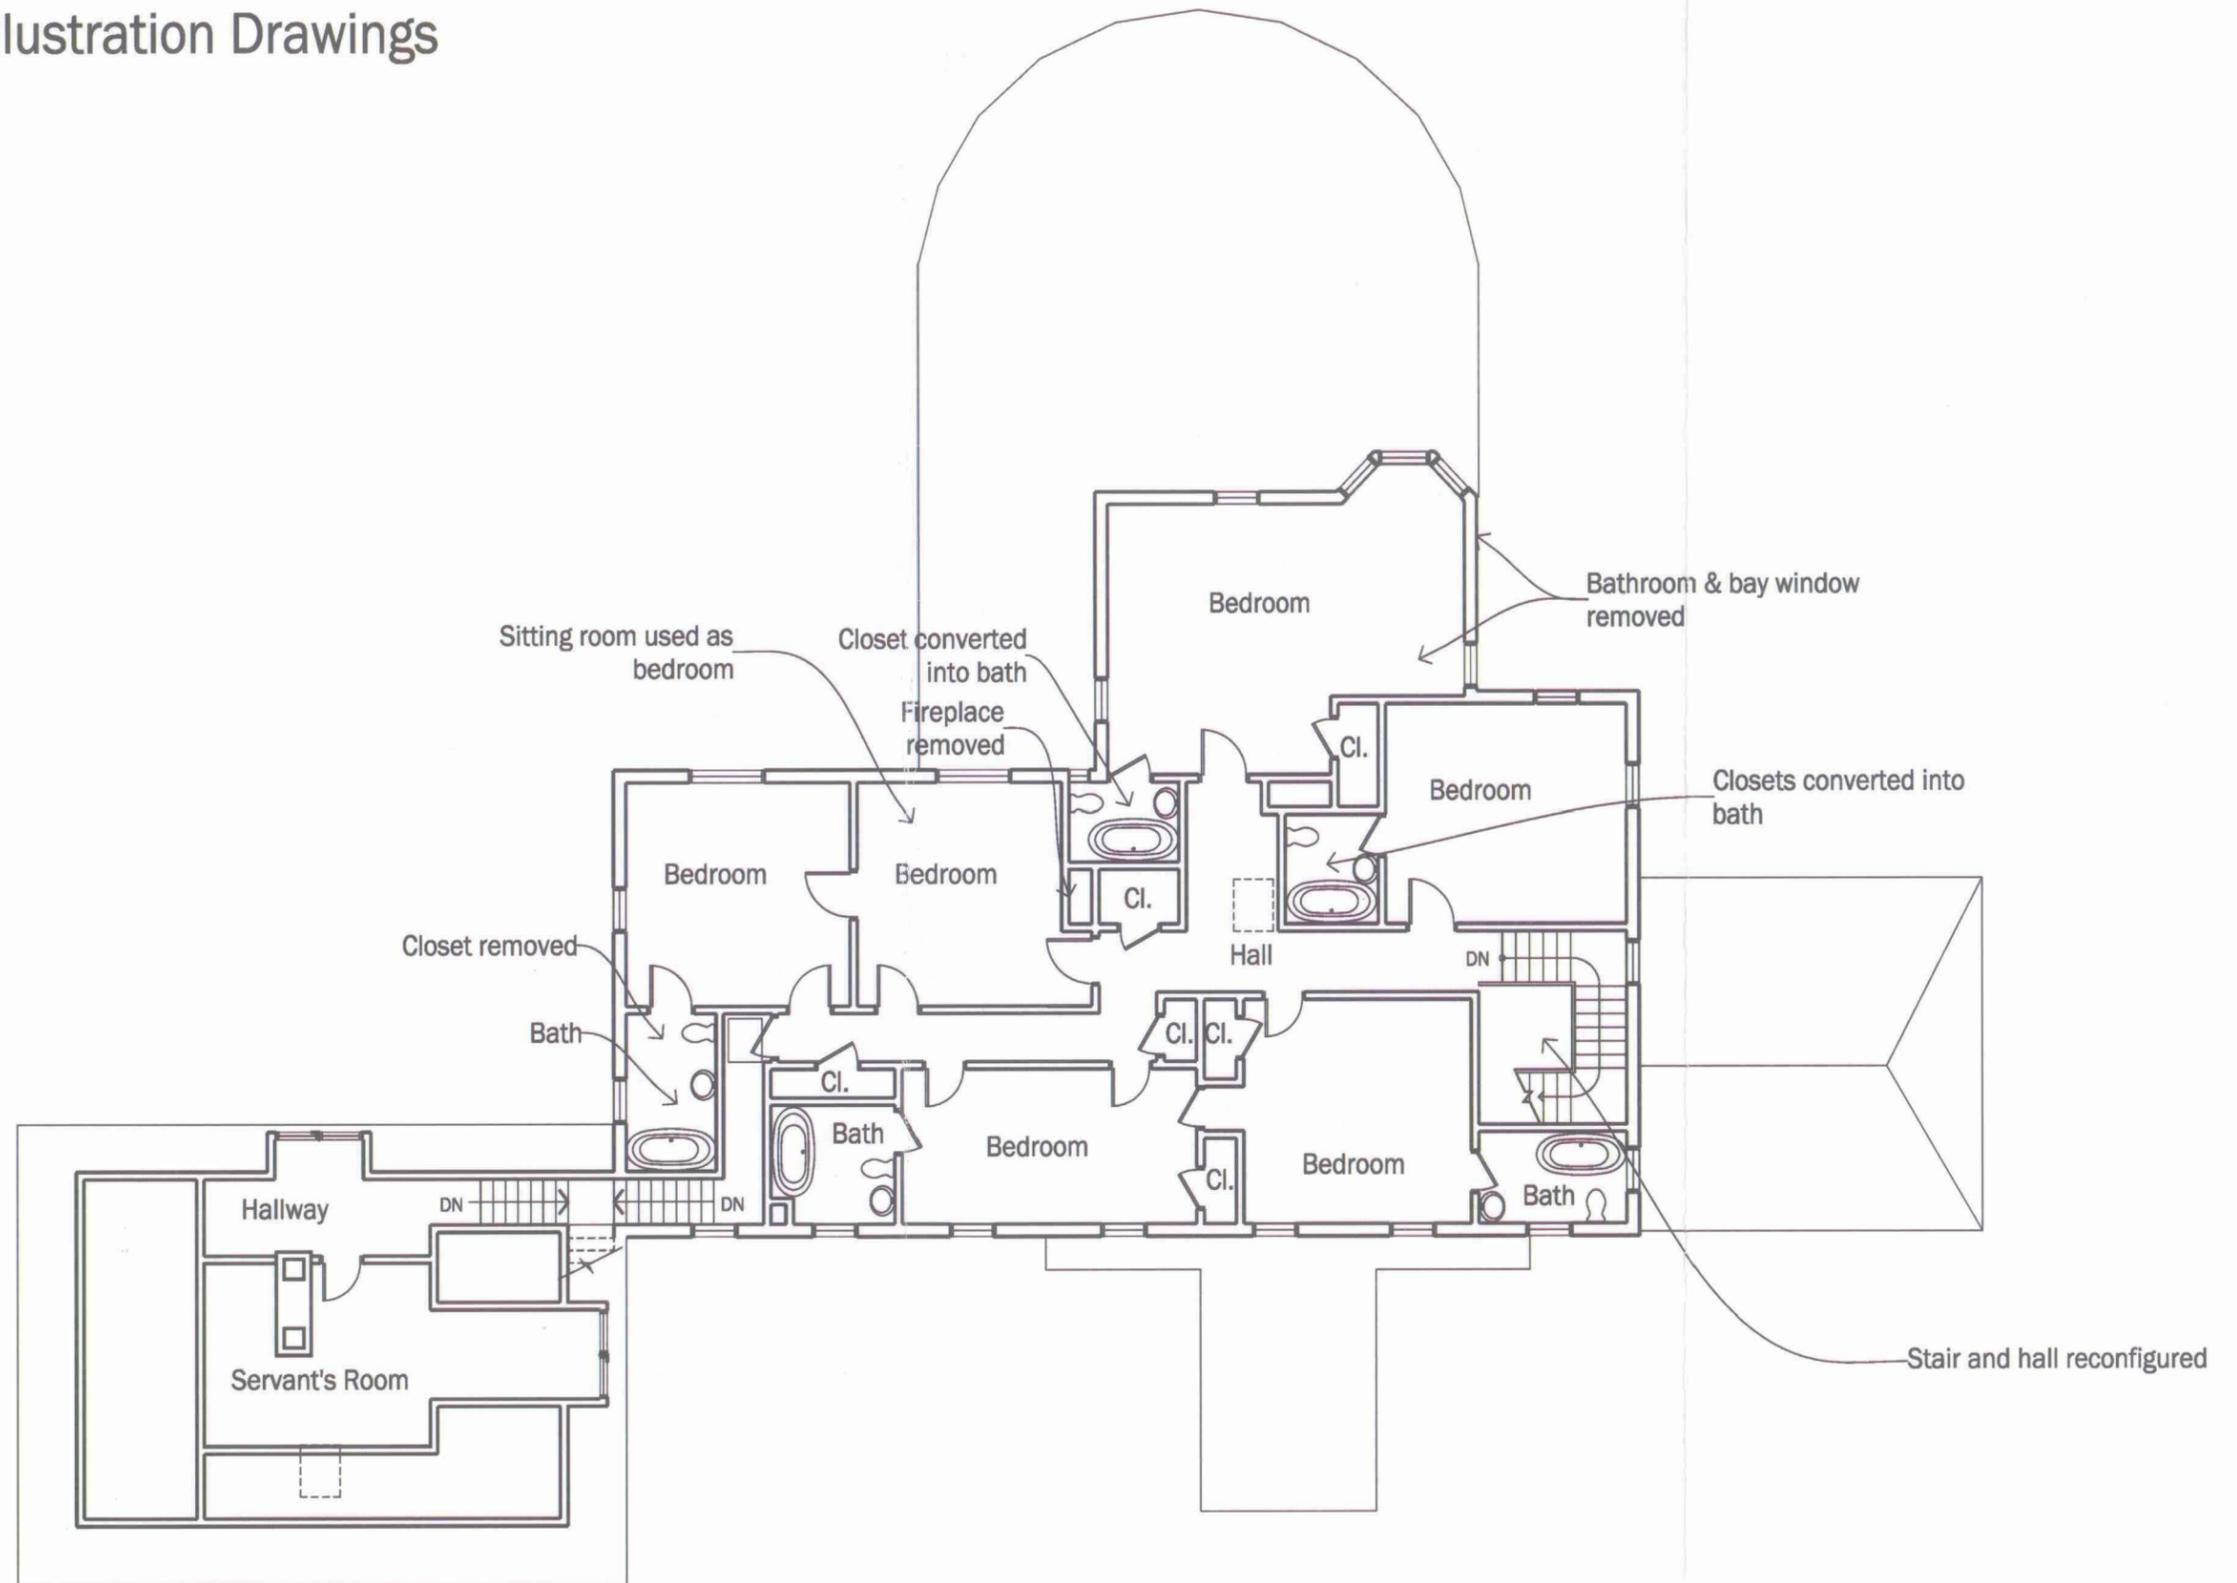
SECOND FLOOR PLAN ca. 1922 to 1938

NOTE: Although based on information obtained from primary and secondary historical sources, these building plans contain conjectural and projected information, and are for the purpose of illustrating the building's evolution. These drawings are not "as-built" layouts of spaces, fixtures and other building components.

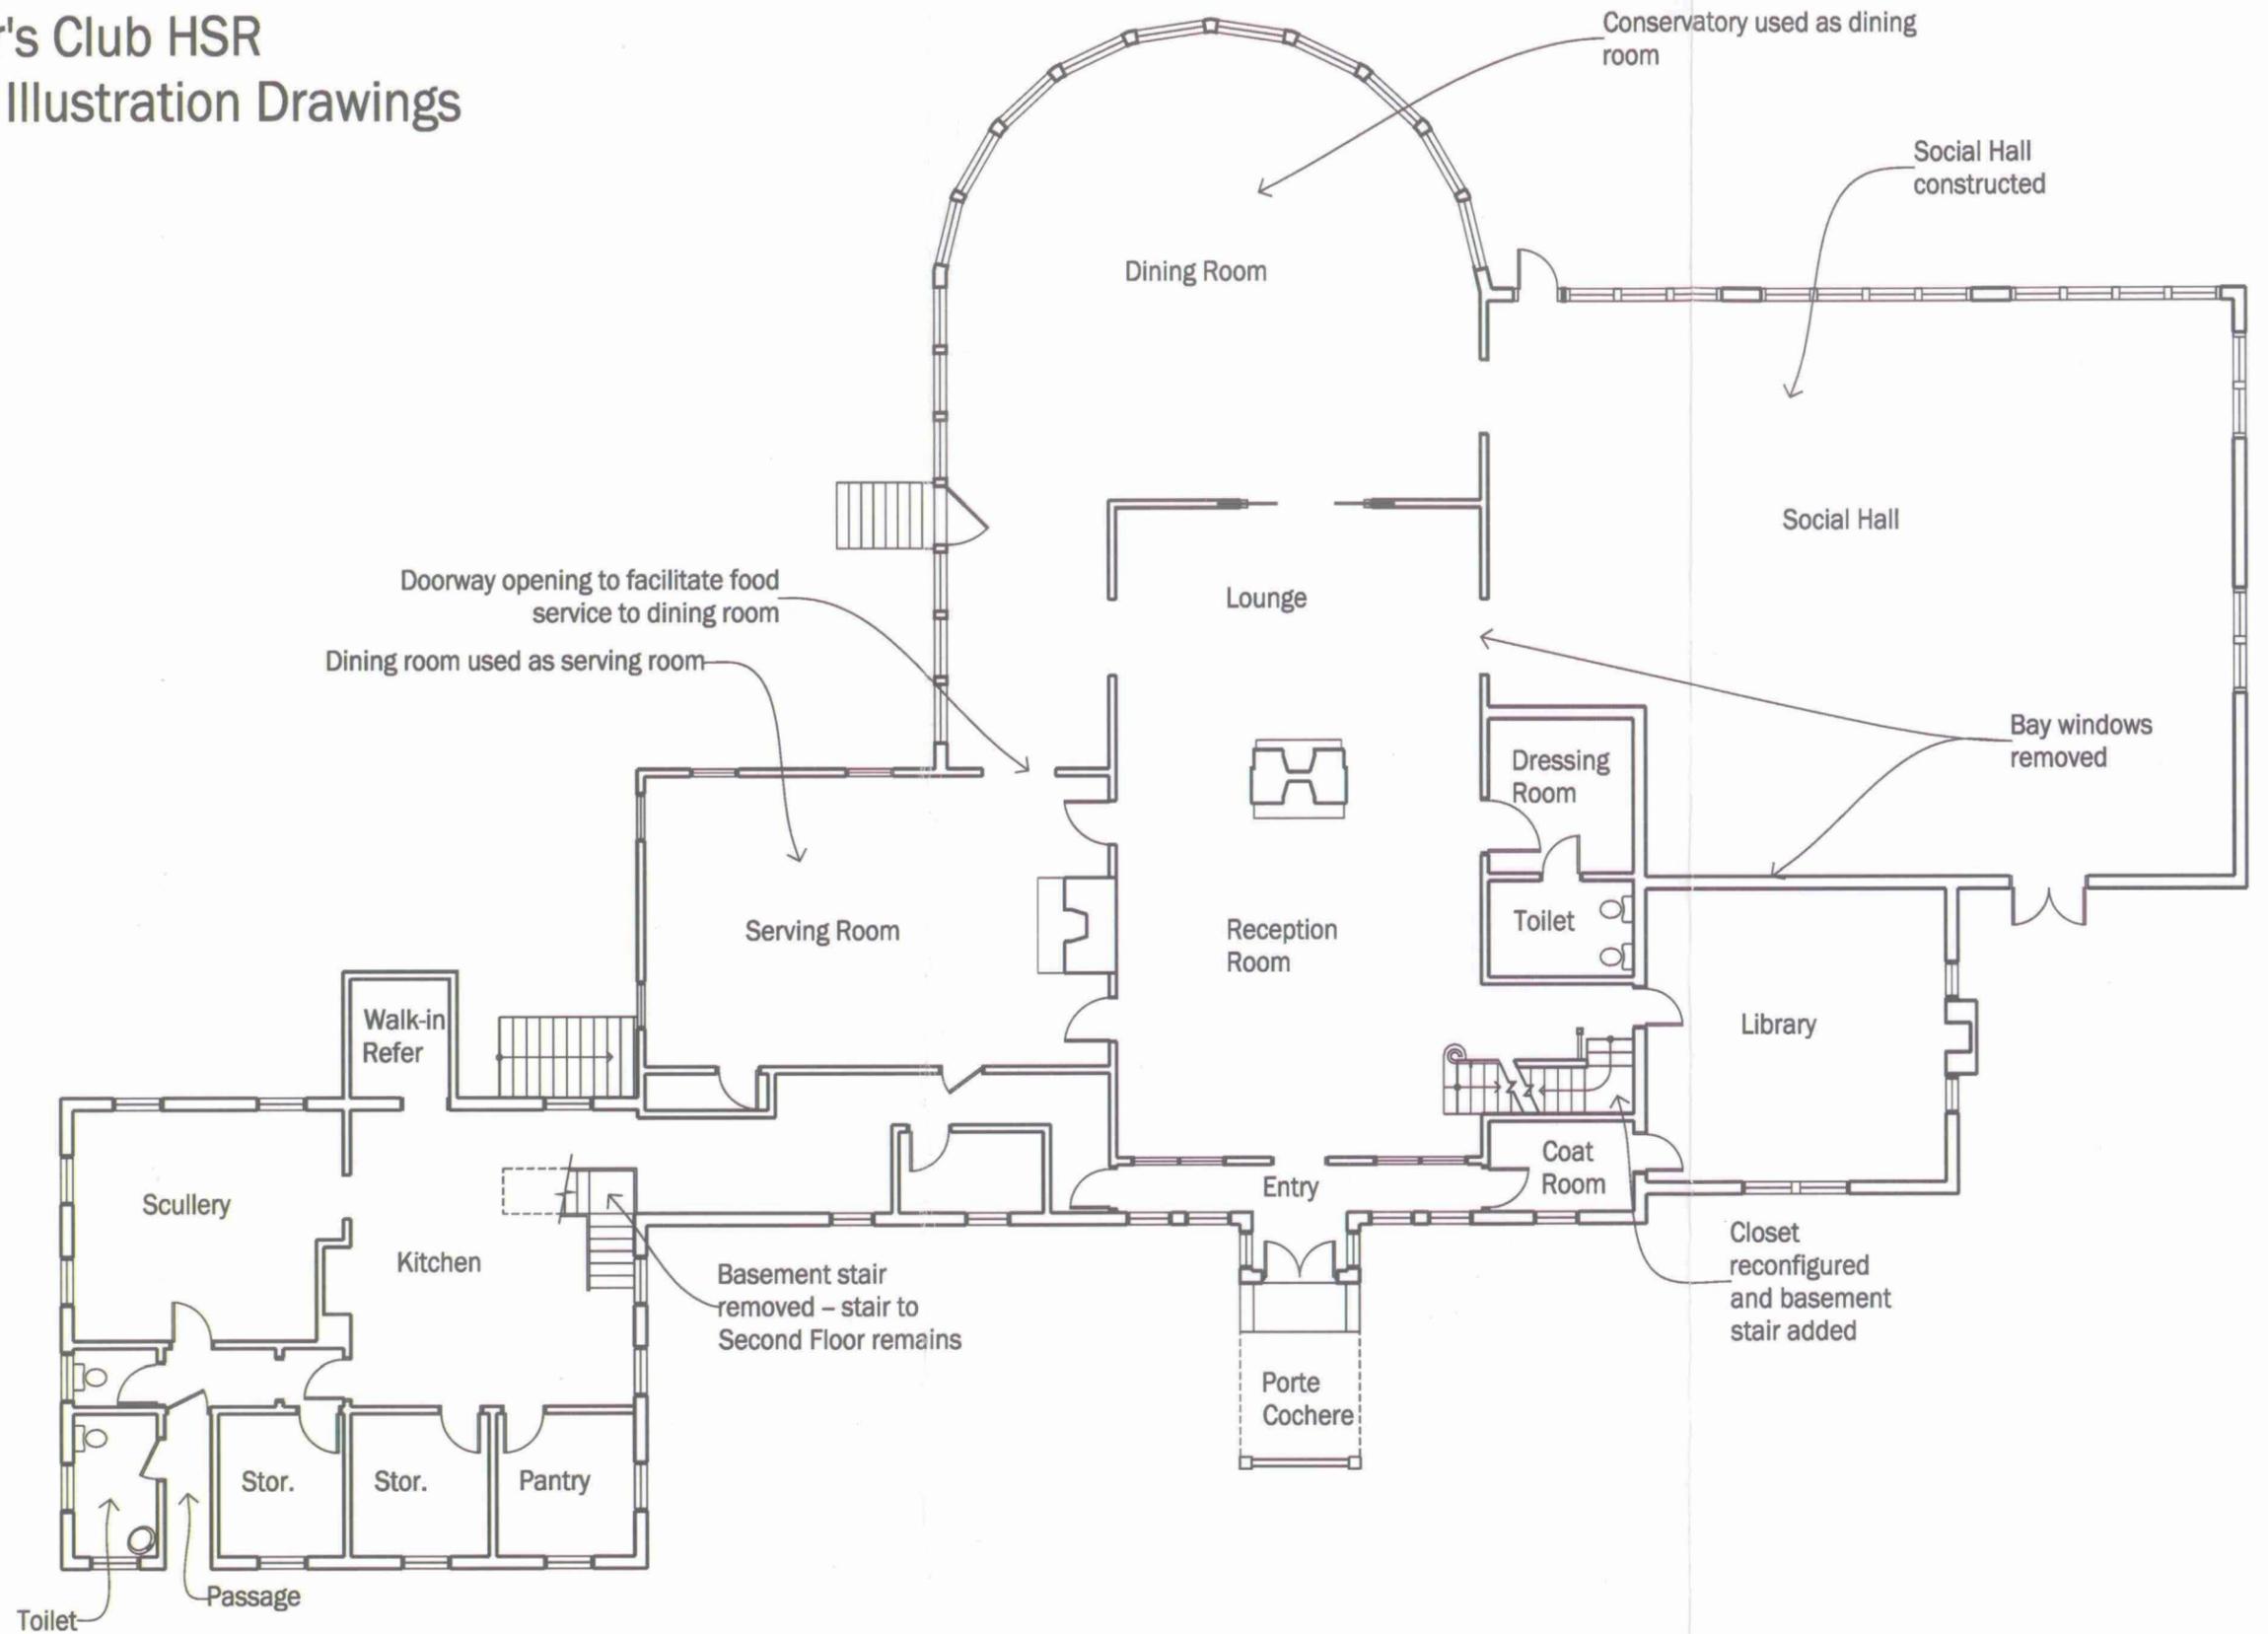
FIRST FLOOR PLAN ca. 1948 to 1953

NOTE: Although based on information obtained from primary and secondary historical sources, these building plans contain conjectural and projected information, and are for the purpose of illustrating the building's evolution. These drawings are not "as-built" layouts of spaces, fixtures and other building components.

A Banquet Room was added to the south behind the Library about 1948 shortly after the building was initially converted to an Officer's Club. No drawings are available for this addition but it appears to be of wood framed construction with reinforced concrete foundations and foundation walls. The floor of this Banquet Room has settled 1 to 2 inches immediately adjacent to where it joins the original construction to its north. This could be due to backfill settlement behind the original basement wall or cracking and inward movement of the original unreinforced masonry walls in this area. Verification of the cause of this settlement would be warranted, since the original masonry basement wall is concealed behind a furred finish wall.

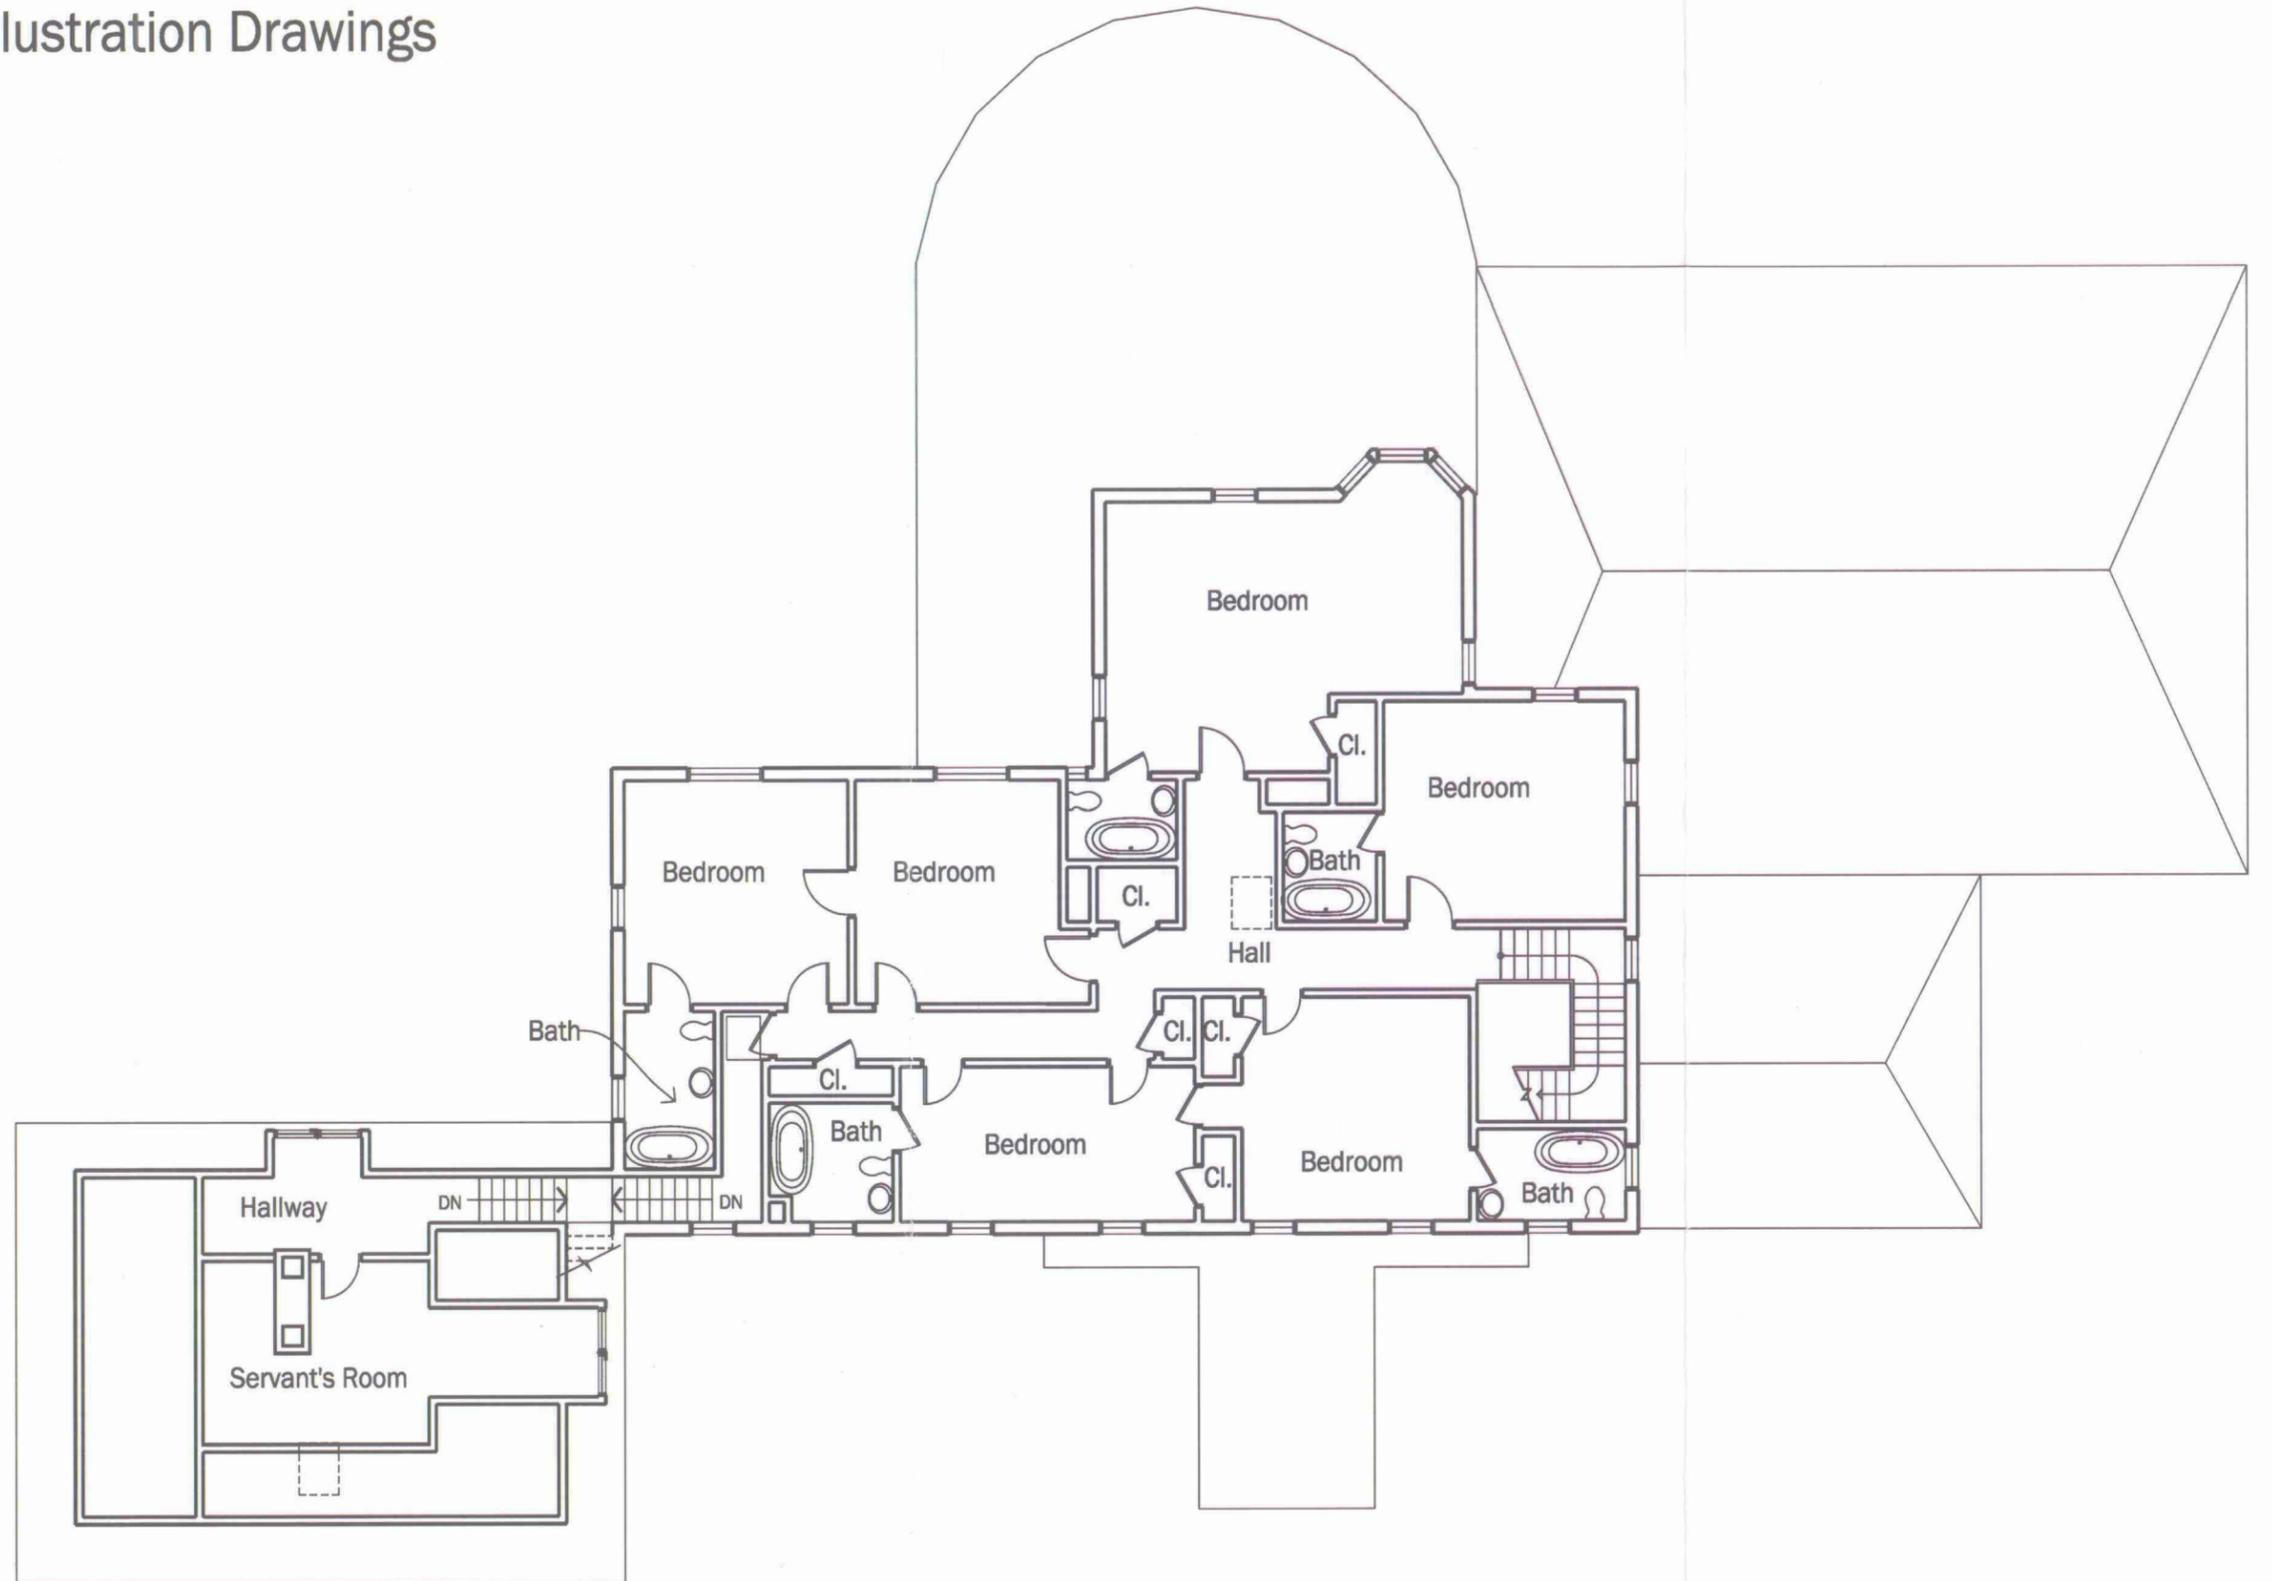
SECOND FLOOR PLAN ca. 1948 to 1953

NOTE: Although based on information obtained from primary and secondary historical sources, these building plans contain conjectural and projected information, and are for the purpose of illustrating the building's evolution. These drawings are not "as-built" layouts of spaces, fixtures and other building components.
