# Fort Mason Officers Club

## Historic Structure Report

## *Historic Structure Report*

**May 2005**

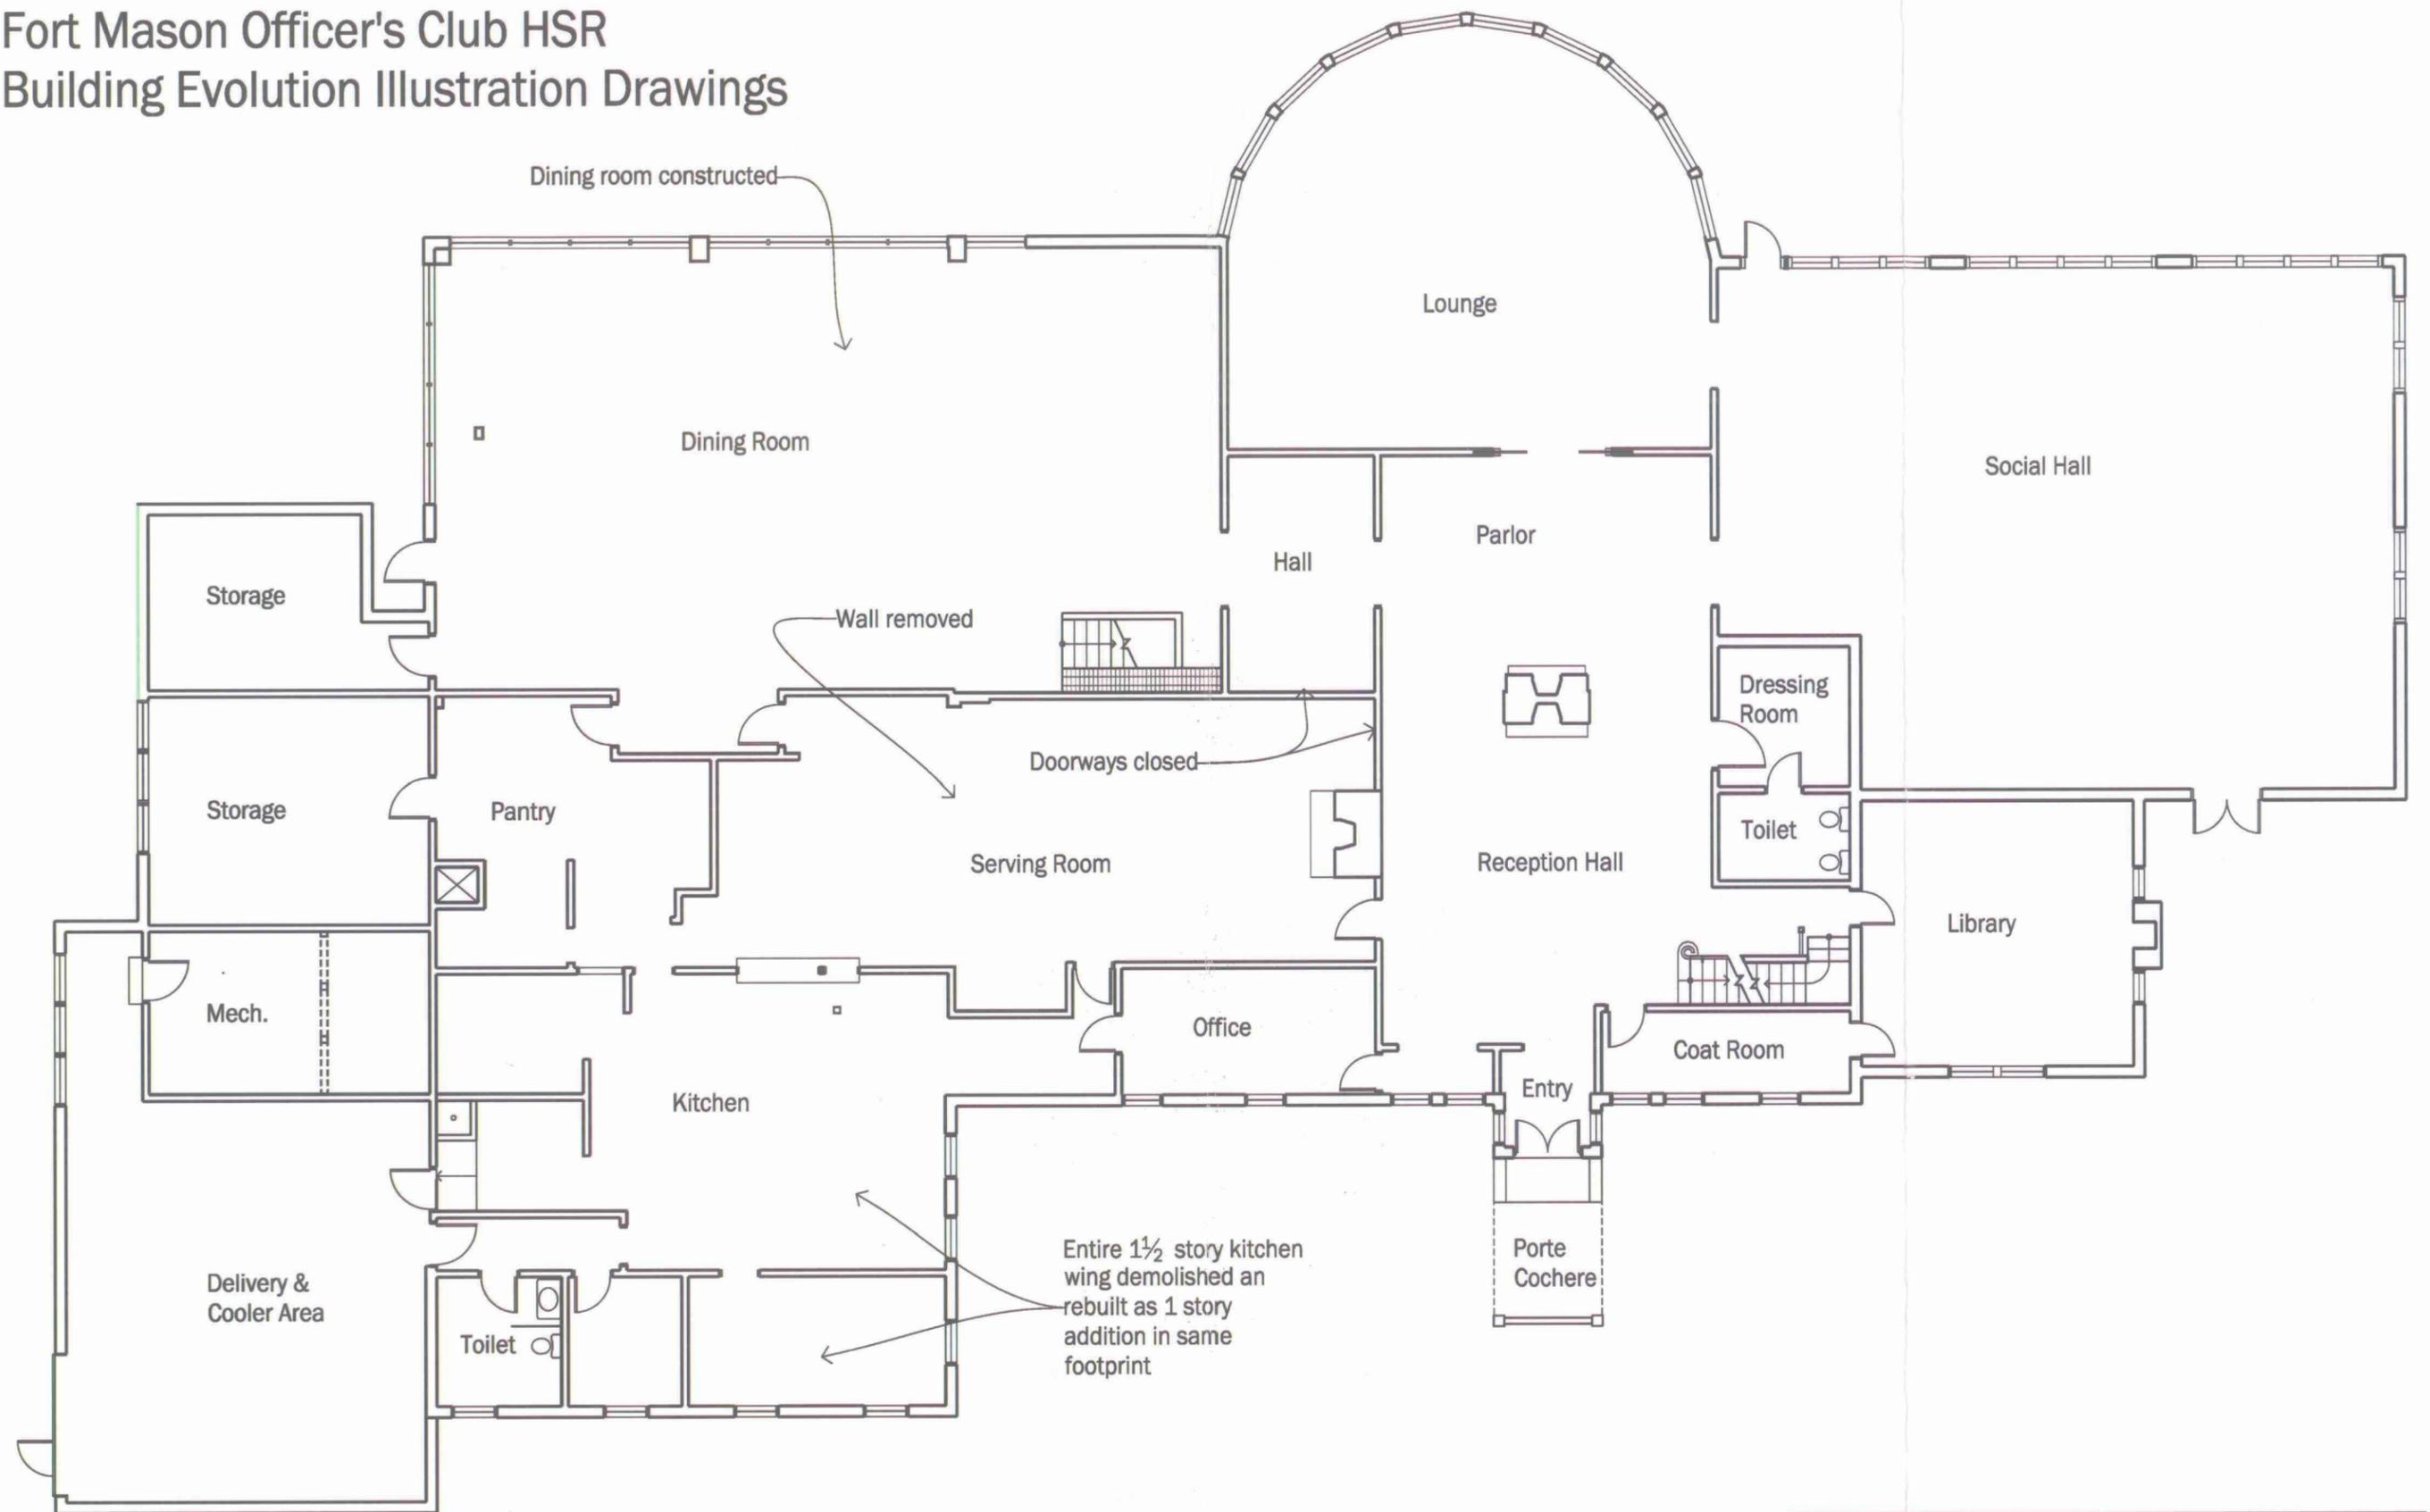
FIRST FLOOR PLAN ca. 1958 to 1960

NOTE: Although based on information obtained from primary and secondary historical sources, these building plans contain conjectural and projected information, and are for the purpose of illustrating the building's evolution. These drawings are not "as-built" layouts of spaces, fixtures and other building components.

The Kitchen area, to the north of the original construction and in the front of the building was completely rebuilt about 1959. Drawings are available and indicate new reinforced concrete foundations and one story wood framed construction with plywood sheathing.

A one story Dining Room was added to the rear of the Kitchen (north of the original building) about 1960. Drawings are available for this construction and indicate reinforced concrete foundations and wood framed construction with several structural steel roof beams spanning the open Dining Room.

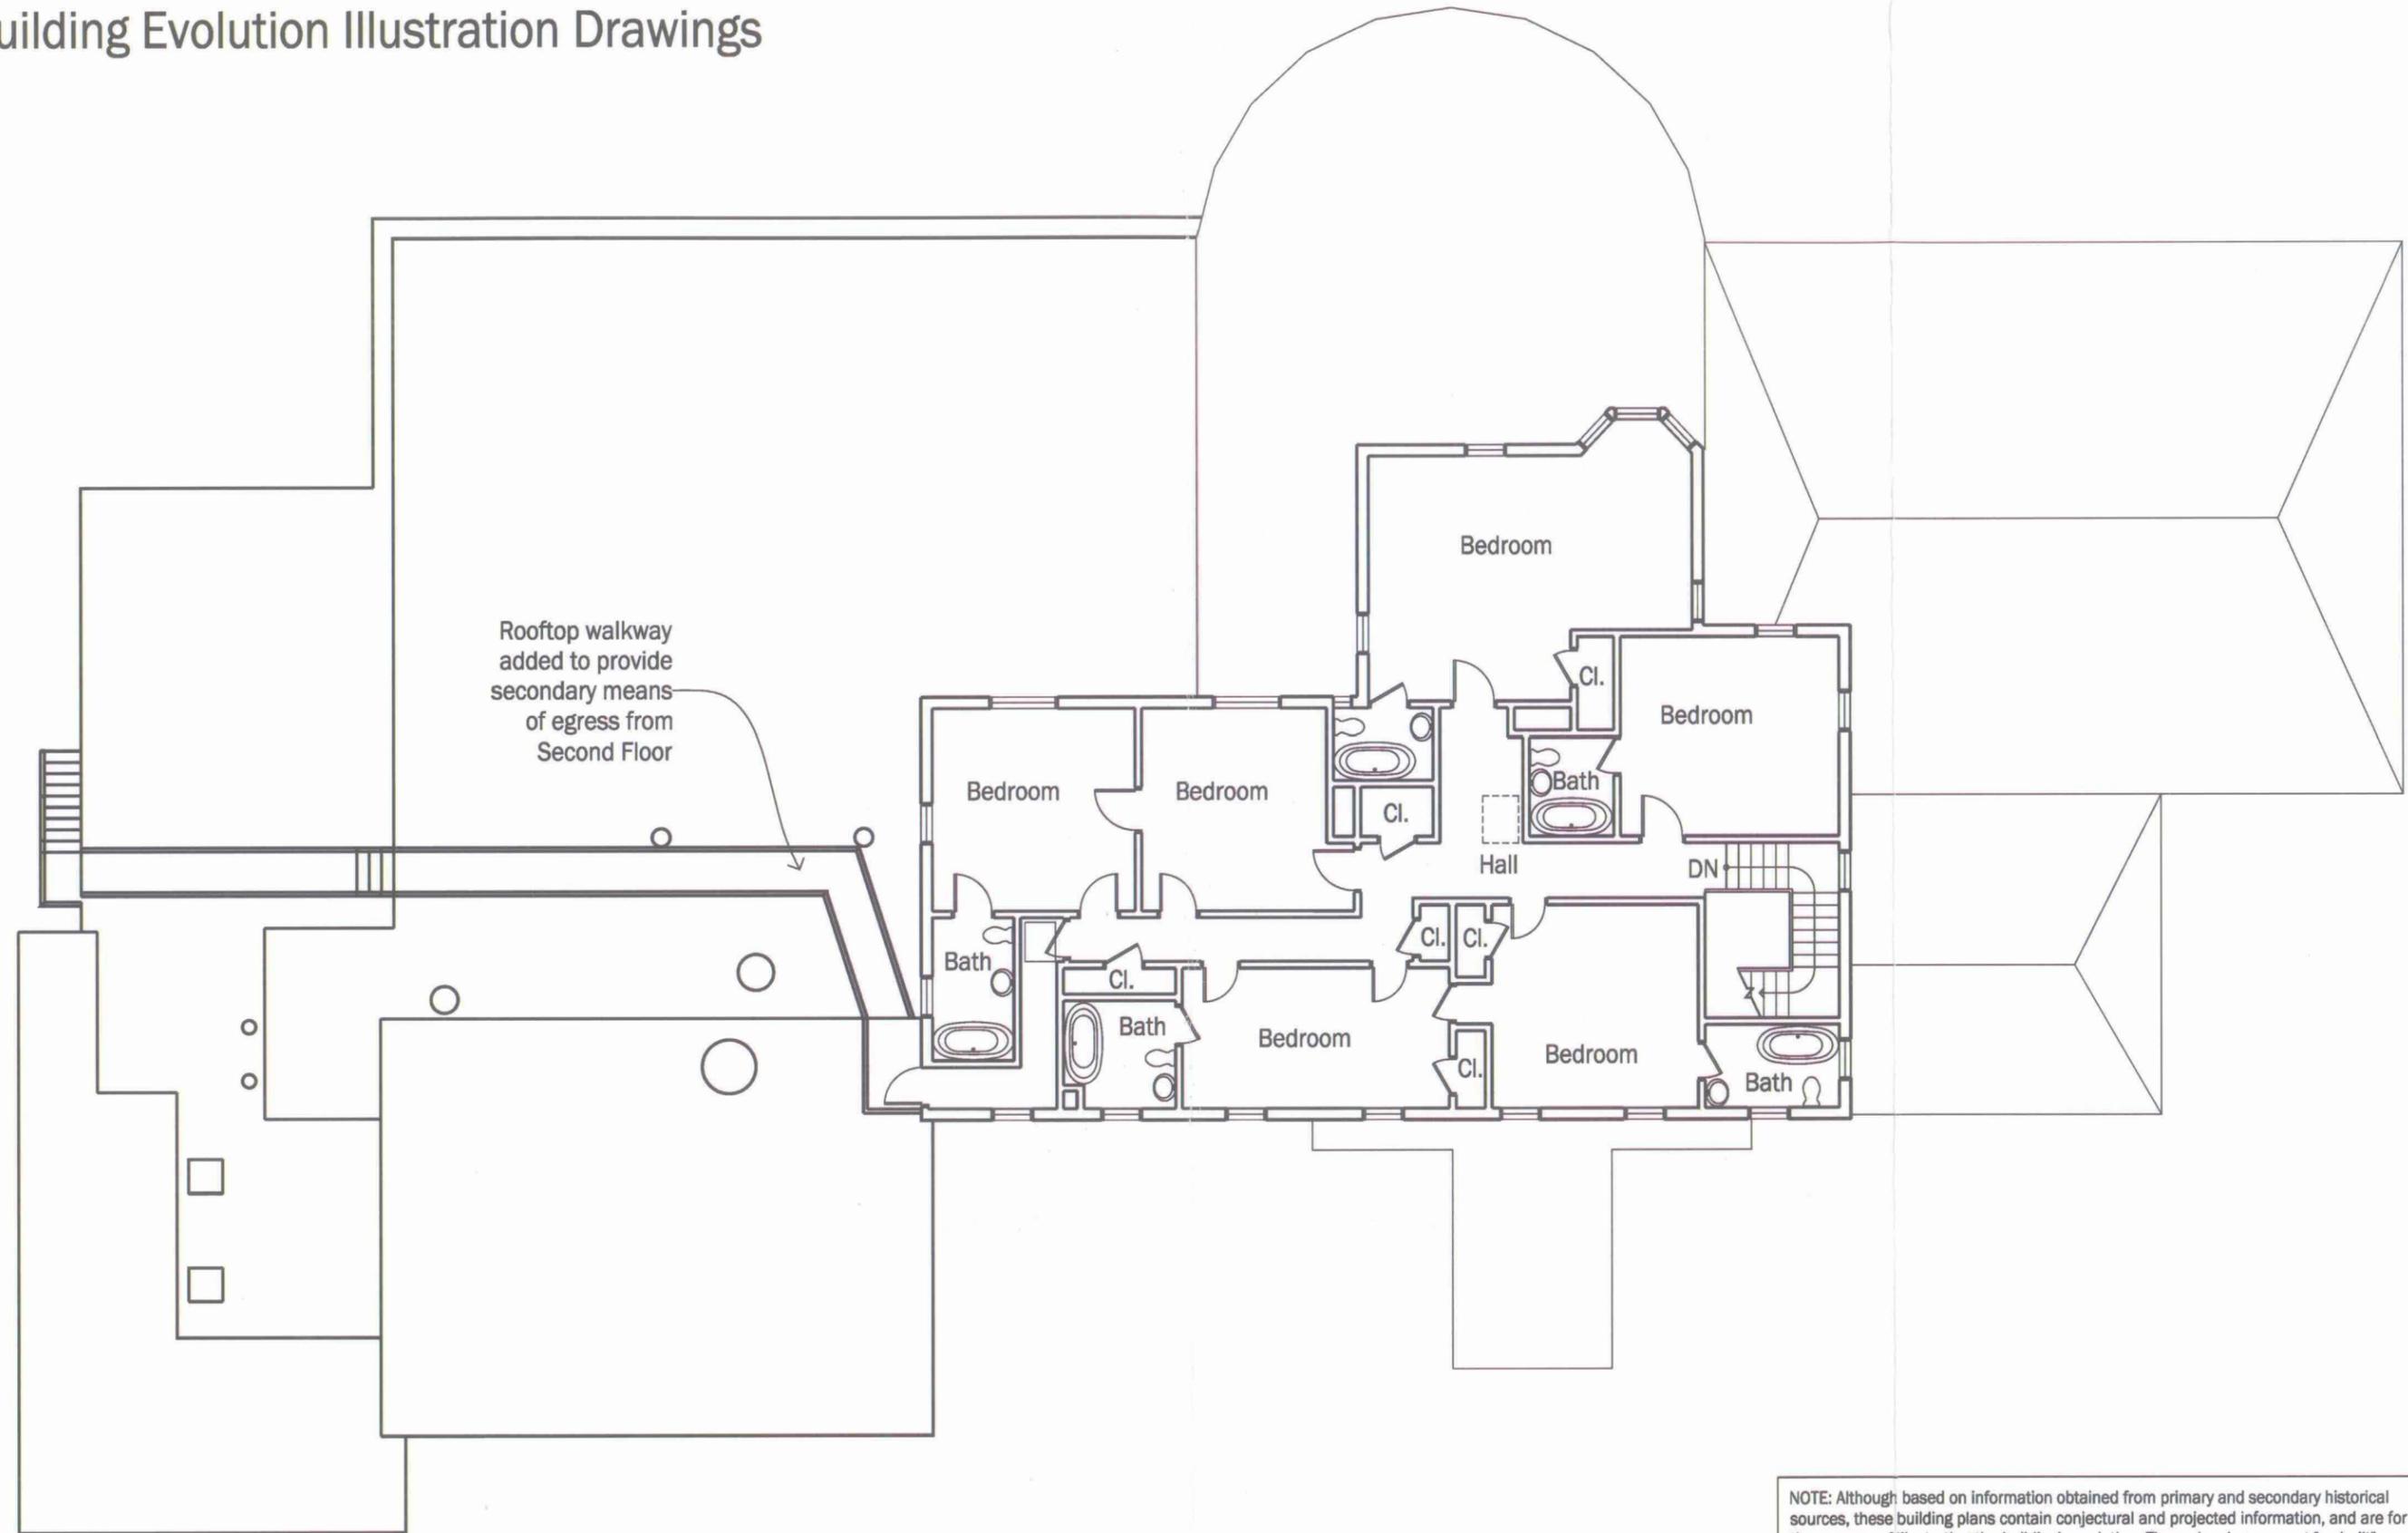
SECOND FLOOR PLAN ca. 1958 to 1960

NOTE: Although based on information obtained from primary and secondary historical sources, these building plans contain conjectural and projected information, and are for the purpose of illustrating the building's evolution. These drawings are not "as-built" layouts of spaces, fixtures and other building components.

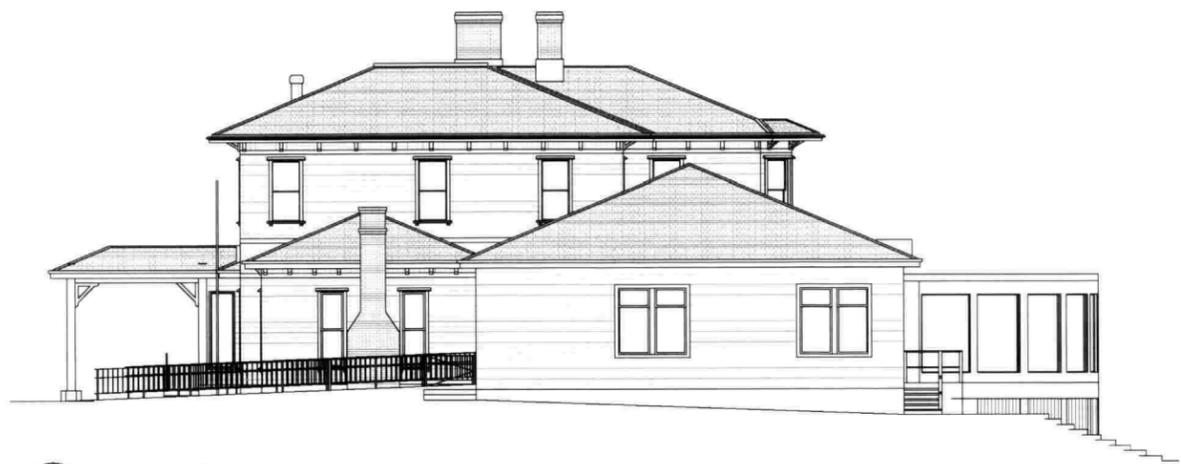
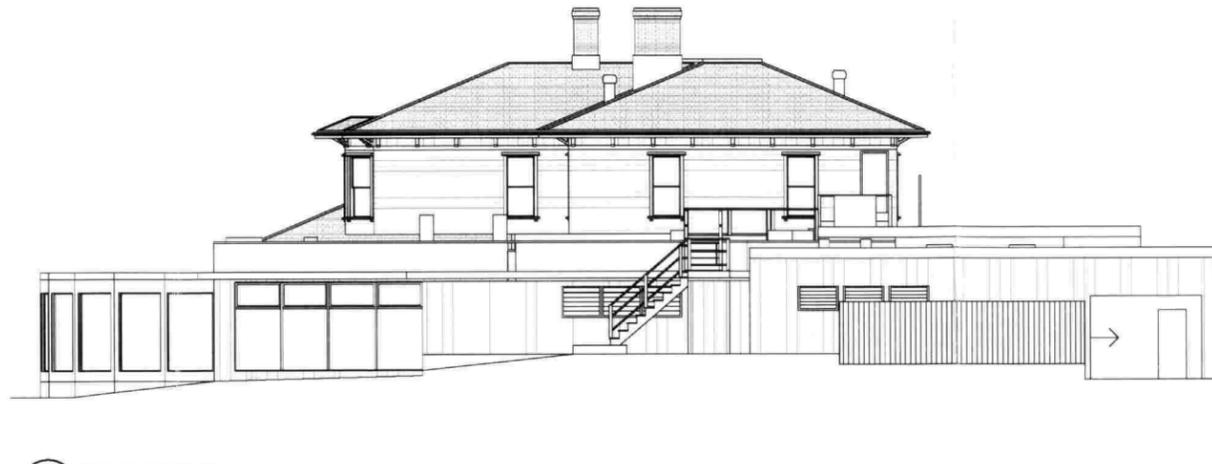
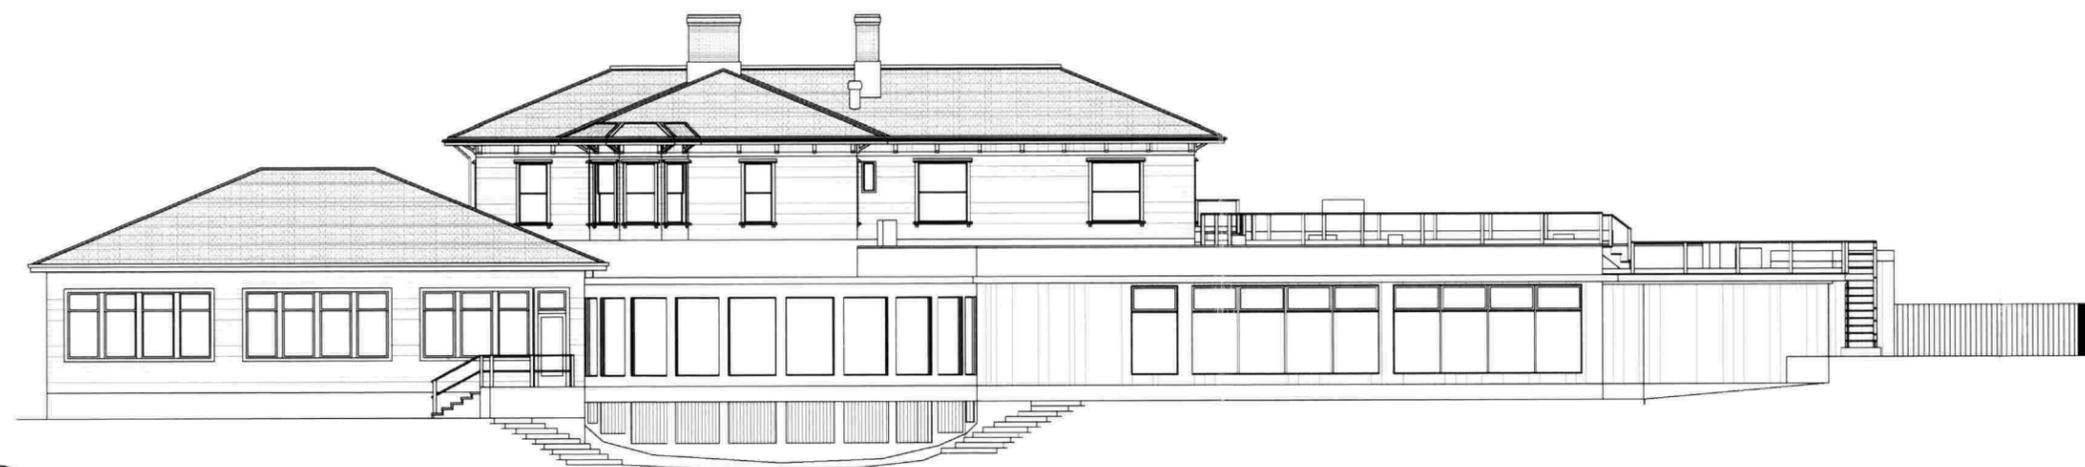
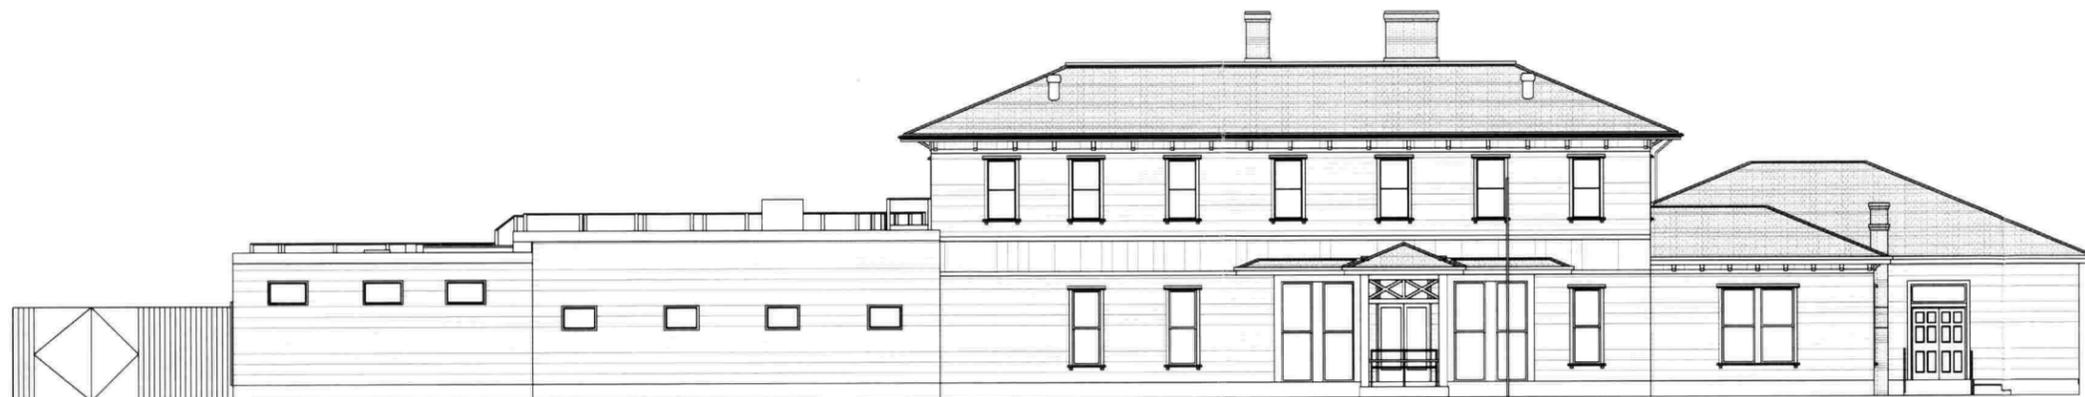
EXTERIOR ELEVATIONS

3 SOUTH ELEVATION  
1/8" = 1'-0"

4 NORTH ELEVATION  
1/8" = 1'-0"

2 EAST ELEVATION  
1/8" = 1'-0"

1 WEST ELEVATION  
1/8" = 1'-0"

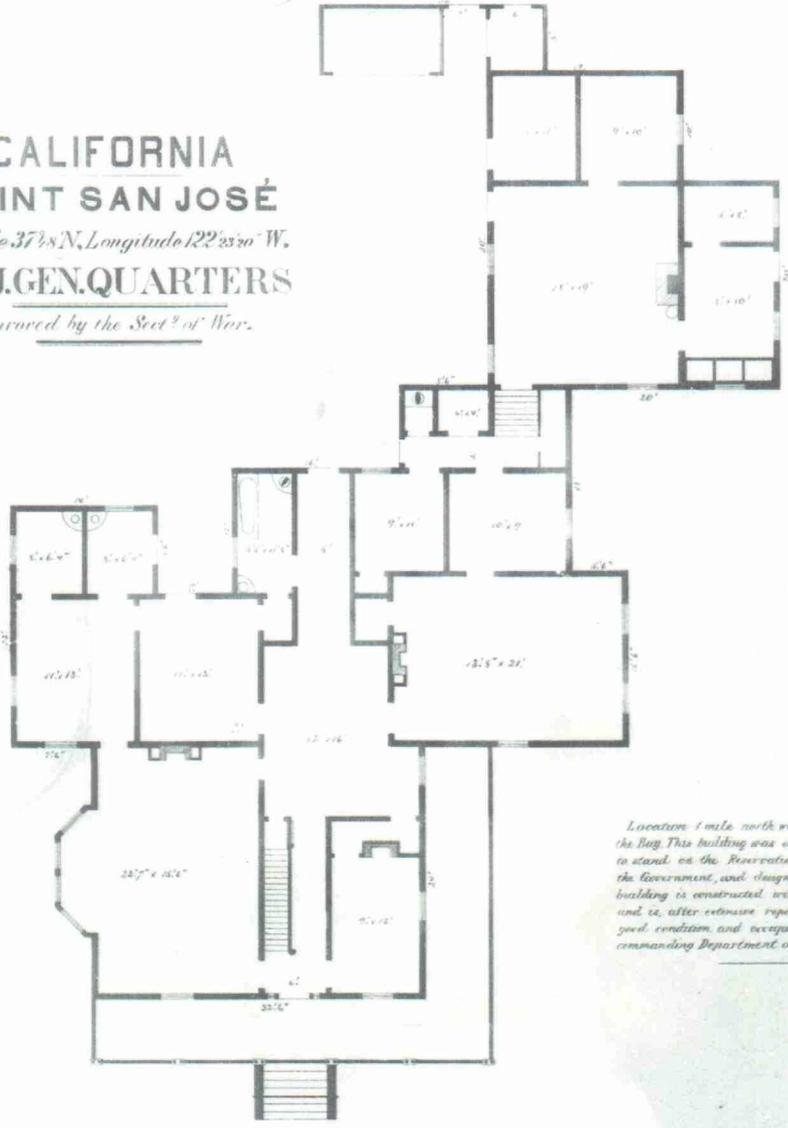
*Location 1 mile north west of San Francisco on the south side of the Bay. This building was erected in 1855, by civilians and being found to stand on the Reservation of this Post, was taken possession of by the Government, and designated to be used as Officers Quarters. The building is constructed with dressed lumber framed & weatherboarded, and is, after extensive repairs, additions &c. made, in October 1865 in good condition and occupied as Quarters by Maj Genl. M. D. B. D. commanding Department of California, November 1865.*

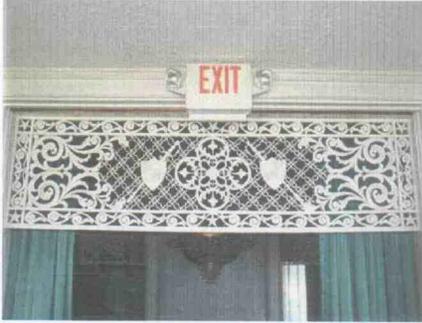
Rm 107 carved grille

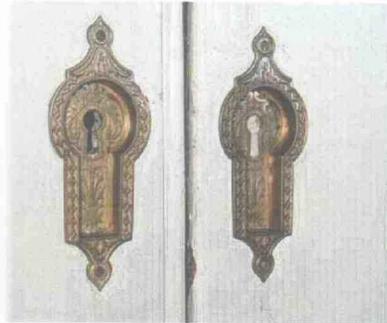
Rm 107 door hardware 1

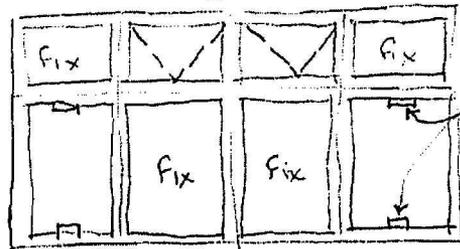
- Windows  
3 sets of 4 on East's

remnants of some type of hardware, long since removed and painted over.

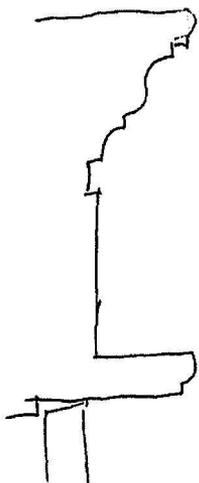
door head

door jamb

All trim is oversized, w/ oak laminate over something. All trim is non-historic

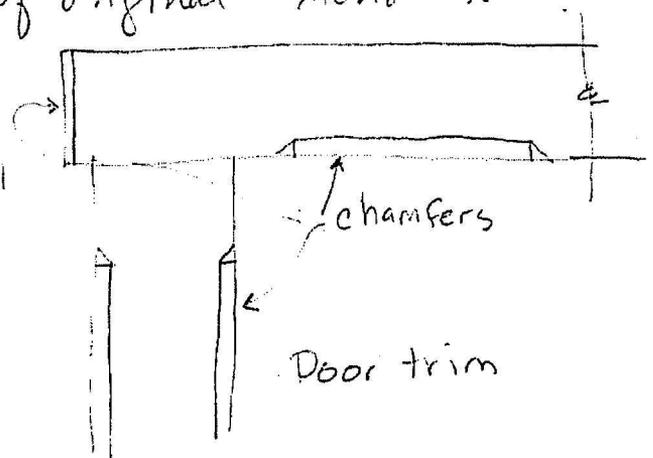
Non historic door hardware

Door lock is not secure  
weather stripping is inadequate, large gaps  
Door swings over front step - unsafe entrance
