# Table of Contents

# Introduction

The *Historic Lighthouse Preservation Handbook* was created through a cooperative partnership between the National Park Service (NPS), U.S. Coast Guard (USCG), and the Department of Defense (DoD). The *Handbook* addresses preservation issues related to historic lighthouses with an emphasis on the maintenance problems associated with the many different materials and construction techniques used in these unique structures. **Historic Lighthouse Preservation** (Part IV) includes data gathered from condition assessments and historic significance evaluations at 21 light stations around the country as well as information from applicable NPS guidance, USCG files, and material generated by non-profit groups, museums, and architectural and engineering firms. **Beyond Basic Preservation** (Part V) includes case studies reflecting lighthouse rehabilitation and restoration projects as well as related activities.

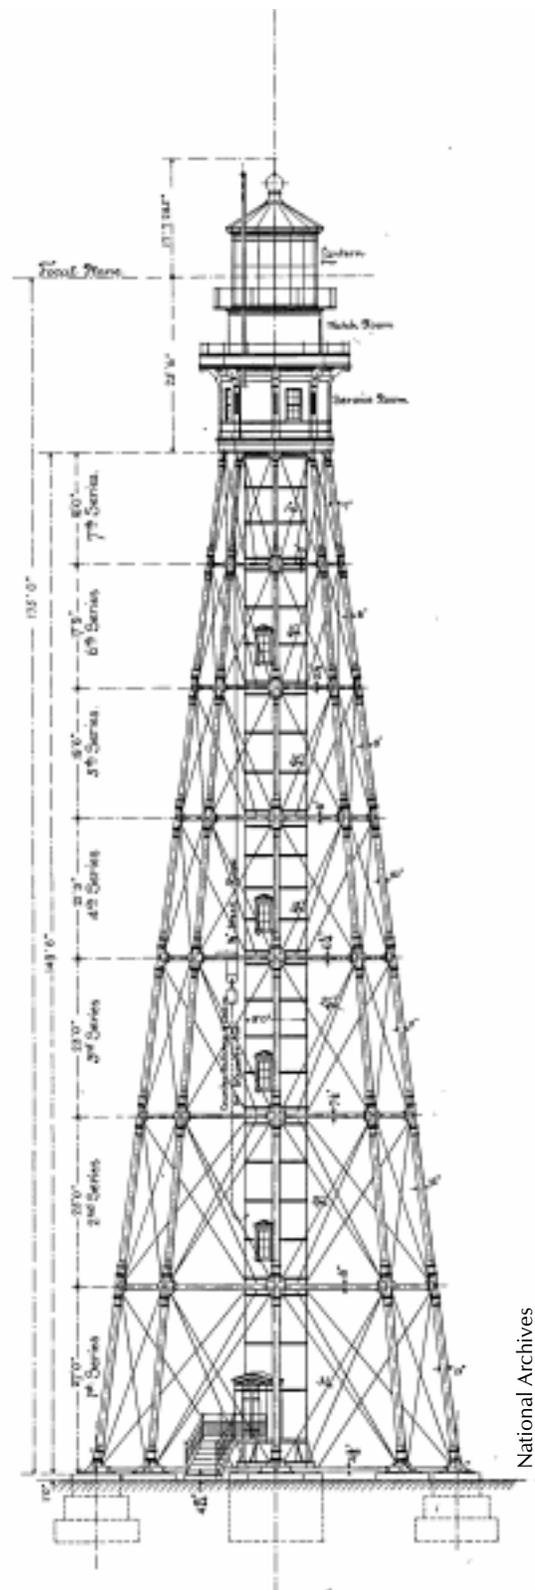
**Figure 5.** Construction drawing for Cape Charles Lighthouse, Virginia, an onshore skeletal tower.

**Skeletal tower:** Onshore skeletal towers were built of metal and were typically constructed on concrete foundations. Offshore skeletal towers were also built of metal and typically constructed with straight or screwpile foundations (discussed below). Manitou Island Lighthouse (1861) and Whitefish Point Lighthouse (1861), Michigan, both built from the same plan, are the earliest onshore skeletal towers built in the United States. Like the cast-iron-plate tower, skeletal towers could also be dismantled and moved.

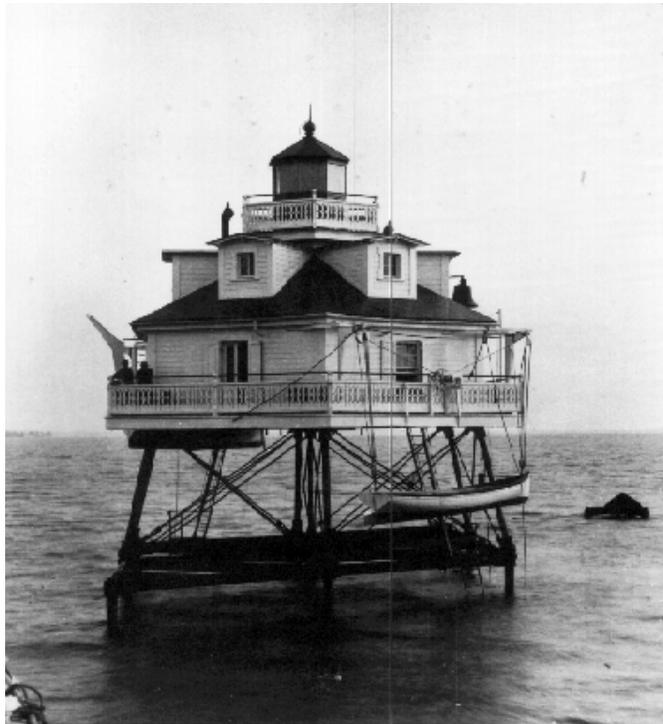
**Figure 6.** Thomas Point Shoals Lighthouse with screwpile foundation located in Maryland's Chesapeake Bay; shown here in 1885.

- Thomas Point Shoals Light Station, Maryland, built in 1875, is the last largely unaltered spider-foundation cottage-type screwpile lighthouse in the United States. As such, it is significant for American architecture and engineering.

**Screwpile:** To increase the holding power of the pile, a screw-like flange was fastened to the bottom of the pile and wound like a screw into the substrate. There are two principal screwpile type lighthouses, 1) low spider-like foundations for rivers, bays, and sounds, and 2) tall offshore coastal towers. Perhaps as many as 100 spider-like screwpile lighthouses were built throughout the Carolina sounds, the Chesapeake Bay, Delaware Bay, along the Gulf of Mexico, and one even at Maumee Bay (1855) on Lake Erie in Ohio. Thomas Point Shoals Lighthouse (1875), Maryland, is the oldest extant, unmoved, spider-like screwpile lighthouse in the United States. The first of the tall skeletal screwpile coastal towers built in the United States was Carysfort Reef Lighthouse (1852), Florida, which still stands. A few offshore screwpile skeletal tower lighthouses built on coral reefs used foot plates or disks to help disperse the weight of the tower. Examples in the Florida Keys include Carysfort Reef Lighthouse (1852), Fowey Rocks Lighthouse (1878), and American Shoal Lighthouse (1880).

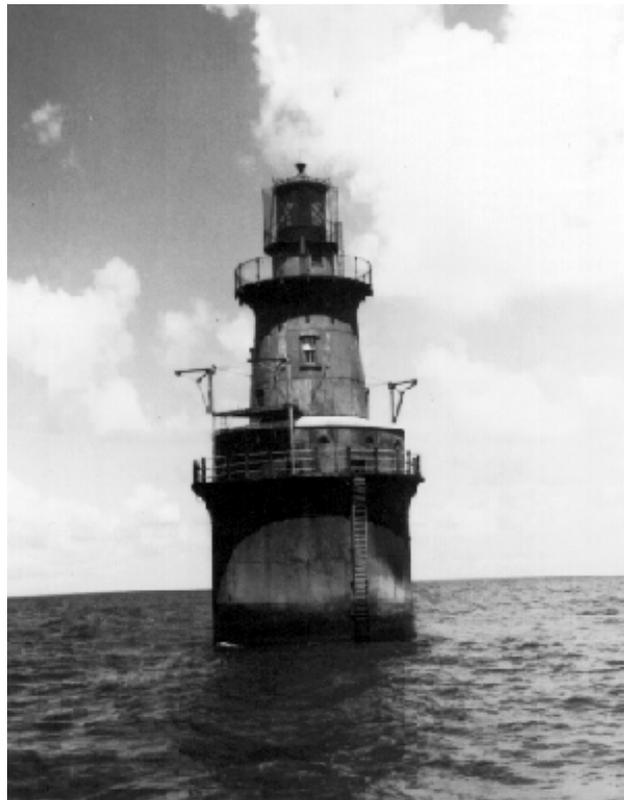
**Figure 7.** Sabine Bank Lighthouse with caisson foundation in Texas.

**Caisson:** Caisson foundations were best suited for unconsolidated bottoms composed of sand or mud. The caisson lighthouse type used a large cast-iron cylinder, which was sunk on the bottom and filled with rock and concrete to form a foundation. The caisson foundation was sturdier and better able

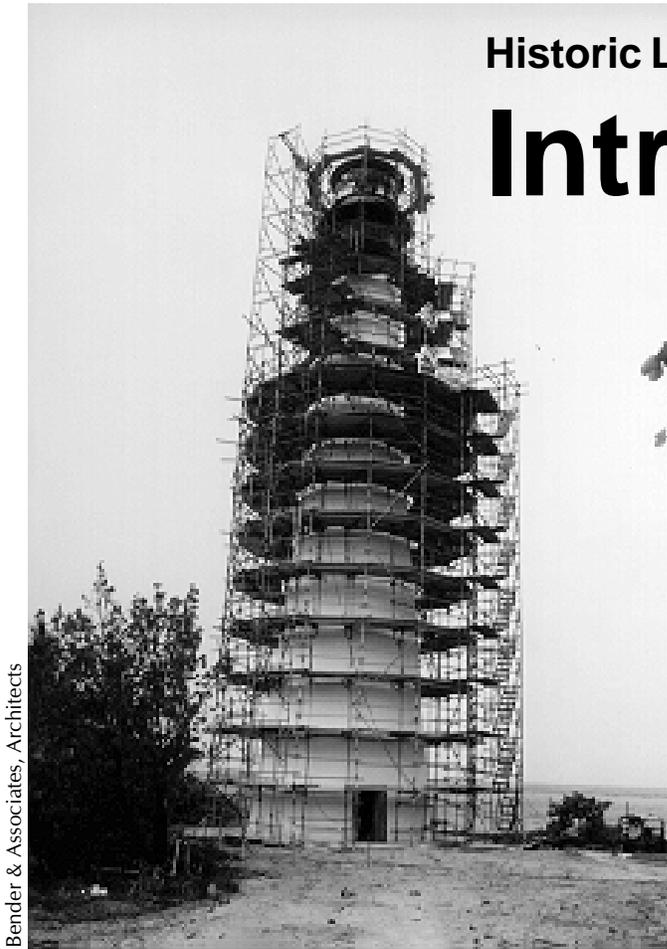
**Figure 1.** Brick replacement in 1996 restoration at Cape Florida Lighthouse on Key Biscayne, Florida.

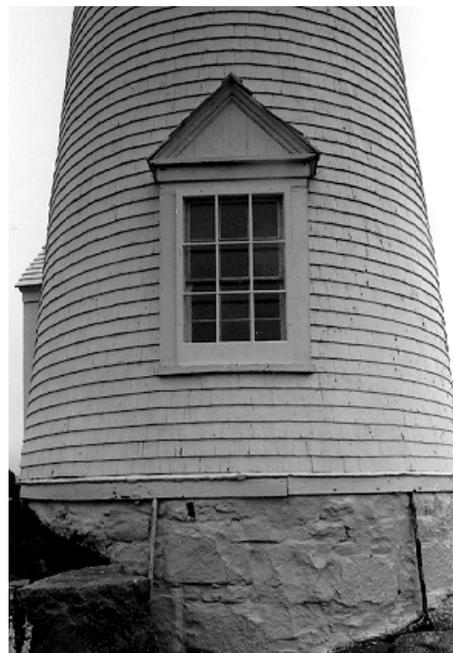
**Figure 2.** Stone masonry foundation in a 38-foot-tall wood-frame lighthouse in Maine.

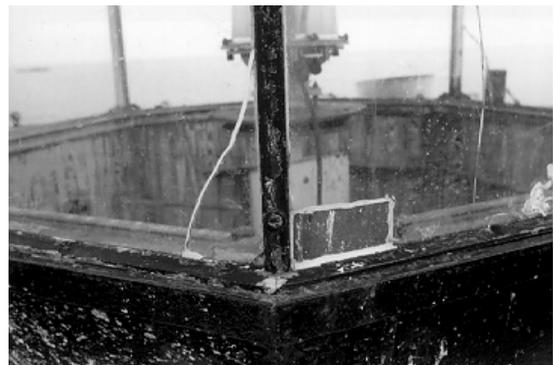
**Figure 8.** Detail of an acceptable temporary repair to a lantern glass using a piece of painted sheet metal that has been adhered to the glass with a high quality, exterior grade caulk. This type of temporary repair will prevent water from entering the lantern and therefore help avoid further damage. This fix should be considered only as an interim treatment until replacement of the lantern glass.

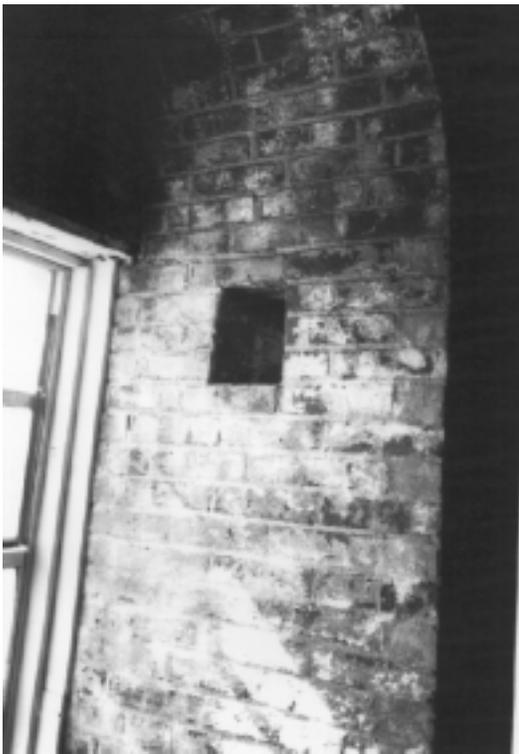
WPTC photo

**Figure 13.** Vent hole located in the window well of a brick lighthouse.

- **Weep and vent holes:** If the walls have cavities between the interior and exterior walls, weep holes may exist at or near the base of these walls. Weep holes typically range in size from small slits to large brick headers. These holes allow any moisture that has entered the cavity between the walls to drain out. These openings must be kept clear in order to provide sufficient drainage of the cavity. In some instances the walls may have vent holes (larger than weep holes) that allow the movement of air through the cavities or voids. Typically vent holes open into the interior. These openings must be kept clear in order to provide sufficient ventilation (see Figure 12).
- **Protective coatings:** Lighthouses were often painted as a protective measure and for identification as a daymark. As part of a

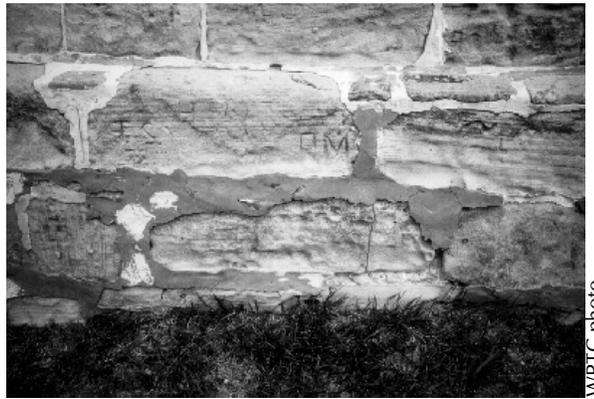
WP/TC photo

**Figure 19.** The use of hard portland cement mortar and sloppy pointing technique have aided in the deterioration of this soft sandstone wall.

When repointing joints in historic lighthouses, special care must be given to the matching of the strength of the replacement pointing mortar with that of the original pointing mortar. Historically, softer lime-based mortars were used for pointing. If the compressive strength of the original mortar cannot be readily determined, i.e., the lighthouse had been improperly repointed with a hard portland cement based mortar, the mortar should be matched to the compressive strength of the brick or stone. For more information on repointing historic lighthouses refer to NPS *Preservation Briefs 2: Repointing Mortar Joints in Historic Brick Buildings*. These softer mortars were flexible enough to expand and contract with the expansion and contraction of the masonry units which made up the wall structure.

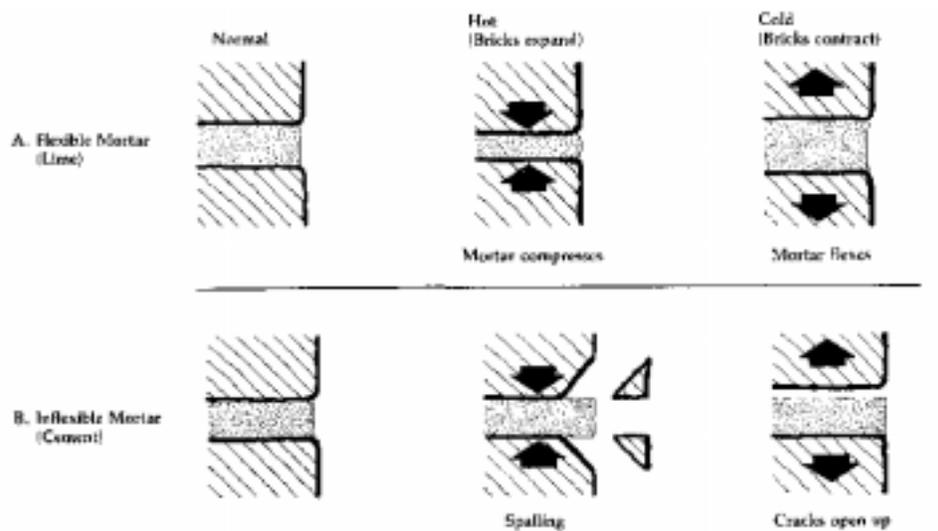
**Figure 20.** Diagram showing the behavior of lime-based mortar and cement-based mortar during relative temperature changes of the surrounding masonry. (Source: NPS *Preservation Briefs 2, 1980*)

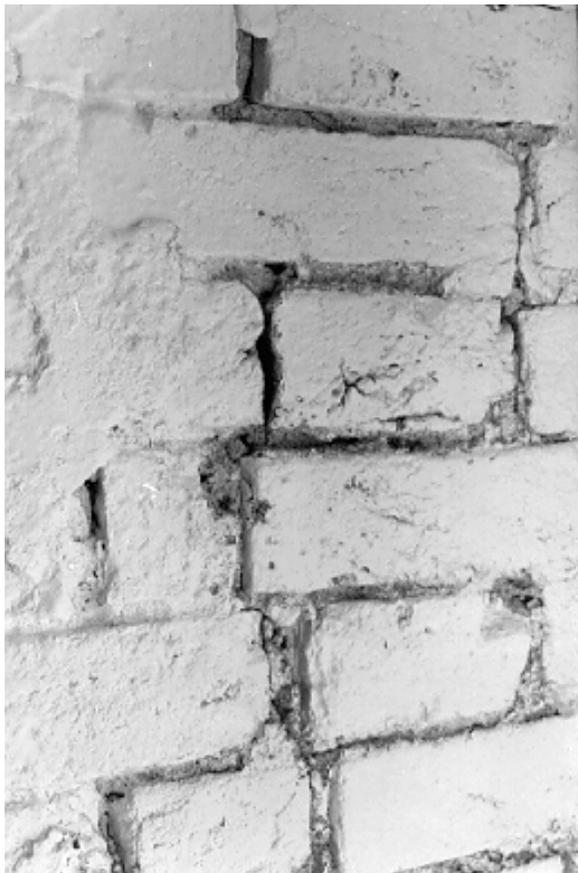
**Figure 21.** Detail of eroded pointing.

is in need of repair shows signs of deterioration such as disintegrating mortar, cracks in mortar joints, loose bricks, or damp walls. The following are guidelines that should be followed when repointing masonry in historic lighthouses.

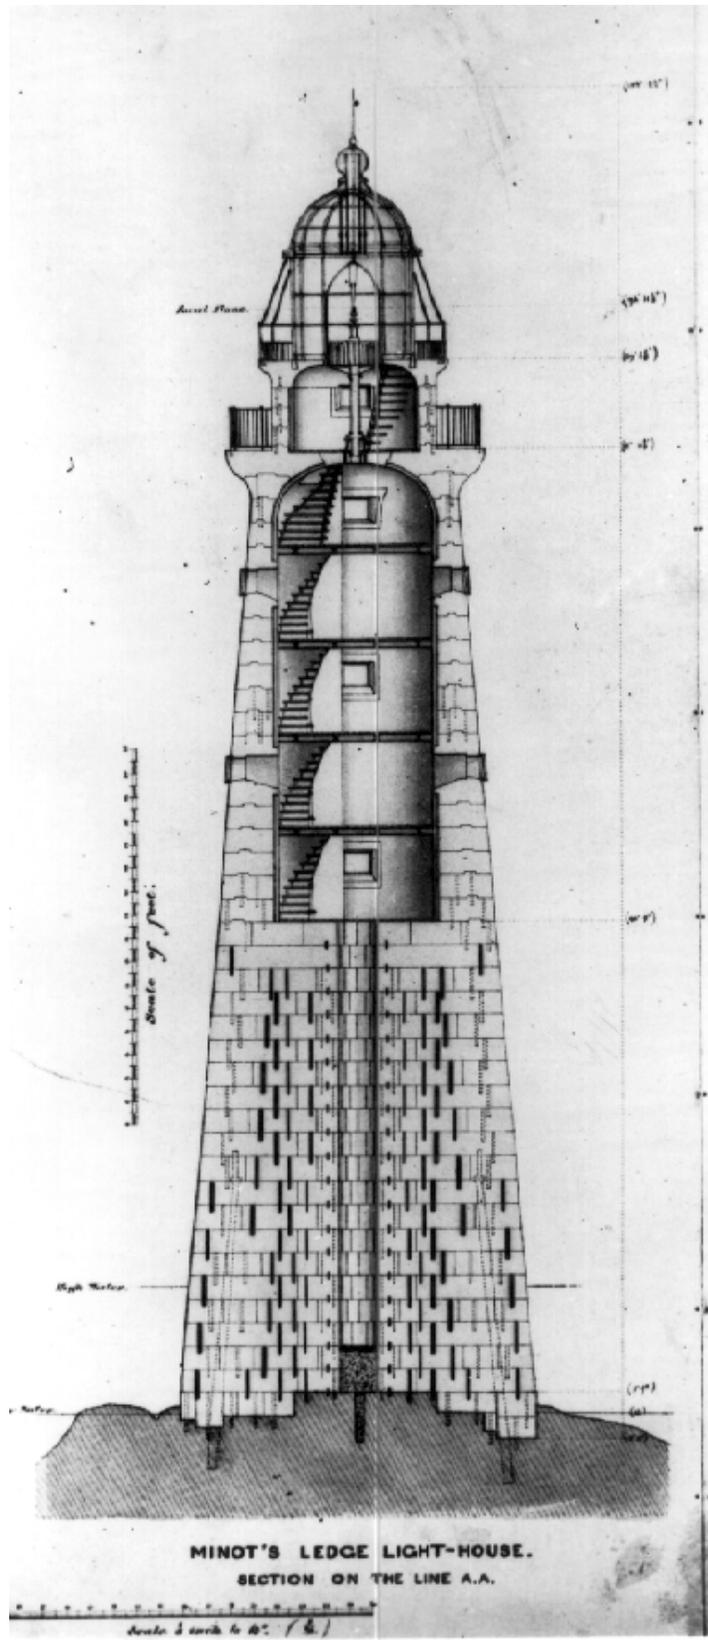
**Figure 29.** Cross section for 114-foot Minots Ledge Lighthouse.

On August 31, 1852, Congress approved the erection of the second and still standing lighthouse on the “Outer Minots rock.” This time the design chosen was one of interlocking granite blocks. The plans consisted of a masonry tower in the form of a frustum of a cone, solid for the lower 40 feet of its 114-foot height. Because the ledge was exposed only at low tide and on calm days, the work was very slow. Tides were found to be right only “six times during any one lunation, three at full moon and three at the change.” It took three years to prepare the ledge for the first course of granite masonry which was cut and test assembled on nearby Gulf (later called Government) Island, near Cohasset, where the government acquired 7.3 acres of farmland for a staging area for the building of the second lighthouse. Here stone-sheds were erected for the stone cutters and a perfectly flat pavement prepared so the stones once cut could be pre-assembled for correct fitness. Granite from Quincy was chosen as being “finest of grain, toughest and clearest of sap.” An iron scaffold was erected on the ledge for the safety of the

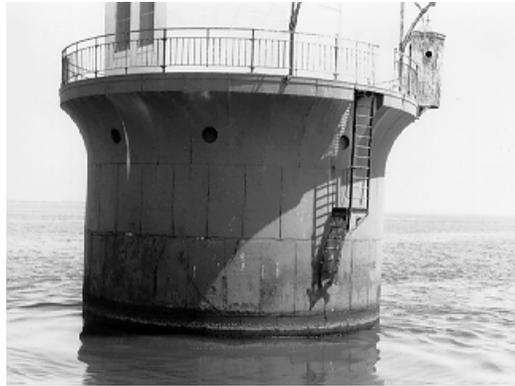
**Figure 17.** The cyclic pressure of the different rates of expansion and contraction of the exterior cast-iron plates and the interior brick lining of the caisson-style lighthouse has caused the cast-iron plates to fatigue and crack.

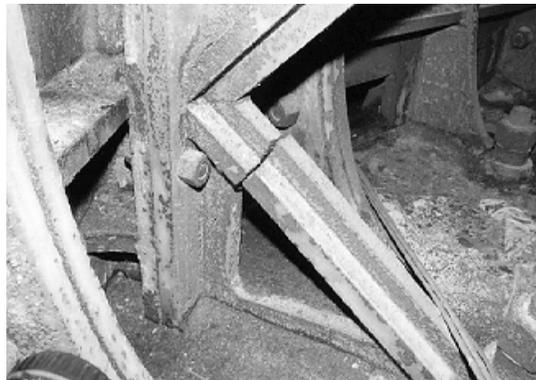
**Figure 18.** The internal structural skeleton of this lighthouse is cracked because of overloading possibly during assembly.

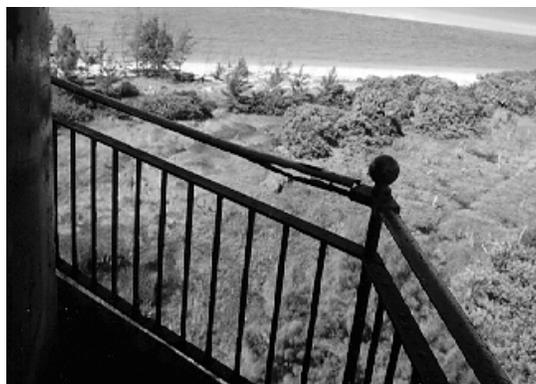
**Figure 19.** This handrail has been damaged by rust-jacking; rusting began between the two pieces of flat bar stock that formed the rail.

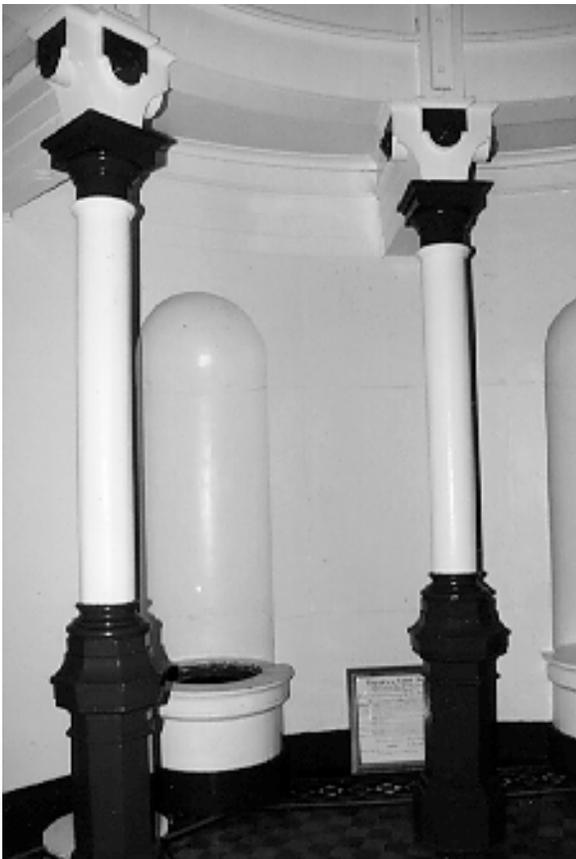
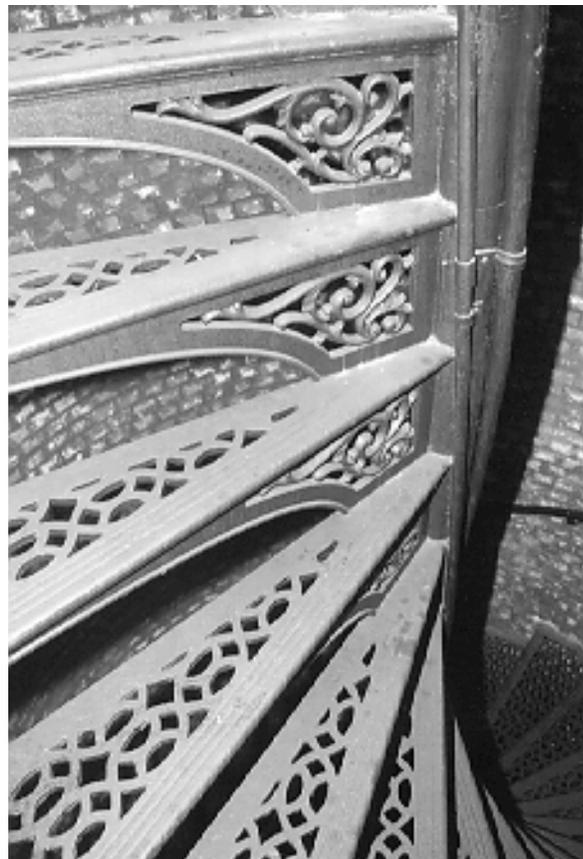
Cast-iron and steel features such as gallery deck brackets, handrails, skeletal structures, pilasters and door pediments, window architraves, as well as textured, finished surfaces such as raised diamond pattern non-skid surfaces, are important in defining the historic character of the lighthouse (see Figures 20 and 21). It is essential that the character-defining features are retained during any treatment. It should also be noted that while cast iron is among the most durable of historic building materials, it is also the most susceptible to damage by improper maintenance or repair techniques and by harsh or abrasive cleaning methods. Therefore, all treatment should be executed using the gentlest means possible. In Part V., **Beyond Basic Preservation**, examples of treatments that are considered rehabilitation and restoration are illustrated and discussed.

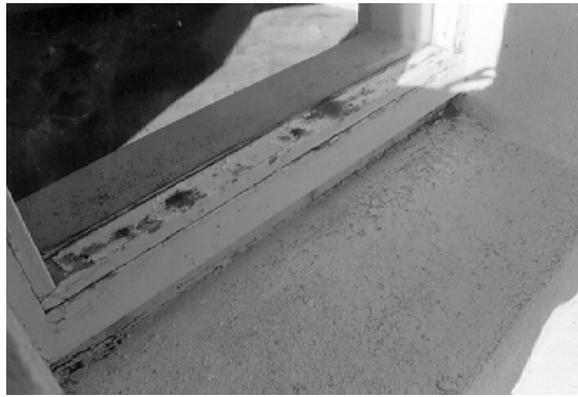
**Figure 26.** This steel casement window frame was not sealed properly and as a result has begun rusting from the inside out.

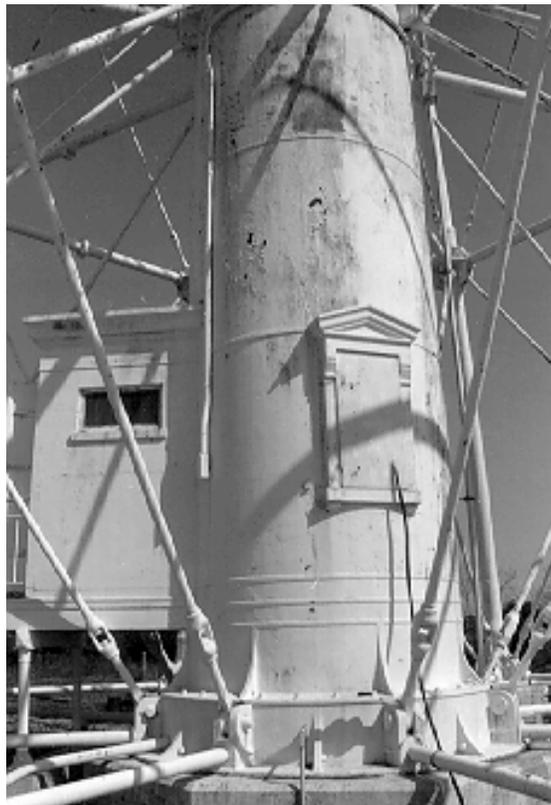
**Figure 27.** Blistering paint, as pictured here, should be removed and the affected areas properly primed and painted.

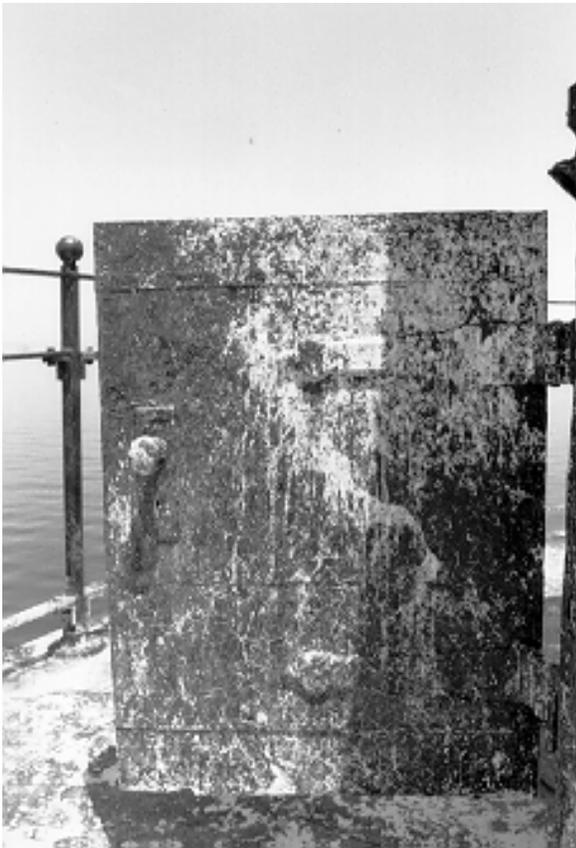
**Figure 28.** Surfaces such as this sheet-steel-covered parapet door that are covered with seagull guano should be thoroughly cleaned before mothballing and should be checked and cleaned once a year during the mothballing period.

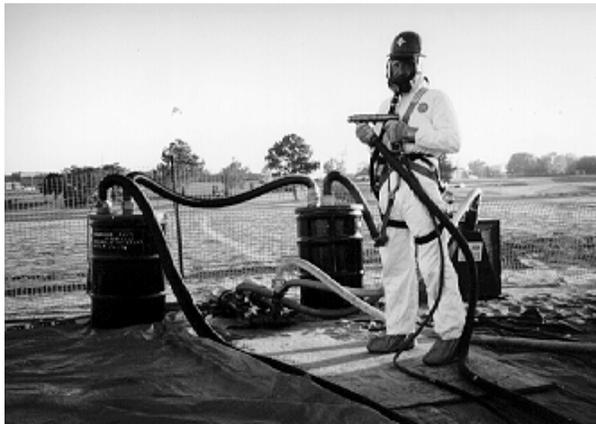
**Figure 29.** Worker dressed in full personal protective gear. The full-face-shield self-contained respirator provides both respiratory and eye protection. The worker is wearing protective coveralls, gloves, and boot covers to prevent lead dust contact. The harness is part of a full protection system. He is holding a pneumatic needle gun that is hooked to a two-stage HEPA (High Efficiency Particulate Air) filtered vacuum system.

outfitted with dust-collection hoods with vacuum hookup. As with any paint removal procedure, personal protective equipment required for health protection should be worn. Typical personal protective equipment includes eye/face protection, respiratory protection, gloves, coveralls, hard hat, and protection from falling if working 6 feet or higher above the ground (see Figure 29).

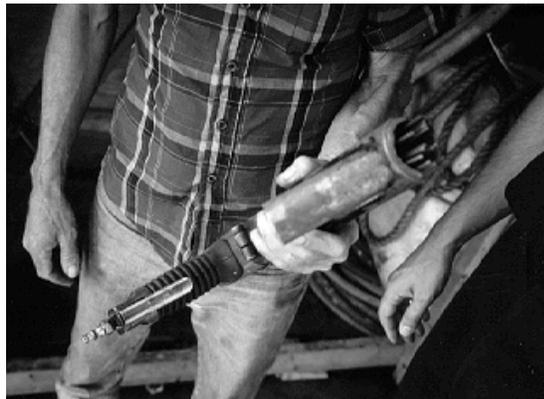
**Figure 30.** Close-up of a pneumatic needle gun. This tool works well for hard-to-reach and detail areas. The needle gun can be pressure-controlled to minimize impact on the iron substrate. This figure shows the vacuum-shroud connection on the right and air-hose connection on the base of the pistol-grip handle on the left.

Figures 30 through 33 are paint removal tools used during the Sand Key Lighthouse rehabilitation. Sand Key Lighthouse is located in open water off the coast of Key West. The paint being removed contained lead; therefore it was essential that all debris be contained for proper disposal.

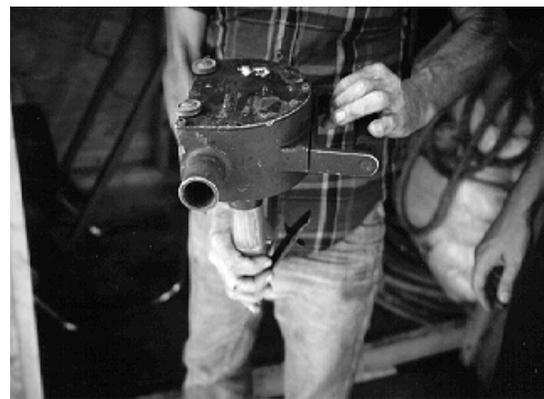
**Figure 31.** The gun is activated by squeezing the lever on the rubber pistol grip. The amount of air pressure controls the speed and impact of the pulsating needles against the iron substrate. The needles can be seen protruding from the vacuum shroud.

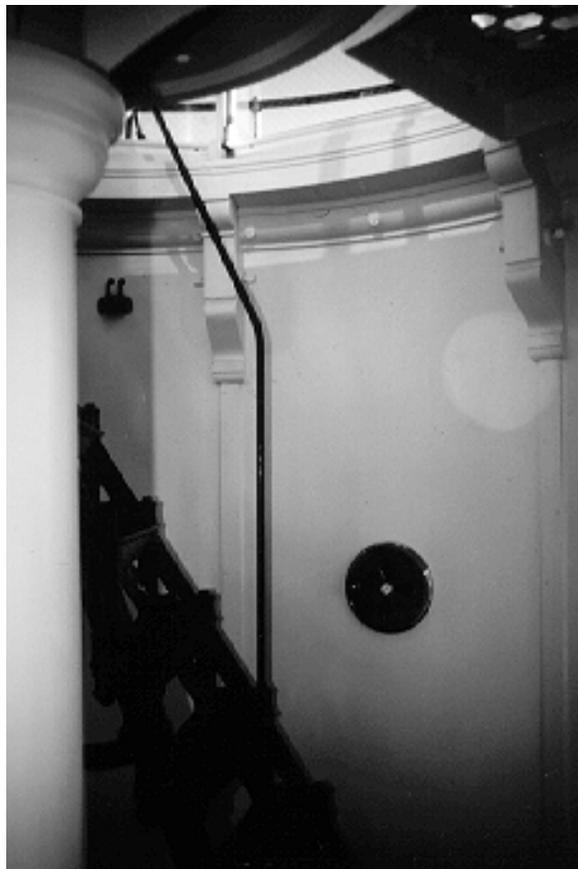
**Figure 38.** Service room bracket after chemical cleaning.

- **Chemical paint removal** using alkaline compounds, such as methylene chloride or potassium hydroxide, can be an effective

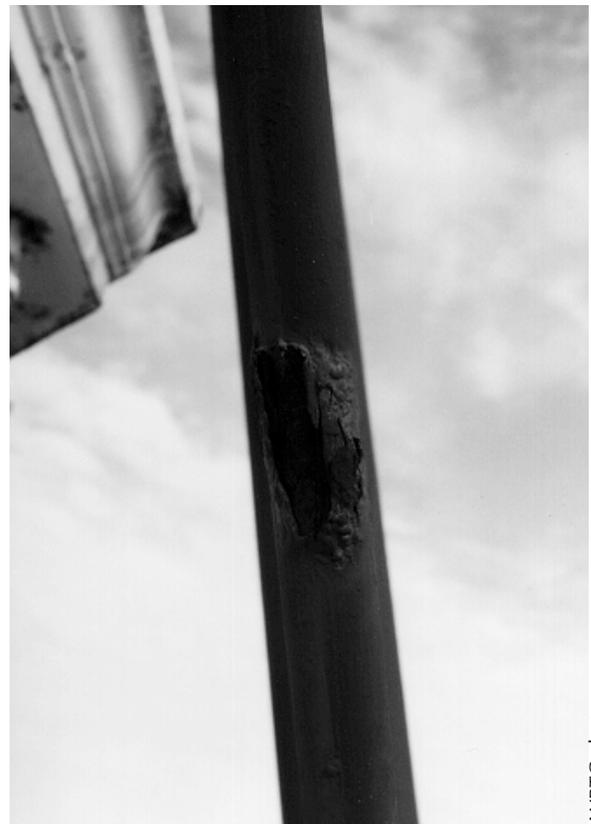
**Figure 39.** The finish on this tension rod failed and localized corrosion (rust) has formed. The rust is exfoliating in layers that are trapping moisture and causing corrosion to occur deeper and deeper into the tension rod. The result is pitting that will compromise the strength of the tension rod. If the area had been touched up in time, the corrosion might not have formed.

The effective protective life span of an existing paint or coating can be greatly increased by routinely touching up areas of deterioration. A small break in the protective finish can lead to accelerated corrosion of the underlying iron (see Figure 39). Areas where the paint or coating has been damaged by mechanical impact or blistering has occurred should be addressed immediately. These areas should have all loose paint and rust scale removed using one of the recommended methods

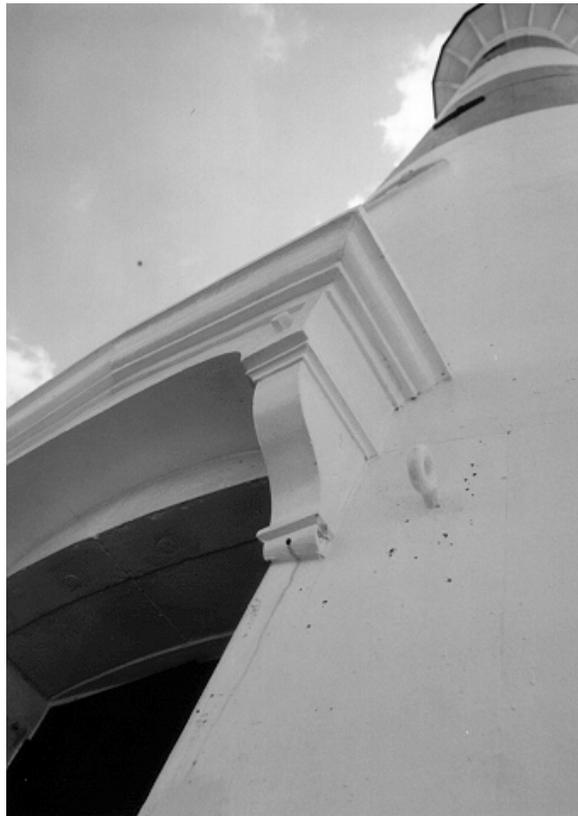
**Figure 45.** Within three months after painting, the rust began to bleed through this weep hole on the bottom of this pediment bracket. Two lessons are to be learned from this condition: 1) keep weep holes open to allow any water that may have entered the casting to escape, and 2) keep joints around applied castings sealed; apparently this was not done and water has entered the hollow cavity of the pediment, causing rust to form inside.

Water that penetrates the hollow parts of iron components causes rust that may streak down over other elements of the lighthouse. The water may freeze and the expanding ice may crack the cast iron. Cracks reduce the strength of the total cast-iron assembly and provide another point of

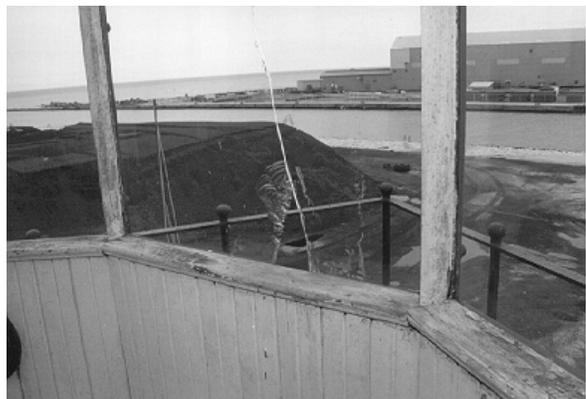
**Figure 5.** Storm glass with holes should be replaced as soon as possible to minimize water infiltration. If immediate replacement is not an option, the storm glass can be temporarily patched.

- **Lantern glass:** Lantern glass, frames, and roofs must be weathertight before mothballing (see Figure 5). Refer to the **Lantern** section for more information concerning the weatherproofing of the lantern components.
- **Built-in guttering systems:** All rainwater guttering systems (lantern roofs, or other tower roof forms) should be cleaned and checked for holes. Water entering the structure will cause premature deterioration of internal structural components. For more information refer to the discussion on roofing in the **Lantern** section.
- **Gallery decks:** In most wooden lighthouses gallery decks are wood covered in sheet metal. These decks are generally laid directly on top of

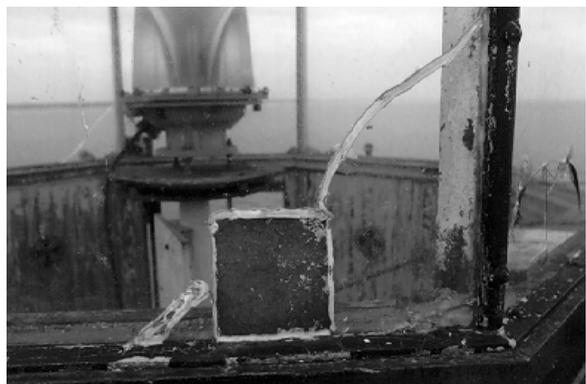
**Figure 6.** An acceptable temporary lantern glass repair made using a small piece of sheet metal and caulking.

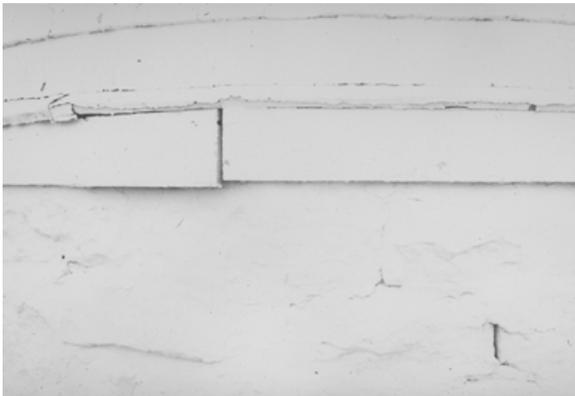
**Figure 11.** Open joints like those between these skirt boards must be properly primed, painted, and filled before mothballing the lighthouse.

- **Loose or open joints:** If the seams between siding boards are open or if the putty in those joints is loose, moisture can penetrate. In order to prevent this infiltration, all putty that is in disrepair must be removed and the affected seams sealed with caulking. For more information on various types of caulking available, refer to the **Windows** section.
- **Protective coatings:** Lighthouses were historically painted as a protective measure and for identification as a daymark. As part of a mothballing treatment, the exterior coating should be checked for loose and flaking paint. Any deteriorating areas should be scraped and

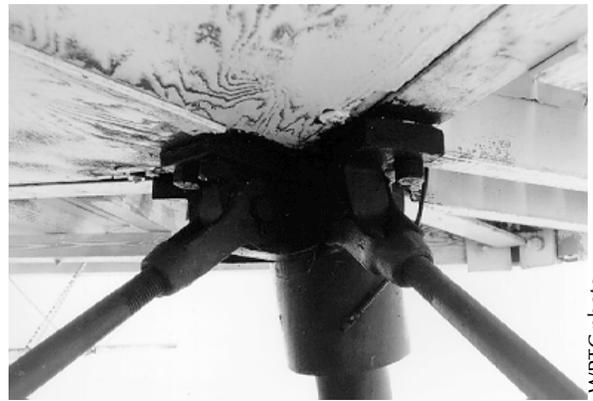
**Figure 12.** View of underside of a screwpile lighthouse. Although these bare wood surfaces are not directly exposed to rain, they are susceptible to mist and condensation moisture; and because there is no exposure to direct sunlight, the surfaces are seldom dry. For adequate protection during the mothballing period, these surfaces should be painted.

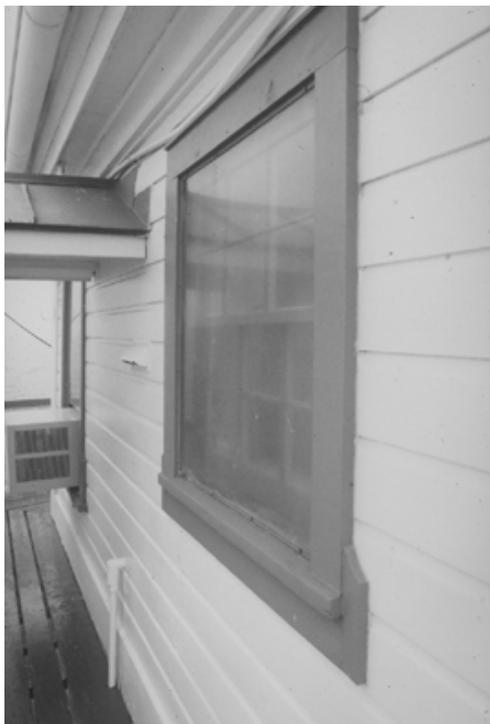
**Figure 13.** This image shows a Class I paint condition: virtually no deterioration, only some soiling and possible salt buildup resulting from the open-water location of the lighthouse.

**Class I:** Generally no paint removal—dirt, soot, pollution, chalking, mildew etc., (see Figure 13).

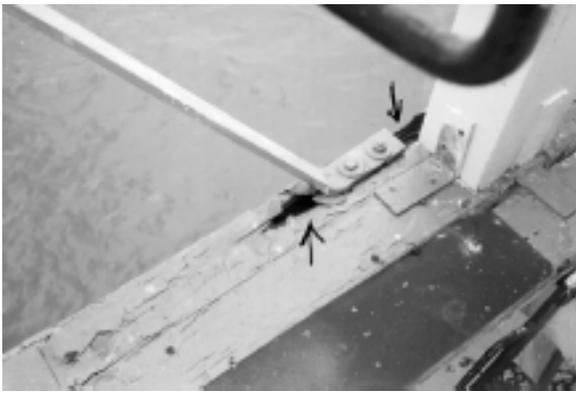
**Figure 18.** The wooden structural member that this bracket is attached to is extensively deteriorated. This condition is a prime example of deterioration that can be repaired by cutting back the rotted wood to a sound substrate, then fitting the void created with a wooden ‘dutchman’ or infill that matches as closely as possible the grain orientation and wood species as the existing member. Once the dutchman has been glued, and if needed, doweled in place, then the affected area should be properly primed and painted. This technique is affordable and incurs only minimal damage to the existing historic materials.

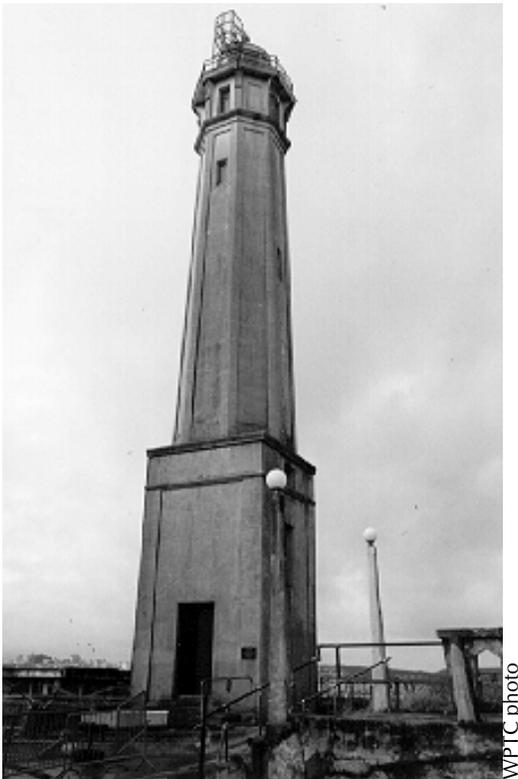
**Figure 2.** View of the Alcatraz Island Lighthouse. Reinforced concrete was chosen for this lighthouse location for its ability to withstand earthquakes.

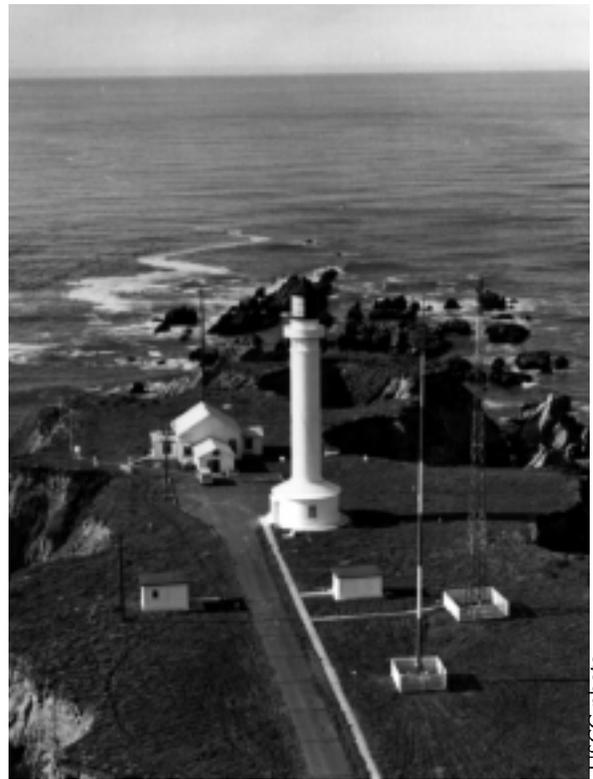
**Figure 4.** The first reinforced concrete lighthouse, Point Arena Light Station in California.

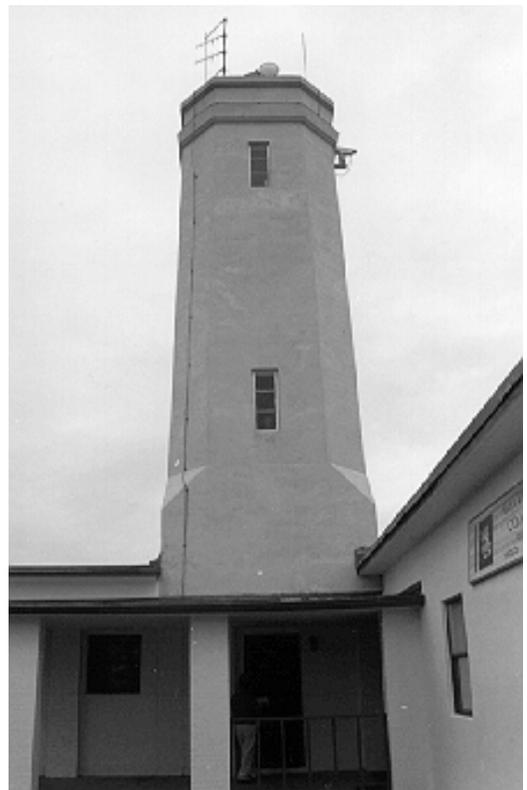
**Figure 5.** St. John's River Lighthouse, Mayport, Florida, was constructed of reinforced concrete for its economy and low maintenance.

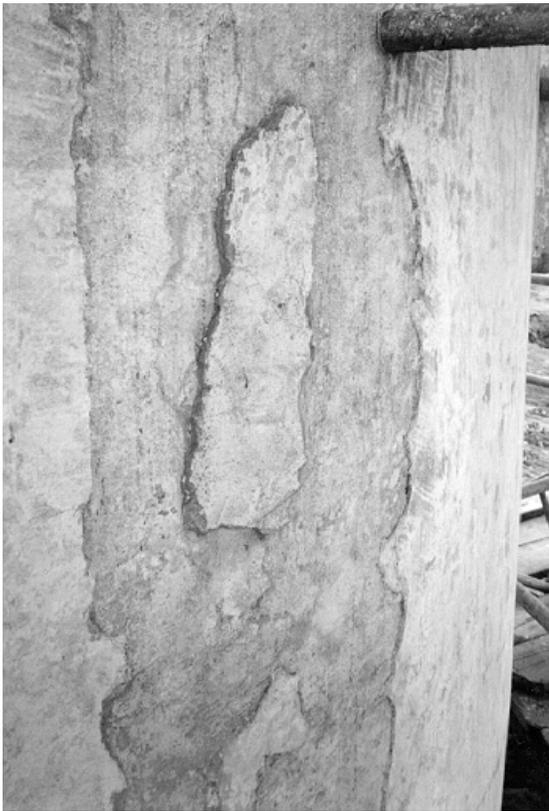
**Figure 9.** Patches of spalled concrete: familiar with lighthouse preservation the one pictured here should be repaired to protect the underlying concrete structure.

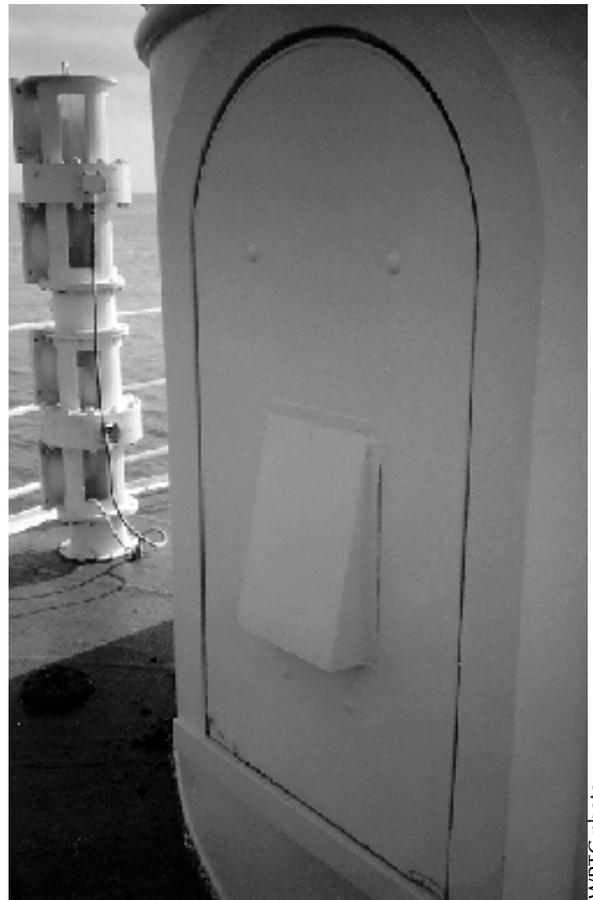
**Figure 4.** A good example of a blocked window using a metal panel fitted with a hooded vent. For more adequate ventilation, the vent should be larger.

- There are a number of ways to insert vented plywood panels into window openings to avoid damage to frame and sash. One common method is to bring the upper and lower sash of a double-hung unit to the midpoint of the opening and then to install pre-cut plywood panels on the inside face of the window using long carriage bolts anchored into horizontal wooden bracing, or strong backs (see Figures 4 and 5).

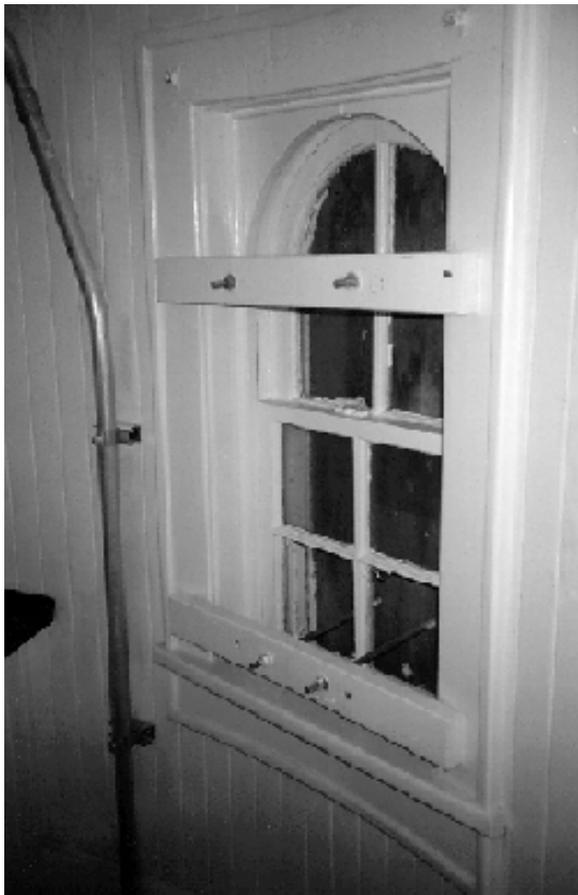
WPTC photo

**Figure 5.** Interior view of the blocked window. If possible, a better solution would have been to raise the lower sash and lower the upper sash and pass the bolts through the openings.

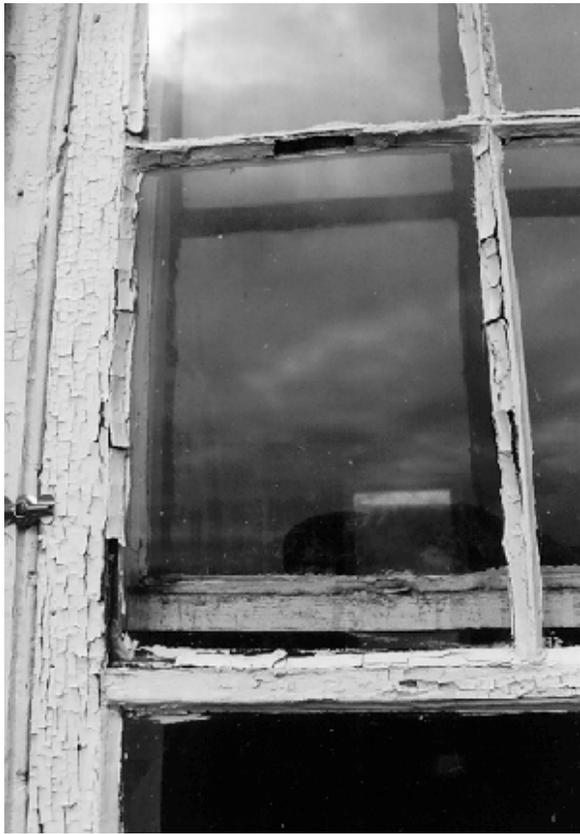
**Figure 7.** Deteriorated glazing putty and peeling paint on a multilite wood sash.

- Figures 7 through 9 illustrate forms of deterioration typical to lighthouse windows. All of these conditions are repairable and do not require total replacement. The following guidelines are intended to aid in the repair of such deterioration.

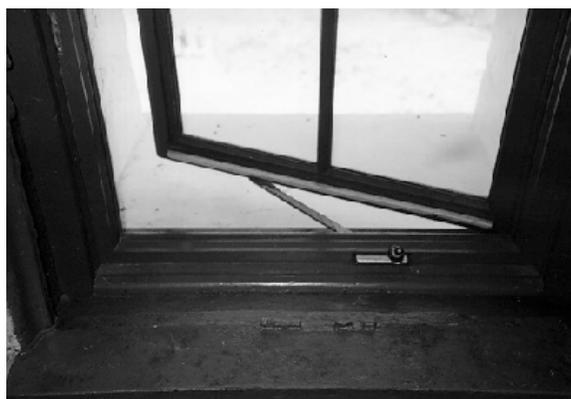
WPTC photo

**Figure 10.** Close-up of a recently restored replacement metal window at Cape Hatteras Lighthouse. Now that the repair work is done, all that this window needs is the hardware lubricated and periodic maintenance to remain in operable condition for the next 50 years. At the time of this lighthouse restoration, it was discovered that the original windows were not repairable and funds were not available to replicate the original cast-iron frame design. The original windows were more like a shutter, constructed in two parts, hinged at both sides and meeting in the middle. The new landing windows were installed as a temporary measure until additional funds are available.

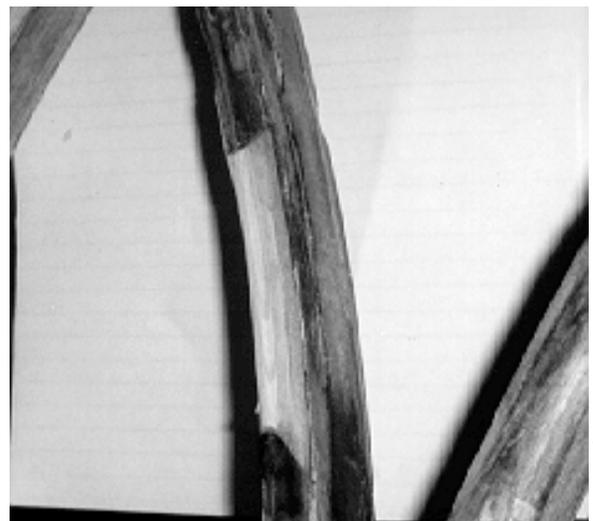
WPTC photo

**Figure 13.** Close-up of a dutchman repair (light-colored wood used to mend a window muntin).

probe the deteriorated area to determine the approximate depth of the deterioration. Second, cut a wood patch or dutchman with its grain aligned with the existing member's. The dutchman can be rectangular or diamond shaped. Both shapes will work; however, a diamond shape is a little more difficult to fit but will provide more gluing surface and blend with the grain better if the window is finished with varnish instead of paint. Be sure the dutchman is large enough to cover the affected area and thicker than the deterioration is deep. Slightly bevel all of the edges of the dutchman so that the widest face is the top. This will ensure a tight cork-like fit. Next, trace the outline of the dutchman's narrowest face on the existing member over the deterioration. Using the outline as a guide, carefully remove all of the deteriorated wood with a chisel. Test-fit the dutchman, and trim the hole until the dutchman bottoms out and fills the affected area entirely; the dutchman should be slightly higher than the existing material. Glue and clamp the dutchman in place. Once the glue has cured, use a chisel or hand plane to make the dutchman flush with the surrounding material. Hand sanding can be used for the final leveling of the two surfaces.

A 'dutchman' is a fitted patch in a wood member that has only localized deterioration. To fit a dutchman, first

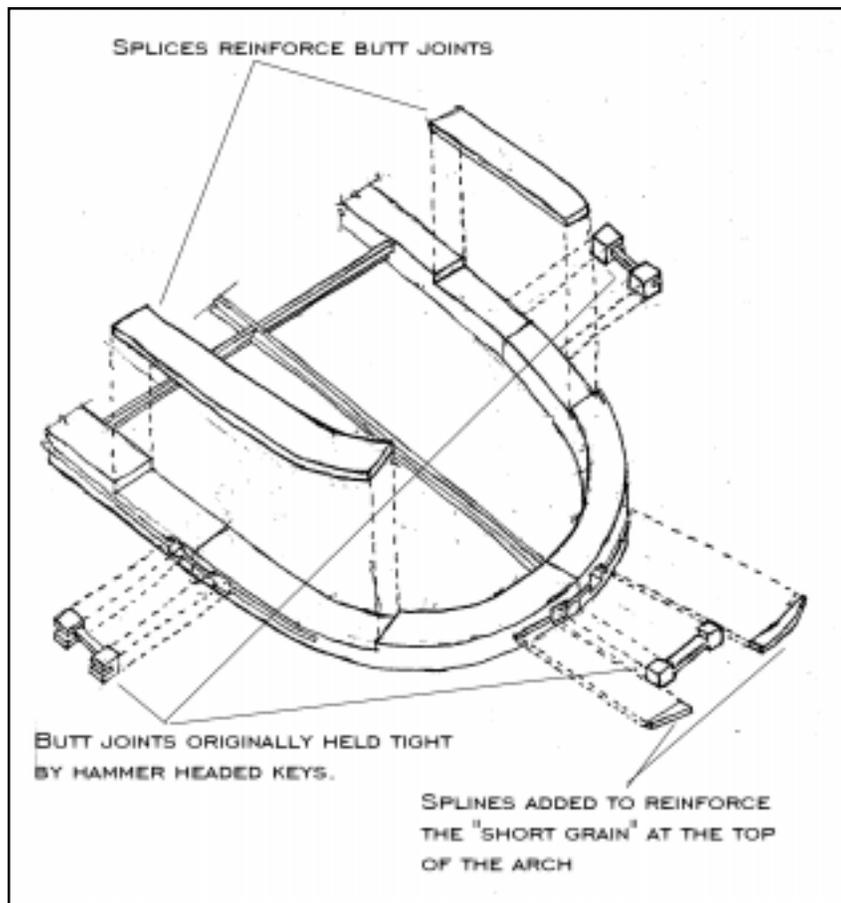
**Figure 14.** A wood window splice repair. (Illustration by Eric Ford, WPTC)

cut the end diagonally to match the existing member; then drill aligned holes in both members for reinforcing dowels.

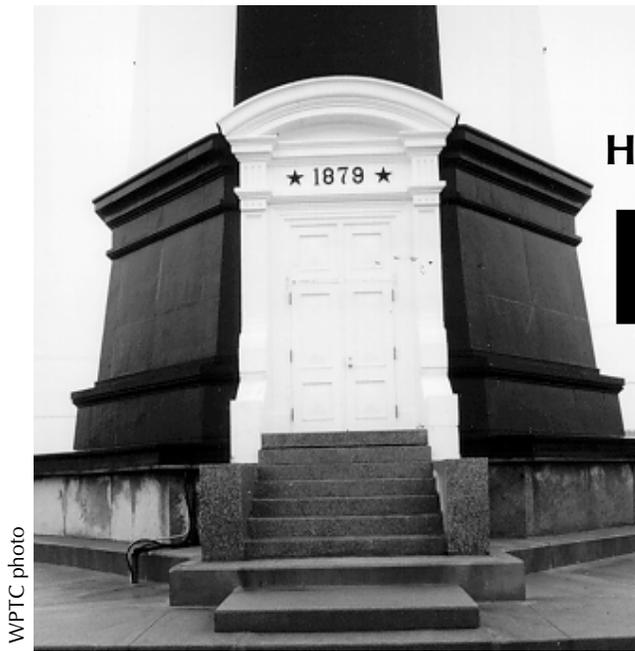
WPTC photo

**Figure 1.** Close-up of large, double-leaf, wood-frame and panel doors at the Cape Henry Lighthouse (second tower), Fort Story, Virginia.
