# Table of Contents

# Introduction

The *Historic Lighthouse Preservation Handbook* was created through a cooperative partnership between the National Park Service (NPS), U.S. Coast Guard (USCG), and the Department of Defense (DoD). The *Handbook* addresses preservation issues related to historic lighthouses with an emphasis on the maintenance problems associated with the many different materials and construction techniques used in these unique structures. **Historic Lighthouse Preservation** (Part IV) includes data gathered from condition assessments and historic significance evaluations at 21 light stations around the country as well as information from applicable NPS guidance, USCG files, and material generated by non-profit groups, museums, and architectural and engineering firms. **Beyond Basic Preservation** (Part V) includes case studies reflecting lighthouse rehabilitation and restoration projects as well as related activities.

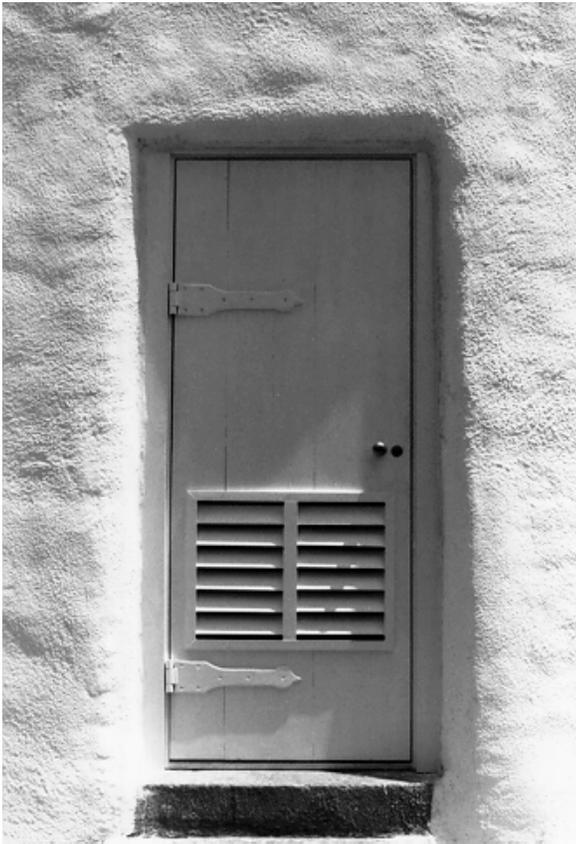
WPTC photo

**Figure 3.** View of the simple pre-Civil-War-style replacement plank door at the Ocracoke Lighthouse, North Carolina.

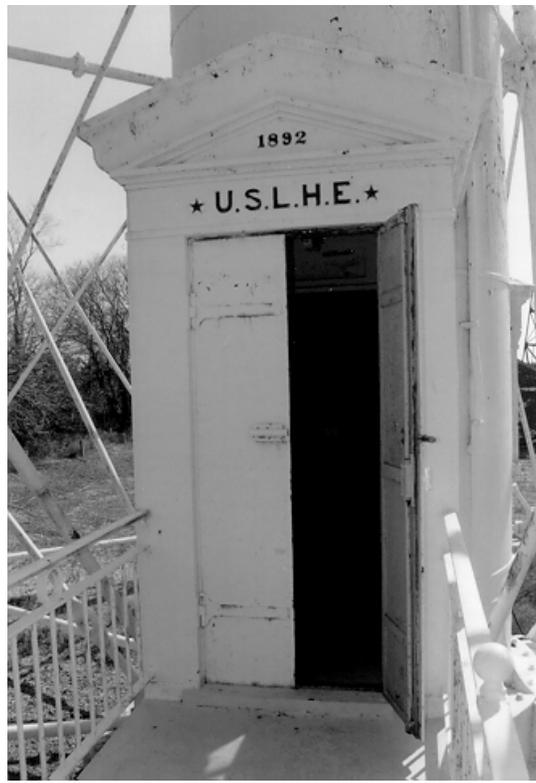
WPTC photo

**Figure 6.** Close-up of the neoclassical, double-leaf, sheet-iron door at the Cape Charles Lighthouse, Smith Island, Virginia.

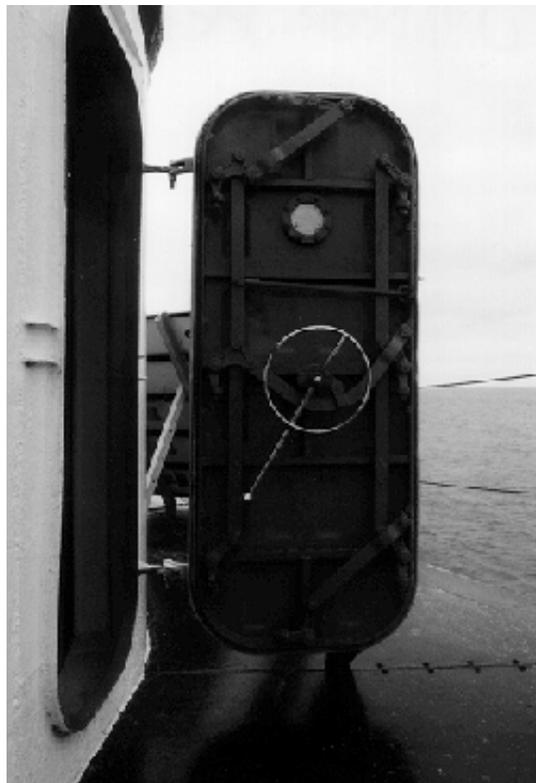
WPTC photo

**Figure 8.** An example of a typical watertight 'ship' style door at Los Angeles Harbor Lighthouse, California.

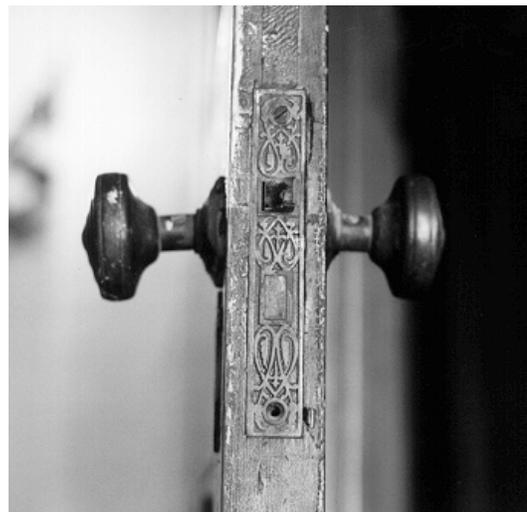
**Figures 16 and 17.** Examples of decorative door hardware found in late 19th-century lighthouses.

Historic lighthouse door hardware is not only functional but also significant in defining the character of the historic door. Lighthouse door hardware such as door knobs, hinges, keyhole escutcheons, and even strike plates were often decoratively detailed with motifs of the architectural style of the lighthouse. When preserving historic lighthouse doors, the existing hardware should be retained. When repairs are made to the door, the hardware should be removed for protection or protected in place to avoid any damage that may be incurred during the repair process. If the hardware is removed, label each piece to

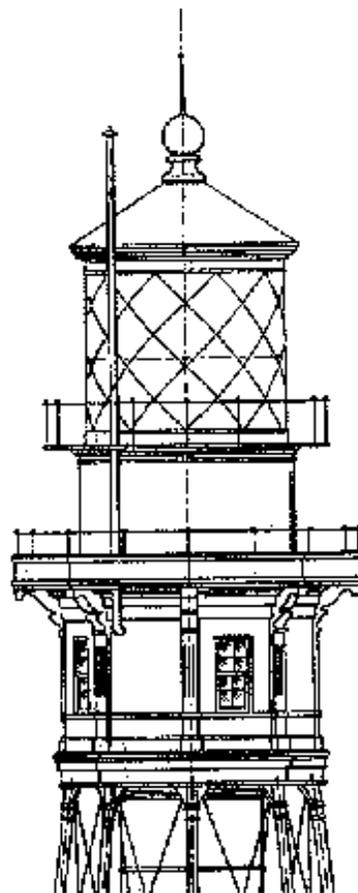
National Archives

**Figure 2.** Original construction drawing of the first-order Cape Fear Lighthouse showing the lantern above the service/watch room.

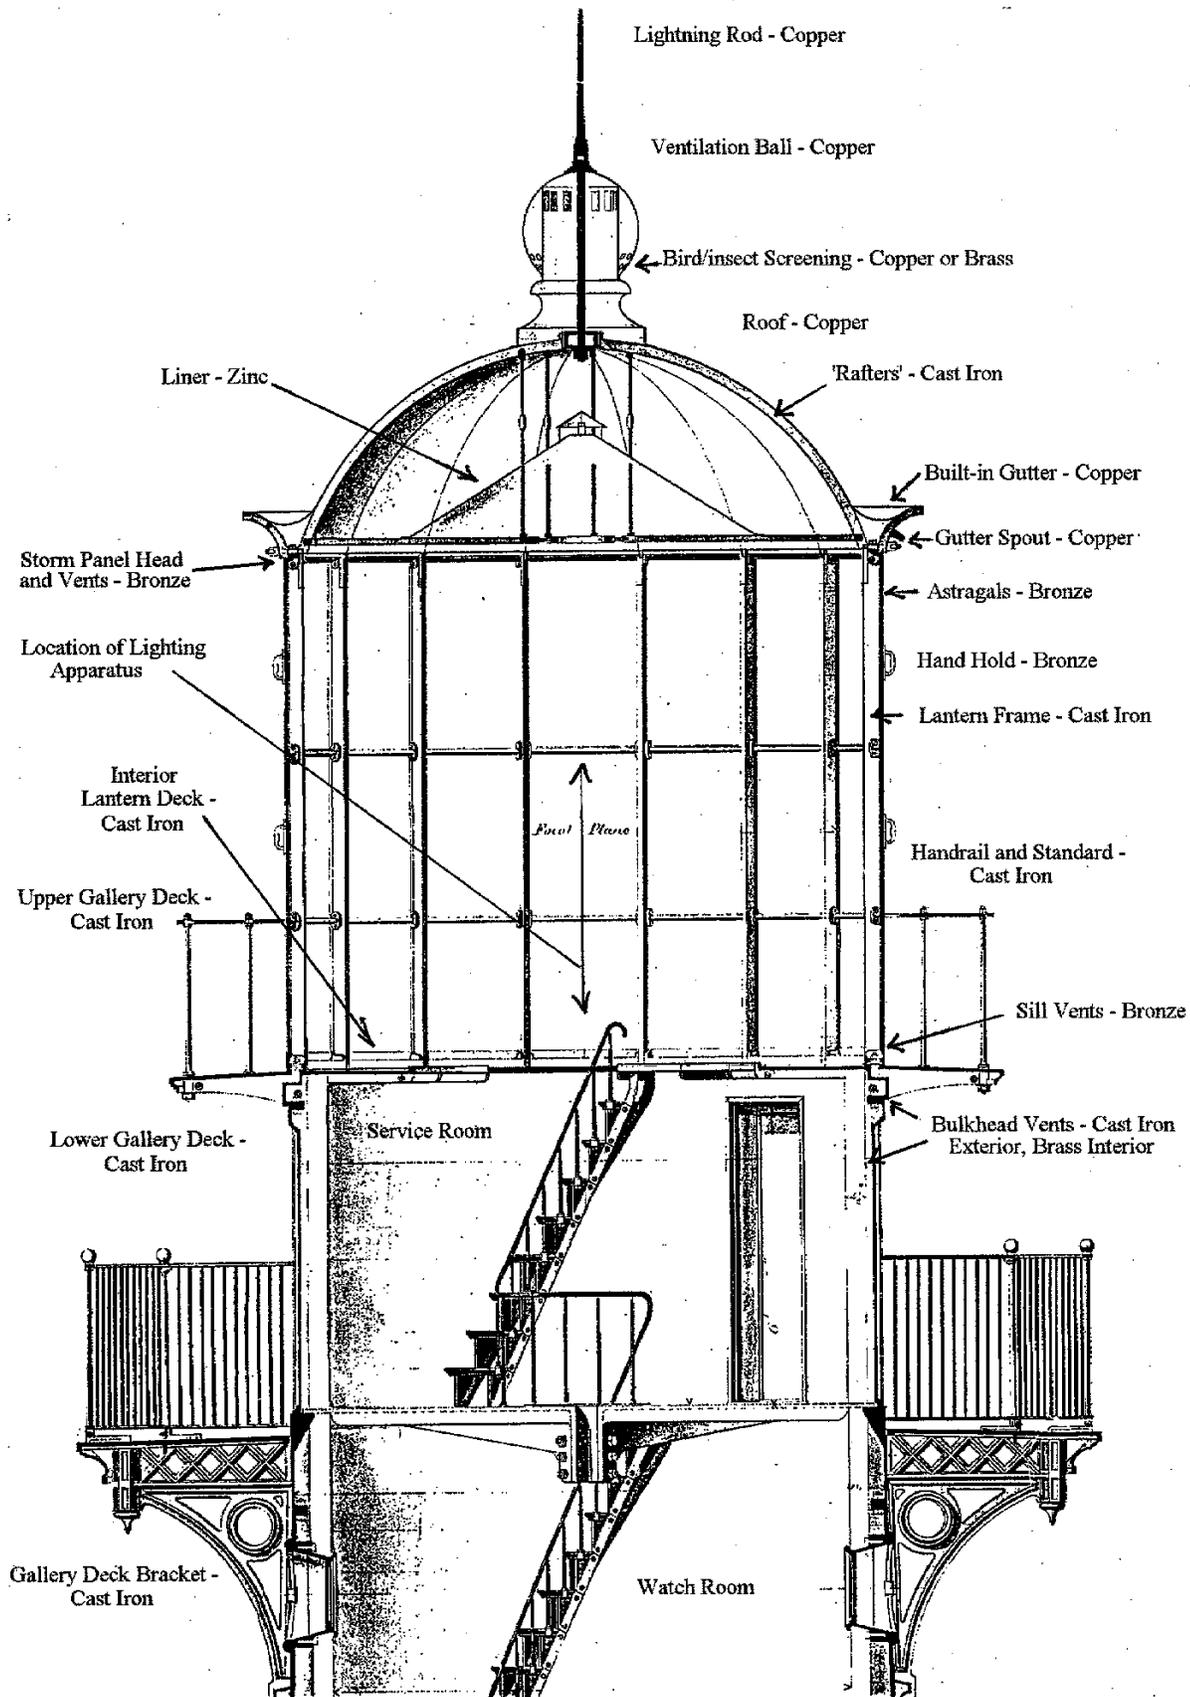
Figure 6. Diagram of a typical first-order lantern; the parts are similar to second- and third-order lights. (Diagram based on USLHS drawing in the National Archives)

In order to withstand harsh weather conditions, the components of a typical lantern are made from a variety of materials and metals. The main support structure (including the floor), certain types of parapet walls, and the lens pedestal are typically made of cast iron for strength. The roof, ventilation ball, and lightning rod are typically made of copper, which can withstand severe weathering (and in the case of the lightning rod, can conduct electricity). The astragals and clamps that hold the lantern glass in place as well as grab handles are typically made of bronze which resists corrosion and is durable. Brass screws compatible with the bronze are typically used to attach the astragals to the lantern frame. If these parts corrode, damage to the lantern glass can result.

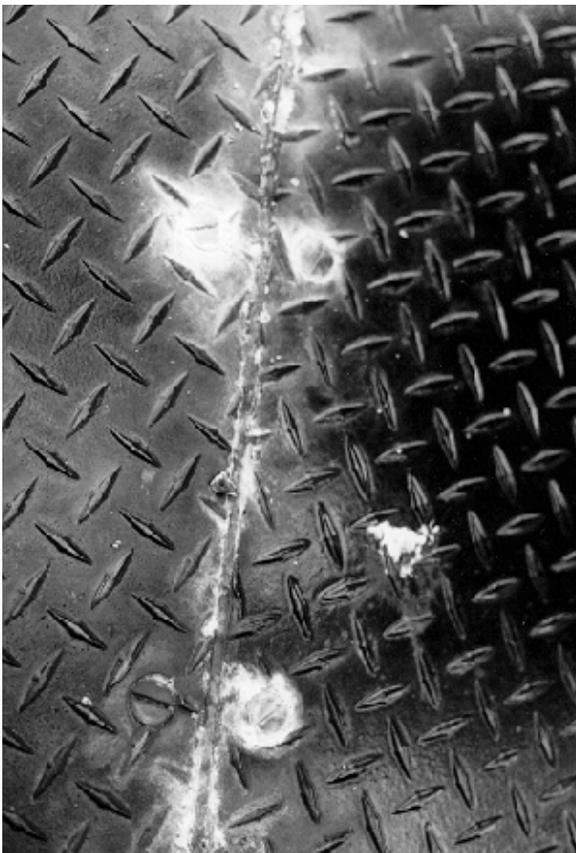
**Figure 7.** The white chalky residue around the steel bolt heads on this aluminum deck is the by-product of the corrosion occurring at these connections.

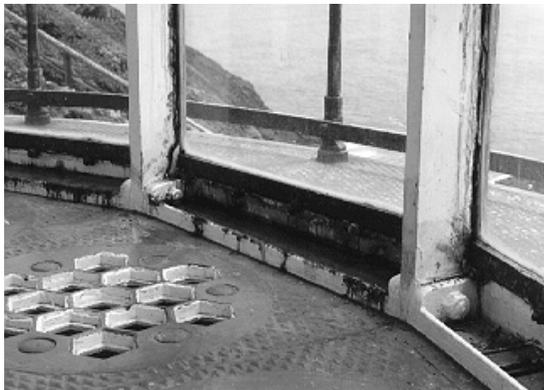
**Figure 11.** The water that has collected in this lantern sill is causing the iron lantern glass frame (the vertical members in the center of the photo) to rust and corrode.

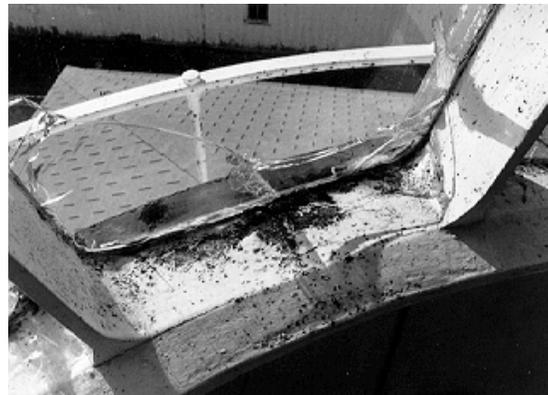
**Figure 12.** The glass in this lantern has been cracked by the rust-jacking that is occurring along the iron frame.

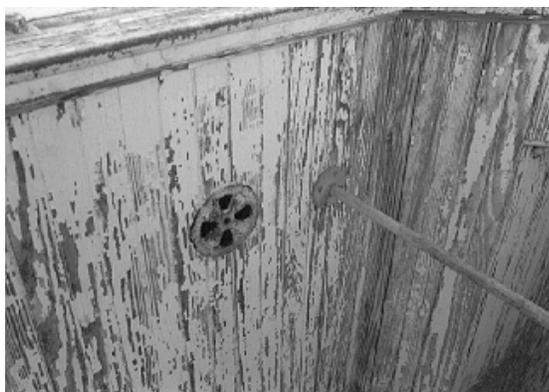
**Figure 13.** The paint coating that once protected this lantern parapet wall has failed.

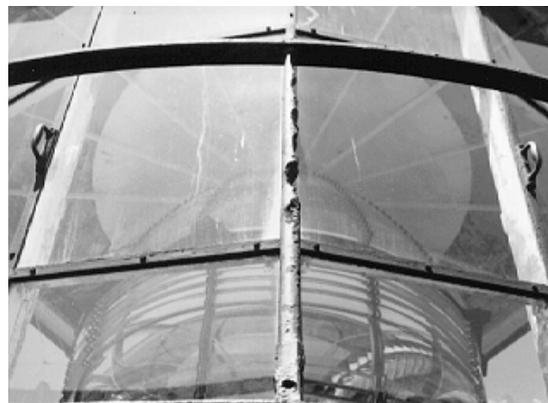
**Figure 14.** Wind and airborne sand have accelerated the deterioration of this lantern gallery deck handrail

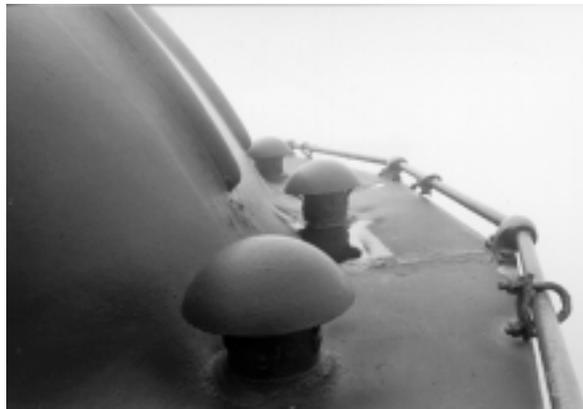
**Figure 17.** Roof vents such as these should be inspected for leaks and maintained during the mothballing period. This shroud-style vent allows air to pass while preventing rain from entering.

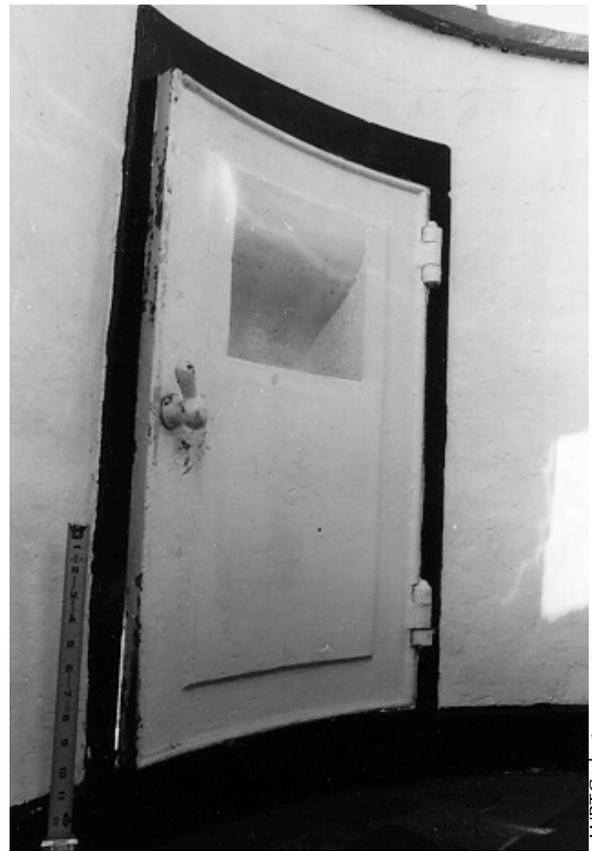
WPTC photo

**Figure 20.** Close-up of a vented parapet hatch in a fourth-order lantern. The hatch should have a good seal and still remain operable. The built-in vent should also be kept open to maximize ventilation of the lantern and tower.

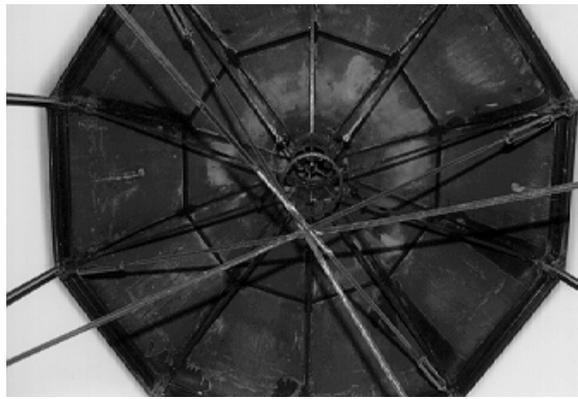
WPTC photo

**Figure 21.** The diagonal tension rods in this empty lantern were installed to brace the lantern against lateral loading caused by high winds.

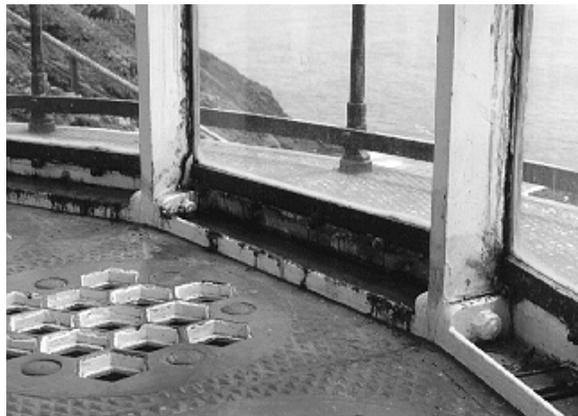
WPTC photo

**Figure 22.** Close-up of sill vents in a first-order lantern. The vents should be kept open during the mothballing period to maximize lantern and tower ventilation.

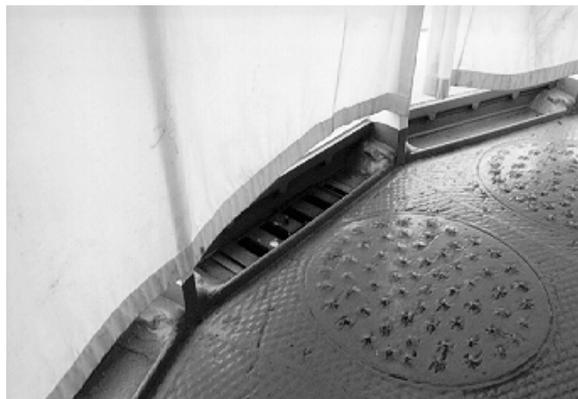
WPTC photo

**Figure 23.** As part of the lantern mothballing treatment the lantern glass sill vents should be kept open (except in extremely damp climates) to allow for the free flow of air through the lantern.

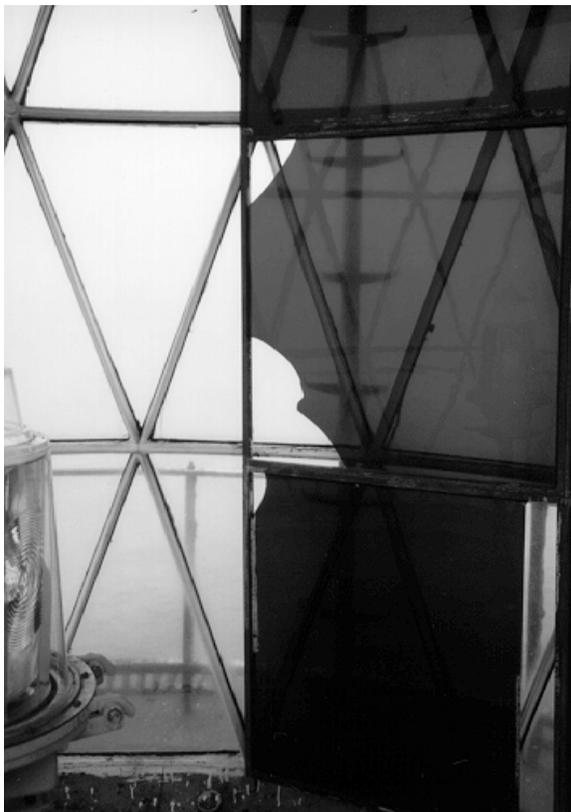
**Figure 29.**

**Figure 29 (bottom left).** Looking out through severely hazed Lexan panels, note the limited amount of light transmission; this greatly hinders the effectiveness of the aid to navigation. If the panels are not replaced, the degradation may continue and diminish the light transmission, ultimately rendering the aid to navigation ineffective.

In 1986 the wire-glass in the lantern of the Sombrero Key Lighthouse was replaced with Lexan (plastic) panels. A 1996 site visit found the Lexan panels hazed by sunlight and salt air exposure. This condition greatly reduces the transmission of light and therefore reduces the effective range of the aid to navigation. The inability of the Lexan panels to withstand the conditions of the marine environment gives the panels a short life expectancy when compared to glass. With these inherent limitations, Lexan or other plastic panels should only be used as a temporary repair and not be relied upon as a long-term lantern glass material.

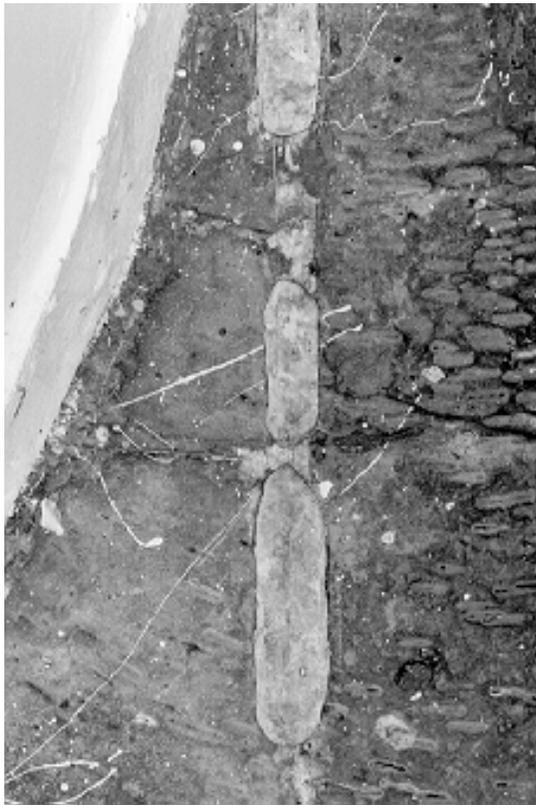
**Figure 32.** This sheet-copper-covered lantern gallery deck has been repaired several times by soldering sheet copper patches over the holes. This method of repair, if performed properly, greatly increases the life span of the roof covering.

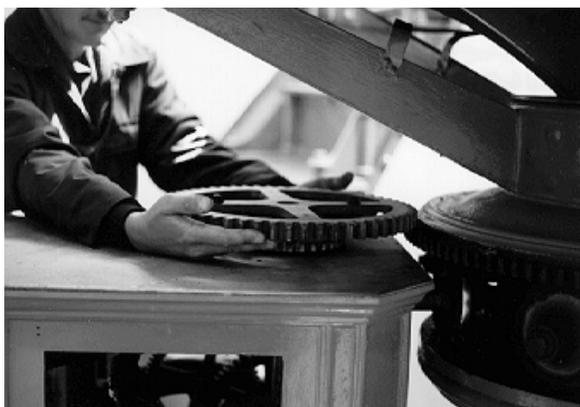
**Figure 34.** When this first-order classical lens was converted to AC power, the original drive gear (pictured here) was the crank used to wind the clockworks.

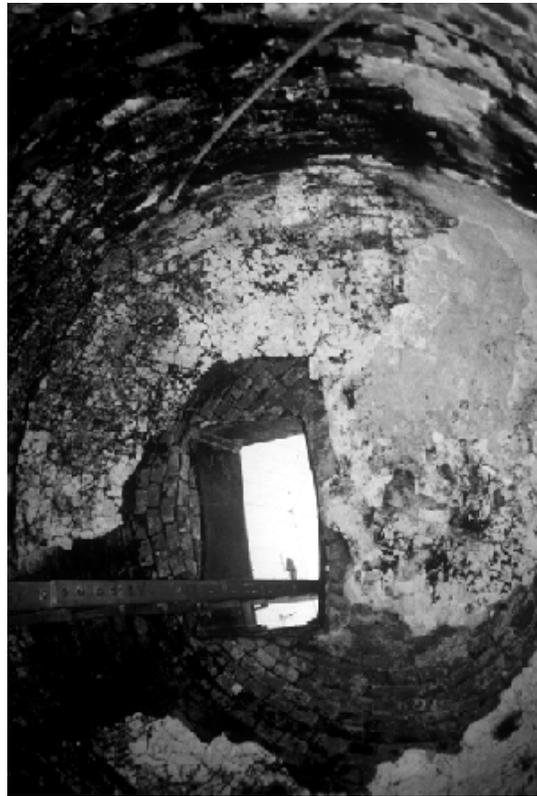
**Figure 4 (left).** Extensive interior finish deterioration in a lighthouse that had holes in the roof which were not repaired.

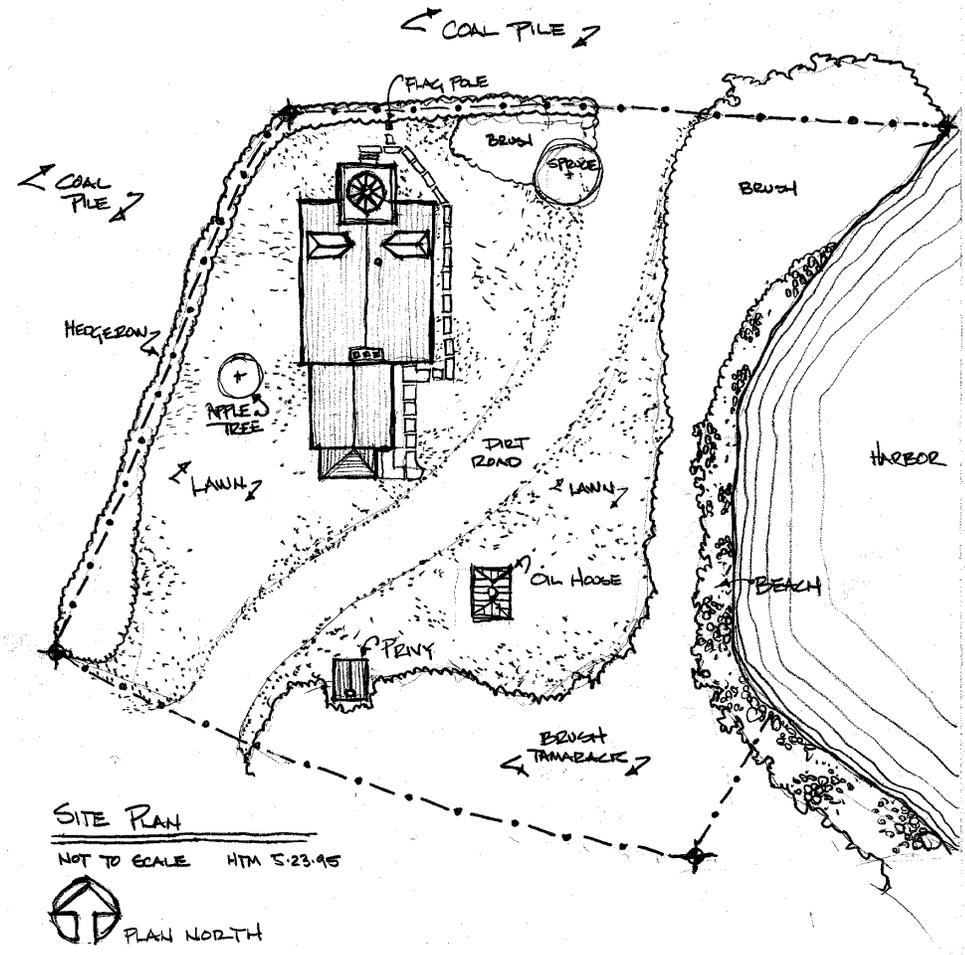
**Figure 5.** A simple sketch site plan records the relationship of a light station's buildings and features. This type of recordation should be dated and filed with the lighthouse maintenance records. (WPTC drawing by H. Thomas McGrath)

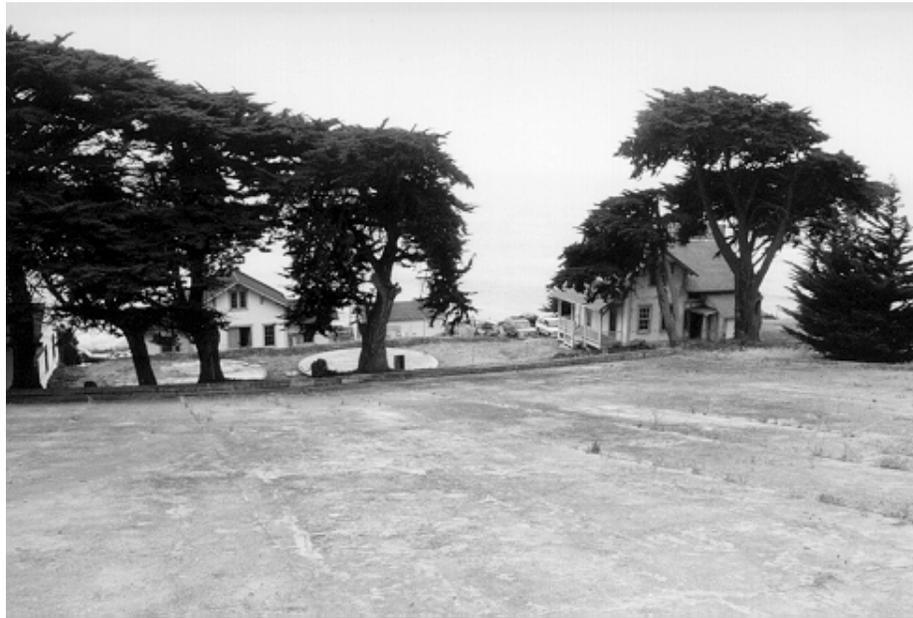
**Figure 9.** View of a highly intact historic light station in California. All principal structures that made up the light station are intact including the large concrete rain water catchment (in the foreground) and the below-grade wood cisterns (just the lids are visible in the center of the photo) used to store the rainwater to produce steam for the fog signal. The preservation of a site at this level of integrity is essential to understanding the relationship of the light station buildings and their contribution to the station's overall operation.

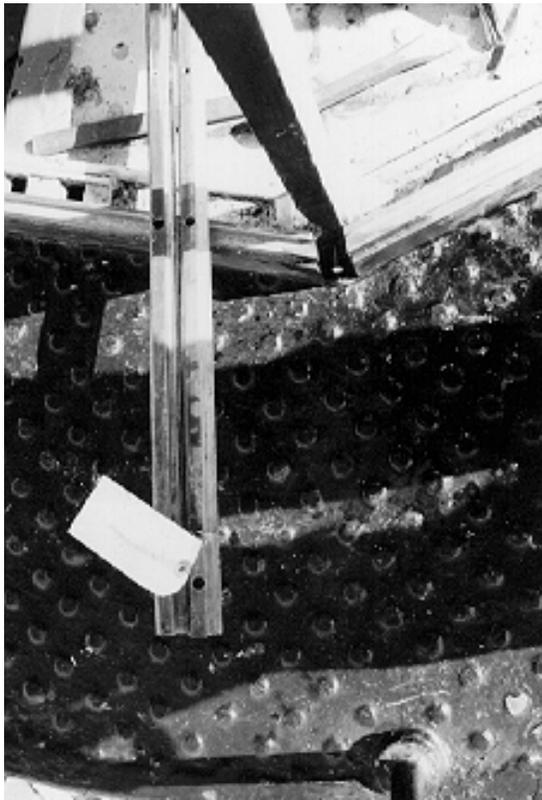
**Figure 13.** This detail of the bronze sill shows the location of the new lower fastener before its removal and resetting with the lower bronze mullion.

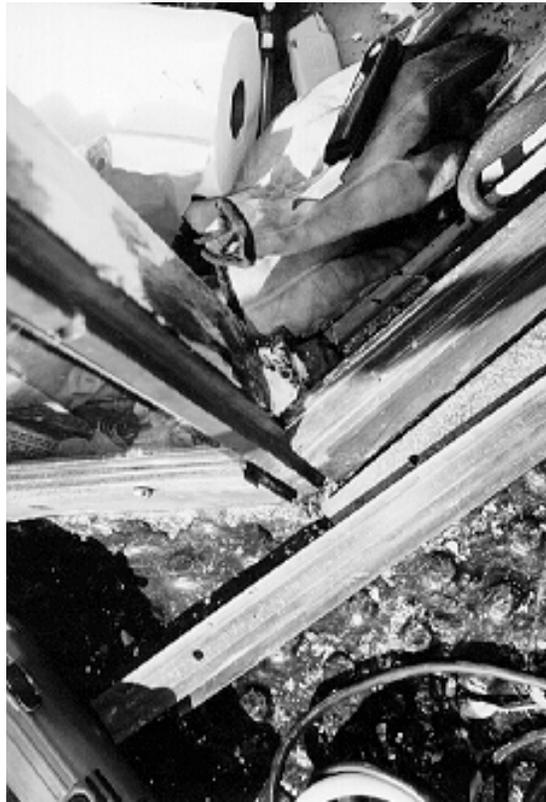
**Figure 14.** Following placement of the restored bronze mullion, the fenestration is ready to receive the new glazing system.

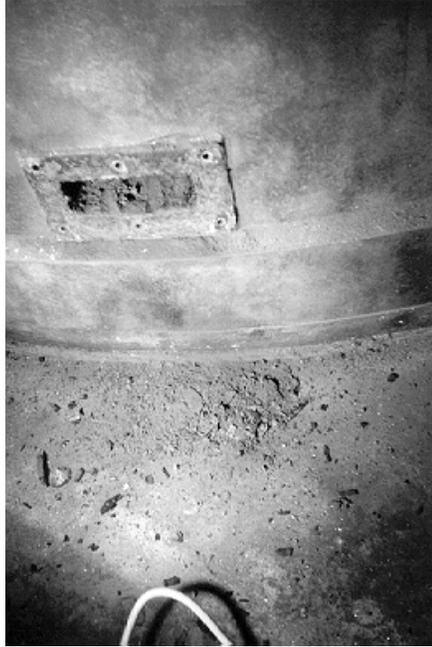
**Figure 19 (left).** Buildup of rust in parapet wall vents.

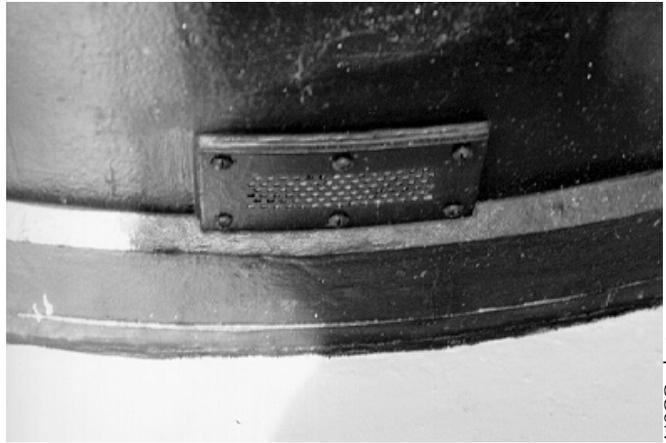
**Figure 20 (above).** The finished vent installation: 15-lb. roofing felt was placed between the bronze vent grill and the cast-iron parapet wall.

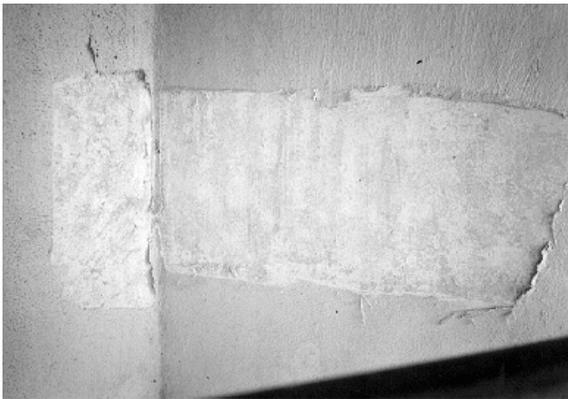
**Figure 23.** The water-based paint stripper was very effective in removing the many layers of paint from the exterior of the tower.

windows. The stripper was water-based and applied by brush and airless sprayer. After soaking for at least 1 1/2 hours, it was scraped off (see Figure 23). The stripped area was then neutralized with water and finished with power sanding where necessary. The interior lead-painted walls which were originally only to be lightly scraped and painted were causing problems. The paint was so old and brittle it continually flaked off. The abatement contractor asked for a change order to completely remove the paint because the current finished product was proving to be unacceptable. Chemical stripping of the interior walls had been selected over light blasting to save on the costs of transporting more blasting media to the island. Air-driven needle gun scalers using low pressure air, however, proved to be a more cost-effective method. The paint was so brittle, it shattered when struck by the needles, leaving the concrete virtually paint free (see Figure 24). There was no damage to the concrete and only lead-paint chips were left to be swept up and disposed of. This method could not be used on the exterior concrete because of the 3/8-inch white mortar skim coat that had been applied as a finish coat when the light was built in 1932.

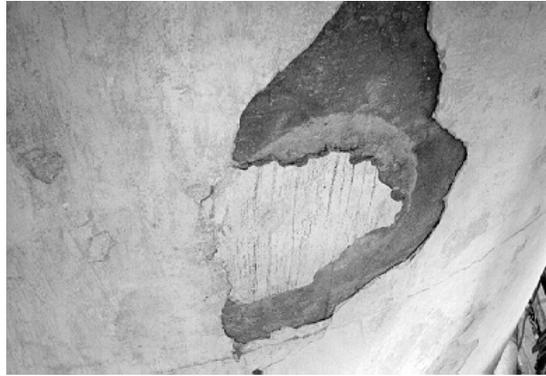
**Figure 26.** Once the scaffolding was erected, areas of the delaminated white mortar finish coat were removed.

The 3/8-inch white mortar finish coat that had been applied over the exterior concrete when the light was built in 1932 was not identified in any of the original drawings. As a result, no one looked during the work site visit for signs of delamination. After the scaffolding was in place, however, several areas were found to be loose between the 10- and 30-foot elevations. The foreman became concerned that other unidentified delaminated areas would fall out after the job was complete and ruin his work. The foreman inspected the entire tower and found an additional 100 square feet of delaminated mortar. After receiving approval to repair any bad mortar, he personally chipped away all the loose mortar and applied a two-part masonry patch material. The repair work was of such high quality that the patches were unnoticeable when the tower was repainted (see Figures 26 and 27).

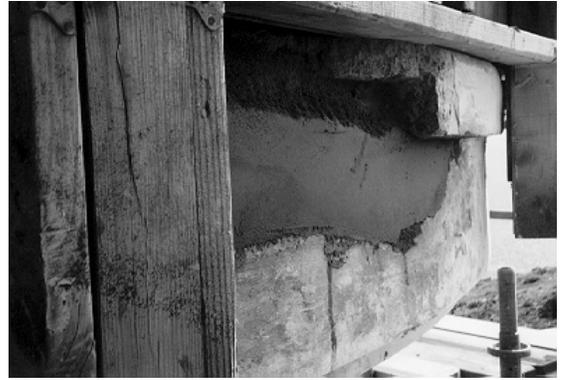
**Figure 29.** The first application of the mortar patch material to the damaged concrete.

broken concrete; the project was already over budget. We decided to do a pressurized epoxy injection and fill all the voids. The area was prepped and pumped full. The outer three inches were left unfilled so the two-part mortar patching compound could be used to restore the damaged area (see Figures 29 and 30).

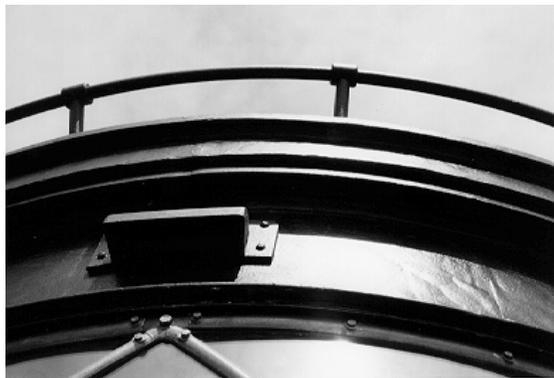
**Figure 31.** Close-up of the finished metal work on the lantern.

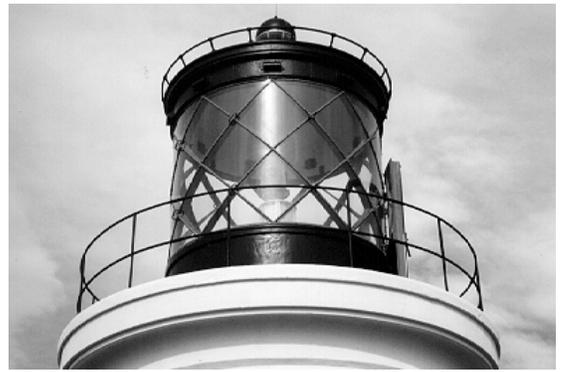
**Figure 32.** View of the finished lantern

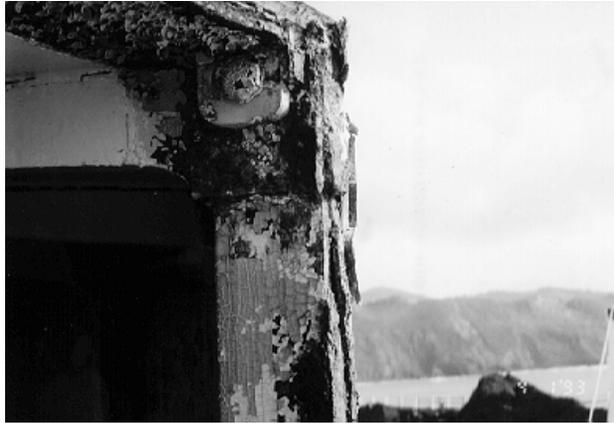
**Figure 34.** Close-up showing what remained after the gallery deck brackets were cut off with a torch. Note the heavy rust and paint failure caused by exposure.

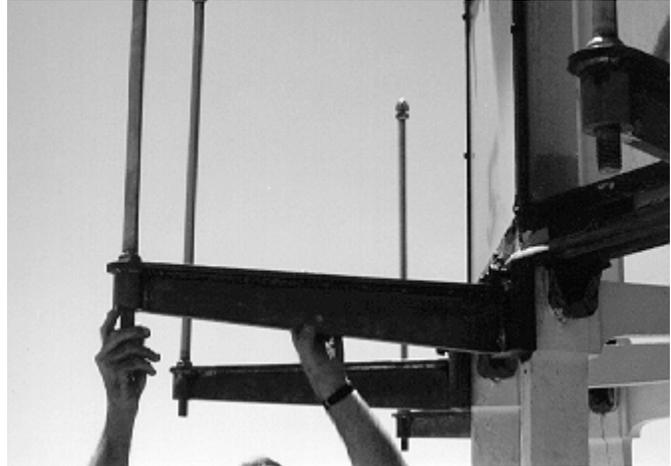
**Figure 39 (left).** View of the mounting surface after the Belzona had cured and the mounting plate had been removed. The 'knobs' or protrusions on the surface are where the Belzona was squeezed through the holes in the mounting plate. These were ground off along with the excess Belzona that squeezed out around the plate.

**Figure 40 (above).** The new gallery deck brackets after installation.

and then slowly tightened until the plate was plumb. The Belzona was then allowed to dry before all excess Belzona was ground off (see Figure 39). This procedure worked very well and took no more than three days to accomplish. The base plates were then primed, painted, and caulked before being torqued in place.

fabricated to match the original cast-iron brackets details. (This is another area where 304 S/S might have been better.) The stanchions were made of 1-inch 304 S/S round stock and 1-inch 316 S/S bolts. The bolts had a 1-inch diameter and 1/4-inch-deep recess machined in the head to ensure the bolts were properly aligned during welding. Custom 1-inch 316 S/S acorn nuts were then purchased to secure the stanchion to the brackets and the handrails. With the brackets and stanchions in place, the 3/8-inch flat bar handrails were then drilled, scribed, and fitted (see Figure 40).

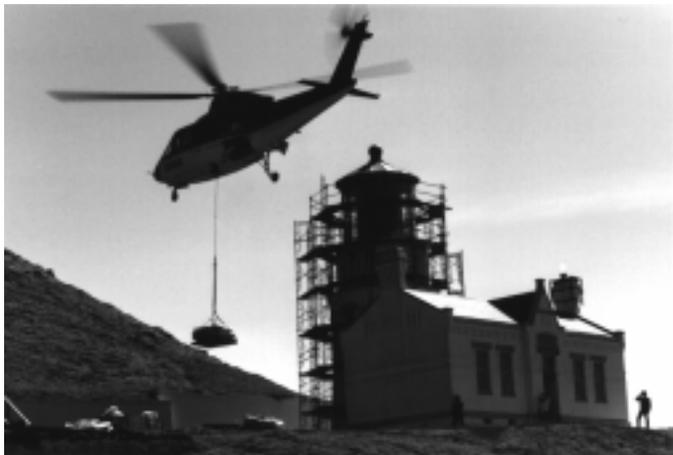
**Figure 45.** *Staging the work.* Note the temporary location of the auxiliary light on the fog signal building chimney.

Because of difficult site accessibility, all materials were airlifted to and from the light station via helicopter. Since helicopter services are very costly, staging had to be planned very carefully. A complete inventory of materials and equipment was required in advance to determine size and weight of the lifts. The proximity of the staging area to the lighthouse was also critical given the radius of the blades and the local wind conditions. No electrical, telephone, water, or sanitary facilities were available for use onsite. Basically, everything had to be brought in and out by the contractor. The lighthouse is 198 wooden steps down from the parking lot; the nearest town is located over 40 miles away, down one-lane roads following hairpin

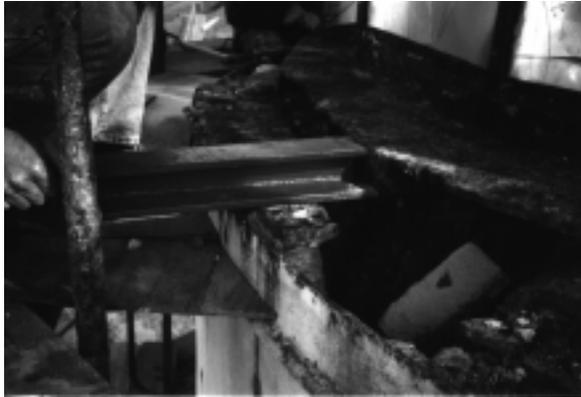
**Figure 49.** *Reconstructing the gallery deck.* After removing the existing concrete, remnants of the original cast-iron deck were found.

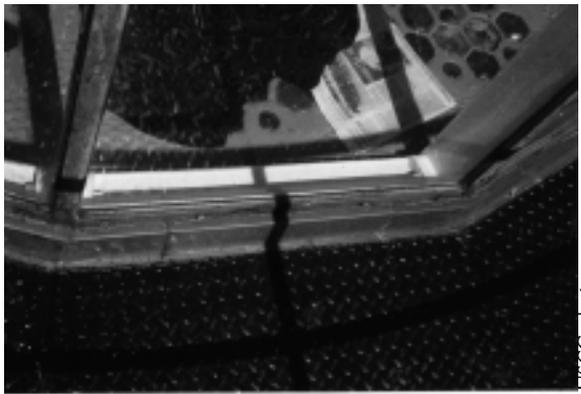
**Figure 51.** *Lantern galley deck after rehabilitation.* The new gallery deck was fabricated with stainless steel diamond plate and carefully flashed with copper at the lantern room. The interior lower sill channels were rebuilt to catch condensation from the glass.

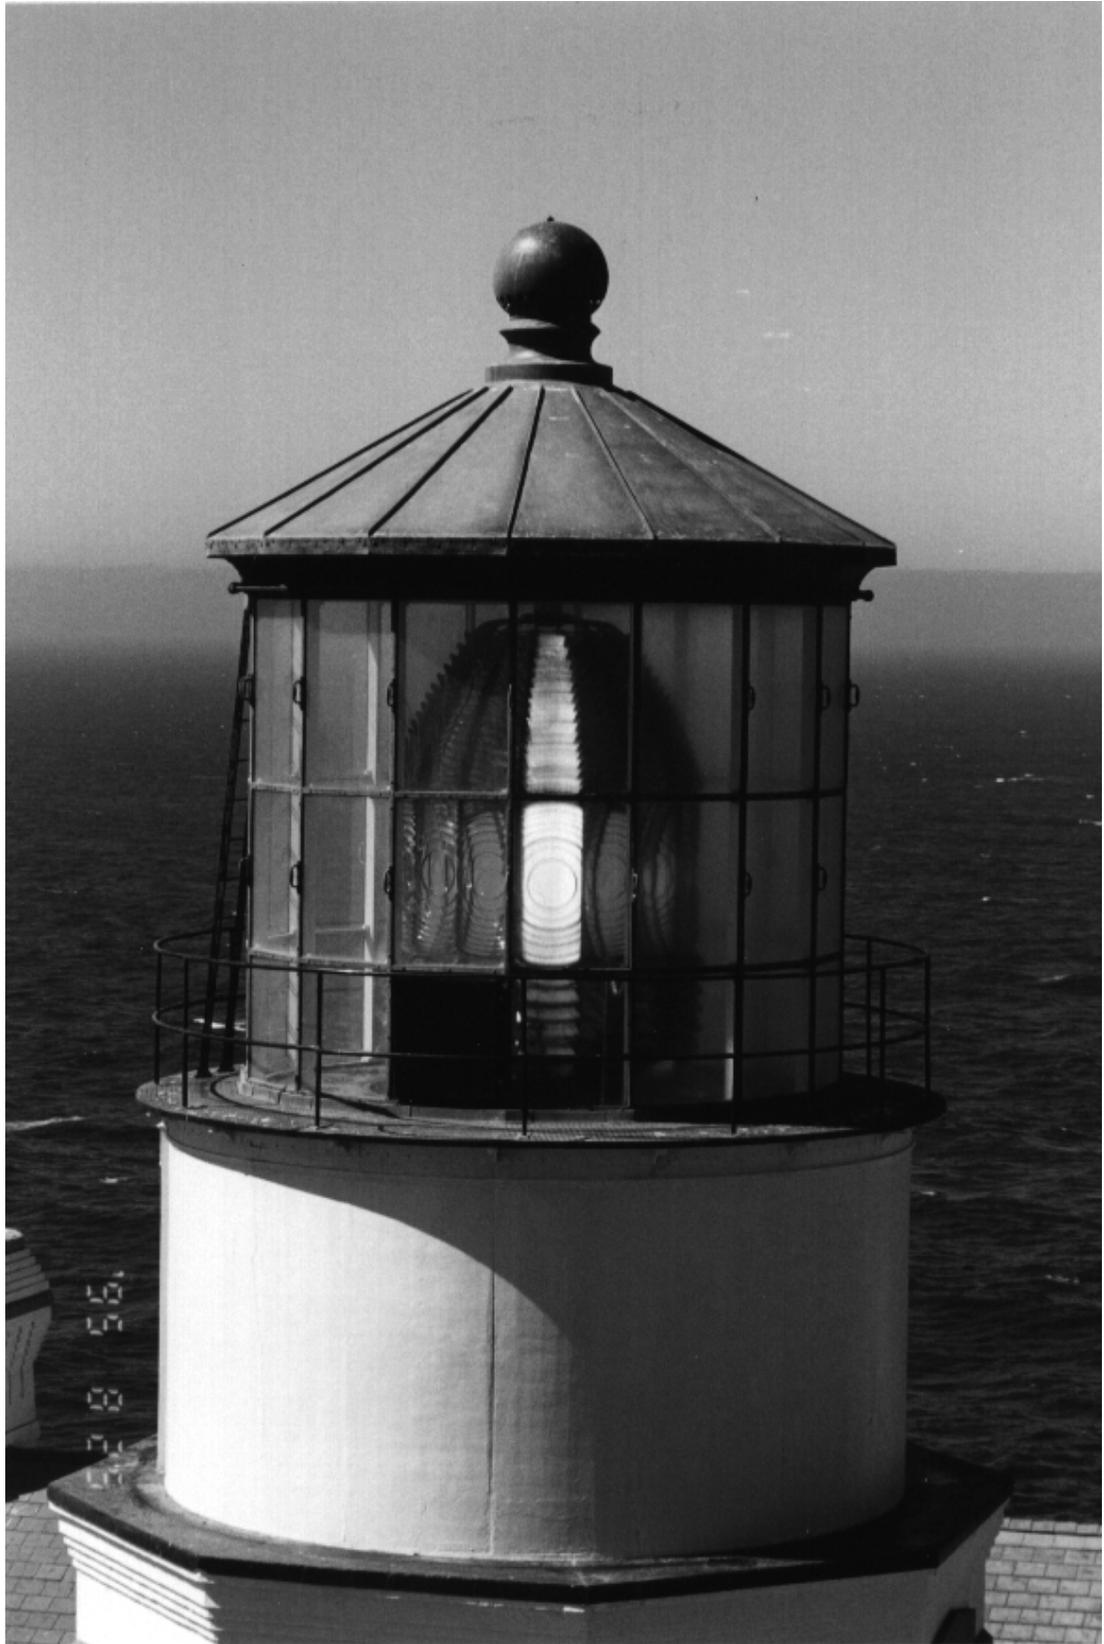
**Figure 52.** *Light tower lantern after rehabilitation.* The nonferrous metalwork at the lantern room is left unpainted and allowed to naturally patina, thus saving maintenance costs.

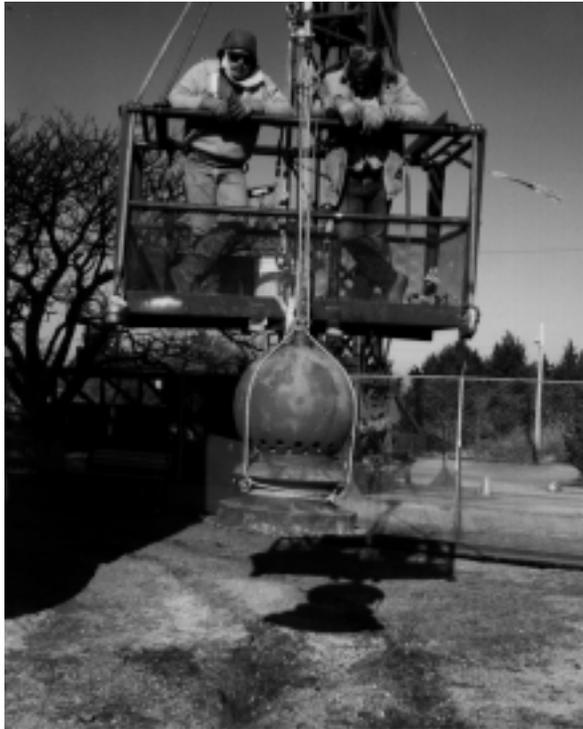
**Figure 4.** The first step in removing the roof was to take off the vent ball. The vent ball not only serves as a lightning rod but also provides ventilation to the glass in the lantern room, limiting condensation.

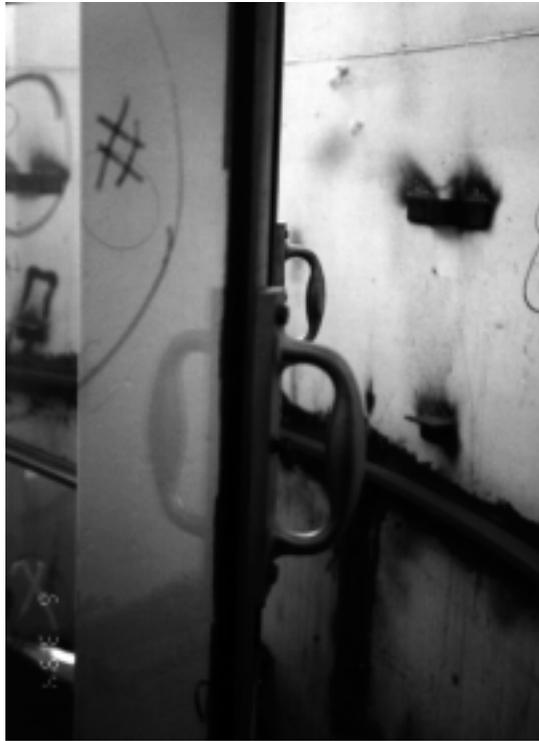
**Figure 8.** New hand holds were replicated to replace missing pieces. These exactly match the originals.

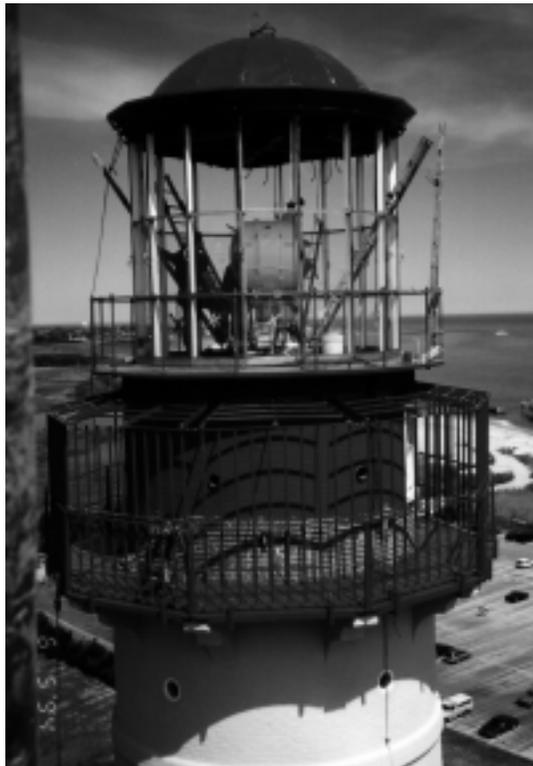
**Figure 9.** The refurbished roof is replaced on the lantern room. The fit is almost exact.

Meticulous preparations were made on the ground and in the air for the lift. The refurbished roof was centered as close as possible to the center line of the lighthouse and turned to allow for the proper fit in its original position. ICC's craftsmen were perched on ladders waiting for the roof to be hoisted. When all was ready, the signal was given and the lift began. The roof was centered above the window wall and began its descent. The result was anticlimactic. The roof came down exactly into position as if sucked in by a giant magnet. The major portion of the restoration was complete.

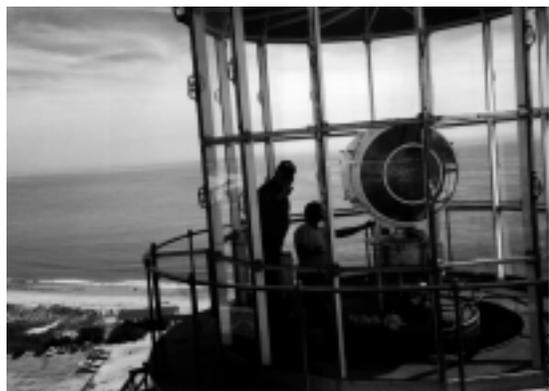
**Figure 10.** All glass is now in place and final preparations are made for the reopening.

New safety glass was installed on the window wall system, and the 'soup can' was no longer needed. A relatively calm wind would be required to remove the enclosure and set down the newly refurbished roof. On the June 4, 1994, conditions appeared favorable. The enclosure was lifted and, for the first time in five months, the efforts of the craftsmen were revealed. The newly lacquered bronze mullions, glazing bars, and sills gleamed in the bright early summer sun.

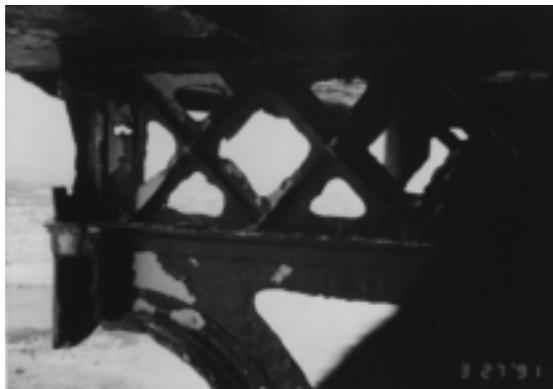
**Figure 12.** Some brackets were so deteriorated that they were totally exposed to the elements.

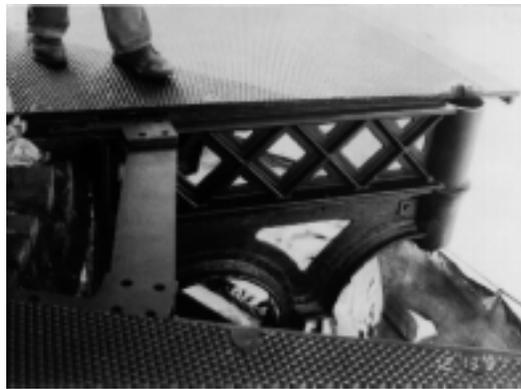
**Figure 13.** After the most severely deteriorated portion of the brackets were removed, new cast-iron pieces were made and installed; and new deck plates installed.

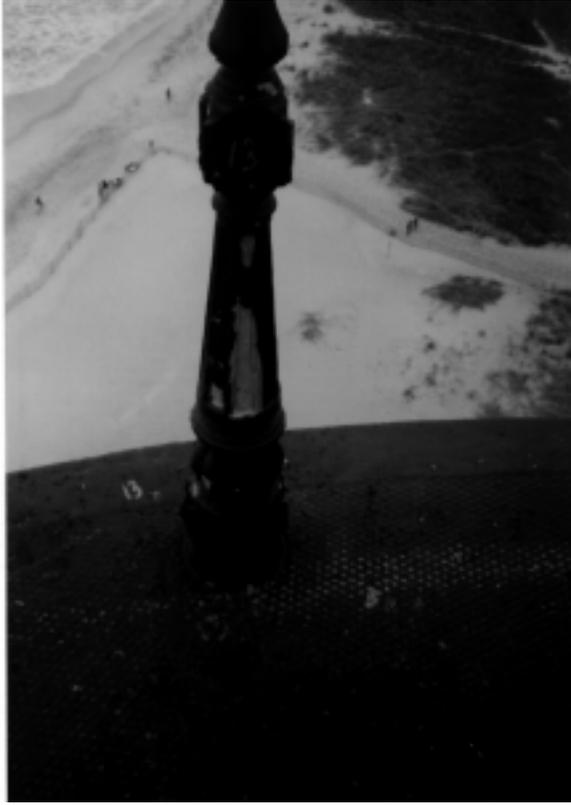
**Figure 14.** The handrail assembly has been removed and the ornate cast-iron post is ready for removal.

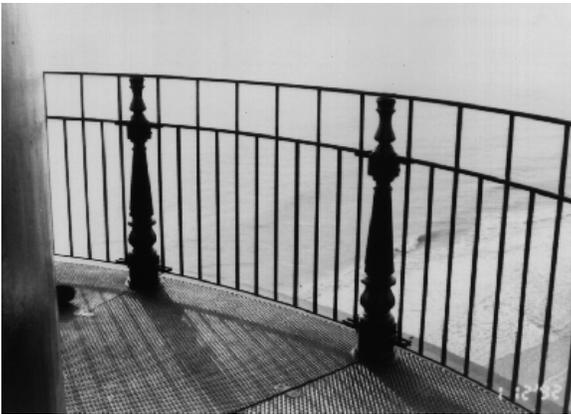
**Figure 15.** A replica handrail is installed.

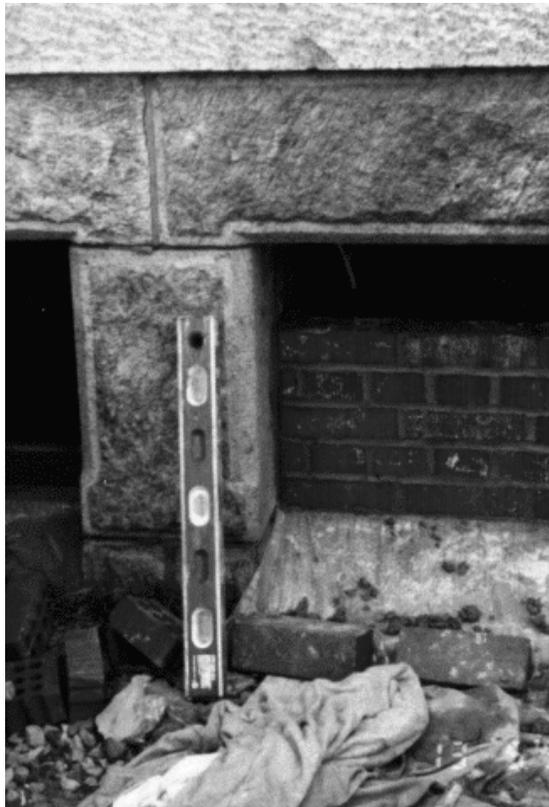
**Figure 12.** In preparation for the move, the cellar windows openings are temporarily bricked in to stabilize the masonry above the lift point.
