# Table of Contents

# Introduction

The *Historic Lighthouse Preservation Handbook* was created through a cooperative partnership between the National Park Service (NPS), U.S. Coast Guard (USCG), and the Department of Defense (DoD). The *Handbook* addresses preservation issues related to historic lighthouses with an emphasis on the maintenance problems associated with the many different materials and construction techniques used in these unique structures. **Historic Lighthouse Preservation** (Part IV) includes data gathered from condition assessments and historic significance evaluations at 21 light stations around the country as well as information from applicable NPS guidance, USCG files, and material generated by non-profit groups, museums, and architectural and engineering firms. **Beyond Basic Preservation** (Part V) includes case studies reflecting lighthouse rehabilitation and restoration projects as well as related activities.

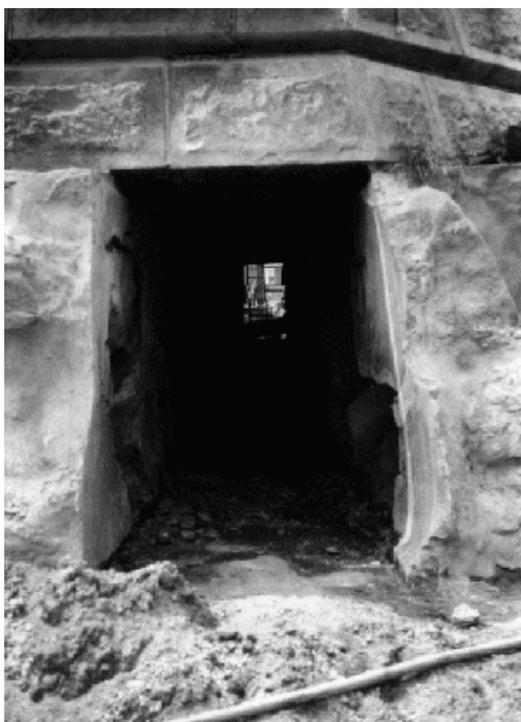
**Figure 16.** Close-up of the opening for the beam cut by the wire saw measuring 5 feet high by 3 feet, 6 inches wide. The depth of the cuts ranged from 18 inches to 16 feet for multiple wall cuts.

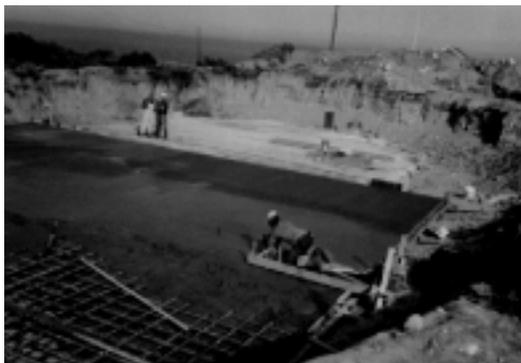
**Figure 17.** A foundation slab is being poured using 36 tons of rebar and 245 yards of concrete. This 18-inch-thick slab was designed to handle the dynamic load of the building travelling across the slab to its final position.

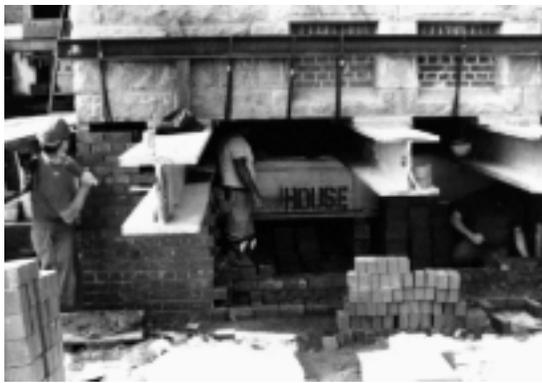
**Figure 22.** Construction of a new foundation around the support beams.

On August 24, 1993, Block Island Southeast Lighthouse reached its new home. It sat positioned with approximately 5 feet between the top of its new reinforced concrete slab foundation and the underside of remaining portions of its original masonry foundation. Solid brick was laid to fill the 5-foot gap (approximately 80,000 brick were required). Beams used to support the lighthouse during its journey were removed after brick was laid between the beams to carry the load. Wooden bracing and other temporary measures were removed; porches were installed; grading, landscaping, and final cleanup tasks completed. Once again, the Block Island Southeast Lighthouse rests a safe distance from the edge of Mohegan Bluffs, still facing in its original direction.

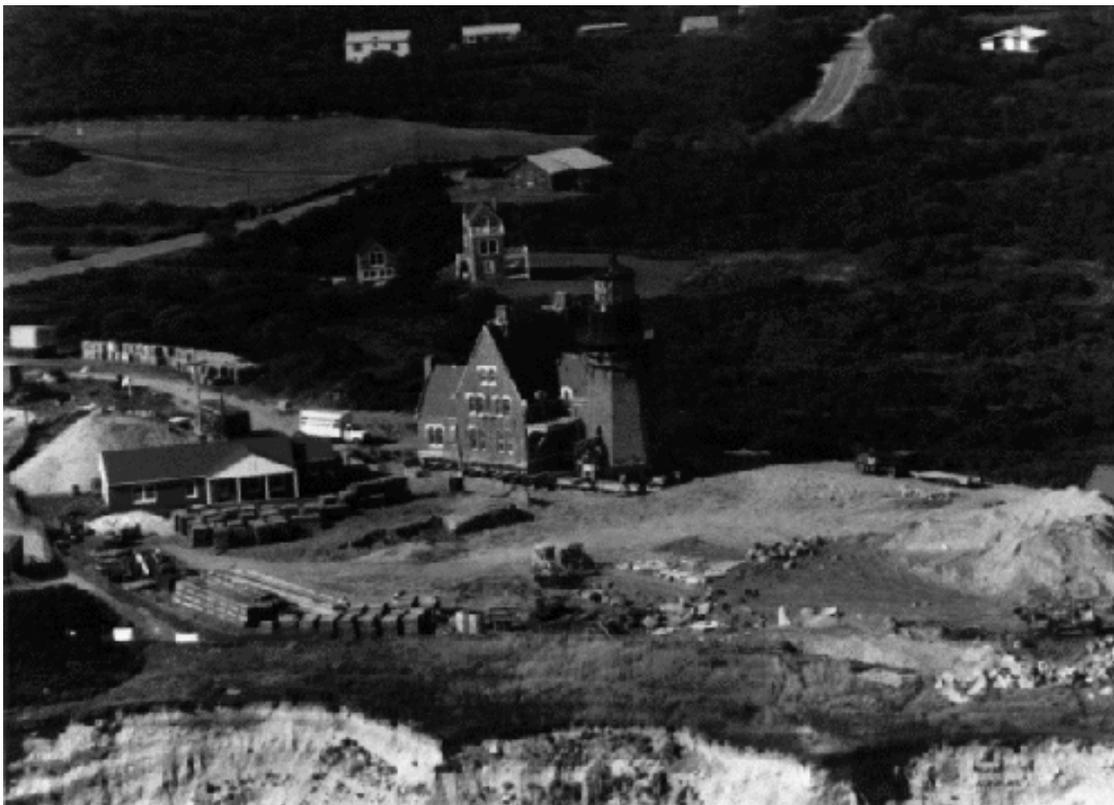
**Figure 23.** On August 23, 1993, the Block Island Southeast Light Station reached its new home.

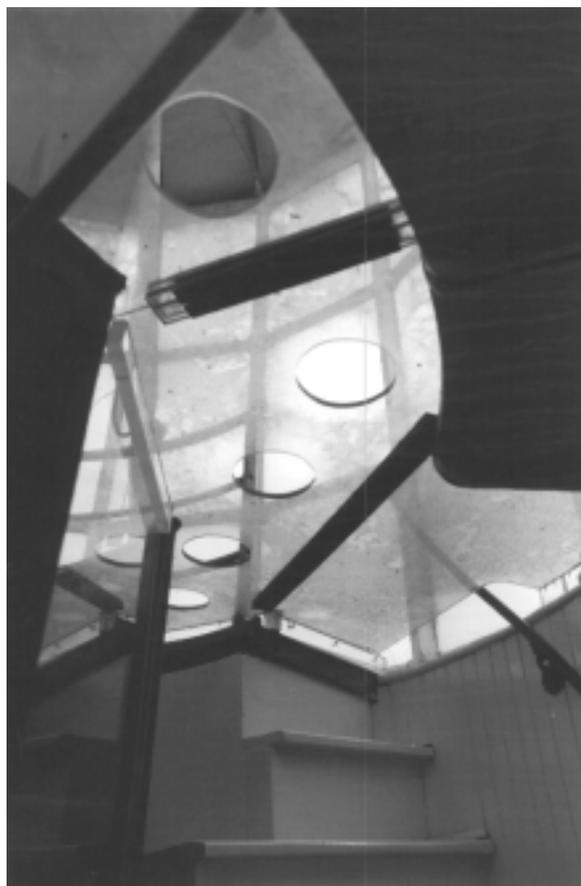
**Figure 24.** Visitors are prohibited from the Barnegat Lighthouse's lantern room; however, they can view it from the watch room through plexiglas sheets. While these protective sheets prevent access to the lantern room, they do collect dust and need periodic cleaning. In other lighthouses, a person is stationed in the watch room to prohibit access to the lantern room as well as control visitor behavior.

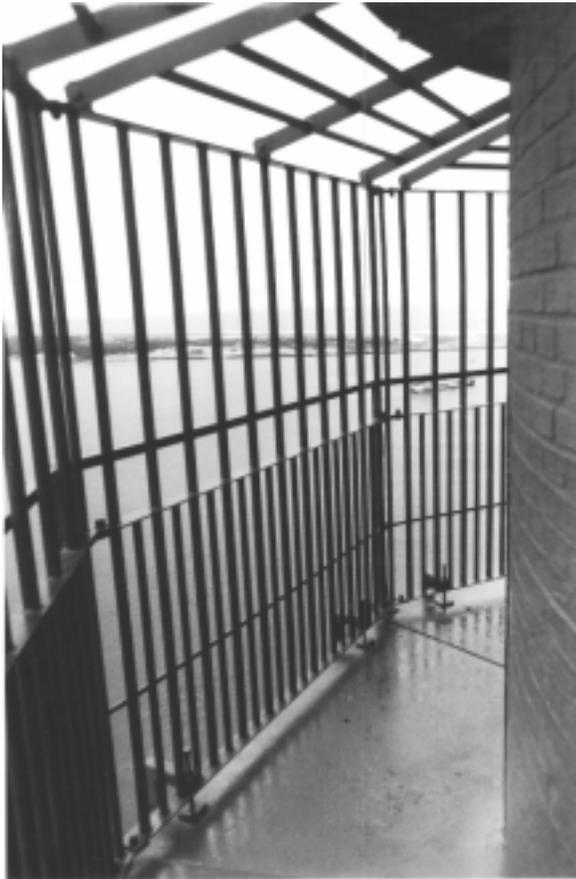
**Figure 25.** To protect visitors from falling or jumping from a lighthouse tower, a safety railing system or ‘cage’ is often built around the gallery decks. The cage at Barnegat Lighthouse was designed so that it has minimal impact on the historic structure and can be removed with little, if any, damage to the original fabric. Note that the cage is also enclosed to prevent climbing over the top.

method used by many lighthouse groups is to build a metal cage that fits around the gallery deck. The maximum space between pickets should be no more than four inches (BOCA, Building Officials & Code Administrators, International). The pickets need to completely extend to a structural element above or bend back to the tower/lantern wall so no one, even if deliberately climbing, could get over the top. One lighthouse suicide in 1995 was accomplished by climbing between overhead cage pickets with 9-inch spacing. Cages can be designed so they are attached reversibly to light towers without doing any permanent damage to the historic fabric of the structure.

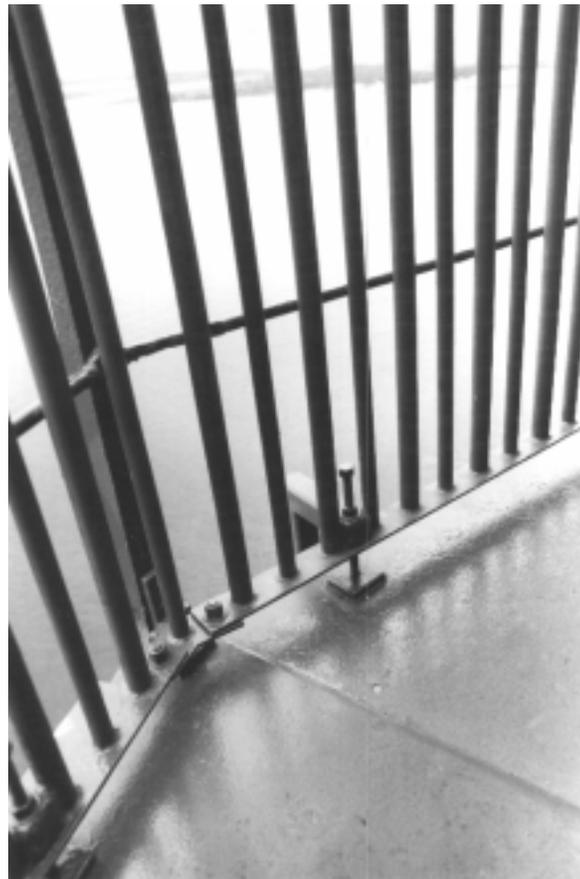
**Figure 26.** Note how the cage is clamped to the gallery deck, minimizing any impact on the structure's original fabric.
